**CHAINAGE 2500-2586,
CITY WALLS,
YORK**

**REPORT ON AN
ARCHAEOLOGICAL
WATCHING BRIEF**

**2000 FIELD REPORT
NUMBER 23**

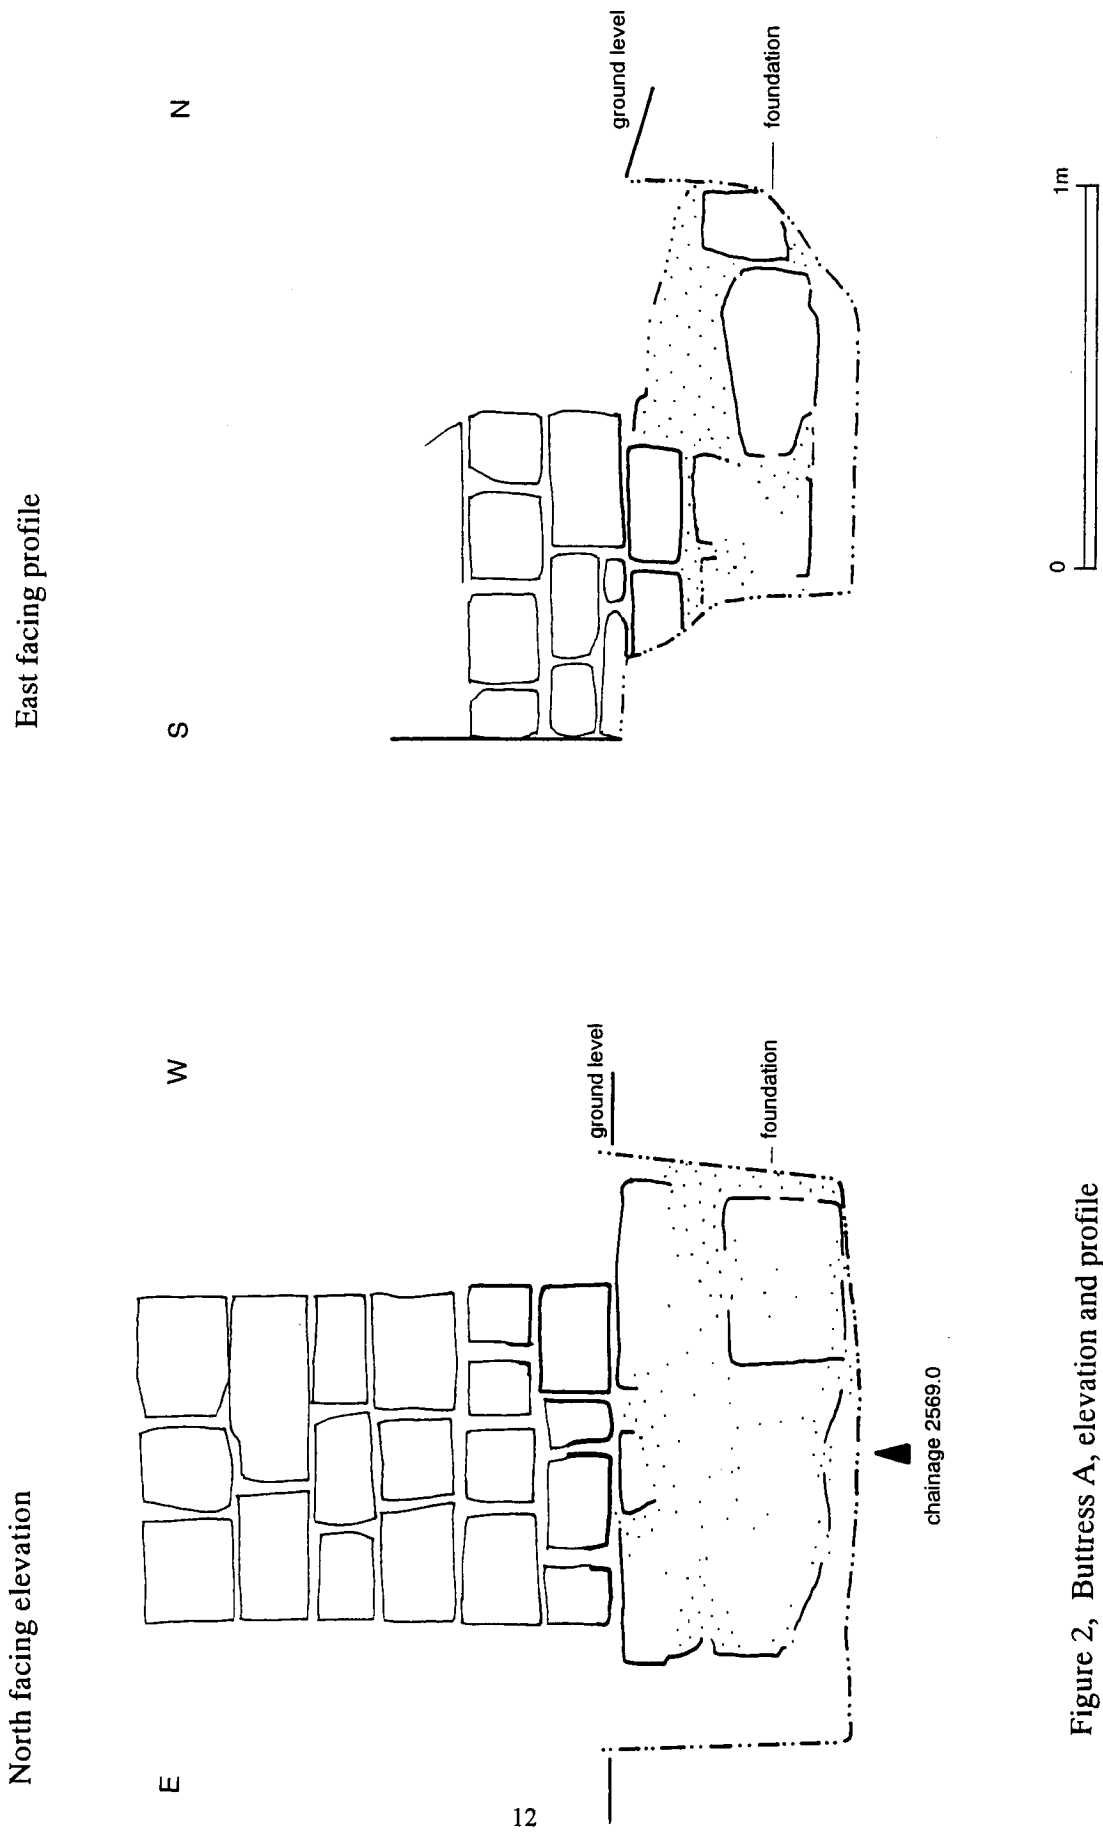
Figure 2, Buttress A, elevation and profile

5.1.1 Buttress A (chainage 2569) (Figure 2)

The foundations of Buttress A measured in excess of 1.30m (east – west) by in excess of 1.40m (north – south) and had a depth of up to 0.61m. The foundation material comprised undressed blocks and fragments of magnesian limestone, many of which were of irregular shape. The largest of these was 0.70m x 0.23m, the smallest some 0.07m x 0.05m. None of this material showed any indication of coursing whatsoever. Copious amounts of mortar had been used to bond the stonework together. This mortar was a weak, buff to cream coloured lime mortar containing small fragments of limestone and grit up to 3mm as aggregate. By contrast, the mortar employed in the buttress itself was slightly paler in colour and considerably harder. It was noted that the buttress did not sit centrally on the foundation but somewhat to the east of centre. It is uncertain if this mis-location of the buttress together with the observed variations in mortar indicate differences in date of construction of both extant buttress and foundation.

The underpinning of this buttress entailed the removal of all of the old foundation material within the trench to within approximately 0.40m of the curtain wall. This void was then filled with concrete.

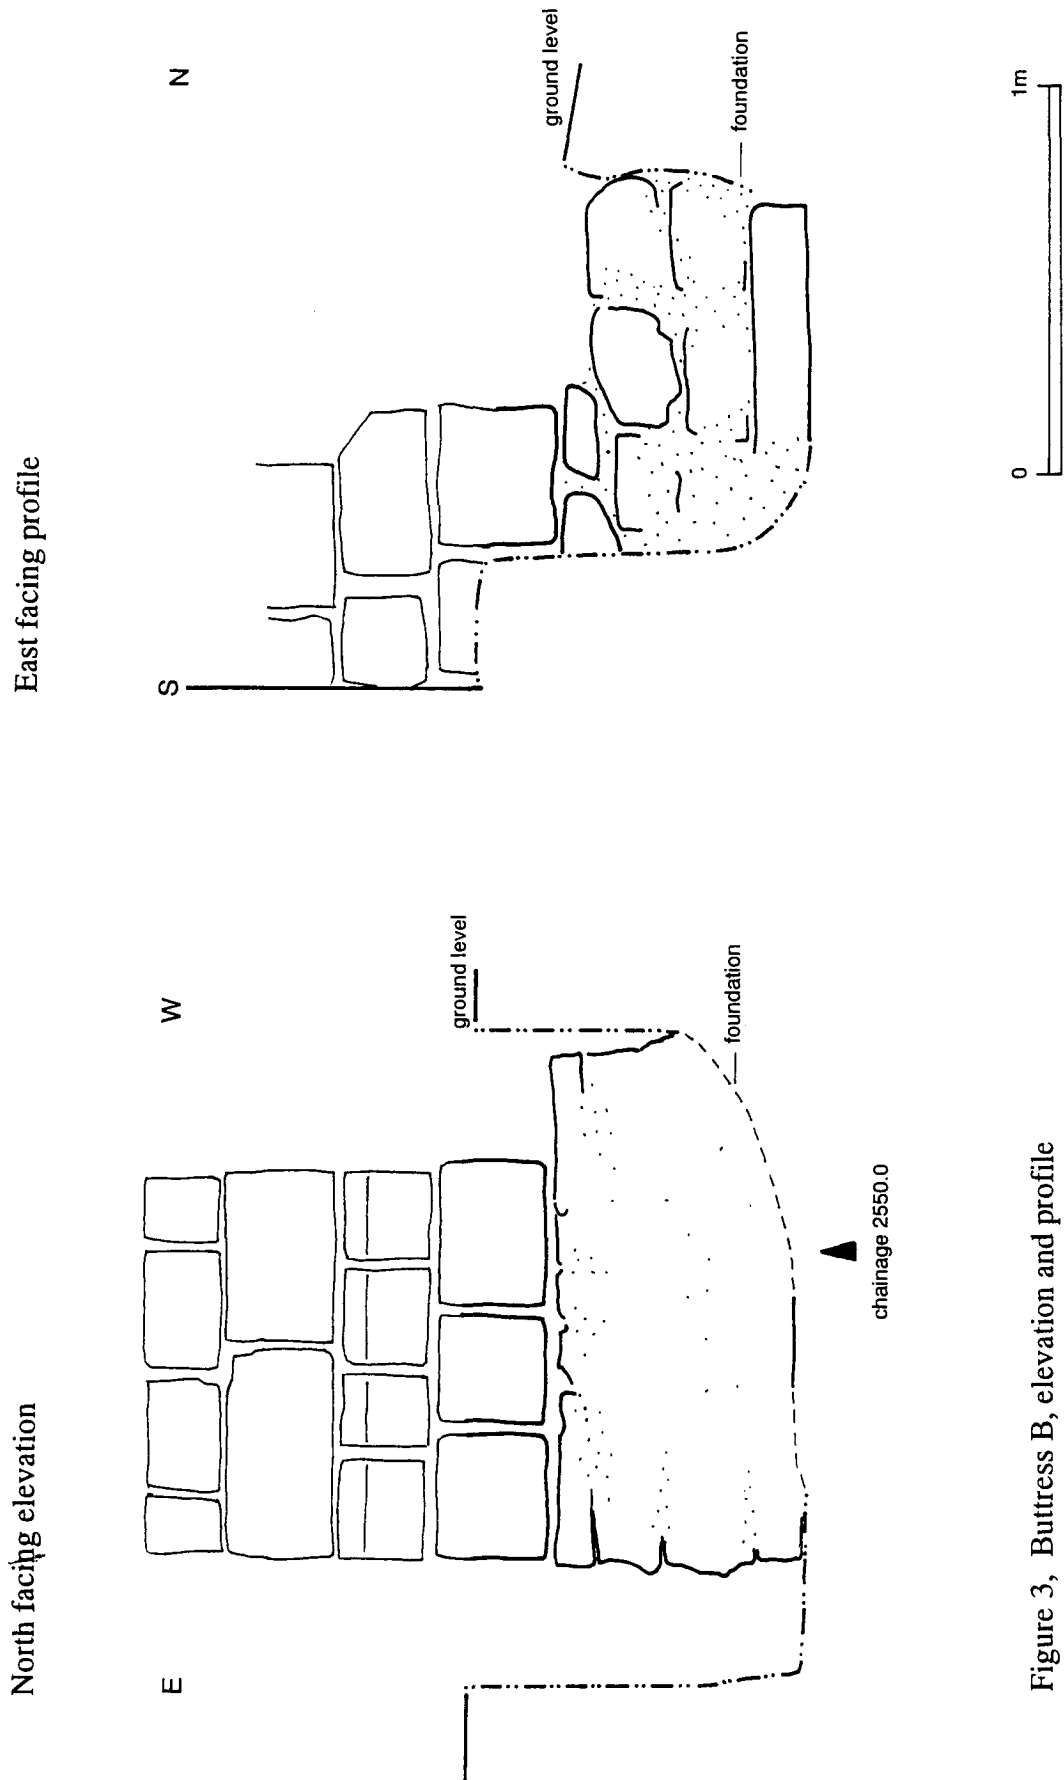
Figure 3, Buttress B, elevation and profile

5.1.2 Buttress B (chainage 2550) (Figure 3)

The foundations of buttress B measured in excess of 1.40m (east – west) by in excess of 1.34m (north – south) and had a depth of approximately 0.68m. The stonework of the foundation was of undressed blocks of magnesian limestone, most of these tending to be either sub-rectangular or sub-square. These ranged in size from 0.10m x 0.05m to 0.44m x 0.32m, with a particularly large flat block or slab forming the lowest south-eastern corner of the foundation. It was noted that the stonework within the foundations was coursed, albeit somewhat crudely and copiously bonded with hard, cream coloured lime mortar. At least two fairly large pieces of tile, laid horizontally, were mortared within the stonework. As with Buttress A, Buttress B did not sit squarely on the foundation, but was fairly hard against the eastern edge. Again it is uncertain if this relates to a lack of contemporaneity between the buttress and its foundation. The mortar of the foundation was so hard that removal of part of the foundation proved difficult. On the basis of this it was surmised

that full underpinning would not be necessary and so those few parts of the foundation removed were simply replaced with concrete.

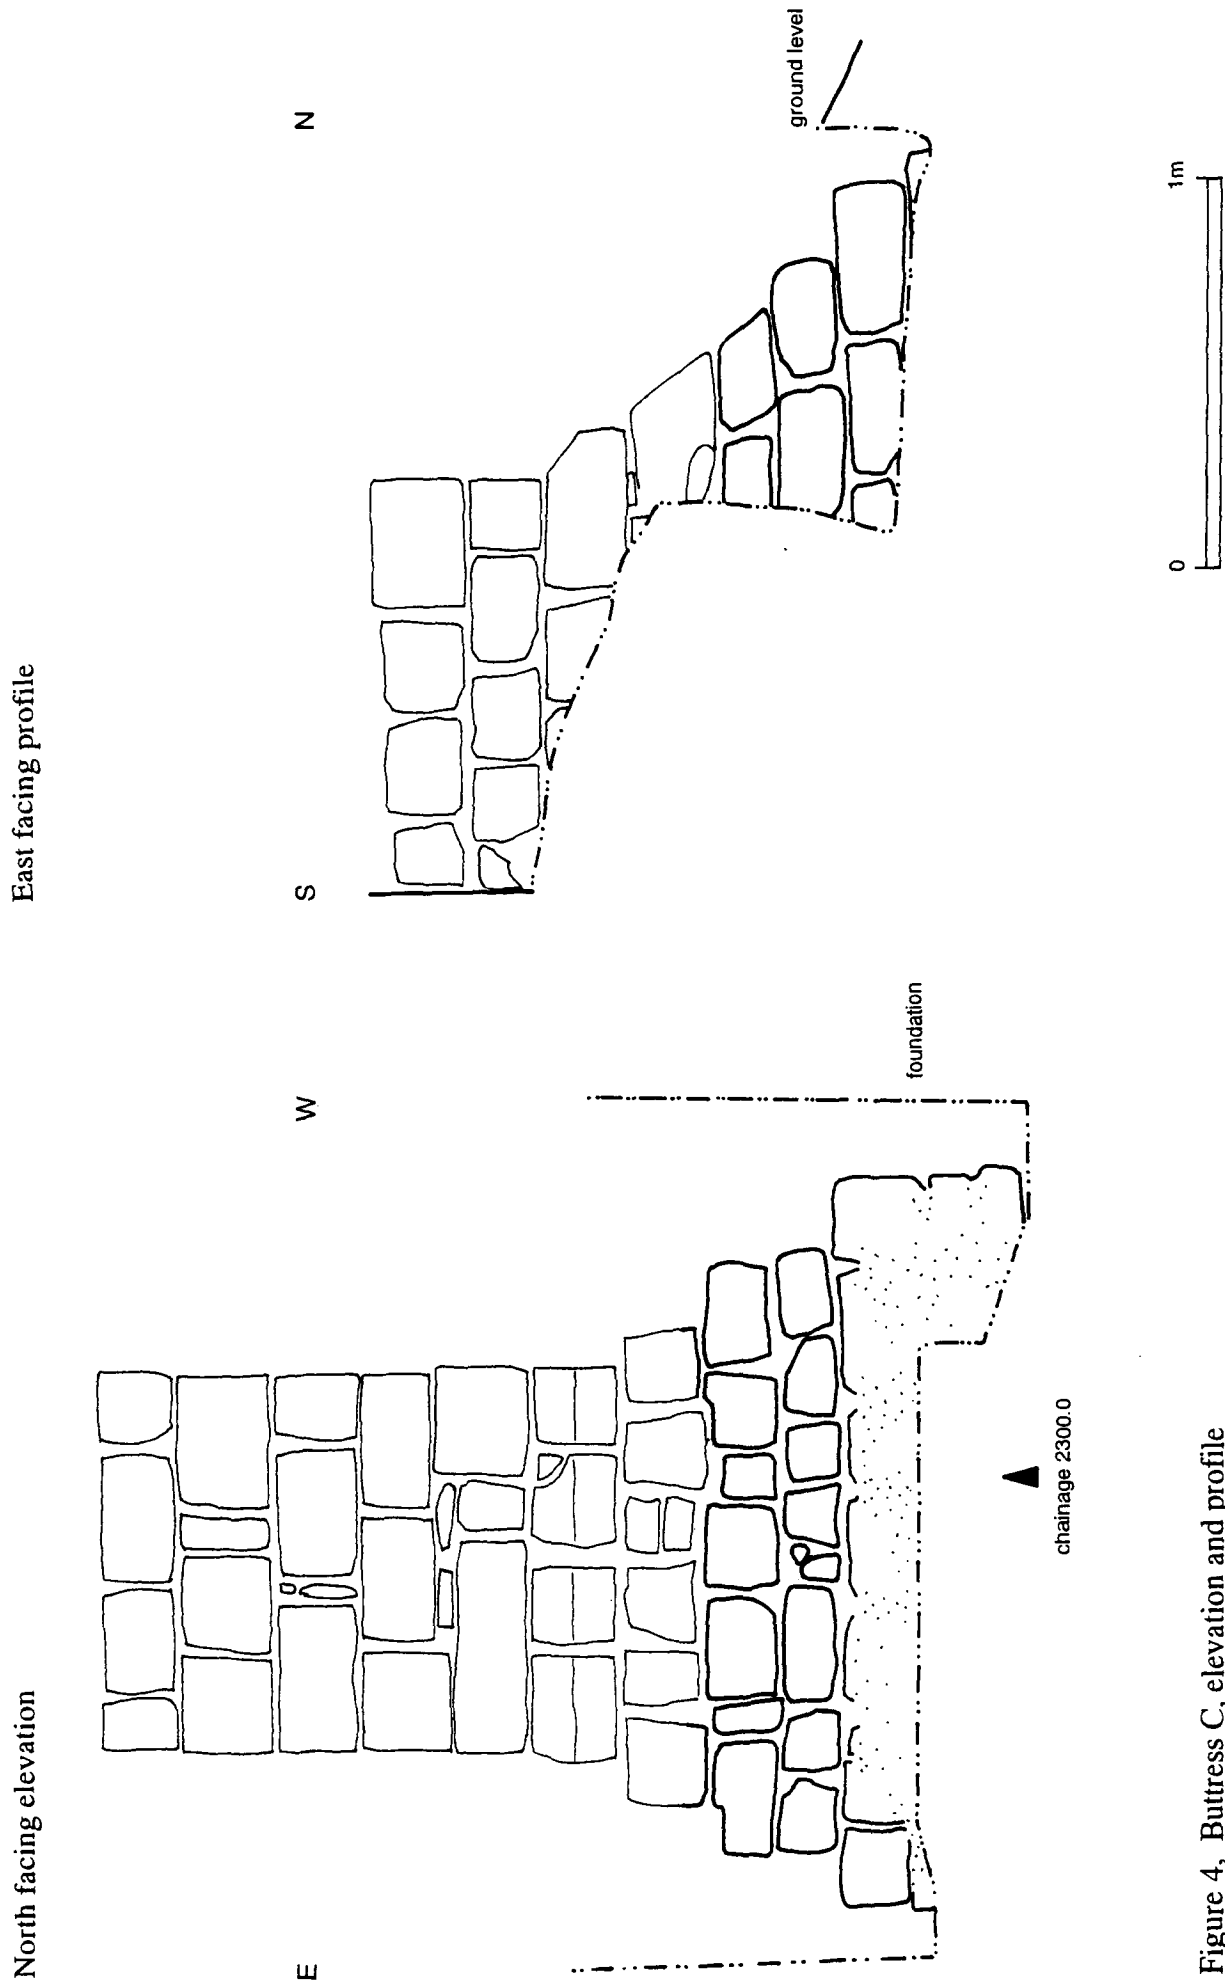
Figure 4, Butress C, elevation and profile

5.1.3 Buttress C (chainage 2300) (Figure 4) The lower parts of Buttress C differed from those of A and B in so far as the lower three courses of C widen towards its point of juncture with the foundation. When viewed from the front this widening has a stepped appearance though viewed from the side the profile is that of a chamfer. The foundation itself measured 2.01m (east – west) by in excess of 1.90m (north –south) and was at least 0.52m deep. All stone used in the foundation was of undressed, but roughly squared, blocks of magnesian limestone mostly of a size 0.20m – 0.40m. This stonework was coursed and bonded with large amounts of a hard, cream coloured lime mortar. The buttress was noted as sitting fairly centrally upon the foundation. Two fragments of brick/tile, at least one of which is of Roman date, were recovered from the interface between the base of the foundation and the rampart material. As with Buttress B, the foundation of Buttress C was, after removal of a small part of it, considered stable. Consequently, only that small part removed was replaced with concrete.

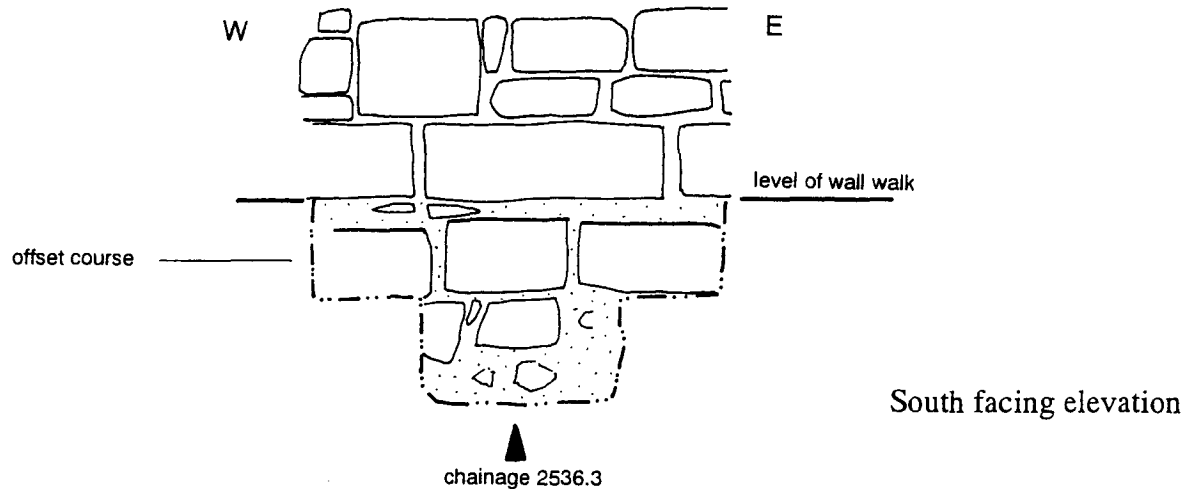
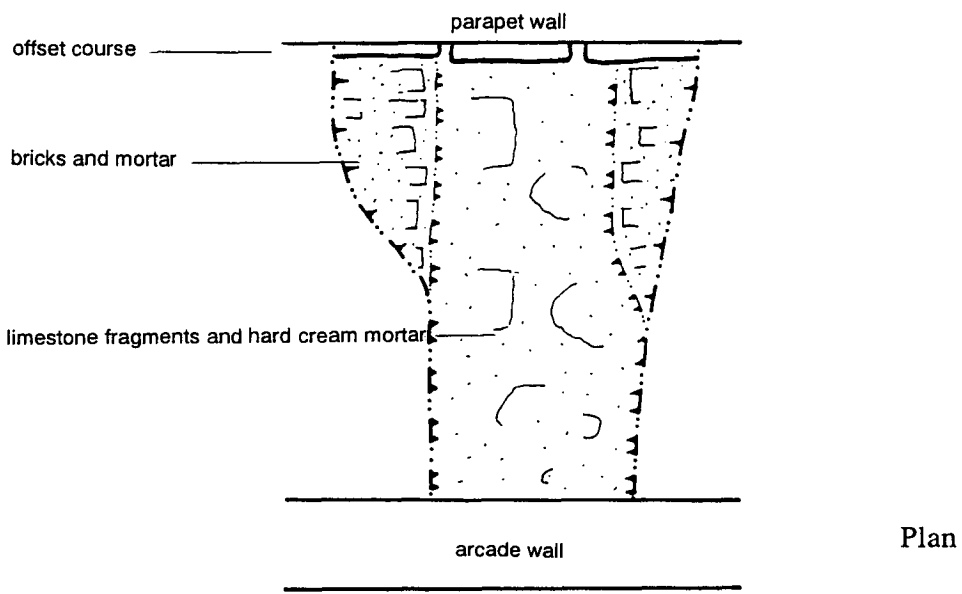
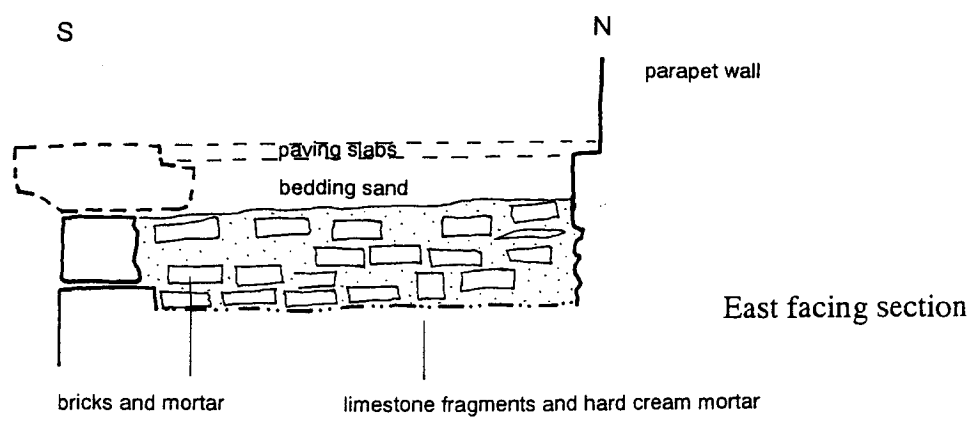
Figure 5, Elevation, plan and section, tie-hole 9

Works likely to be attributable to the 19th century were apparent in a number of places. Within tie-holes 8, 9, 10 and 11 a deposit of roughly coursed bricks, up to five courses deep and copiously bonded with large amounts of pale grey-cream lime mortar was noted beneath the bedding sand. (This material in turn lay directly over mortar and rubble that was probably contemporary with the construction of the arcading). Deposits within tie-holes 12, 13 and 14 proved to be comprised of extremely loose rubble, mostly fragments of limestone, some cobbles and a few fragments of brick. All were bonded with very weak lime mortar in which numerous, and often very large, voids were present. So loose was this material that it proved necessary to excavate large, deep holes and backfill them with concrete before the process of tying in could be carried out. Within tie-holes 18, 19 and 20 further loose deposits were encountered though in this instance they were much less rubbly and void free. These were essentially comprised of smaller sized limestone rubble with lesser quantities of brick fragments in a matrix of mortar rich sand of dirty appearance. Although the full depth of most of these putative 19th century deposits was not reached within the tie-holes it will be noted that they occur exclusively within the western part of chainage 2500 – 2586. It has been noted in 4.3.2 above that on stylistic and construction material grounds the arcades and intervening wall-walk supporting walls east of the eight westernmost identical arches (with the possible exception of the two at the extreme west) appear to be of late date; some probably 19th century. The evidence from the sub wall-walk deposits lends considerable weight to this notion of extensive 19th century renovation.

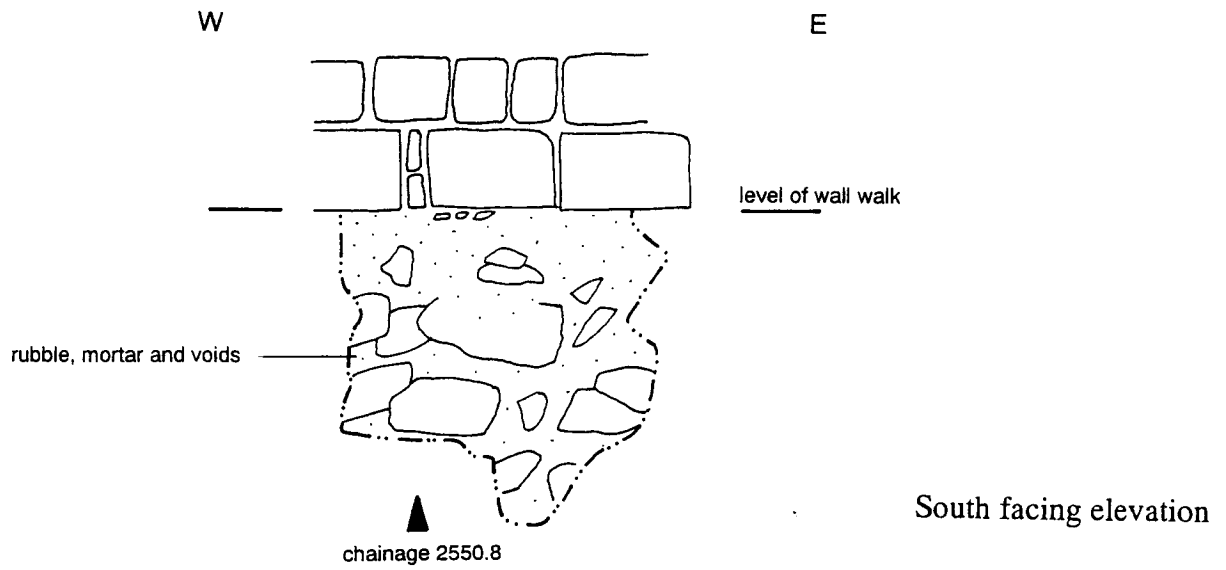
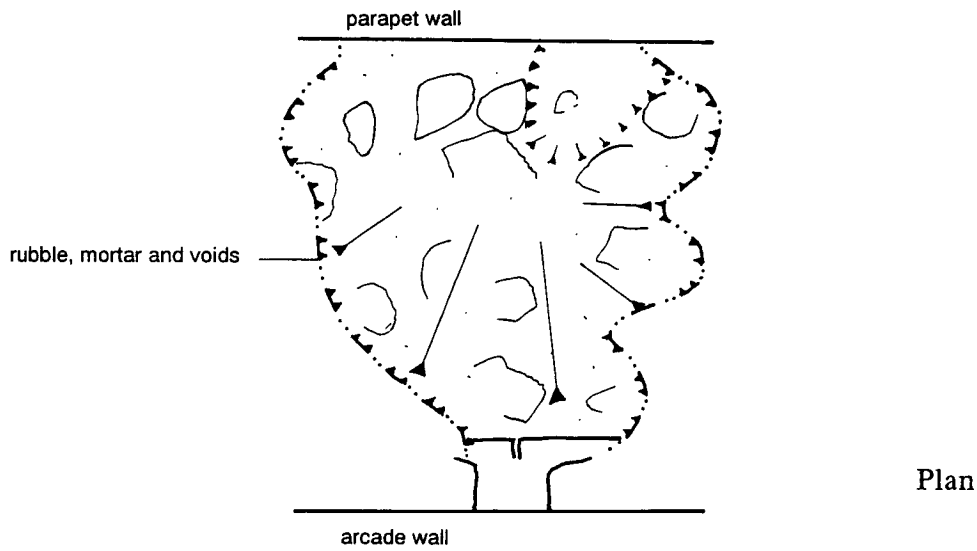
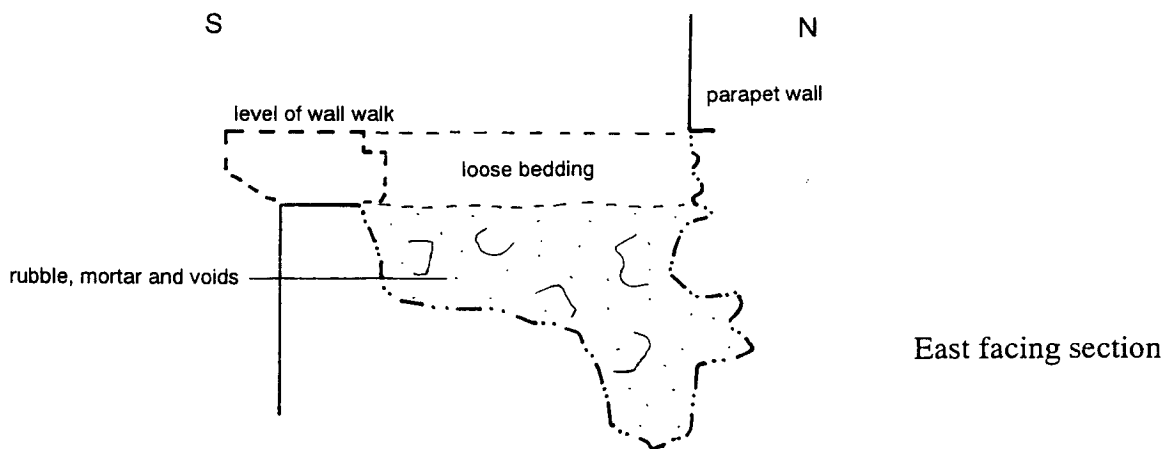
Figure 6, Elevation, plan and section, tie-hole 13

5.2 Wall walk (Figures 5, 6 and 7: tie-holes 9, 13 and 11)

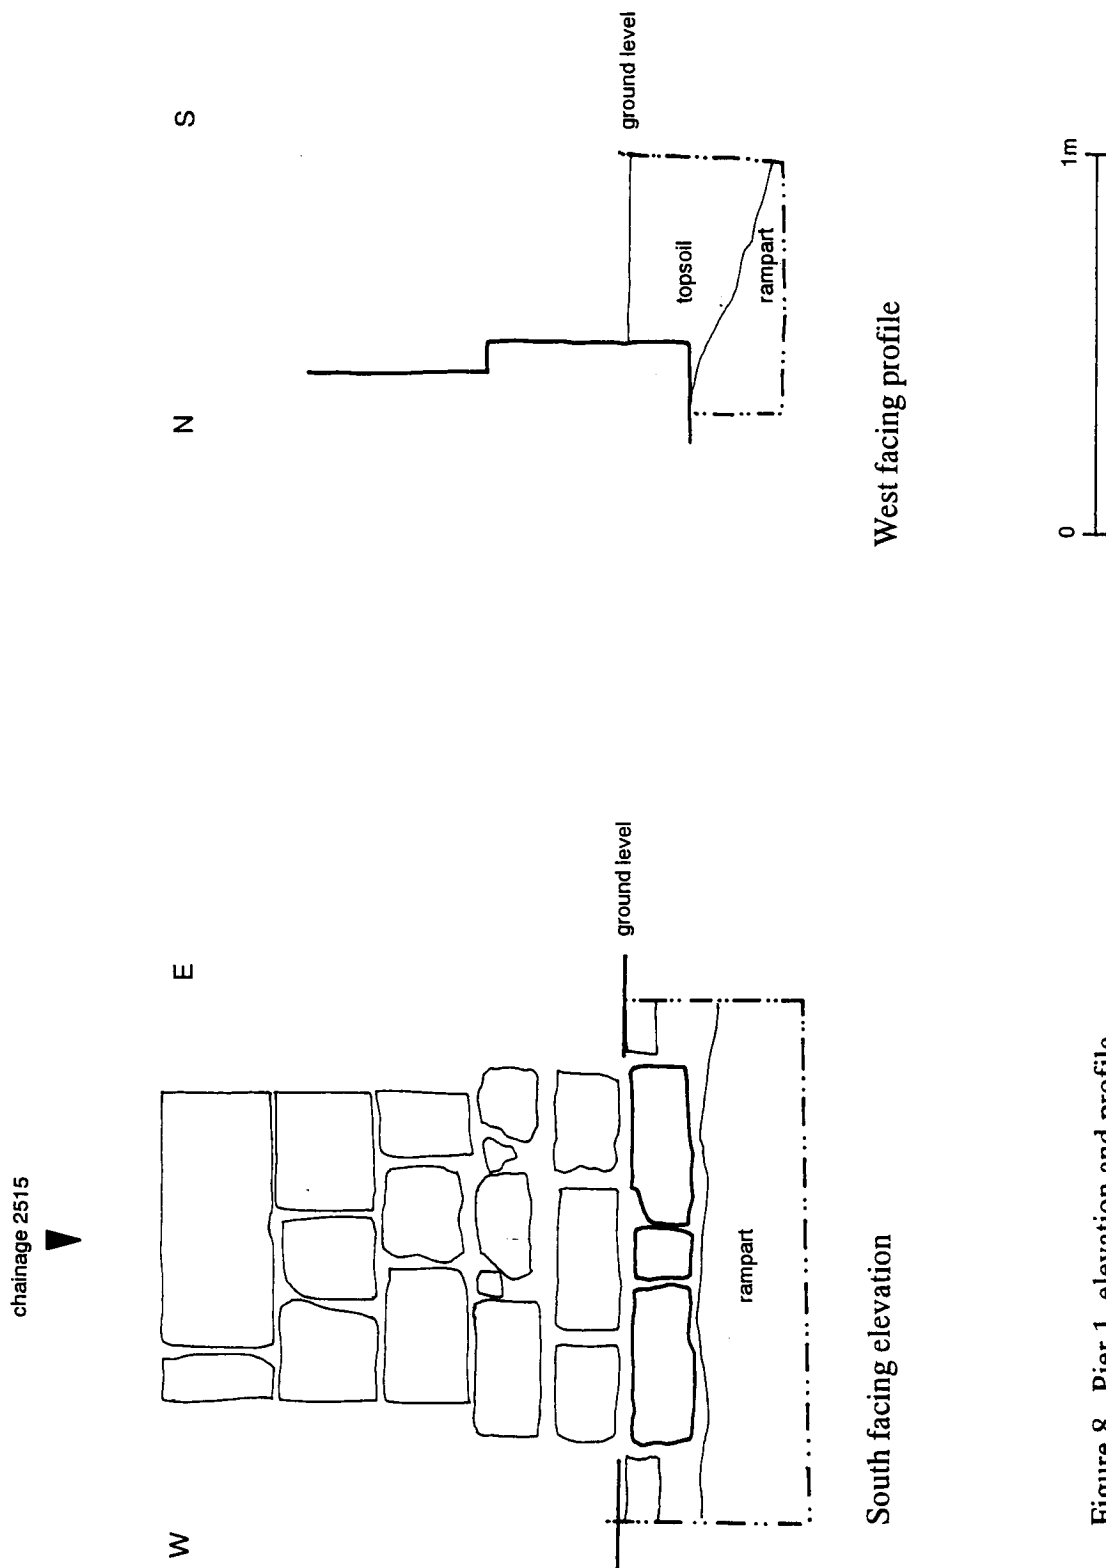
Figure 8, Pier 1, elevation and profile

5.3.1 Pier 1 (chainage 2515) (Figure 8) Only a single course of pier blockwork, bonded with hard, cream coloured lime mortar, was present below existing ground level. This blockwork did not extend beyond the limits of the pier blockwork which lay above. As such, this additional course of stone formed part of the pier itself rather than part of a foundation. Not only was no foundation present, it was also noted that the southern side of the pier only just sat on top of the rampart material. It is possible that the pier originally sat at a greater depth within the rampart and that subsequent truncation has removed much of this.

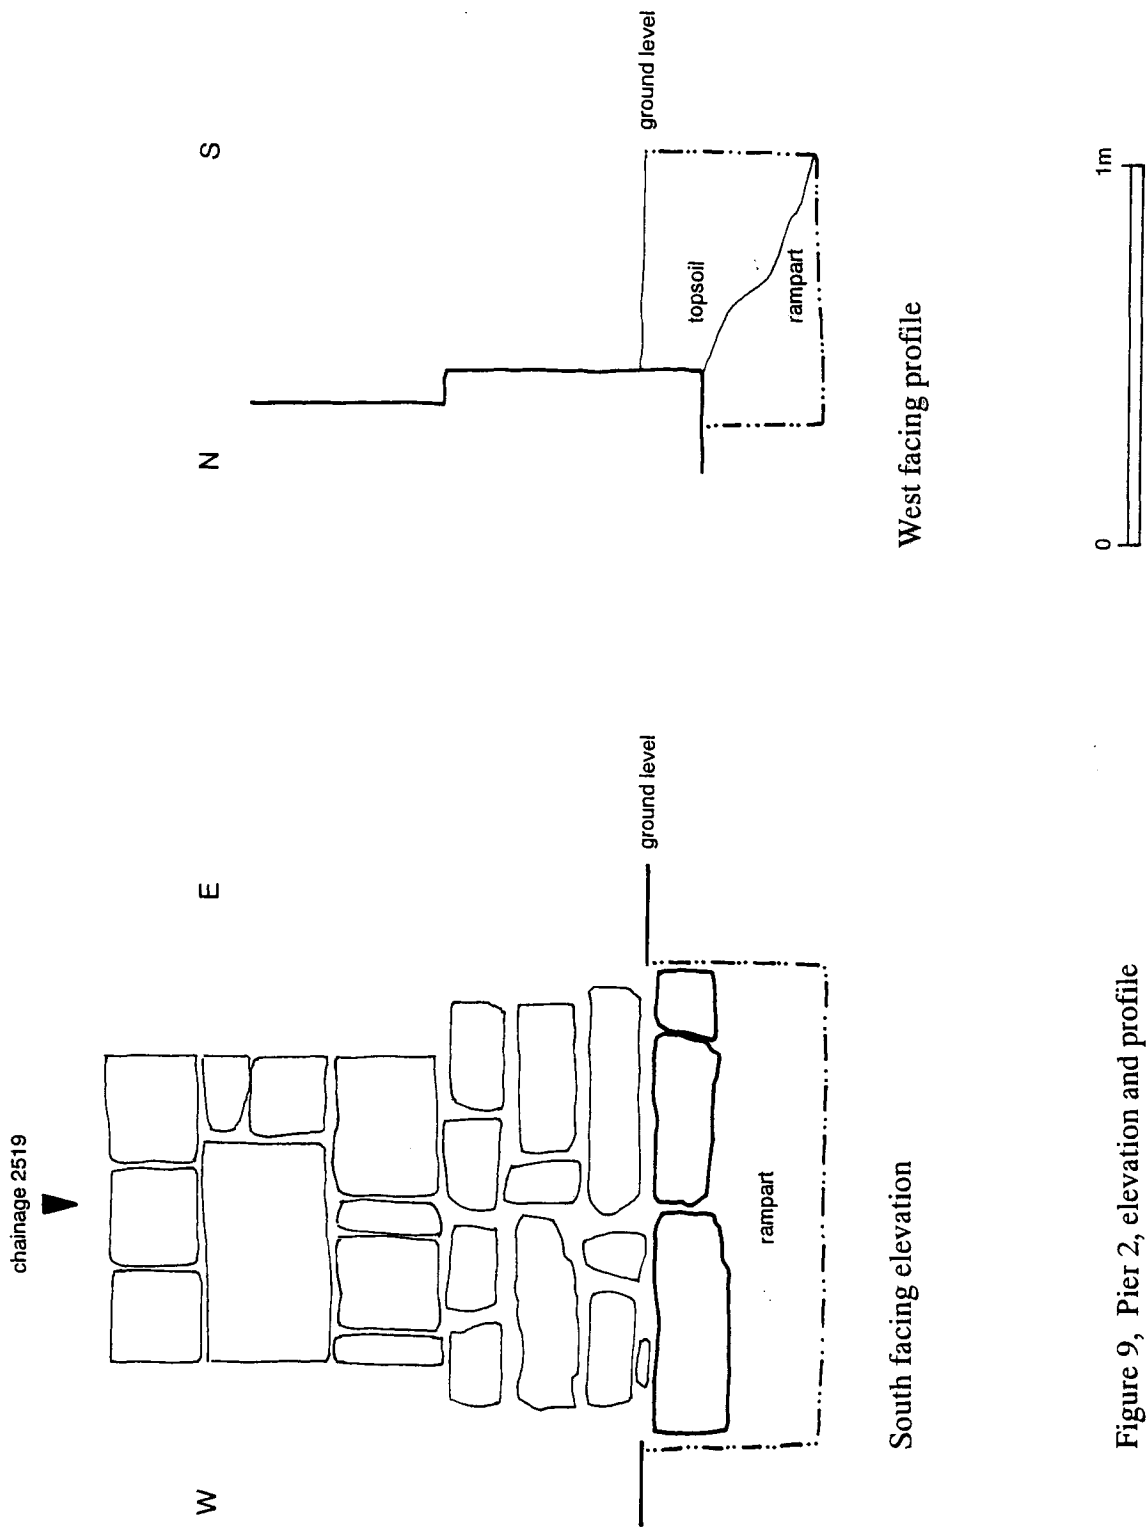
Figure 9, Pier 2, elevation and profile

5.3.2 Pier 2 (chainage 2519) (Figure 9) Again, only a single course of stonework was present below ground level; likewise bonded with hard, cream coloured lime mortar. In this instance however the stonework did extend beyond the side limits of the overlying stonework, though it did not project out to the front. In this sense, this additional course can be argued to represent a foundation. As with pier 1, the southern side of the pier only just sat on the rampart material.

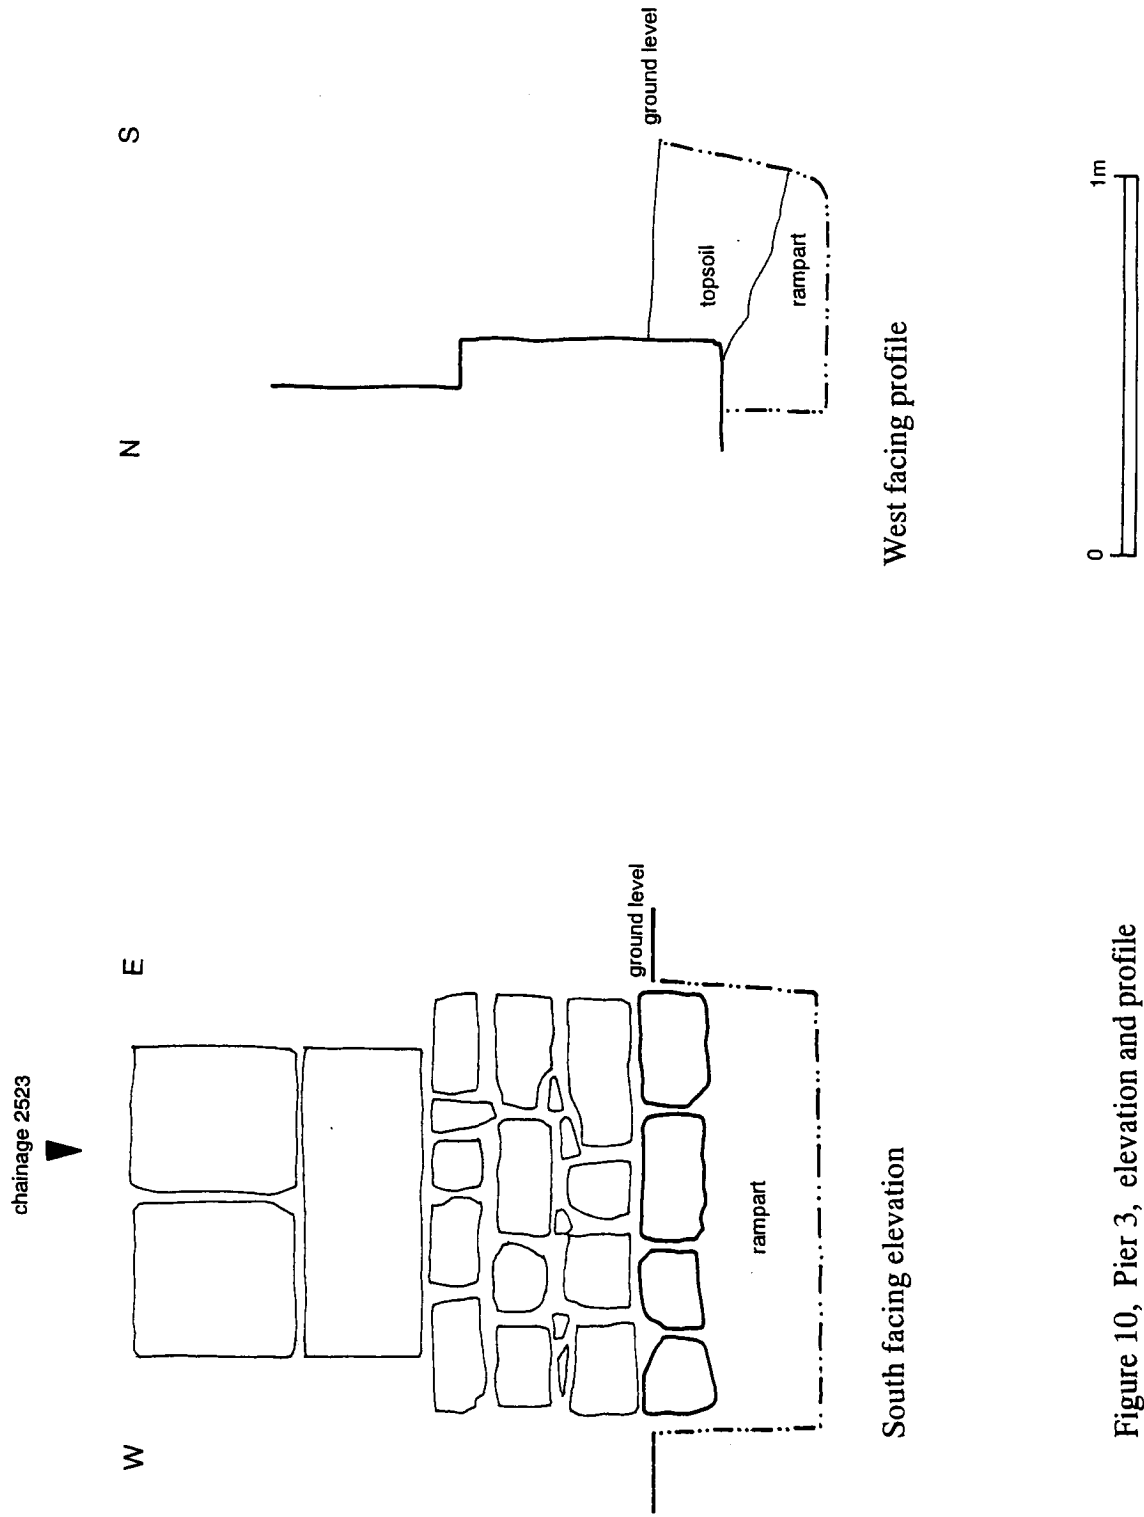
Figure 10, Pier 3, elevation and profile

5.3.3 Pier 3 (chainage 2523) (Figure 10) Only a single course of below ground stonework bonded with hard, cream coloured lime mortar was present below the remainder of this pier, which again barely sat atop the rampart material on its southern side.

The lack of anything resembling foundations of substance was particularly marked in all three piers. It is uncertain if these are representative of the remaining piers, most of which are likely to be contemporary. This lack of foundations is largely at variance with the buttresses on the exterior of the wall. It was noted above that the southern sides of the piers only just sit on top of the reddish brown rampart material. One might have expected the piers to be more fully embedded within the rampart. This observation raises the question of whether or not this may once have been the case and that the upper part of the rampart has subsequently been truncated.
