ARCHAEOLOGICAL
TRUST

**YORK CITY WALLS,
CHAINAGE 3000-3100**

**REPORT ON AN
ARCHAEOLOGICAL
WATCHING BRIEF**

**1998 FIELD REPORT
NUMBER 45**

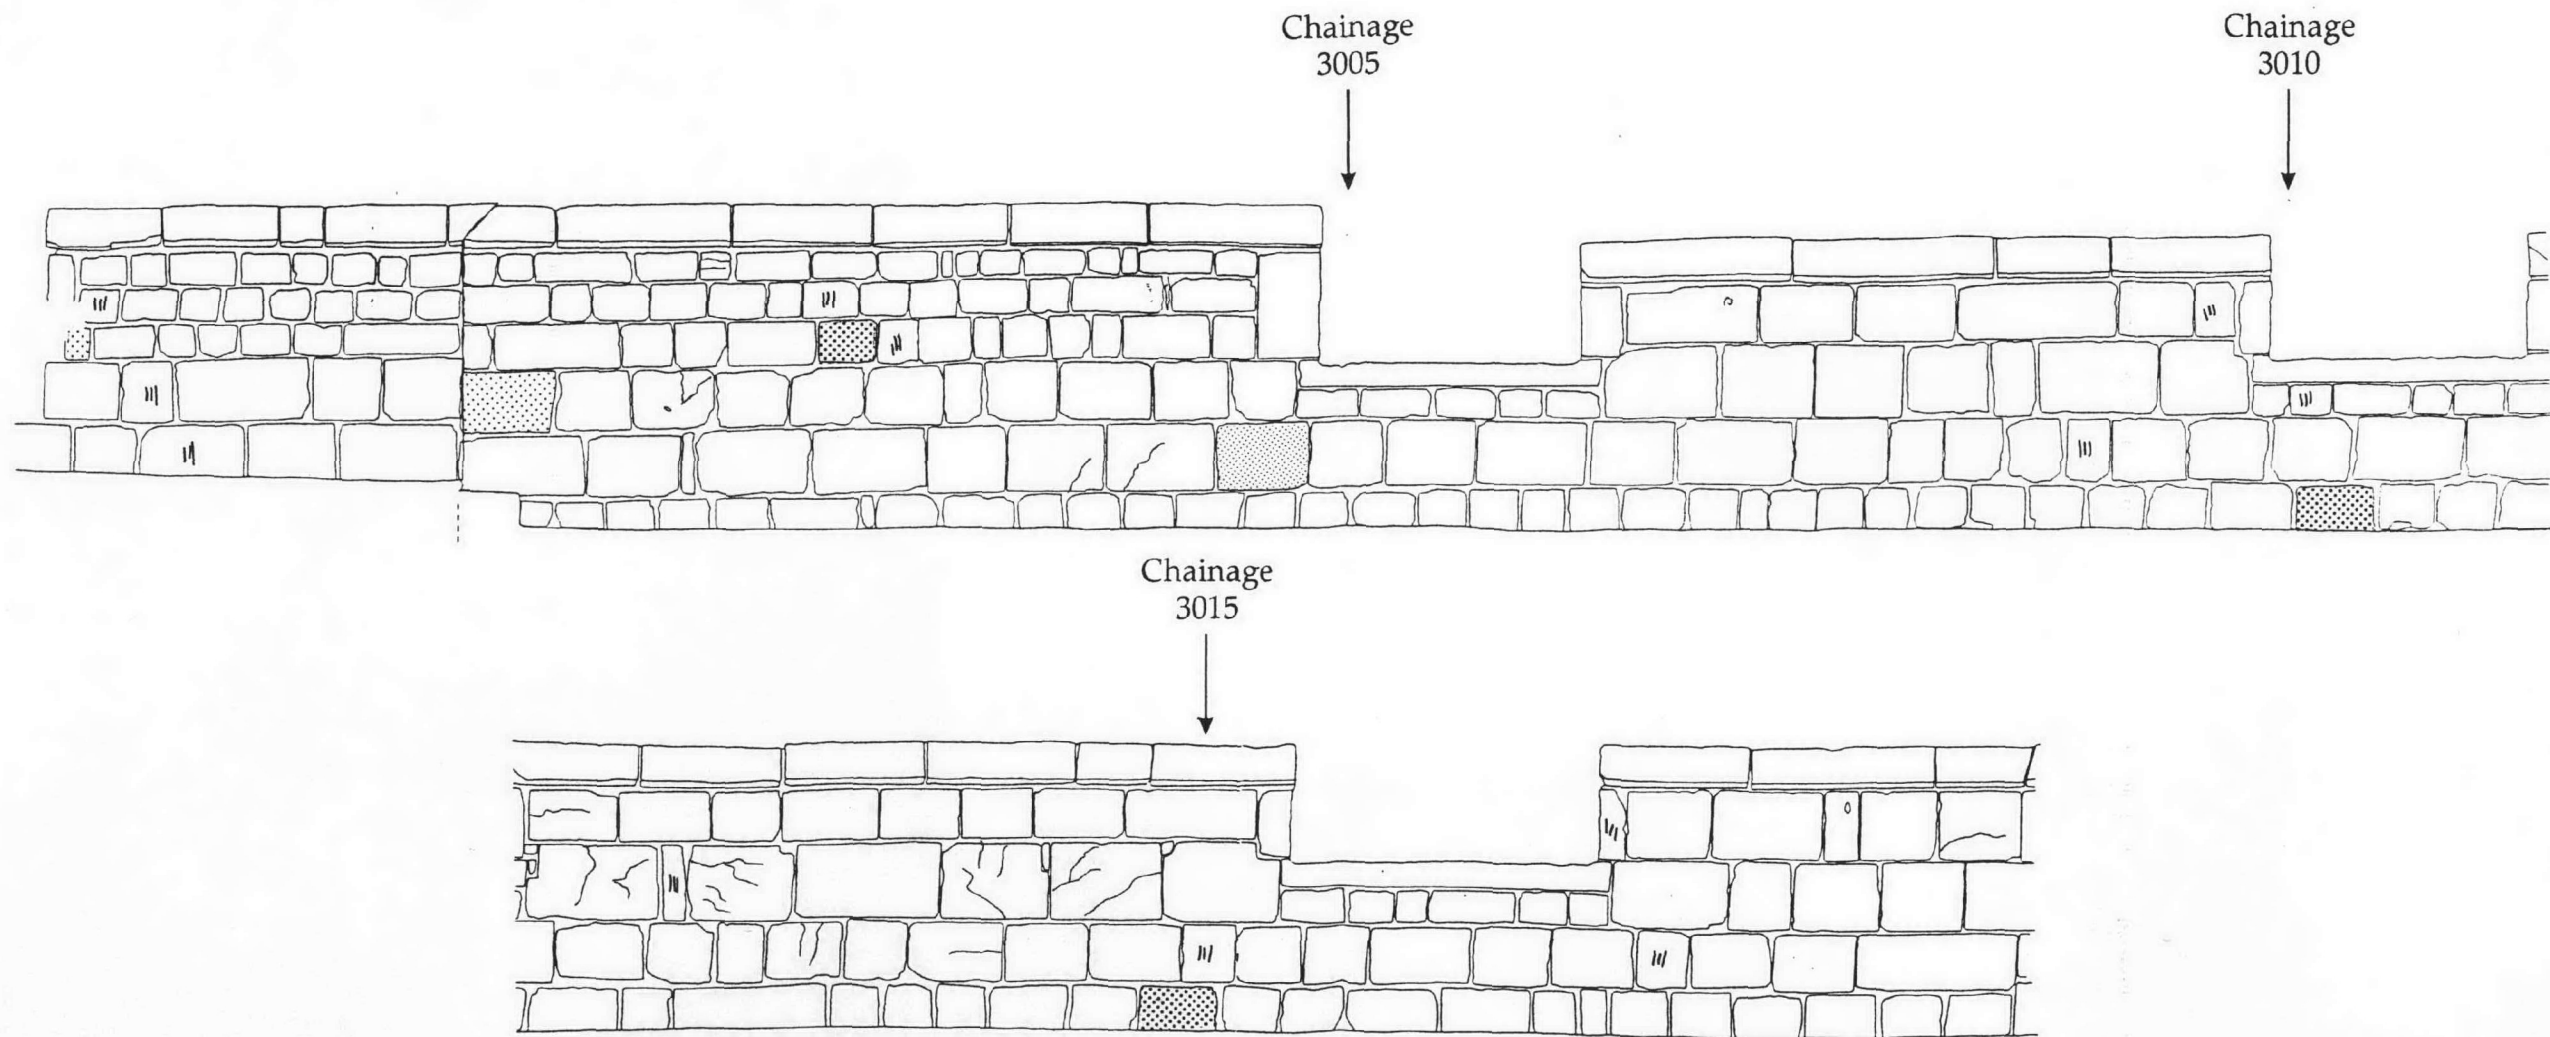
INTERNAL ELEVATIONS (Chainage 3000-3019.40)

The mortar on the inside of the rampart wall was mainly of a similar nature all along the entire length of the observations. The bottom course of blockwork was bedded with a modern repair of cement mortar between chainage 3000 - 3040. This was probably undertaken during paving/re-paving of the wallwalk.

Several crenellations showed shrinkage around their joints and those around chainages 3005, 3010, 3028 and 3084 were seen to be the worst with large voids around the blocks.

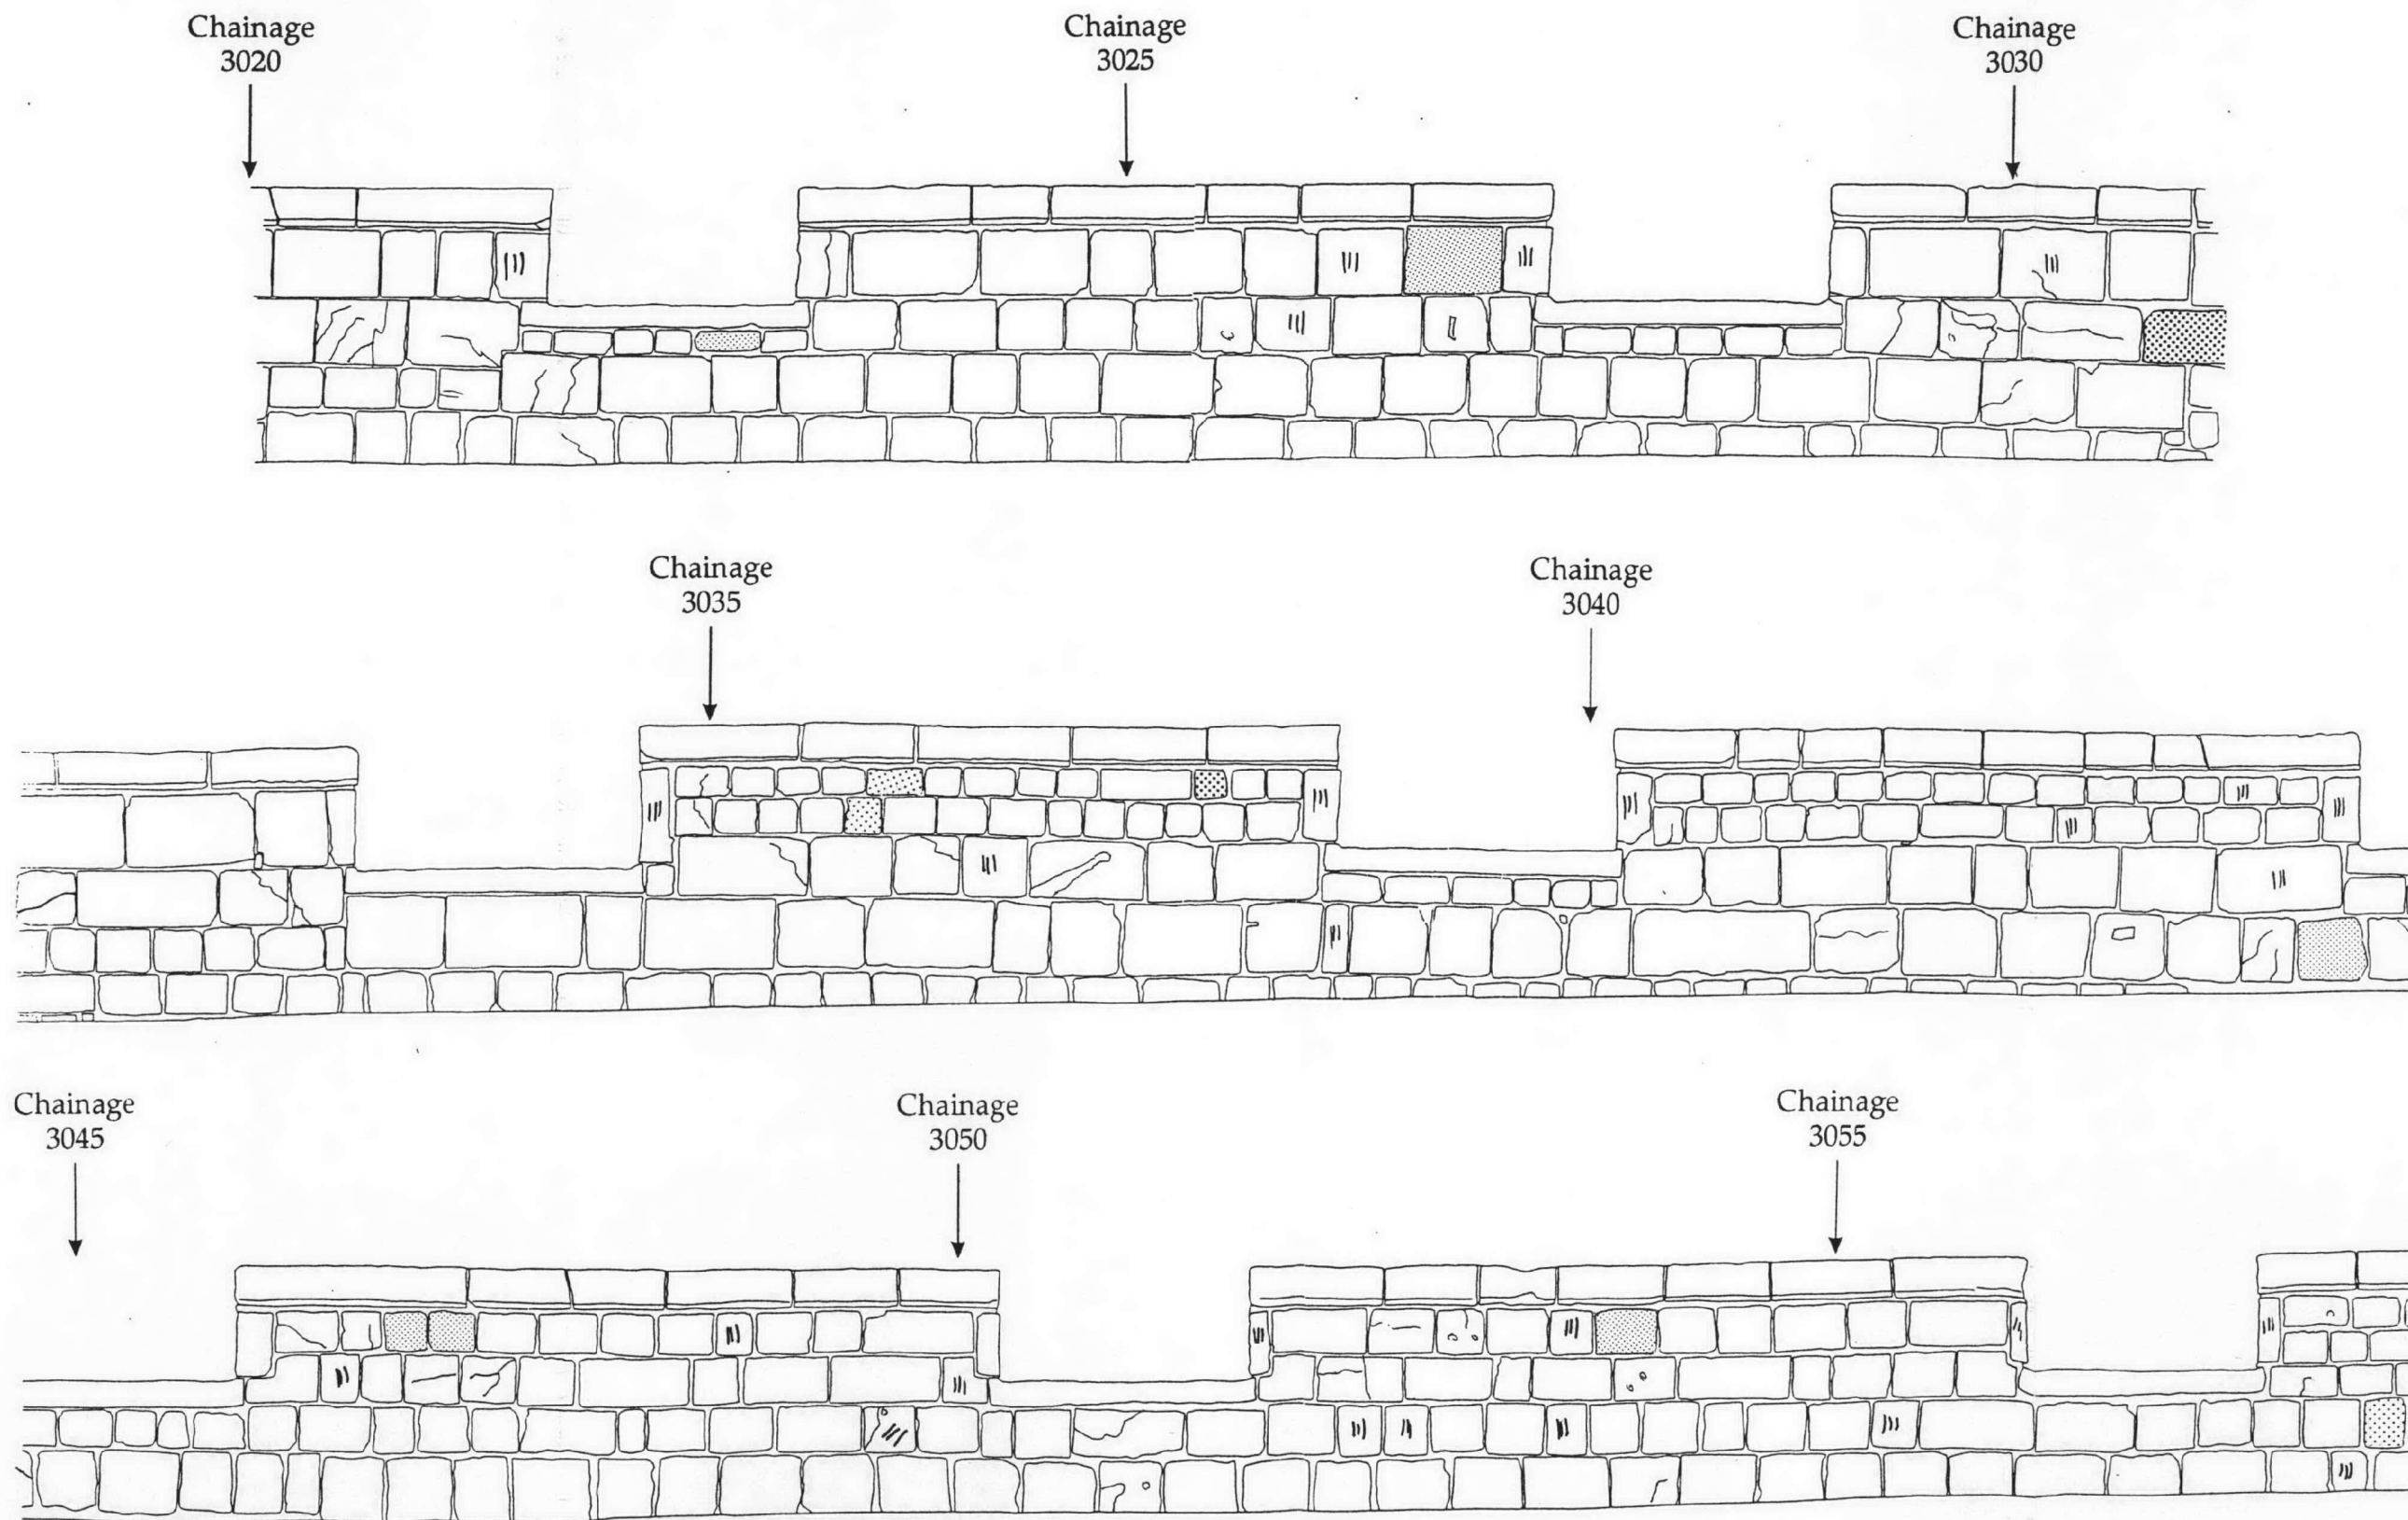
INTERNAL ELEVATIONS (Chainage 3020-3058.25)

The bedding for the coping stones was found to be in a poor state. Indeed around chainage 3046 - 3050, it was almost non-existent whilst the remainder was so loose that it fell away when touched, this was especially the case around chainage 3094 - 3097.

It would appear that pointing repairs had been undertaken along the top three courses of blockwork from chainage c. 3044 - 3090. This consisted of a light grey mortar with a hard exposed aggregate, with a flush finish which has weathered back in several beds up to c.0.10m. Those areas which had not been repaired consisted of an equal proportions mix of off white fine lime mortar and a mid/dark grey mortar with an exposed aggregate. It had deteriorated badly and some patches of it were loose or missing.

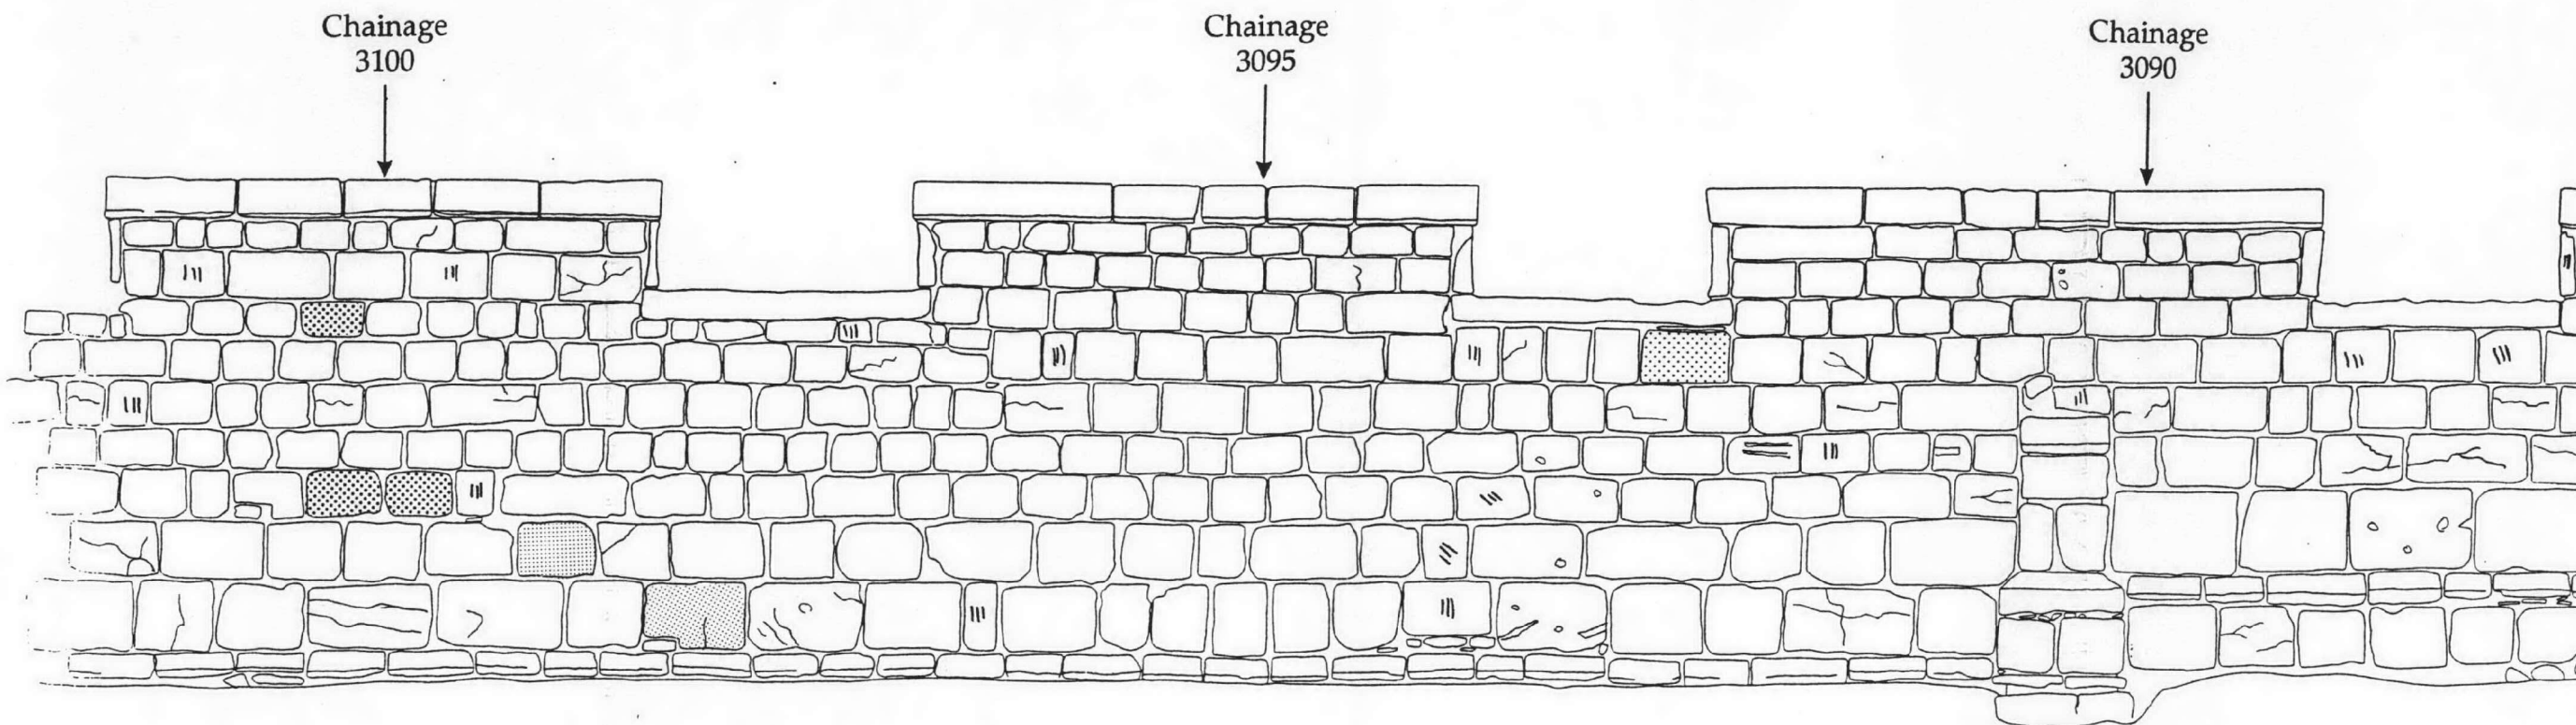
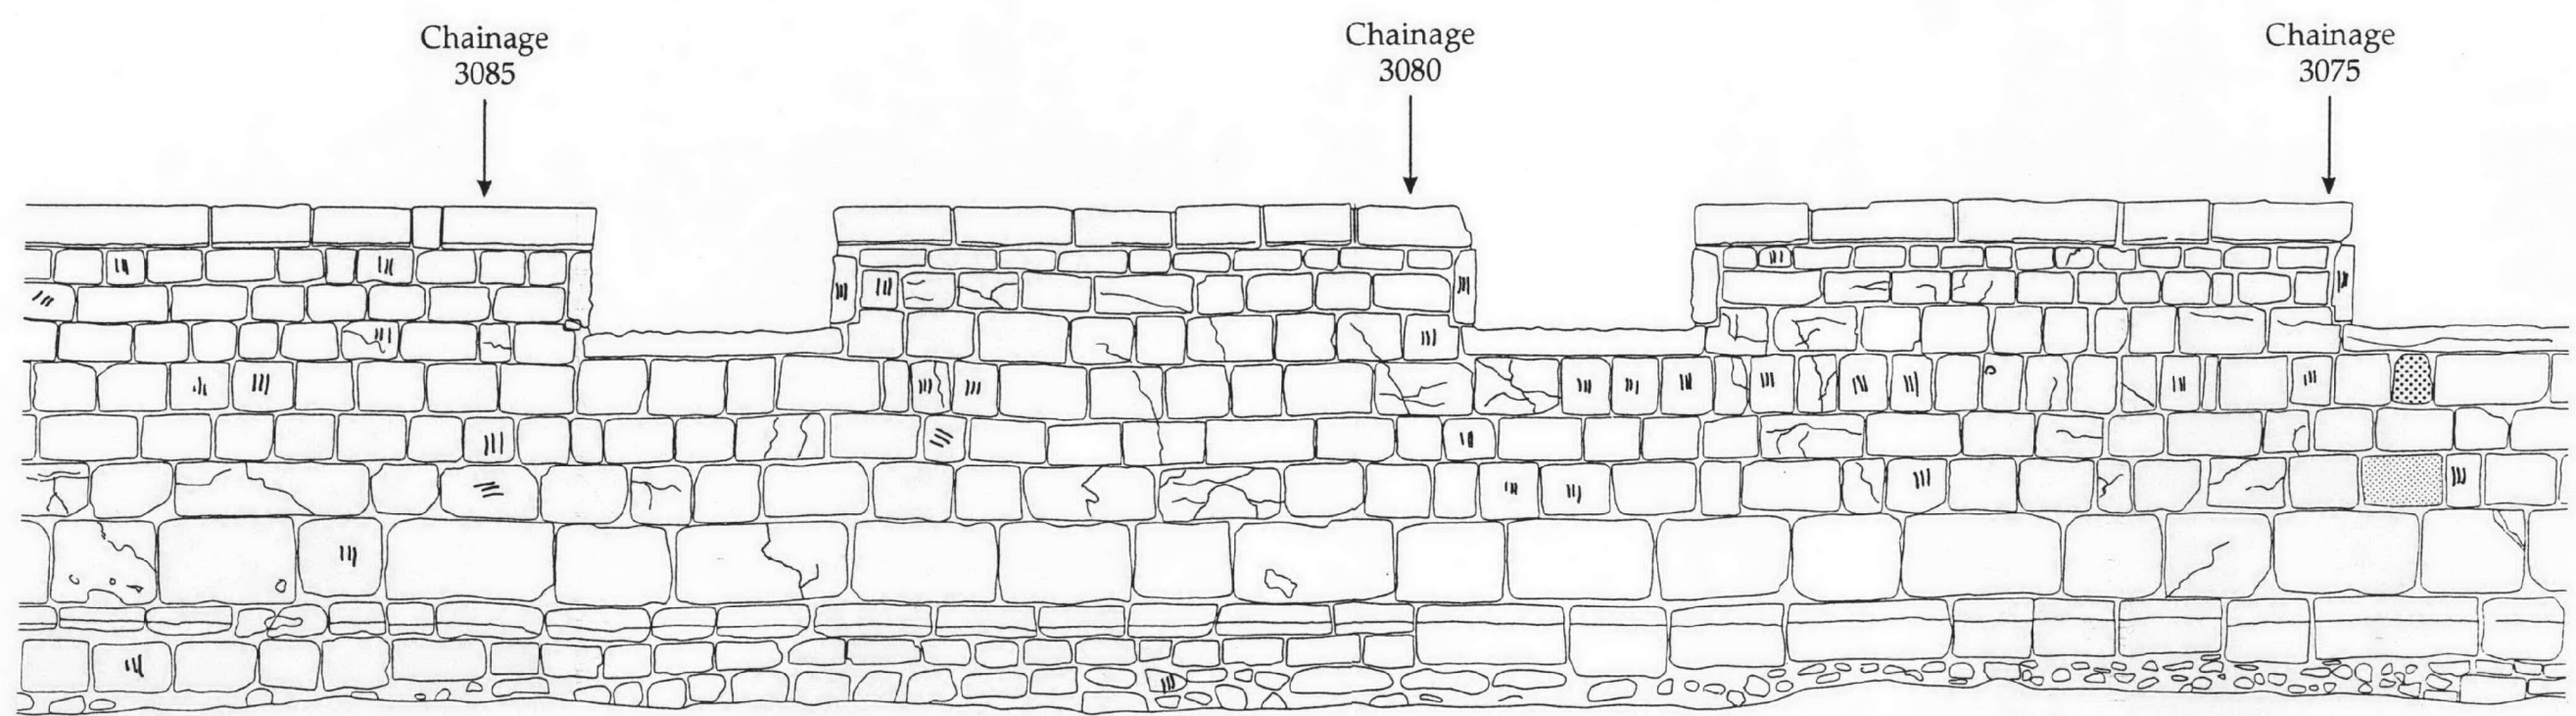
EXTERNAL ELEVATIONS (Chainage 3100-3073.76)

On the external face and beginning at chainage 3100, the two courses of blockwork above the plinth seemed to be bedded with a light grey lime mortar, which, showed signs of being initially flush finished. Approximately 50% had weathered badly and many beds were loose or absent. Several fragments of tile seem to have been wedged in as makeshift repairs. This form of bedding became restricted to the one course at chainage 3095 and with several repairs of flush cement mortar seemed to disappear at chainage 3078.

The remainder of the mortar beds from chainage 3100 - c.3090 mainly consisted of fine, compact, dark grey lime mortar tamped into the beds on top of a cream coloured lime mortar. The crenellations around chainage 3097-3094 did have many voids and cement repairs had weathered and become loose. Cement mortar was also present under the crenellation at chainage 3098.50 and 3097. An area of mortar shrinkage also occurred under the crenellation at chainage 3094 - 3093.75.

The next obvious change in mortar was noticed at chainage 3078. Here, and running back to chainage c.3090, the bedding consisted of a soft mid grey, fine lime mortar with several patches of large pebbles visible in the mix which seemed to have a brushed finish. There was the very occasional patch of cement repair but the main body of the wall seemed to be fairly solid with no signs of movement or excessive weathering on the mortar.

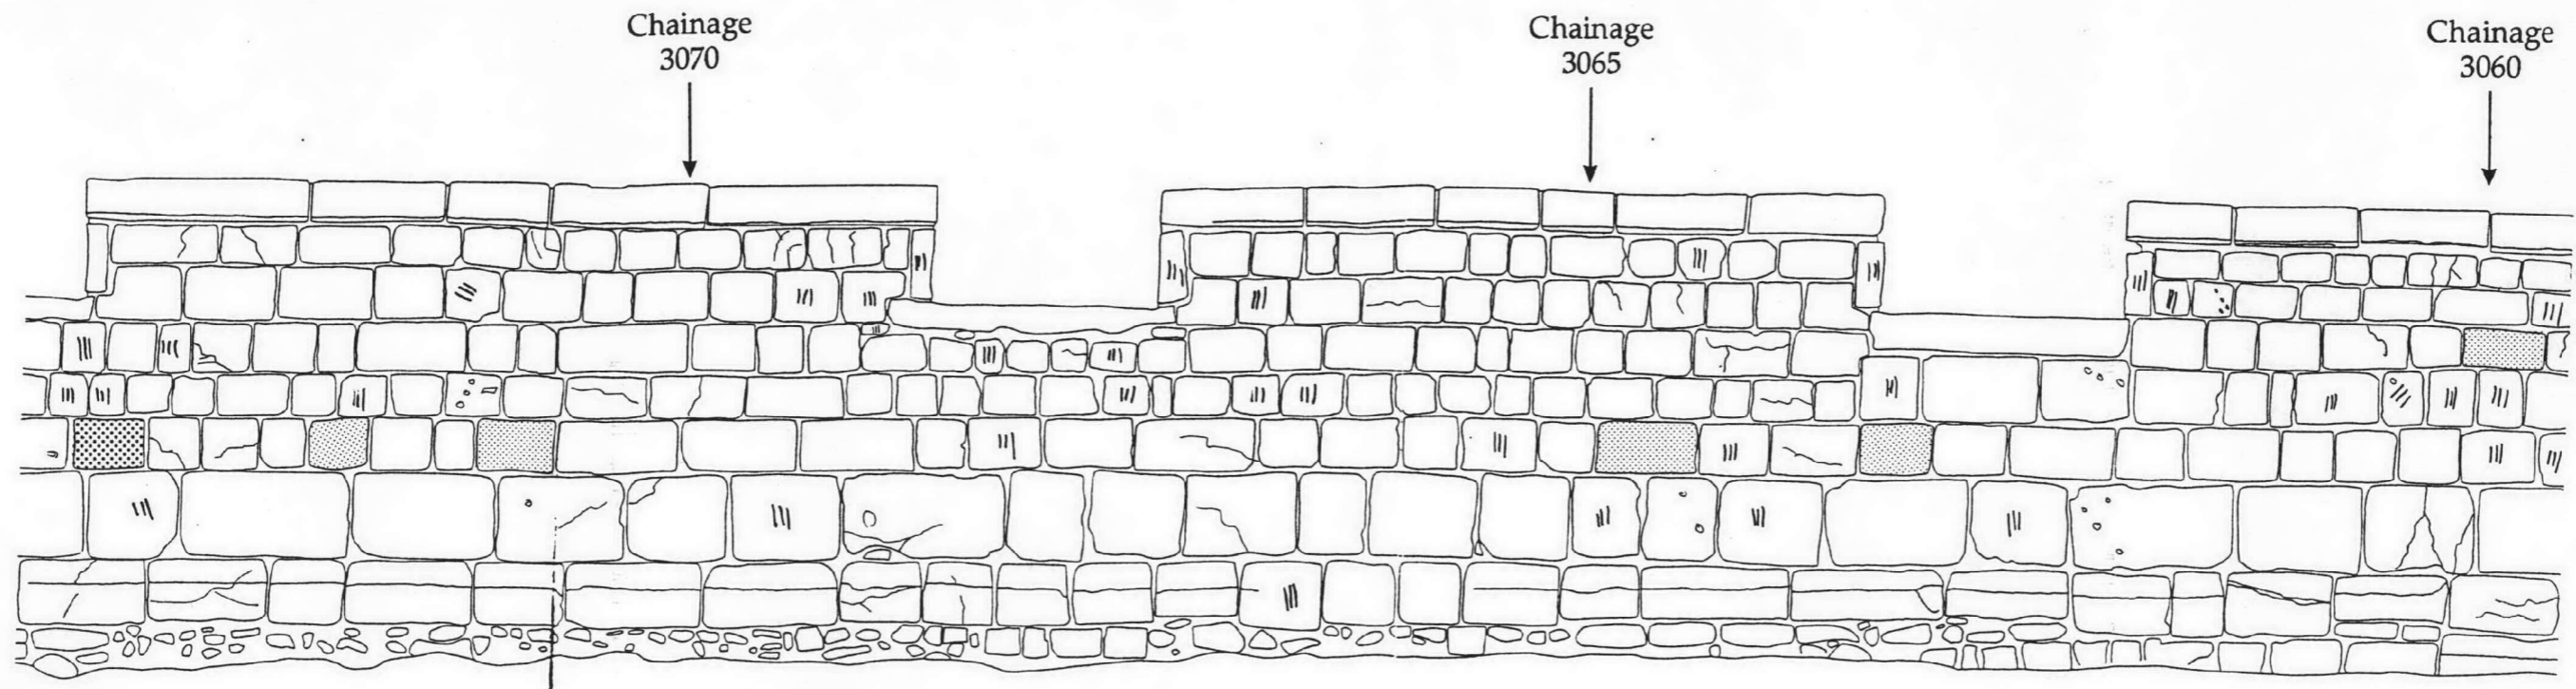
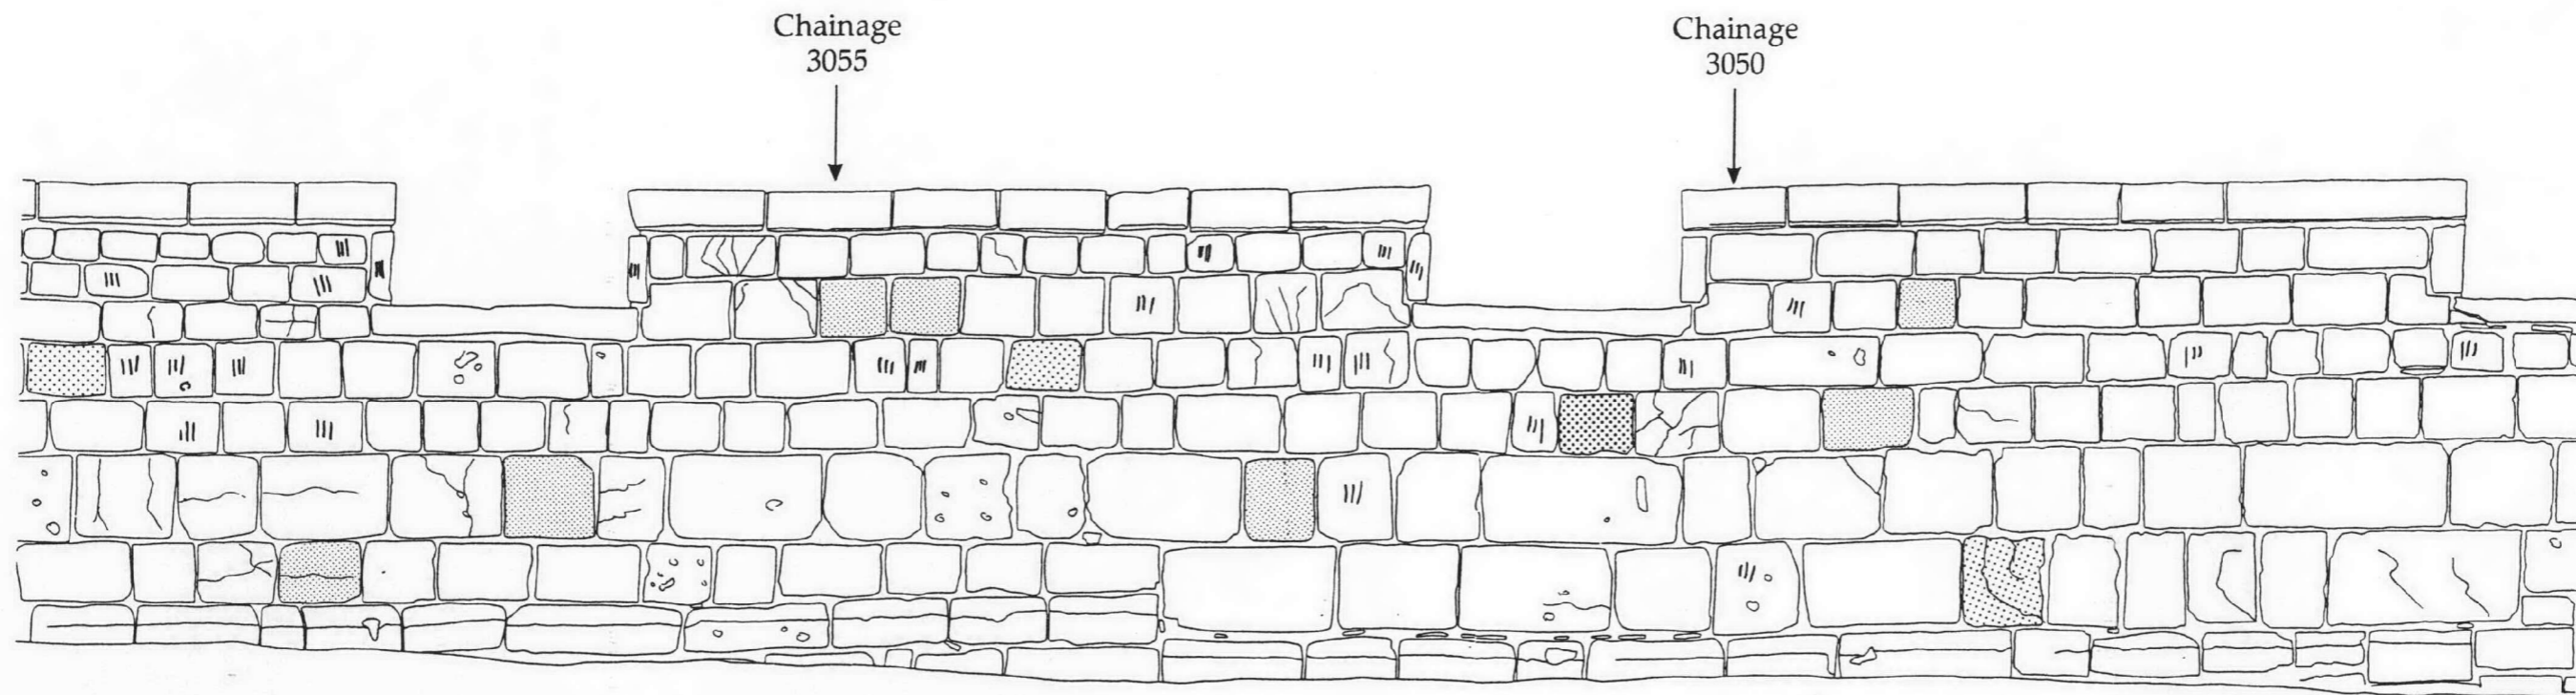
EXTERNAL ELEVATIONS (Chainage 3073.76-3045.36)

The remainder of the wall between chainage 3078 - 3063 consisted of a fine, compact lime mortar made with a fine off white pale sand. Approximately 20% of the bedding is repaired with concrete which is in poor condition.

From chainage 3063 - c.3042 the mortar used consisted of a white, flush finished, fine lime mortar with fewer, but much larger exposed aggregates. The majority of vertical joints being weathered back to between 0.05 and 0.15m. At chainage 3052 the joints became much more substantial with little weathering. There was a slight shrinkage on the beds of the upper, smaller sized blocks, which revealed a fine aggregate.

The crenellations between chainage 3056 - 3052 seemed to have been extensively repaired and the beds were more or less evenly weathered back but in some places the concrete mortar still remained.

A 3m length of bedding along the top of the plinth between chainage 3053 - 3050 consisted of a very weak, powdery mortar with inclusion of tile fragments.

The wall did seem to be fairly vertical along the observed length, especially between Tower 37 and the buttress at chainage 3020. The base of the wall did come forward slightly between chainage 3050 - 3035, but the main change in alignment came between chainage 3072 - 3067 where the top of the wall bowed out substantially.

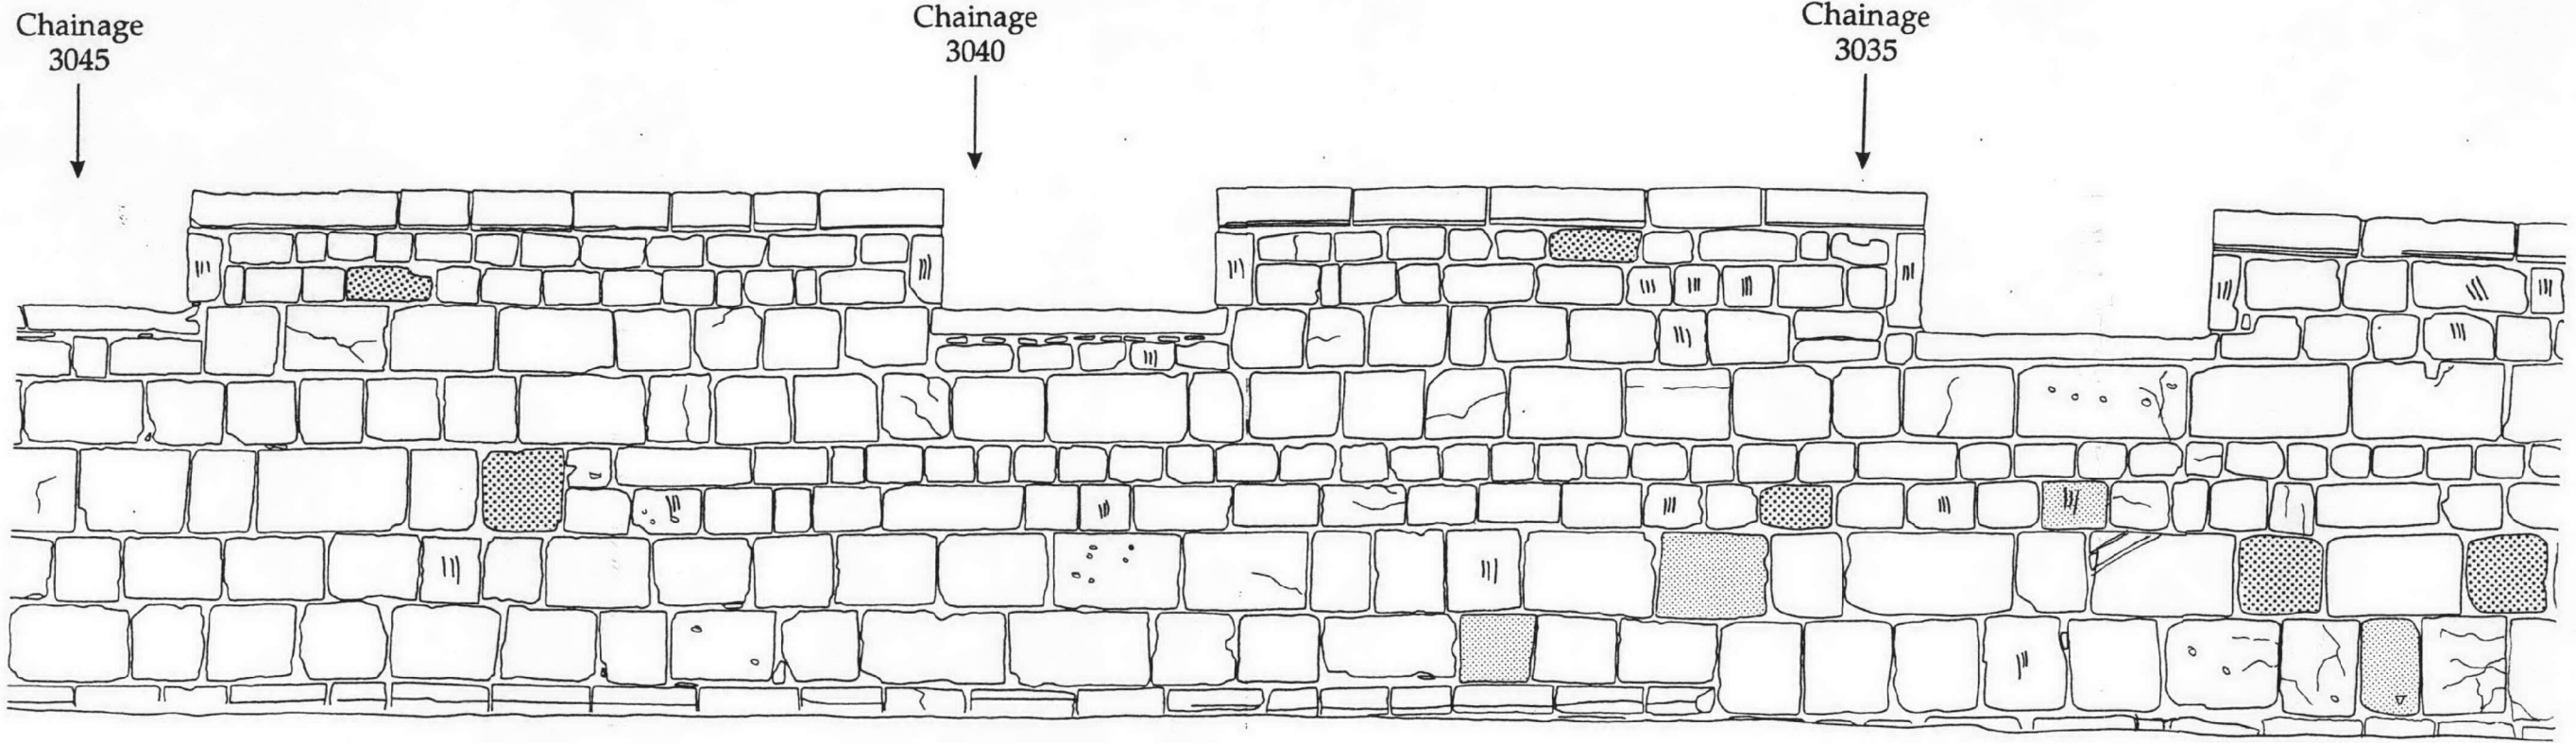
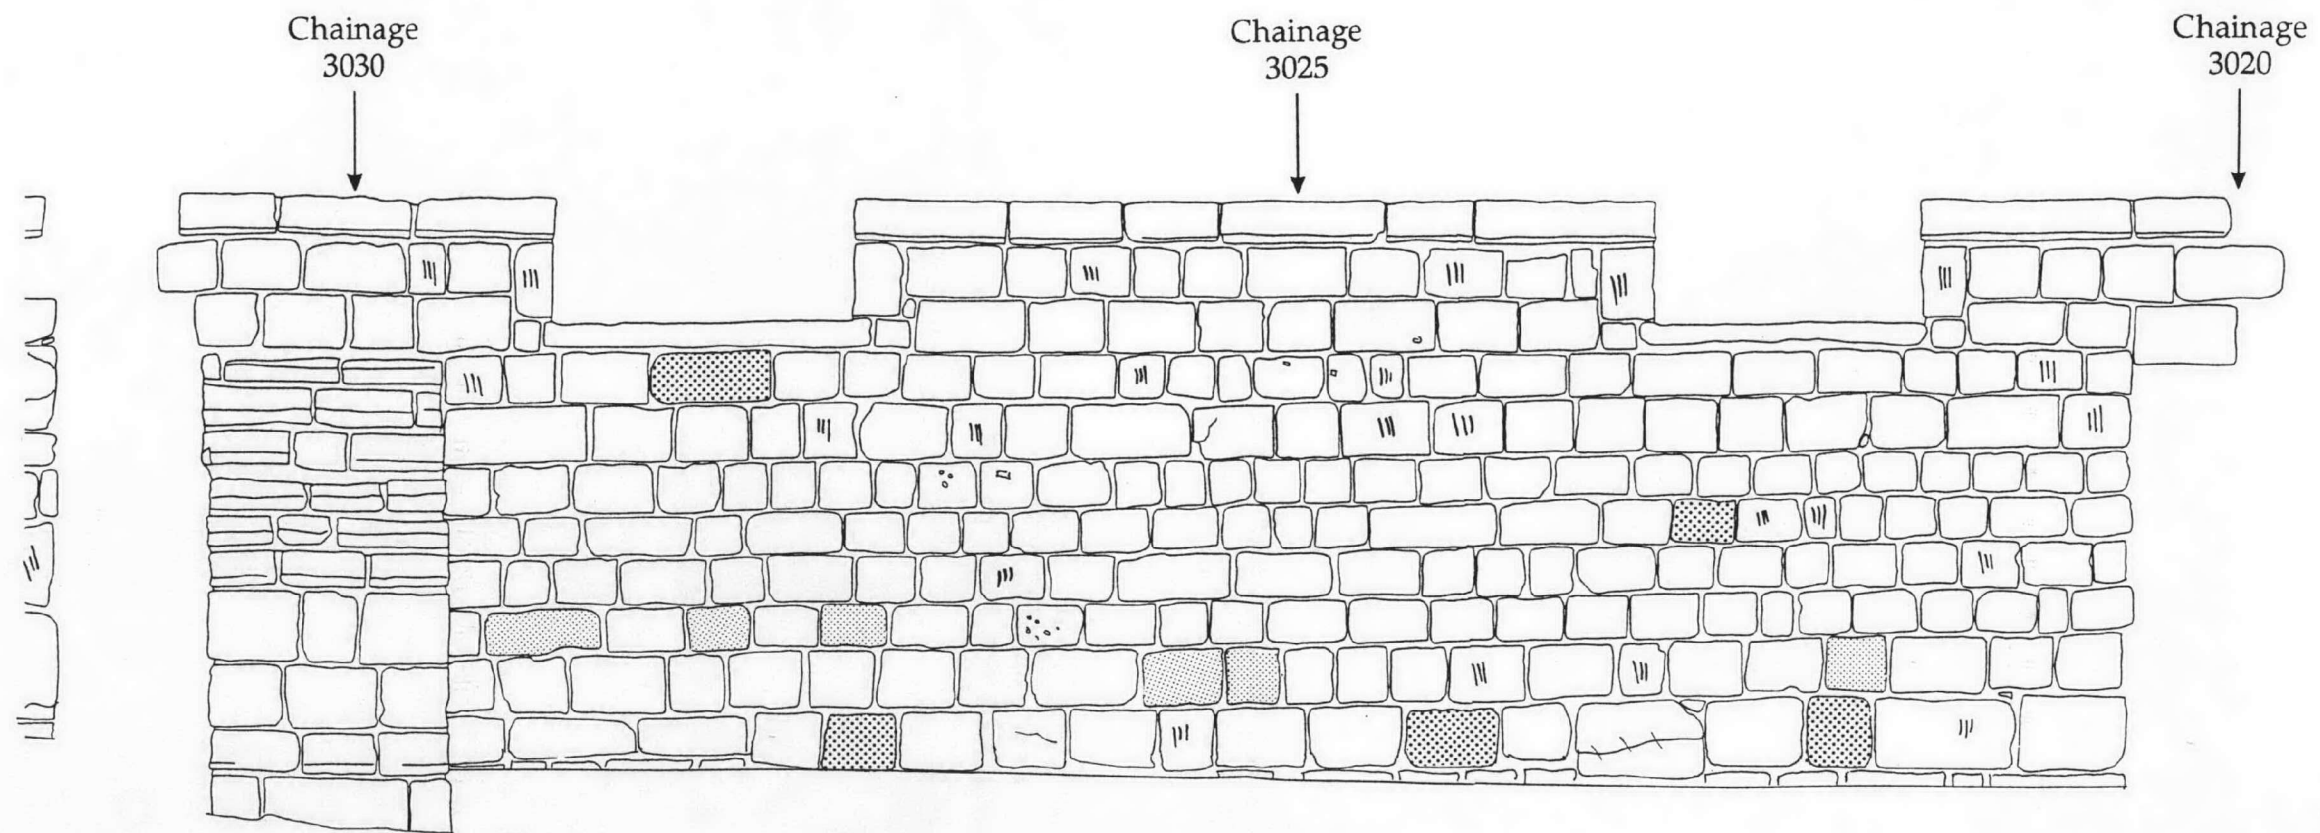
EXTERNAL ELEVATIONS (Chainage 3045.36-3020)

The second buttress at chainage 3030.20 was located on a slight change of alignment of the wall. The blocks are all magnesian limestone bonded with a hard, off white, lime mortar and seem to have suffered little in the way of weathering. The mortar beds were initially flush finished but have weathered back a few centimetres in certain places. There is occasional pitting around the base of the buttress and an occasional patch of concrete pointing. It was not possible to relate the buttress to the rampart wall as the joints had been raked out before the buttress was inspected.

The bedding around the crenellations between chainage 3040 - 3035 was made up of at least 75% concrete patching, the rest being a fine white lime mortar which included large white pebbles. This had weathered to a dark grey colour along the bottom two courses of block work.

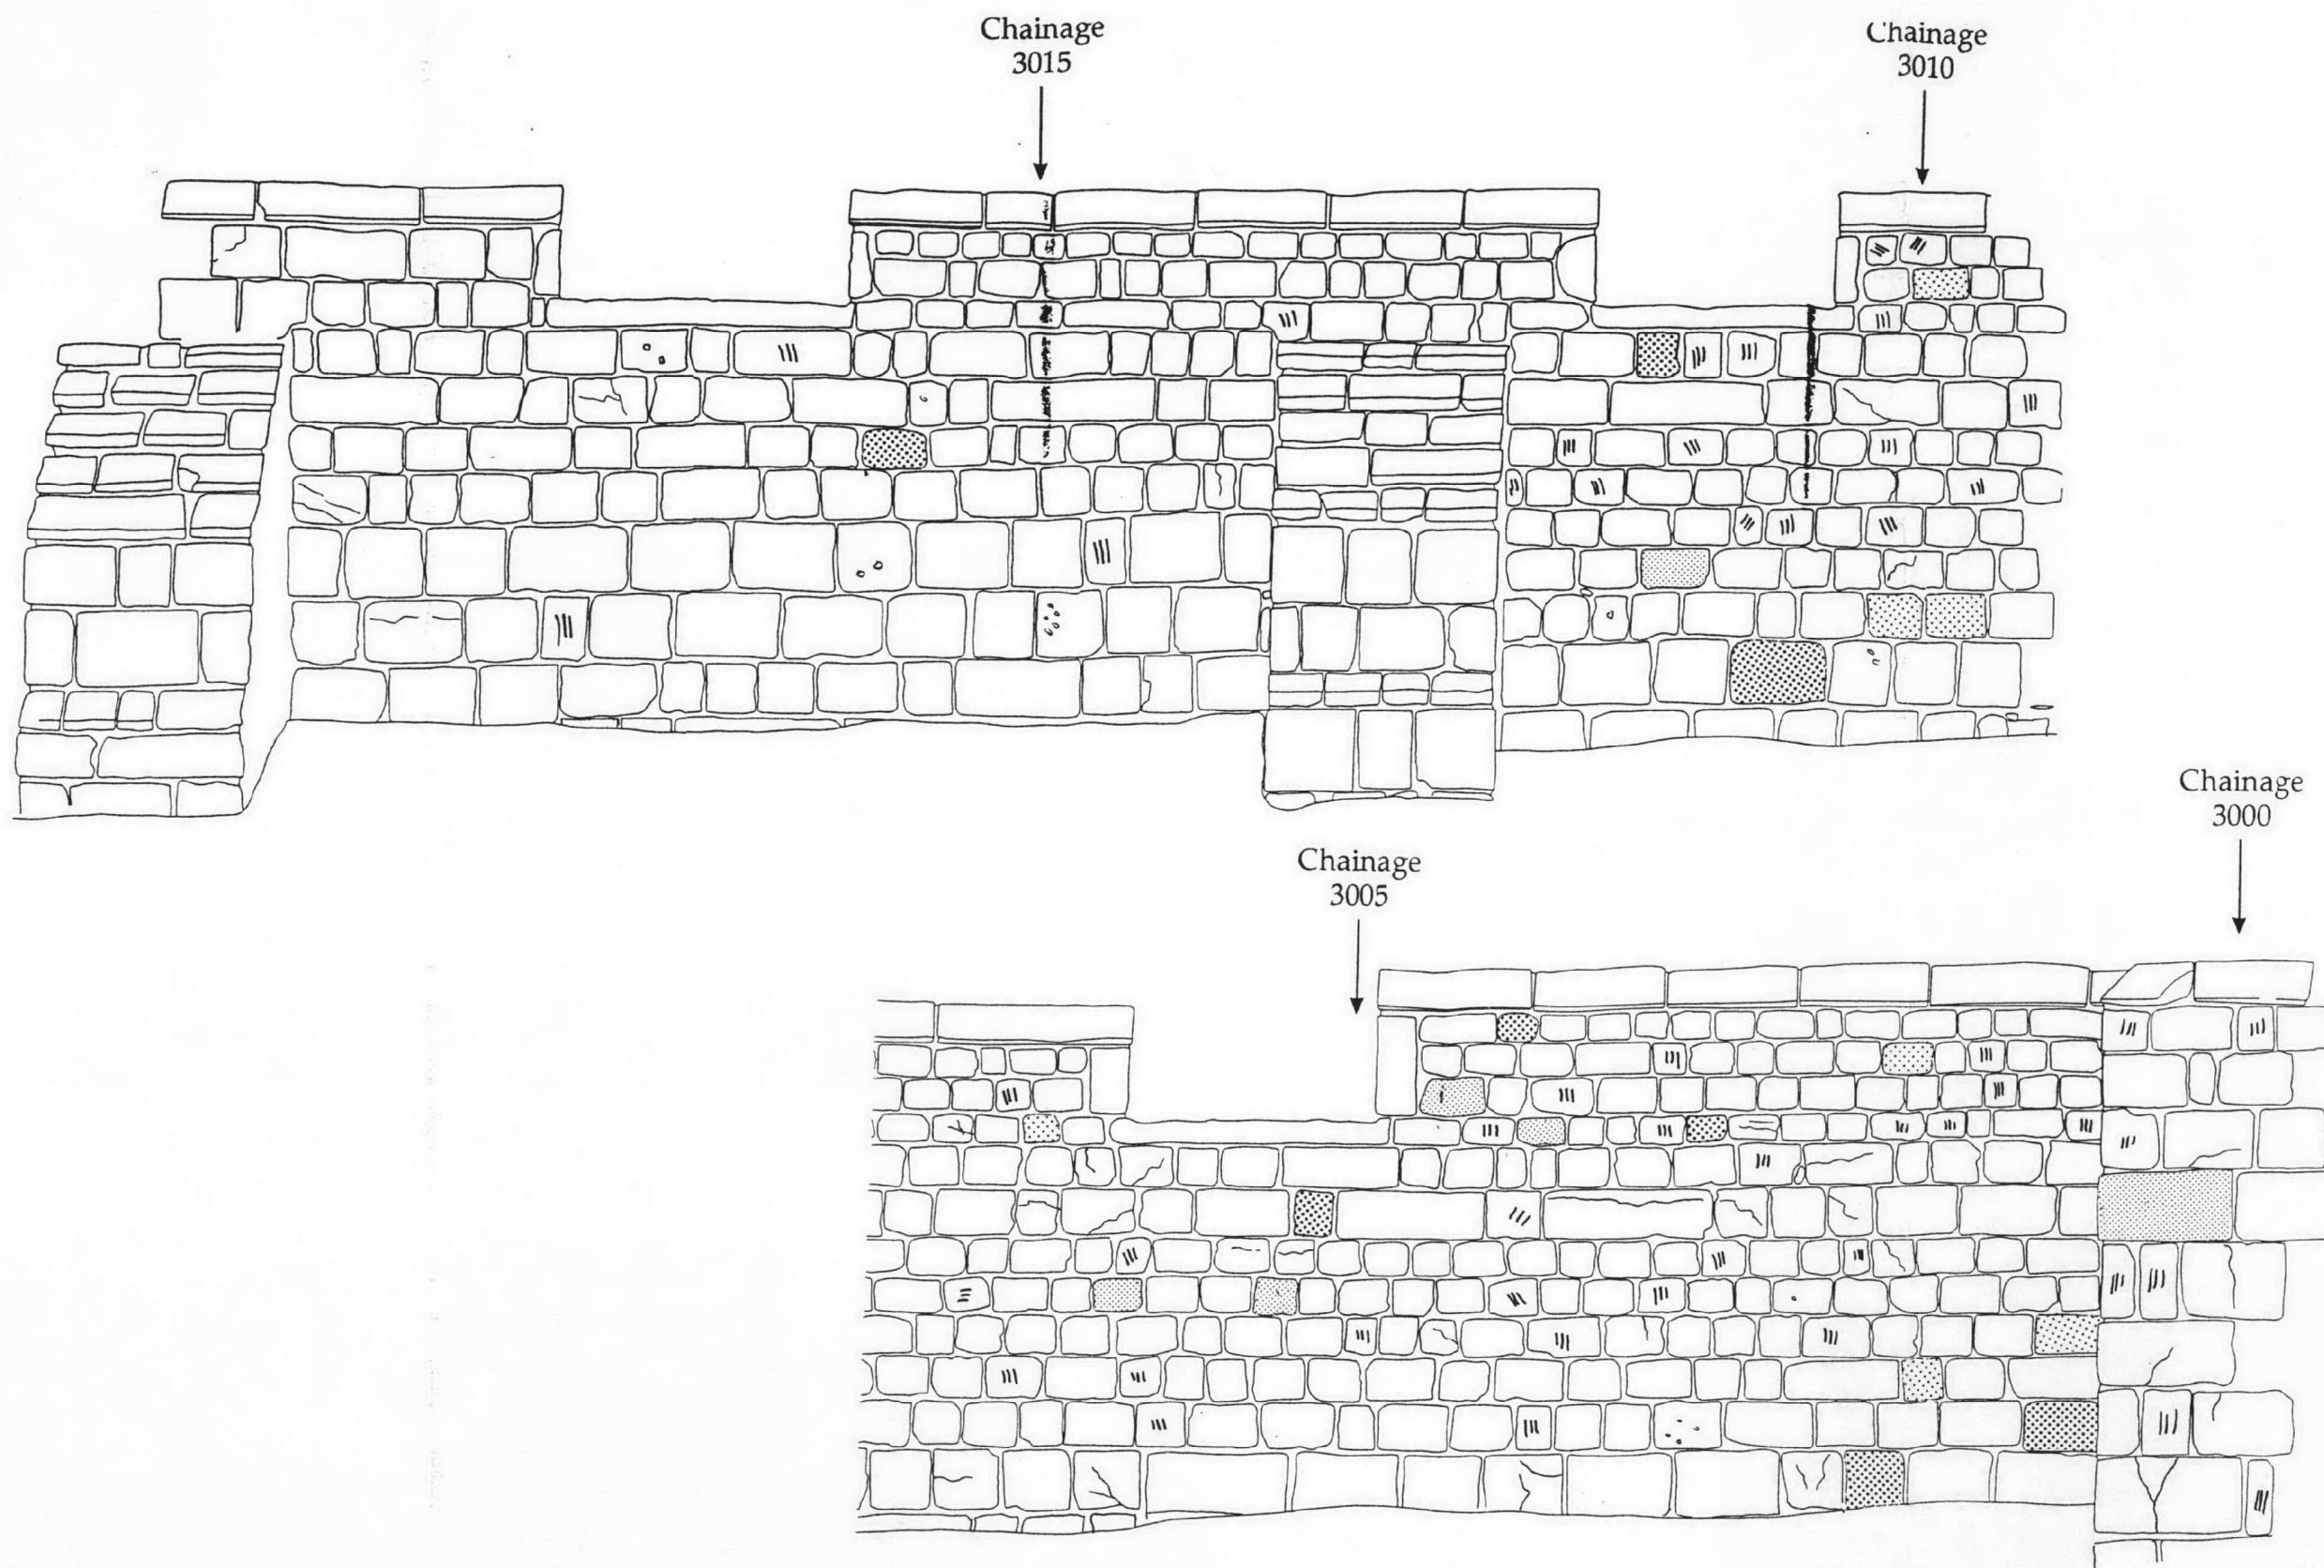
EXTERNAL ELEVATIONS (Chainage 3020-3000)

The final buttress at chainage 3013 had chamfered offsets and was made up of large magnesian limestone blocks. The upper courses were badly pitted and weathering had damaged the upper chamfered courses. The very light grey, hard lime mortar had 90% flush finishes and the whole structure seemed solid. Indeed, the mortar used in this buttress was much harder than that used in the other three. There was no evidence to suggest its date of erection but it appeared to have been initially keyed in to the rampart wall.

The remainder of the bedding up to chainage 3000 consisted of a light grey mortar with a hard exposed aggregate, with a flush finish. This appears to have only weathered after the stone face had crumbled back although there were a few isolated patches of deep weathering, nearly 0.20m deep. There was no evidence of shrinkage or movement.
