ARCHAEOLOGICAL
TRUST

**YORK CITY WALLS,
CHAINAGE 3000-3100**

**REPORT ON AN
ARCHAEOLOGICAL
WATCHING BRIEF**

**1998 FIELD REPORT
NUMBER 45**

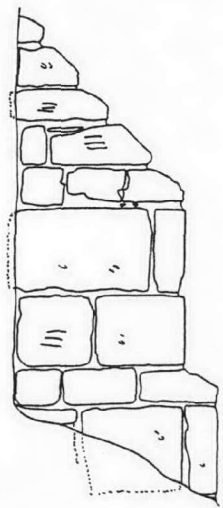
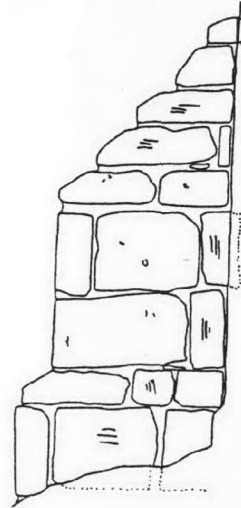
Chainage 3013

The final buttress at chainage 3013 had chamfered offsets and was made up of large magnesian limestone blocks. The upper courses were badly pitted and weathering had damaged the upper chamfered courses. The very light grey, hard lime mortar had 90% flush finishes and the whole structure seemed solid. Indeed, the mortar used in this buttress was much harder than that used in the other three. There was no evidence to suggest its date of erection but it appeared to have been initially keyed in to the rampart wall.

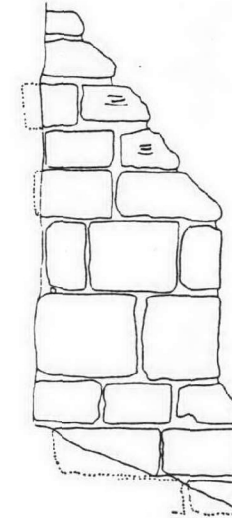
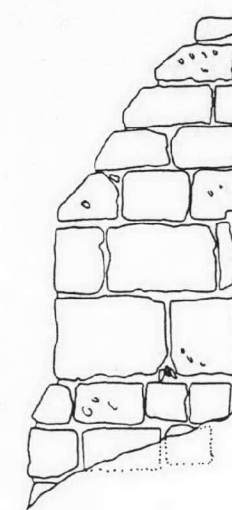
Chainage 3020

The third buttress at chainage 3020 was also located on a slight change of alignment of the wall. It had chamfered offsets and was bonded with a hard, cream coloured lime mortar. It was slightly paler on the south-east and north-east facing sides possibly due to the effects of weathering. Here, the mortar was initially flush finished but had weathered back up to 0.20m in places. There was also limited signs of pitting on the upper courses, especially on the north-east face and on the south-east face, what could have been a musket ball scar. The plinth of the rampart wall was visible behind the west facing side of the buttress, suggesting that this buttress may have been added to the wall at a later date or it may be the position of an earlier buttress which has been later enlarged by encasing an earlier one.

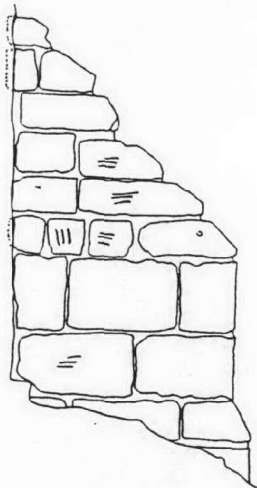
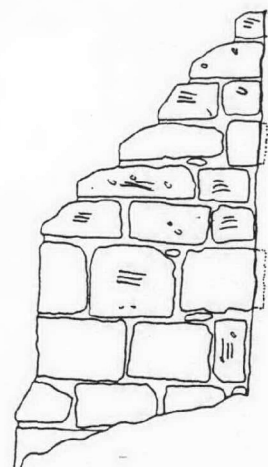
Chainage 3030.20

The second buttress at chainage 3030.20 was located on a slight change of alignment of the wall. The blocks are all magnesian limestone bonded with a hard, off white, lime mortar and seem to have suffered little in the way of weathering. The mortar beds were initially flush finished but have weathered back a few centimetres in certain places. There is occasional pitting around the base of the buttress and an occasional patch of concrete pointing. It was not possible to relate the buttress to the rampart wall as the joints had been raked out before the buttress was inspected.
