**THE OLD MANOR HOUSE  
CLIFTON, YORK**

## **HISTORIC BUILDINGS ASSESSMENT**

**NAA 04/32**

**June 2004**

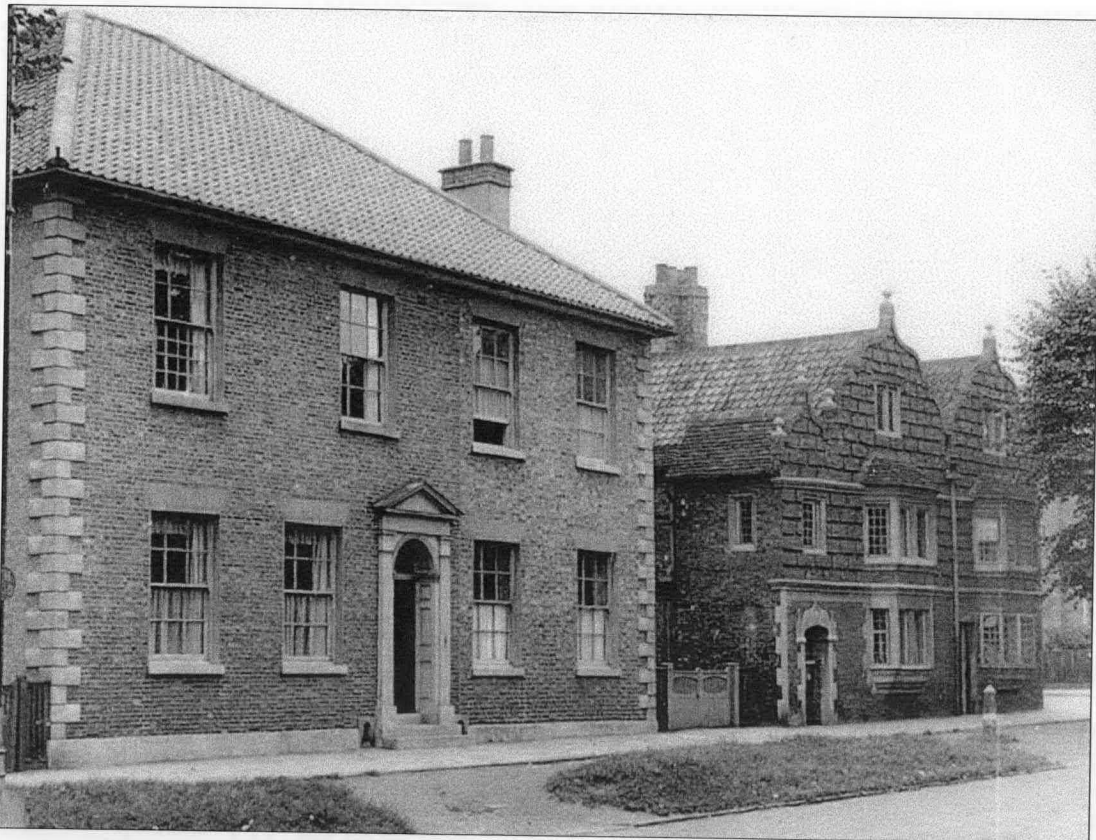
*Figure 15 The Old Manor, Clifton: photograph c. mid 1960s after renovations work showing changes to south-east oriel. Clifton Manor in foreground (York City Library)*

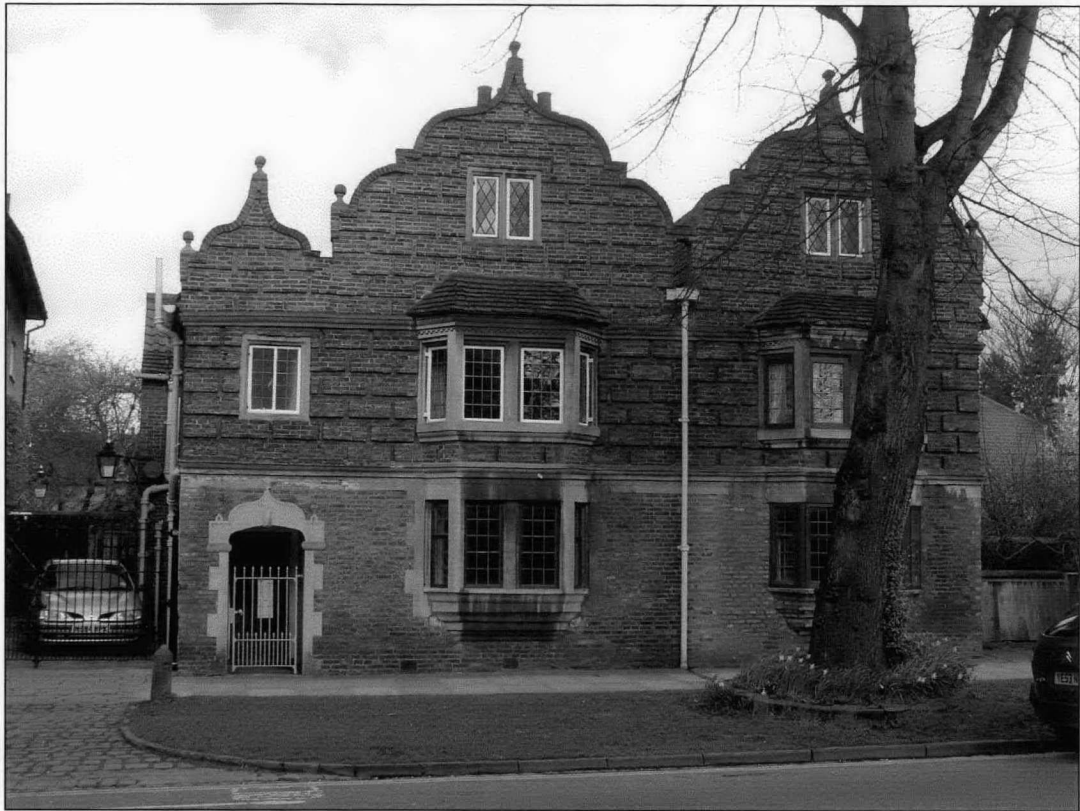
- 3.1.3 The front (SW) elevation (Plate 1) features two brick Dutch gables popular in the mid 17<sup>th</sup> century; a further smaller gable sits above a porch tower on the north-western edge of building. All three gables are surmounted by ball finials although photographic evidence shows that these have taken on various forms during the buildings history. The ground floor up to the first string course is plain, while the upper floors are rusticated rising up to the gables. The gables include two, double light, square headed windows with brick drip mould above. The distinction between gable and first floor is stressed by a second string course. The two main gables are joined across the roof valley by a 3 course brick tie over a rectangular gap. Under the gables, running the height of both floors, are two oriel windows set on stepped brick corbelling. These have been extensively modified, particularly the south-eastern window which has been largely replaced in wood. The entrance features a four-centred arch with ogee curved decoration above, this is centred and flanked by ball finial reliefs (much of which are now missing). Above the entrance, on the first floor is another double light window, slightly narrower than the gable windows, with the central mullion missing. Cement render over moulded brickwork has been used to simulate stone dressing on the string courses, window mullions and doorway detail. The decorative elements on the front façade, including the string courses and rustication, place considerable stress on the horizontal line of the building and act to unify the structure.

*Plate 1 The Old Manor, Clifton: Front (south-west) elevation*

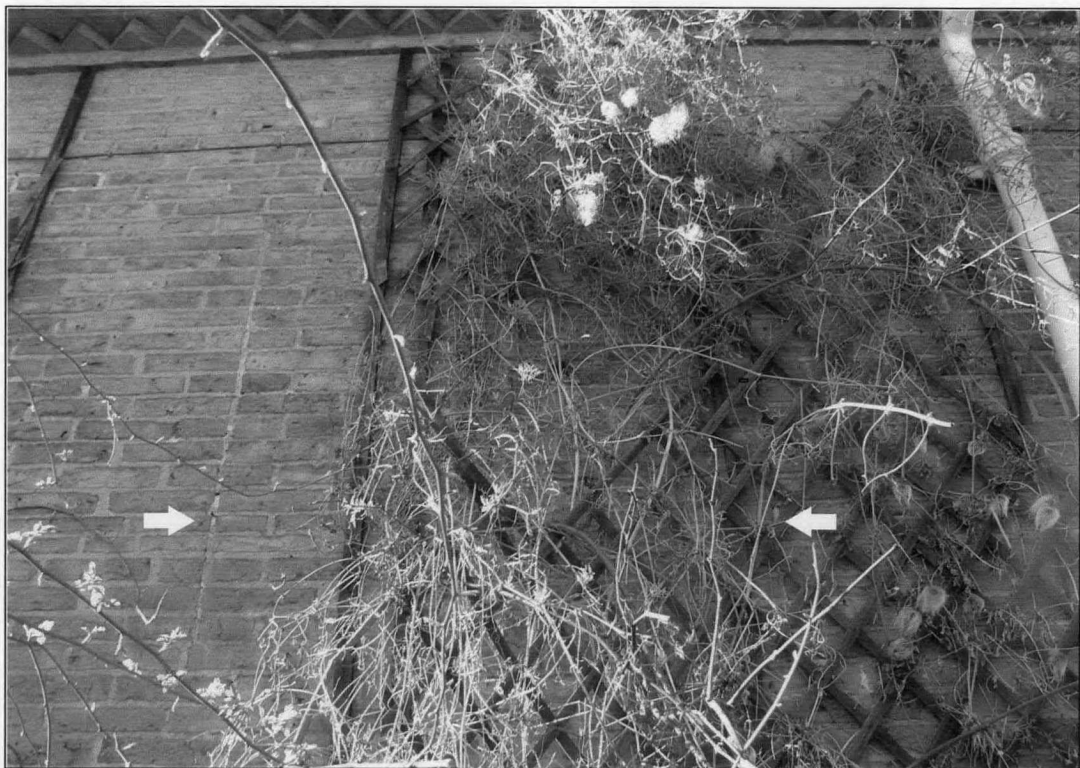
*Plate 2 The Old Manor, Clifton: joint scars on north-east elevation*

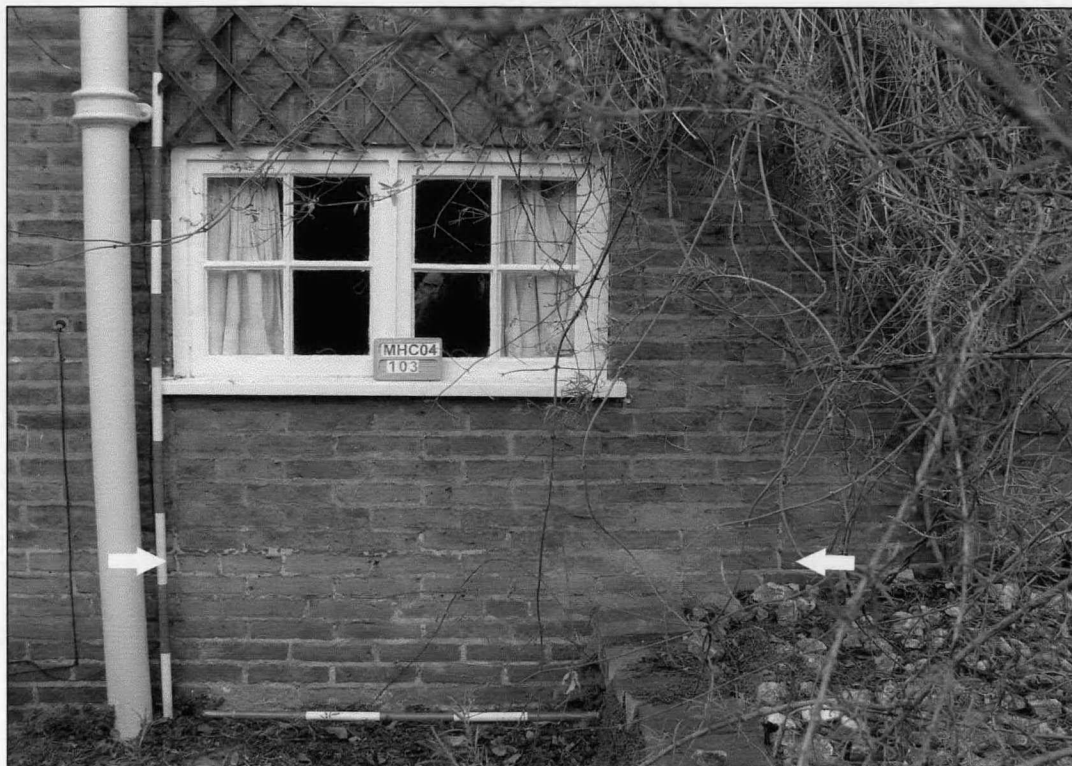
*Plate 3 The Old Manor, Clifton: joint scars on south-east elevation*

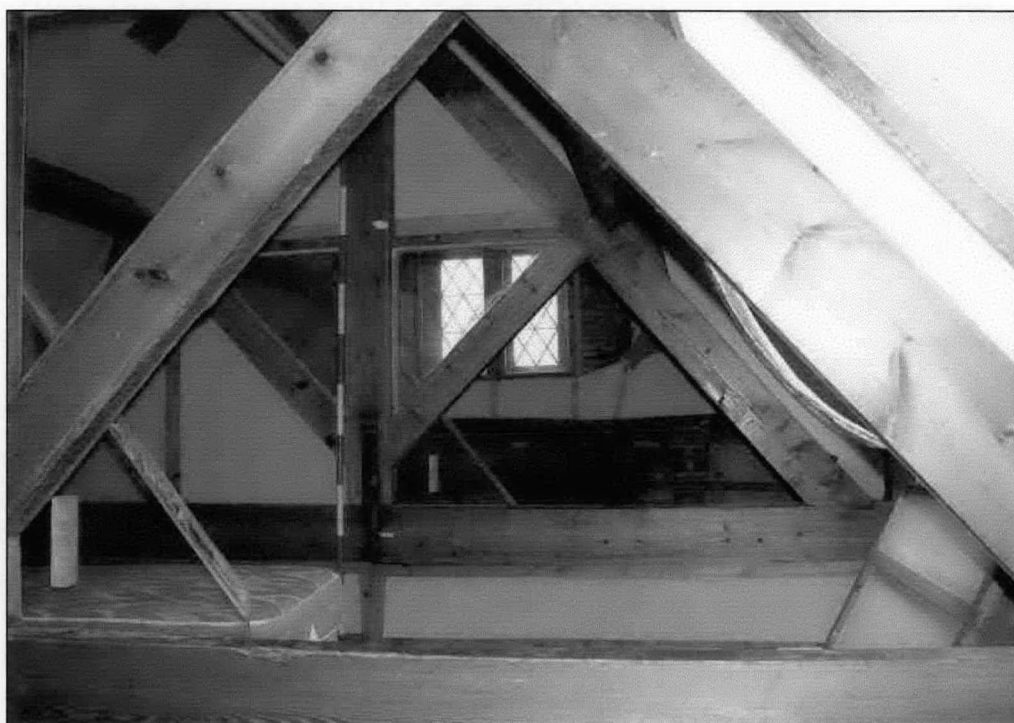
- 3.1.10 The original 17<sup>th</sup> century roof structure was replaced in the 1930s. The present structure is in soft-wood and comprises three sets of king post trusses spaced evenly along the main attic space on both sides of the property (Plate 6). These are in turn spanned by a single large, angled through purlin. The rafters and tie beams are bonded with modern brick into the external walls. Only the attic space in no.64 has been re-boarded for use as a bedroom, the NE side of the property is not currently utilised although fragments of earlier floorboarding remain. The tie beam for each truss sits approximately 0.60m above the floor surface on the SE side, inhibiting free movement through the space. Movement is further impeded by a series of Perspex sliding screens attached to each truss. The present structure is constructed of soft-wood supported on a central steel joist running the depth of the building; the joists for the replacement floor are suspended from the same joist.

*Plate 6 The Old Manor, Clifton: modern roof trusses in no. 64*

4.1.1 *It is proposed to improve the existing attic floor living space in the east range (No. 64) by the adaptation of the modern trusses to provide a more open roof structure which will provide for easy access throughout the length of the room. It is also the intention as part of the repairs to the roof, to reposition the modern rooflights on the inner roof slope and create an emergency/maintenance link to the west roof void.*

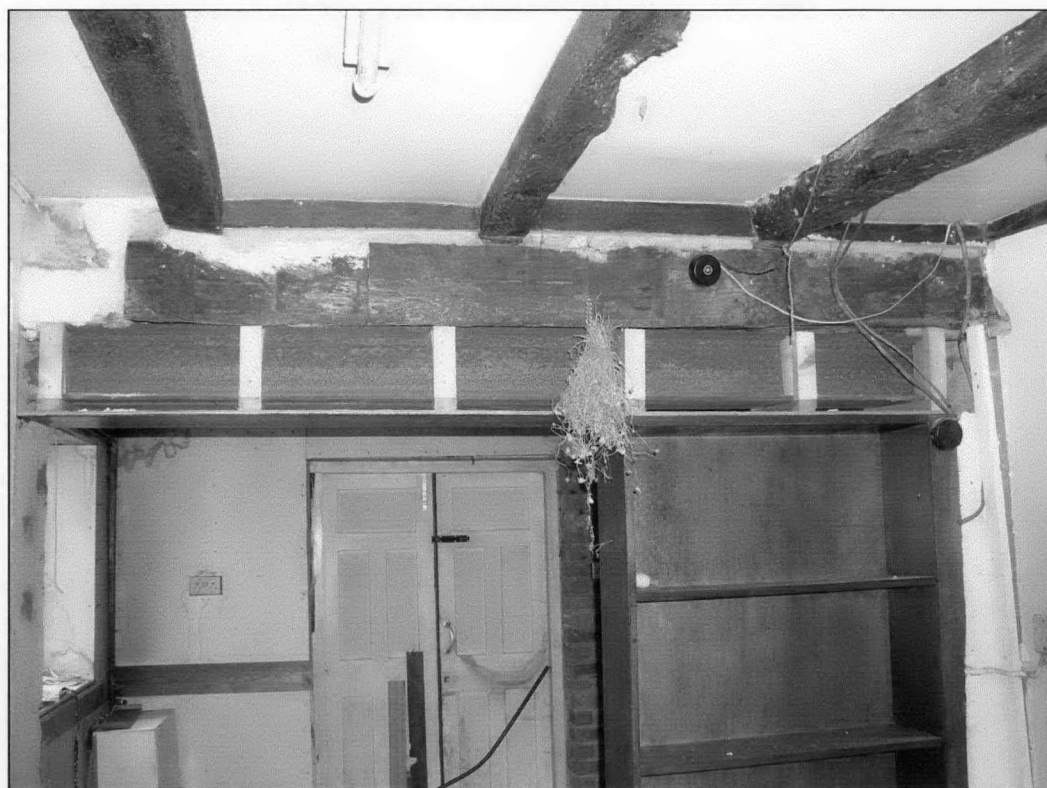
*Plate 10 The Old Manor, Clifton: timber lintel inserted over doorway during construction of workshop extension, note floor joist sit above timber.*

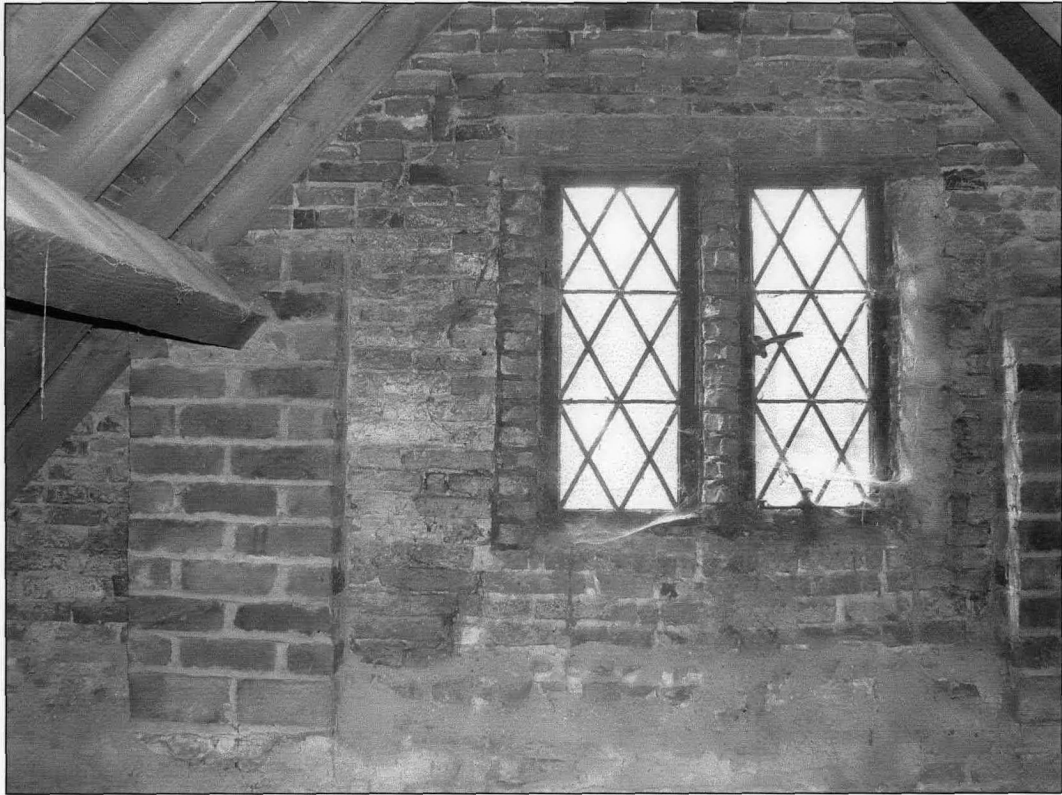
*Plate 13 The Old Manor, Clifton: gable window (NW side) showing moulded brick mullions and plaster work concealing void over oriel. Brick pier on left hand side of frame carries modern roof purlin*

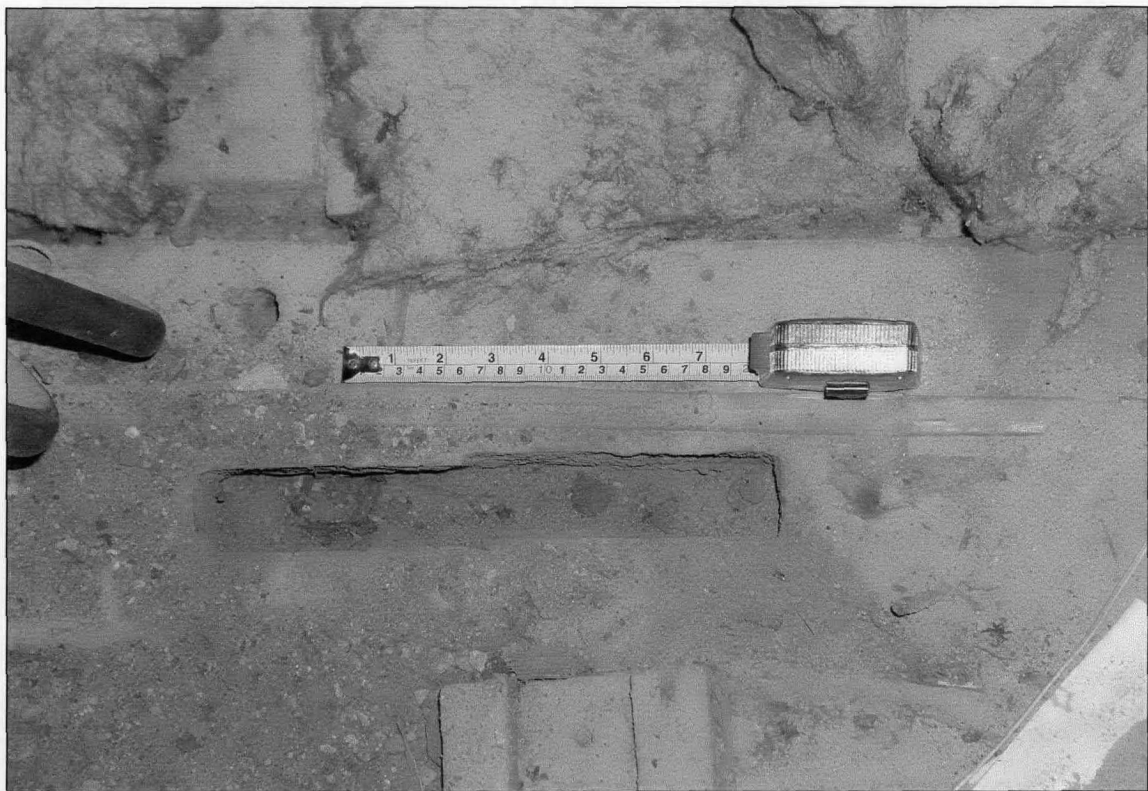
- 3.2.15 On the west side of the building, where the roof structure is better preserved, the position of a mortice joint (Plate 14) on the rear tie beam strongly suggests that the original roof was not a king post structure. The mortice joint is set too close to the NW side of the building to support a king post (approximately 1.40m to the east) and instead suggests either a queen post roof structure or a simple 'A' frame truss with diagonal side struts supporting the principal rafters. No evidence of a central mortice joint for a king post truss was found on any of the surviving tie beams. The primary advantage of using queen post trusses rather than king posts is that they would have provided for a relatively unimpeded roof space. This, in addition to the evidence mentioned above (sections 3.2.13) would seem to indicate that from a very early

*Plate 14 The Old Manor, Clifton: mortise for queen post or 'A' frame strut on rear tie beam, west attic space.*
