Section1: Tower 1 to Bitchdaughter Tower (walls and minor towers)

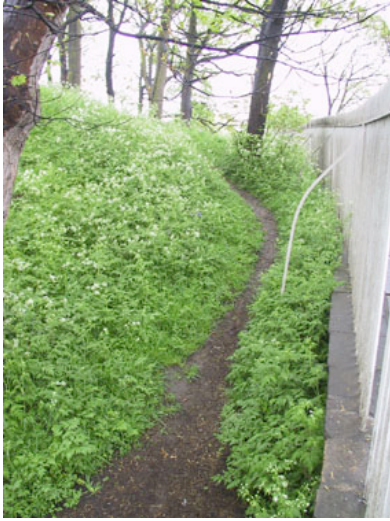
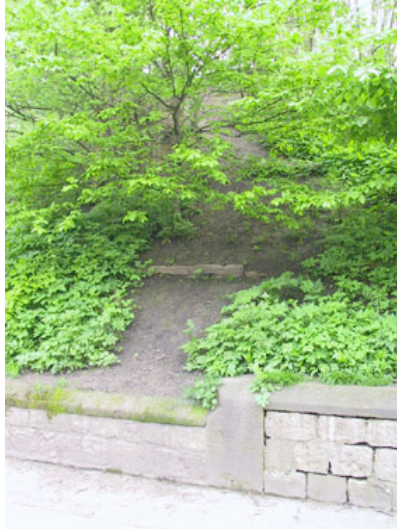
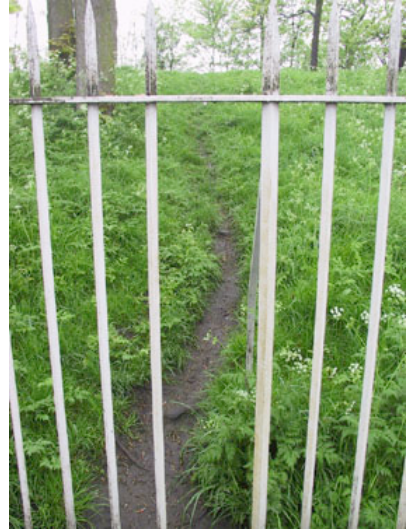
Erosion on Baile Hill

The severe cracking should be investigated by the City Engineer. The wall walk comes very low to the rampart near to Baile Hill, which provides an opportunity for improving physical access to the wall walk by provision of ramp or similar. The two shallow steps up onto Bitchdaughter Tower and two shallow steps off onto the wall heading north west to Victoria Bar, where the wall is at its widest, could also be overcome through use of ramping to provide access to a large section of the wall walk. A ramp at Baile Hill could be curved to complement the topography. Further research regarding the 18th century planting scheme may provide opportunities for the restoration of this landscaping. This may also suggest an appropriate design for the ramp, although an obviously modern, well-designed structure would also be appropriate. This area has an interesting history; being used at various times as a castle, for grazing, for musters, a gun emplacement, a prison, for Shrovetide games and as a prospect mound. These uses provide many opportunities for interpretation and encouraging use by local communities. In addition, its use as a prospect mound could be reinstated, possibly with the judicious removal of trees/tree limbs/vegetation. There is an opportunity for the re-instatement of the steps on the south west side to combat the problems of erosion, but an archaeological assessment must be undertaken

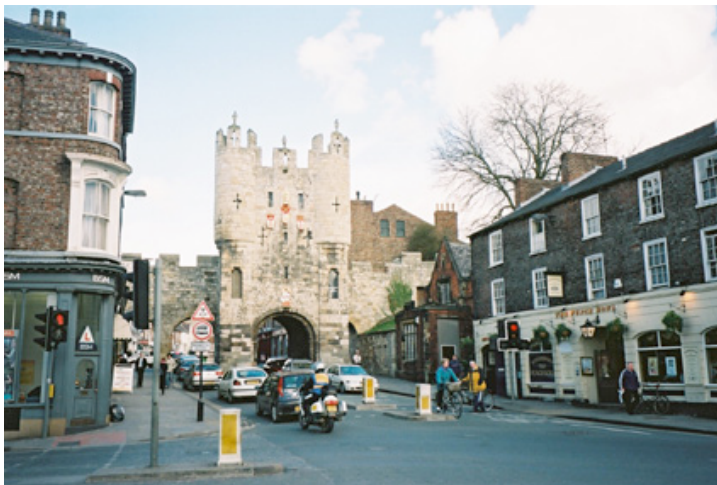
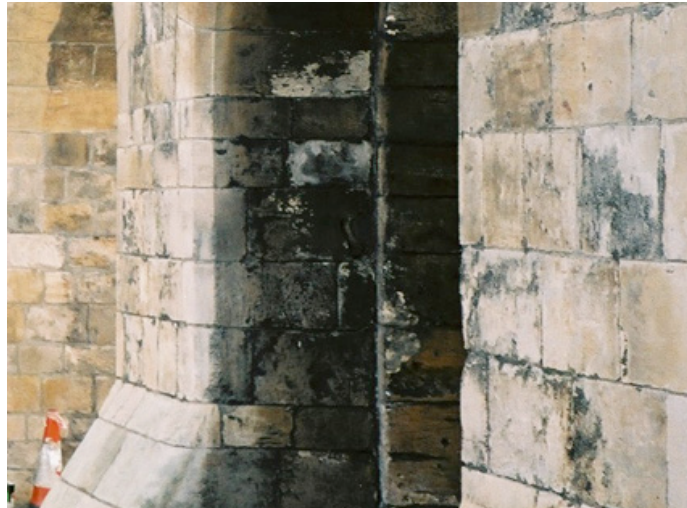
Damage from traffic pollution to the stonework and collision damage is particularly obvious inside the central arch

As with all the Bars it would be preferable if it could be closed to vehicular traffic, or at least restriction of large vehicles, in order to prevent the inevitable serious damage to the historic fabric.

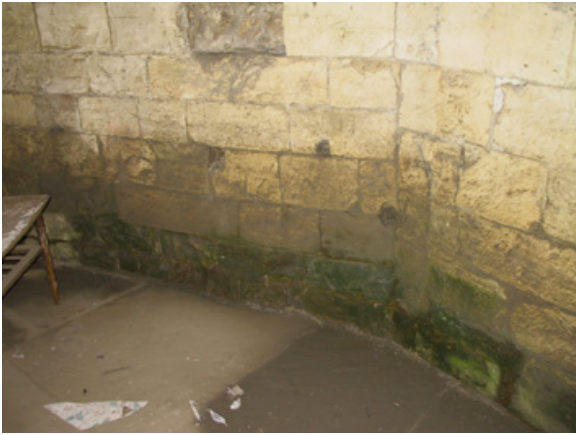
Frequent flooding and the tower's position has resulted in damp in the ground floor stonework

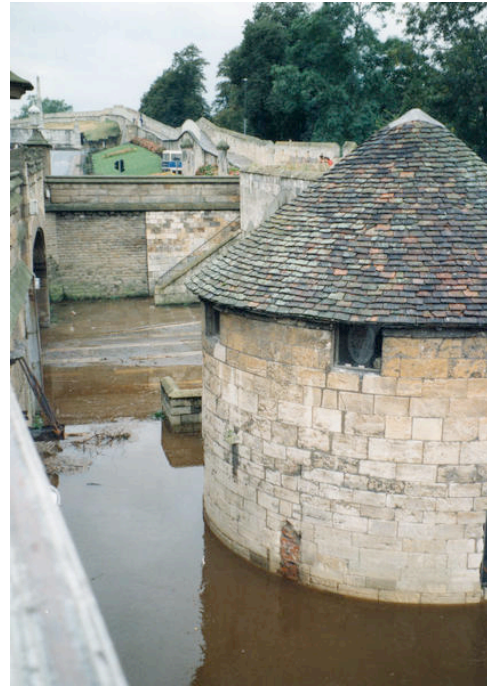
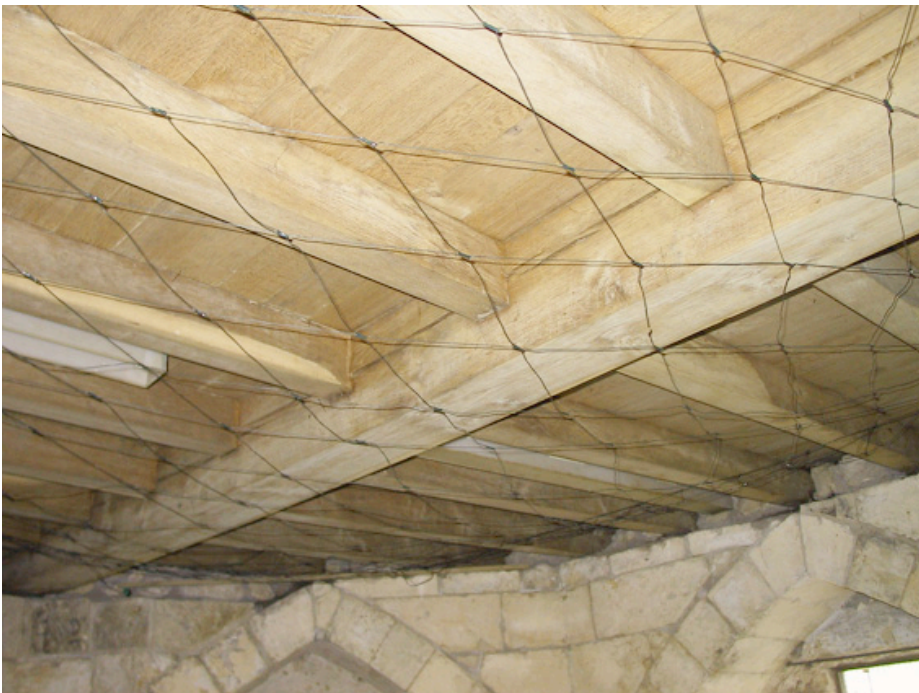
This building is not currently occupied. The stone flagged floor of the upper floor flexes under a slight load and is supported on recently replaced timber joists, the main beam of which is severely cracked. The ground floor interior room floods badly and unsurprisingly there is evidence of damp in the stonework. The roof timbers have either been extensively altered or are re-used wood. The only trace of the staircase mentioned in the RCHME volume is a blocked trapdoor in the first floor. The top step of the external flight leading to the first floor is badly cracked.

The main beam supporting the first floor flags is cracked along its length

The cracking of the main timber beam supporting the first floor should be investigated as a priority.

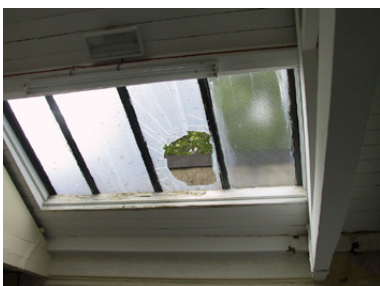
The engine house / payments hall suffers from repeated vandalism

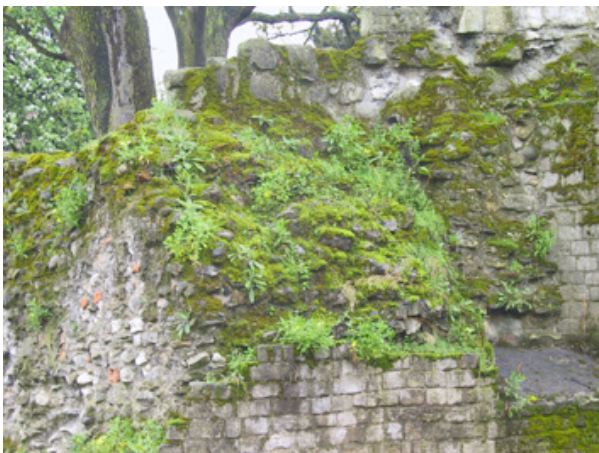
Vegetation on the Multangular Tower could be replaced with a controlled 'soft capping' technique

The vegetation covering much of the tops of the Walls in this area should be carefully removed ensuring that pulling out roots does not damage the stonework, where necessary a weedkiller should be used prior to removal or plant growth covered until it has died back. Soft capping could be considered for the Multangular Tower and potentially the Wall from this towards Museum Street.

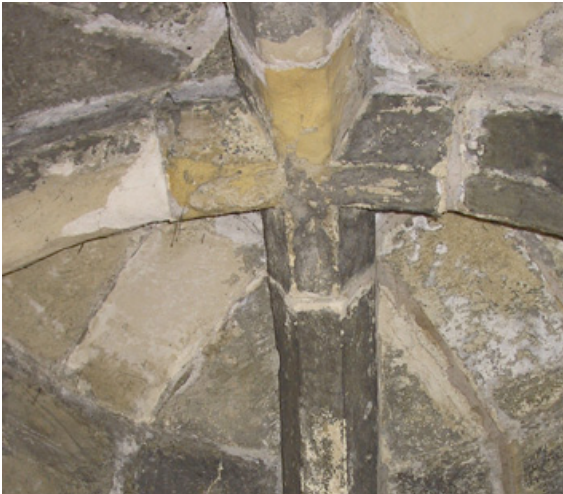
The fabric internally is liable to decay and delamination; there are several areas where this is severe. This may be due to changes in temperature caused by using heaters internally and the ingress of water. There is a damp smell in some areas, particularly the "Little Ease Prison", which suggests water ingress. Inappropriate mortar has been used for repairs in some areas and could be exacerbating the problem. The roof, however appears to be sound and have been replaced relatively recently. In places there appear to be traces of plaster and red colouring on the internal stonework.

The internal stonework is subject to decay

A specialist stone conservator should investigate the causes of stone decay. As a priority the traces of plaster and colouring should be sampled and analysed, as they are likely to disappear as the stone decay continues. This could provide evidence for the historical internal decoration of the Bar.

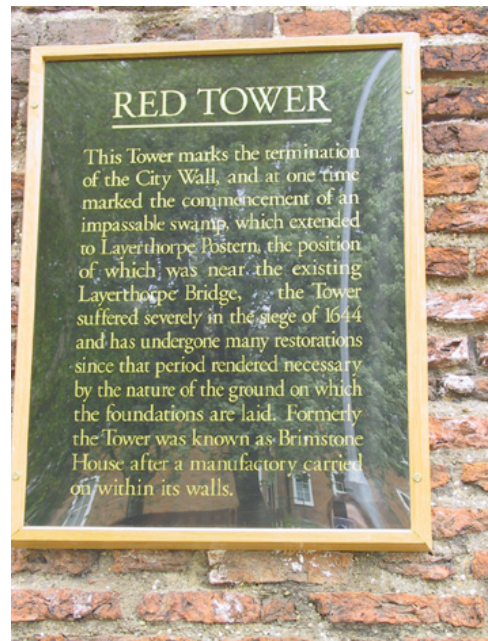
The syntax on the interpretation panel should be corrected, while the text and method of presentation would benefit from updating

There are opportunities relating to the previous use of the building, especially regarding its use as a sulphur factory, to provide additional interpretation and links with the national curriculum. The building is currently underused and provides an opportunity to provide undercover interpretation facilities, especially for small school groups. Any opening of this building to the public should take account of issues regarding security and antisocial behaviour. The errors on the current interpretation panel should be resolved.
