# No.1 Little Shambles York

Historic Timber Assessment

April 2019

Annotated rear elevation

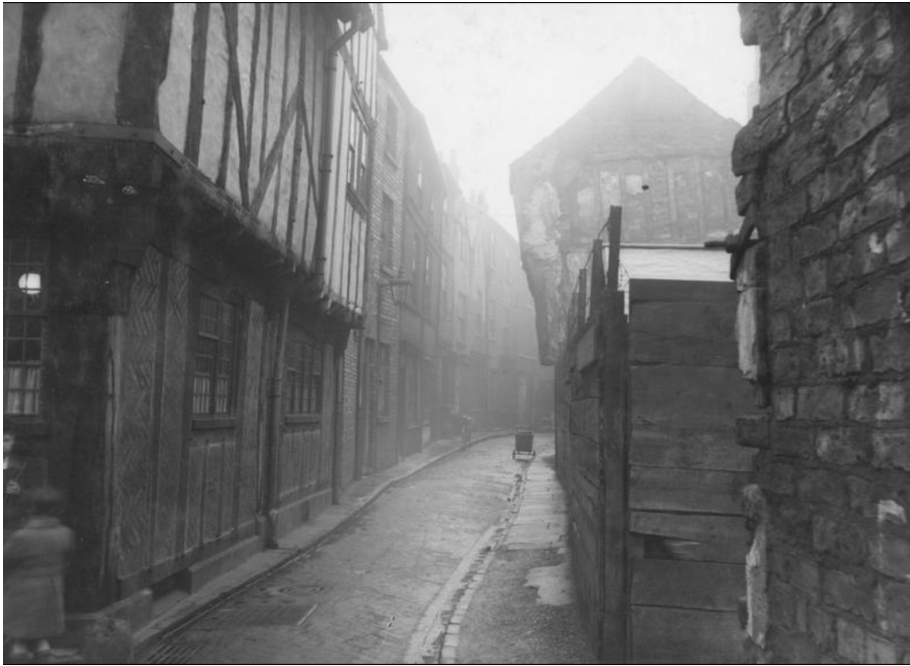
Looking east along Little Shambles c.1933 prior to clearance (c) City of York Council.

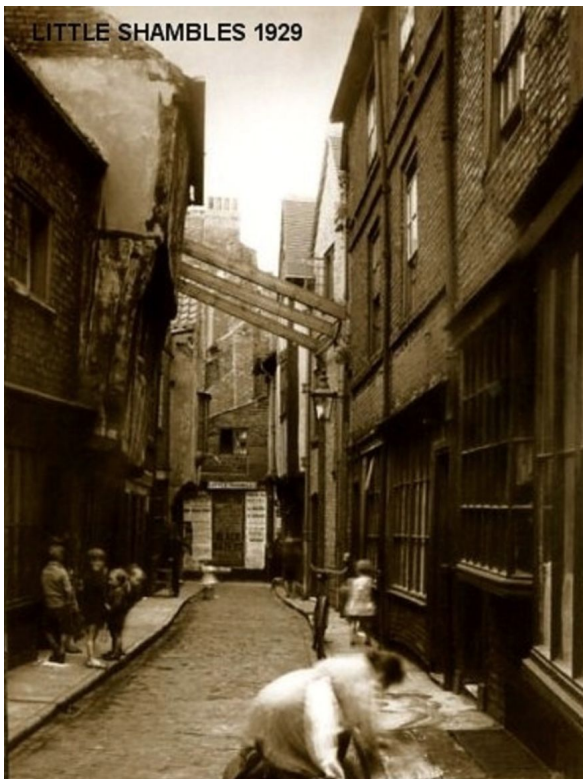
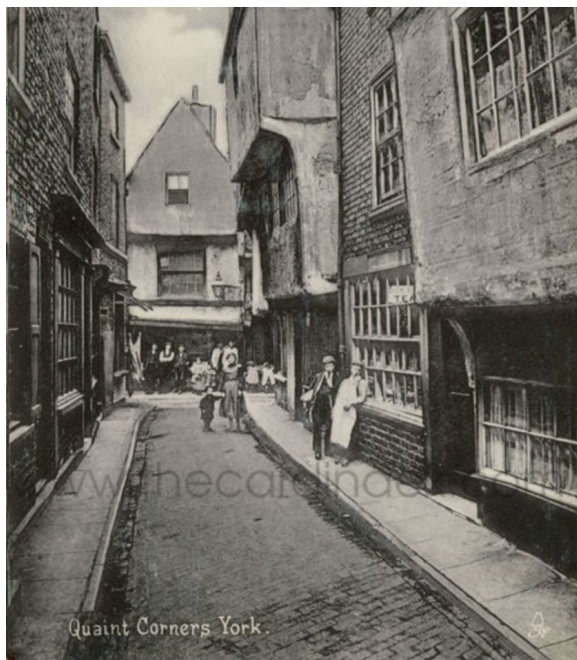
No.1 Little Shambles (L) seen far left in 1929 with the second floor propped © YAYAS; and (R) seen far right in the late C19/early C20 showing considerable lean in the front elevation © www.thecardindex.com.

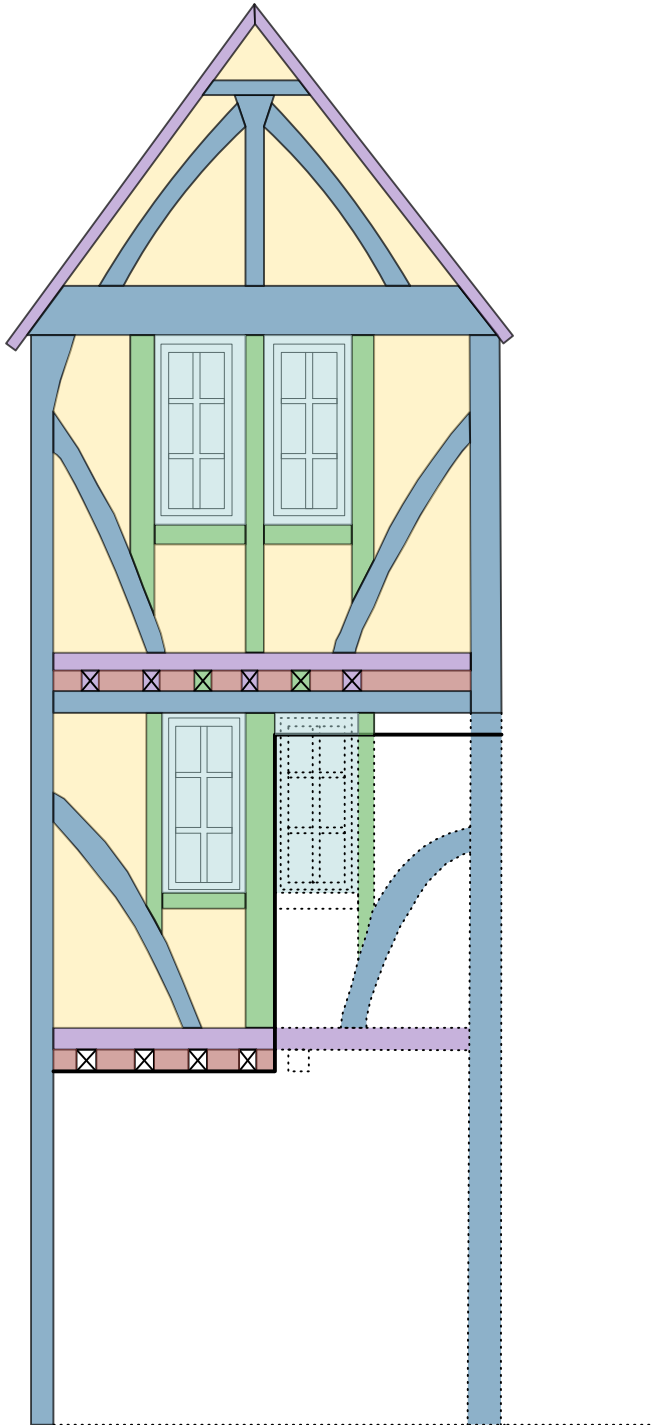
3150-0-001

Visual analysis revealed many timbers demonstrated signs of considerable age, including weathering, shaking, later alteration (including peg holes, notches/indentations/mortices, and staining from nails commonly used as a key for render). Based on these features many of the main frame components, including the corner posts, rails, braces, and crown post are likely original timbers. Many of the subsidiary studs and window rails appear later, but may represent earlier (possibly C19th) repairs and replacements, and thus likely pre-date the 1950s restoration. Overleaf is a table, which accompanies the annotated elevation (drawing 3150-0-001), detailing the visual assessment of the timber.

Ref	Type	Description
	1	Jowl Post	Clear sign of aging (weathering, shaking etc.) and historic alterations internally. Very likely original.
	2	Jowl Post	Clear sign of aging (weathering, shaking etc.) and historic alterations internally. Very likely original.
	3	Principal Rafter	Very crisp and clean-edged. Much of the roof structure was replaced during c.1950 restoration. Very likely 1950s.
	4	Principal Rafter	Very crisp and clean-edged. Much of the roof structure was replaced during c.1950 restoration. Very likely 1950s.
	5	Truss Tie Beam	Clear sign of aging (weathering, shaking etc). Likely original.
	6	SF Upper Rail	Unusual placement, likely related to reinforcing structure. Very straight timber with little sign of aging. Possibly C19, but likely 1950s.
	7	SF Lower Rail	Heavily weathered with evidence of historic shaping and later lead flashing. Likely original.
	8	FF Upper Rail	Unusual placement, likely related to reinforcing structure. Very straight timber with little sign of aging. Possibly C19, but likely 1950s.

9	Gable Brace	Clear sign of aging (weathering, shaking etc) and evidence of nail staining from rendering. Likely original.
	10	Gable Brace	Clear sign of aging (weathering, shaking etc). Likely original.
	11	SF Brace	Clear sign of aging (weathering, shaking etc). Likely original.
	12	SF Brace	Clear sign of aging (weathering, shaking etc). Likely original.
	13	FF Brace	Clear sign of aging (weathering, shaking etc). Likely original.
	14	Collar Tie	Nail stains suggesting rendering prior to 1950s restoration.

Ref	Type	Description
	15	Crown Post	Clear sign of aging (historic peg holes and indents). Likely original.
	16	SF Stud	Largely obscured by pipework, but signs of aging. Likely historic, but inconsistent pegging suggests this might be a later replacement (C19?).
	17	SF Stud	Largely obscured by pipework, but signs of aging and historic nail stains, dating it to before the 1950s restoration. Inconsistent pegging suggests this to be a later replacement. Likely historic (C19?).
	18	SF Stud	Signs of aging. Likely historic (C19?), but inconsistent pegging suggests this might be a later replacement.
	19	SF Window Rail	Nail stains suggesting rendering prior to 1950s restoration, but otherwise very straight timber suggesting not original (C19?).
	20	SF Window Rail	Nail stains suggesting rendering prior to 1950s restoration, but otherwise very straight timber suggesting not original (C19?).
	21	FF Stud	Largely obscured by pipework, but signs of aging. Likely historic, but inconsistent pegging suggests this might be a later replacement.

22	FF Stud	Largely obscured by pipework, but some signs of aging. Very straight and no evidence of nail stains. Likely historic.
	23	FF Stud	Largely obscured but clear signs of aging and nail staining. Likely historic (C19?).
	24	FF Window Rail	Some evidence of aging, suggesting pre-1950s but likely not original.
	25	FF Brace	Largely obscured, but clear sign of aging (weathering, shaking etc). Likely original.
	26	SF Floor Joists	Internal inspection reveals most joists are 1950s replacements, with no.2 exceptions. The 3rd joist (from west) features an etched carpenter's mark (VIII) suggesting a C19? Replacement scheme.
