**SKELTON HALL  
SKELTON  
NORTH YORKSHIRE**

**HISTORIC BUILDINGS ASSESSMENT**

*Colin Briden*

*April 2019*

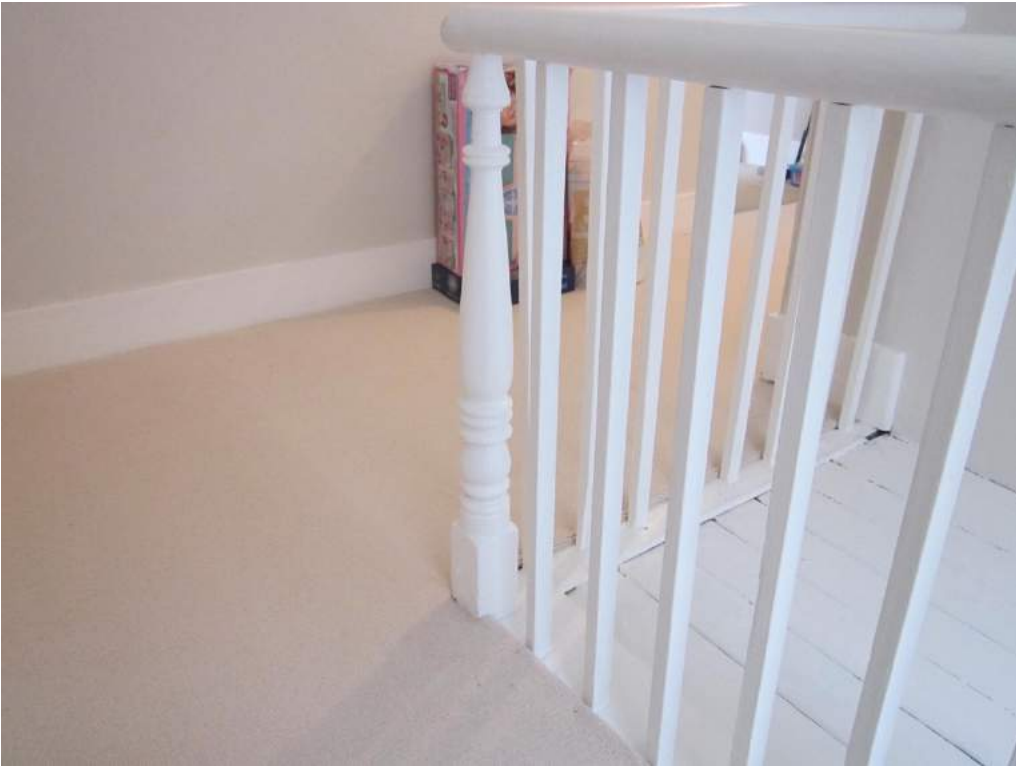
The service stair, which rose to the attics through the full height of the house, was at the east end of the axial passage. A ground floor division here – the traditional ‘green baize door’ – has evidently been lost and with it the lower flight of the stair which was apparently entered directly from the kitchen. An upper flight, cut about and altered, still survives (Fig 9), as does its protecting balustrade in the attic (Fig 6). This has stick balusters, two turned newels, and a slender handrail, all of about 1820.

Fig 6: Attic floor: head of Phase I service stair

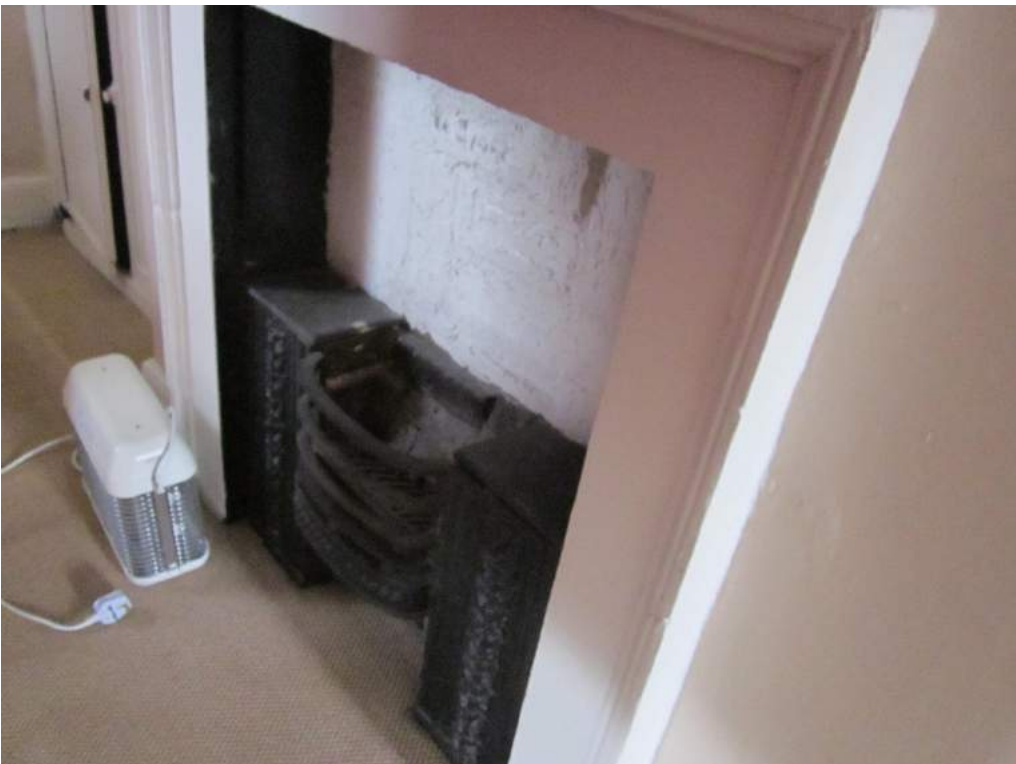
Some original fireplace surrounds survive although rather fewer actual fireplaces. Bedroom 4 retains both (Fig 7) – a simple surround and a hob-grate – while Bedrooms 2, 3 and 5 have more elaborate surrounds with later C19 tiled inserts. The ground floor rooms have late C19 fireplaces and surrounds or – in the drawing room – modern reproductions. The library fireplace, which was formerly that of the saloon, is entirely missing; it has been replaced by a large stove. A very large late C19 fireplace heats the cloakroom.

Fig 7: Bedroom 4: Phase I fireplace in contemporary surround

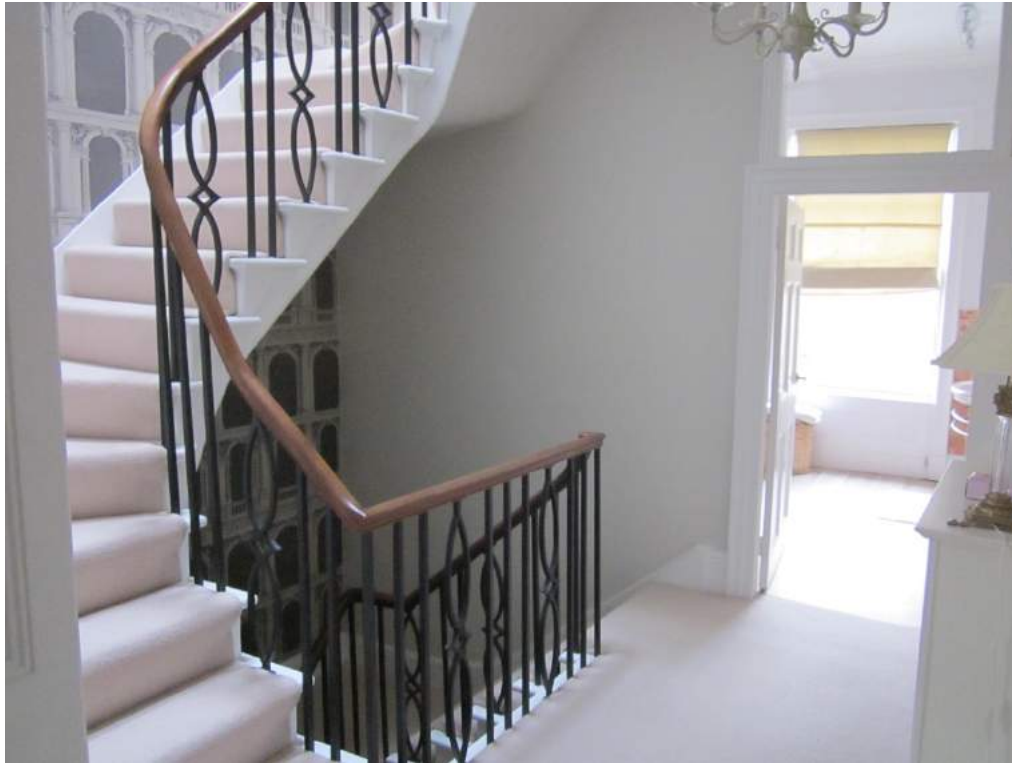
Fig 8: Phase III stair hall 1980: first floor landing and stair

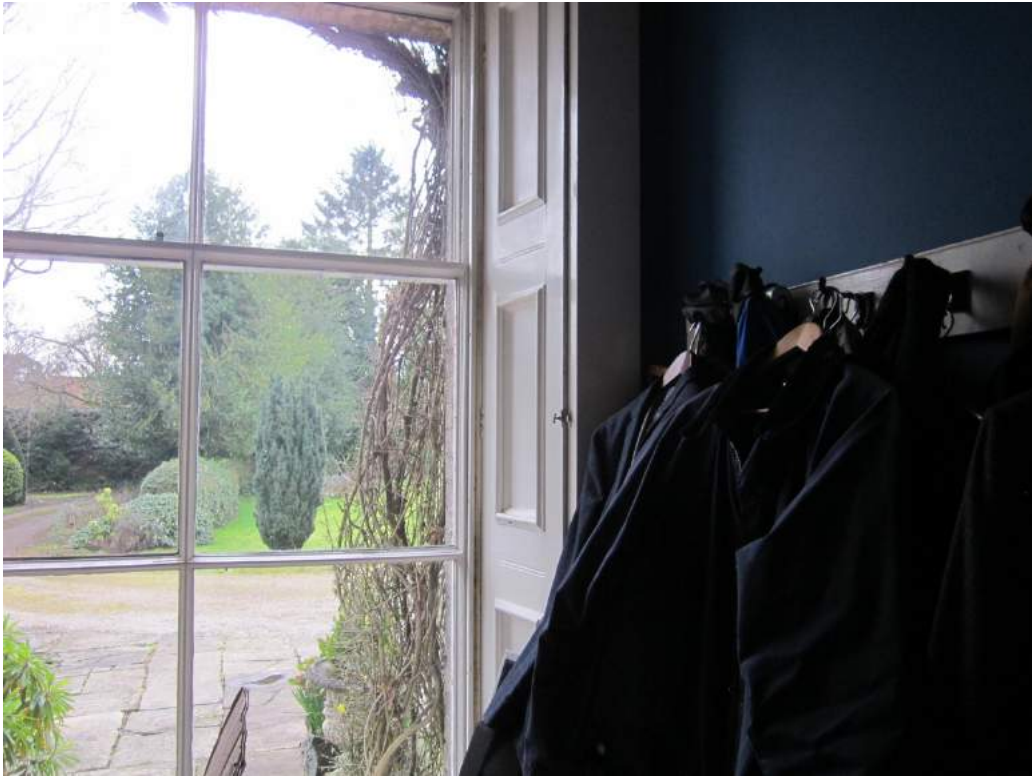
Doors are generally four-panelled and either of sunk moulded, bolection moulded, or plain (in the west attics) panels. Early C19 architraves survive throughout the house. The windows to the principal elevations retain folding panelled shutters with panelled soffits where these are appropriate and practicable (Fig 10). Generally the standard of joinery in the house is high and it has survived well.

Fig 10: Cloakroom: detail of Phase I beaded folding panelled shutters

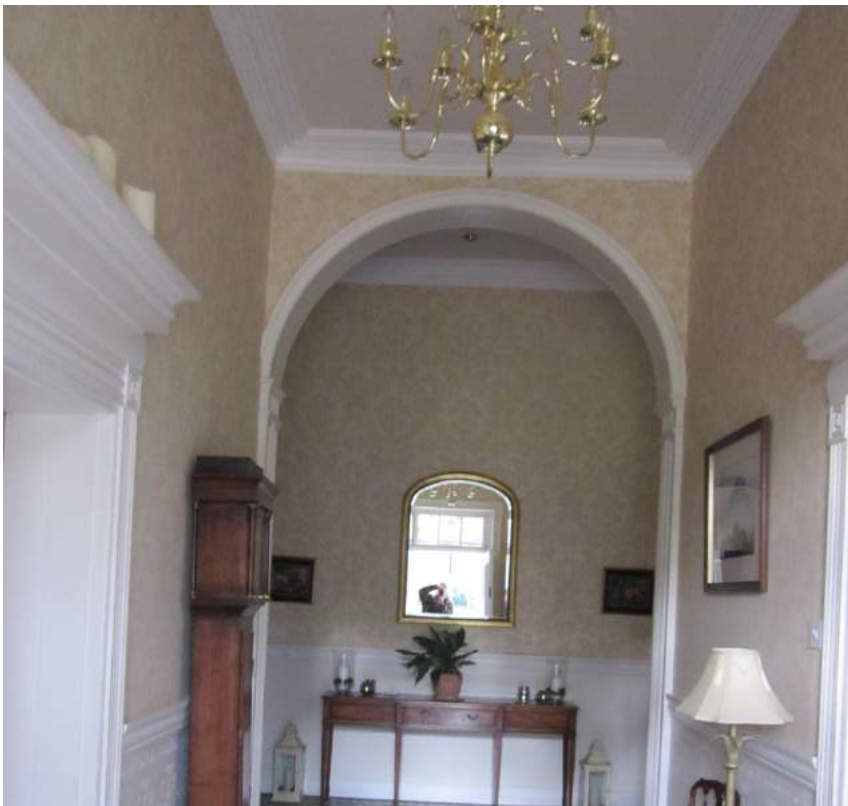
Above the entrance hall at its junction with the axial passage there is a round-headed moulded plaster arch on fluted pilasters (Fig 11). At the south end of the entrance hall there is an exceptionally wide and heavy early C19 external door of four bolection moulded panels on strap hinges with sunk-panelled reveals to an outer, glazed, screen door.

Fig 11 Entrance Hall: Phase I moulded arch on moulded impost and pilasters; Phase I doorcases

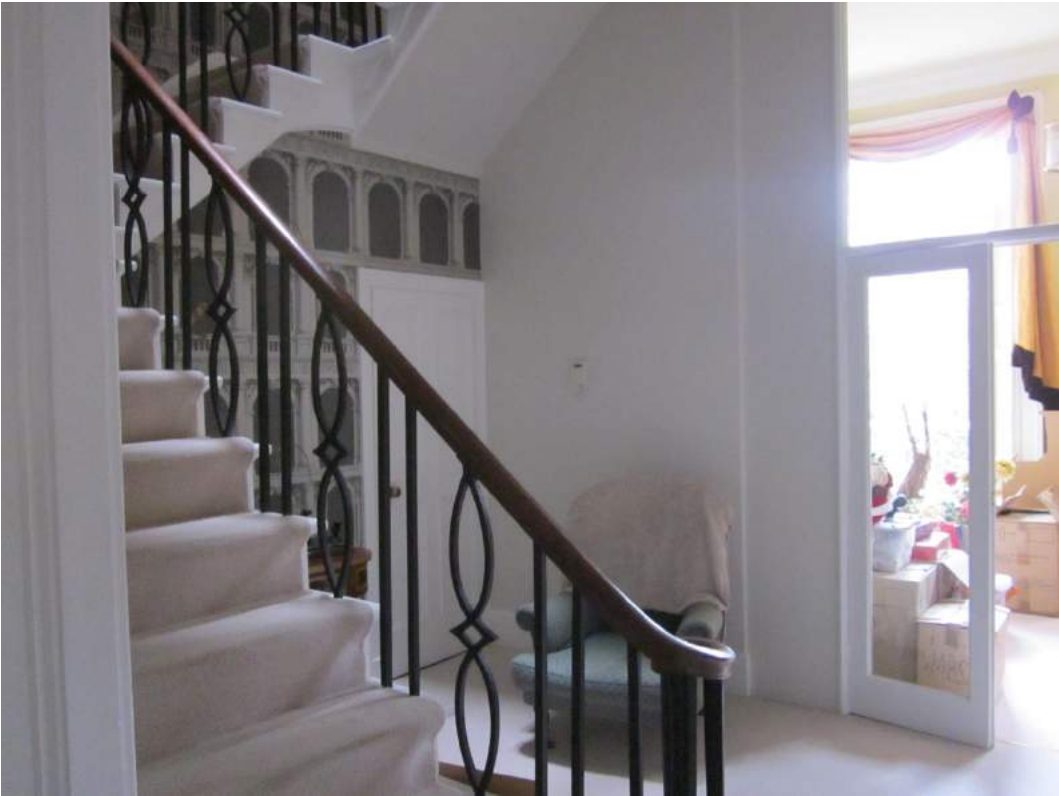
Fig 12 Phase III 1980 ground floor stair hall

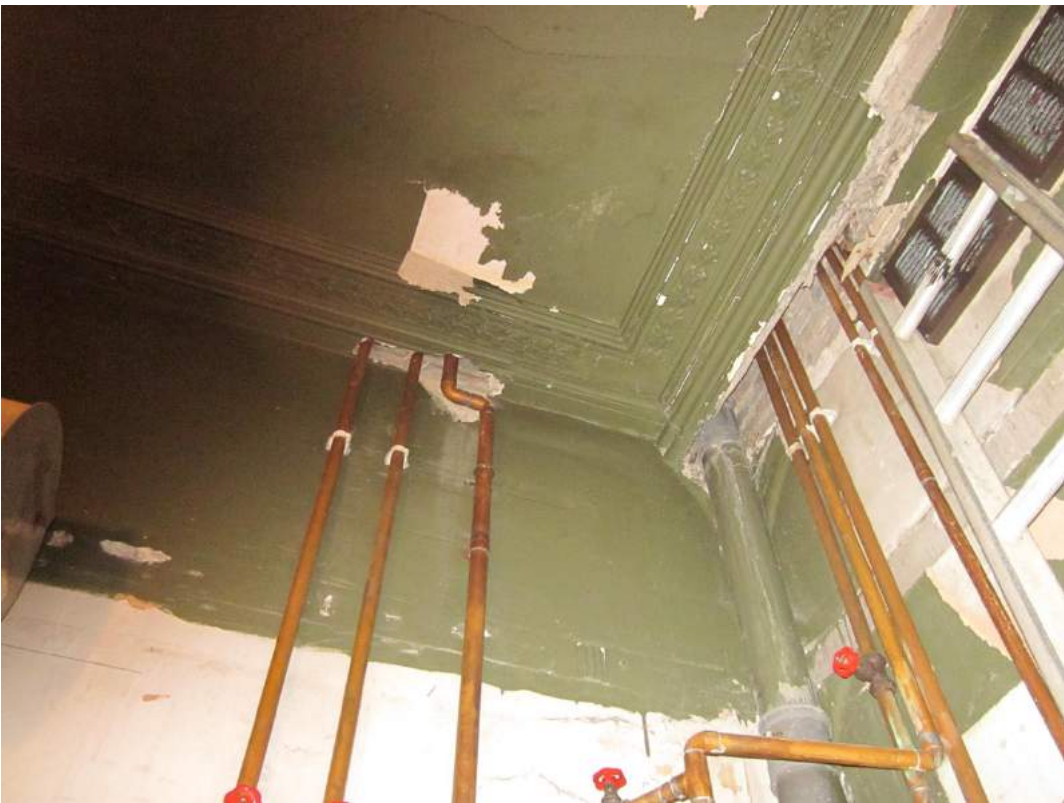
Moulded plaster ceiling cornices are more problematical. One interesting survival is seen in the present boiler room (to the north of the C20 inserted main stair) where short lengths of the early C19 cornice around the north-west corner of the ceiling of the lost saloon have survived among the central heating pipes (Fig 13). Other remnants of this cornice may survive above the C20 inserted ceiling in the library. This now has a modern palmette cornice. The dining room ceiling and cornice seem to have been superseded by an elaborate late C19 coffered arrangement although this room does retain its all-important four-panelled door and architrave from the kitchen. As already described the high-status doorways opening off the entrance hall have fluted architraves with square paterae in a developed late Georgian style.

Fig 13 Fragment of Phase I moulded plaster ceiling cornice to NW corner of lost Saloon

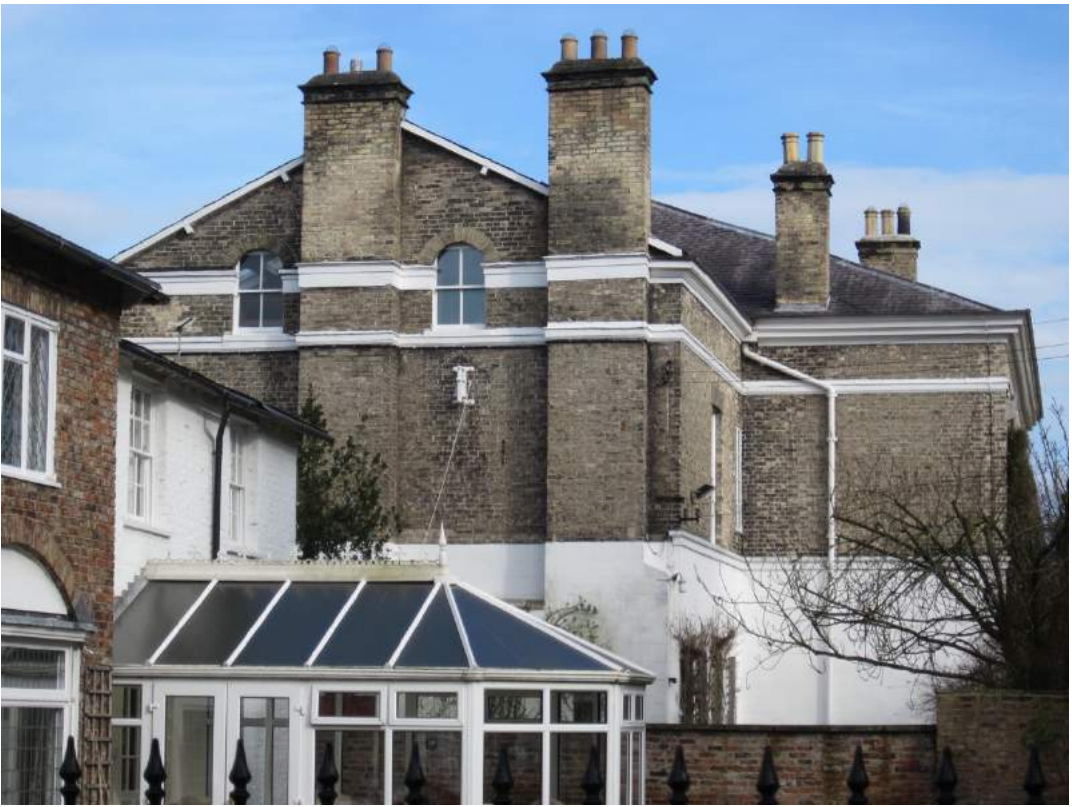
Fig 17 West elevation with evidence of demolished single-storey service range

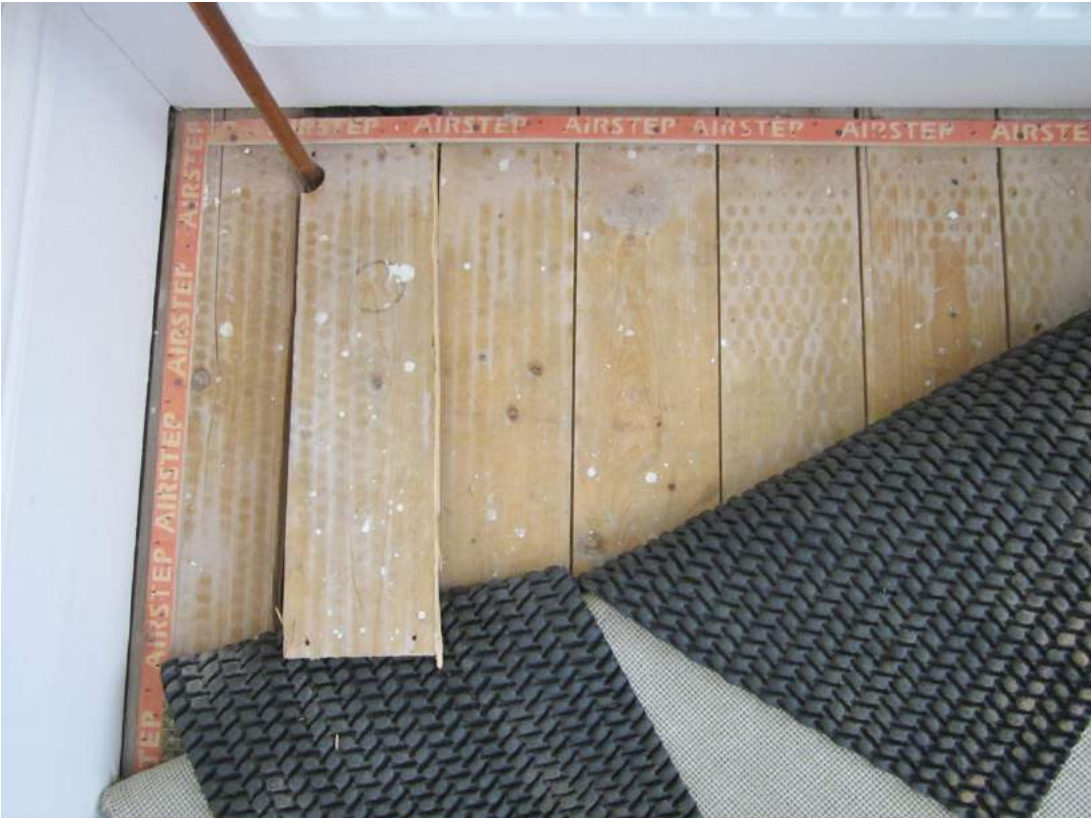
The most dramatic alteration was the removal in c.1980 of the original stair in the south-east corner of the main block of the house. Opening-up work has revealed that the present first-floor structure in that area is of late C20 narrow T&G boards on 10" x 2" plank joists lodged on a rolled steel joist. Below the joists can be seen ceiling joists of the same date and also the upper surface of the ground floor ceiling itself; which is of plasterboard panels (Figs 18 & 19). The stair-window in the east wall of the ground floor room (now a study) was removed, the embrasure blocked, and the window re-used in a new opening on the floor above to bring additional light to what was intended to be used as a dance studio as described below. A new doorway was made in the east wall at ground floor level to give access to the conservatory, the subject of a successful planning application in 1980 (Fig 20).

Fig 18 Inserted floor of c.1980 in former Phase I stair hall

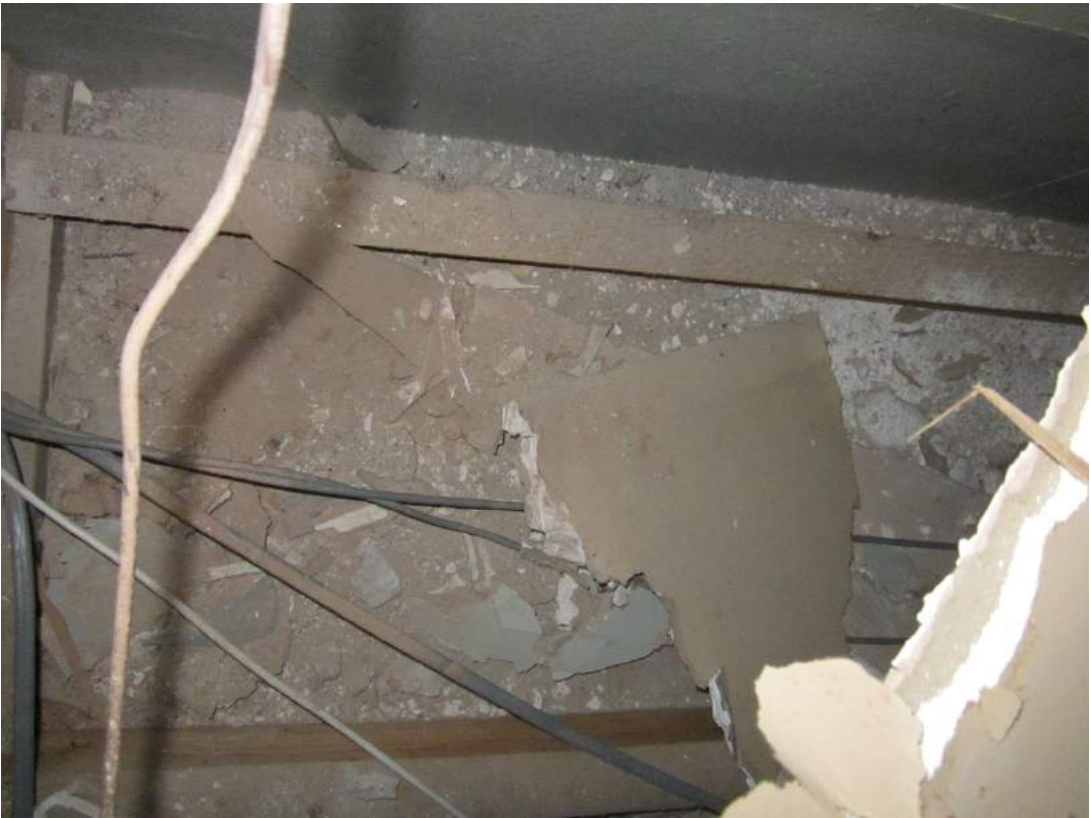
Fig 19 View from above of inserted plasterboard ground floor ceiling in former Phase I stair hall

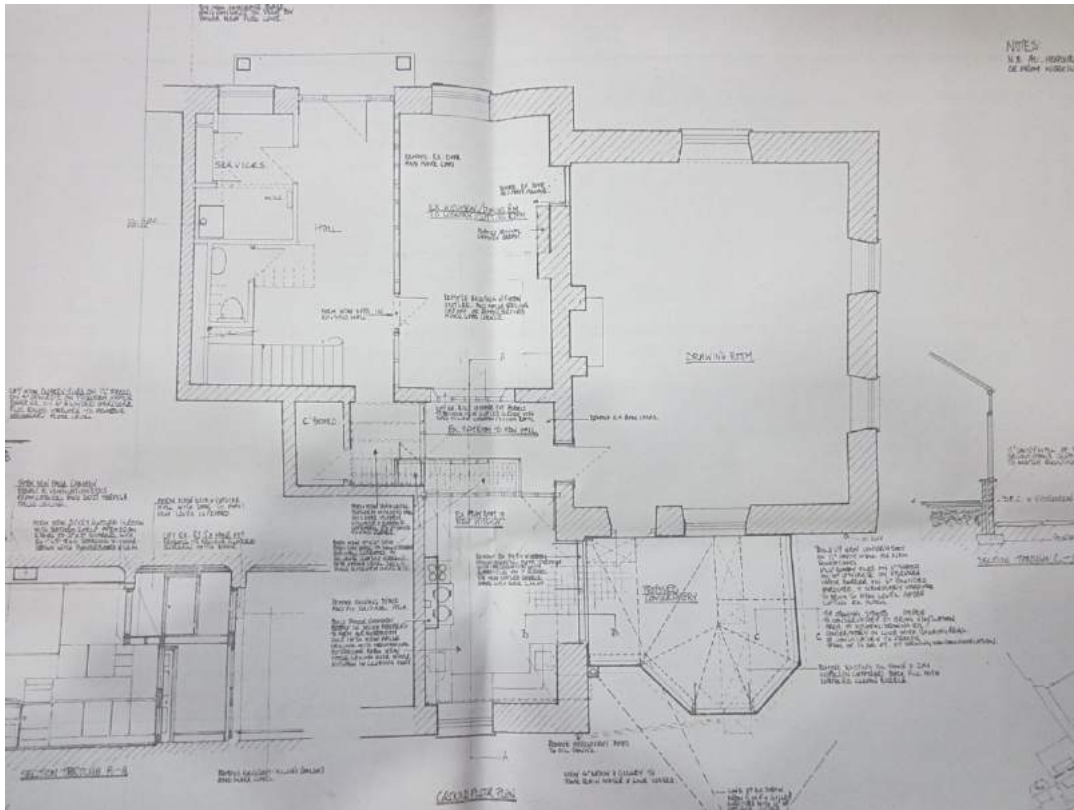
The evidence for the line of the division comes in a general way from the 1965 OS sheet and in more detail from a proposal drawing of 1980 when the east house was altered (Fig 20). This drawing shows the dividing wall at ground level crossing the axial passage. Photography taken in 1998, when the wall had been broken through, shows that it took the same line at first floor level. The situation in the attics is now slightly less clear as a result of late C20 alterations but that they were also divided at about the same point is certain.

Fig 20 1980 planning application: proposal drawing, ground floor east house

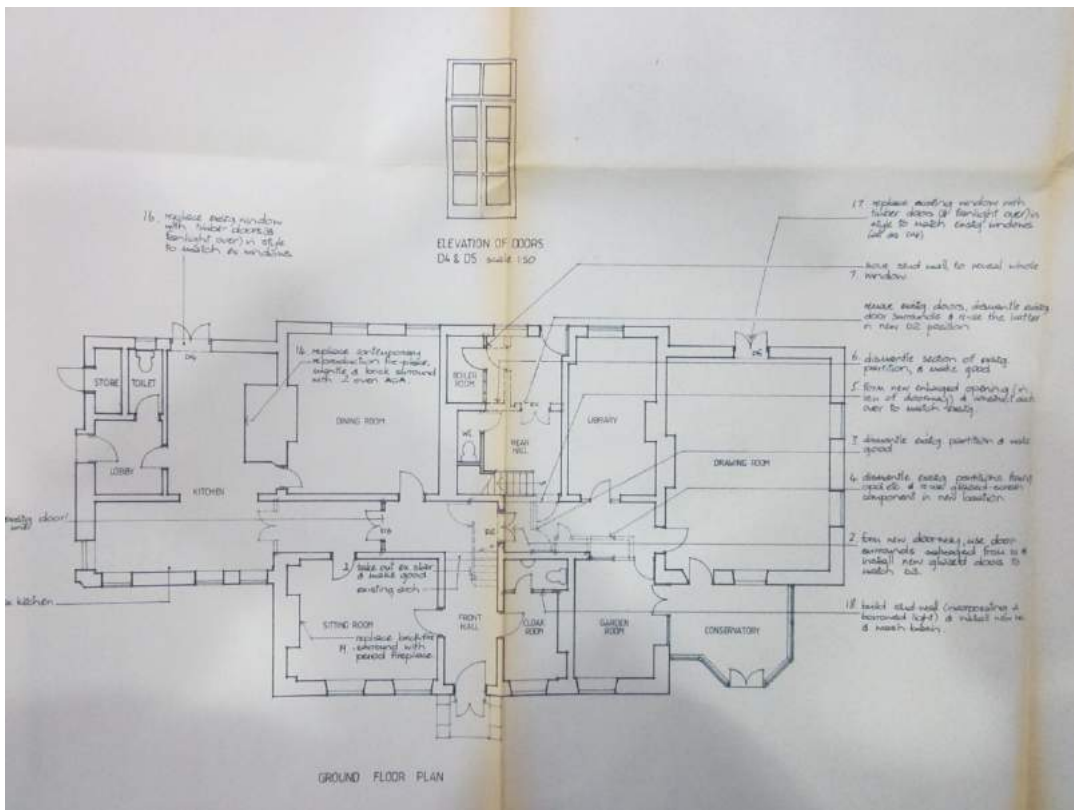
In 1998 both the houses were sold to a new owner who immediately submitted a Listed Building Consent application to return the Hall to single occupancy (Fig 21). The inserted dividing wall between the houses was removed, the inserted 1952 main stair to the west house was removed from the entrance-hall, and some minor lightweight partitions introduced to form en suite bathrooms and WCs.

Fig 21 1998 LBC application: proposal drawing, ground floor
