ARCHAEOLOGICAL  
T R U S T

**ST MICHAEL'S CHURCH,  
SPURRIERGATE,  
YORK**

**REPORT ON AN  
ARCHAEOLOGICAL  
WATCHING BRIEF**

**1999 FIELD REPORT  
NUMBER 63**

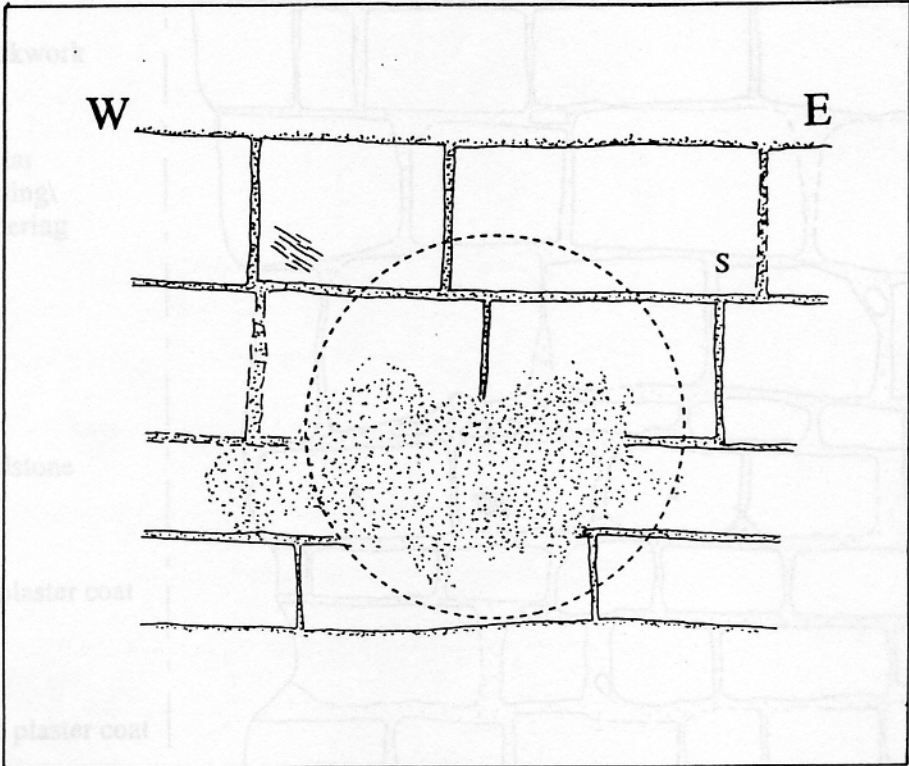
Figure 3 West tower, south gallery, internal wall, external elevation

The affected fabric was the uppermost four courses in the 0.35m-wide internal wall of the south gallery, opposite the doorway onto the roof (Figure 2). The area of stonework removed formed a circle 0.60m in diameter, the top of which was 0.15m below the stone corbel of the gallery ceiling (Figure 3).

The courses varied between 0.13-0.18m in thickness (1000). The squared blocks measured 0.25-0.40m long, and were limestone with one example of sandstone. The visible face of each stone had been well dressed using a chisel, although patches of mortar up to 0.48m in diameter suggest that the stonework had once been rendered.

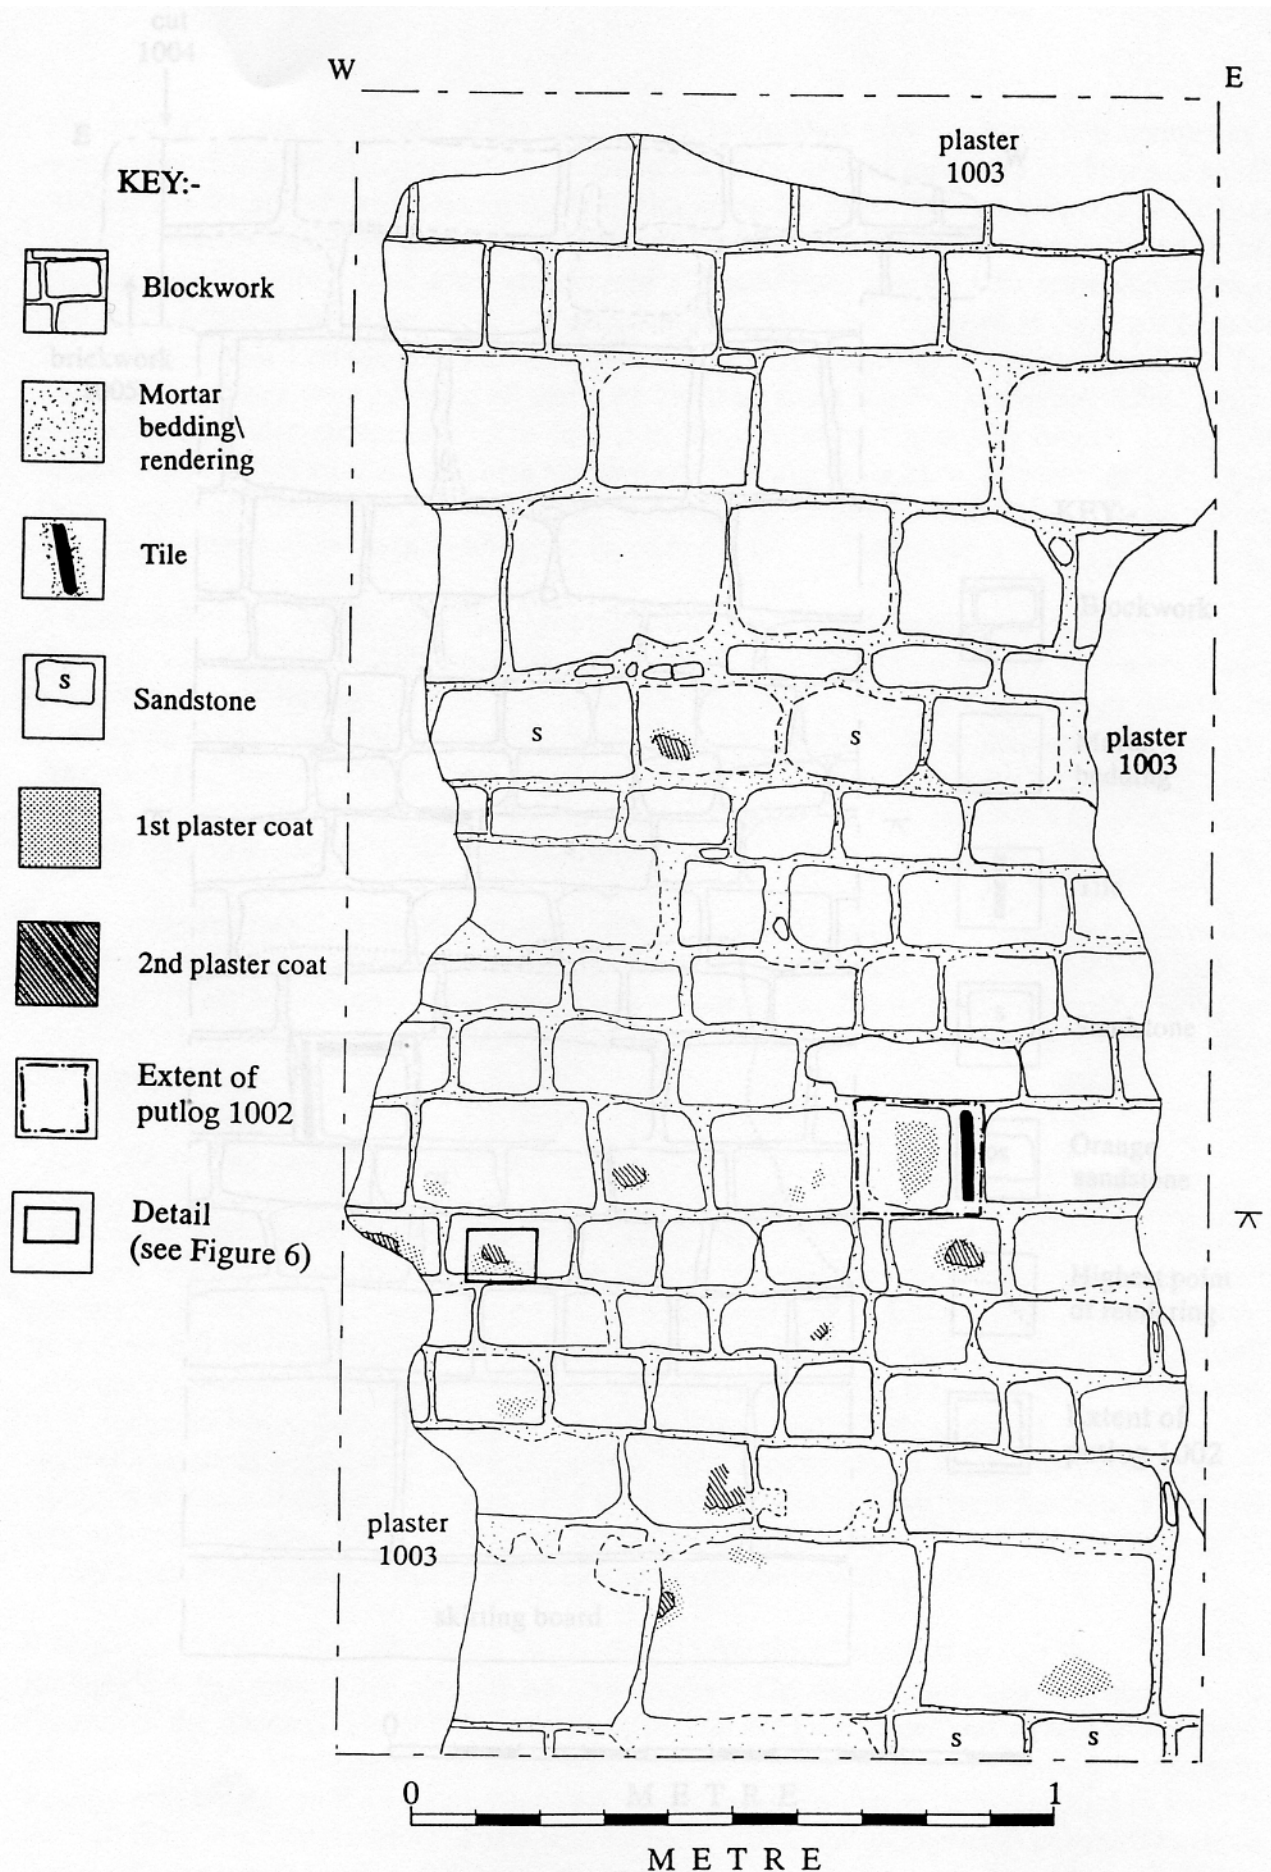
Figure 4. North wall, internal elevation

The area of masonry removed to form the doorway in the north wall formed a rectangle 2.52m high (Figures 4 and 5). It was an average of 1.0m wide, although due to the cutting out of individual stones the sides of the opening were irregular (measuring as little as 0.93m wide) and the insertion of a lintel required an opening 1.4m wide at the top. The bottom of the doorway was at first floor level in St. Michael's Chambers, but as the mezzanine in the church was much lower the opening was 1.1m above the mezzanine floor level (to be reached by a stairway).

There were signs that three successive layers of plaster had been applied to the internal face of the north wall; the latest formed a complete surface, whereas the others survived only in small patches. The earliest layer was light grey/brown in colour, and lacked a mortar base. In places, the plaster had been applied to the mortar bonding where it infilled slight concavities in the wall face, but elsewhere the plaster had been applied directly onto the stones. The plaster bore traces of a design in black paint, the largest surviving element of which appeared to form an 'x', suggesting part of a medieval script (Figure 6). The second plaster layer was light brown in colour, and also lacked a mortar base. The third layer was mid brown, on a 5mm-thick layer of fine grey/white mortar. The plaster had been stained with numerous dark grey vertical lines around 5mm wide, probably due to water having run down the walls (1003).

Subsequently, the existing plaster on laths, some 15mm thick, attached to two layers of lattice studding that had been nailed onto the wall, was added. The studding measured 75mm square in the area of the doorway; although measurements could not be obtained due to lack of access, it was clear that the scantling of the studs was very small at the foot of the wall, and increased steadily with height. In the area of stonework investigated, the plaster face was 0.3m in front of the wall face. It would therefore appear that the north wall of the church leans outwards by more than 0.3m, perhaps as much as 0.5m, and the scantling of the studding was increased with height

in order to offset this lean and form a vertical internal surface. Coats of cream, light brown and mid grey paint were observed on the plaster beneath the extant whitewash, which suggests that the plaster and studding was constructed some time ago.

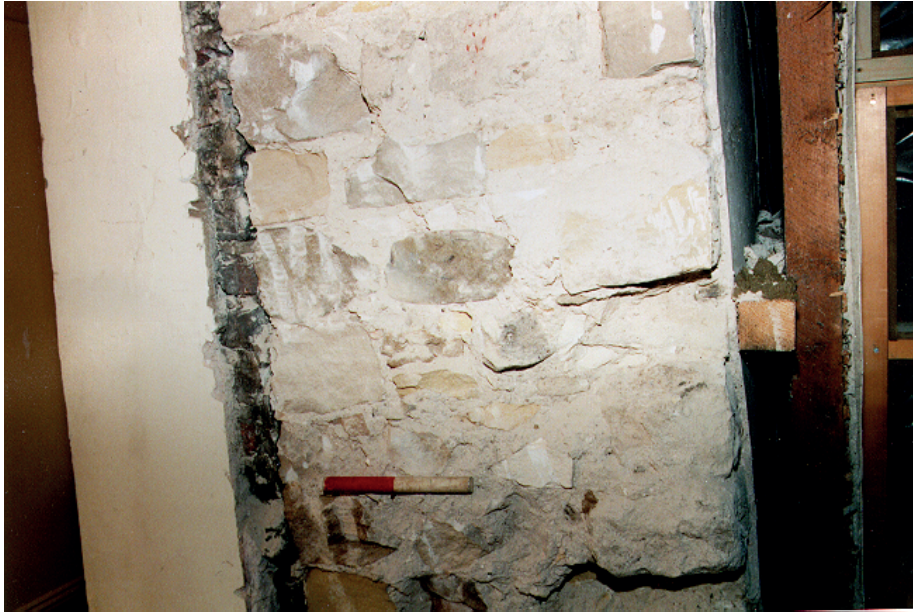
Plate 1 Section through north wall,  
looking east. Scale 20cm.

The masonry in the north wall of the church was 0.60m thick (1001; Plate 1). It comprised a mortared core of small-large limestone fragments with occasional sandstone cobbles and small-medium tile fragments, which was roughly 0.20m thick; the larger stones appeared to have been laid in courses rather than as randomly deposited rubble. The core was faced internally and externally with coursed limestone and occasionally sandstone blocks, also some 0.20m thick. The joints between the stones were generally less than 5mm, but appeared to be larger because the slightly rounded visible edges of the stones had been concealed by the mortar bonding. The backs of the stones were rounded so that they could be fitted together along the visible edges, producing an ashlar appearance. The height of the courses was generally around 0.12m, but ranged between 0.05m–0.32m. There was a degree of correspondence between the courses of facing stones and the masonry core, although this was less evident in the courses of larger stones. The tile fragments found in the wall fabric dated to the 13<sup>th</sup>-16<sup>th</sup> centuries.

A single hole some 0.19m wide by 0.17m high, which continued through the complete width of the wall was recorded. This hole was evidently a putlog that had carried a 6-inch square horizontal timber through from one side of the wall to the other, presumably to secure the scaffolding erected on either side of the wall during the construction of the church. After use, the putlog had been infilled on both faces of the wall with square limestone fragments, wedged in with fragments of ceramic roof tile and sparingly mortared (1002); the core was left as a void. The tile fragments date to the 14<sup>th</sup>-16<sup>th</sup> centuries.

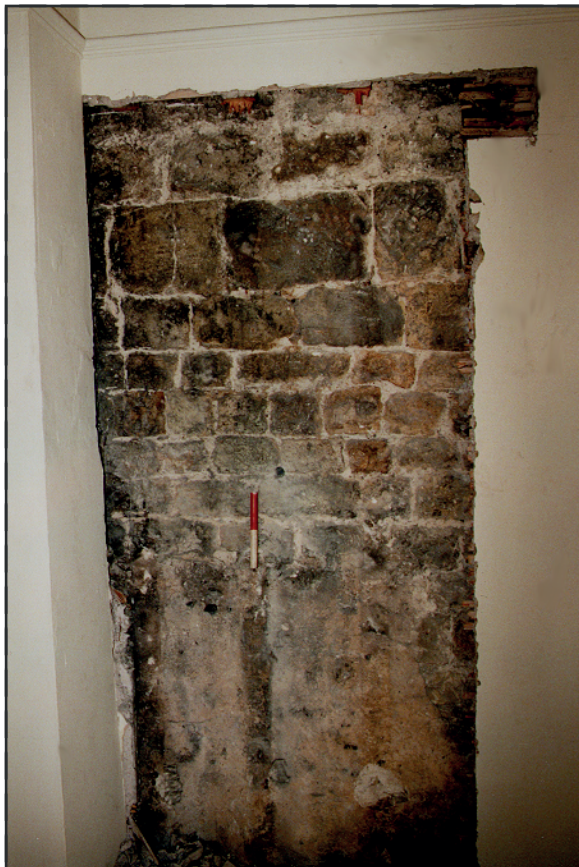
Plate 2 External elevation showing  
rendering. Scale 20cm.

The external face of the church wall had been covered at one time in a 5-10mm-thick layer of light grey/white mortar, which survived over much of the lower half of the exposed masonry (Figure 5; Plate 2). A brick chimney in St. Michael's Chambers (1005) immediately east of the stonework examined butted against, and so post-dated, the mortar layer, indicating that the mortar originally acted as rendering on the exposed external face of the church wall, prior to the construction of 24 Spurriergate and its chimney. The bricks in the chimney measured 2.125-2.25 inches thick, which suggests they date to the 17<sup>th</sup>/18<sup>th</sup> centuries.

When 24 Spurriergate was built, it was not given its own south wall; the north wall of the church was used instead (Plate 2). The church fabric was concealed by plaster and laths fixed to half-inch thick vertical studs. There was evidence for a coat of light brown paint beneath the existing cream paint. The chimney immediately to the north of the exposed stonework was partly formed by a brick frontage (1005) butting against the church wall, but the rear part of the flue had been created by hacking out the church fabric to a depth of approximately 0.17m (1004).
