# LEVEL II HISTORIC BUILDING RECORDING REPORT

Frederick House, Fulford Road, York

**Planning Ref: 19/00603/FUL**

December 2020

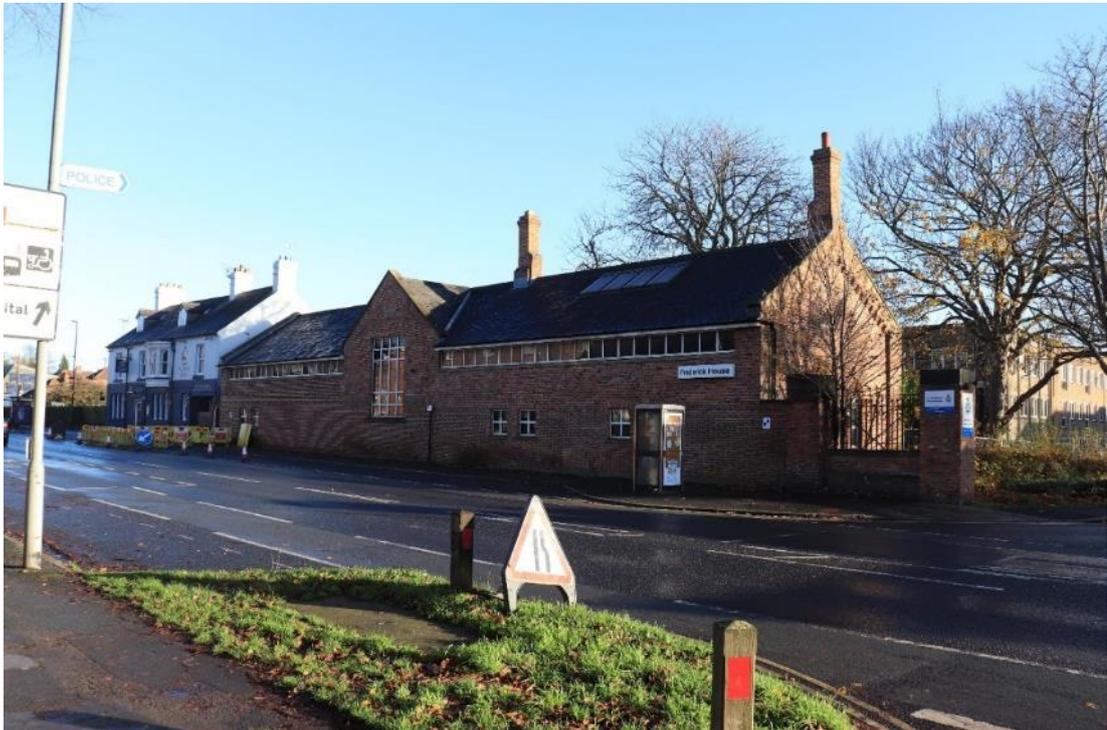
- 4.1. The Guard House is a one and a half storey building (**Photograph 6**) of a combination of red and dark grey brick in a Flemish bond. The building appears to have been completely re-fenestrated in the late 20th or early 21st century with modern double glazing in uPVC frames. Covering this is a large, pitched roof of slate, within which is two original chimney stacks topped with ceramic pots (**Photographs 7 & 8**). These chimneys are set within the southern extent, and in the centre of the building. In terms of plan form the building is F-shaped, with this pattern created by two projecting wings with gables on the eastern side. In the centre of the building on the western side, facing onto Fulford Road, is a gable. The edges of all of these gables have been topped with sandstone coping.

**Photograph 6: View of The Guard House from the south west.**

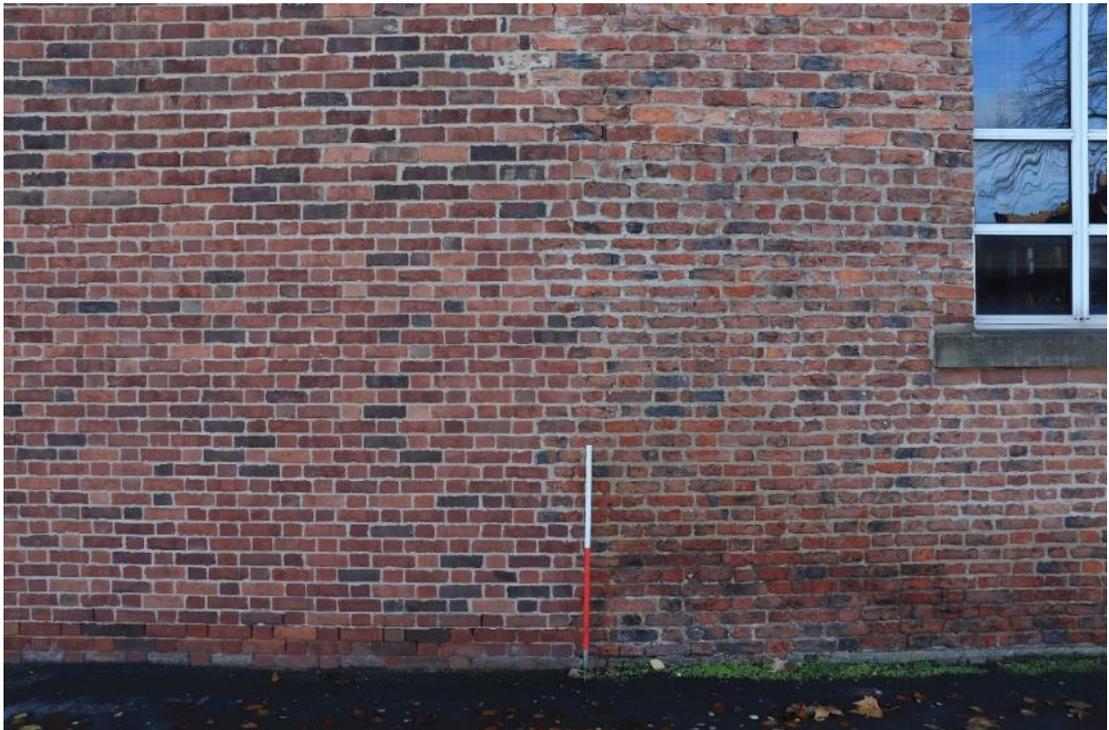
4.2. The principal western elevation faces onto Fulford Road (**Photographs 9-16**). It is from here that a clear break in coursing is visible just to the north of the projecting gable (**Photograph 10**), indicating the former extent of the building. Interestingly, the lower courses of brick along the northern extension are in a Flemish bond, and the courses above are of a standard stretcher bond. Although this section of wall appears relatively modern, it is possible that these lower courses could be the remnants of the boundary wall. However, this section of wall does match that of the southern block of this building. This southern section, with a likely 19th century date, also consists of a Flemish bond below and stretcher bond above. Therefore, it is also a possibility that the late 20th century block has been constructed in respect to the earlier section of wall to the south, and the coursing has been matched. Despite this, the break between the two blocks of this building is interesting, as the brickwork has clearly been altered. Along the top of this elevation, just below the eaves, is a line of fixed uPVC windows, incorporating long concrete sills. In the northern part of this elevation are two ground floor windows designed to mirror the those situated on the southern side. These are fixed windows of uPVC, covered by flat arches with brick voussoirs, and sandstone sills.

**Photograph 10: The break in coursing between the southern block and the northern extension.**

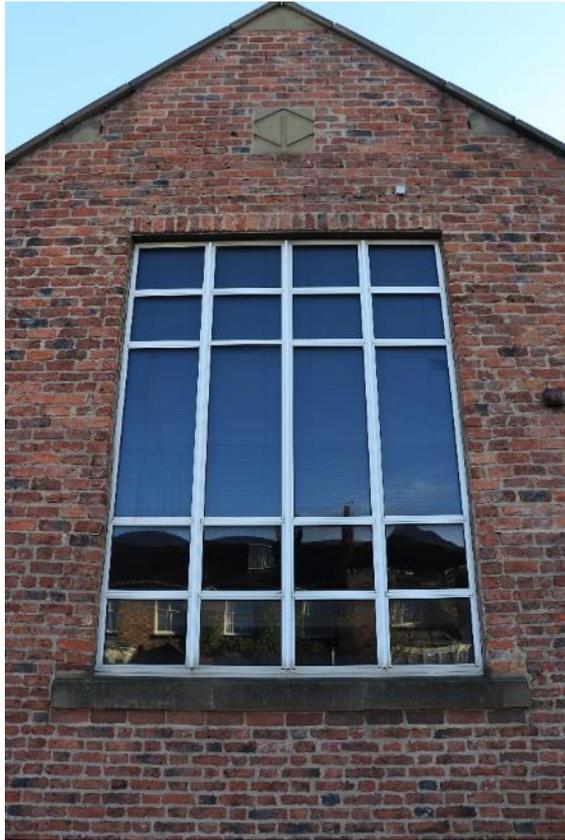
4.3. Another large modern window has been inserted in the projecting gable in the centre of this elevation (**Photograph 11**). This is also of uPVC and consists of a flat arch of red brick and a large sandstone sill. To the right of this large window, roughly in the centre of the wall are a few courses of brick in an English bond. As mentioned in paragraph 4.2 above, this is indicative of this section of wall being demolished and rebuilt to accommodate the northern block of this building. The gable here has been topped with sandstone coping, kneeler and ridge stones. The modern northern extension of this building abuts what appears to be an earlier gateway (**Photograph 12**), leading to a footpath. This gate is headed by a round arch with red brick voussoirs, and the wall is capped with limestone coping. It is possible that this pathway originally related to the buildings to the north west of the site that were also present in the 19th century, prior to the expansion of this building to the north.

**Photograph 11: The projecting gable in the centre of the western elevation.**

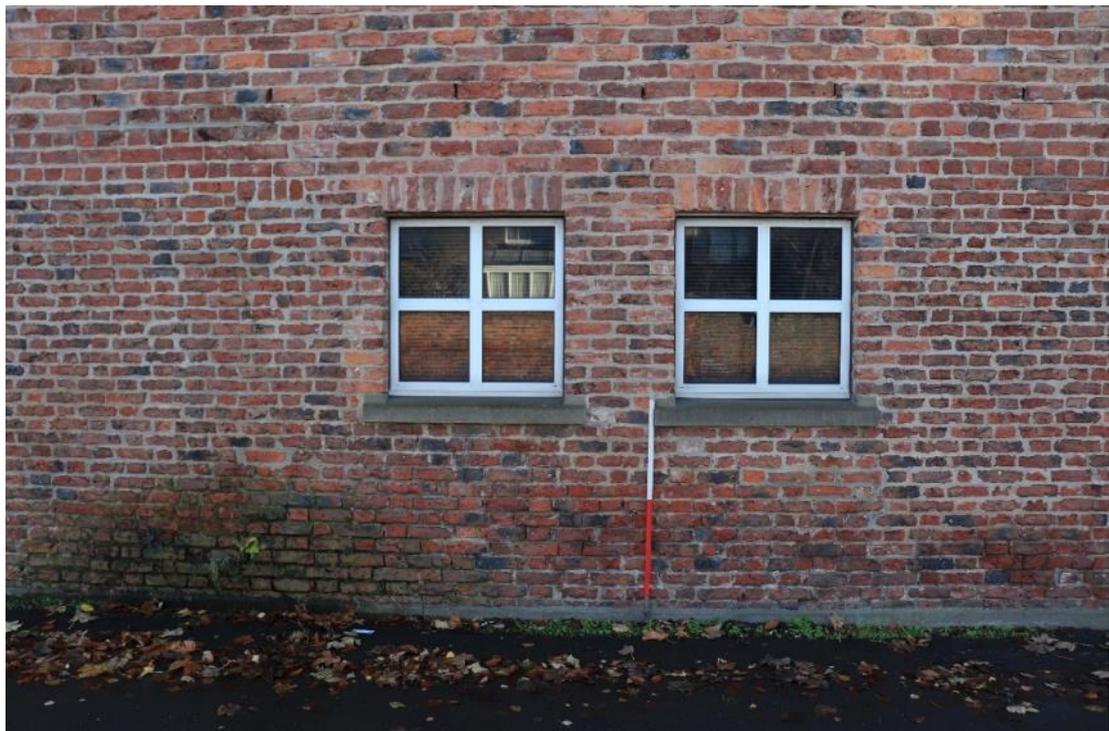
- 4.4. On the southern side of this elevation (**Photographs 14-16**) are two more identical sets of the ground floor double windows (**Photograph 15**). However, these have arches of original red brick. Slight breaks in coursing around these windows suggest that the openings were partially rebuilt when the modern windows were inserted. Despite this, they largely appear to be in their original positions. The entirety of this half of the elevation, although also built in red brick, is significantly more weathered. Attached to the south-western corner of this elevation is the extended boundary wall (**Photograph 16**), with spiked iron railings, sandstone coping, and a brick plinth. It is likely that this western boundary wall also dates to the 19th century.

**Photograph 15: One of the sets of windows on the southern end of the western elevation.**

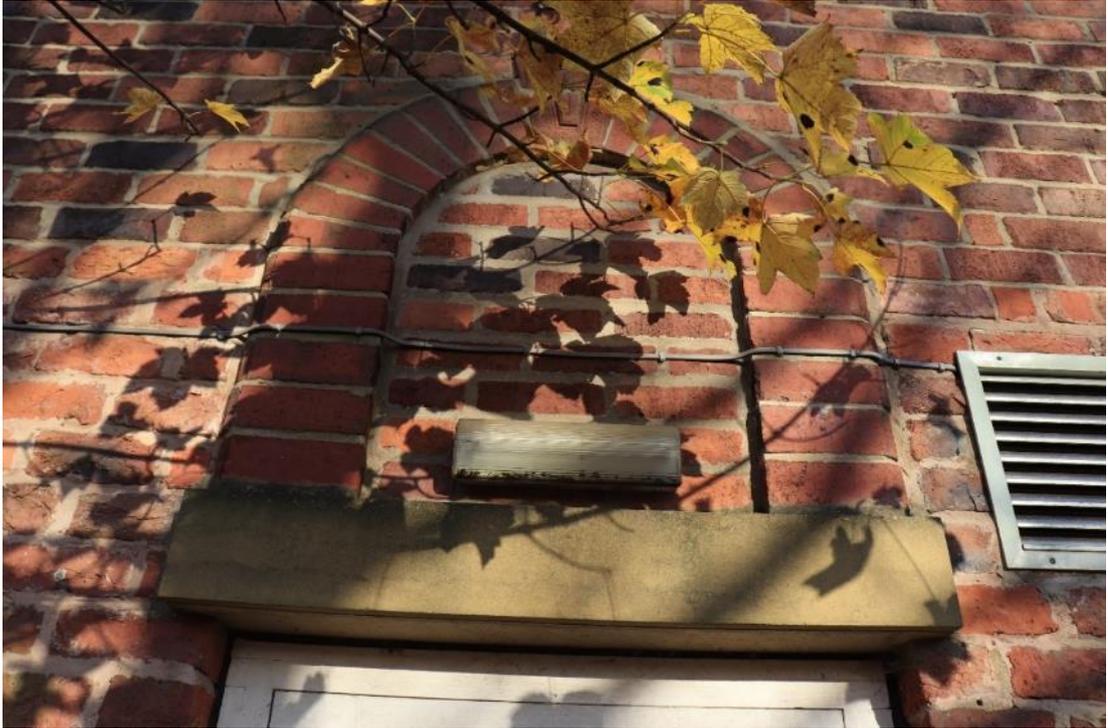
- 4.5. The southern gable end (**Photographs 17-23**) comprises red brick laid in stretcher bond. Just below eaves level (**Photograph 22**) is a line of moulded dressed brick that projects outward. Much like the other gable ends on this building, this one has been topped with sandstone coping; however, there are no kneelers. The apex of this gable incorporates a large red brick chimney stack (**Photograph 23**), with a ceramic flue. At ground floor level are two apertures (**Photographs 19-21**), a doorway to the left and a window to the right. These are both headed with round arches with red brick voussoirs and finely dressed keystones (**Photograph 21**). The keystones themselves appear to be of significance. Based on their stylistic form they have likely been re-used from another, possibly earlier, building on site. Both the jambs and the arches surrounding these features project slightly. The keystones themselves are embellished, however, deterioration has meant that the insignia is not recognisable. Although, at the top of the keystone the outline of a crown is visible. It is possible that both of these features originated as windows, and the left hand one has been opened up to create a doorway. The doorway most likely dates to the 20th century, and is wooden, panelled, and set within a wooden frame. It also has a sandstone lintel that mirrors the sill of the window to the right. The remaining area of the arch above the doorway has been infilled with red brick (**Photograph 19**).

**Photograph 19: The infilled arch above the doorway in the southern elevation.**

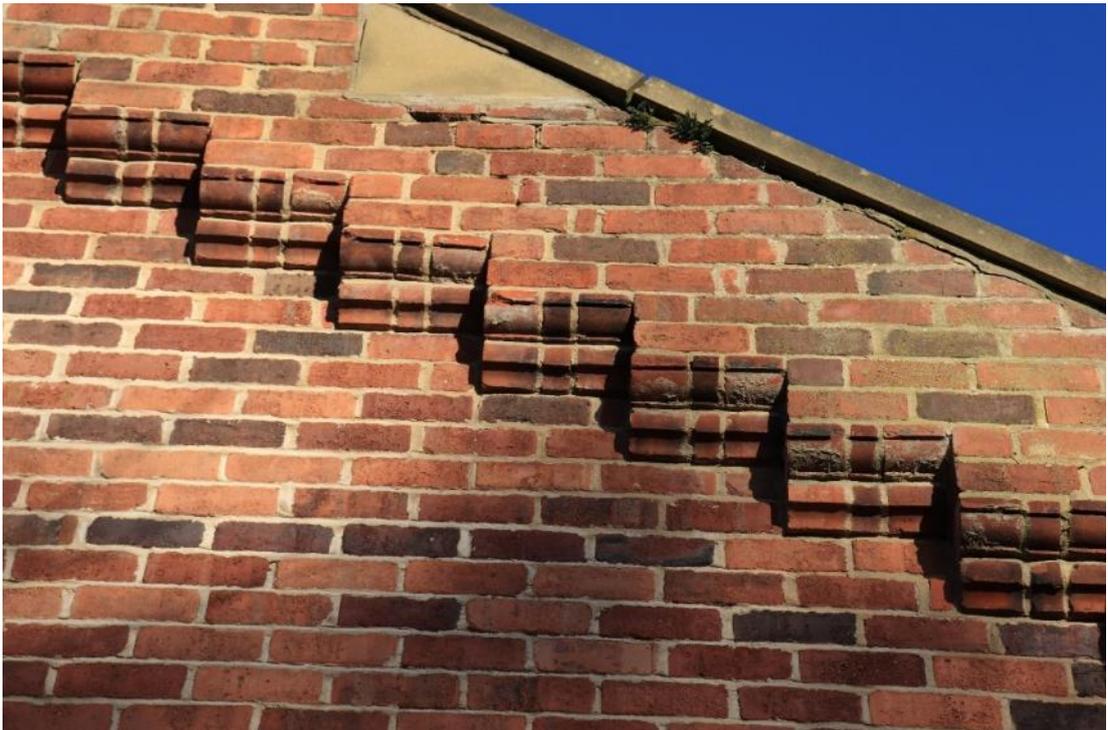
**Photograph 22: Detail of the brickwork below the eaves in the southern gable end.**

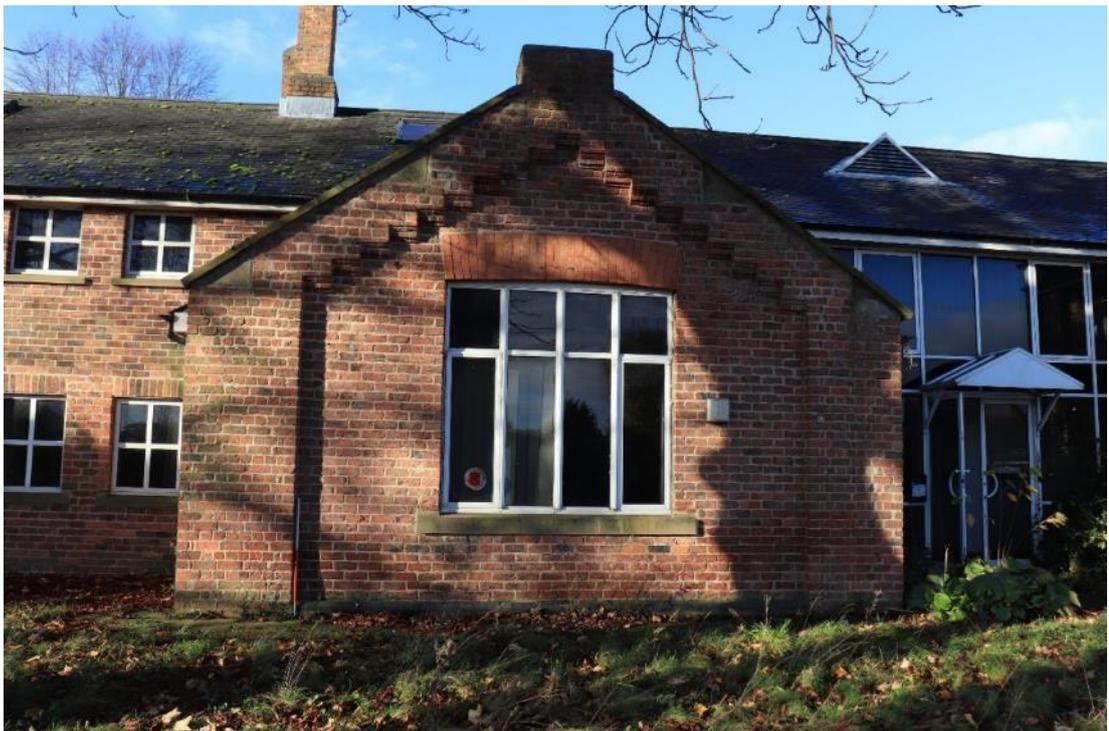
- 4.7. To the north of this is the central projecting gable (**Photograph 30**), the northern extent of which was part of the original northern elevation of the 19th-century building, visible on historic mapping. This projecting gable contains a large central window under a large, curved arch with multiple courses of red brick voussoirs. The sill of this

**Photograph 30: The southern projecting gable in the eastern elevation.**

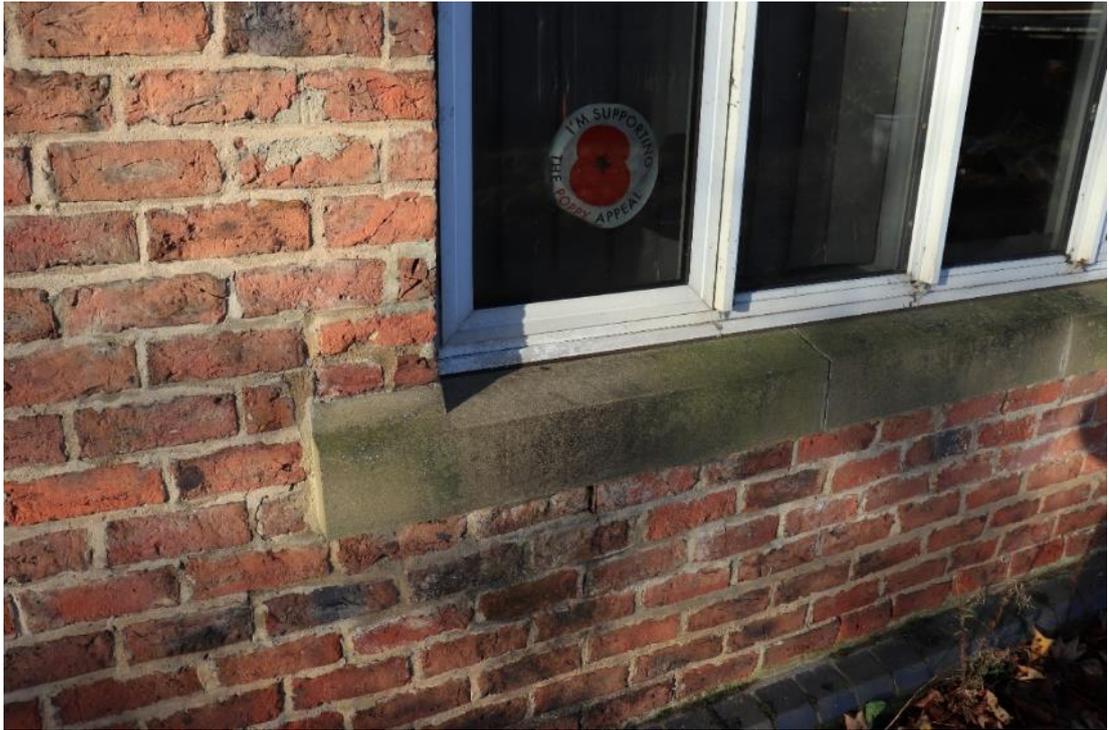
feature appears to be made of concrete (**Photograph 31**), most probably inserted when the modern window was added. The northern half of the eastern elevation (**Photographs 32 & 33**) contains another large glass wall with a central doorway and covered porch, as well as another projecting gable with a large central window. Although this later half of the building resembles that of the 19th-century southern half, the bricks are noticeably modern in comparison to the more weathered red brick on the southern side.

**Photograph 31: Detail of the sill in the large window of the southern projecting gable.**

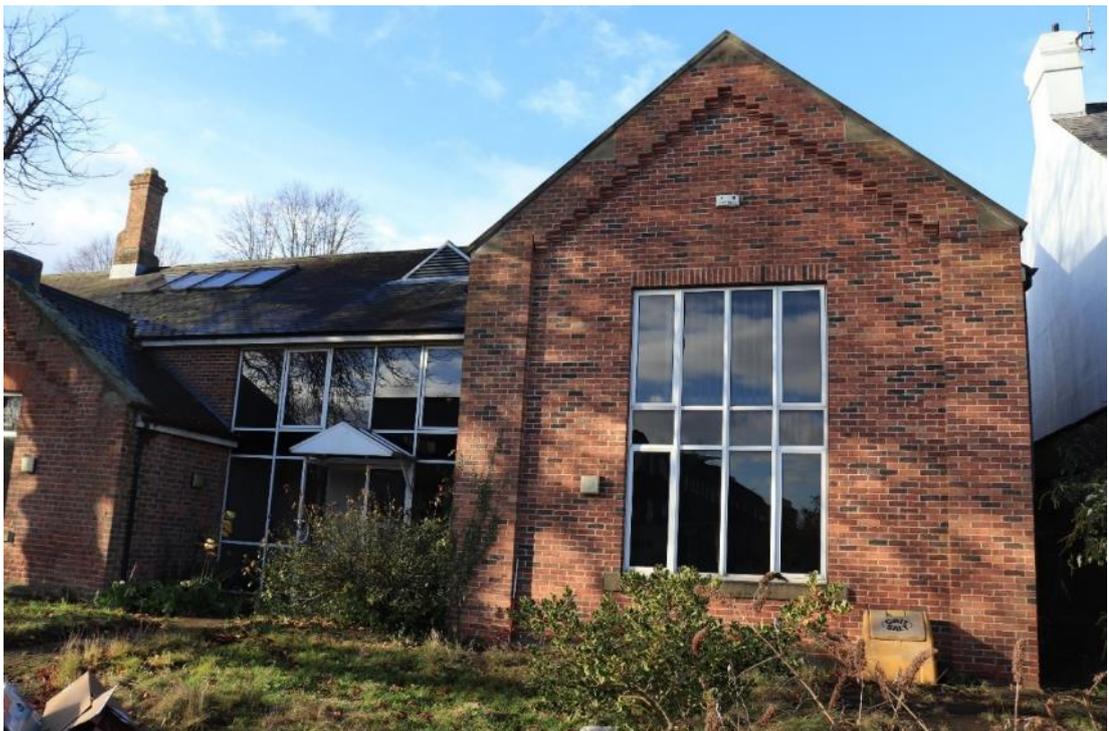
**Photograph 32: The northern half of the eastern elevation.**

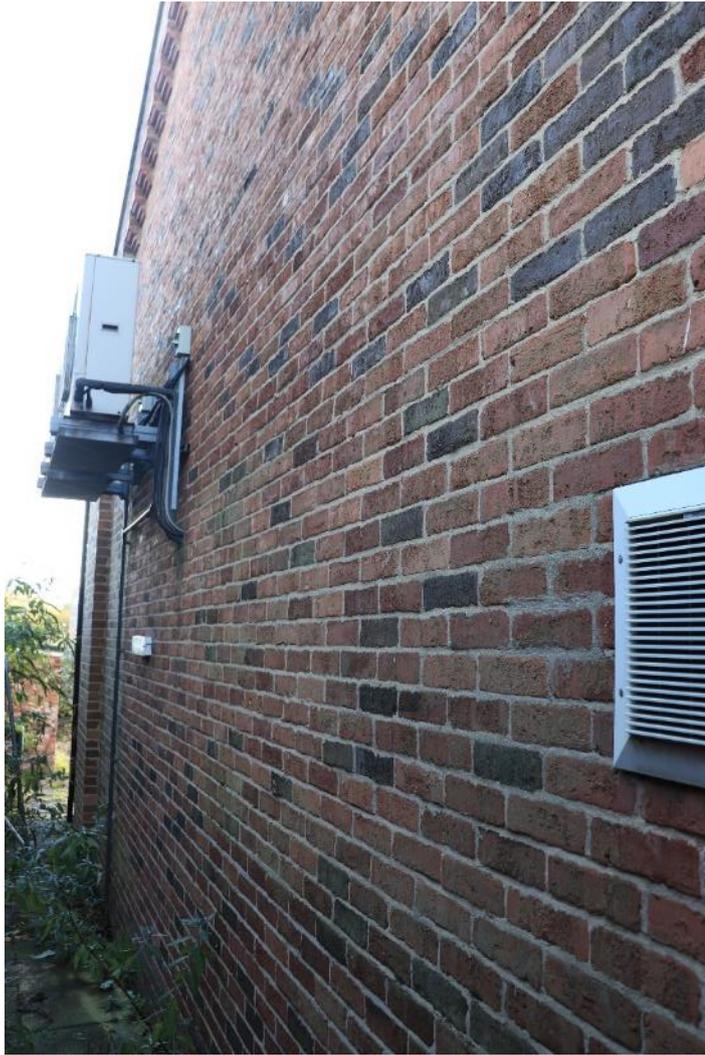
- 4.8. The northern elevation (**Photograph 34**) faces out onto a very narrow alleyway, accessed from the wooden gate onto Fulford Road. This late 20th century elevation again resembles the rest of the gables on this building through the incorporation of a recessed gable and decorative brickwork. However, no windows or any other features are visible here.

**Photograph 34: The northern elevation of the building.**

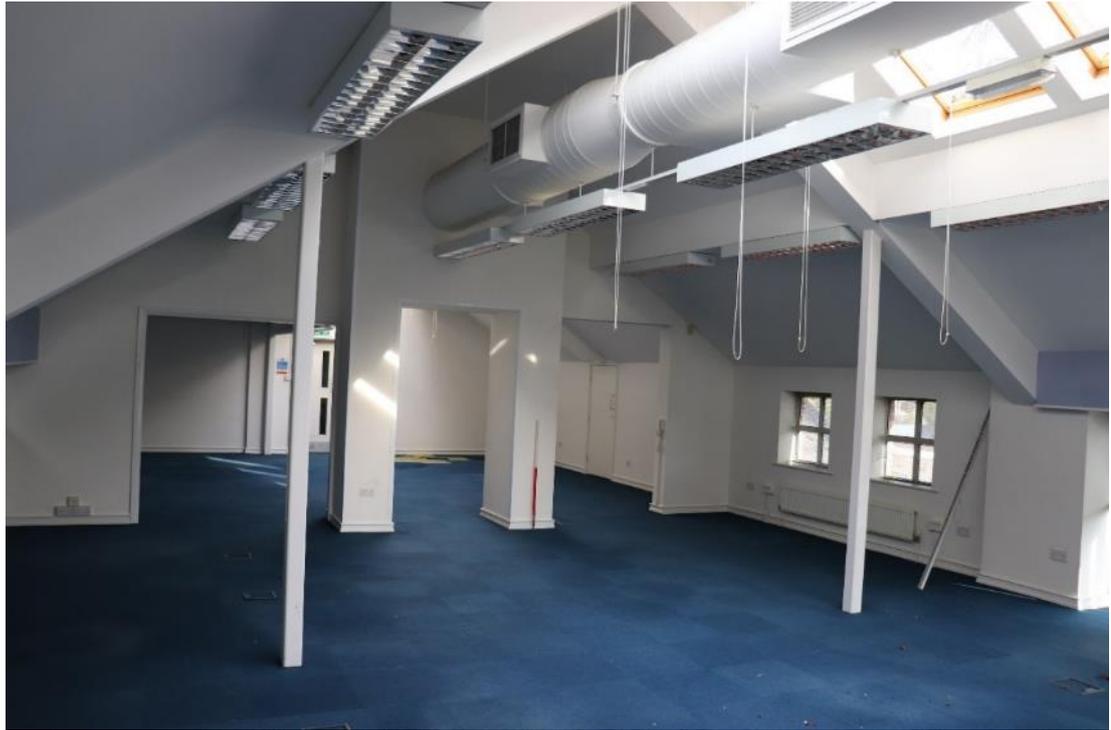
- 4.12. At first floor level there are some features worth noting. On this floor the central chimney stack is visible (**Photograph 50**). This has been knocked through in order to allow further access between Rooms F4 and F5. Either side of this stack are two moer large opening allowing access between these two spaces. There may have been access between these rooms when it was in use in the 19th century, as it would have made sense to have this area in order to bolster the storage space. The stack of the southern chimney is also partially visible in Room F2, although modern plasterboard has blocked any potential features associated with it. At this level the roof structure of the building is visible (**Photograph 51**), as the base of the trusses are set just below the ceiling level. These are visible in Room F5, on the northern and southern walls. An open loft hatch in Room F5 shows that the roof of this building has been renewed, with modern steel trusses and insulation (**Photograph 52**). This was most likely added when the northern extension to this building was inserted in the late 20th century.

**Photograph 50: The northern end of Room F4.**

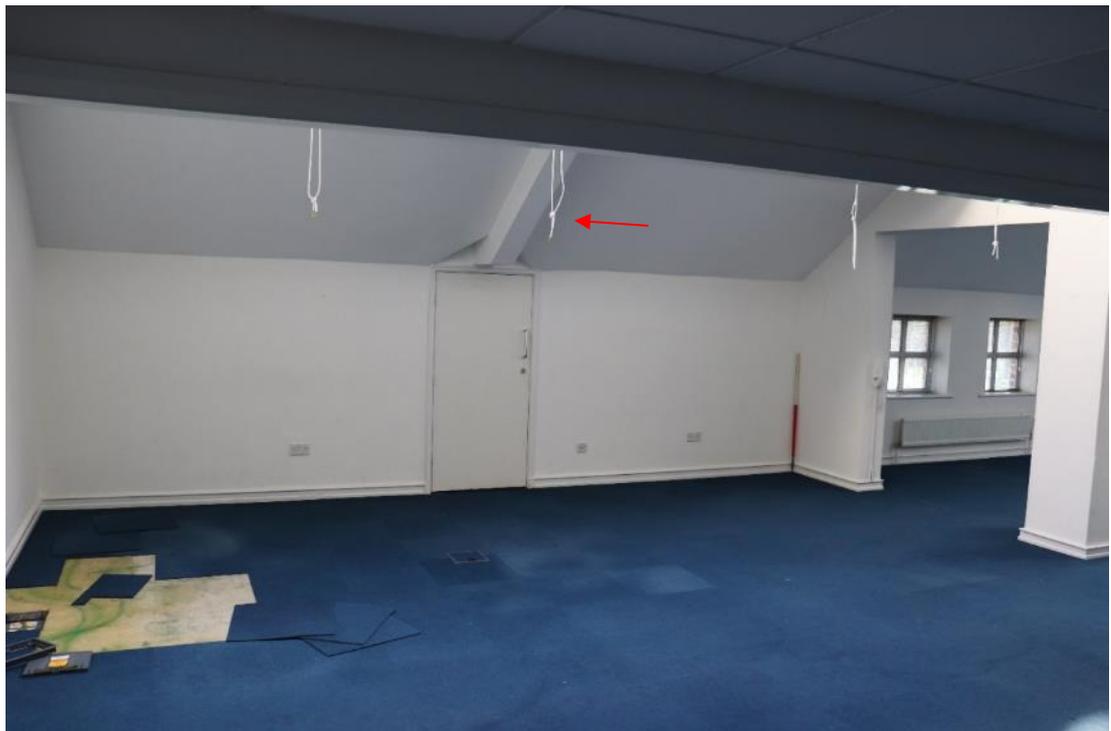
**Photograph 51: The eastern end of Room F5. The red arrow indicates the exposed roof truss.**

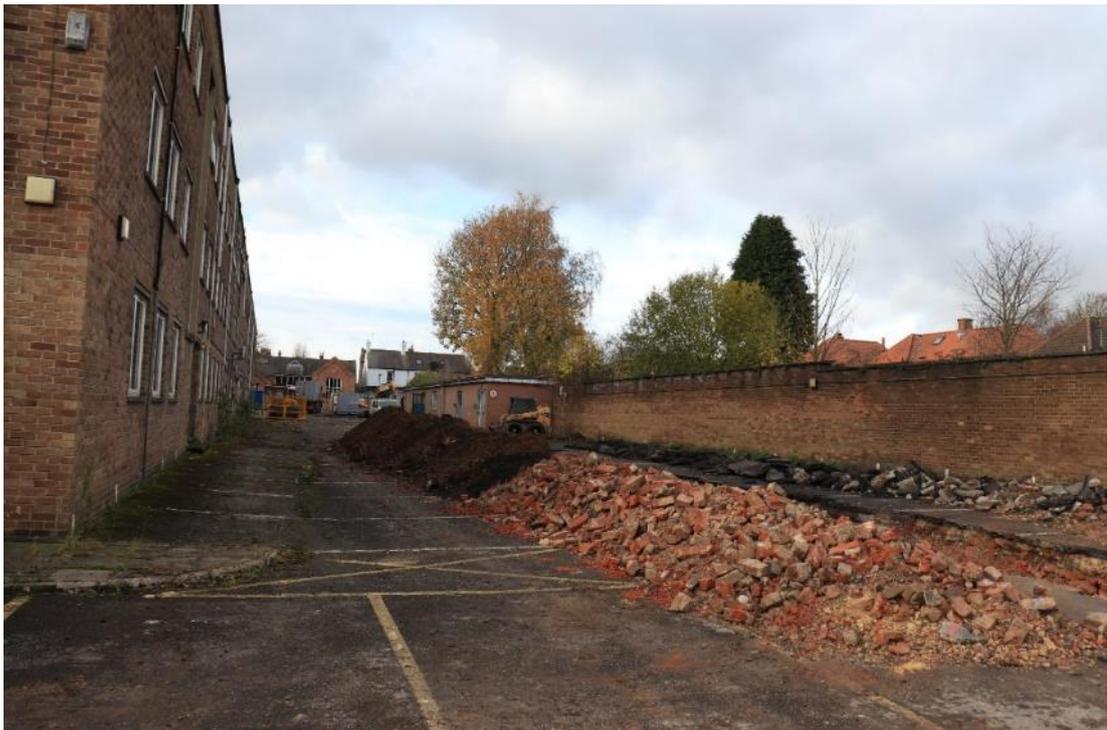
- 4.13. The 19th-century boundary wall (**Photograph 56**) on the northern end of the site has largely suffered from 20th and 21st century interventions. The most notable of these changes are visible in the centre of the wall (**Photographs 57 & 58**), where much of the it has been replaced with 20th century brickwork in American bond, capped with sandstone coping. In the centre of this are the 20th-century store buildings. At the western and eastern ends of this 20th century wall are what appear to be fragmentary sections of original 19th-century boundary wall.

**Photograph 56: The northern boundary wall and the stores.**

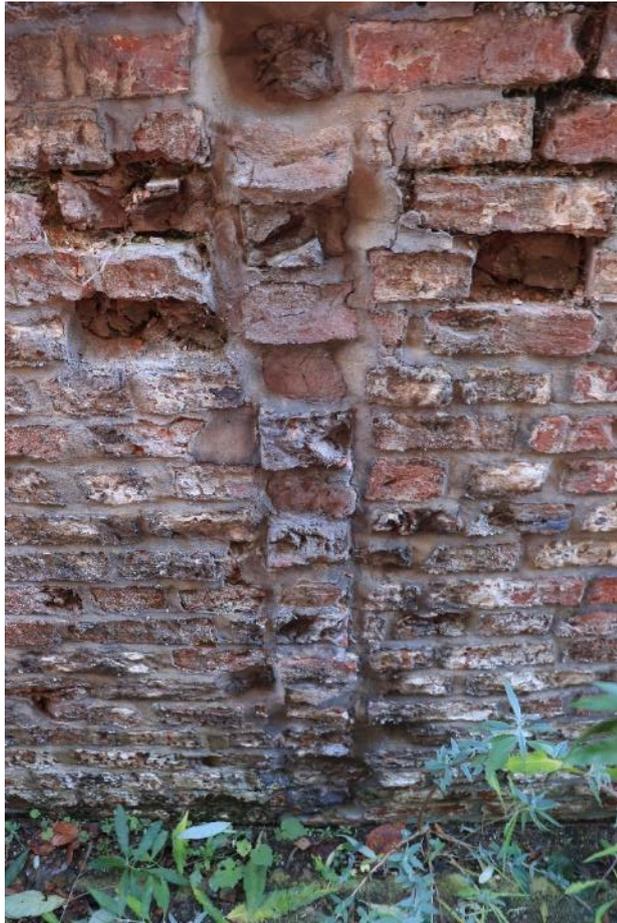
4.14. The western part of the boundary wall (**Photographs 59-61**) is made up of irregularly coursed red brick, the closest bonding it resembles is that of monks' bond. These bricks are extremely weathered. This has also been capped with sandstone coping and is slightly taller than the central section of wall. Also within this part of the boundary wall there are clear breaks in the coursing, as well as scarring, showing the position of former perpendicular projecting walls (**Photograph 60**). This, as well as fragmentary remains of whitewash paint, suggest that this part of the wall was once internal, indicating that there were buildings along this section of the northern boundary. Much of this section of the boundary wall has been obscured by the bike shed.

**Photograph 60: One of the building breaks indicative of former perpendicular walls.**

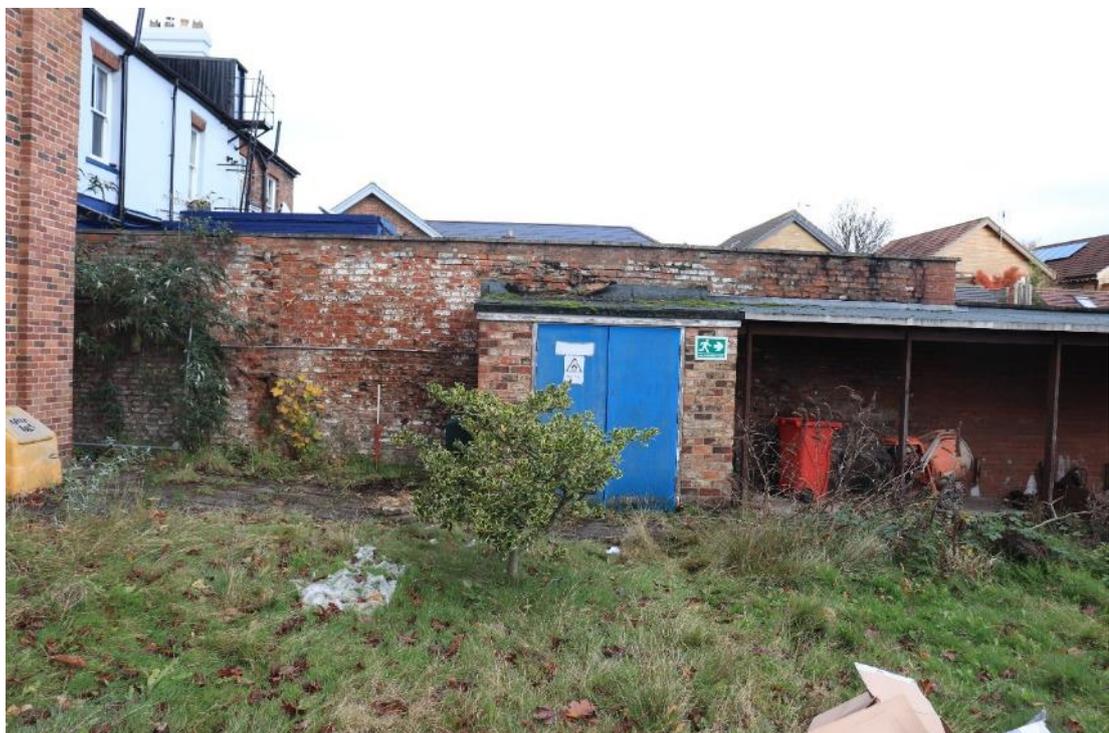
**Photograph 61: Part of the potentially 19th-century boundary wall, now partially obscured by the bike shed.**

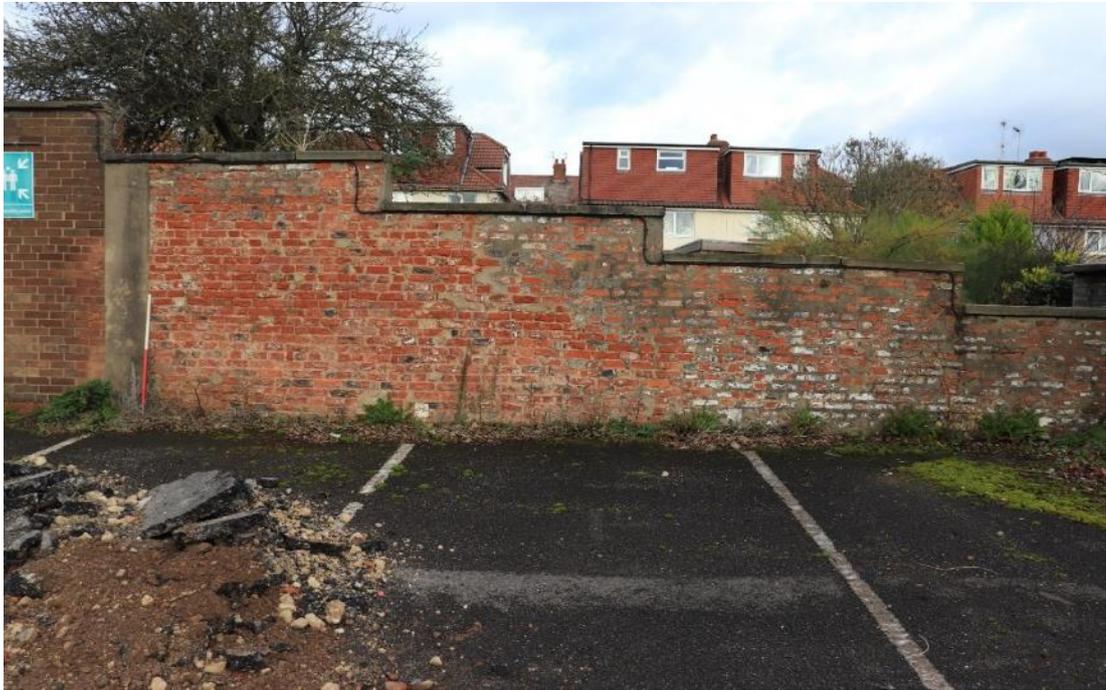
- 
- 4.15. The eastern part of the northern boundary wall (**Photograph 62**) resembles that of the western in terms of materials and coursing. This section of the wall, however, does not contain any features indicative of early internal divisions, as seen on the western section. There are, however, some fragmentary remains of whitewash paint.

**Photograph 62: The potentially 19th century eastern part of the northern boundary wall.**
