Archaeological Investigations at 1 Little Shambles, York

Structural Watching Brief Report YA/2022/127 July 2022

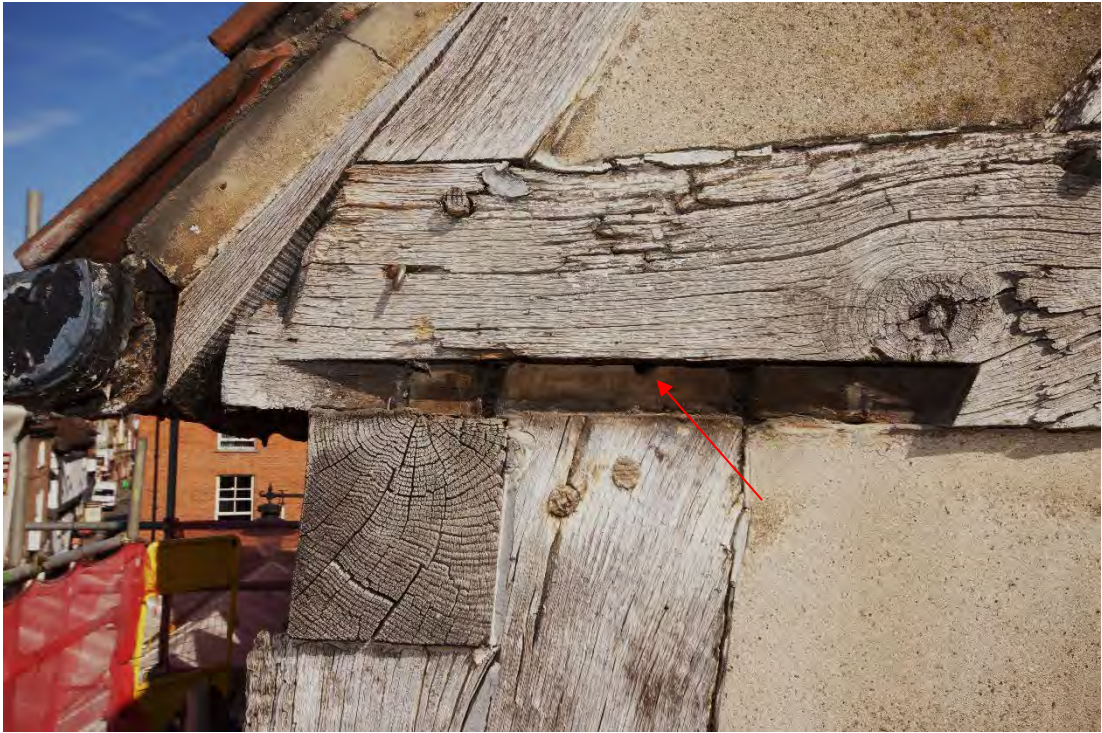
The removal of an earlier repair splice within tie-beam 5 immediately above jowl post 1 and corresponding wall plate revealed a teazle or jowl tenon of post 1, which would have been introduced into a mortice within the tie-beam and secured with a peg, although the tenon has an empty peg hole. While the earlier splice partially obscured the teazle tenon, the associated empty peg hole extends further up beyond the splice housing; thus, the current tie-beam would have not been attached to a discerned joint of post 1 which should be the normal assembly. Furthermore, the jowl post 1 includes two pegs adjacent to the later machine-sawn wall plate and immediately below the tie-beam 5, which bears no association with any apparent joint assembly and may instead be an ornamental feature (Plate 7).

Plate 7: Removed splice revealing a teazle tenon of jowl post 1 with empty peg hole (arrow)

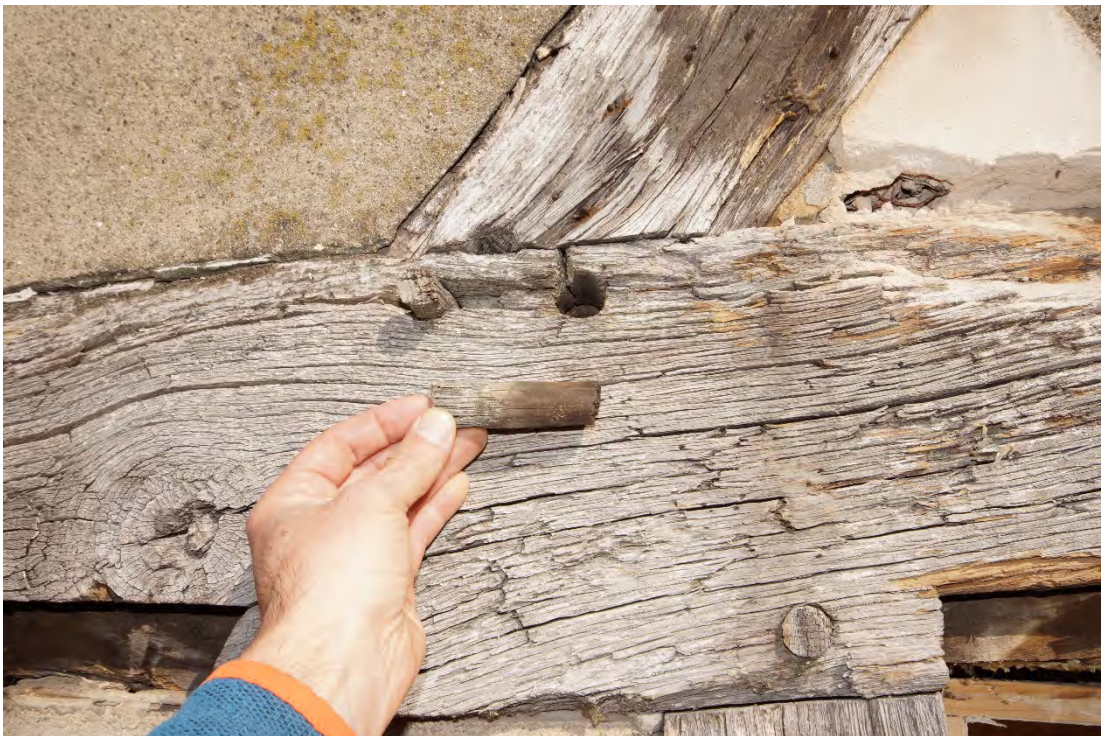
Another possible ornamental peg was identified within the putative joint between tie-beam 5 and left gable brace 9 which is a short type (rather than being broken) acting as a plug inside a partially drilled shallow hole that does not lead into a mortice (Plates 8 and 9).

Plate 8: Joint between tie-beam 5 and the left gable brace 9 with later ornamental short peg

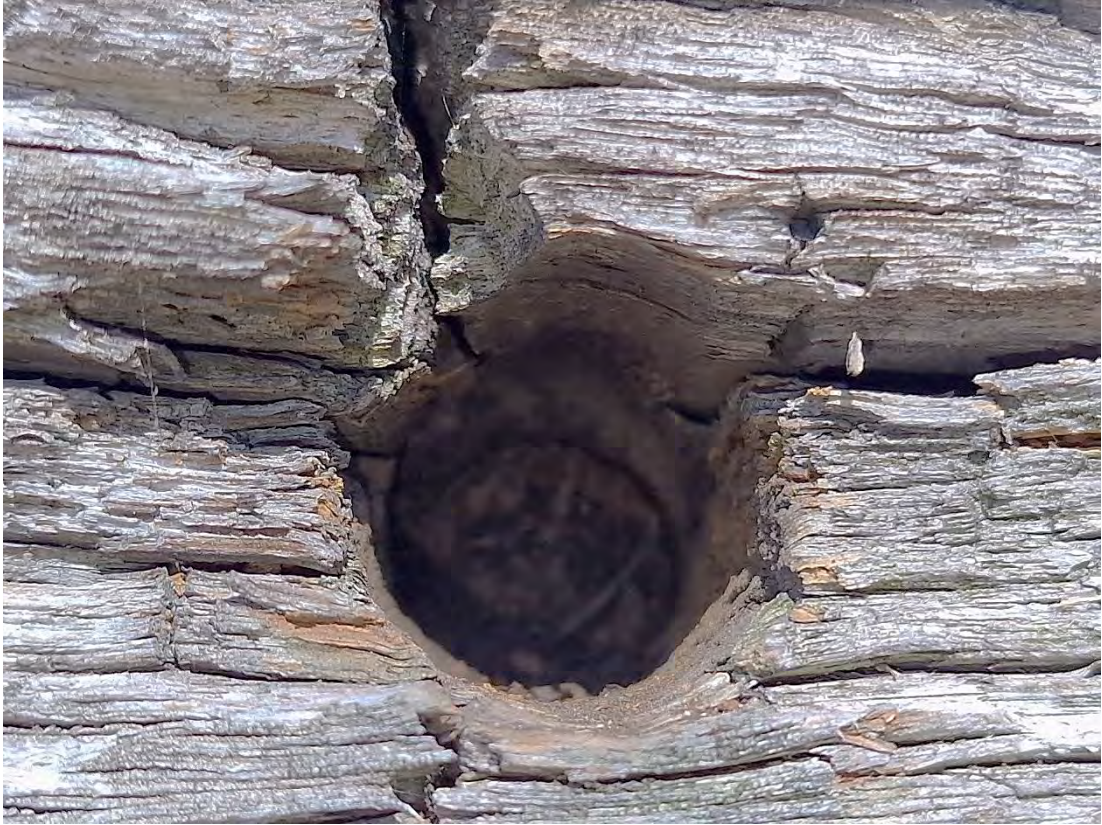
Plate 9: Detail of peg hole which does not pierce the tie-beam or extends through to a mortice

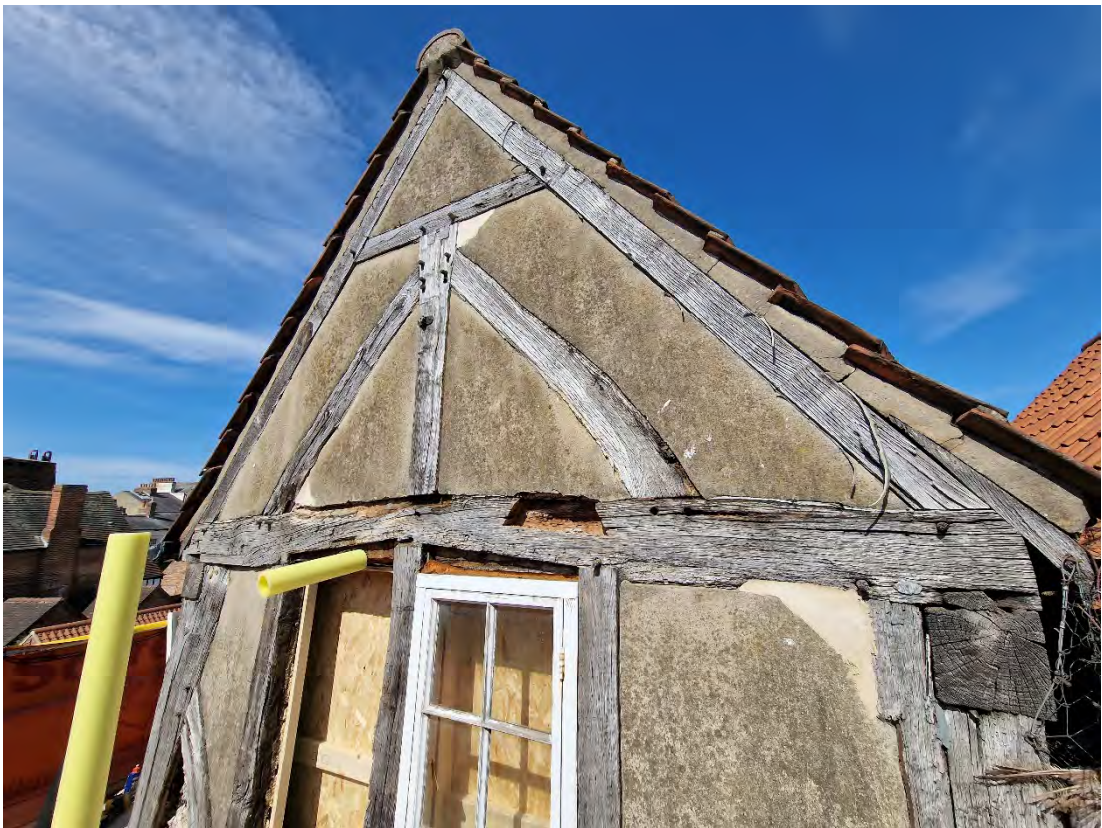
The joint between tie-beam 5 and post 2 appears to be secured with a peg; a second may have decayed or been removed and the corresponding peg hole is now filled with lead. It is possible that post 2 might have had a jowl similar to its counterpart, although this may have been subsequently modified as a result of a later repair of rot, creating the current angular stepped form. The wall plate of the corresponding side elevation appears to be a historic member partially assembled into a slightly irregular dovetail housing within the tie-beam, although the timber had decayed and the section within the housing is now detached from the wall plate itself (Plates 10 and 11).

Plate 10: Joint between the tie-beam 5 and principal post 2 to the northeast end of the rear elevation

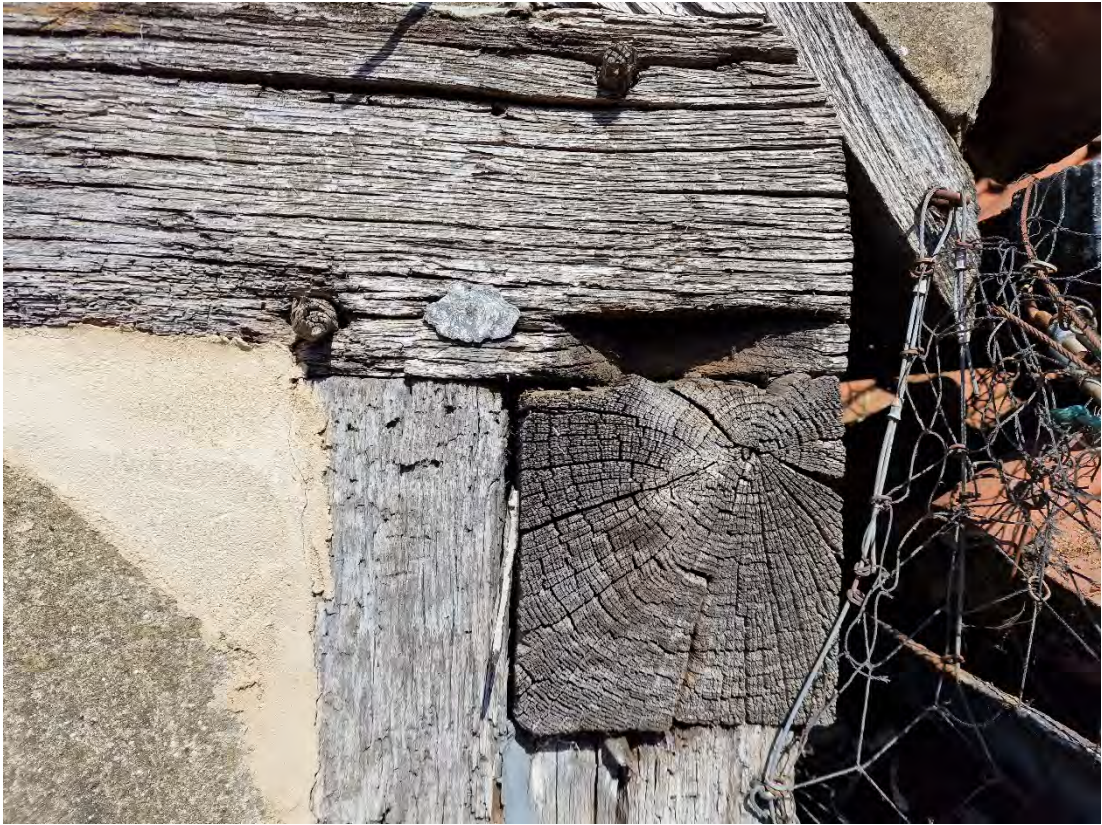
Plate 11: Detail of partially decayed upper section of the wall plate and dovetail mortise above it

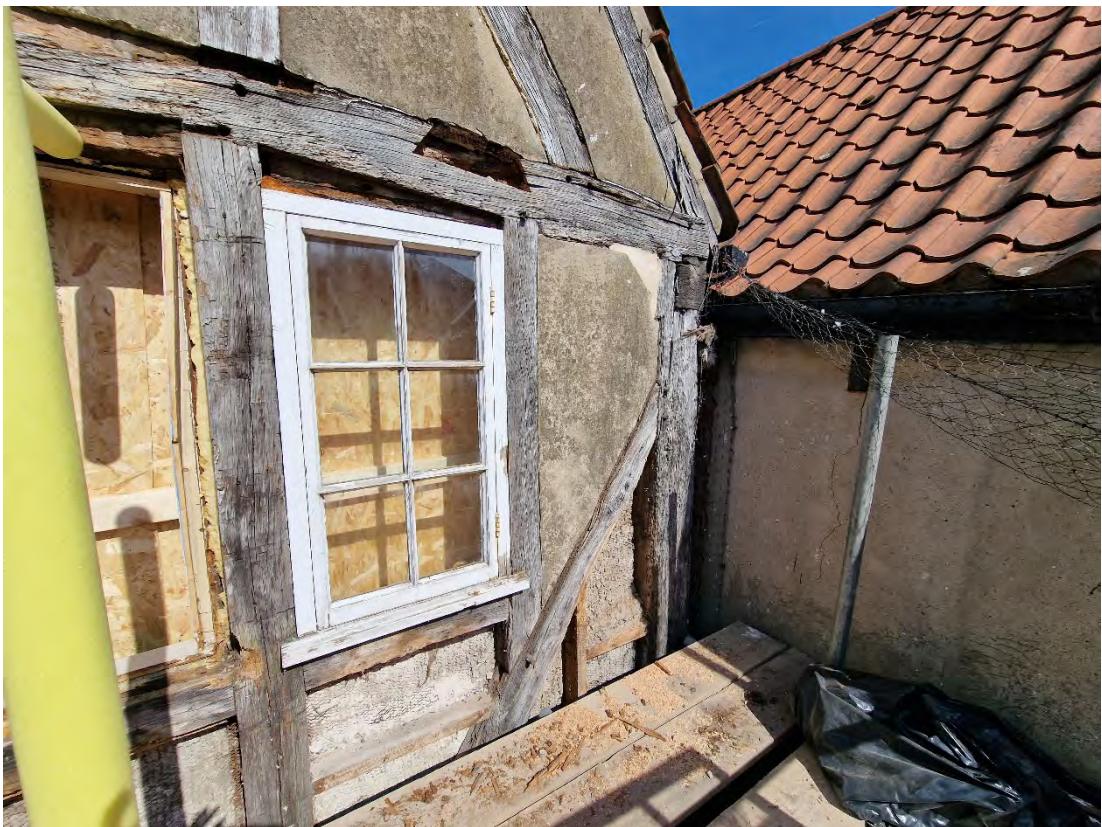
The partial removal of infill panels, previously established as being modern replacement, did not reveal any evidence of wattle-and-daub construction which requires stave auger holes and grooves in the opposite timber member (Plates 12-14).

Plate 12: Northeastern side of the second floor during the partial removal of infill panels

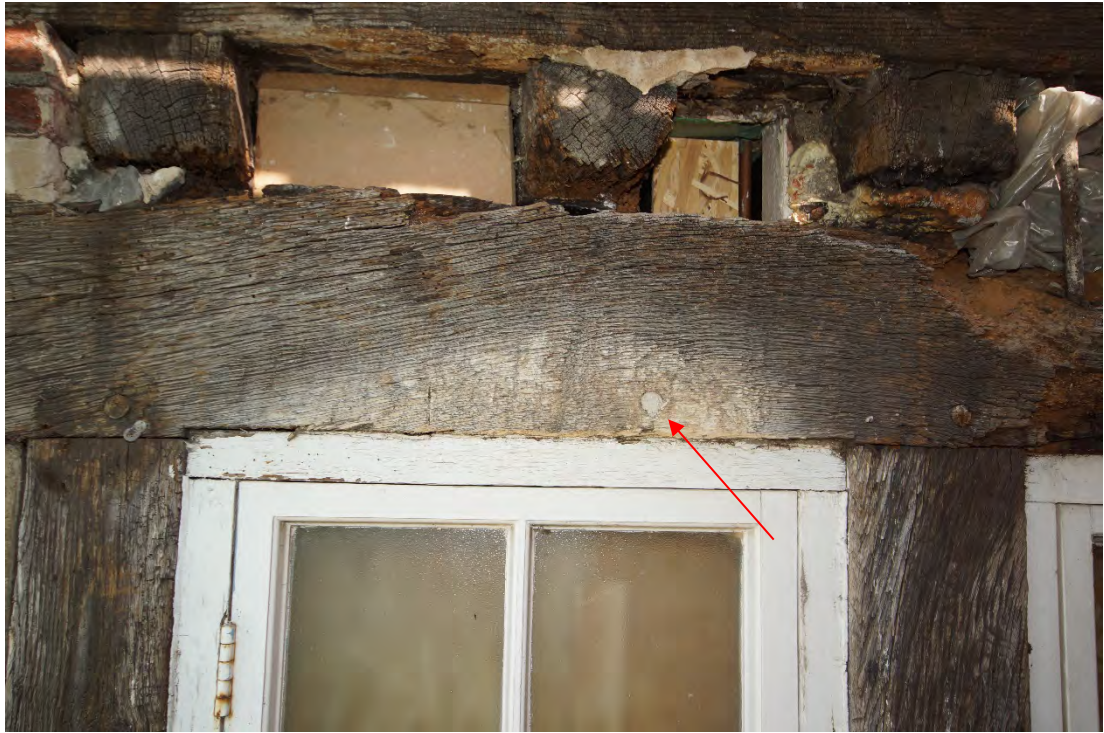
Another vacant peg hole filled with lead was noted further along beam 7 whose associated mortice does not appear to bear any association with the present timber-framed assembly (Plate 17). The joint between beam 6 and associated second-floor braces 11 and 12 and stud 17 are secured with pegs, however the beam includes an empty peg hole and mortice immediately to the southwest of stud 17 which do not correlate with the assembly of any timber member (Plates 18). It is possible that beam 6 might have been reused. Stud 17 also appears to have an empty mortice which once again does not bear any association with the present construction. Directly to the northeast of stud 17, there is a later iron bolted rod securing beams 6 and 7 which might have been fitted during the 1950s restoration work (Plate 19).

Plate 17: Beam 7 with vacant peg hole filled with lead (arrow)

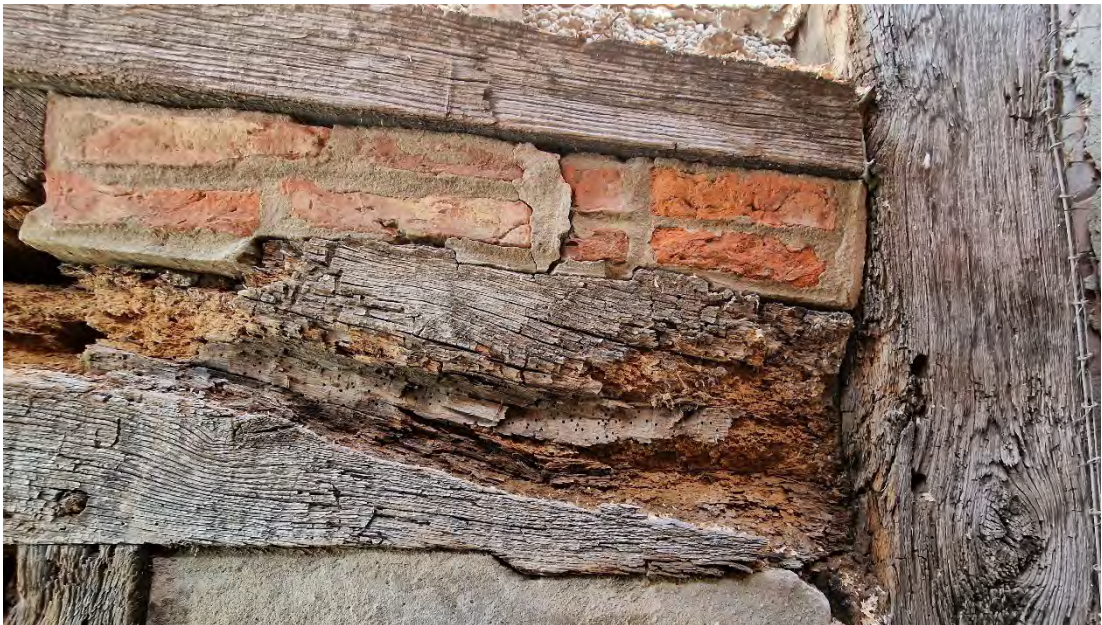
The joint between the northeast end of beam 7, with an underside chamfered edge, and post 2 appears to have a pair of empty peg holes although their heads might have decayed partly; whereas the corresponding joint between post 2 and first-floor brace 25 is fixed with a pair of pegs (Plates 20 and 21).

Plate 20: Chamfered northeastern end of beam 7 and empty peg holes within post 2

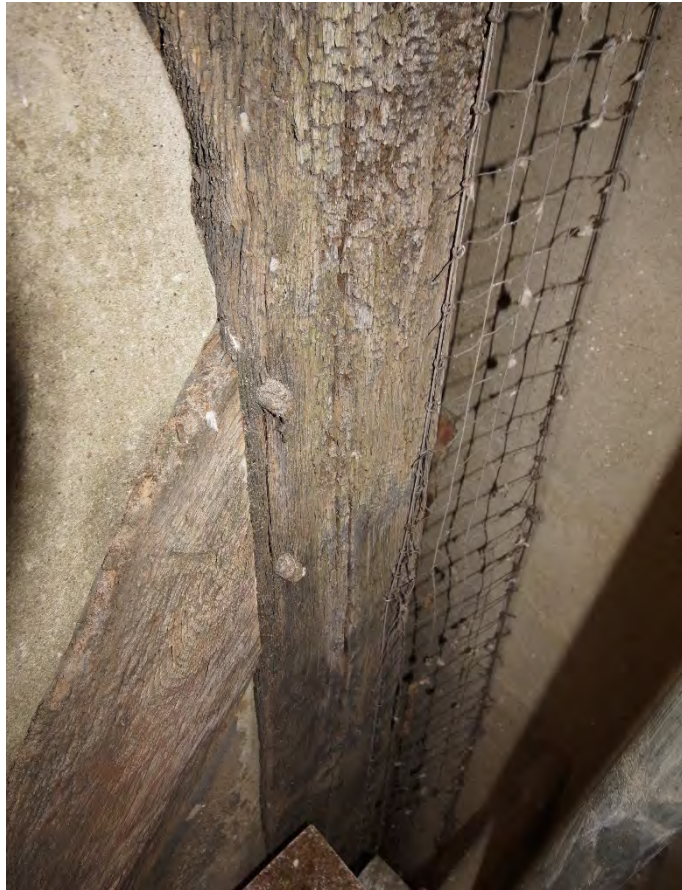
Plate 21: Joint between post 2 and first-floor brace 25 with pegs

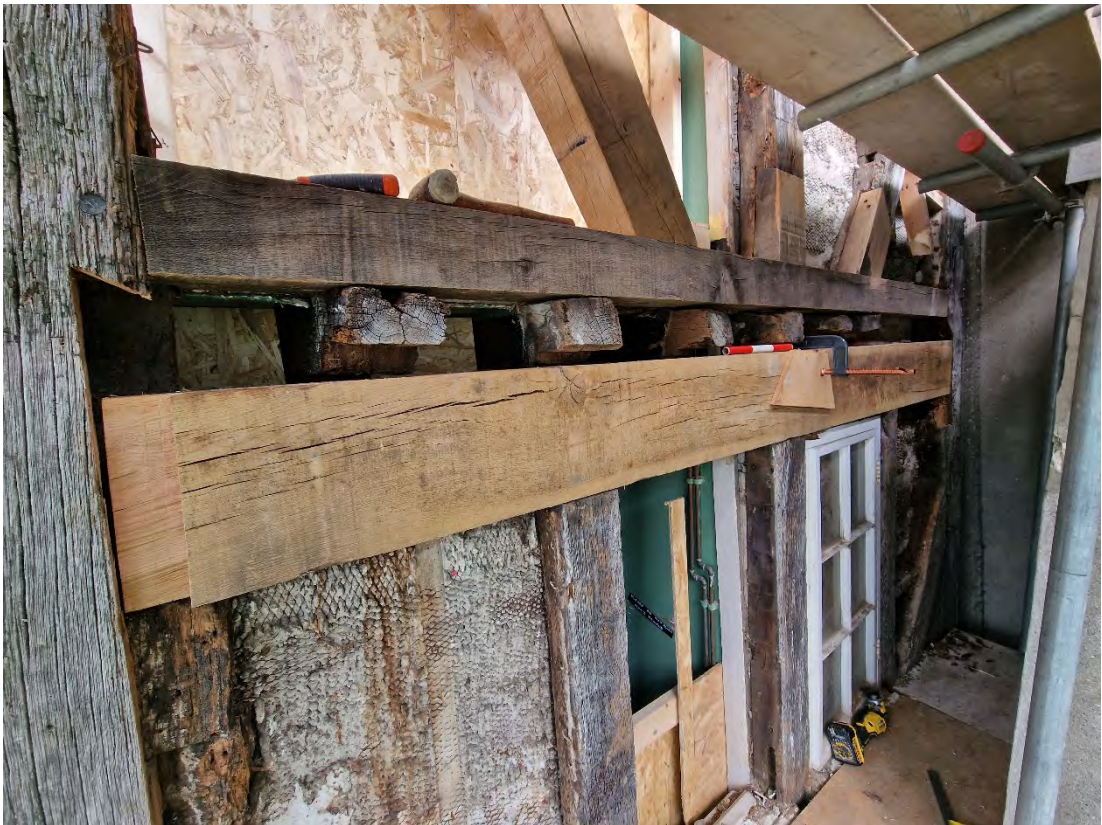
Beams 6 and 7 were replaced during the second watching brief, as were additional members such as the second-floor brace 11, and other sections of timbers. The brick nogging between the second-floor joists 26 were also removed enabling a view of the construction which revealed that the joists 26 are placed immediately underneath the internal plaster ceiling of the first floor. This implies that the joists were fitted subsequently to the ceiling being skimmed. This is slightly incongruous, as if the ceiling is earlier than the joists. The joists may have been fitted during the 1950s restoration; there would have been former joists above the plaster coat, although no evidence for that was identified. It is also possible that the joists, or at least some of them, might have been in their place and plasterboards fitted later immediately above their upper sides. One of the joists includes a chiselled carpenter's mark (VIII) although no association with other members, such as a girthing or bridging beam was identified (Plates 38-42).

Plate 38: Replaced beam 7 and second-floor joist 26

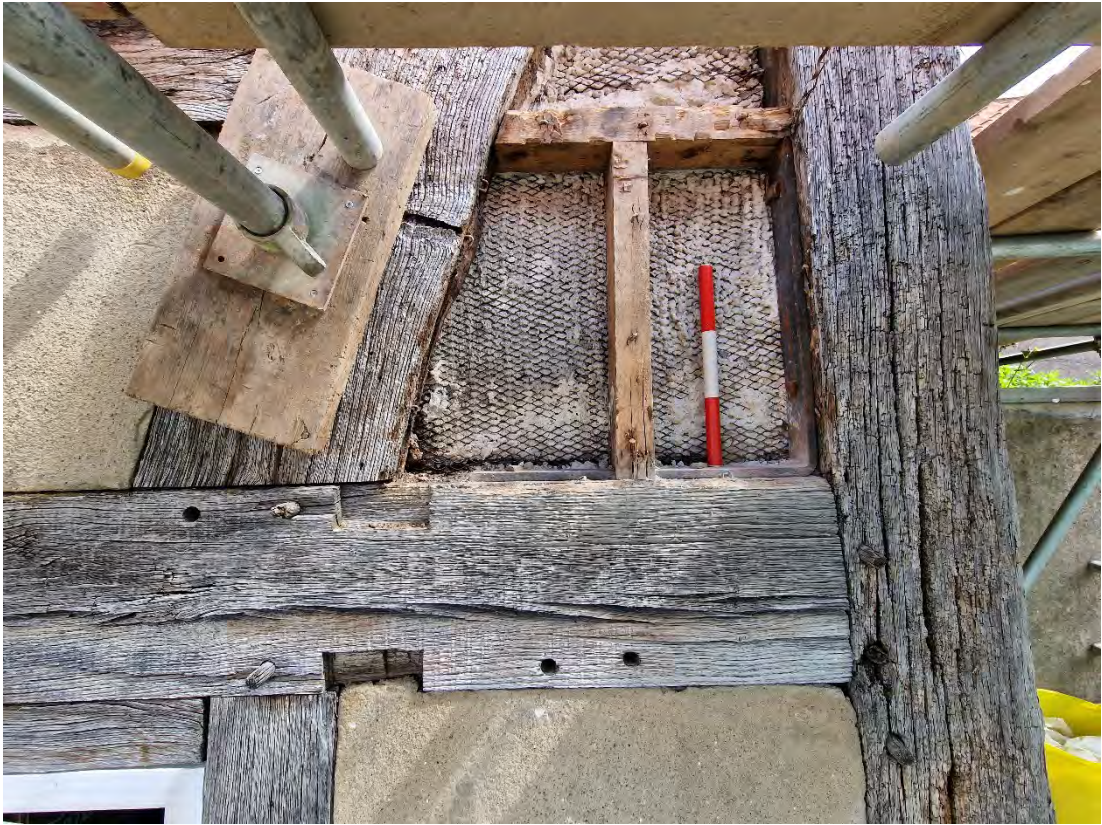
Additional removal of part of infill panels took place within the southeast end of the southwest side elevation adjacent to jowl post 1 where a series of vacant housings were identified previously. An iron bracket, comparable to the ones identified within the southwest elevation, was also observed attaching post 1 and the girthing beam between the first and second floor. The girthing beam has a pegged joint to the post 1, although there is another peg positioned just below the girthing beam which does not correspond with such as putative joint (Plate 43).

Plate 43: Partial removed infill panel within the southwest elevation with iron bracket

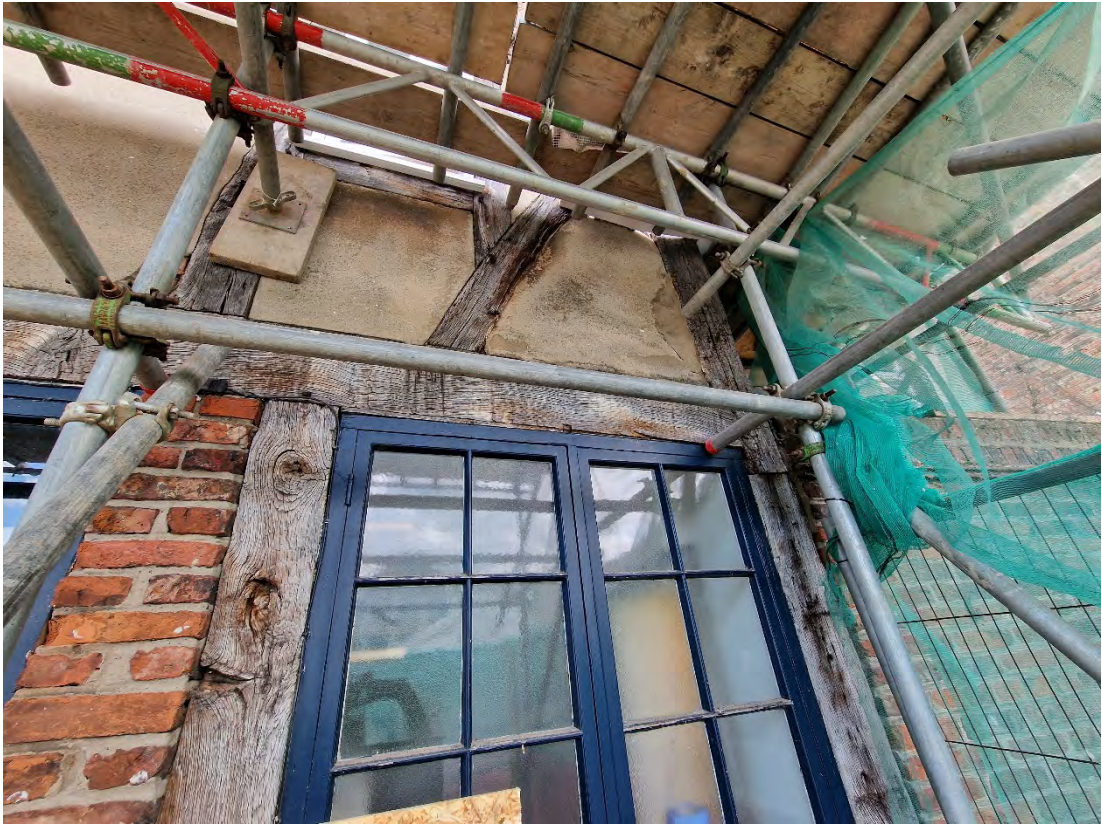
The girding beam between the ground and first floor has a pegged joint to jowl post 1. A short distance below the joint, it was noted that the post had been truncated in the past and is currently propped with a later post immediately beneath it (Plates 47 and 48). It is likely that the lower section of post 1 might have been severely decayed and restored in the 1950s.

Plate 47: Southwest side elevation with truncated post 1 below the girding beam

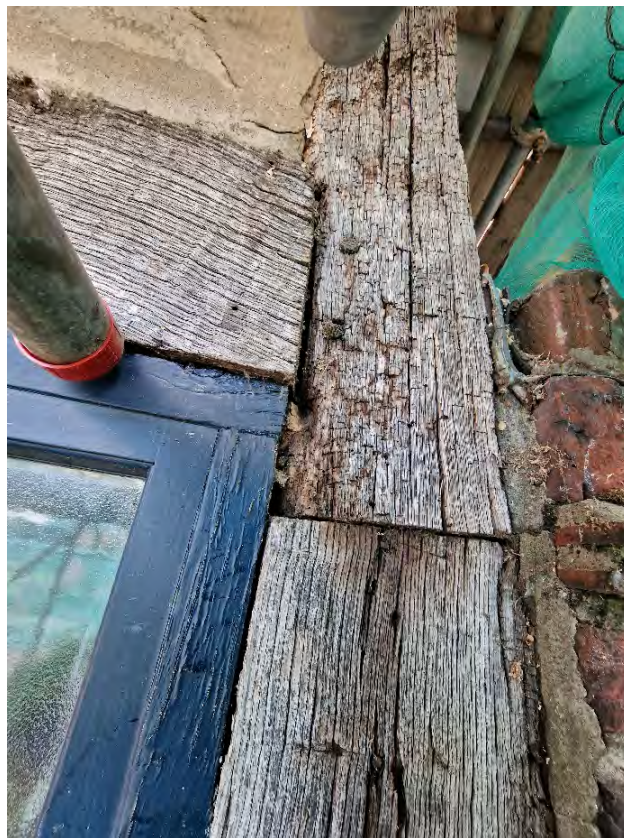
Plate 48: Detail of truncated post 1

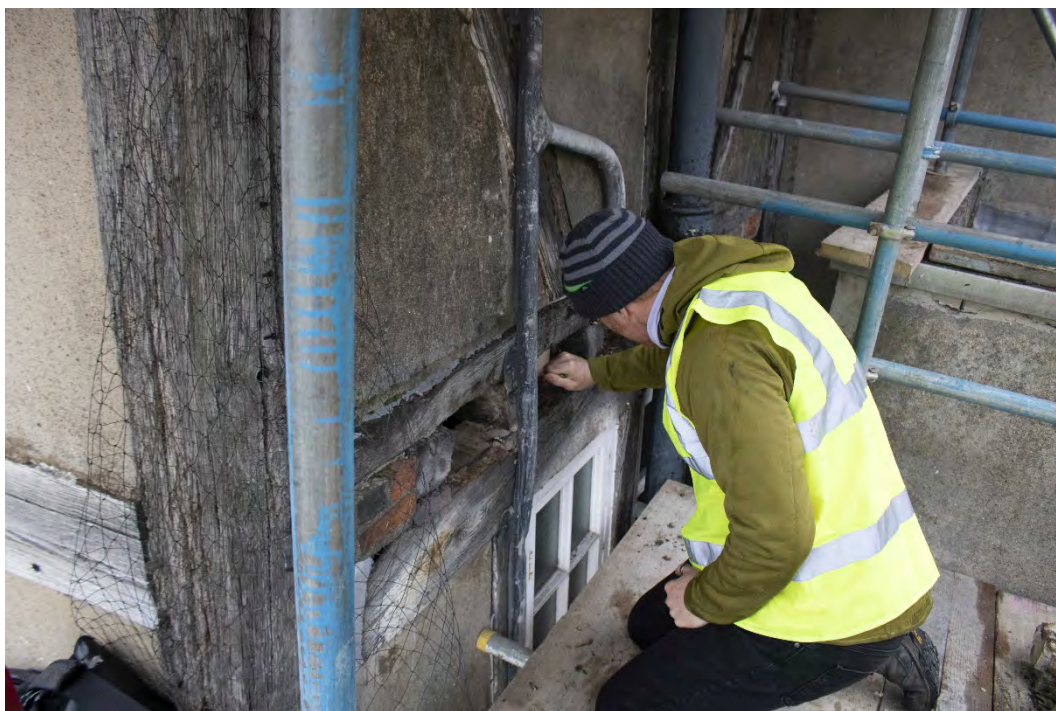
Each timber and window frame was visually inspected by Paul Pegram, City of York Council Building Technologist, and probed to establish the extent of decay (Plate 1). Elements of re-set brickwork around joists at 1st and 2nd floor level were removed to allow access to joist ends as well as upper and lower rails in those locations (Plate 2).

Plate 1 Inspection of timber frame, facing north

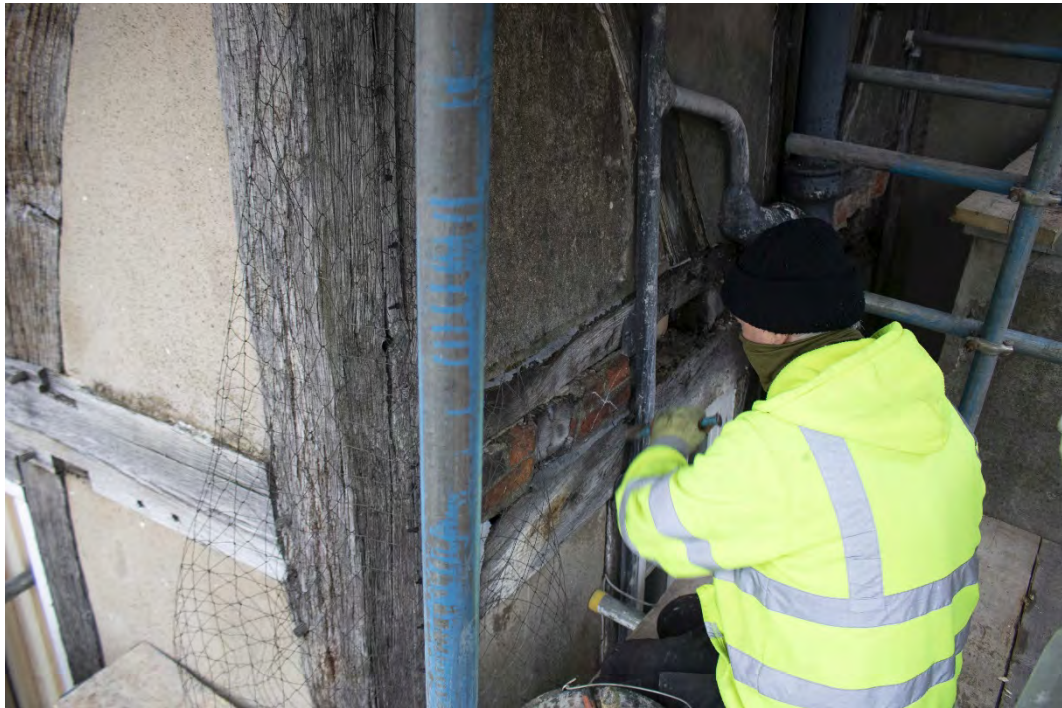
Plate 2 Removal of re-set brickwork between 2nd floor joists and upper and lower rails, facing north

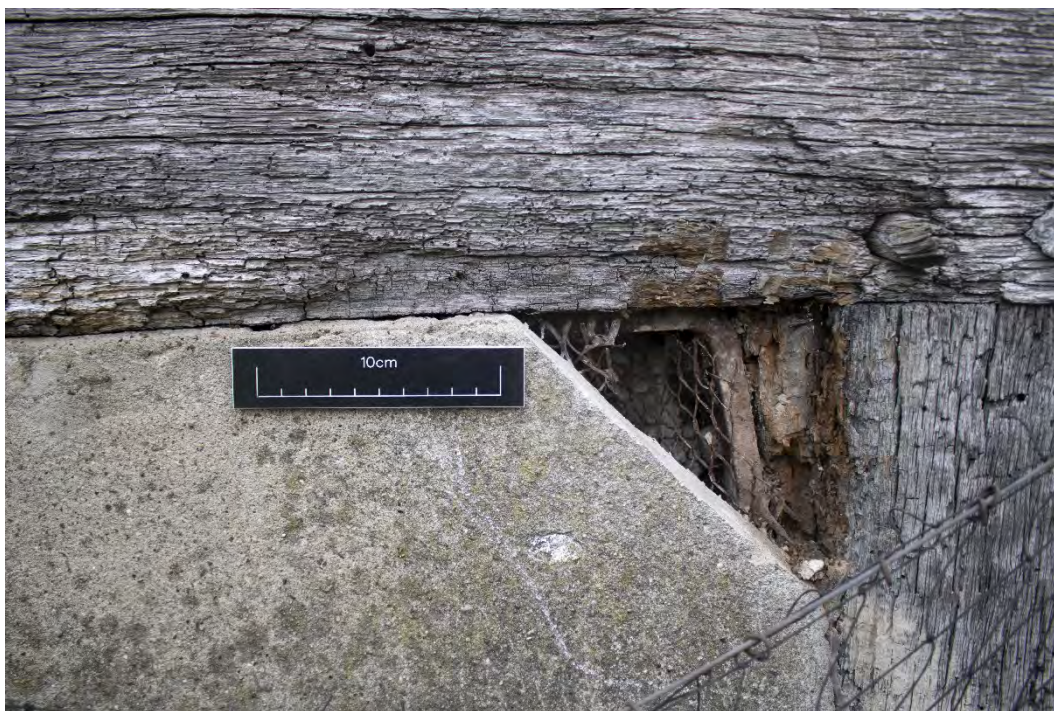
The infill panels were found to consist of render comprised of fine aggregate, sand and cement applied over expanded metal mesh fixed to the timbers (CYC 2020) (Plate 3). This form of modern construction likely dates to the alteration and renovation of the building around 1950. No structural elements were found behind the infill panels of brickwork (Plate 4).

Plate 3 View of inspection cut-away in mid-20th century render infill panel, facing north, 0.1m scale

In addition, the mid-20th century cement render will require removal and replacement.

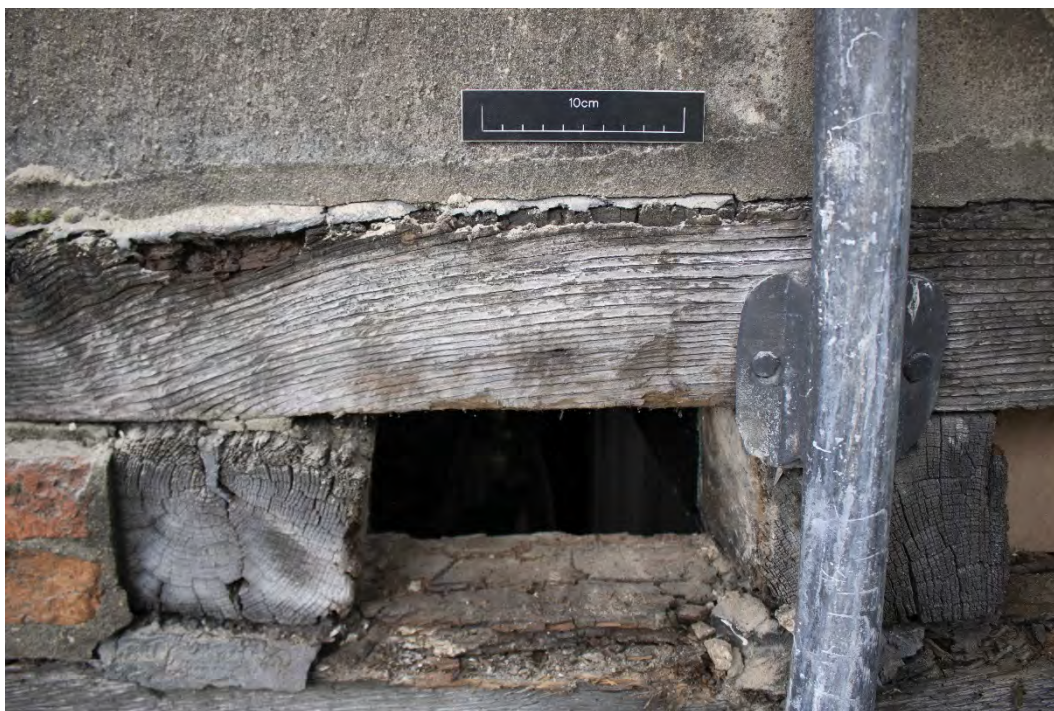
Plate 4 Void behind re-set brickwork between joists at 2nd floor level, facing north-west, 0.1m scale
