Photographic Recording Report
Relating to Structural Timber and Render Repairs at
72 Goodramgate, York, YO1 7LF

ON BEHALF OF:
North Country Properties Ltd c/o Vine Property Management

Reference: WACBLD272

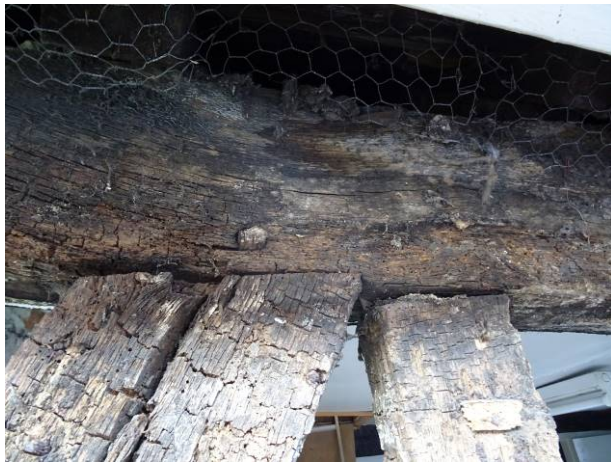
05 - Front elevation – degraded timbers

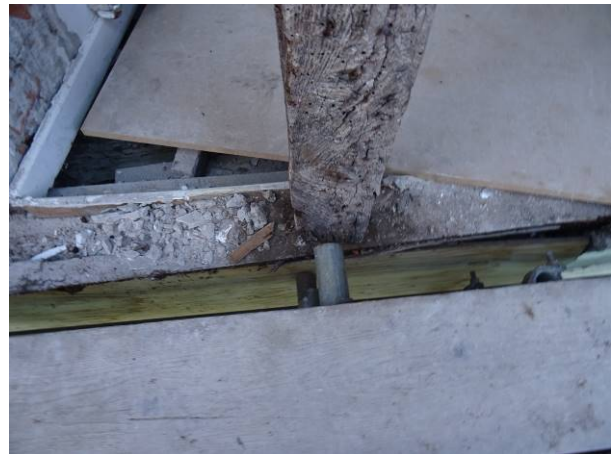
06 - Front elevation - timbers

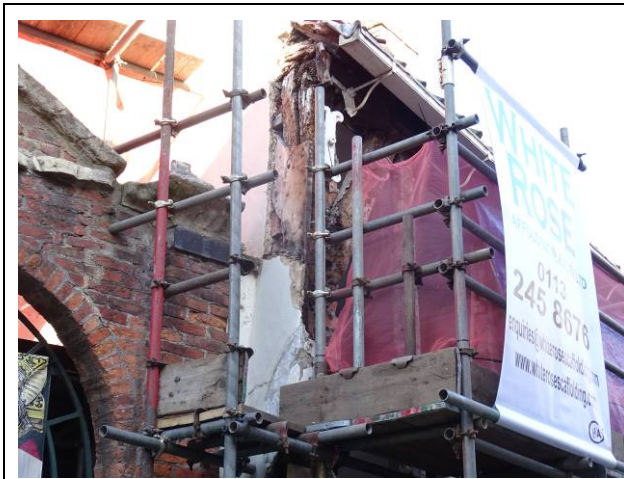
11 - LHS corner of property with previous repairs

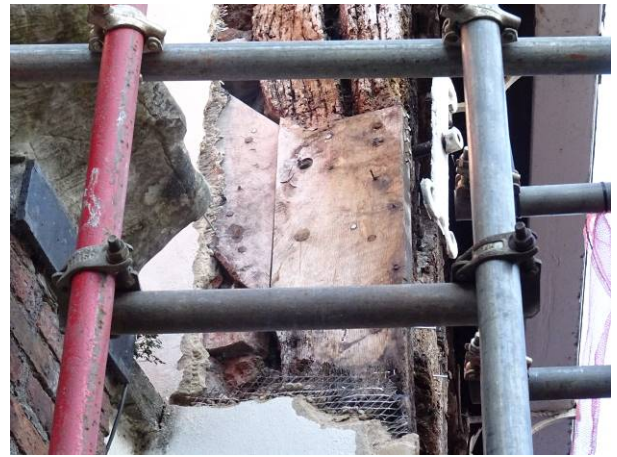
12 - LHS corner showing previous repairs

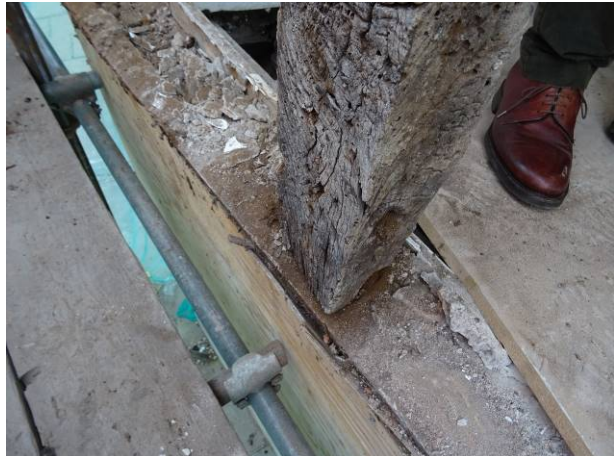
<p>15 - Exposed timbers at front elevation</p>	<p>16 - Exposed degraded timbers at front elevation</p>

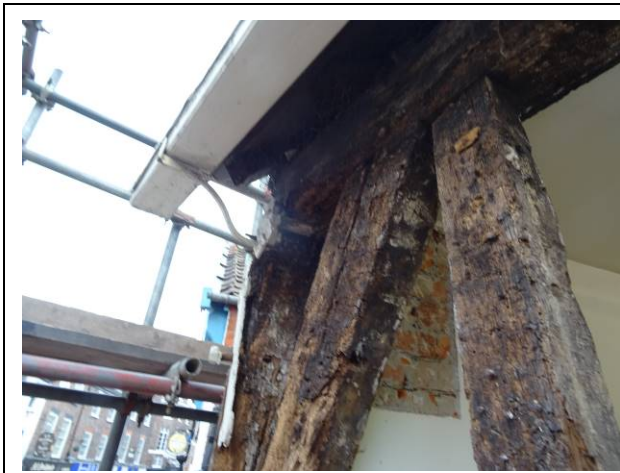
17 - Exposed timbers at front elevation

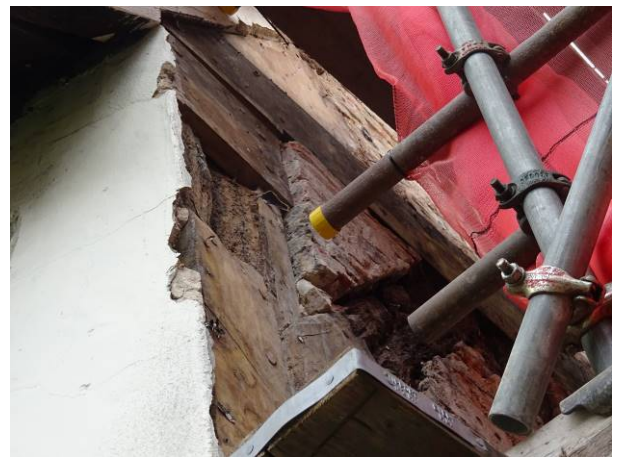
18 - Timbers at LHS elevation with previous repairs

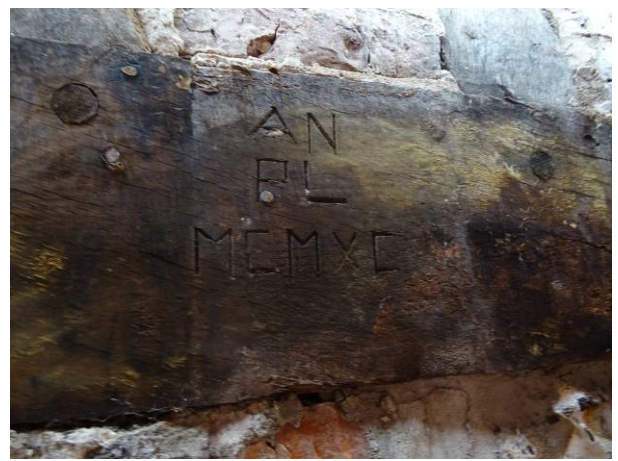
20 - Structural timbers at LHS elevation (previous repairs dated)

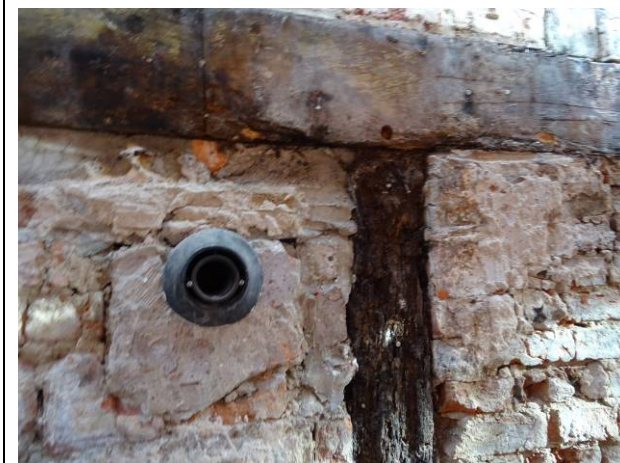
21 - Degraded structural timbers at LHS elevation

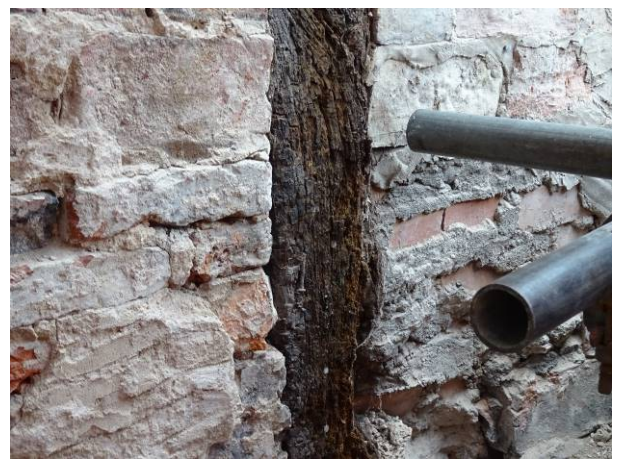
22 - Degraded structural timbers at LHS elevation

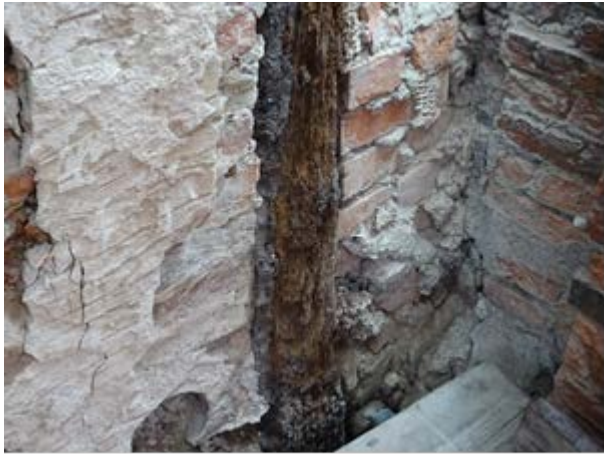
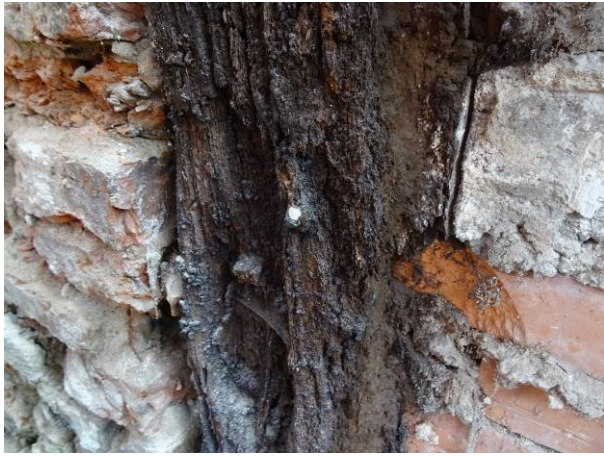
23 - Degraded structural timbers at LHS elevation	24 - Degraded structural timbers at LHS elevation

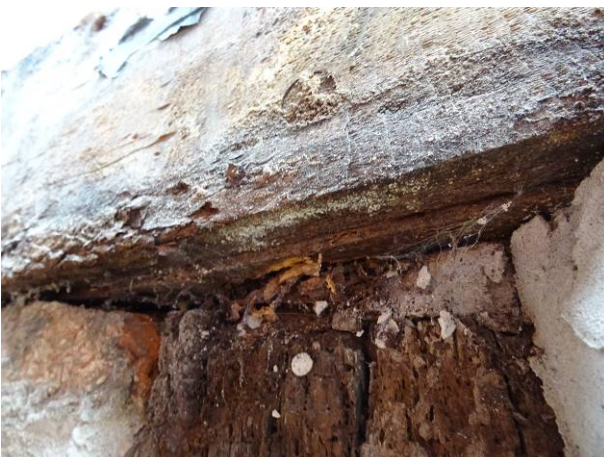
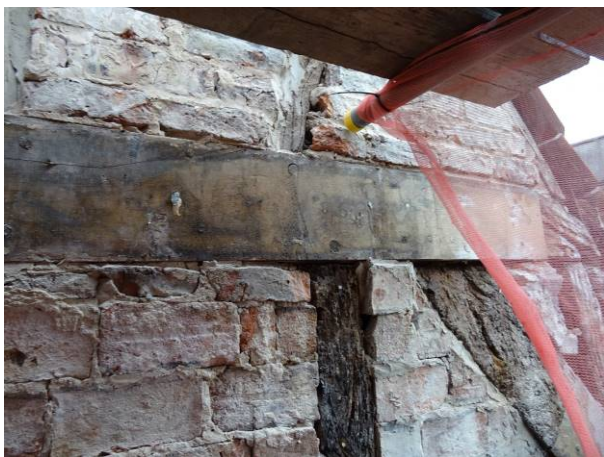
25 - Degraded structural timbers at LHS elevation	26 - Degraded structural timbers and previous repairs at LHS elevation

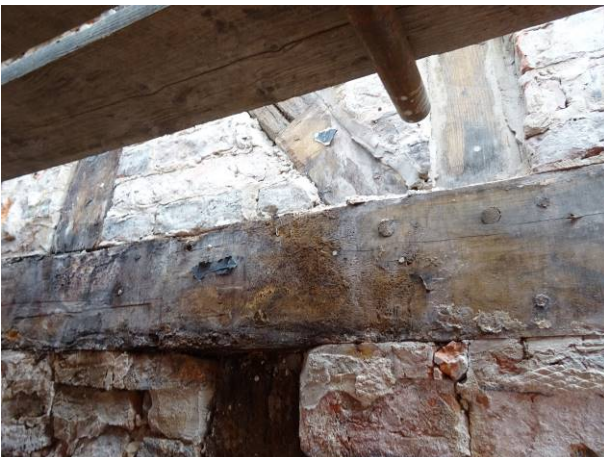
27 - Degraded structural timbers and previous repairs at LHS elevation	28 - Degraded structural timbers and previous repairs at LHS elevation

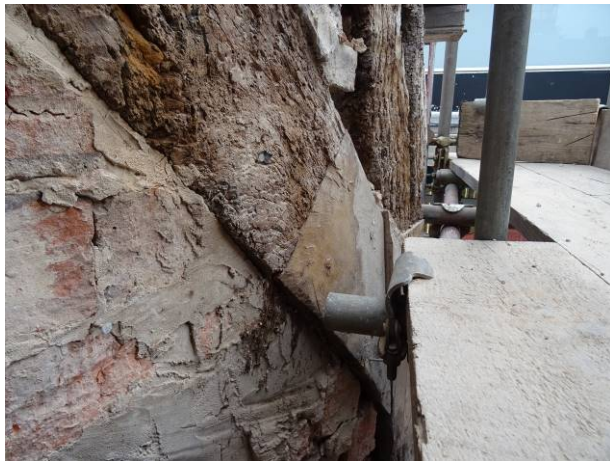
29 - Degraded structural timbers and previous repairs at LHS elevation

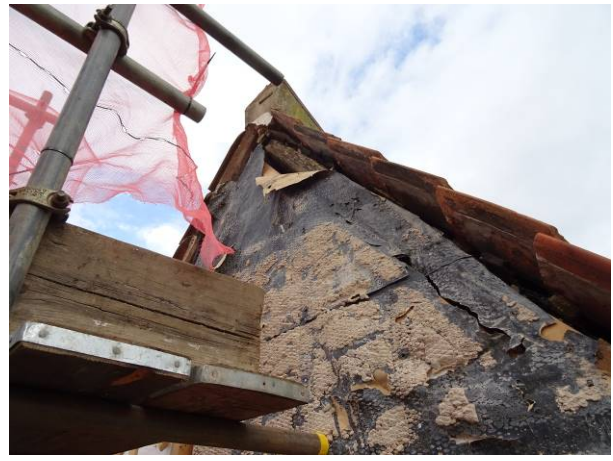
30 - LHS elevation with assumed builder's paper and bitumen paint from previous repair

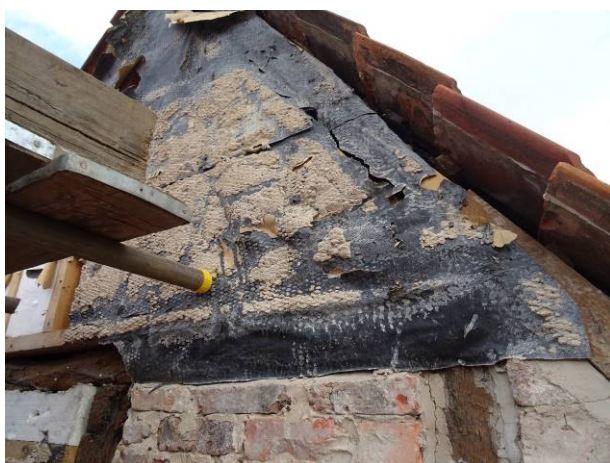
31 - LHS elevation with assumed builder's paper and bitumen paint from previous repair

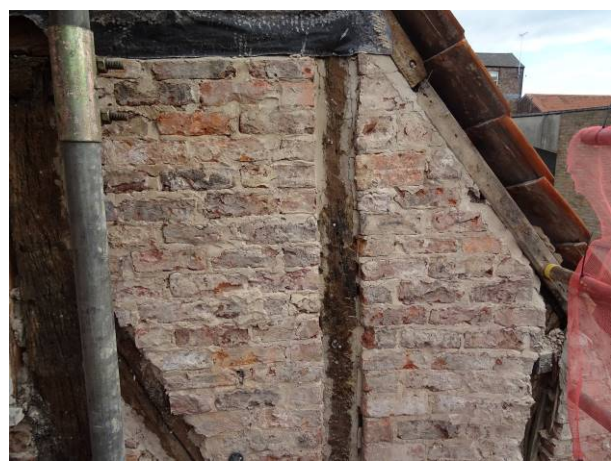
32 - Degraded structural timbers and previous repairs at LHS elevation

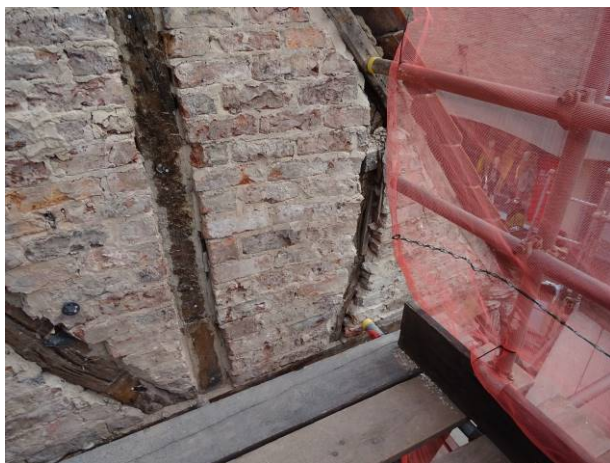
33 - Degraded structural timbers at LHS elevation

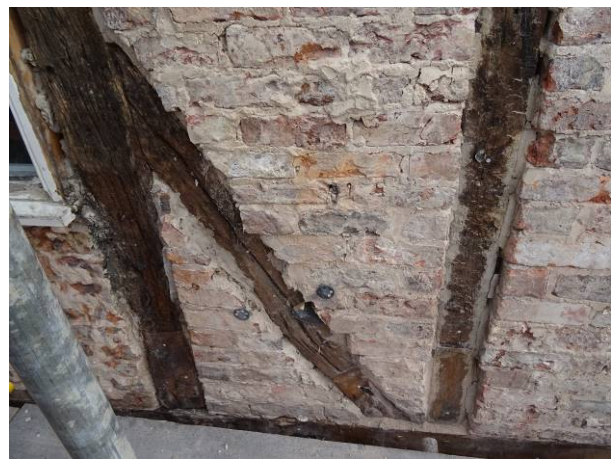
34 - Degraded structural timbers at LHS elevation

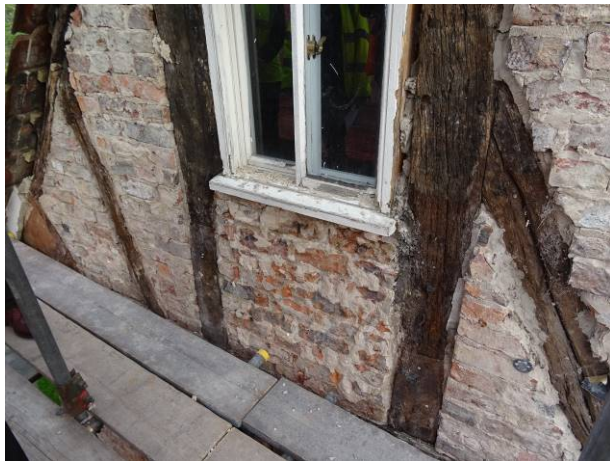
35 - Degraded structural timbers at LHS elevation and window

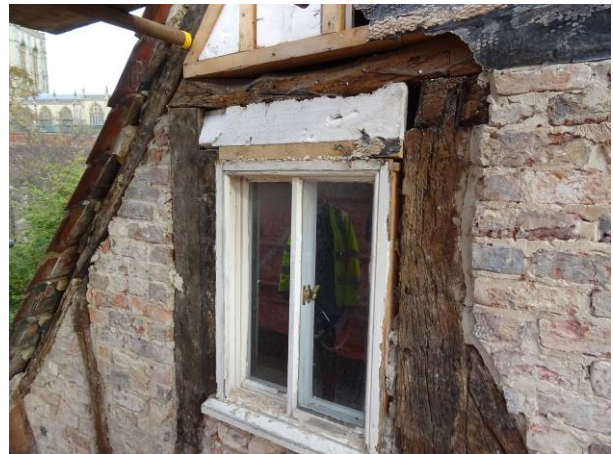
36 - Degraded structural timbers at LHS elevation and window

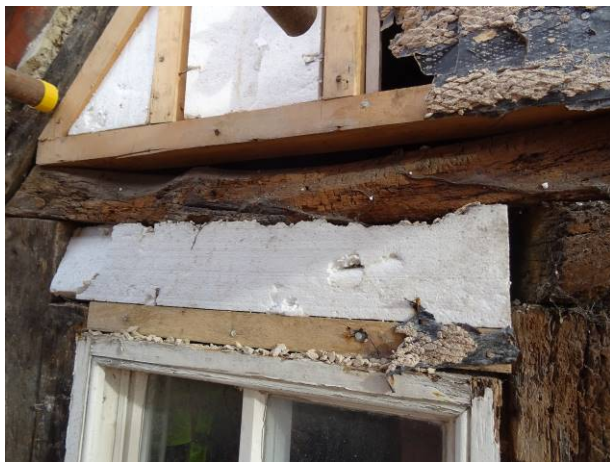
37 - LHS elevation – degraded timbers, window, gable timbers and polystyrene infill

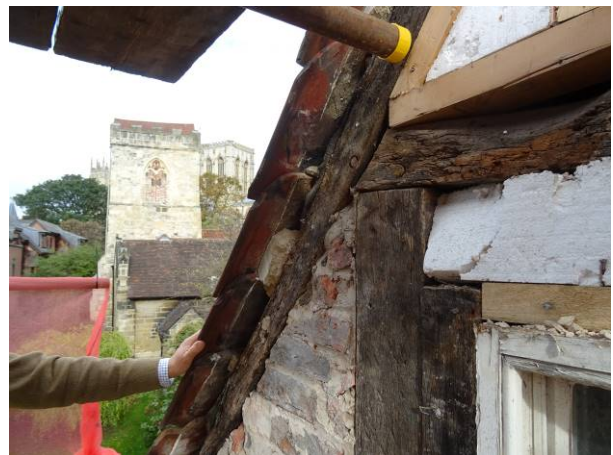
38 - LHS elevation – degraded timbers, window, gable timbers and polystyrene infill

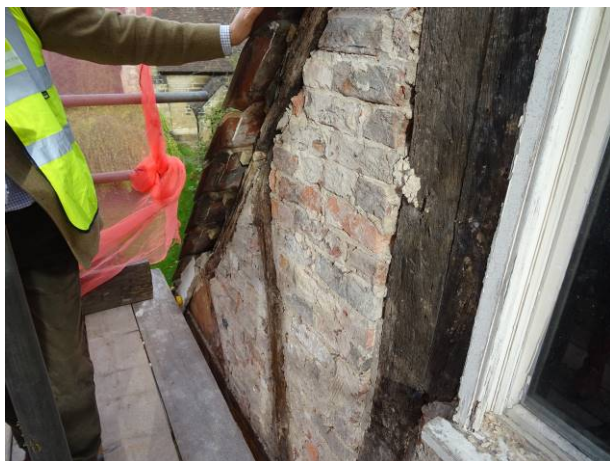
39 - LHS elevation – degraded timbers and infill brickwork

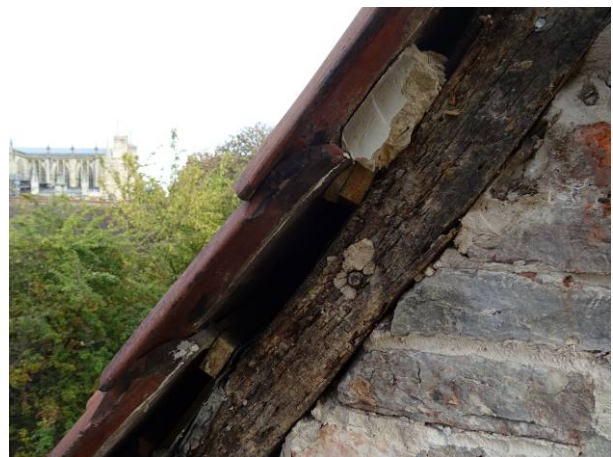
40 - LHS elevation – degraded timbers

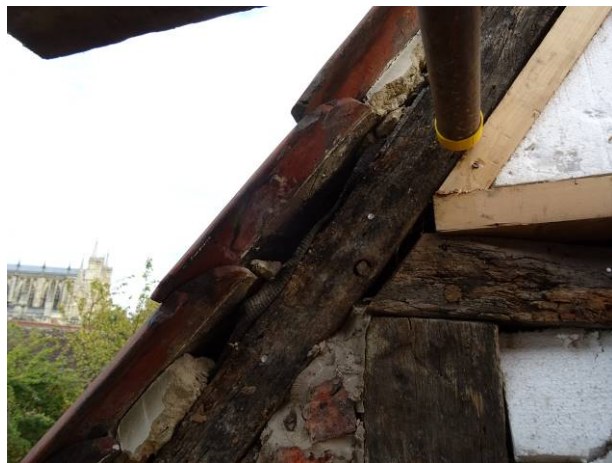
41 - LHS elevation – degraded timbers

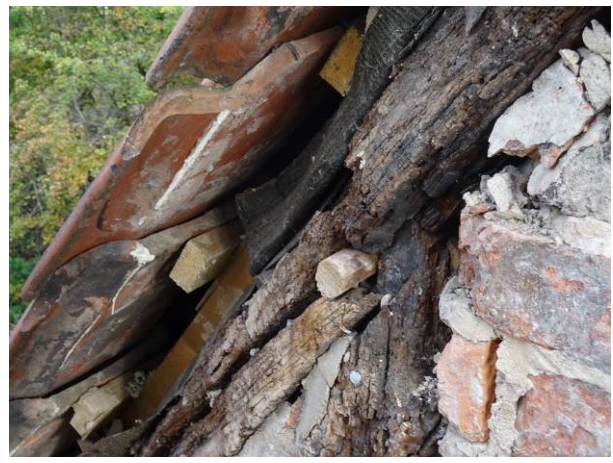
42 - LHS elevation – degraded timbers

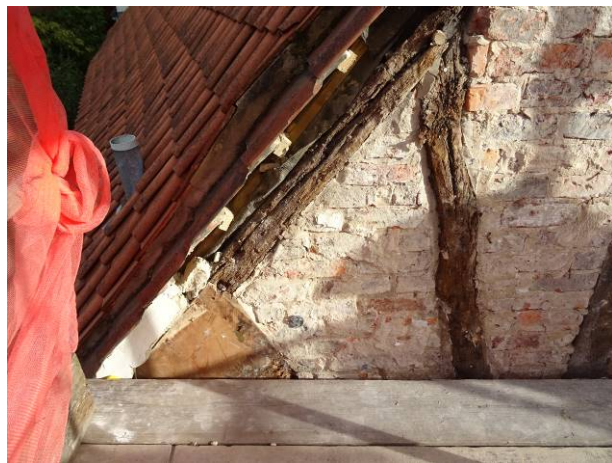
43 - LHS elevation – degraded timbers and infill
brickwork

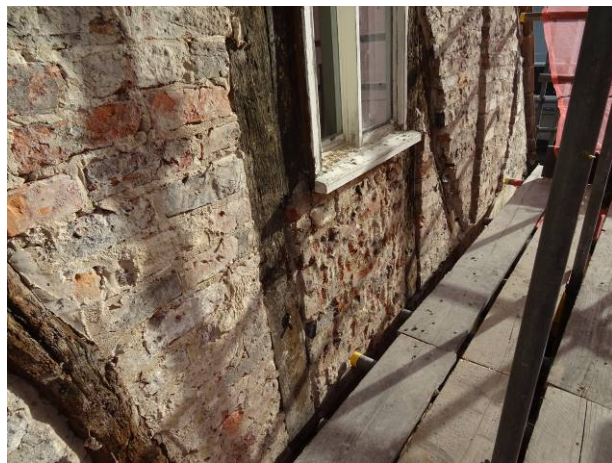
45 - LHS elevation – window, degraded timbers
and infill brickwork

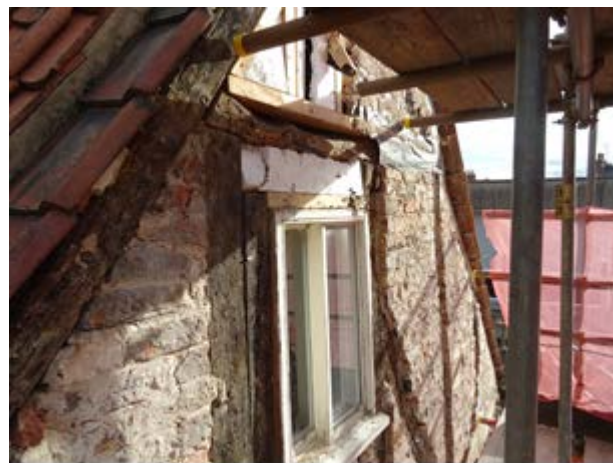
46 - LHS elevation – window, degraded timbers
and infill brickwork

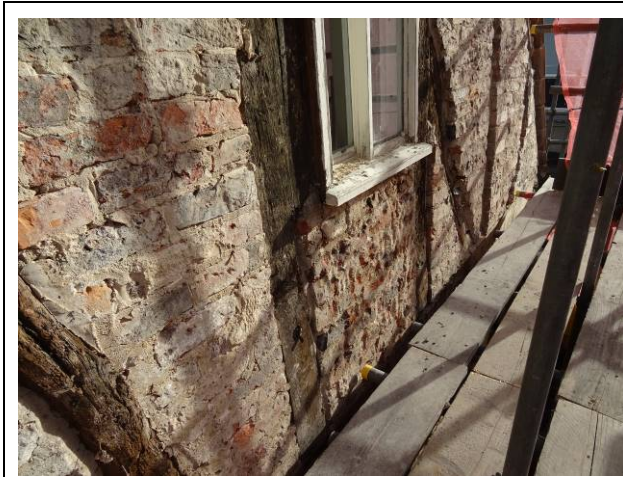
47 - LHS elevation – degraded timbers, window and infill brickwork

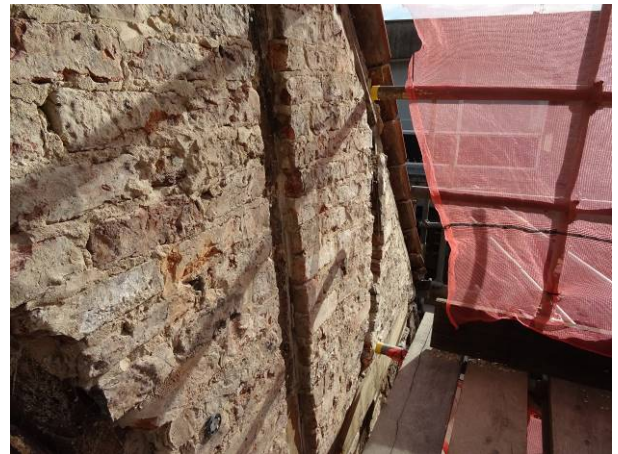
48 - LHS elevation – degraded timbers and infill brickwork

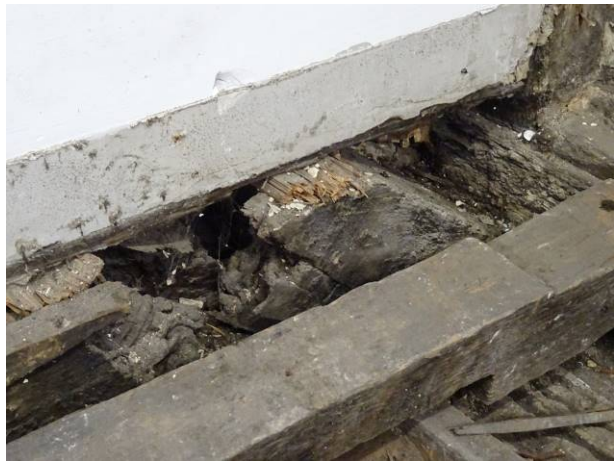
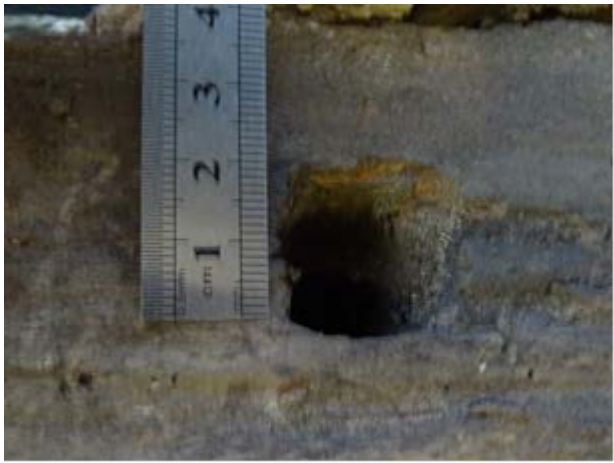
58 - Internals – defective timbers	59 - Internals – dowel hole

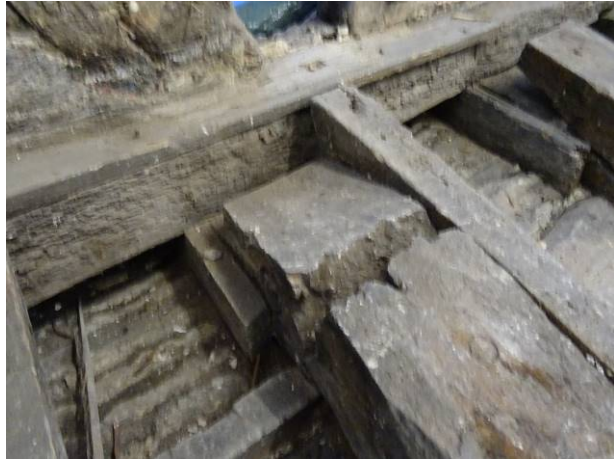
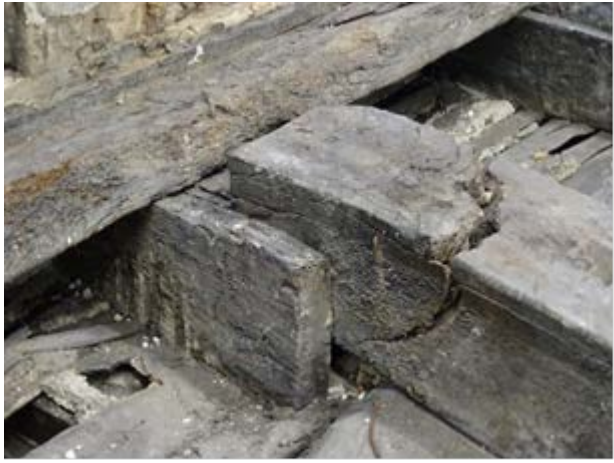
60 - Internals – defective floor joists	61 - Internals – defective floor joists

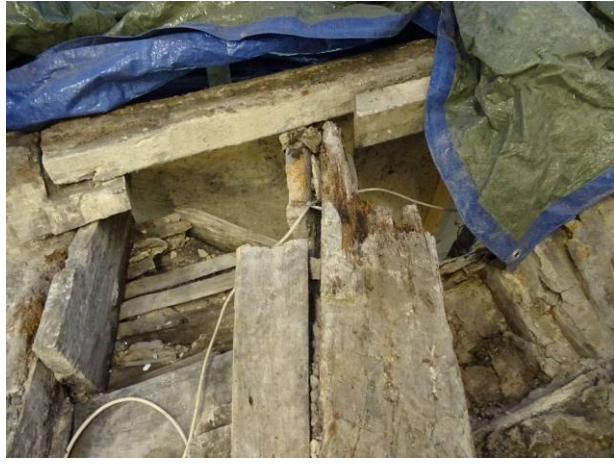
62 - Internals – defective floor joists	63 - Internals – defective floor joists

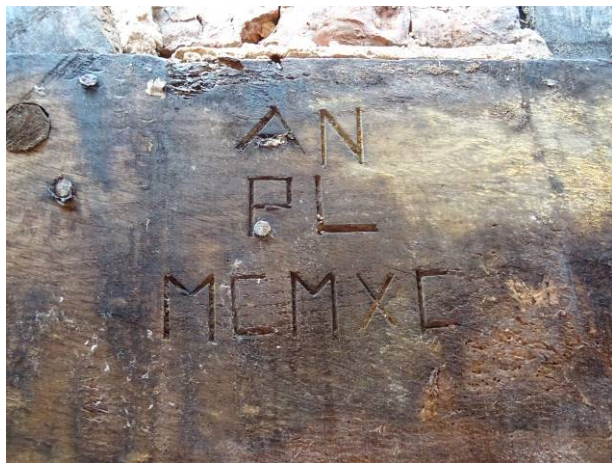
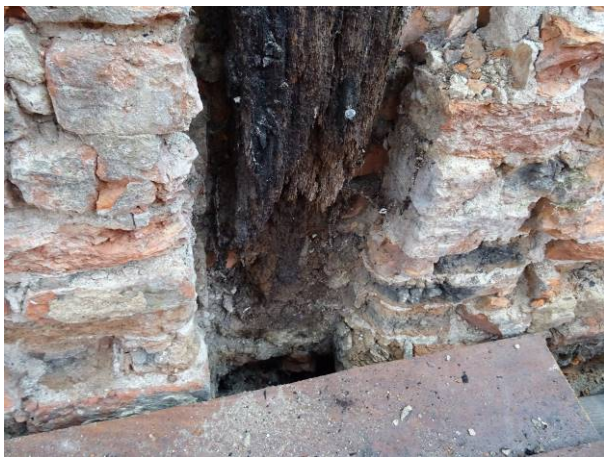
<p>102 - Dated timber from previous repairs</p>	<p>103 - LHS elevation – decayed timber</p>

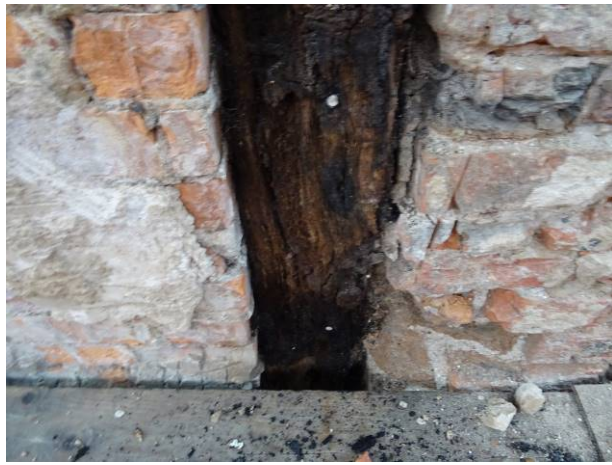
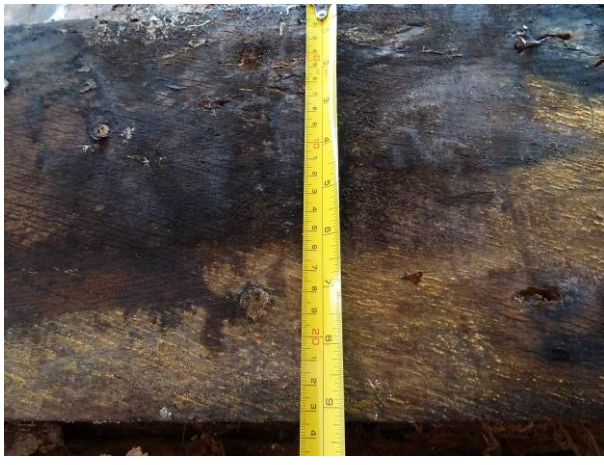
<p>104 - LHS elevation – decayed timber</p>	<p>105 - LHS elevation – previous timber repairs</p>

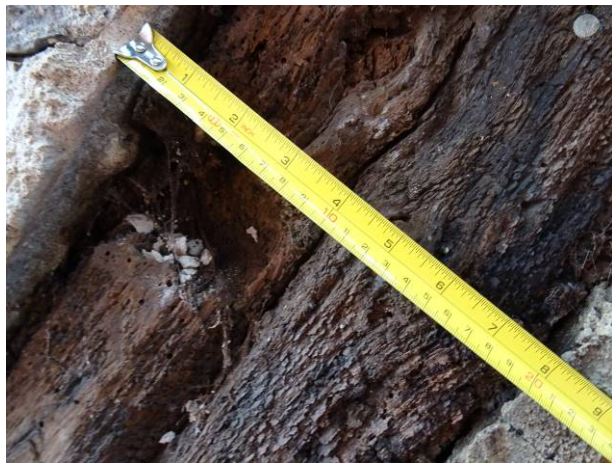
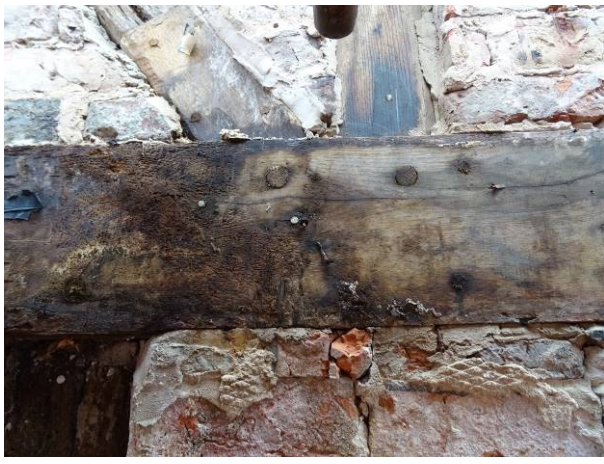
<p>106 - LHS elevation – decayed timber</p>	<p>107 - LHS elevation – previous timber repairs</p>

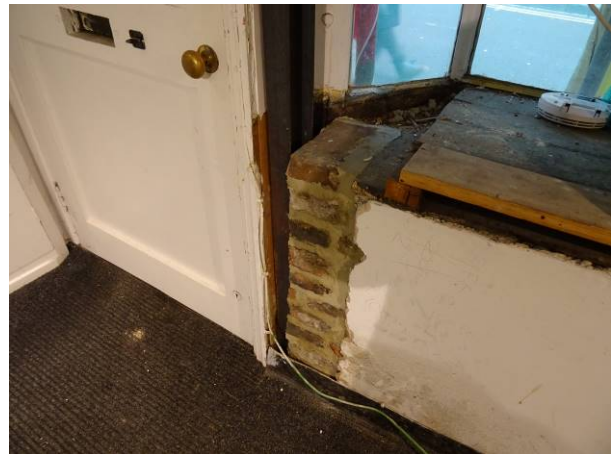
147 - Internals – Ground floor, newly installed prop at side of entrance door

- Internal straps to the first floor gable masonry corner post / front elevation brickwork infill. Straps to be galvanised at 500mm centres vertically.
- Vertical galvanised steel prop at ground level up to first floor beam to be installed next to the front entrance door.
- Strengthening of first floor joists with galvanised steel channel sections. Channels to extend from the central beam, cantilevering over the ground floor bay to support the first floor elevation.
- Additional timber floor joists are to be installed between the existing to add further structural stability.

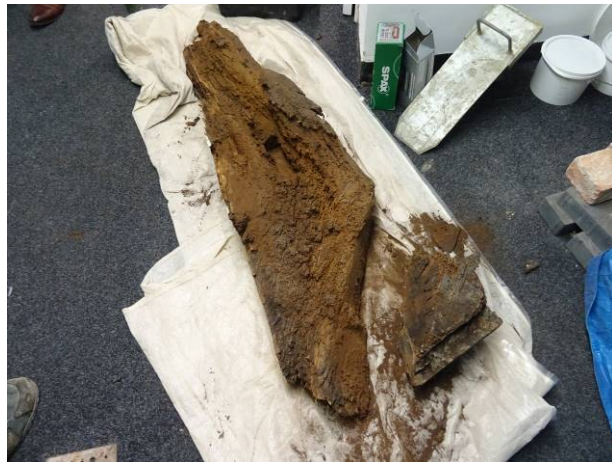
148 - Decayed corner post

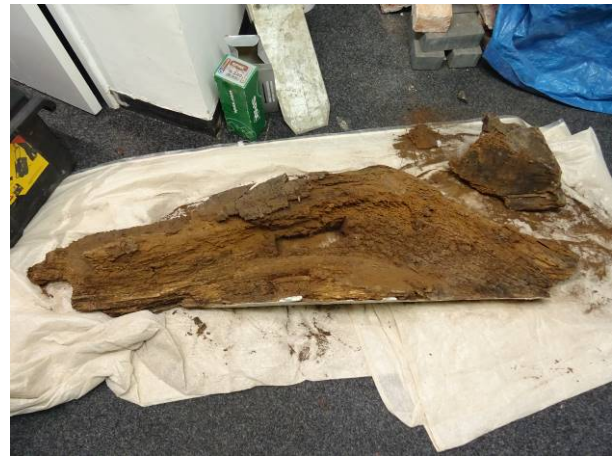
149 - Decayed corner post

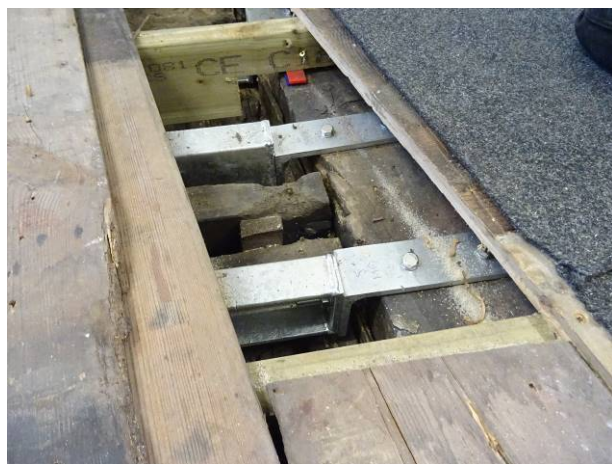
150 - Steel channels tied into the central beam
