**36 CONEY STREET**

**YORK**

**HISTORIC BUILDINGS  
ASSESSMENT**

**REPORT v1  
FEBRUARY 2023**

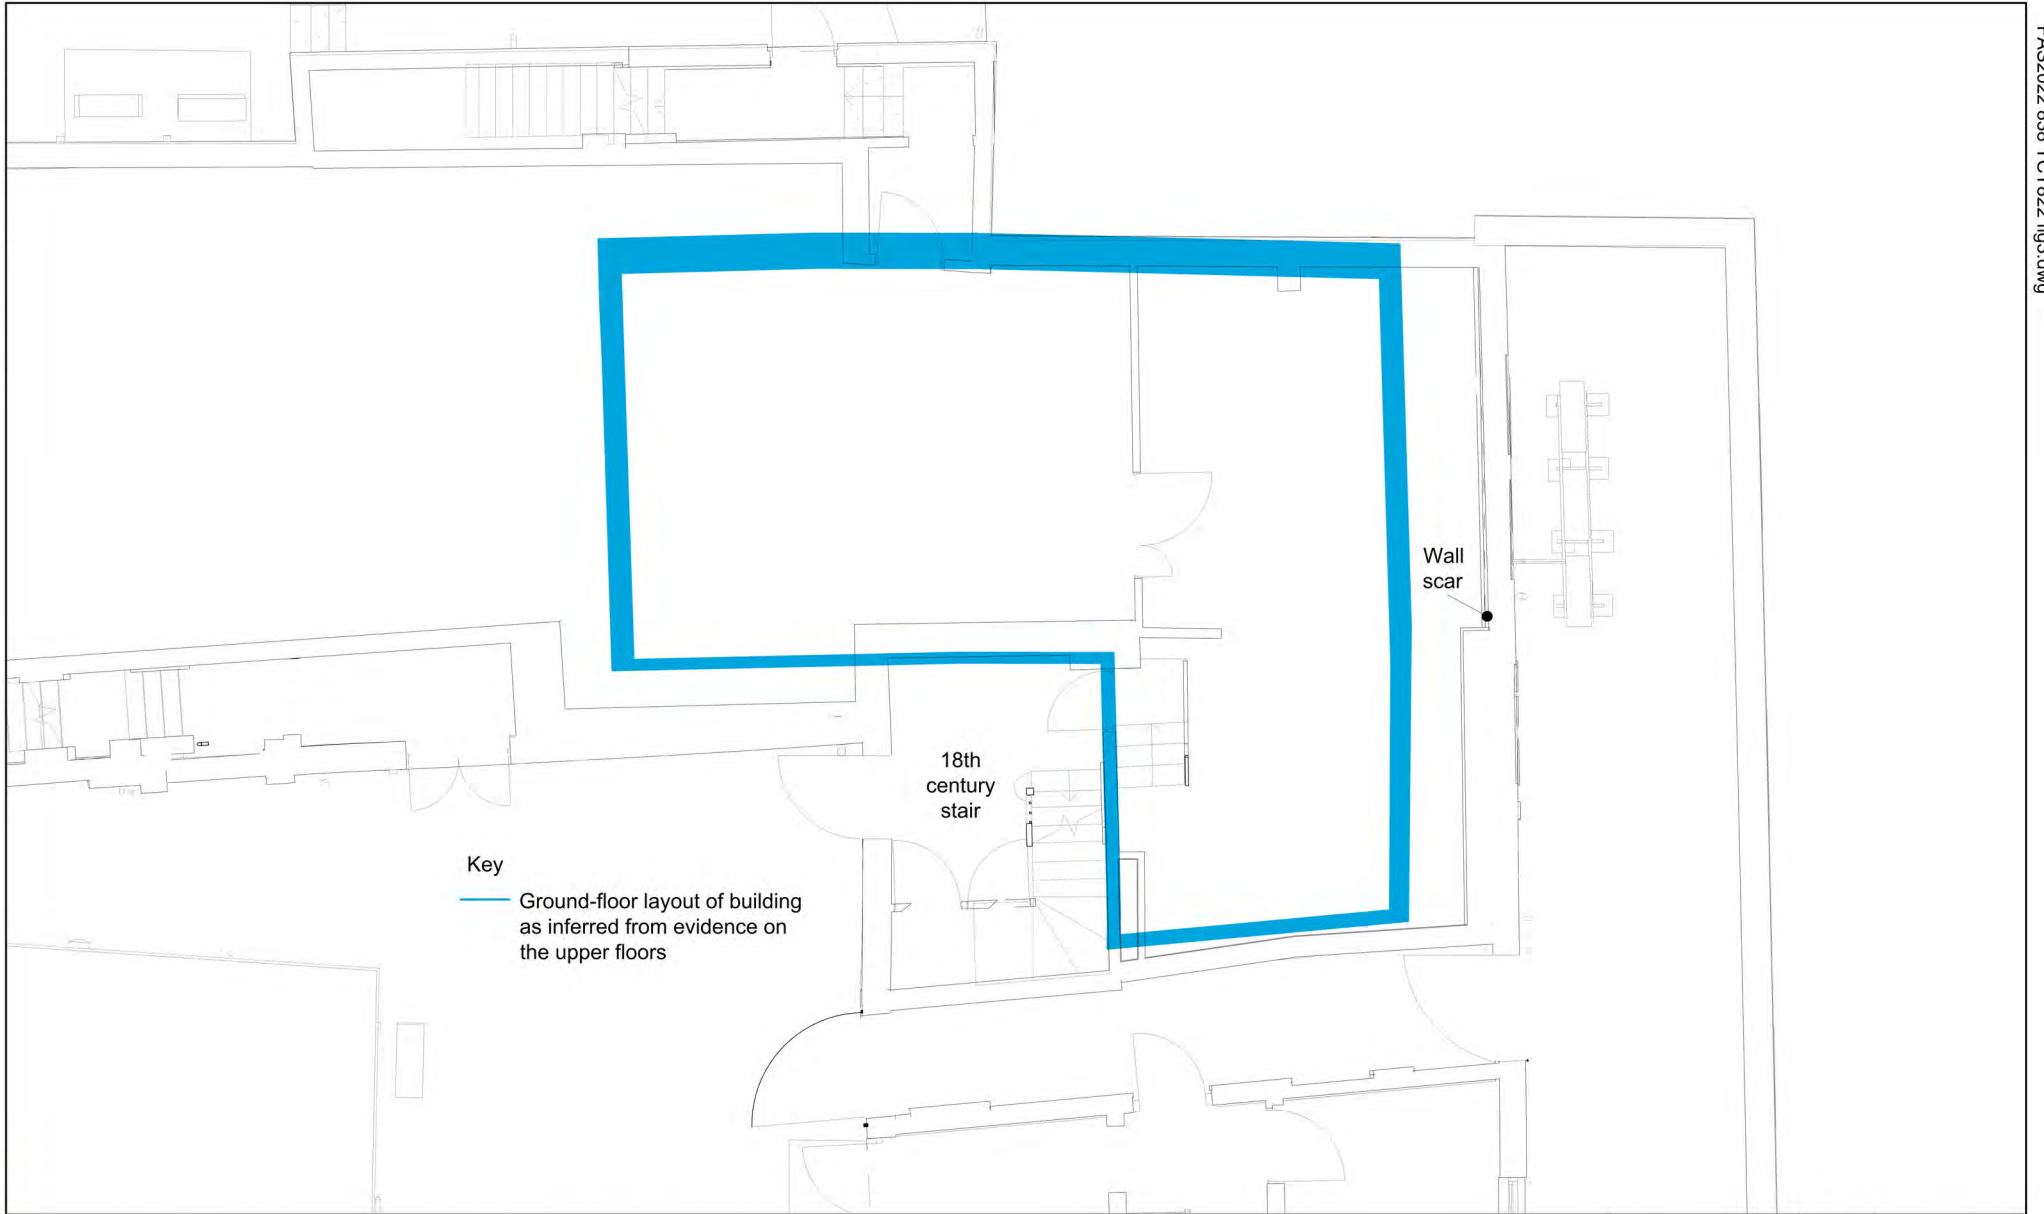
Ground-floor plan showing reconstructed building layout

There was no timber framing exposed at ground-floor level, and so the reconstructed floor plan has been inferred from posts on the floors above (Figure 3). While it can be inferred where the timber-framed structure should be at ground-floor level, particularly where corner posts should be located, there was no exposed framing at this level.

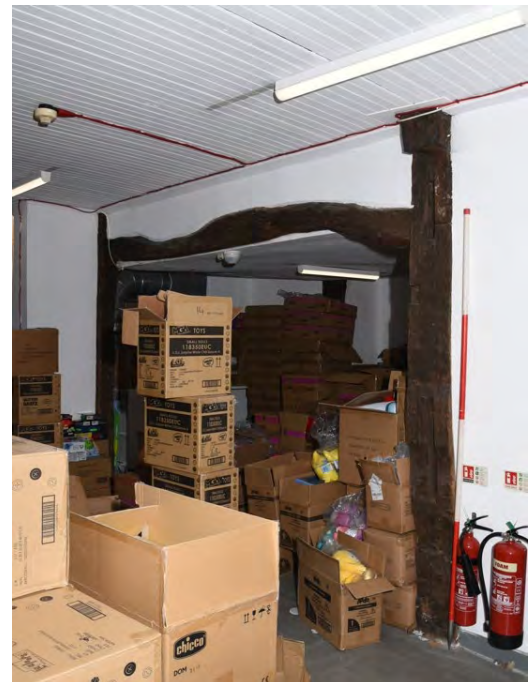
**Plate 9** First floor showing posts A (right) and B (left) and wall plate (looking E, 2m scale) (YCY015)(scale 2.0m)

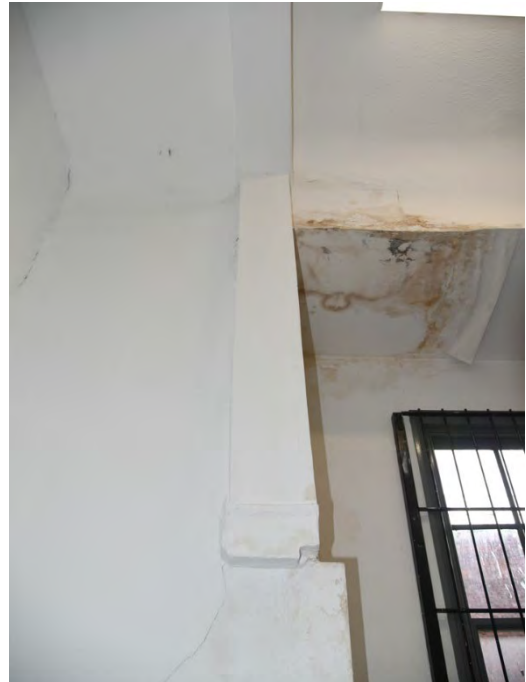
**Plate 10** Corbel at first-floor level, between Bay 1 and Bay 2 (YCY025)

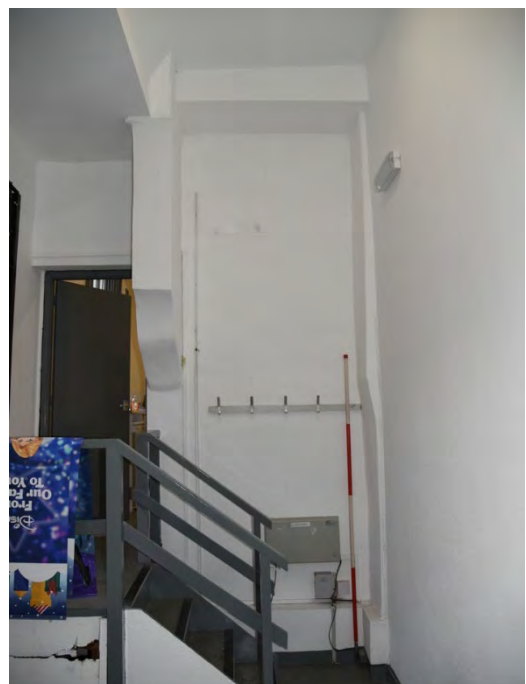
**Plate 11** Corbel at first-floor level, (YCY027)(scale 2.0m)

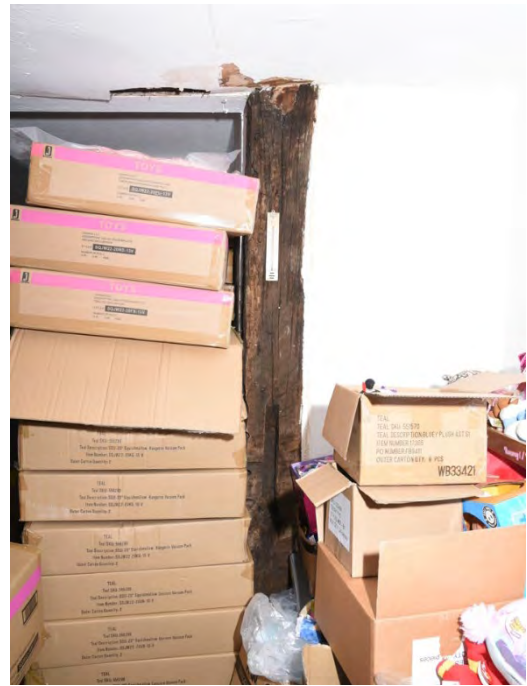
Post C is located in the eastern corner of the building and retains evidence for arch braces springing from its northwest and southwest faces, indicating solid walls in these directions (Appendix B: YCY020; Plate 12).

**Plate 12** View of post C, looking NE (YCY020)

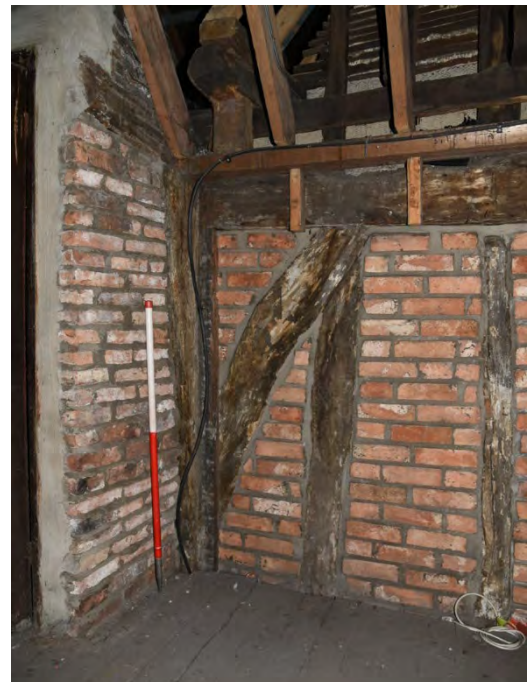
**Plate 13** View of post E, looking E (YCY046)(scale 1.0m)

Post E also retains evidence for a removed brace and wall plate on its southeast face. Further, it is evident that the northeast face of the post has been subject to considerable weathering, confirming that this must have been the original external elevation of the timber-framed building.

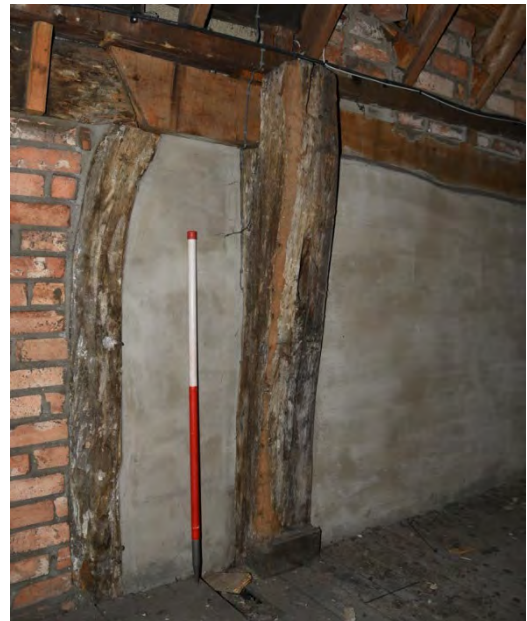
Two sets of three pegs in the lower part of the northwest face of post D indicates that arch braces would have been jointed into either side of the post and braced up to the wall plate; both braces have been removed (Plate 14). In addition, post D has a long empty mortice, also in its northwest face, for a further brace springing to the northwest. This would have braced a tie beam that would have been located between posts D and G.

**Plate 14** View of post D, looking S (YCY047)(scale 1.0m)

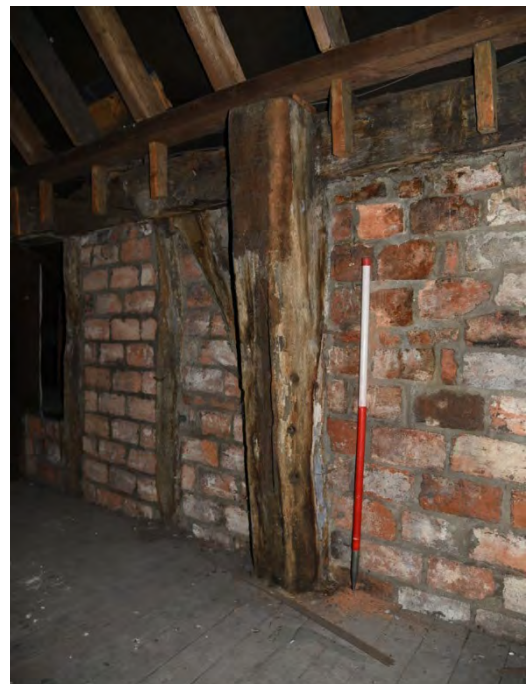
**Plate 15** View of post G, looking W (YCY048)(scale 1.0m)

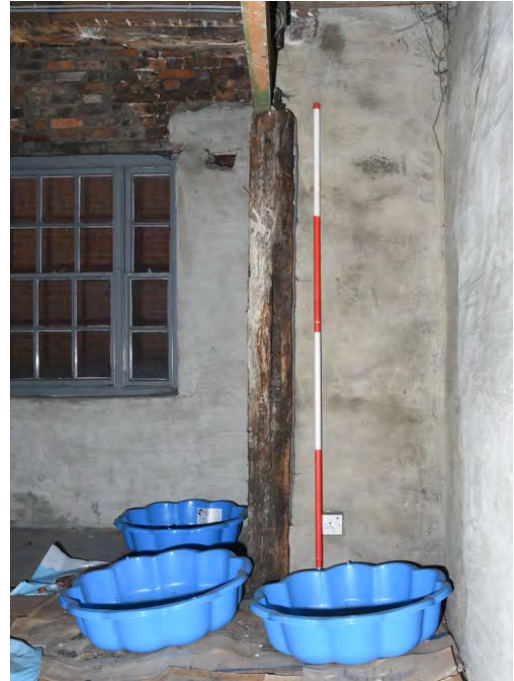
**Plate 17** View of post E, looking N (YCY035)(scale 2.0m)

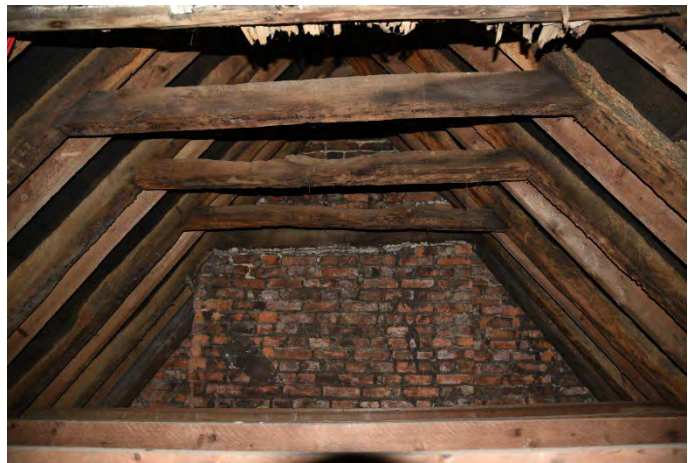
The roof structure above the southeast range appears to have largely been replaced. The roof structure over the northwest range has also been subject to reconstruction, probably during the early 1980s repairs. However, the southwest end retains several close coupled trusses of collar form (Appendix B: YCY049-54).

**Plate 18** View of roof structure (YCY050)

Given the arrangement of the main timber-framing, the close coupled collar truss form is surprising; it would be expected that the trusses would be seated on the main wall posts where they were at least provided with a tie beam. Common rafters would have been employed between these main trusses seated directly onto the wall plates.

Given these anomalies, the surviving elements of the historic roof might be a replacement arrangement dating to sometime after the original timber-framed structure.

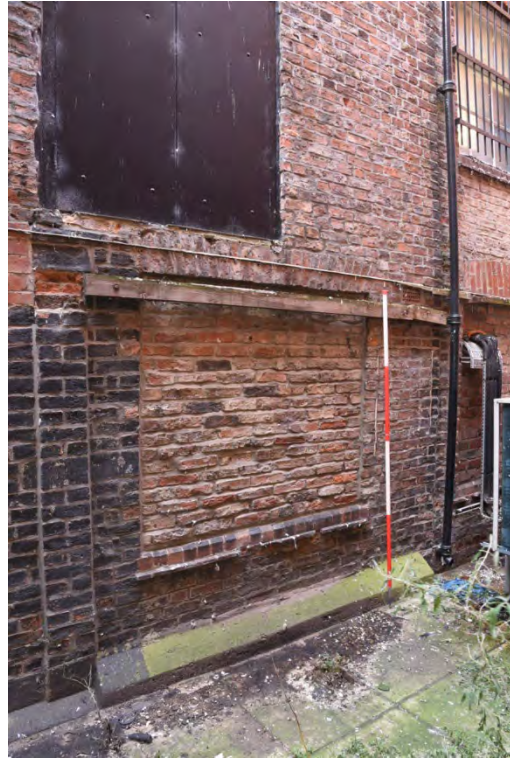
**YCY006** Blocked opening in northeast elevation (2m scale)

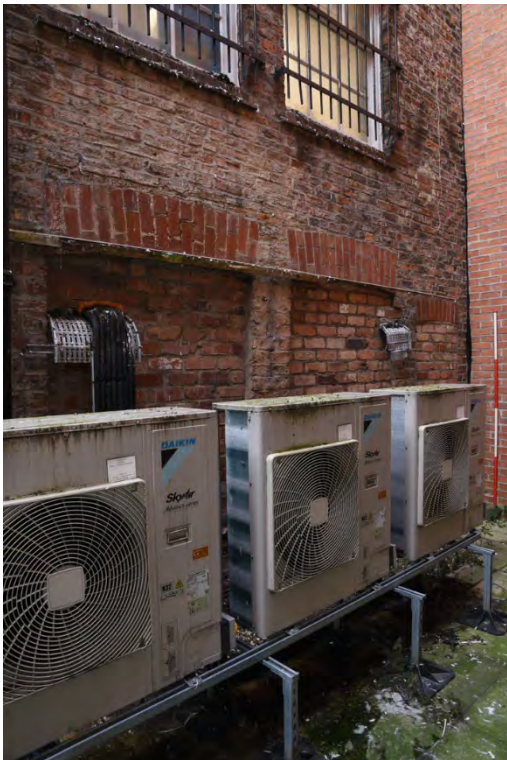
**YCY007** Blocked window openings in northeast elevation (2m scale)

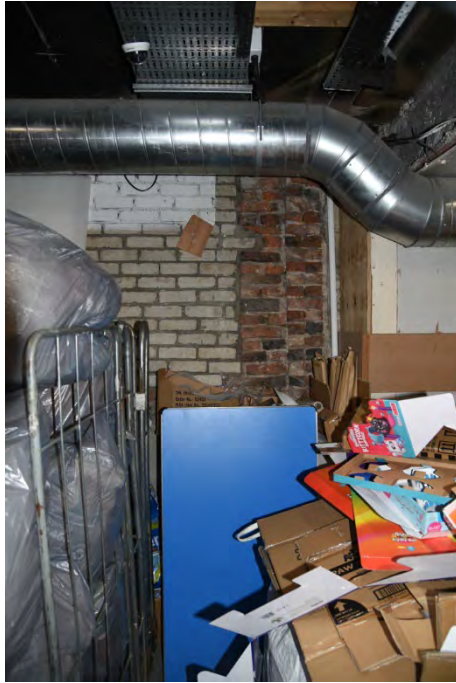
**YCY011** Interior ground floor looking northeast showing wall scar (2m scale)

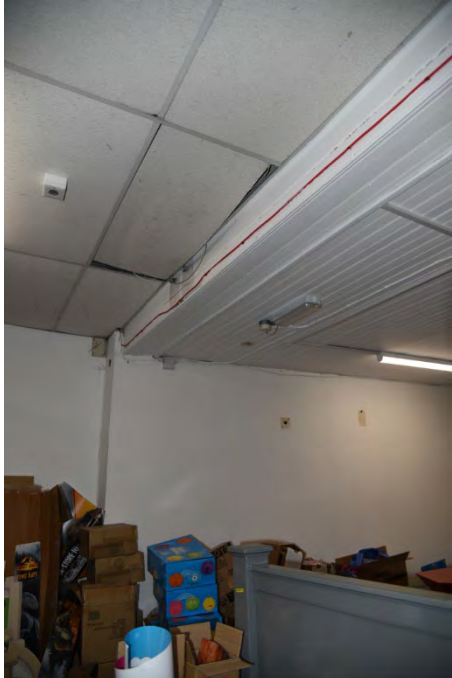
**YCY023** Interior first floor looking north showing post position and boxed replacement bridging beam

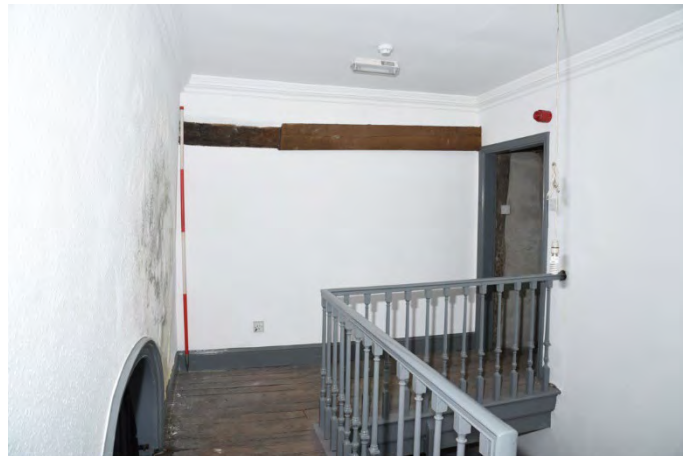
**YCY029** Interior second floor looking northwest showing wall plate with replaced section (right) (2m scale)
