# No.4 Jubbergate | Repairs and Minor Alterations

Design, Access & Heritage Statement

File: 3251

Date: 17 February 2022

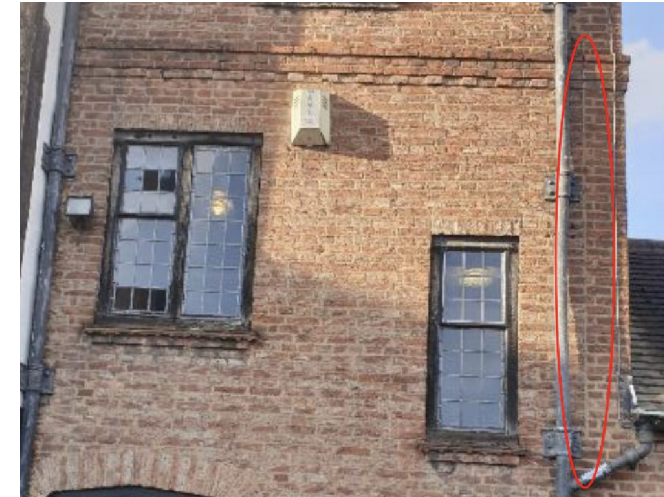
Figure 22 Building break to corner of Wall 2 (red ellipse) requiring brick anchors.

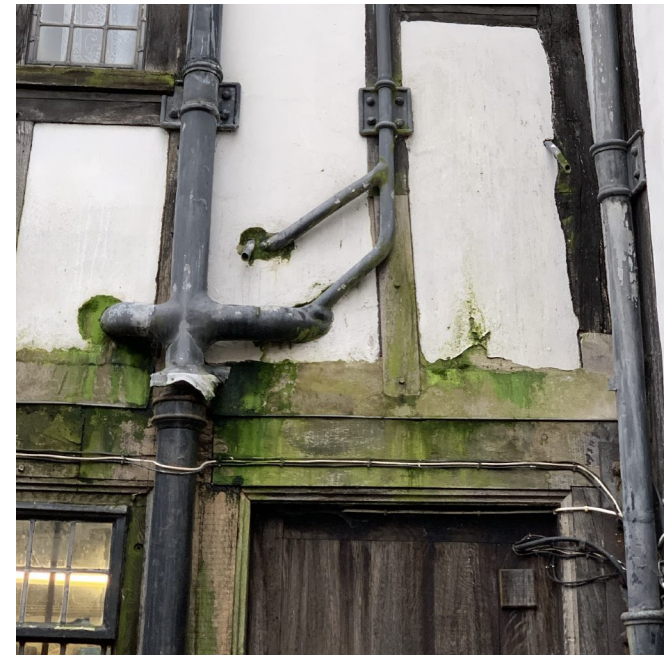
Figure 23 Detail of poor quality repairs and ongoing waterlogging damage to Wall 13 caused by the wall's 5 degree lean. Note also the blocked D3 and quantity of pipework across this wall (see I.13).

<b>1.04</b>	<b>Wall 13 Repairs and Alterations</b>
	Wall 13 requires significant timber replacement (most timbers date from the 1920s restoration). The wall leans back by ~5 degrees from vertical which has allowed the lower portion of the wall to become saturated (see fig. 23). All infill panel render to be replaced with lime render and redecorated following timber repairs/replacement. There are three lead lined roof-lets extending beyond the face of the wall which have been added at first & second floor and gable collar level to reduce water saturating the base of the wall. These have failed due to a lack of water capture. Gable collar projection to be replaced on a like-for-like basis. Propose three larger lead-covered roof extensions to be provided above ground, first and second floor window levels projecting ~400mm out from the wall with each provided with a small section cast-iron gutter to control water run-off. The lead-dressed timber roof-lets to be supported on black-finished custom stainless steel brackets (see drawing 3251-015).

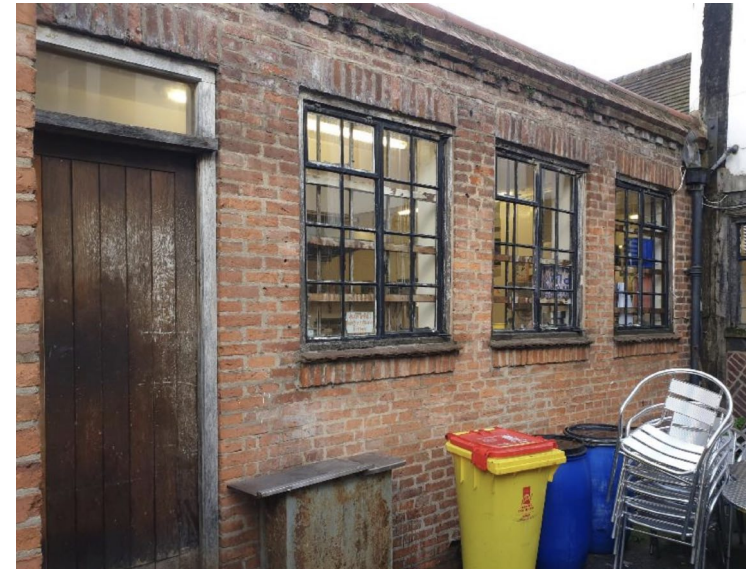
Figure 24 Kitchen viewed from the courtyard - note the salt staining around the lintels, indicative of waterlogging from roof runoff. It is further proposed to raise the height of these walls by ~450mm, retraining the existing corbelled parapet (1.05).

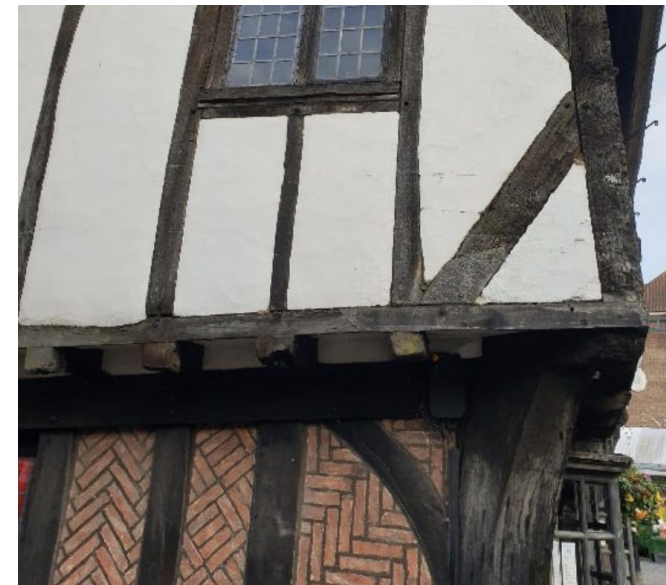
Figure 25 The present roof covering (& possibly later infill panel material) has overloaded the historic jetties, causing ongoing strain to the supporting joists.

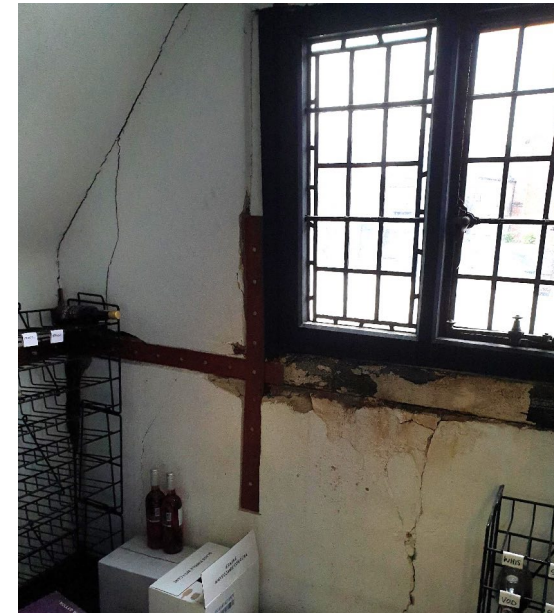
Figure 26 Temporary steel strapping to inside of Gable Wall 3A/3B as an emergency repair to halt ongoing structural failure.

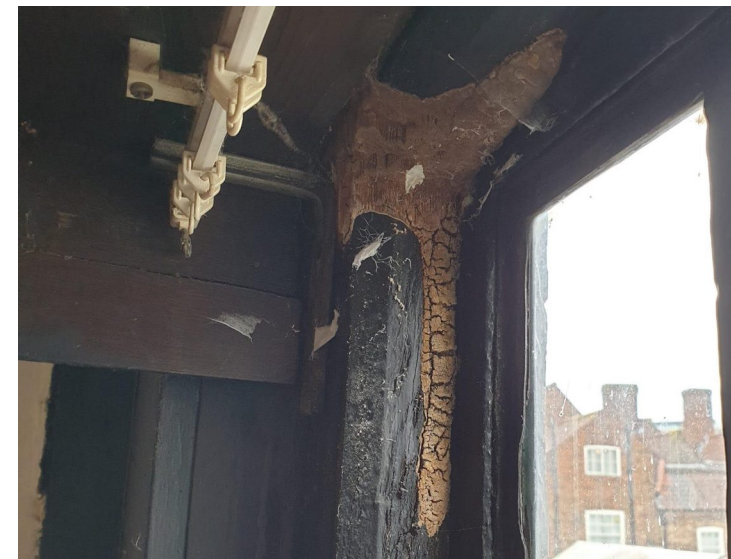
Figure 27 Example of oak rot to a window frame.

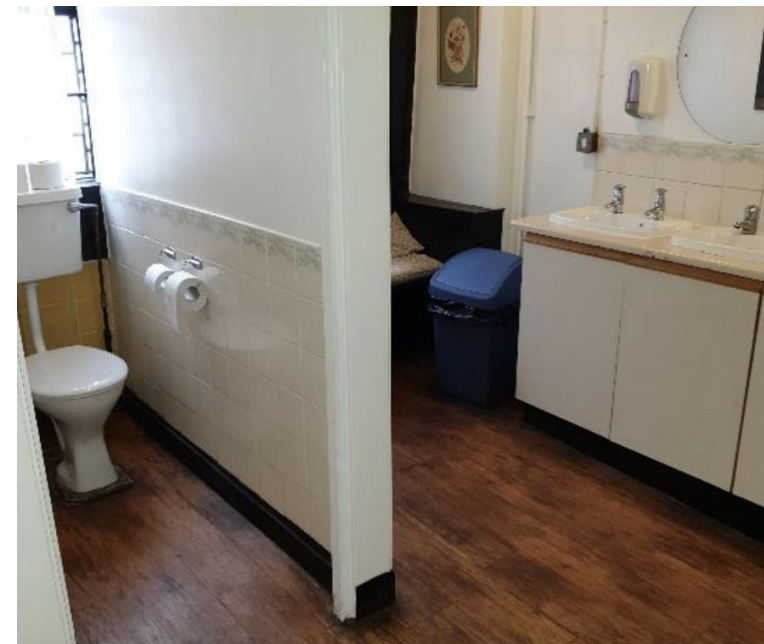
Figure 28 Poor quality later C20th plumbing in the ladies lavatory.

<b>2.06</b>	<b>Plumbing</b>
	Property to be replumbed using existing openings with Armitage Shanks fittings to male and female lavatories (see fig. 28).
<b>2.07</b>	<b>Central Heating</b>
	External Gas Central Heating Boiler to be removed from the rear yard. To be replaced by up to 3no. Stiebel Eltron (or similar) heat pumps for air to water heating. Solid ground floor floors to be provided with under-floored heating (see 4.01 below). All other rooms to be fitted with new aluminium radiators.
<b>2.08</b>	<b>Hot Water Heating</b>
	Provide new gas hot water boiler in the kitchen, with new external vent to Wall 15.
<b>2.09</b>	<b>Internal Engineering Works</b>
	The inner side wall in the cellar requires underpinning to prevent ongoing movement continuing vertically up the structure. Cracks to masonry to upper floors immediately above require tying with stainless steel helical bars and plastering repairs to match existing. The cellar steps show an area of movement which requires underpinning (see fig. 29). Engineer to advise on methodology. Cracks to masonry to upper floors immediately above require tying with stainless steel helical bars and plaster repairs to match existing.

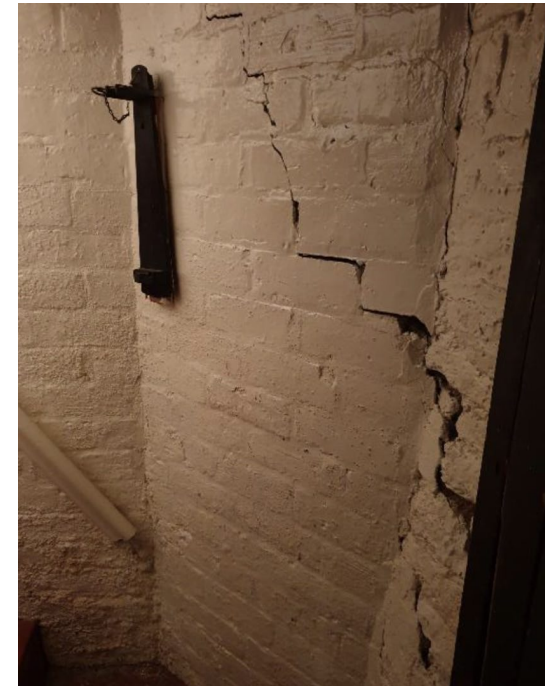
Figure 29 Structural cracking to wall cellar staircase (stair 3).

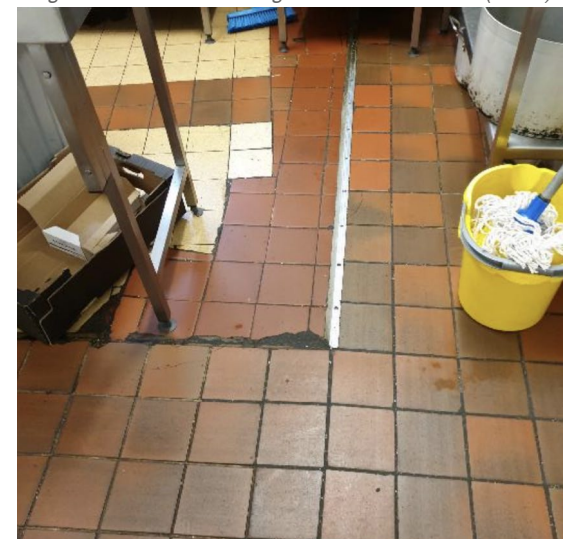
Figure 30 Poor quality floor tiles on concrete slab in the c.1960 kitchen.

4.0 GROUND FLOOR REPAIRS & INTERVENTIONS	
<b>4.01</b>	<b>Concrete Floor Replacement / Floor Recovering</b>
	Rooms GF1 & GF3 - GF1 I - remove existing cover and concrete floors completely. Replace with Glapor insulating foam glass with hydraulic limecrete finish to improve insulation and slope. Floors to be provided with water-based under-floor heating. Floors to be tiled with new handmade terracotta quarry tiles (York Handmade Brick Company or similar) (see fig. 30). Room GF2 - remove laminate floor cover. Repair, stain and wax existing floor boards, or recover with Polyflor Eton Oak Parquet if floorboards not suitable.
<b>4.02</b>	<b>Stair Covering Replacement (Stairs 1 &amp; 2)</b>
	Take up all coverings to stairs and re-lay non-slip vinyl cover and safety nosings (see fig. 31).
<b>4.03</b>	<b>GF Internal Timber Plating</b>
	Provide painted mild steel plates to splits to major floor joists in ceiling of GF1. Provide painted mild steel plates to connect 2no. Floor joists into dragon tie in ceiling of GF2. Engineer to advise on plating repairs.

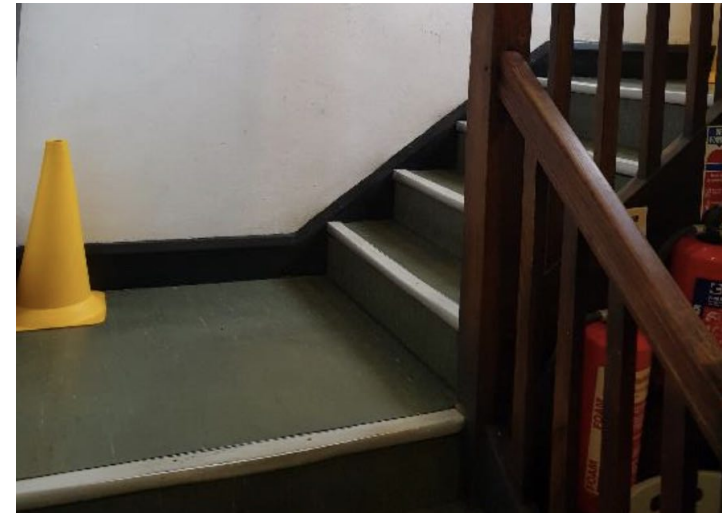
Figure 31 Existing stair covering (stair 2).

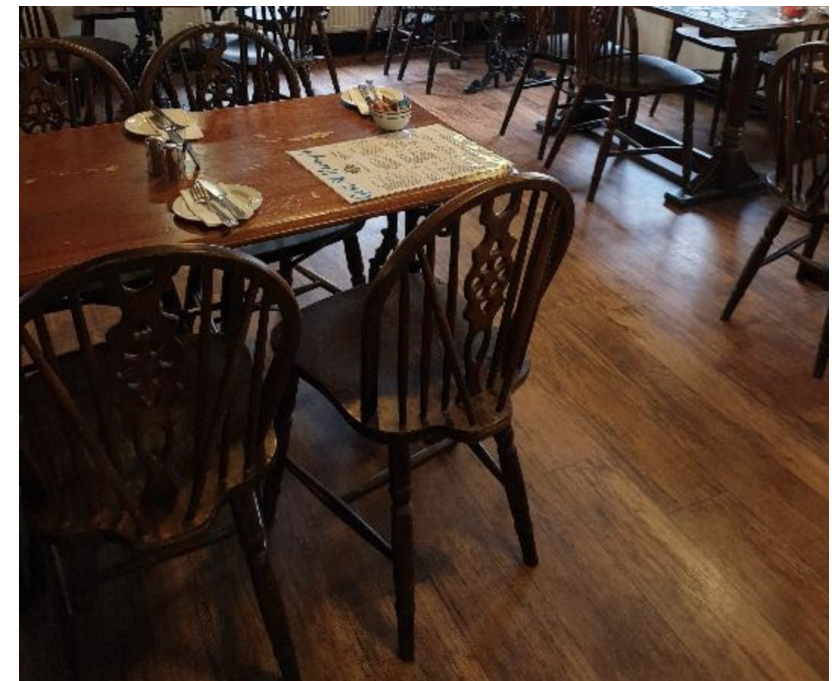
Figure 32 Existing laminate floor covering to first floor rooms (Room FF3).

5.0 FIRST FLOOR REPAIRS & INTERVENTIONS	
<b>5.01</b>	<b>Floor Covering Replacement (FF1-FF5)</b>
	FF1 & FF4 - Take up floor covering, and overlay with 9mm ply sheeting. Recover in Polyflor Eton Oak Parquet floor covering. FF2 & FF3 - Remove floor covering, sand down and stain floorboards with a wax finish (fig. 32). FF5 - Take up floor covering, and overlay with 9mm ply sheeting. Recover in Polyflor Ultima floor covering (fig. 28).

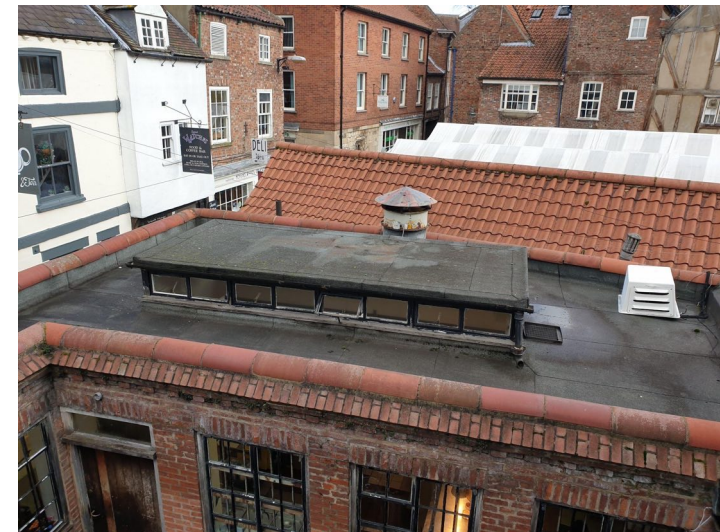
Figure 33 Present roof covering and skylight on the c.1960 kitchen range.

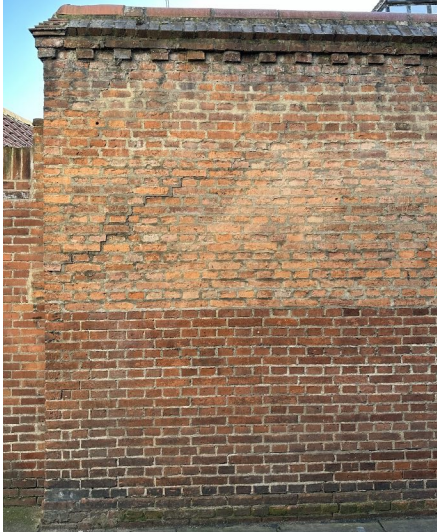
<p><i>Section of kitchen wall showing the c.1928 and c.1960 heightening and parapet. The impact of structural movement and water penetration from the roof can be clearly seen.</i></p>

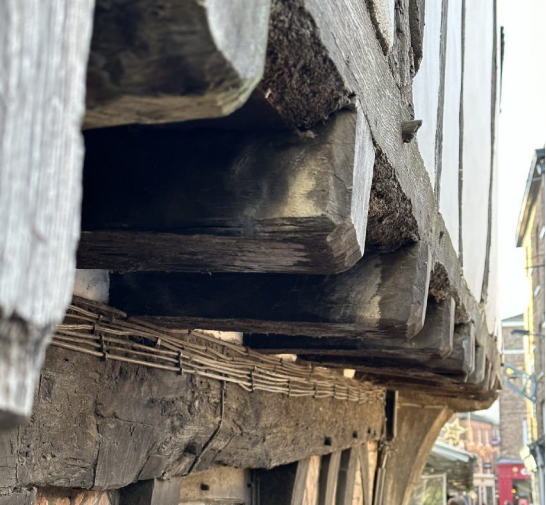
<p><i>The joist ends supporting the jetties across the site are bowed downwards due to overloading of the frame above.</i></p>
