17-21 Piccadilly York

Historic Building Recording Report

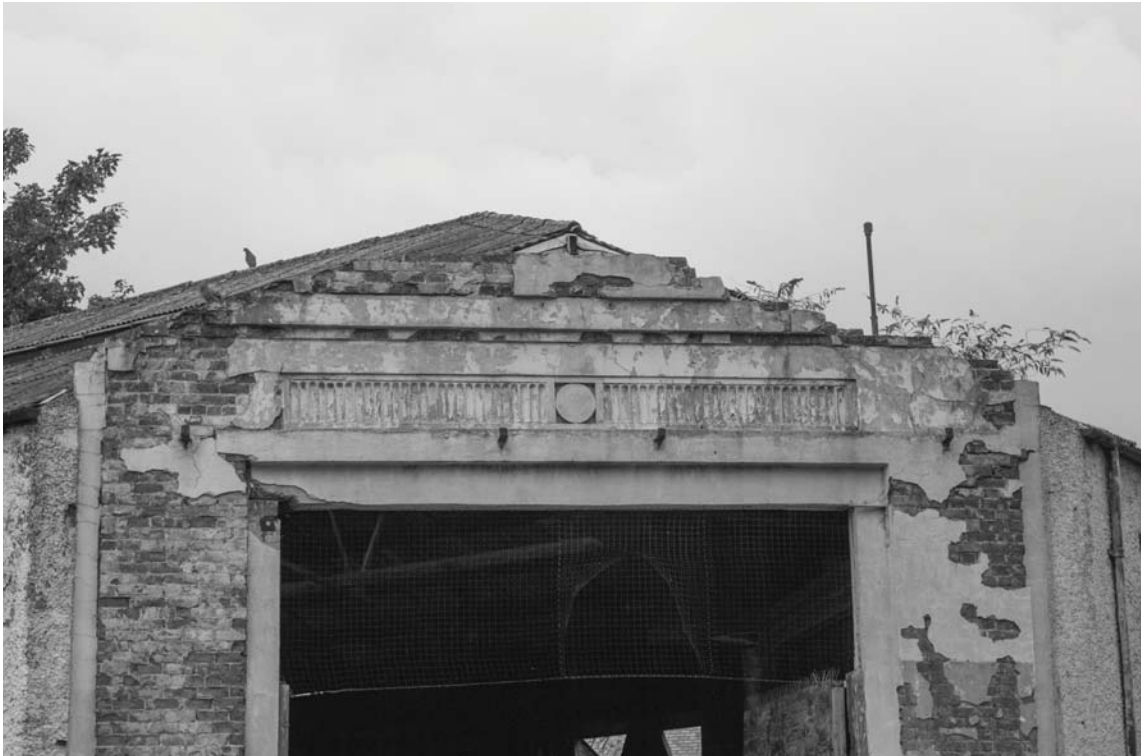
Photograph 15. Detail of the southern gable frieze and stepping towards apex with damage

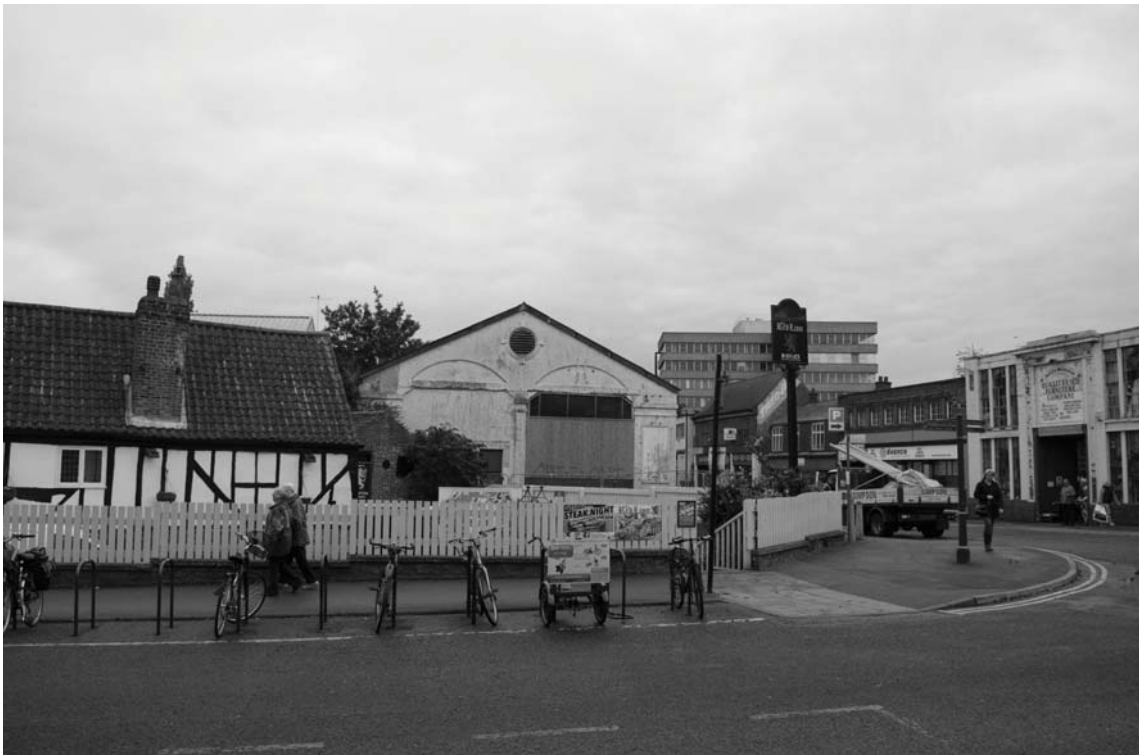
Photograph 16. General view of 17-21 from Merchantgate

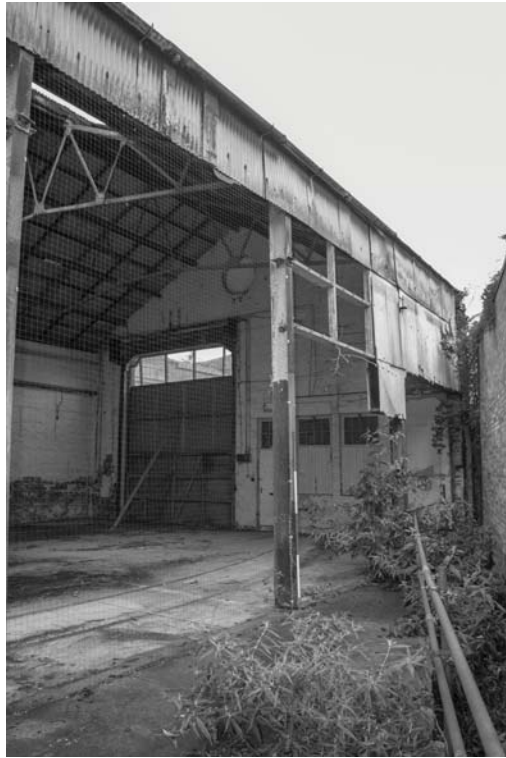
Photograph 27. The rear of the building with missing timber frame and exposed steel frame

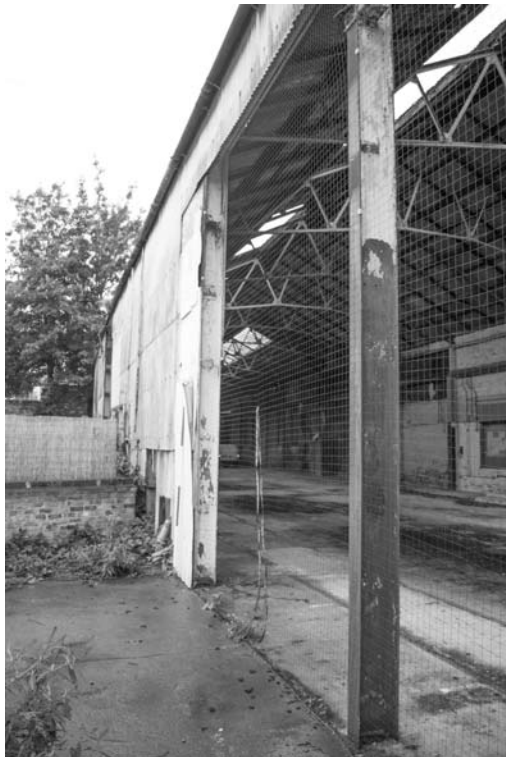
Photograph 28. The rear of the building with missing timber frame and exposed steel frame

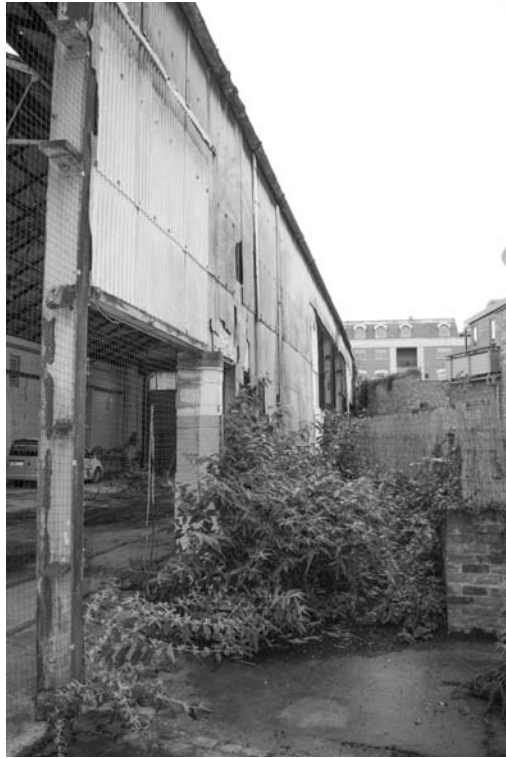
Photograph 29. The rear of the building with panels missing at low level

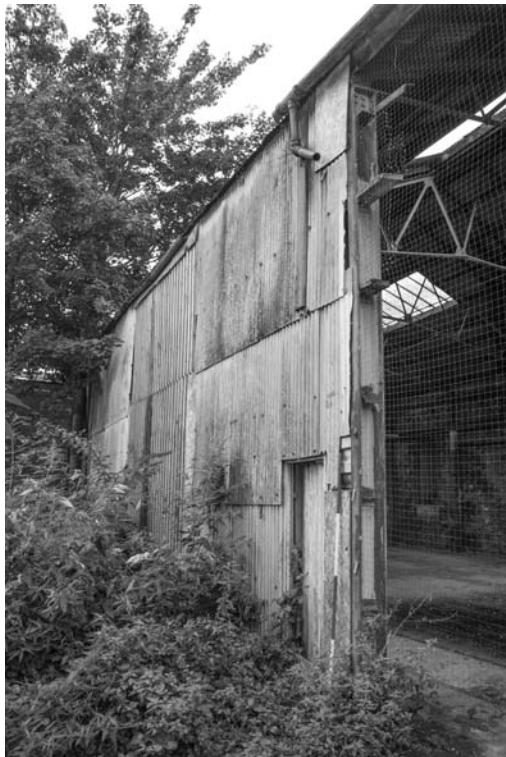
Photograph 30. The rear elevation with a small doorway in the asbestos cladding
