Heritage, Design & Access Report

14-16 Castlegate, York, YO1 2DN

Higgs Young Architects
June 2017

3.0 Existing Buildings Condition Survey

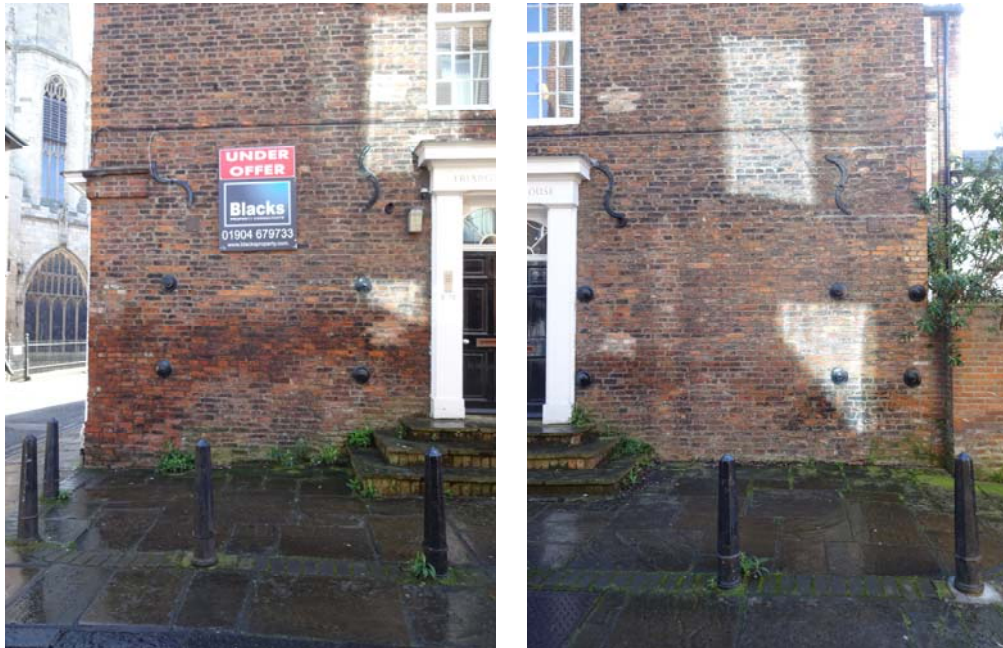
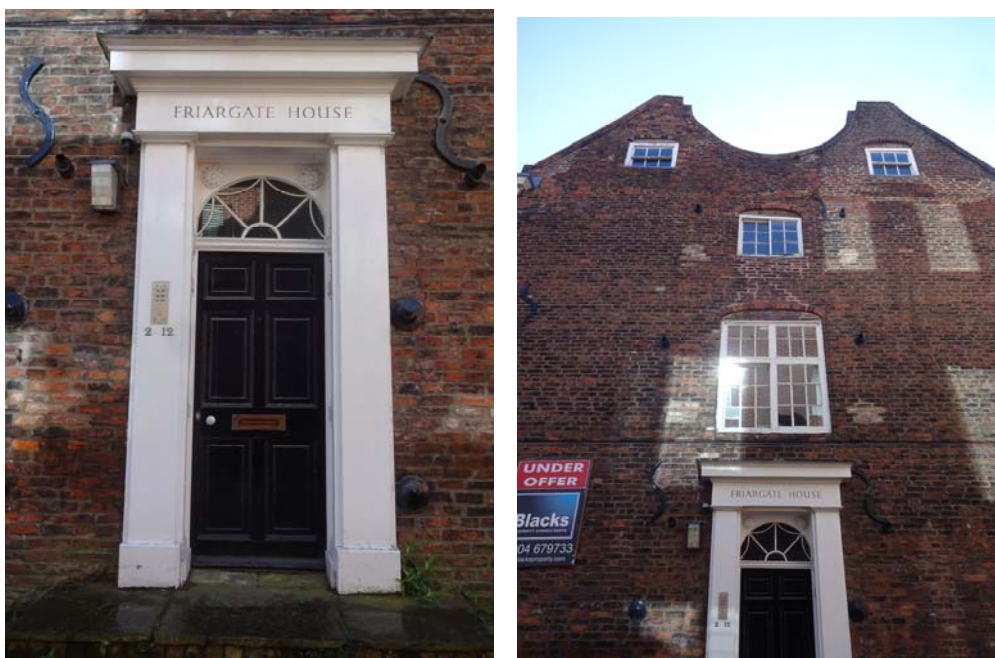
Main entrance and elevation to Friargate

Friargate House (nos. 12 & 14 Castlegate) has its main entrance off Friargate. The main entrance is centrally placed with a painted timber door surround, and accessed by three stone steps supported on brick risers. The steps are not original, simple square edges paving slabs which show some damage and have plants growing at their edges.

The lower brickwork courses to this elevation also have plant growth, moss and staining. At ground level the brickwork appears to have a band of wet brickwork running across indicated by darker brick colour, which could possibly be caused by the use of the internal rooms behind as showers.

The historic photograph evidences extensive brick repairs to the second floor of this façade. Areas of more recent brickwork repairs have taken place at roof gable level and also underneath the 2nd floor window above the entrance. The brickwork to the elevation facing Friargate also displays a number of areas that have been previously used for flues or services that have been bricked up. Six no. replacement boiler flues have then been inserted at a higher level through the brickwork.

There are many historic cast iron ties painted black on the façade which provide visual historical interest. However, the boiler flues and additional brown pvc extract vent covers create visual clutter and are not in keeping with nor enhance the building's character.

There are 4 windows on this façade, two over the entrance which are positioned on the staircase landings and two in the gables which light the roof space attics. With the exception of the 2nd floor window all are in fair condition and need only decorating. The 2nd floor horizontal sliding sash requires timber repairs to the lower edge of one of its sashes.

4.5 Basements will be tanked for utility and storage uses. No excavation or underpinning is proposed. The ground floor walls will have injected dpc added. Plants, mold and moss will be removed from the lower brickwork and stone paving.

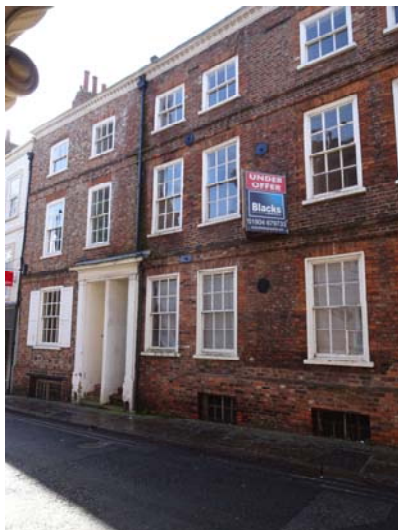
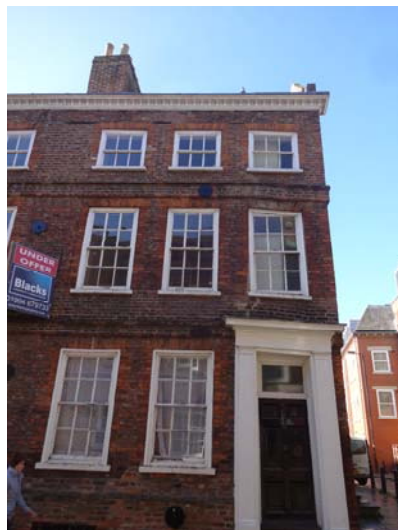
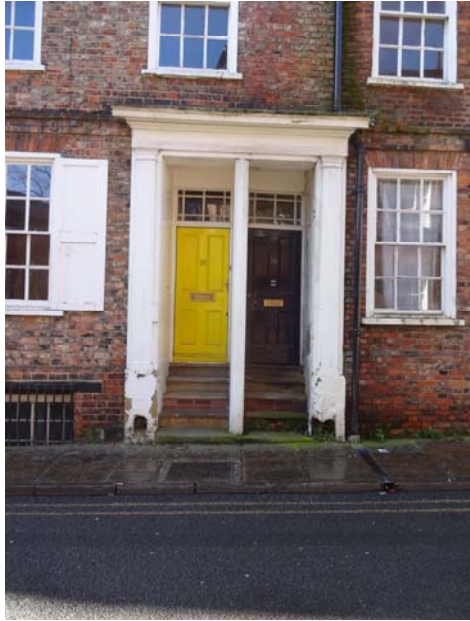
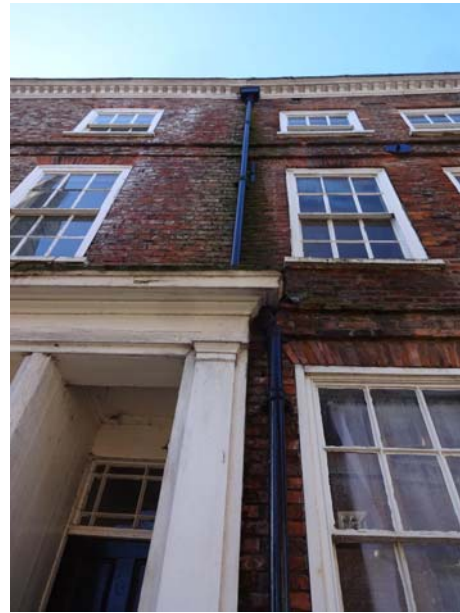
The doorways and surrounds to nos. 16 and 14 have five bull nosed stone steps to their entrances. The risers to two steps have been replaced with air bricks and the lower riser of no. 14 is broken.

The door surround is mainly intact but requires decoration. The lower edge has water damage and the boot scraper is broken at no. 14.

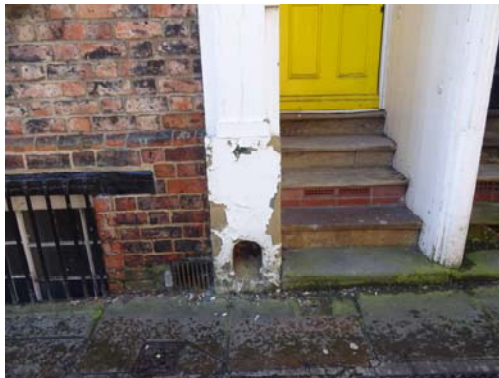
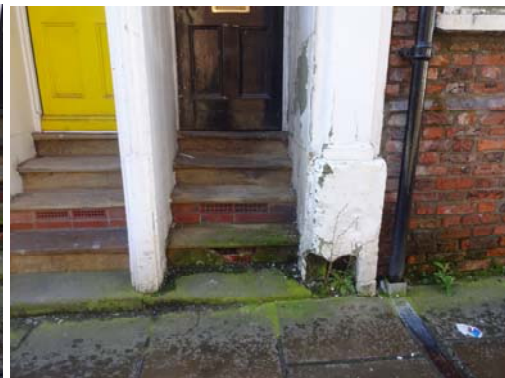
The entrances and brickwork above have been damaged by water from a broken gutter and rainwater hopper above. At the lower ground level the brickwork has suffered from damp, but otherwise the brickwork on this elevation is in fair condition. The historic subsidence of the corner of the building is evidenced by the sharply angled frame to the redundant doorway and window above to the house at no. 12. This long standing repair will be investigated further when works start on site.

4.7 External rainwater goods and gutters will be replaced and any new proposed to be in cast iron to match existing.

4.8 Brickwork will be repointed and repaired where necessary. The approach to repair will be conservative, in line with SPAB guidance. That is, past repairs

will be retained as part of the history of the building. Similarly the subsiding brickwork at the corner will not be interrupted if structural engineers deem it safe.

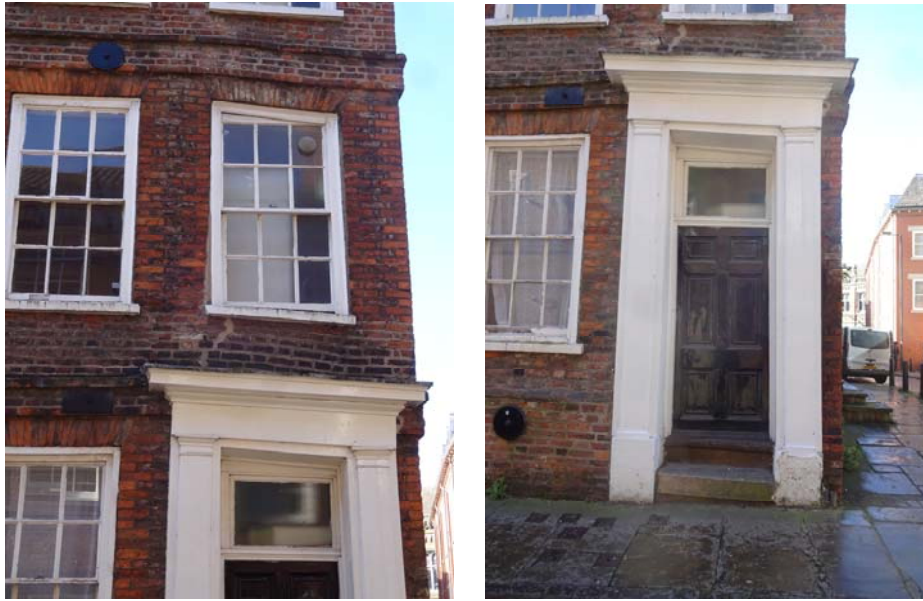
Distorted doorway and sash window to no. 12 Castlegate

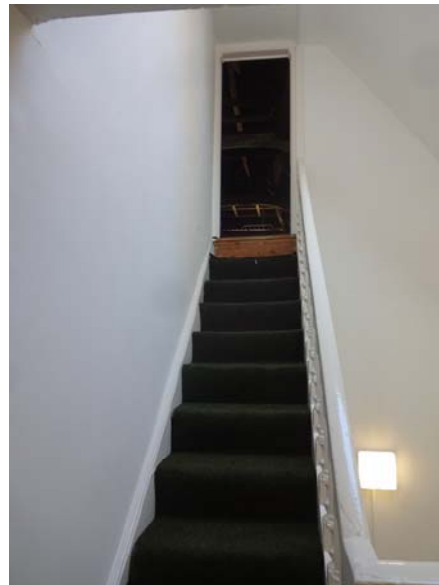
Balustrade, strings and handrail painted. The conversion added timber boxings and cupboards in places. York stone paving at landings with steps covered with carpet and nosings. A more modern access stair is extant up from 2nd floor landing to access the roof space attics above both nos. 12 and 14. The stairwell has been extended vertically and opened up with a Velux rooflight added to light the space.

The staircase in no. 14 will be retained as existing giving access from basement to 2nd floor. The upper flight which is a non-original staircase is proposed to be altered at the top to access just its own attic.

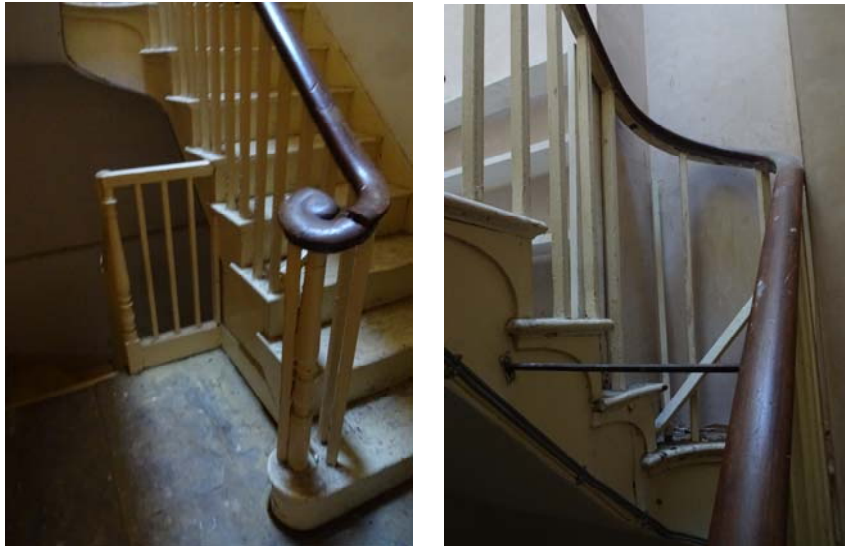
The staircase at No. 16

Staircase is intact and requires minor repairs to fabric damage by it being walled off with plasterboard partitions for building regulation compliance when the building was converted to flats.

The staircase in no. 16 will be opened up and restored to access basement to 2nd floor. The roofspace in no. 16 will be accessed by a hatch in the ceiling.

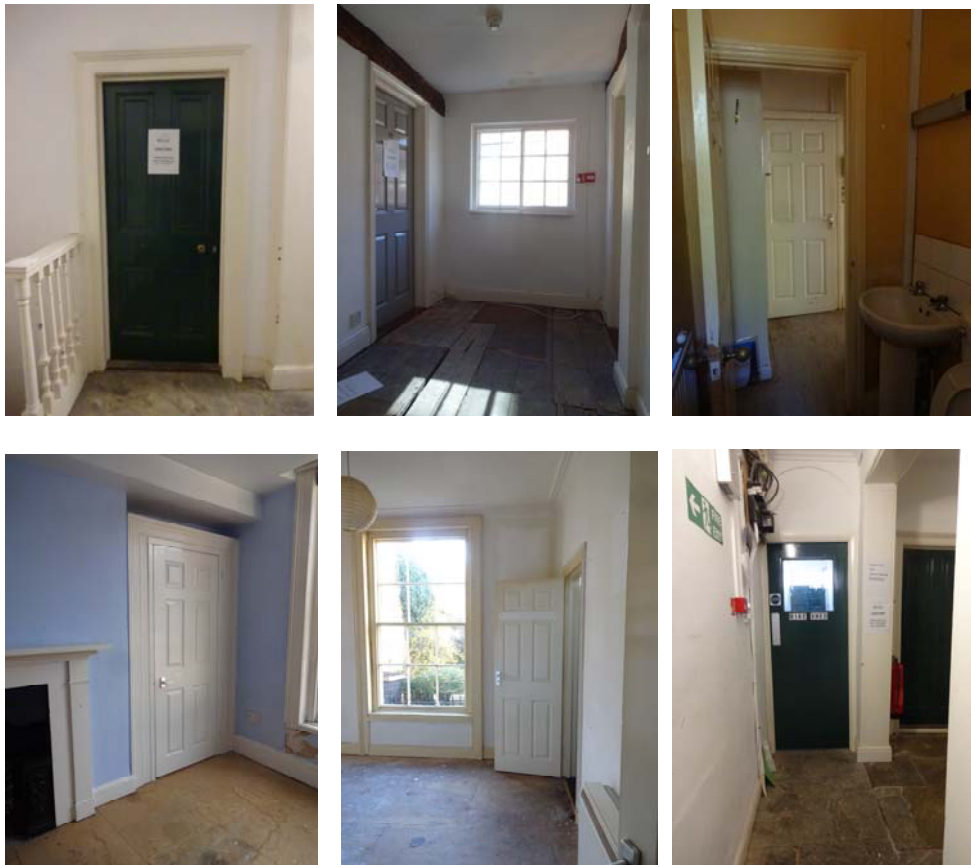
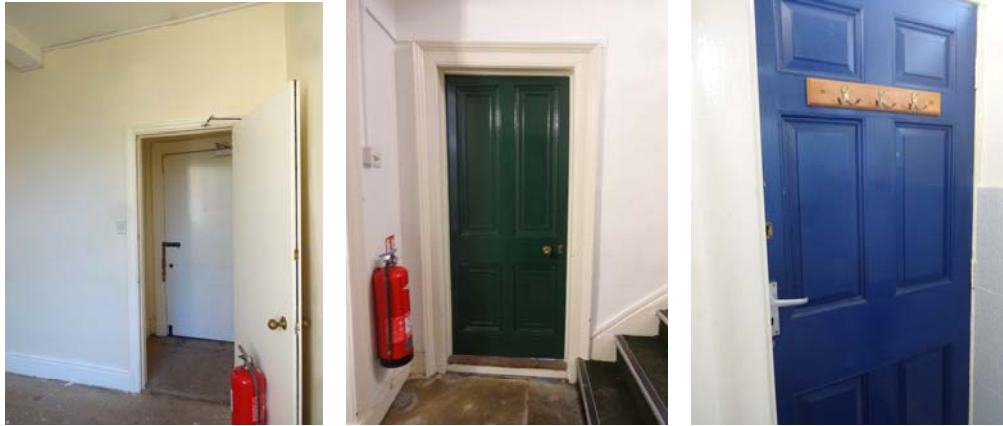
Period panel doors are existent to principle rooms in all three buildings. Doors opening onto the staircases have been lined or replaced with fire doors. Skirtings, architraves and other joinery items are generally intact.

Cornices to ceilings indicate original rooms and where missing will be reinstated.

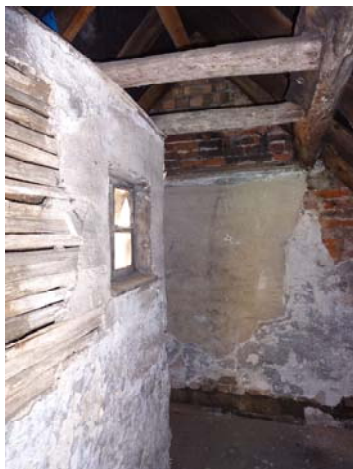
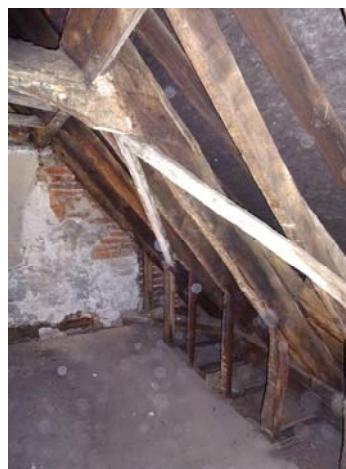
Attic to no. 14 Castlegate

This has had an access stair built and requires further investigation on site. No access is currently possible to the attic at no. 16 Castlegate.
