# Character Area Six: Lord Mayor's Walk

## Overview

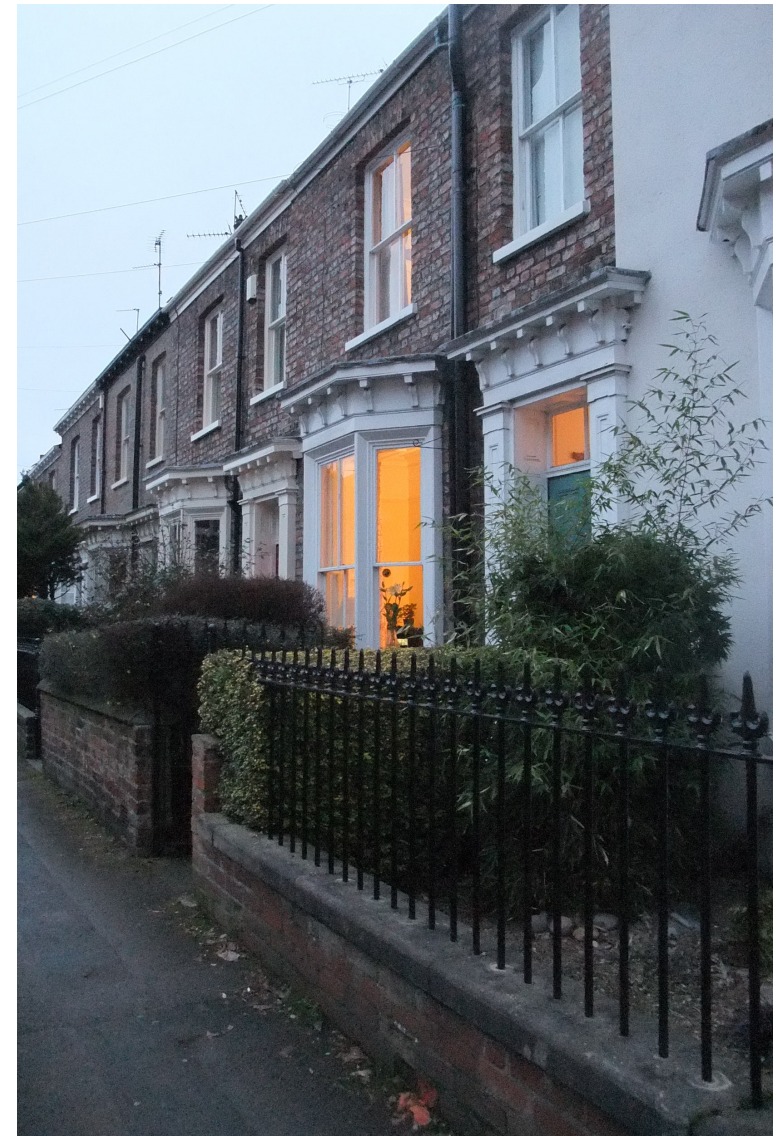
*St John Street has been included within the Conservation Area because of its strong cohesive character and well preserved front gardens*

At present the boundary of the Conservation Area excludes residential streets adjacent to St John's College. However, St John Street and St John's Crescent in particular possess high quality buildings with a largely uniform appearance and survival of original features. This, together with attractive front gardens and iron railings, forms a street scene which contributes positively to the Conservation Area.

These streets are also important because of their close proximity to the Grade II listed College and the city wall. The houses on each side of St John Street form a very distinctive framing view of the Minster. Therefore, it is recommended that they are included within the boundary of the Conservation Area.

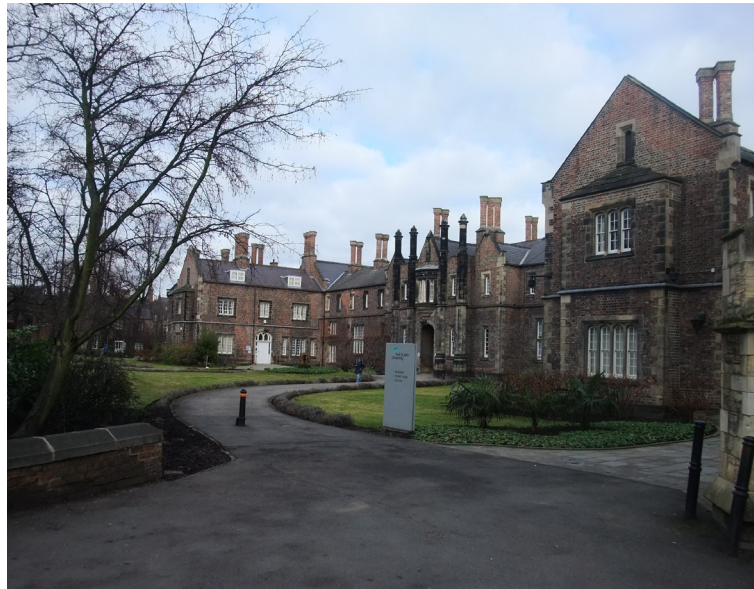
*19th century St John's College is set in landscaped gardens*

St John's College was originally the York and Ripon Diocesan Training School, built 1845-6 by G.T. Andrews. It is a Tudor style building, originally on an H shape plan, built in red brick with slate roof. There is a lively roofline with tall diagonal chimney stacks. In 1903, a quadrangle was created to the rear by the addition of a new red brick building by W. H. Brierley.

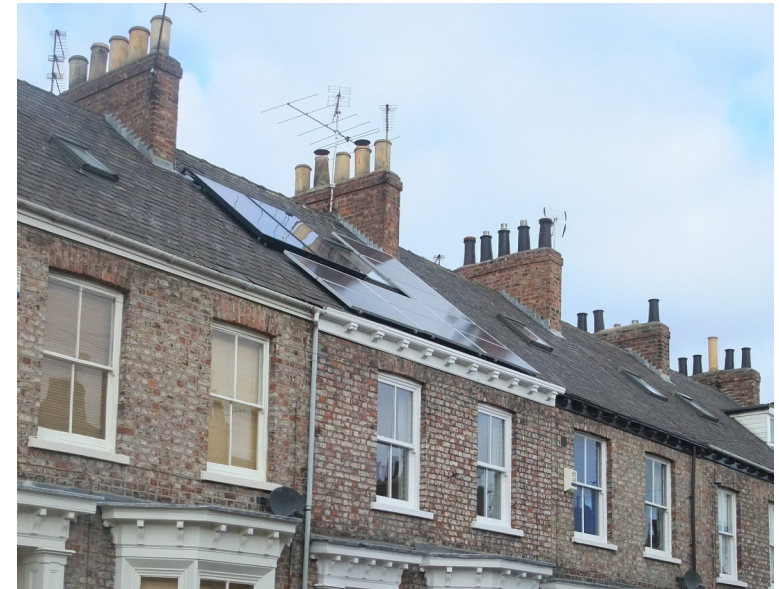
*Solar panels have been added to a house on St John Street*

- Some houses on St John Street have been altered by roof extensions and the addition of solar panels. These need to be managed to preserve the uniformity and appearance of the street.

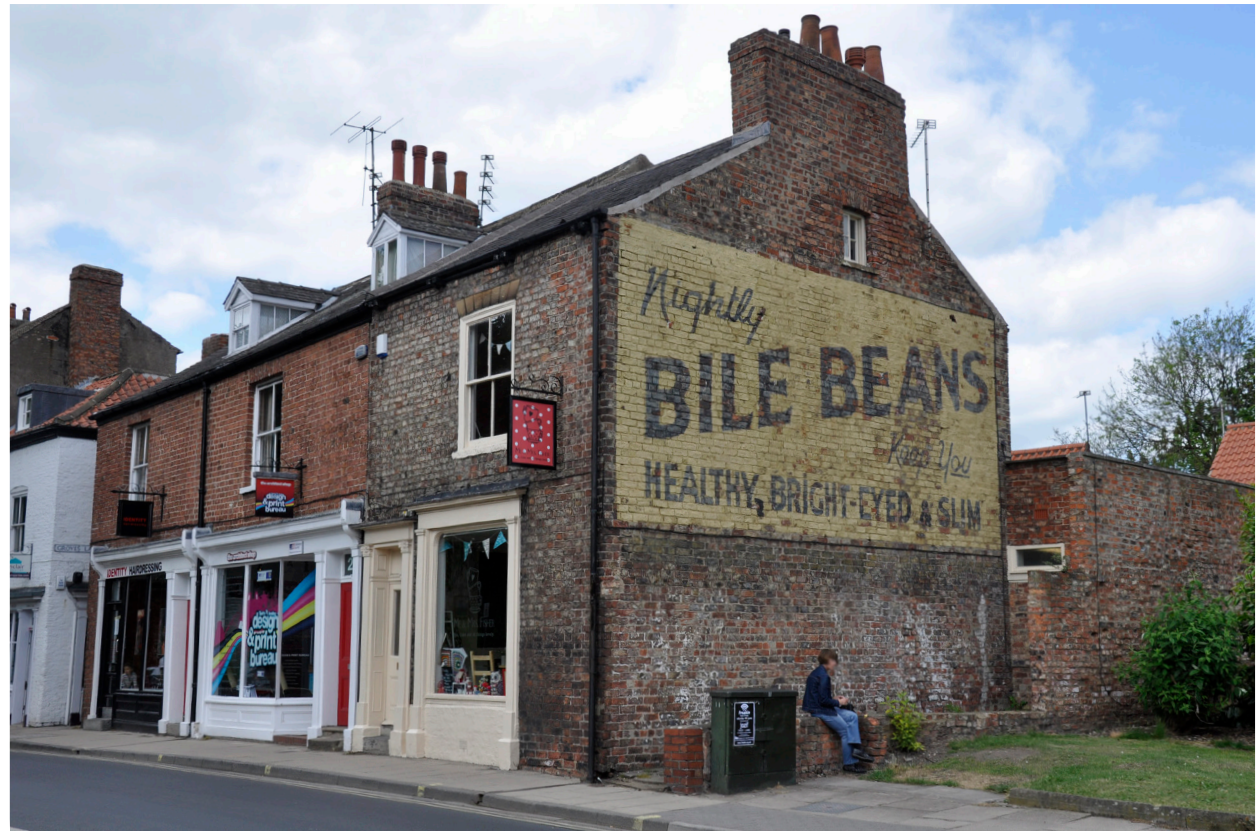
No. 18 is a mid-19th century two storey terraced house, one of three which have been converted for retail use on the ground floor. There is an interesting advertisement painted on the side advertising Bile Beans which is a local landmark.

*Nos. 18-22 Lord Mayor's Walk, with "Bile Bean" advertisement on side*

- One building is at risk – No. 32, Lord Mayor's Walk. The house is Grade II listed and is vacant pending a change of use.
- No. 22 Lord Mayor's Walk is a building of merit with a distinctive local landmark advert painted on the side. In order to protect this feature, an Article 4 direction should be applied.

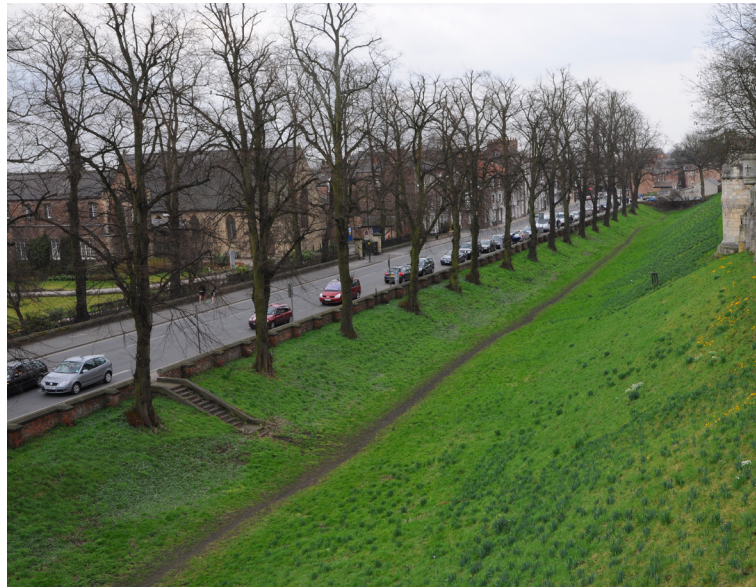
Lord Mayor's Walk is part of the inner ring road and is therefore heavily used. There is some congestion at the junction with Gillygate and Clarence Street. Lack of crossings between this junction and that at Monkgate restricts pedestrian movement.

*High volumes of traffic along Lord Mayor's Walk*

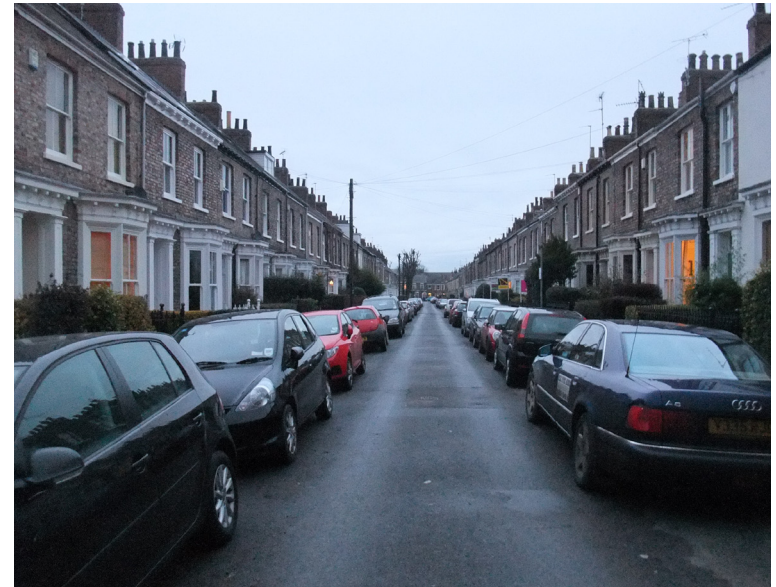
St John Street has restricted vehicle access and is much quieter than the main road despite the southern end leading to Monk Bar car park. However, parking on either side of the street reduces its width and limits its visual appeal.

*Large numbers of parked cars along St John Street*

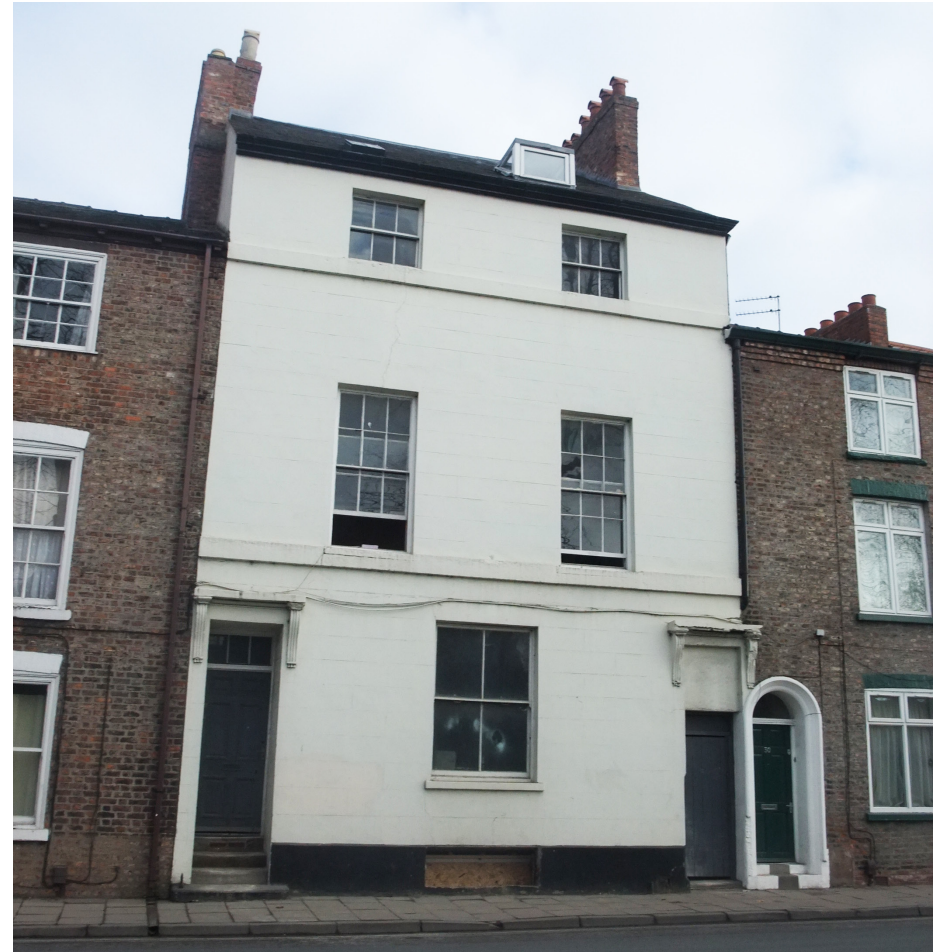
*No. 32 Lord Mayor's Walk is a building at risk. It has been used as offices in the past*

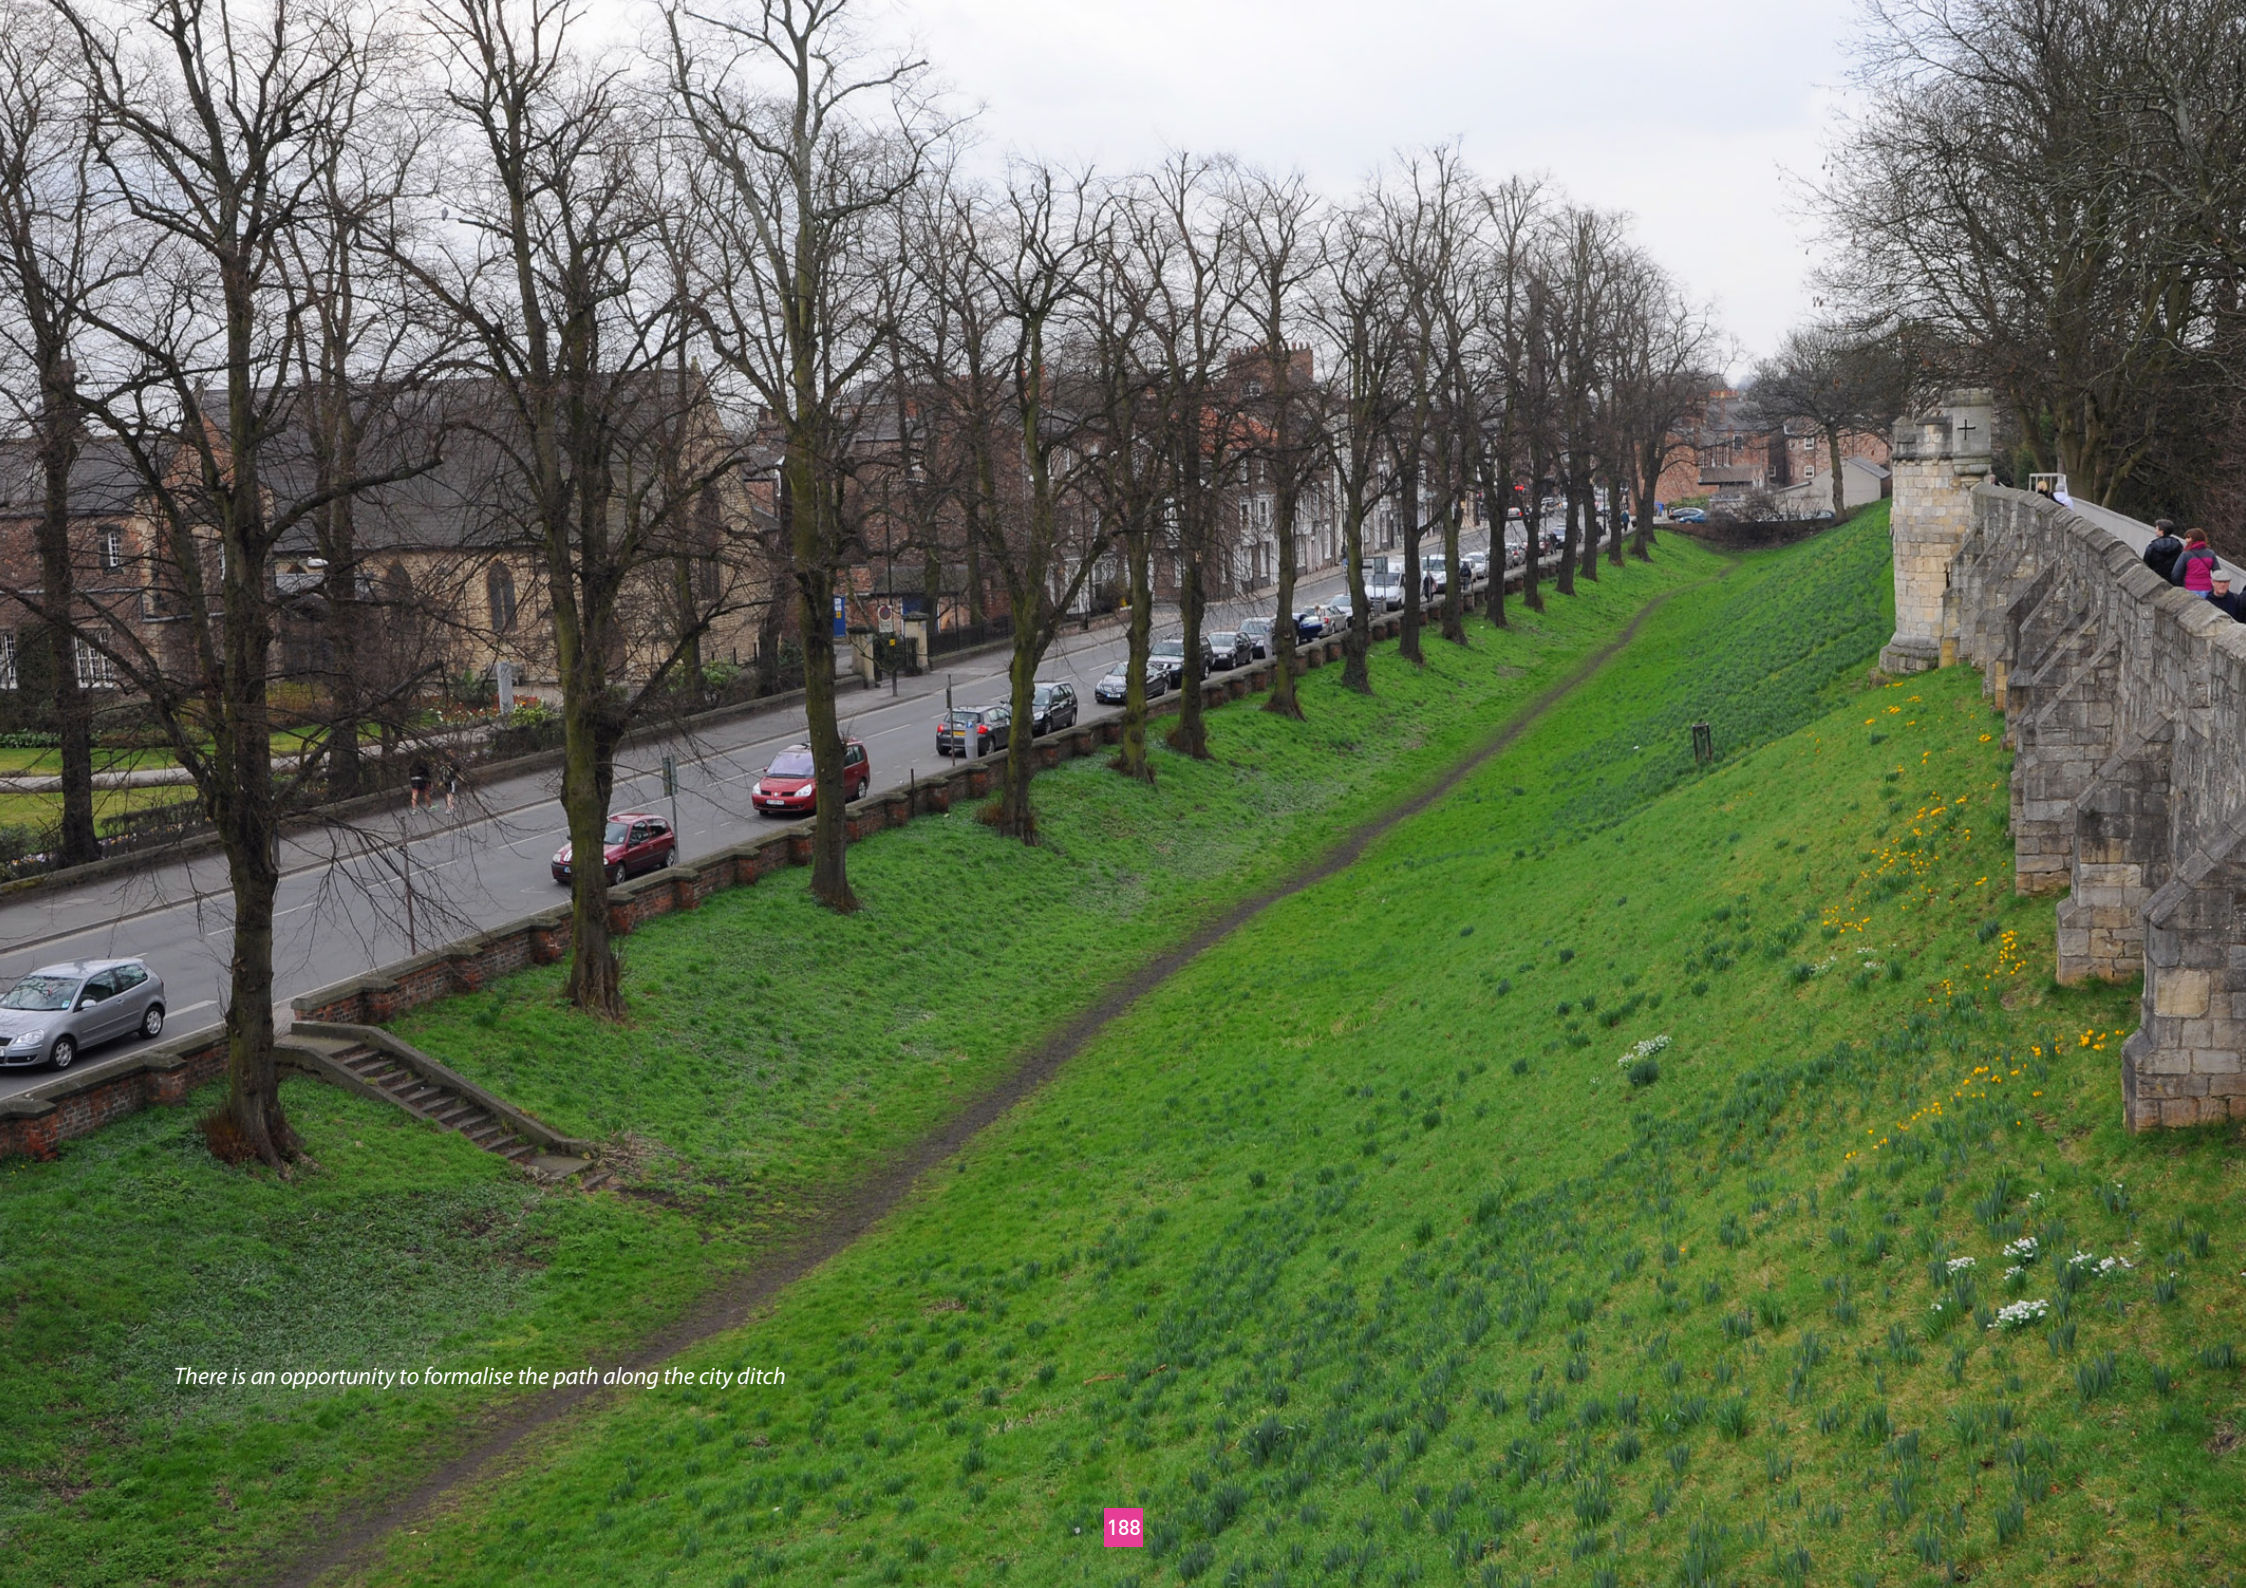
*There is an opportunity to formalise the path along the city ditch*

- The depth of the medieval ditch and height of the rampart can be fully appreciated in this area. The 'Lord Mayor's Walk: Enhancement. A feasibility study for the Minster Quarter Committee' (8 February 2011) included some ideas for the informal ditch path. The viability of this as an alternative for pedestrians walking at traffic level would depend on very careful design, potentially including lighting at night.
