YORK ARCHAEOLOGICAL TRUST REPORT

SITE	31 The Shambles, York, Watching Brief		
CLIENT NAME	Northern Power Grid		
YAT PROJECT #	5844	YAT REPORT #	
MUSEUM ACCESSION #	N/A	GRID REFERENCE	460462,451853
PLANNING REFERENCE #	N/A	AAI OPS NOTICE #	15005

INTRODUCTION

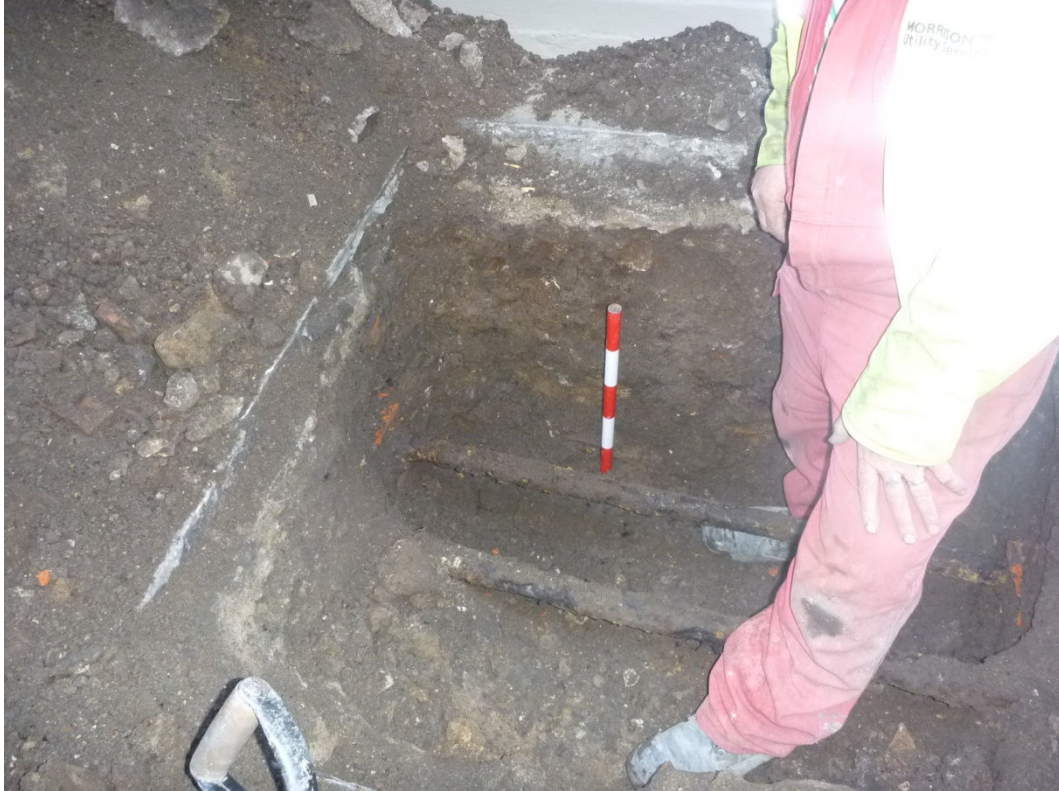
The lifting of the current flagged foot path (Context 100), revealed a layer of compacted sandy mortar make up material (Context 101). Beneath this material was a mixed friable, greyish brown, sandy silt (Context 102) containing frequent mortar flecks with occasional brick and tile fragments and stones (ranging in size from small to large). This material was excavated up to a maximum depth of c. 650mm within the c1m square hole in the footpath. Context 102 appeared to be a mixed deposit overlying several services including the active armoured cable (overlain by ceramic tiles), a second armoured power cable, a water pipe and a broken lead gas pipe. The separate service trench cuts were not visible in section due to the homogenous, mixed nature of their backfills. Extending approximately 0.15m from kerb edge was a friable, yellowish grey clayey sand (Context 103) that appears to relate to the kerbs construction. This deposit was only excavated to a depth c450mm and not investigated further once the cables were identified.

Plate 1: View of trench showing exposed armoured cables at maximum extent of excavation.

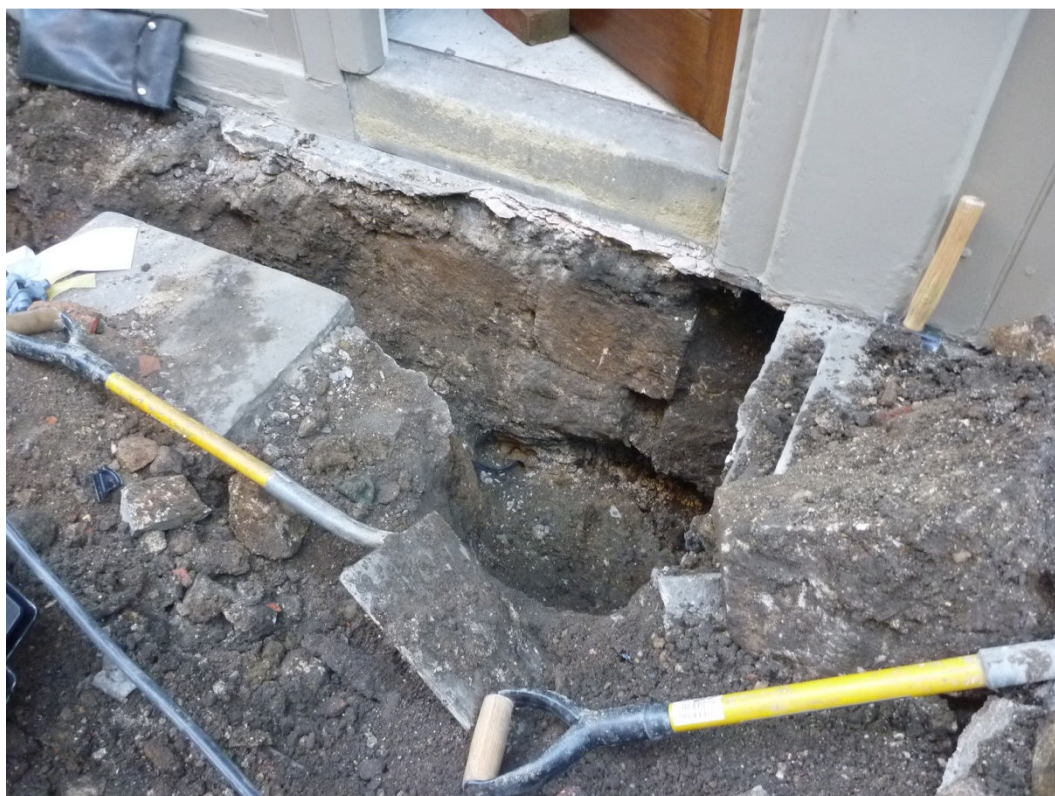
The works relating to the installation of a new power supply under part of the footpath on the Shambles have only disturbed deposits that were previously disturbed by 20th century service installation. The visible elements of the shops stone foundations were not damaged by the works as the previously established access for the power cable was tunnelled beneath them from within the building.

Plate 2: Exposed stone foundation of 31 The Shambles (cable access point beneath visible stone work).
