NEWGATE MARKET REFURBISHMENT, YORK.

REPORT ON AN ARCHAEOLOGICAL INVESTIGATION.
OSA REPORT No: OSA13WB32

July 2015

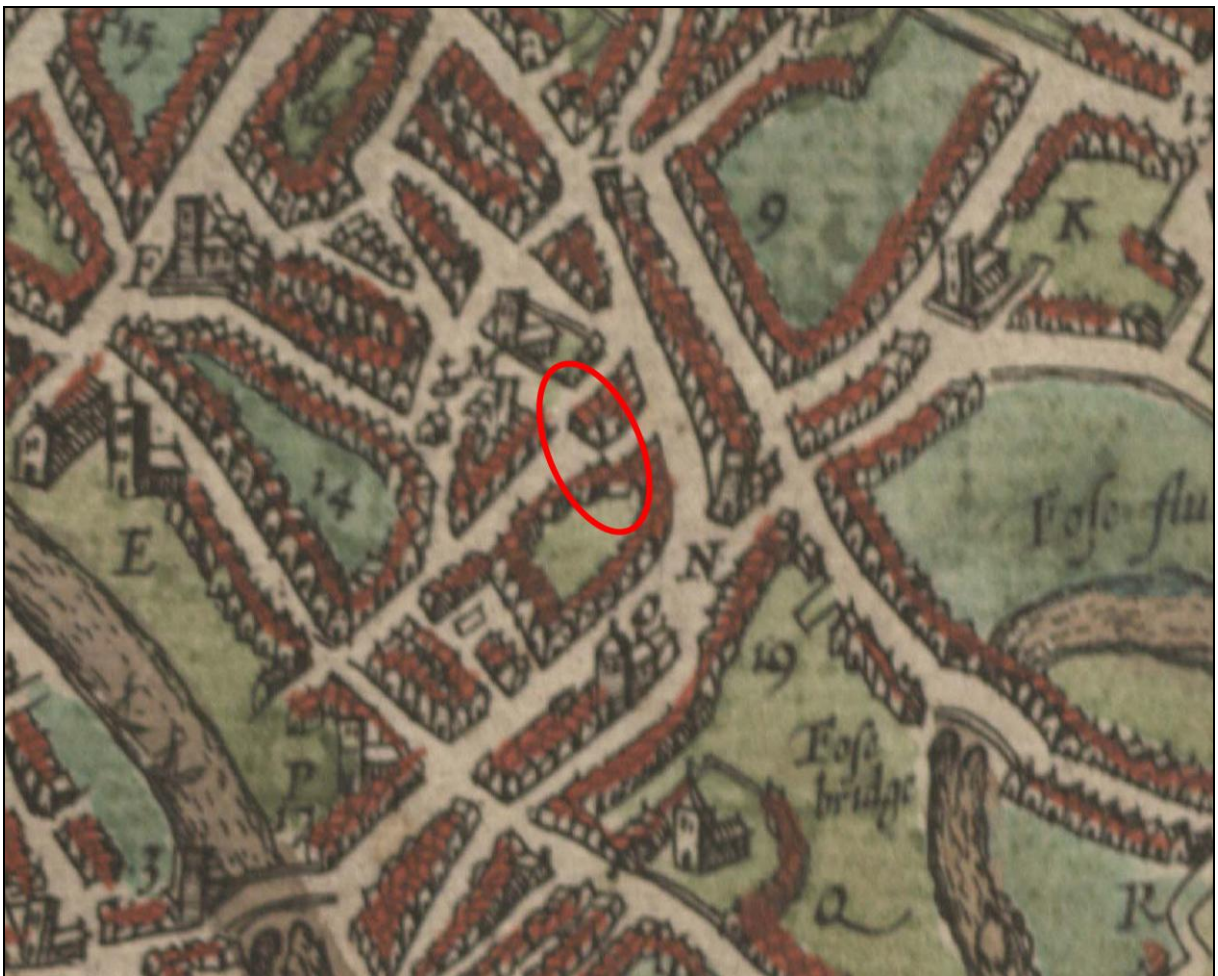
Figure 2. Speed's 1611 map (approximate site of Newgate Market in red)

Old maps elucidate the history of the Newgate Market area. Pre-Ordnance Survey depictions of York depict a limited amount of detail, but the general geographical area is shown. The earliest map, that of John Speed in 1611, shows the southern part of the market area to be buildings backing onto a green space where Parliament Street now lies (Figure 2). The former street of Little Shambles clearly shown with more buildings to its north, beyond which is Newgate. Braun and Hogenberg's 1617 evolution of Speed's map shows the same. Horsley's 1697 plan shows Newgate Market to be a built up area, with Little Shambles cutting through it (Figure 3). A building, identified in his map key as 'Butchers Hall' (i.e. guildhall) is shown; it is unclear whether elements of the building are within the western side of the site. Gent's map of 1730 and Cossins' 1748 map also show the guildhall (unlabelled), lying just below and to the east of the junction of Jubbergate, Newgate and Little Shambles (Figures 4 and 5). Both show the area as built-up but do not show individual buildings. Chassereau's 1750 map only shows the basic elements of the area, but Jeffereys' 1771 depiction labels, but does not illustrate, the position of the Butchers Hall (Figure 6).

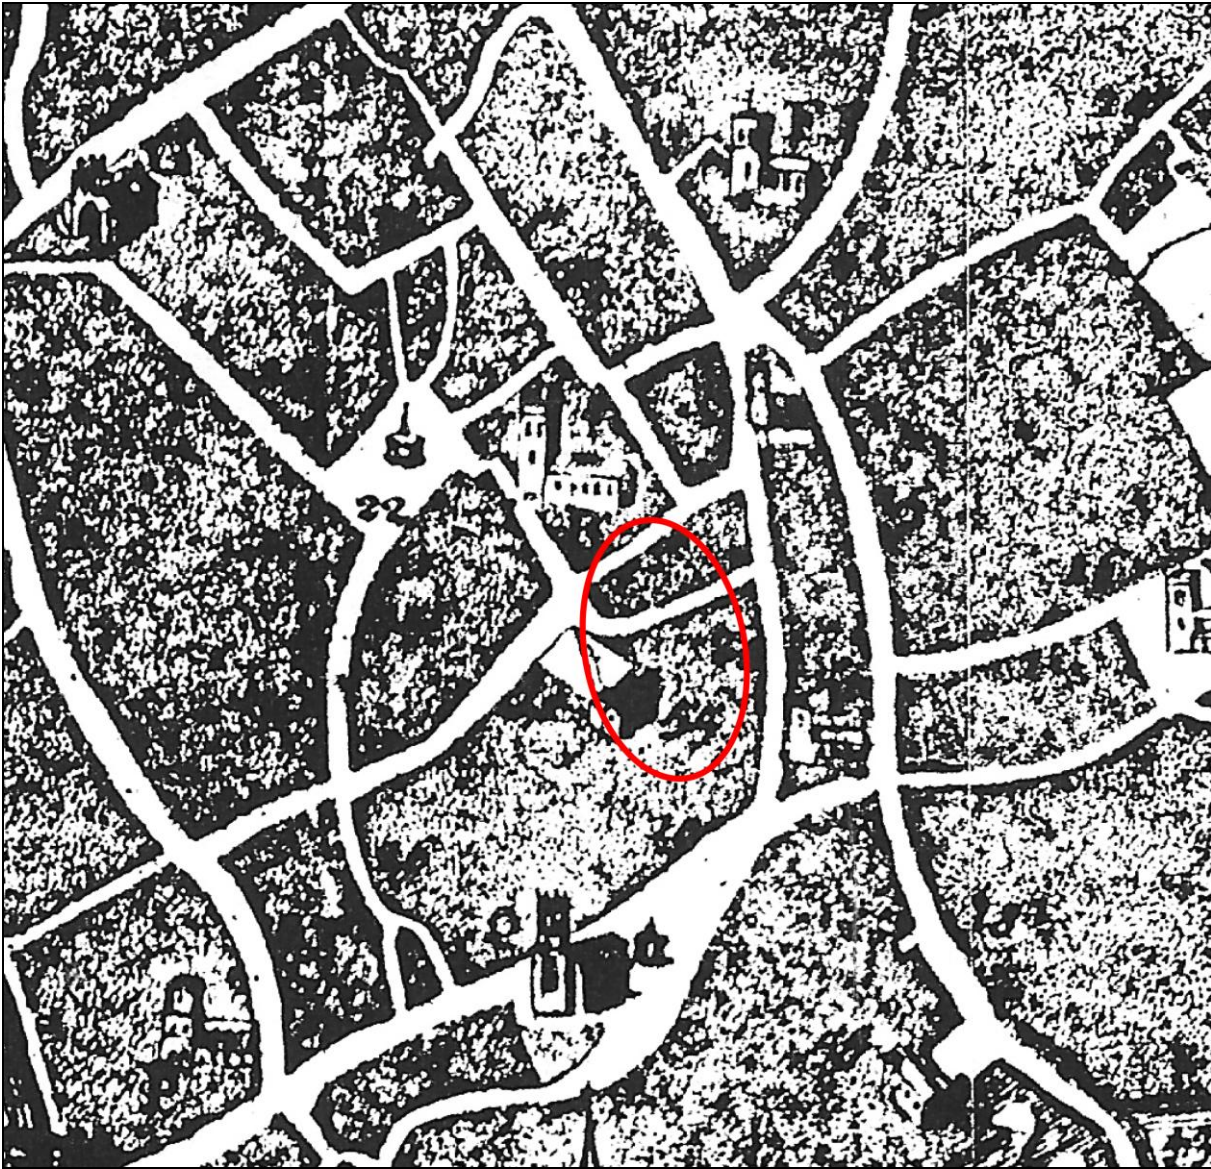
Figure 3. Horsley's 1697 map (approximate site of Newgate Market in red)

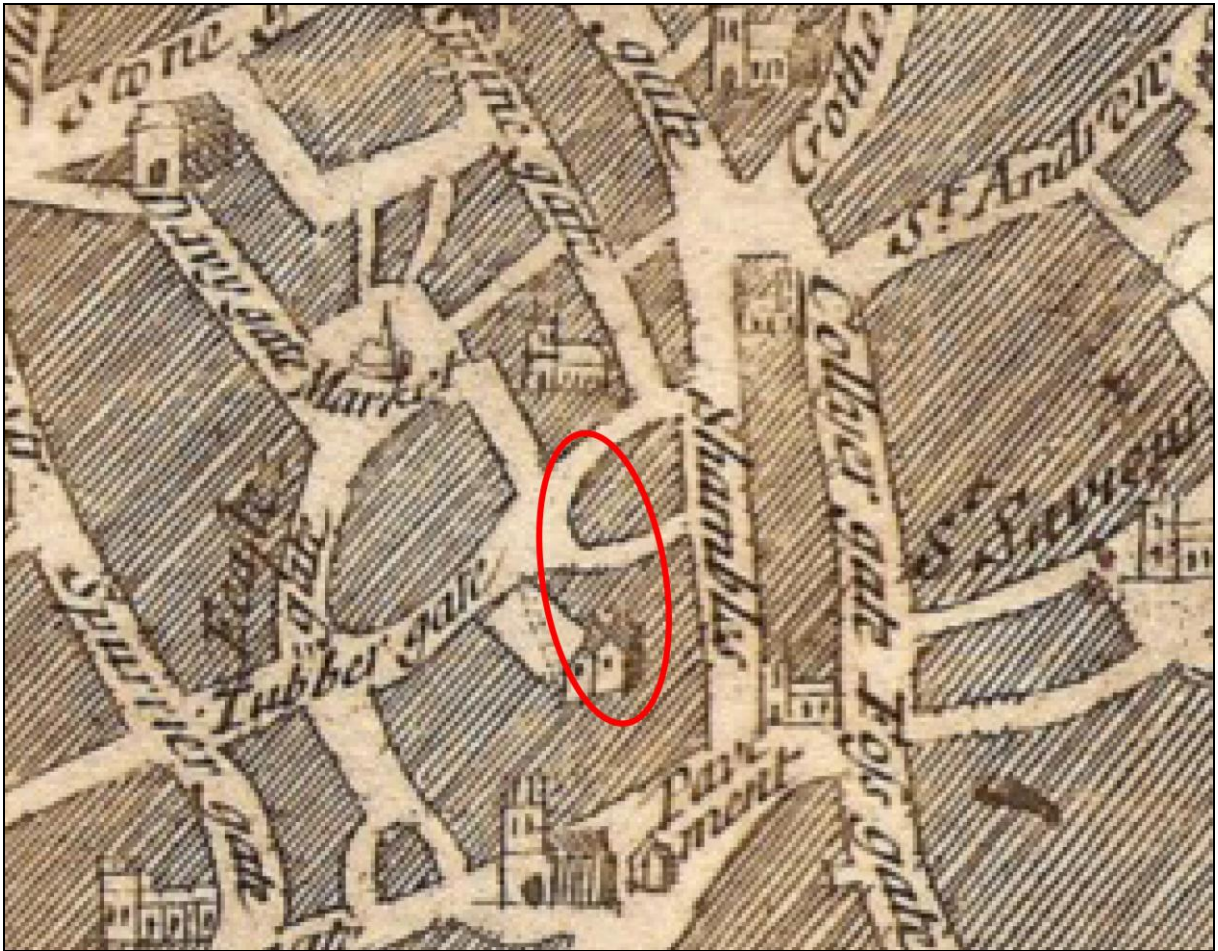
Figure 4. Gent's 1730 map (approximate site of Newgate Market in red)

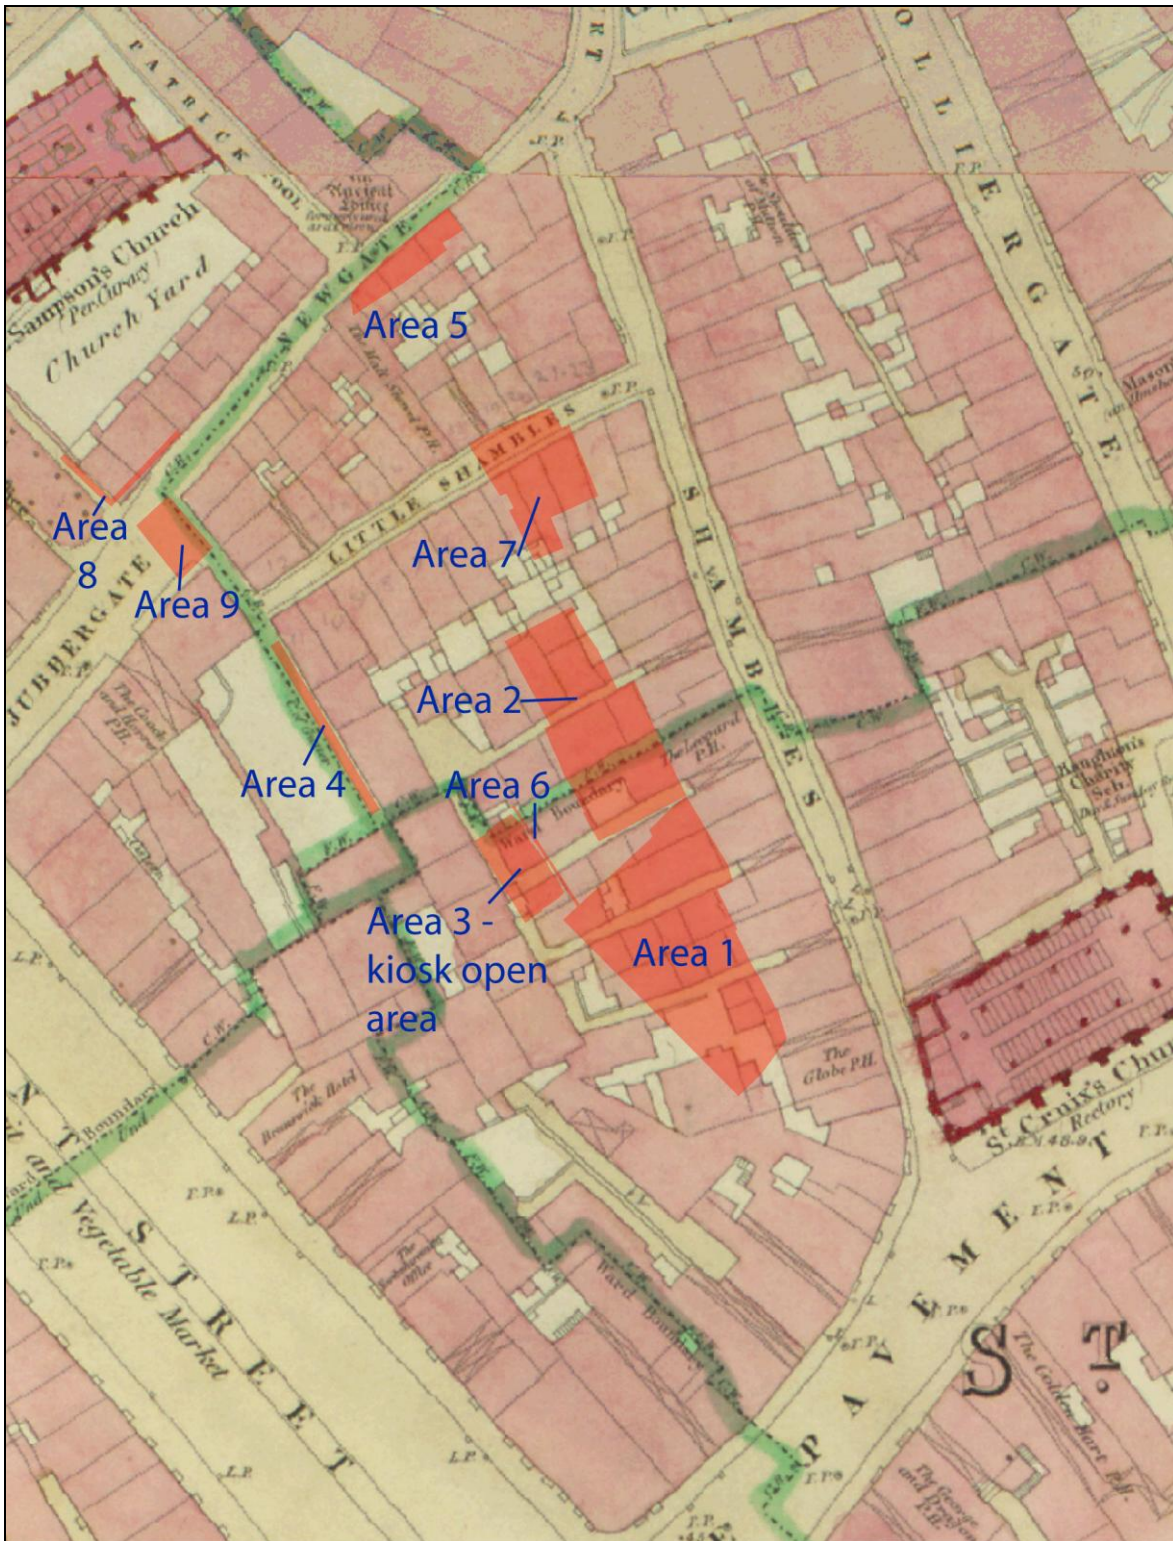
Figure 7. 1852 Ordnance Survey large-scale plan of York, with investigation areas overlain

Adjacent to the cellar and to the rear of 31 Shambles was the remains of a room with an ash pit in the centre (Plate 2). The room – in the approximate position of an outbuilding shown on the 1852 OS map – was defined by two fragments of wall (129) and (128). Both were crudely built of single-skinned limestone rubble with lime mortar. In the approximate centre of the enclosed space was an ash pit consisting of a foundation trench [126], backfilled with dark brown sand with mortar and brick fragments (125). The ash pit (124) was constructed of mortared hand made brick creating an internal space of 800mm x 700mm. It was filled with the remains of a fire, ash cinders and other burnt material (123). The purpose of the ash pit was unclear; it may have been simply used for a stove or cooking oven, or it may indicate the use of the room for small-scale industrial processes requiring a forge or furnace.

At the rear of 33 Shambles, another room was revealed containing another ash-pit and a furnace base. The room was within a range of outbuildings shown on the 1852 Ordnance Survey map behind the present-day 33 Shambles. Its northwest wall was (144), the southeastern wall was (143) and the southwestern wall was (142) (Plate 3). The southwestern

Just to the northwest of Trench 1 were the remains of an outbuilding shown on the 1852 map lying behind the Leopard Public House. The outbuilding was defined by two walls. The southeastern wall (200) was roughly 500mm wide and was made of roughly dressed limestone blocks with a rubble core, bonded with lime mortar (Plate 7). Occasional flat roof tile of probable medieval or early post-medieval date was noted within its core. The northwestern wall (214) was of similar construction, except that it was unusually wide at c.880mm. It incorporated a fragment of a well-carved pillar, presumably re-used and originally from a high status building (Plate 8). To the northeast and southwest both walls were truncated by twentieth century drains or other services.

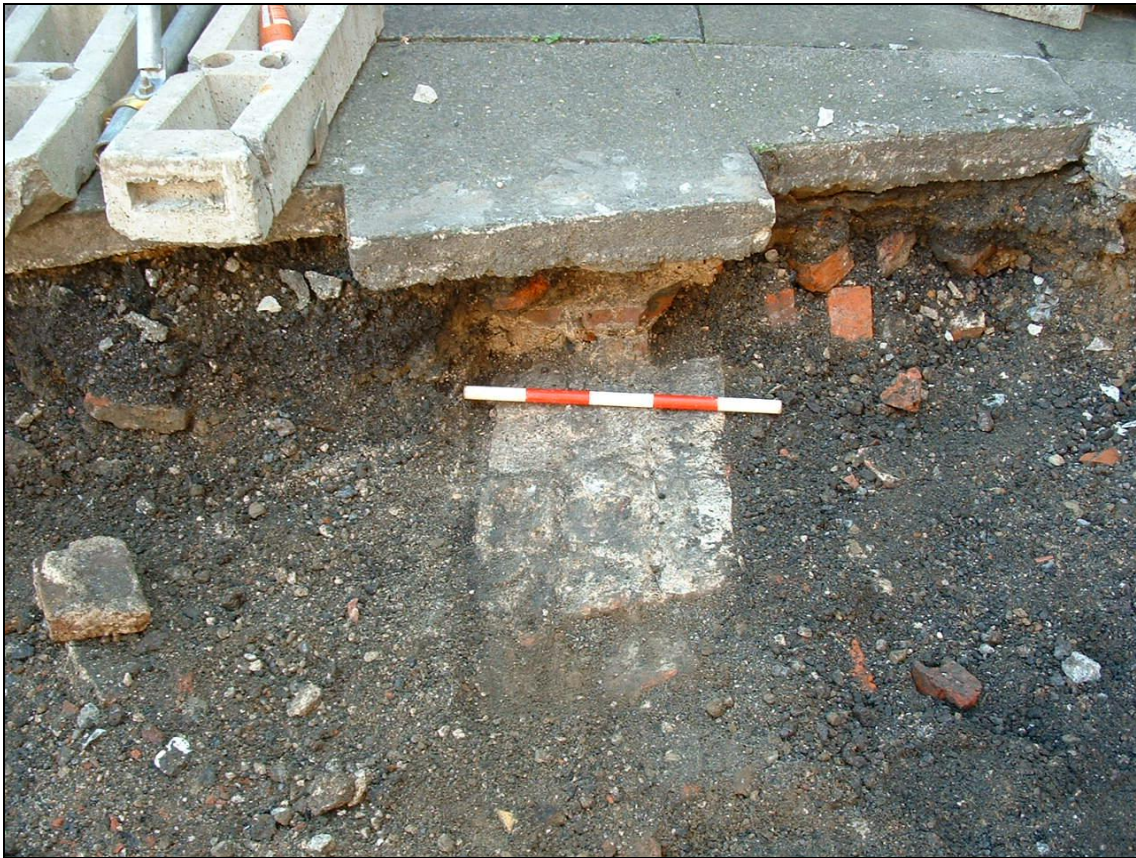
To the east of the modern cellar entrance was a short section of foundation wall (104), exposed in a small section of deeper excavation (Plate 1). It was made up of a mixture of handmade brick and limestone rubble bonded with lime mortar. Just over 0.5m length of this wall was exposed, which was 375mm wide. An overlay of the 1852 Ordnance Survey map suggests that this was the northern foundation wall for a building that formerly stood fronting Shambles and extending into the market area in this position, which is now a wide alley.

Plate 1. Wall (104), looking NE

In the southern part main resurfacing area watching brief (Area 1), the isolated foundation fragment (104) of hand-made brick and limestone rubble may be of anything from early post medieval to early modern date. However, the room/building delineated by walls (128) and (129) is made of mortared limestone rubble and is of potentially medieval form. More tellingly, within the room was a layer of dark grey/black sand that contained 8 sherds of medieval pottery and fragments of flat tile. In the absence of any later finds, it is quite likely that this deposit was of medieval date. It was cut by a post-medieval/early modern ash pit.

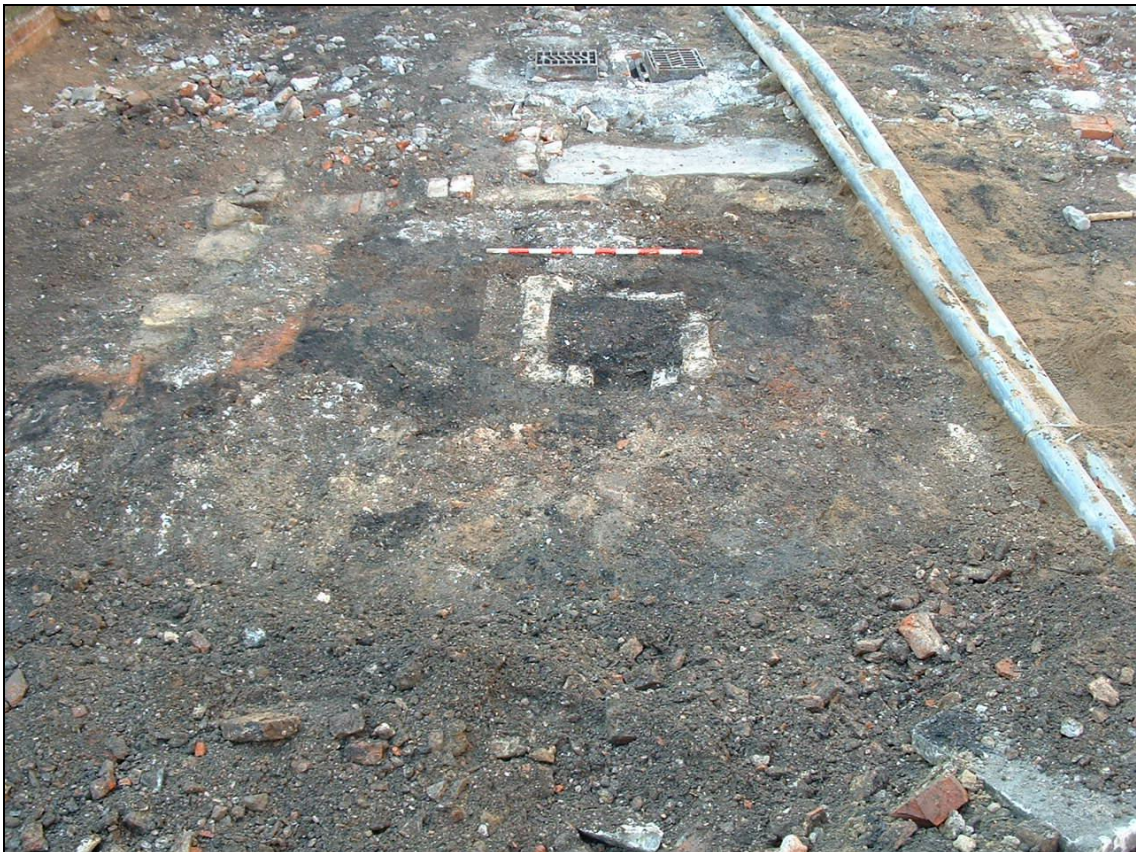
The ash pit cut through dark greyish black sand with fragments of charcoal, shell and broken brick and/or tile (122). It also contained eight sherds of pottery, exclusively of medieval date with the latest being of fourteenth to fifteenth century date. The deposit is potentially of medieval date. It was only occasionally revealed below more modern demolition rubble but may have been the original surface, or foundation for the surface, of the room. A similar deposit (127) was present alongside wall (128) that may have had a similar interpretation. Surface (122) was also cut by a sub-rectangular pit [119], filled by chalk rubble and charcoal (118). The pit measured 1.6m x 1m and its function was uncertain.

Plate 2. Walls (128) & (129), ash pit (124), deposit (122), looking SE

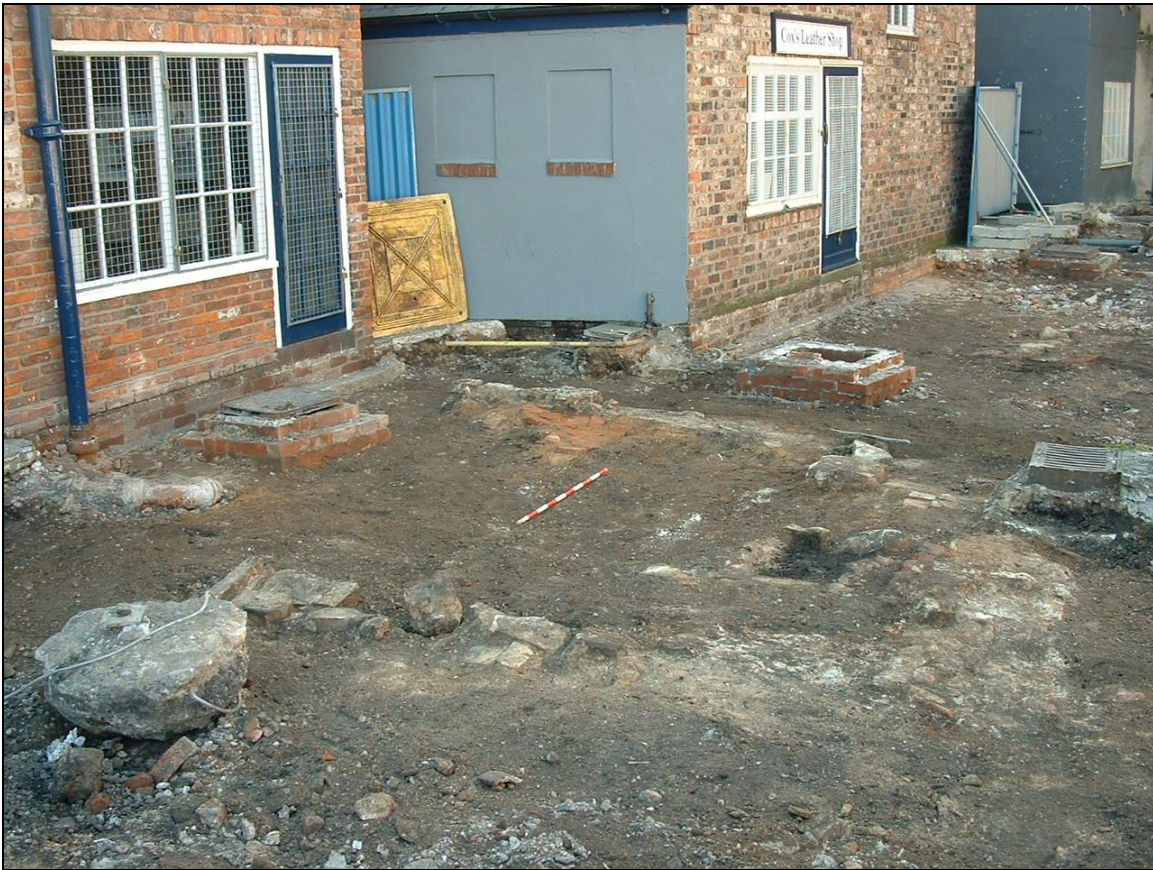
Plate 3. Wall (142), (143) and (144), looking SE

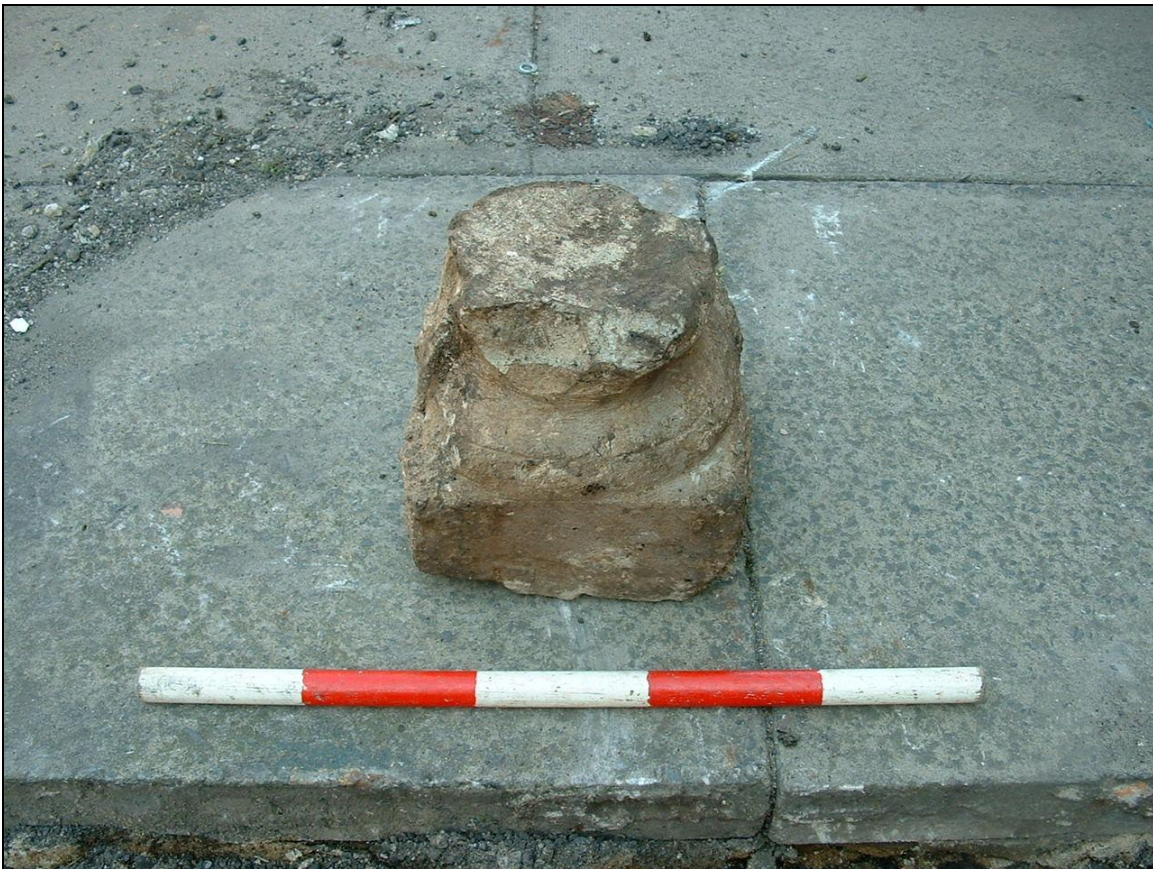
Plate 4. Pillar base from wall (142), (143) & (144)

Finally, it is worth noting the presence of a number of blocks of ashlar or architectural forms like pillars, which were re-used in the otherwise vernacular-styled walls. One such fragment was in wall (312), four pieces were found in walls (142/143/144) and a fragment of pillar was found in wall (200). With the exception of walls (220) and (222), which were well-faced on their external surfaces, all of the stone-built walls found in the investigation were either roughly-shaped or were true rubble in their form, albeit in walls built with varying degrees of skill. The ashlar and architectural features must have originated from a high status building, probably in the vicinity, whose remains were re-used in the foundations/walls described above. It is tempting – albeit entirely conjectural – to link these fragments with the hypothetical church that may once have stood nearby, connected to the former burial ground found previously to the south of Newgate Market.

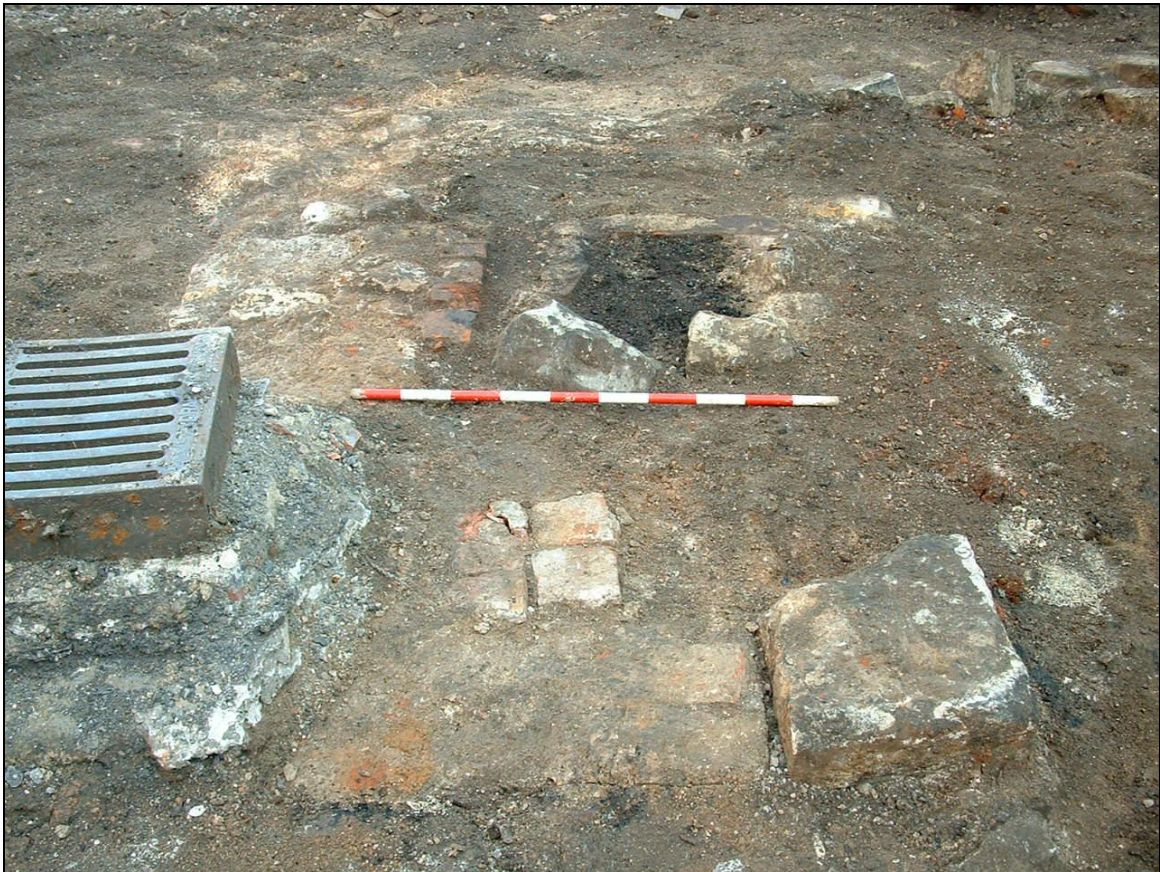
At the possible entrance threshold was a fragment of floor made up of hand-made brick (138) (Plate 5). Traces of limestone were visible below, perhaps indicative of an earlier wall/foundation. A similar surface (141) was seen in the northern half of the room. In the southern quarter of the room this surface was missing, revealing a deposit of greyish brown clayey sand containing occasional flecks of brick/tile, shell and bone (132) as well as a single sherd of mid-twelfth to mid-thirteenth century pottery. This material was reminiscent of cess pit fill, but it was impossible to confirm this due to the limited excavation (Plate 6). It was potentially of medieval date.

Plate 5. Entrance (138) and ash pit (139), looking NW

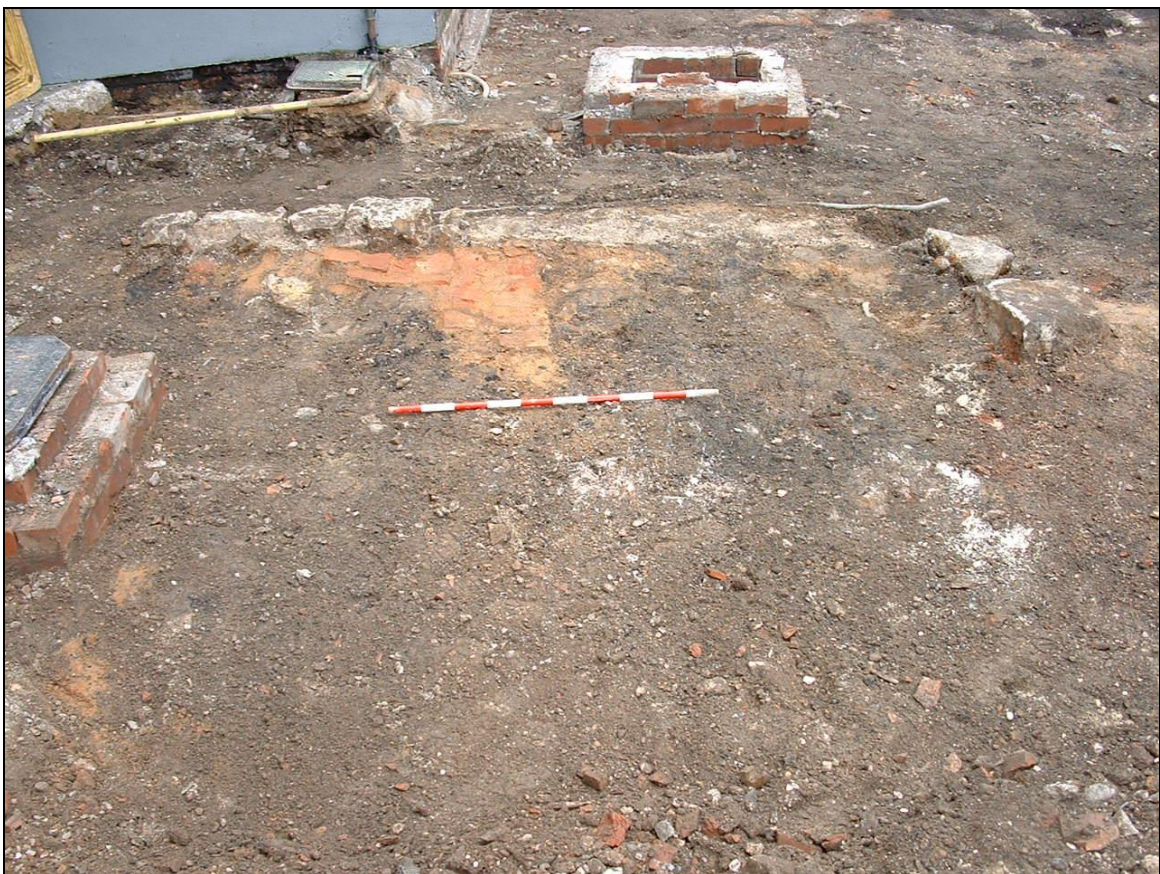
Plate 6. Wall (143), floor (134), deposit (132), looking SE

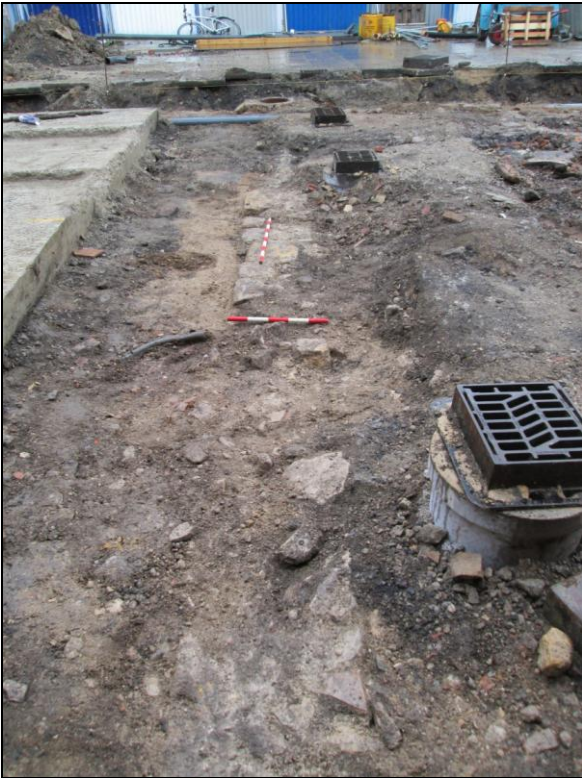
Plate 7. Wall (200), looking SW

In the central part of the main resurfacing area, further features of potentially medieval origin were also found. A building delineated by walls (200) and (214), which contained no dating evidence other than flat tile observed in their construction but that are of a form that could be medieval in origin. Within the building, the earliest deposit was mortar floor (201) (or foundation for a tiled floor). This deposit contained 4 sherds of medieval pottery, and no later artefacts. It extended beyond the building into an alleyway as shown in 1852, strongly suggesting that this floor belonged to an earlier phase of building dating from before the alley was established. It was cut by posthole [203], also in the alleyway shown in 1852 and also likely to belong to an earlier phase of building. The floor and posthole are likely to have been medieval in date.

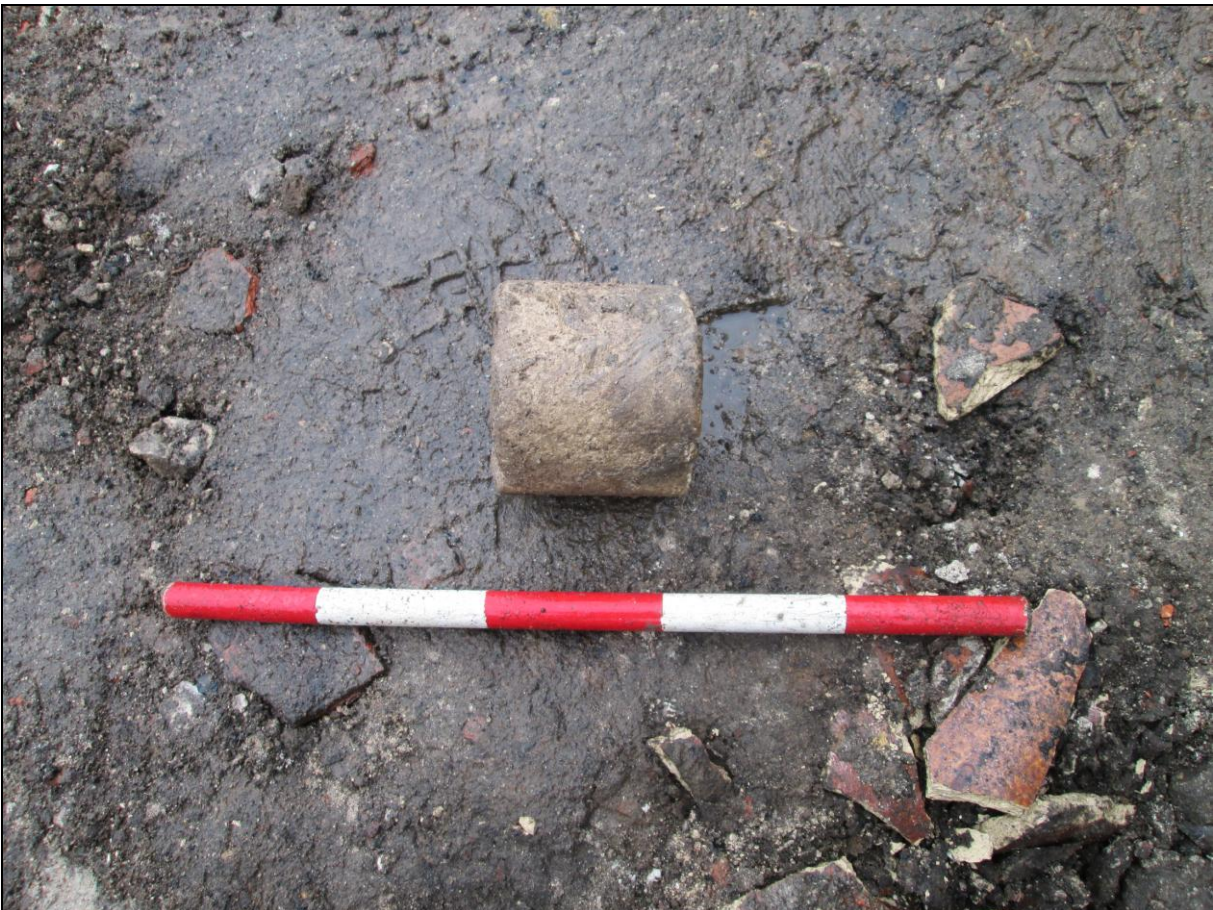
Plate 8. Pillar fragment from wall (214)

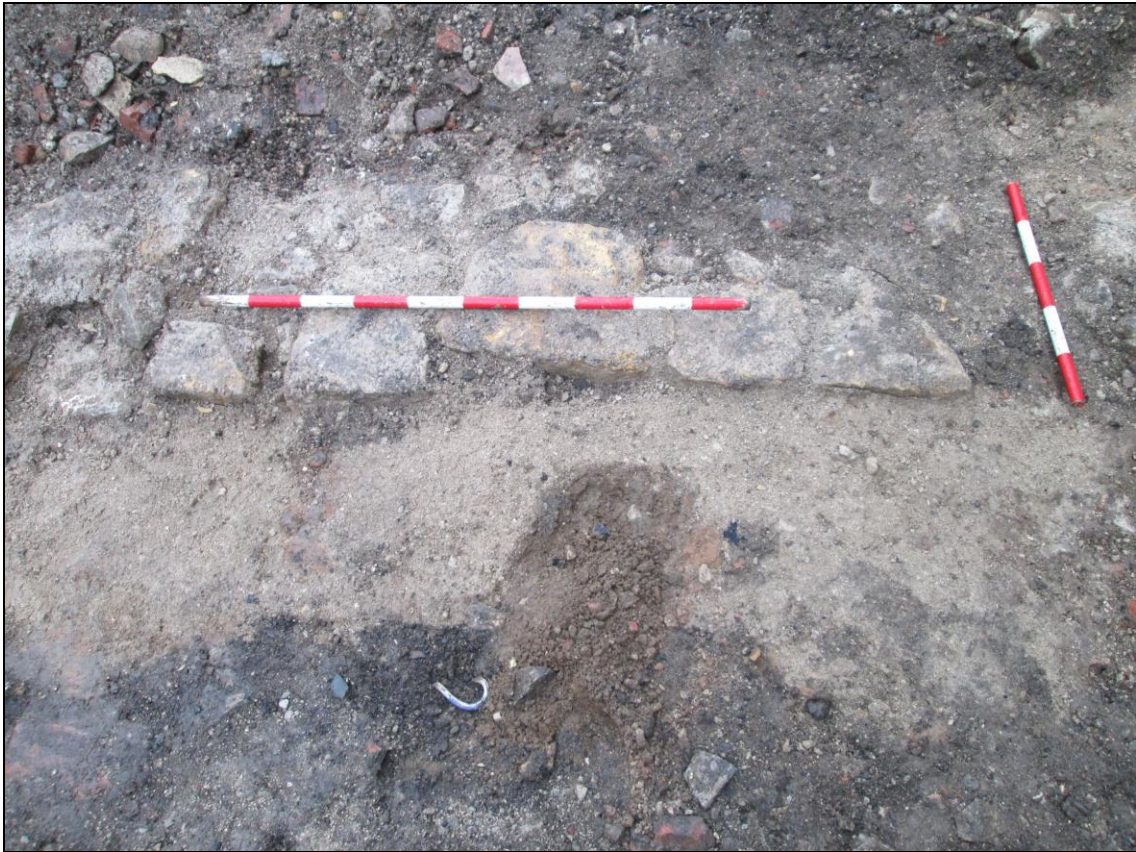
Plate 9. Posthole [203] cutting floor (201), looking NW

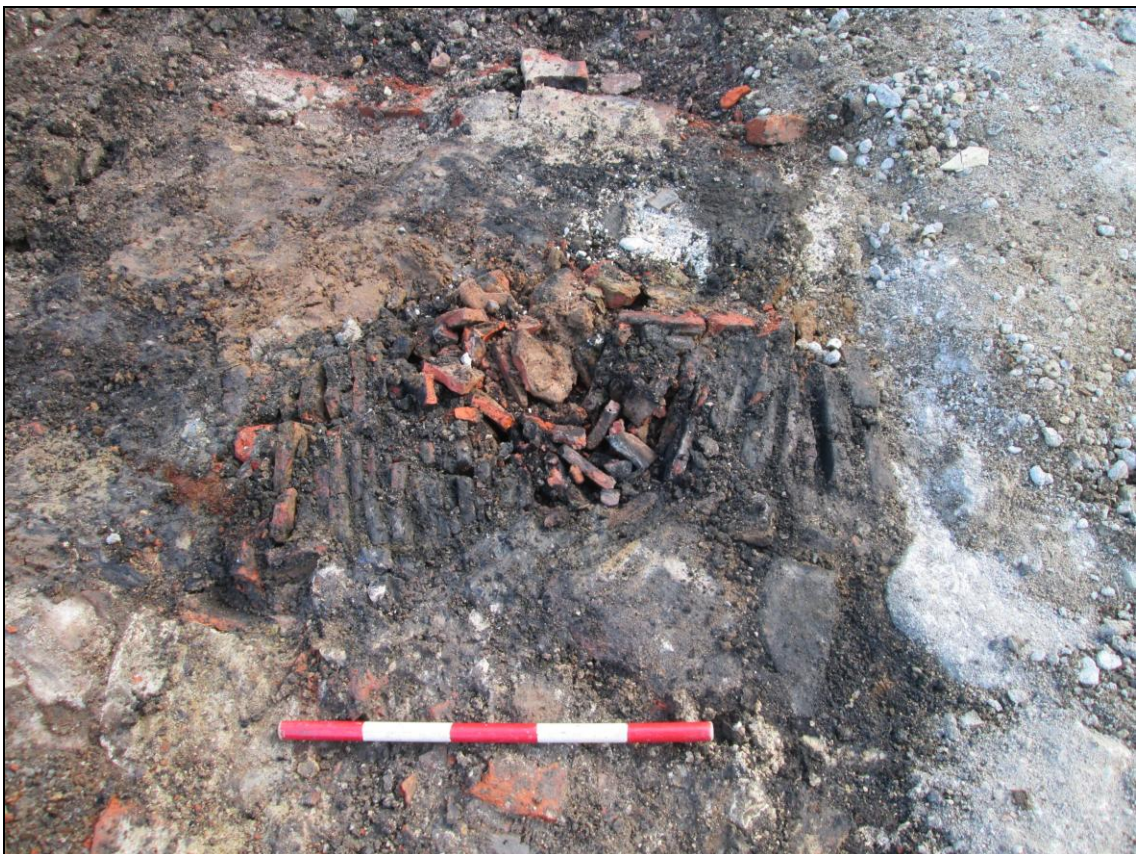
Plate 10. Hearth (213), looking NE

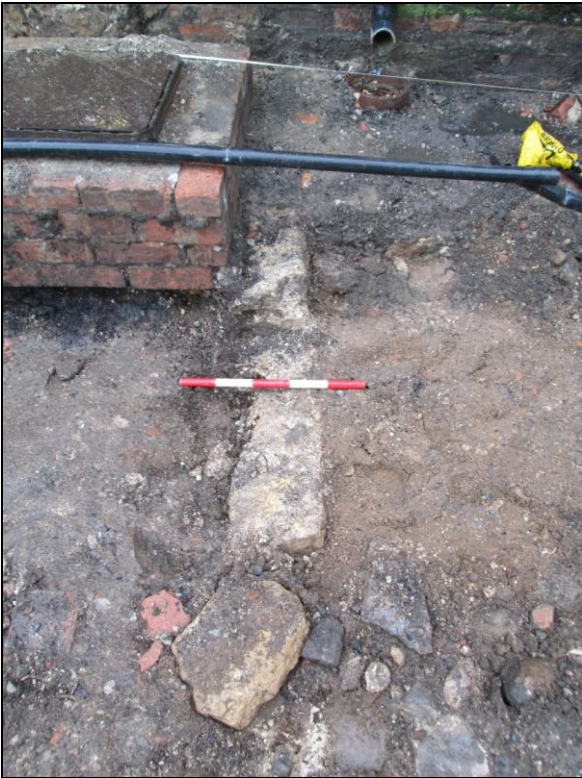
Plate 11. Wall (214), looking NE

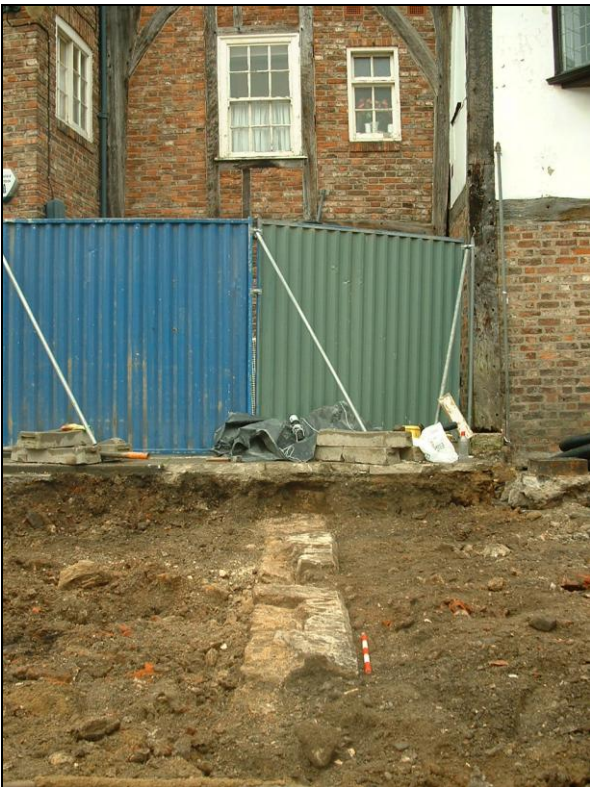
The southeast wall of the complex of outbuildings shown in 1852 was a 500mm wide limestone wall, bonded with lime mortar (220) (Plate 12). It was noted that the wall was well-faced to the southeast, but rubble finished to the northwest (i.e. inside the building) (Plate 13).

Plate 12. Wall (220), looking NE

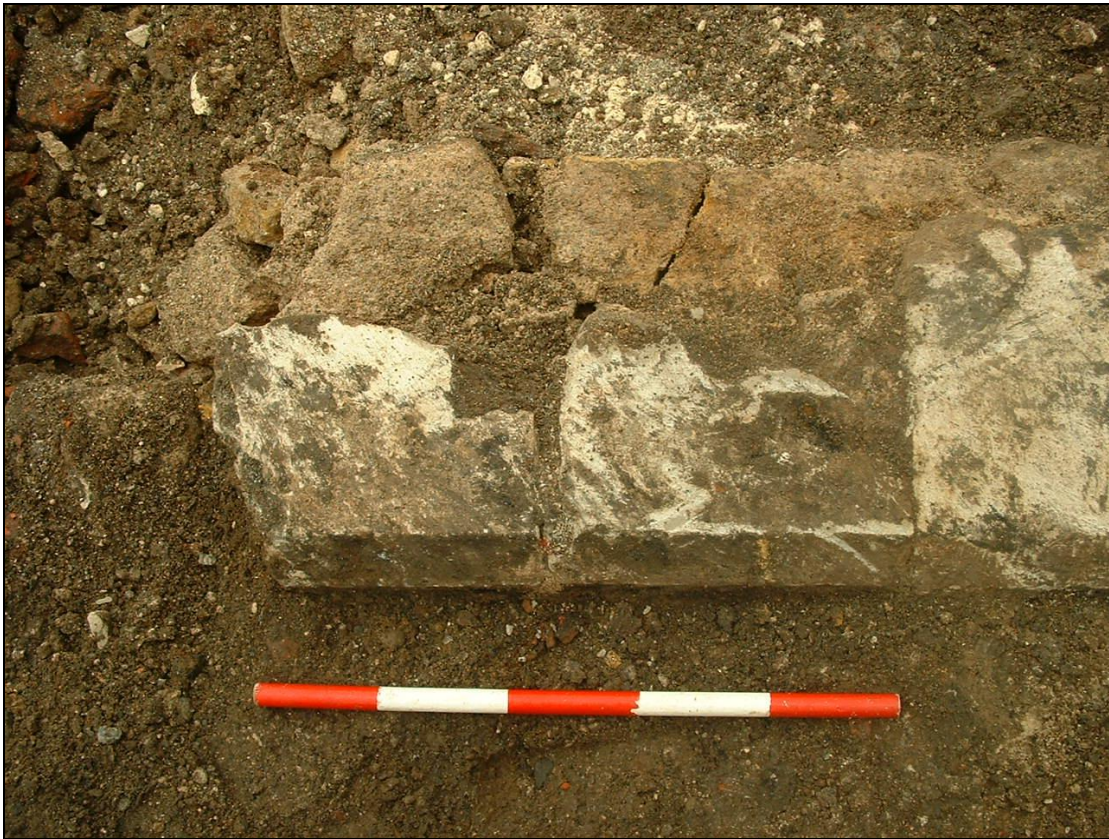
Plate 13. Wall (220) detail, looking NW

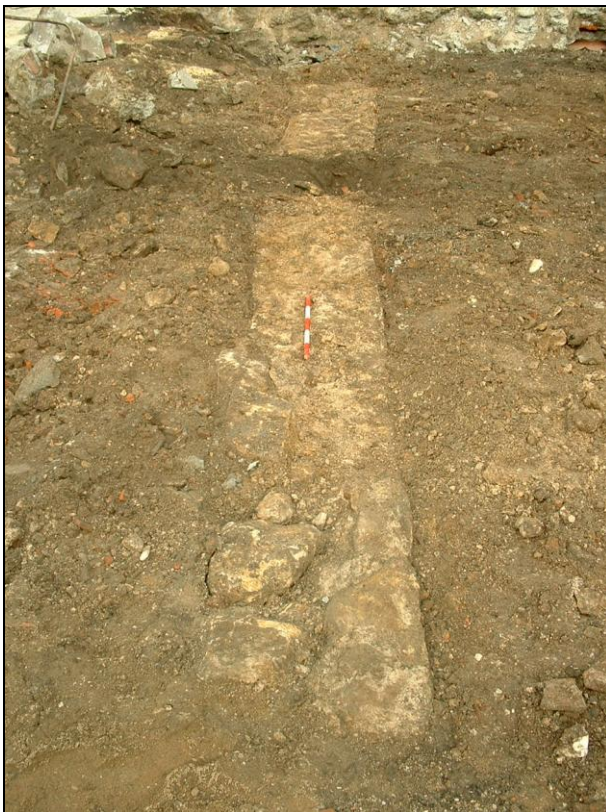
Plate 14. Wall (222), looking NE

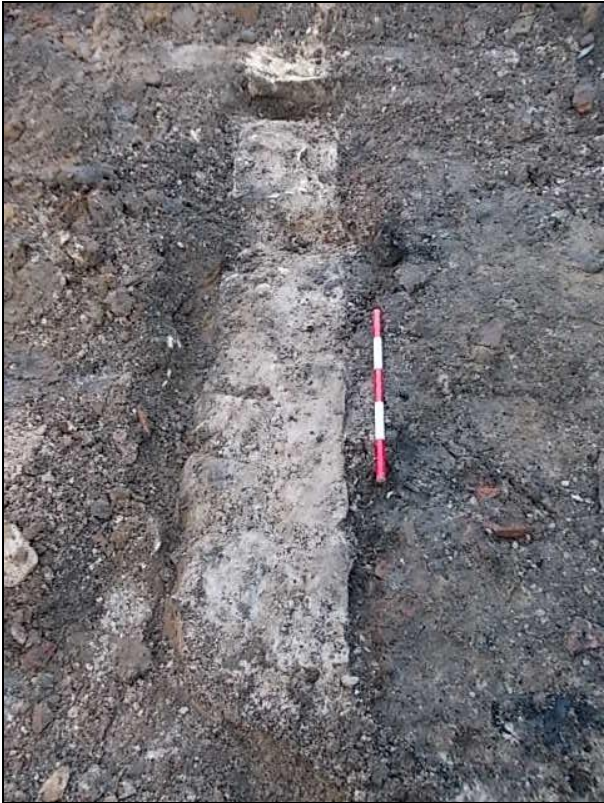
Plate 15. Wall (702), looking NW

In the northern part of the resurfacing area (Area 7), potentially medieval/early post medieval features were limited to two parallel walls (702) and (704), defining a plot fronting the former street of Little Shambles. These were made of lime mortared sandstone rubble, but no dating evidence was found.

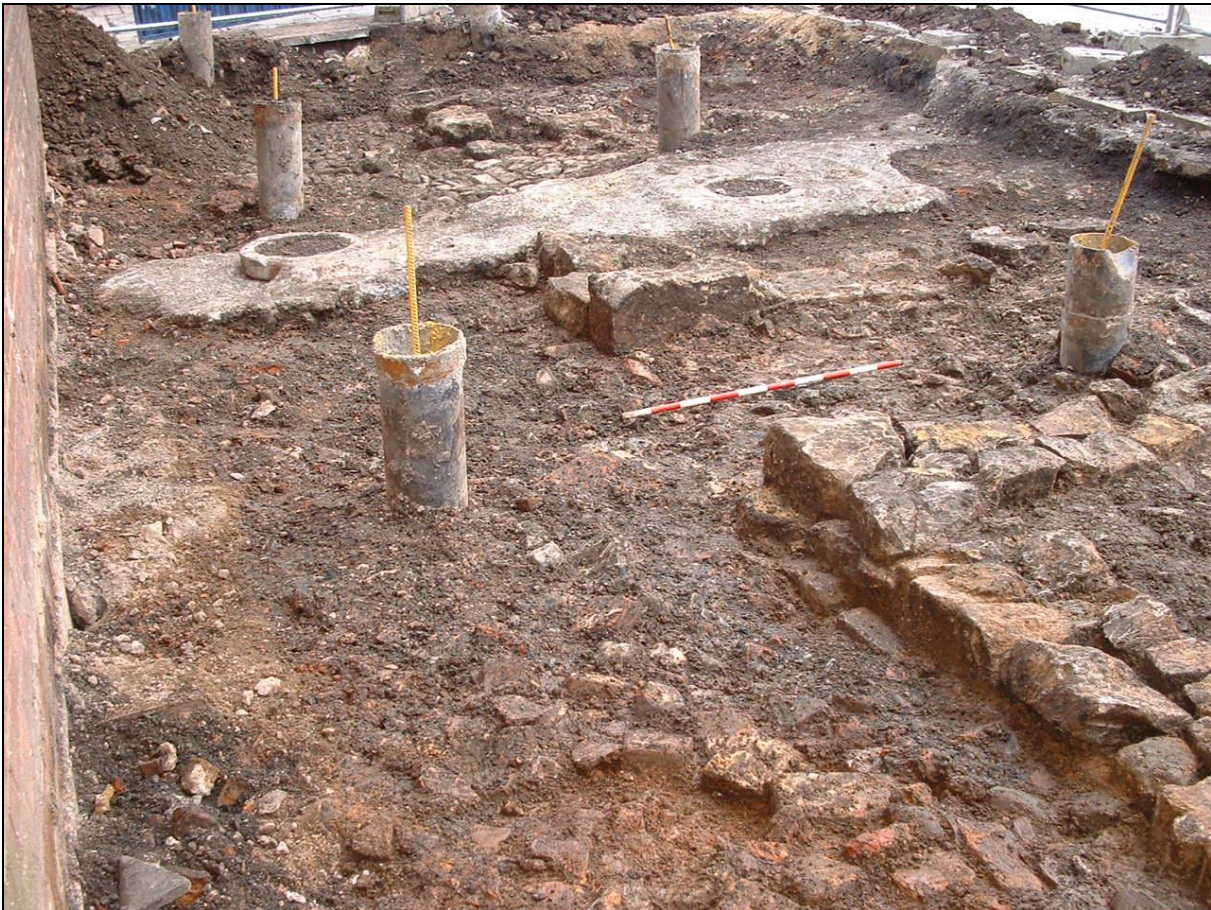
Plate 16. Area 3 overview, looking N

In the open area kiosk excavation (Area 3), the remains of two buildings and associated cobble surfaces (both internal and external) were found, and these were some of the best-investigated features on the site. Where pottery sherds were present, these were exclusively medieval in date as was the case with wall (303) (a single sherd) and floor (306) within the northwestern building (two sherds of medieval pottery). Wall (303) and deposit (304) that filled its foundation trench, floor (306), and below it foundation layer (307) and wall (313) to the southeast all contained varying amounts of broken flat roof tile. While not exclusively medieval in date, flat roof tile nonetheless is likely to date from the medieval or early part of the post-medieval period. As there were no artefacts of later date, it is possible that the two buildings are medieval in origin. By extension, this would mean that the well-made cobble

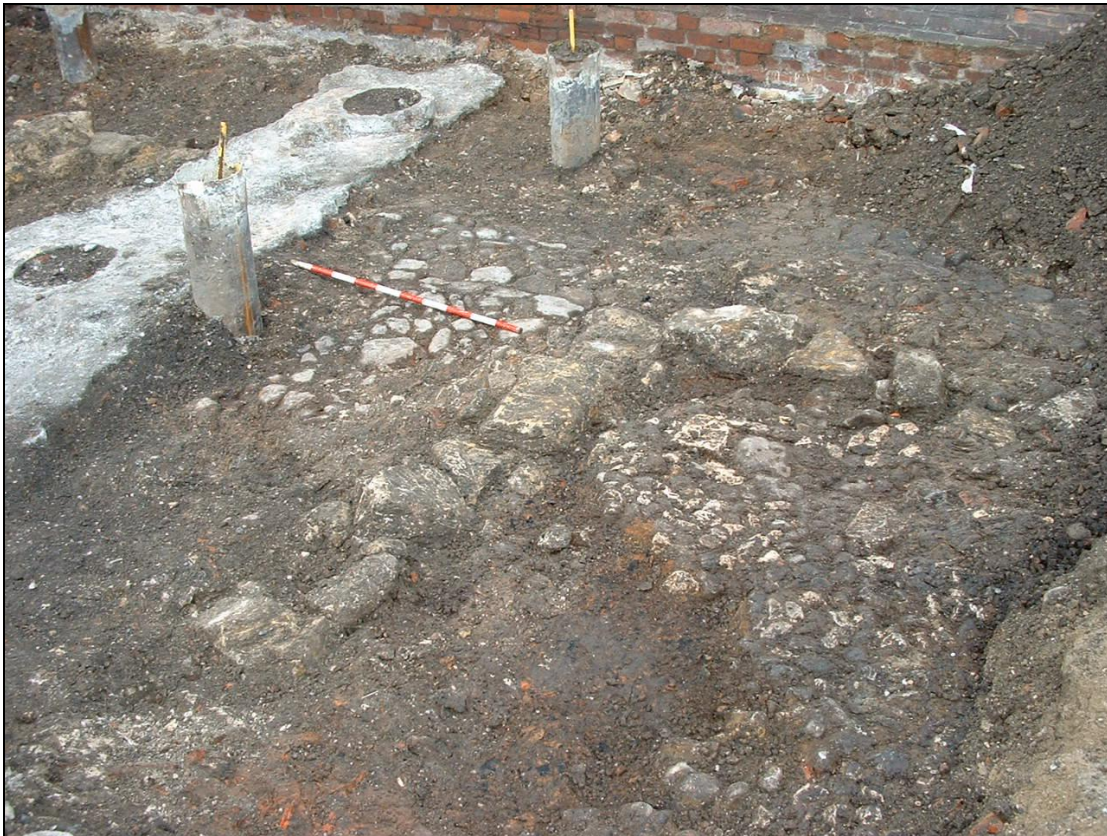
Plate 17. Wall (303), cobbled surface (308), floor (306), looking S

The building that lay in the northeastern corner of the trench consisted of a stone wall (303). This was composed of large limestone blocks, infilled with smaller blocks and bonded with lime mortar. The wall was only a single course wide and appeared to be a fairly crude construction, suggestive of a lightweight building. A small building is shown in this position on the 1852 Ordnance Survey map. Flat tile of medieval or early post-medieval date and a single sherd of medieval pottery were found within its construction, but these may have been residual.

Wall (303) appeared to be trench-built within foundation trench [305], which was visible (as a cut that was c.300mm wider than the wall) on its western side and on its southern side (where the cut was much tighter to the wall). This apparent foundation trench was filled with dark brown silty sand containing copious limestone or sandstone fragments and frequent broken pieces of flat roof or floor tile (304). The foundation trench cut through the cobbled surface (308)/(309).
