NEWGATE MARKET REFURBISHMENT, YORK.

REPORT ON AN ARCHAEOLOGICAL INVESTIGATION.
OSA REPORT No: OSA13WB32

July 2015

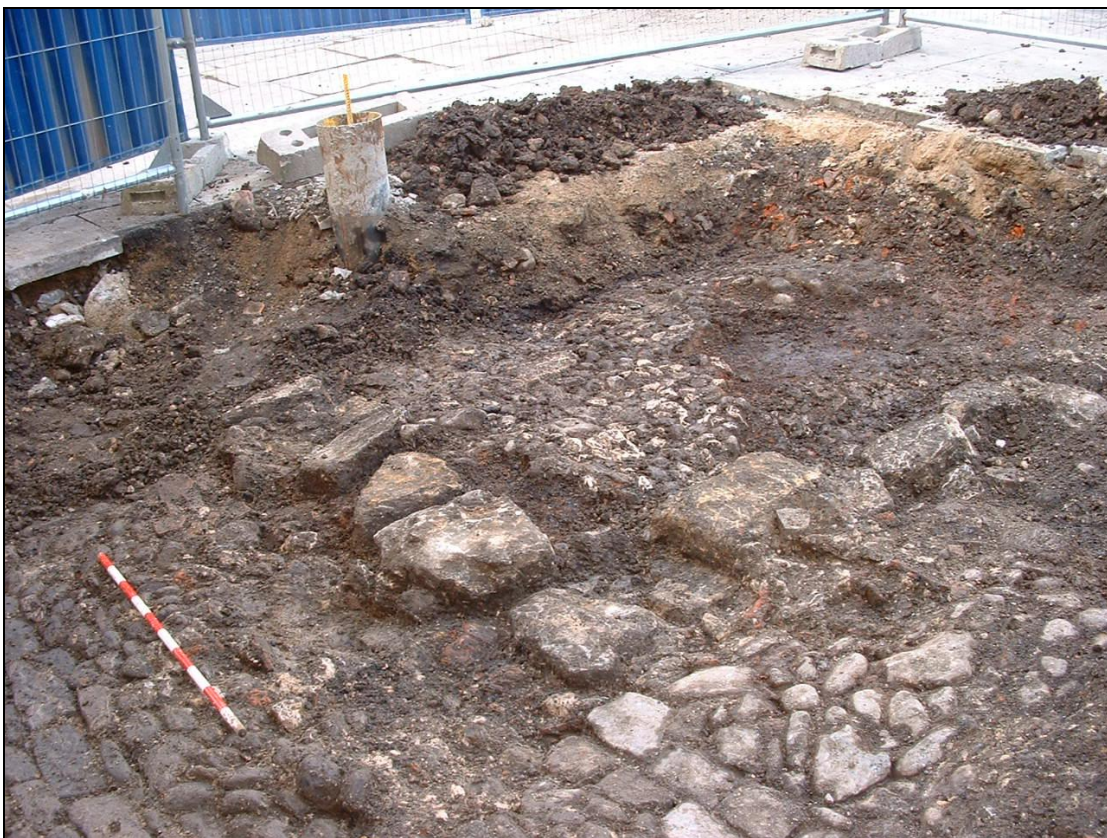
Within the small building defined by wall (303) was a rough cobbled surface (306) (Plate 18). This comprised a single layer of cobbles (70% grey river cobbles, 30% limestone cobbles) and was later than or contemporary with wall (303). Two sherds of late medieval pottery were recovered from the cobble layer. The surface was missing in places exposing the foundation layer for this surface, which consisted of brown silty sand with occasional fragments of flat tile (307).

Plate 18 Wall (303), cobbled surfaces (308), (309), (310), floor (306), looking N

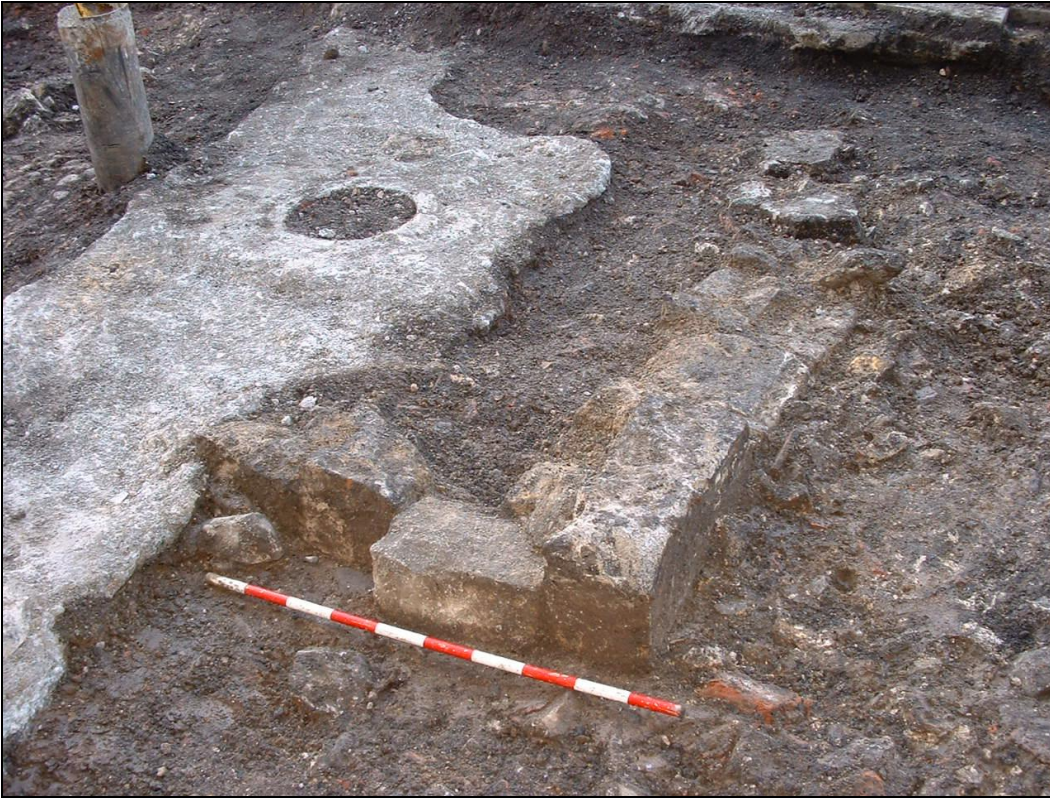
Plate 19. Wall (313), looking NE

It was noted that the alley between walls (313) and (312) continued the line of an existing alley between buildings fronting Shambles, and is shown on the 1852 map. The alleyway surface, and any surface to the west of walls (313) and (312), was not found. The area was covered by dense rubble (311) composed of early modern (or older) brick fragments, flat roof tile, cobbles and limestone fragments and including a (presumably residual) sherd of medieval pottery. This butted against the walls, suggesting that it was contemporary or more recent. Although this may have been a crude yard surface, it is more likely that this material was demolition rubble, probably dating to the twentieth century demolition of the area.

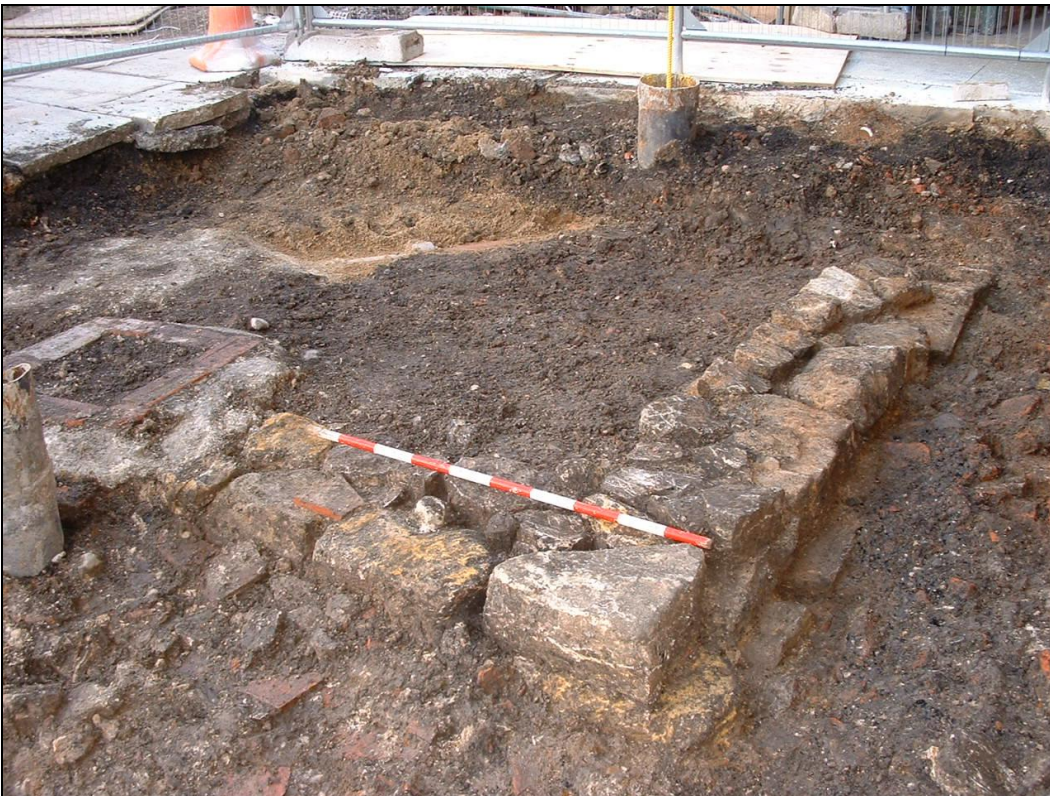
Plate 20. Wall (312), looking SE

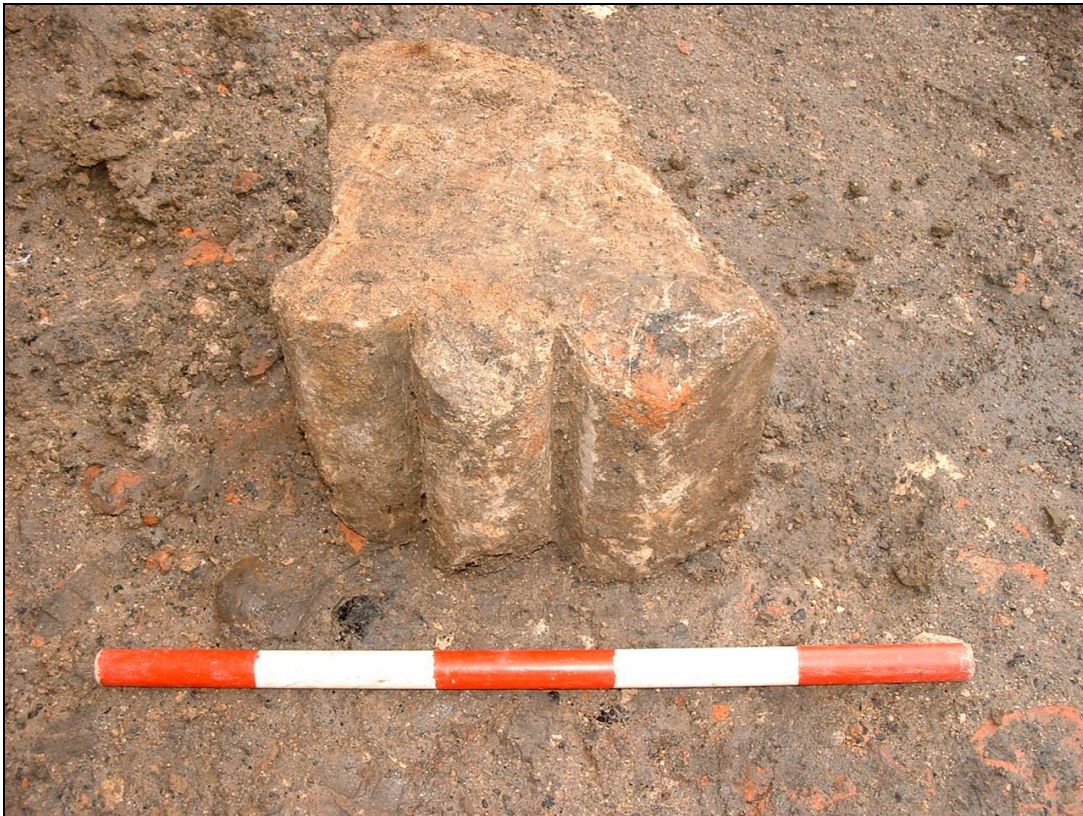
Plate 21. Architectural fragment from wall (312)

Finally, it is worth noting the presence of a number of blocks of ashlar or architectural forms like pillars, which were re-used in the otherwise vernacular-styled walls. One such fragment was in wall (312), four pieces were found in walls (142/143/144) and a fragment of pillar was found in wall (200). With the exception of walls (220) and (222), which were well-faced on their external surfaces, all of the stone-built walls found in the investigation were either roughly-shaped or were true rubble in their form, albeit in walls built with varying degrees of skill. The ashlar and architectural features must have originated from a high status building, probably in the vicinity, whose remains were re-used in the foundations/walls described above. It is tempting – albeit entirely conjectural – to link these fragments with the hypothetical church that may once have stood nearby, connected to the former burial ground found previously to the south of Newgate Market.

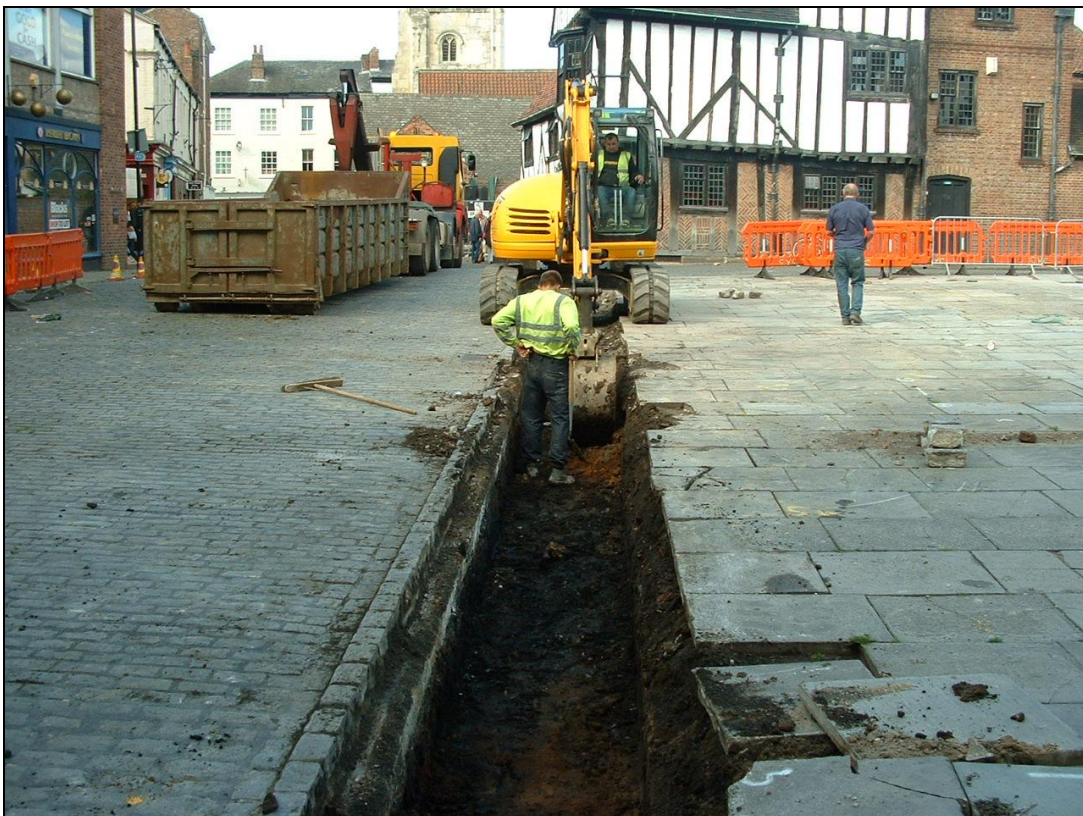
Plate 22. Area 4 under excavation, looking NW

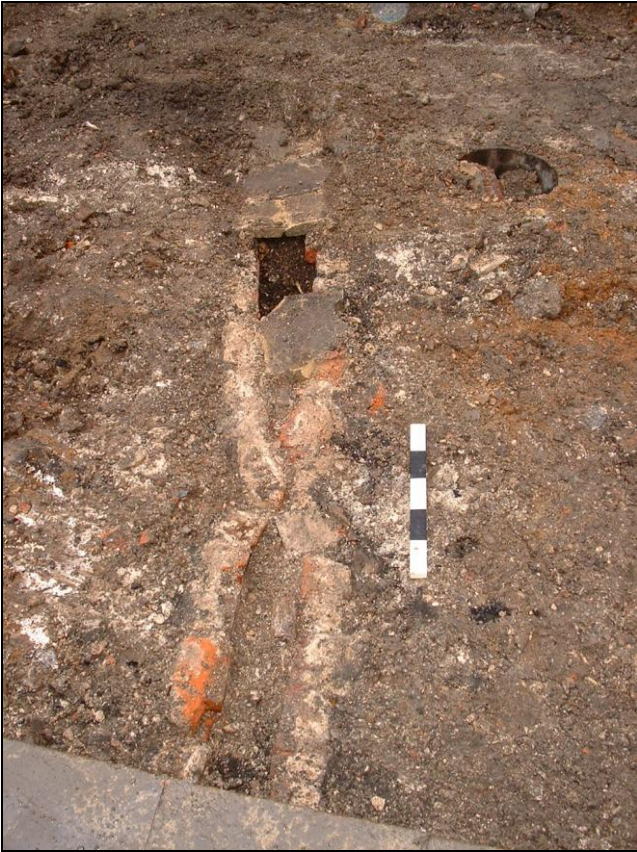
Plate 23. Drain (503), looking NW

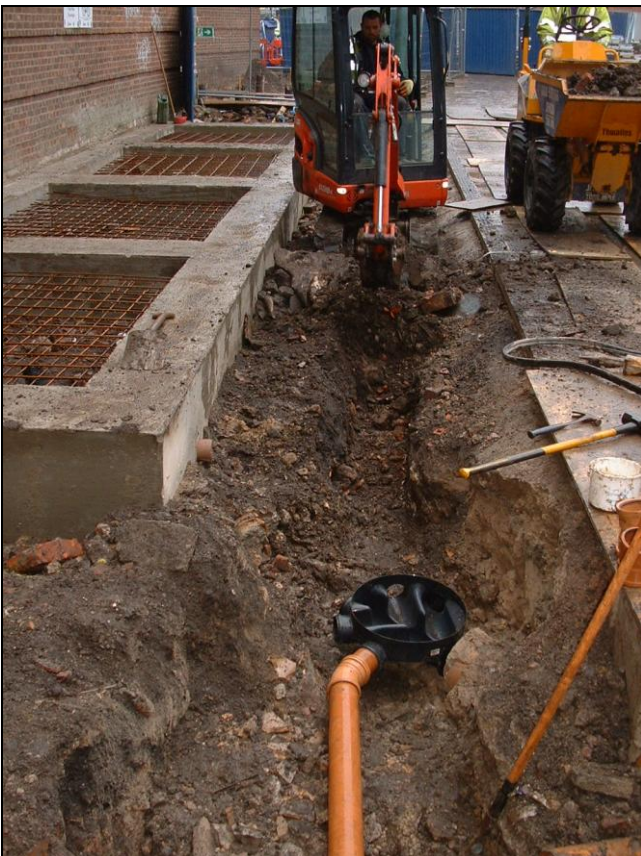
A twelve metre long service trench was excavated immediately adjacent to the kiosk open area excavation (i.e. Area 3). The trench was 300mm wide and was up to 1m deep (Plate 24). No archaeological features were observed and it was noted that a wall of modern brick had truncated any earlier features in the central part of the trench.

Plate 24. Area 6 under excavation, looking NW
