**TECHNICAL APPENDIX 5.1
CULTURAL HERITAGE DESK-BASED ASSESSMENT**

PROPOSED SOLAR PV INSTALLATION

**ON LAND ADJACENT TO
THE WATER TREATMENT WORKS,
ELVINGTON, NORTH YORKSHIRE**

APRIL 2015

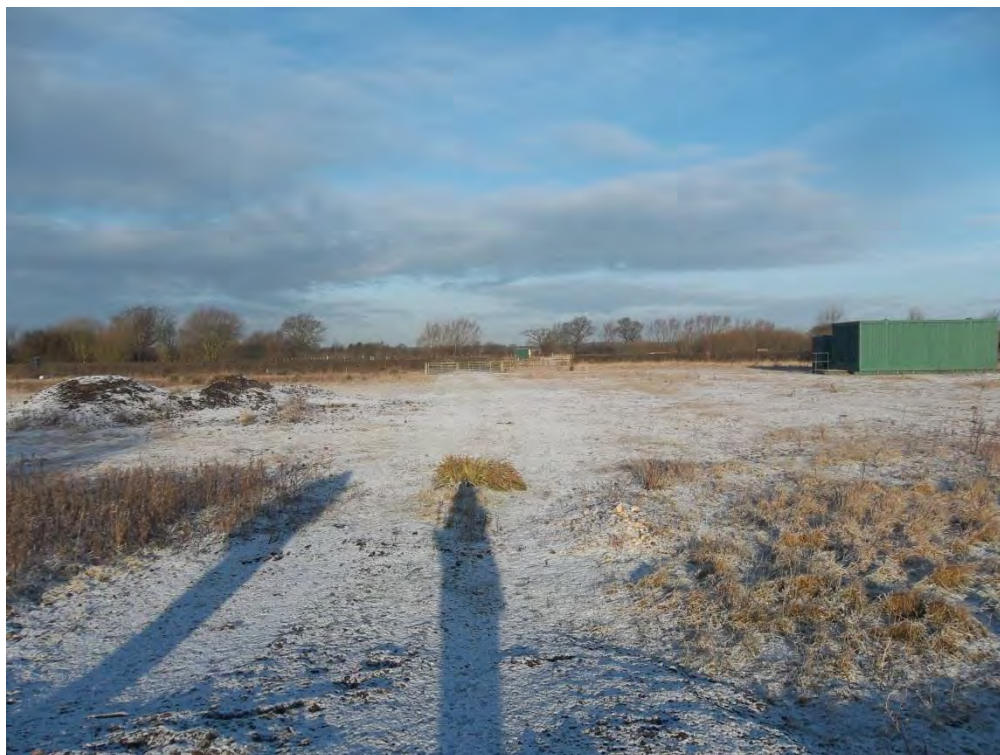
Plate 1: Looking north across area of hard standing at the north end of the core study area

A site visit was undertaken on the 03/02/2015. The conditions were sunny with good visibility however a thick layer of frost lay on the ground. Rough uncultivated vegetation covered most of the site and there was an area of hard standing covering part of the northern section of the site. Modern earth and vegetation mounds are scattered through the site probably related to construction of the bund, hardstanding or general vegetation clearance. No additional features were identified however based on the evidence in the wider study area any potential existing features would most probably be earthworks relating to agricultural practice (ridge and furrow) and so difficult to see under such a thick layer of vegetation. Ridge and furrow was not observed in the adjacent field to the east.
