# HEWORTH CROFT

YORK

## HISTORIC BUILDINGS ASSESSMENT

REVISED FEBRUARY 2004

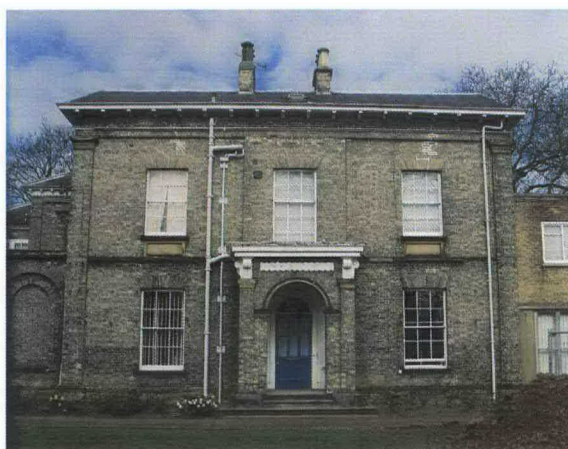
**Plate 6** South facade

The main building is of two storeys, with additional attic space and basement. The fabric is of pale yellow brick in Flemish bond with a Welsh slate roof (Plate 6). Two chimneys flank the centre of the building, with a third at the rear to the west. A low brick plinth encircles the building, while at eaves level is a decorative timber modillioned cornice. This ornament is repeated on the gable pediments, which also reveal evidence for a domestic attic storey. Each elevation is further defined by flanking corner pilasters of brick, with stone bases and capitals which support a projecting floor band at attic level.

The facade displays the fashionable Italiante architecture of the early Victorian period, and is symmetrically divided into three equal bays with flanking corner pilasters. The elevation has an additional horizontal division, with the brick plinth and attic floor band being supplemented by a simple stone band at first-floor level. Above this are two stone panels (below the first-floor windows) which emphasise the piano nobile; a Classical convention denoting the main floor of the house. The flanking bays each contain a single 6-over-6 (12 pane) hung sash window at ground-floor level, which is repeated on the first floor. Each window is framed by a rubbed and gauged flat brick arch.

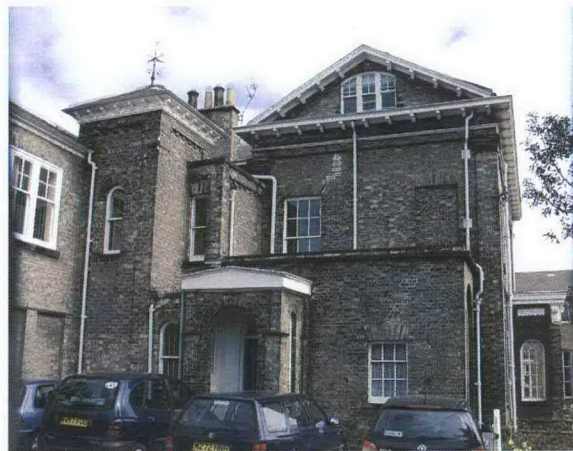
**Plate 8** West elevation

The west elevation is less regimented in its classical emphasis, which may reflect the piecemeal replacement of an earlier building (Plate 8). The main elevation is of two bays and is divided horizontally into three distinct areas. The attic is defined by a modillioned pediment and contains a large triple hung sash under a segmental arch. Below this, the area is symmetrically divided by two openings under flat brick arches; while that to the north presents a 6-over-6 hung sash, the opening to the south is blind. The ground floor represents a single-storey extension with a 3-over-6 pane hung sash under a flat brick arch. Situated to the north is the west entrance porch, which is a copy of that on the front facade. However, it is apparent that this represents a secondary entrance with no decorative frieze. The porch retains its original fittings including a letter box and night bell.

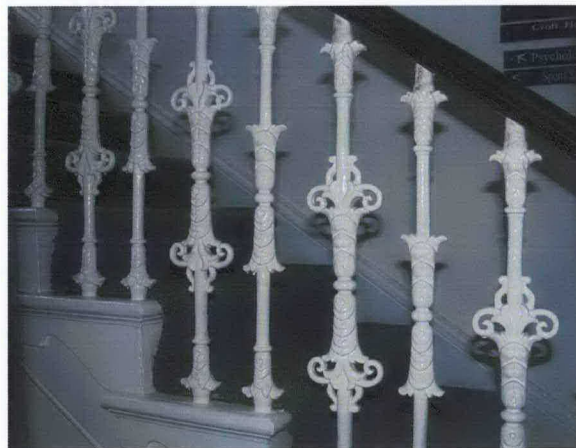
**Plate 10** Cast iron balusters

The first space to be encountered upon entering the house is a large central stairwell which provides access to the rest of the house. As such, it was highly decorated; the room retains its original high skirting and deeply moulded ceiling cornice with two ornate plaster ceiling roses. Also surviving from the early Victorian period is the open tread staircase with elaborate cast iron balusters (Plate 10). The stair is lit at half-landing by a single arched hung sash with original furniture.

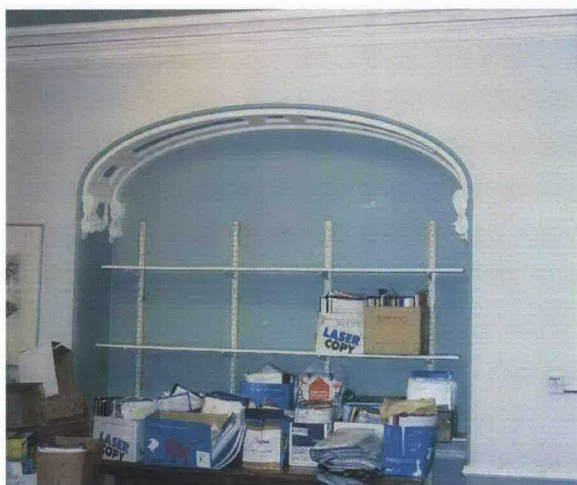
**Plate 12** Dining room with buffet recess

The rooms to the north are accessed via a four centred-archway, located opposite the entrance lobby. Access to the west was denied, but it is apparent that this partition represents a later division. To the east is the dining room, which is lit by two 6-over-6 hung sashes in the north wall, both retaining their panelled embrasures. The fireplace to the west has been lost, and an 1840s dado rail and skirting pieced in. Its function as a dining room is indicated by the arched buffet recess located in the east wall (Plate 12). This retains its 1840s moulded plaster decoration and would originally have contained a serving board.

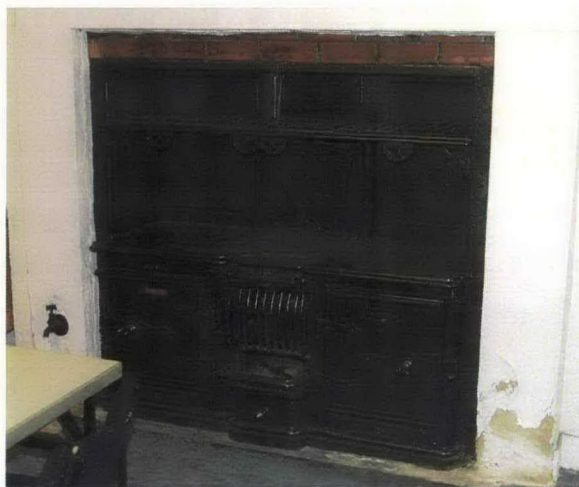
**Plate 13** Early Victorian range

A further room located at ground-floor level is the kitchen. Presently, this room can be entered only from an external door to the rear of the property. The kitchen contains a significant amount of evidence from the earlier, late Georgian, building on the site. Two chamfered beams running east-west transect the ceiling, with stops at each end denoting the room's original size. Within the west elevation is a centrally-placed cast iron range typical of the early Victorian period and made locally in York (Plate 13). However, this is contained within an earlier late Georgian fireplace. Also from the earlier phase is the panelled cupboard located next to the fireplace and the 8-over-8 hung sash window in the northern elevation. However, the doors and architraves are contemporary with the 1840s alteration.

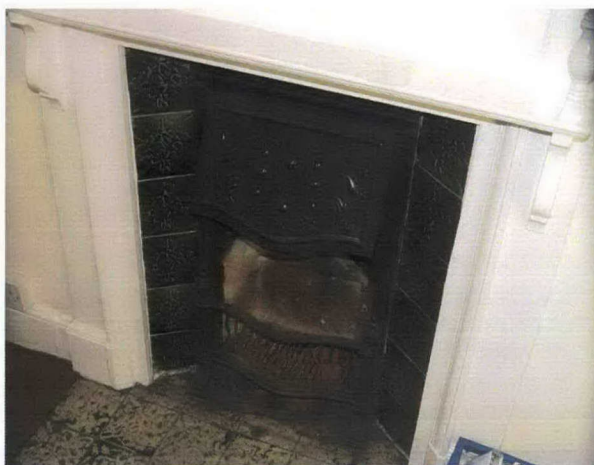
**Plate 15** Late Victorian fireplace

The room to the east has been heavily subdivided, its original size being denoted by the 1840s ceiling cornice. Its cast iron fireplace in the west wall is a late Victorian insertion. It is likely that this room was a principle bedchamber, with access to a large dressing room to the west. This adjoining room has also been subdivided, but retains its original ceiling cornice throughout. The late Victorian addition of skirting and a picture rail, with embossed wallpaper above, suggests that the subdivision of this room occurred at a contemporary date (Plate 14). The original room had a corner cupboard, still present, within the chimney breast to provide heated storage. It was also lit by a large 6-over-9 pane hung sash in the south wall.

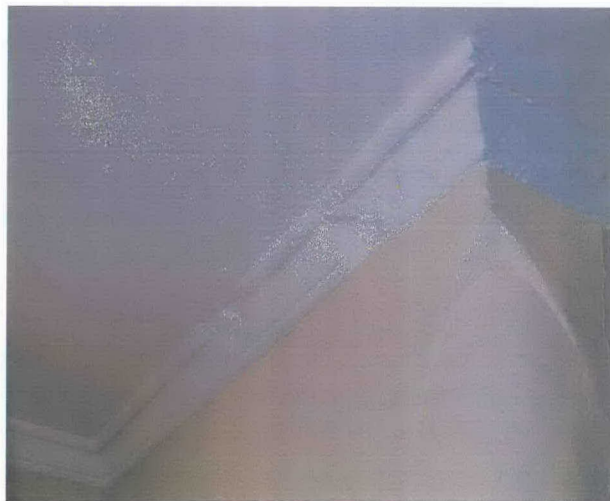
**Plate 16** Late Georgian cornice

The late Georgian evidence continues into the corridor, which displays a plaster ceiling cornice similar to that found in the main rooms (Plate 16). The eastern room also displays remains of a late Georgian skirting with a contemporary fireplace in the east wall (Plate 17). These rooms, in conjunction with the kitchen below, represent the surviving remains of the earlier 'Queen's Villa' building.

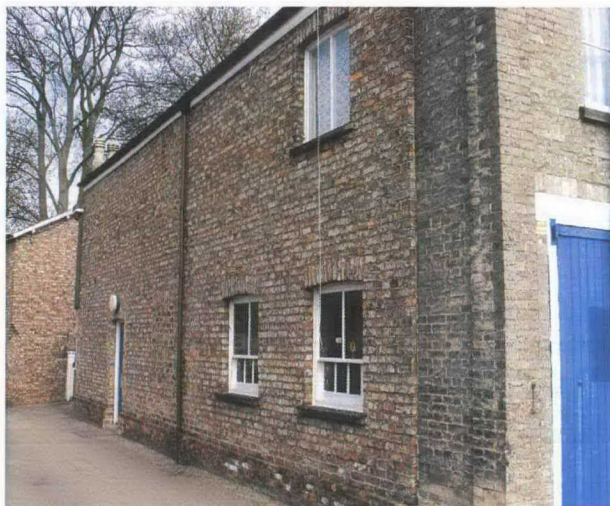
**Plate 18** Refacing on Coach House

Adjoining the main house to the west is a two-storey building aligned north-south. It is predominantly of fine red brick construction in English garden wall bond, with a slate roof. However, the south facade was been replaced in the 1840s in order to unite the building with the main house (Plate 18). This elevation employs the contrasting yellow brick, laid in Flemish bond. The gable pediment is decorated with a timber modillioned cornice and is pierced by a single brick oculus, thus uniting it with the wider Italiante architectural scheme.

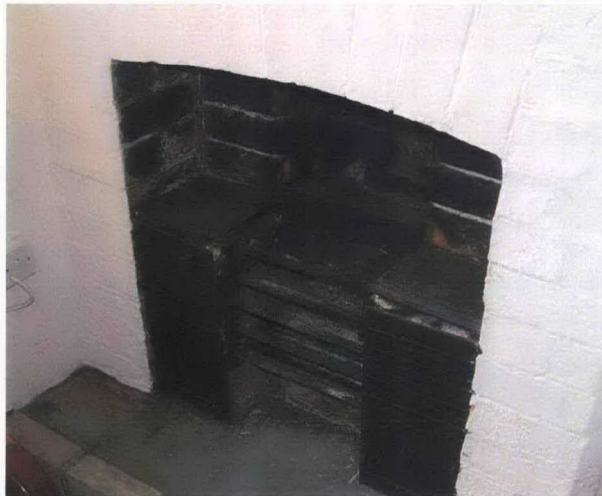
**Plate 20** Reused late Georgian fireplace in stable office

Internally, the building is divided into two rooms at ground-floor level. To the east is a small office which, although heavily modernised, contains an late Georgian cast iron fireplace (Plate 20). As this pre-dates the building itself, it is possible that it was retained when the earlier house was destroyed. There is no direct access from this office into the Stable proper.

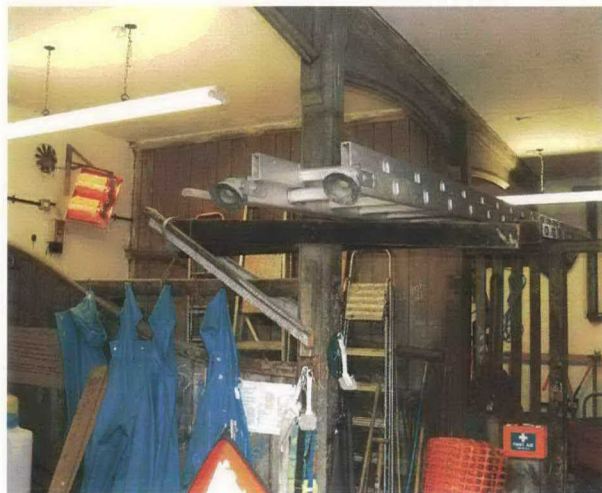
**Plate 21** Internal fittings in stable

The Stable itself retains much of its original fittings and fixtures, which are consistent with a late 19th century date (Plate 21). Three stalls remain with timber slat divisions and moulded segmental heads. The floor also retains its original late 19th century tiles. In the southeast corner is a simple wooden stair providing access to the first floor. This room is open to the roof and lit by low

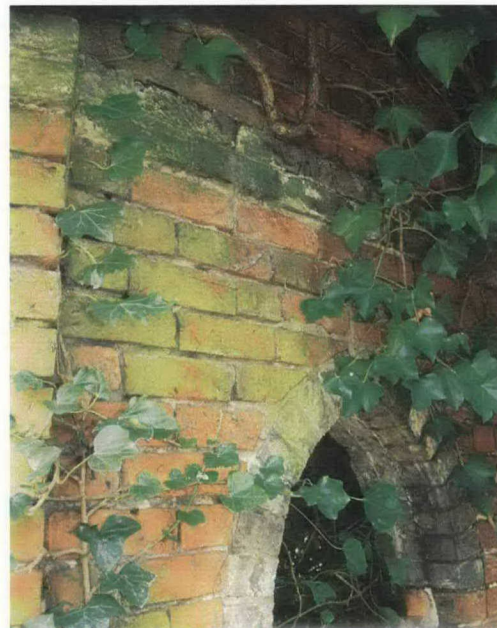
**Plate 22** Yellow brick detailing on summerhouse

Despite being badly damaged and largely concealed by unregulated vegetation, the building still stands to its full height. The summerhouse is octagonal in plan, with a pilaster strip at each corner, echoing the classical detailing on the main house. The structure is predominantly of red brick construction, laid in English Garden Wall bond. However, contrasting yellow brick detailing has been employed on the arched openings and surrounding frieze (Plate 22). These openings take the form of simple single-light windows under 2-centred arches. The door, situated in the west elevation, has a round-headed arch lintel also defined by yellow brickwork.

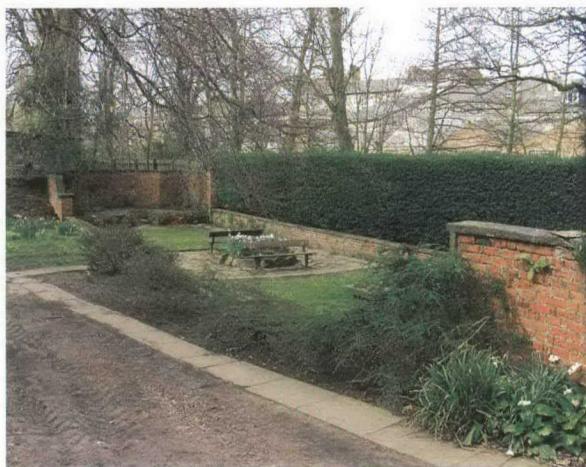
**Plate 23** Formal walled garden

Prior to 1909, Heworth Croft was encompassed by open ground and irregular winding paths. By 1931 much of this informality had been lost, and the present walled garden had been added at the northern extreme. This feature is defined by a low red brick wall with symmetrical curved ends (Plate 23). The random bond and concrete capping reinforces its late date.
