**BUILDING RECORDING AT THE LODGE,  
FORMER FIRE STATION SITE,  
PECKITT STREET, YORK**

*BUILDING RECORDING REPORT*

Report Number 2016/45 July 2016

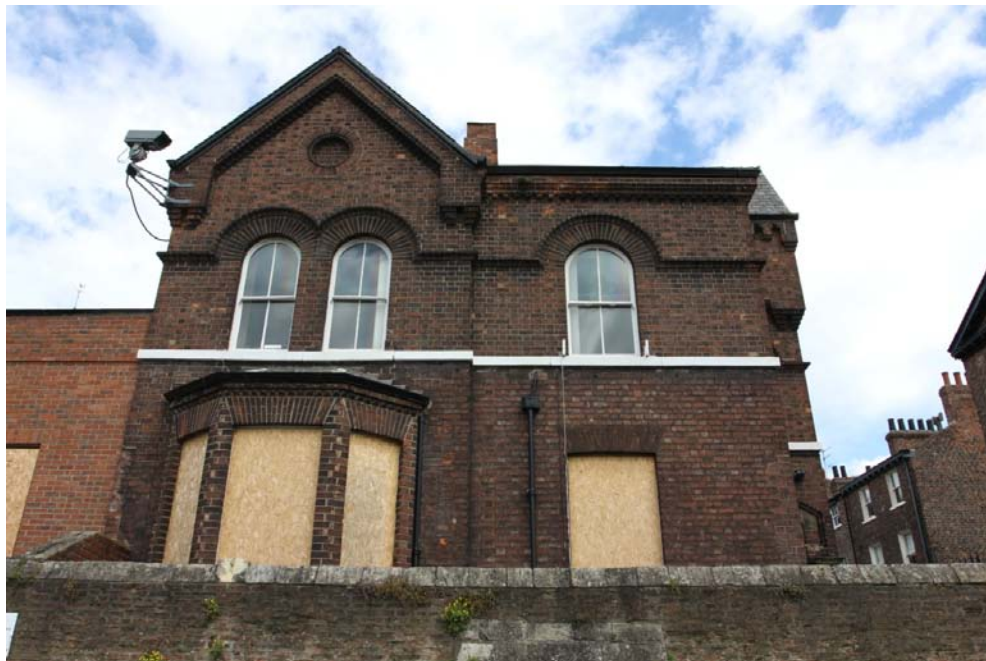
**Plate 1: South Esplanade elevation**

The principal elevations face out onto South Esplanade (the river Ouse) and Peckitt Street. The South Esplanade elevation incorporates a front-facing gable and a canted bay window. There is a blind oeil-de-boeuf window in the gable. The Peckitt Street elevation incorporates a front-facing gable and an imposing central entrance tower which extends across three storeys. The asymmetrical footprint of the building means that the tower is visually prominent at the south-west corner. It has a steep, front-facing gable roof and slim, lancet-type windows. The fenestration scheme across the South Esplanade and Peckitt Street elevations includes two-over-two sash windows to the ground and first floor. The windows to the first floor have arched heads. There are a number of blind windows at the south-west corner.

The building is constructed out of red brick laid in Flemish bond with a slate roof. The South Esplanade and Peckitt Street elevations are decorated with moulded brickwork including a prominent cornice at eaves height and a string course which traces around the upper section of the arched windows at first floor level. The top of the entrance tower is also decorated with moulded brickwork. The main entrance on Peckitt Street is flanked by brick columns with sandstone steps and details. An original six panelled door is in situ.

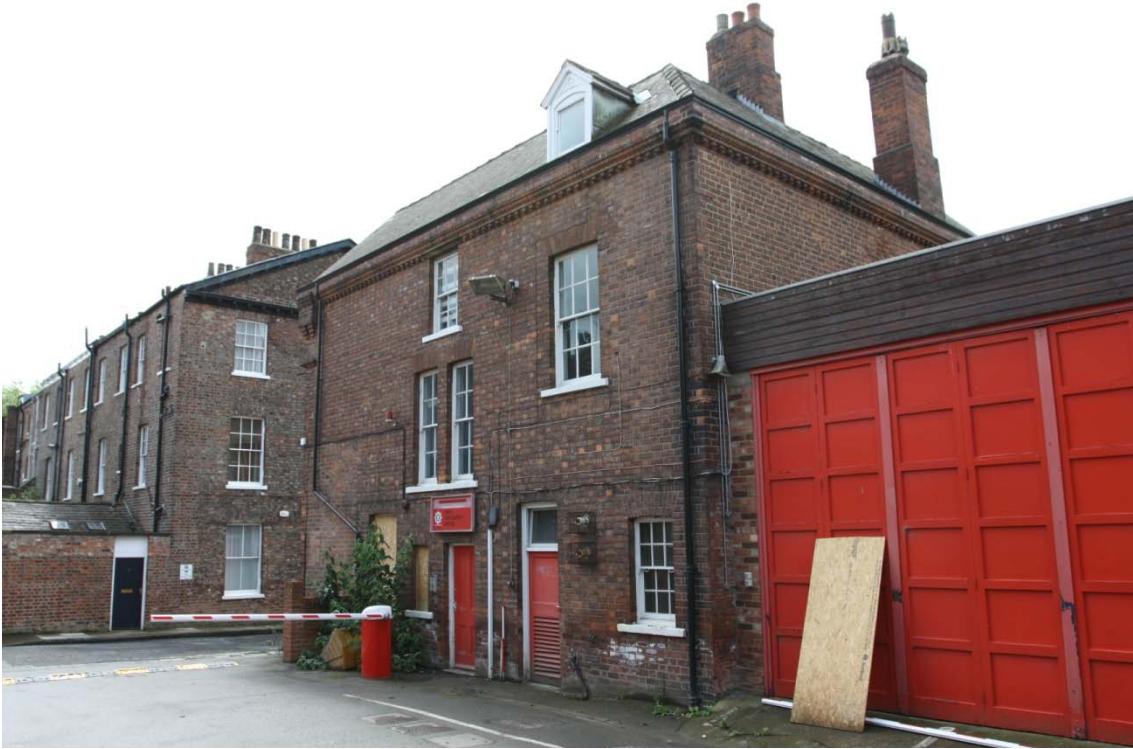
**Plate 3: Rear elevation**

The rear and side elevations are much plainer in style. The cornice continues around these elevations, though other features are absent. The north elevation is largely obscured by a modern garage structure which butts up to the building. The fenestration scheme to the rear elevation includes two centrally-positioned half-landing windows between ground and first floor, and first and second floor. The windows include six-over-six, and four-over-four sash windows. There is an original, centrally-positioned doorway to the rear elevation. The doorway to the north of this is a later addition created out of a former window opening.

The scar of a former single-storey lean-to structure is present at the southern end of the rear elevation.

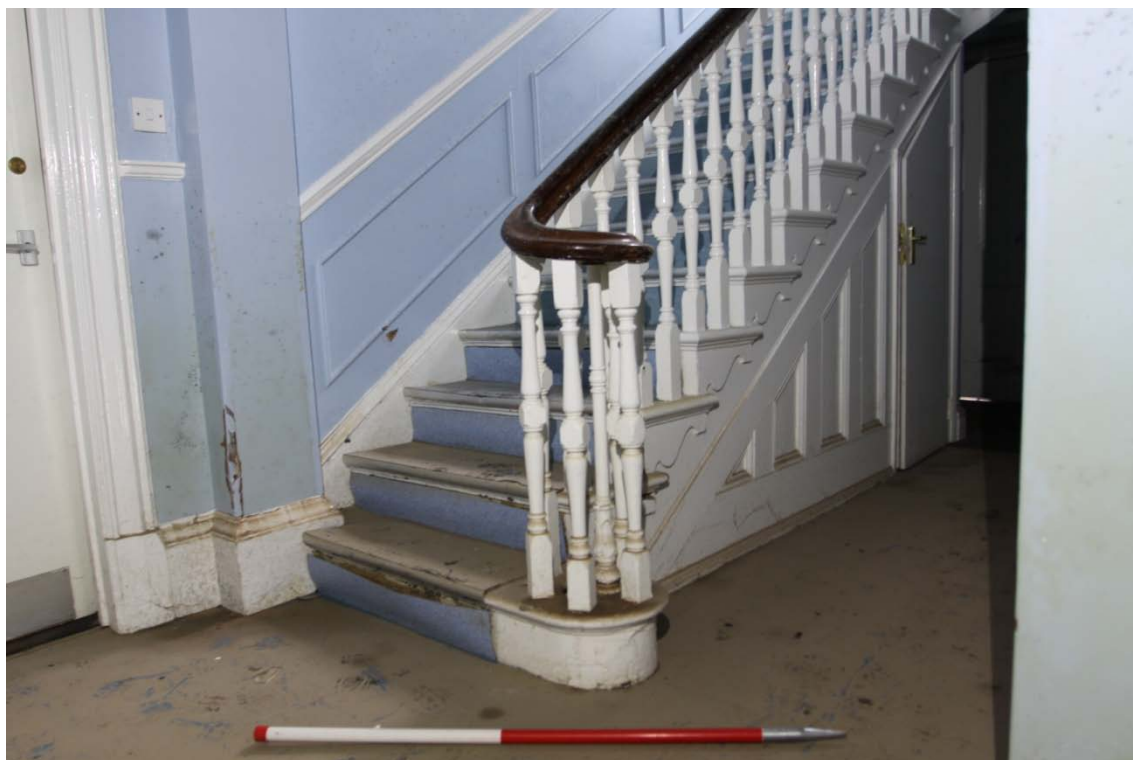
**Plate 5: Room 5, staircase and hallway**

A dog-leg staircase with half landings rises up continuously from the ground floor to the second floor of the building. It is orientated east-west and is positioned at the centre of the rear of the building. It is a display feature, and has an open string, moulded handrail, turned balusters, carved brackets, and a curtail step.

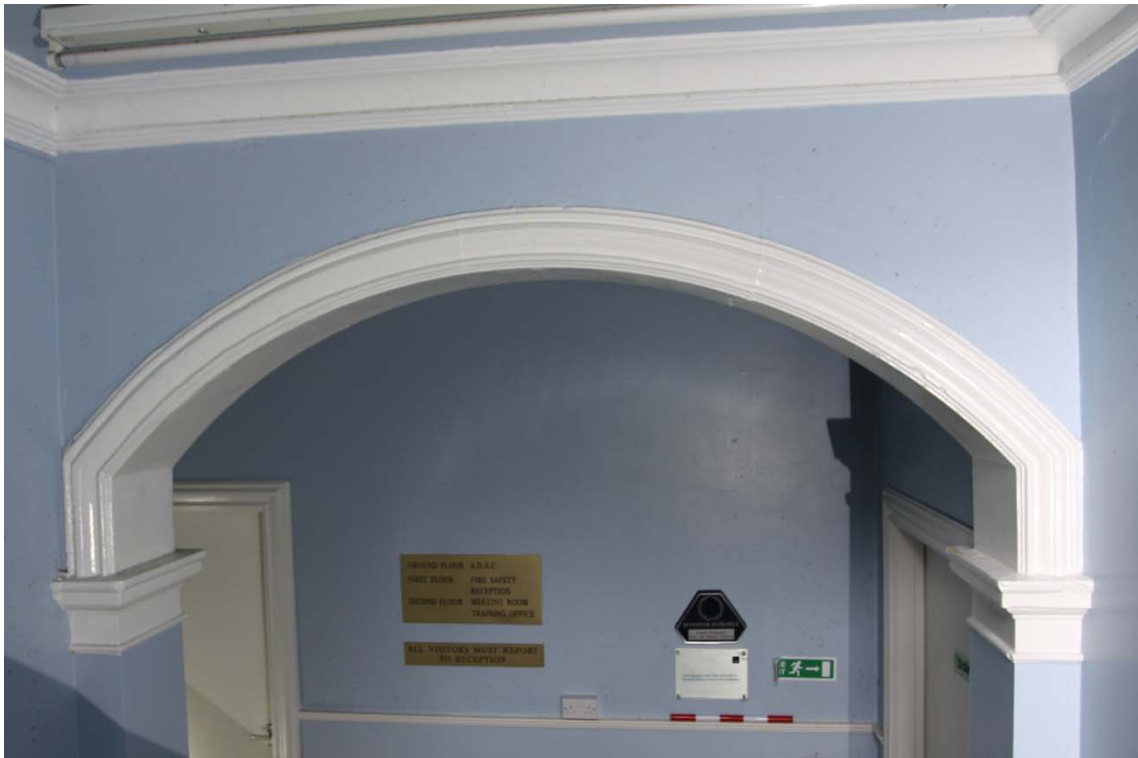
**Plate 6: Room 5, archway to ground floor hall**

At ground and first floor level, there are wide arches on square-shaped columns positioned mid-way along the hallways. Tall skirting boards, dado rails and cornices are present up to (and including) the second floor half landing. Only the skirting continues up to the second floor landing. There is a pair of tall, four over four sash windows to the first floor half landing and a smaller, six over six sash window at the second floor half landing. All of the rooms are accessed from the entrance hall. The architraves surrounding the doorways are original, though the doors are modern replacements.

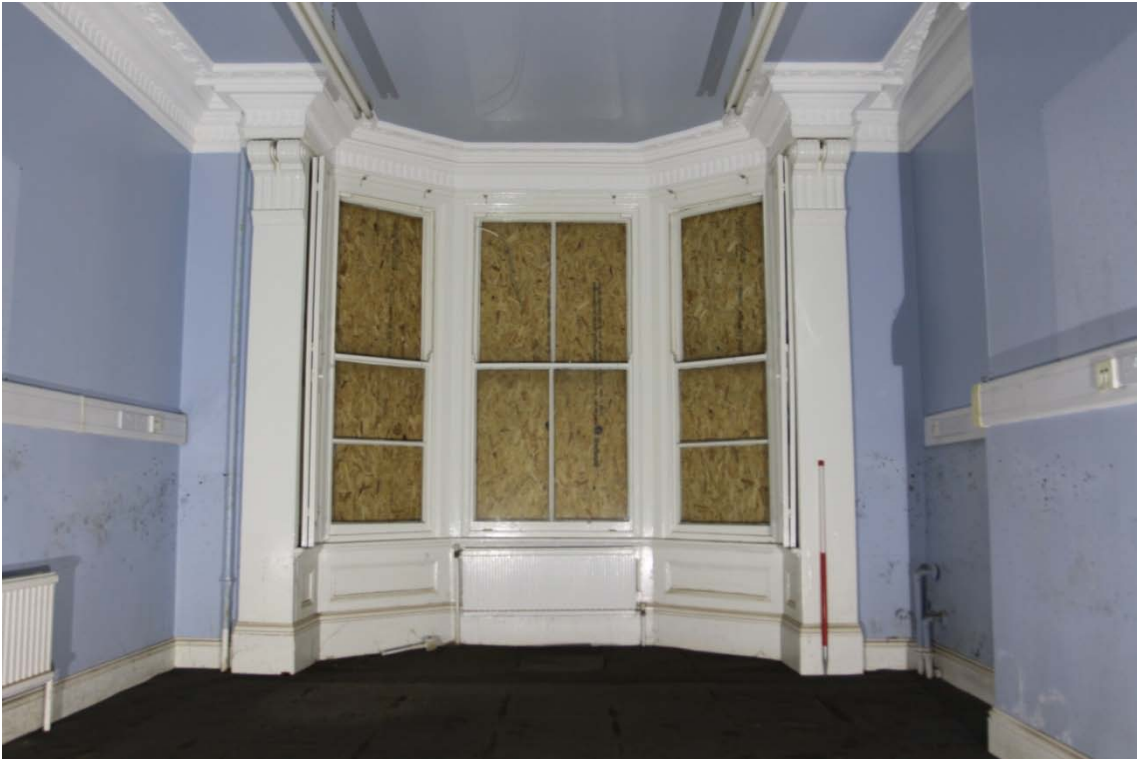
**Plate 7: Room 1 bay window**

Room 1 is the largest and grandest of the rooms at ground floor level. The large, canted bay window is a dominant feature that extends across the width of the room. The window is flanked by wide shutter boxes forming square-shaped columns with decorated capitals. The original shutters survive intact. A deep, decorated cornice runs around the perimeter of the room and there is a ceiling rose in the centre. A chimneystack is present on the north wall, though the fireplace has been removed and the opening blocked up. There is a small, shallow recess at window height to the east of the fireplace.

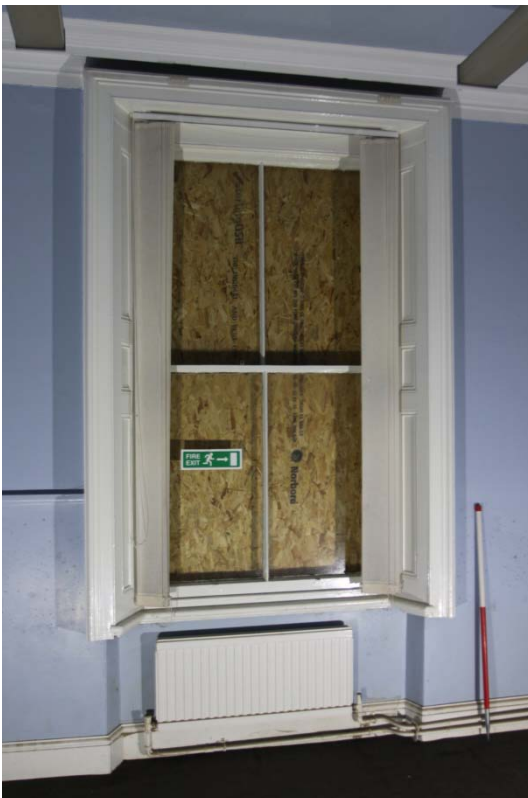
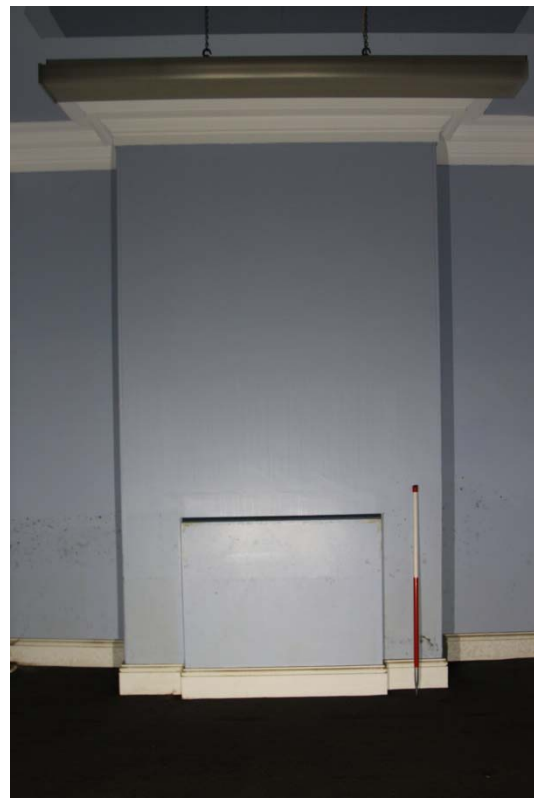
**Plate 8: Room 3, window and chimneystack**

Room 3 is a smaller room with a single sash window with shutters. There is cornicing around the perimeter of the room and a chimneystack to the north wall. The fireplace has been removed and the opening blocked up. A plain dado rail is present to the west of the window opening and along the south wall.

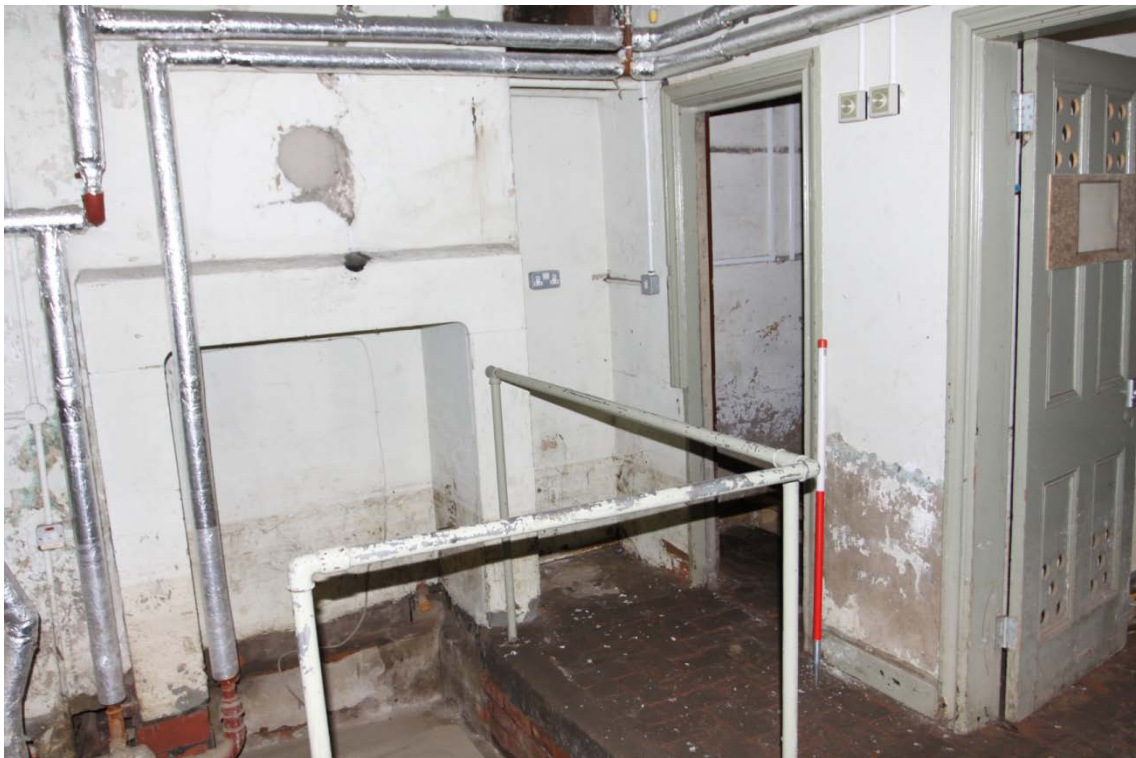
**Plate 9: Room 2, looking north-west**

Room 2 is accessed from an external doorway. This is a later addition; the original doorway was located to the east of the staircase (see Figure 2). A rectangular-shaped scar and an area of disturbed brickwork and re-plastering on the south wall of Room 2 indicate a former blocked-up opening. To the west wall of Room 2 is a large chimneystack with a wide opening and an original stone surround. On the north side of this room are two smaller walk-in compartments. The eastern compartment is fitted with an original four panelled door. The floor throughout Room 2 is the original brick floor laid in a 90 degree herringbone design.

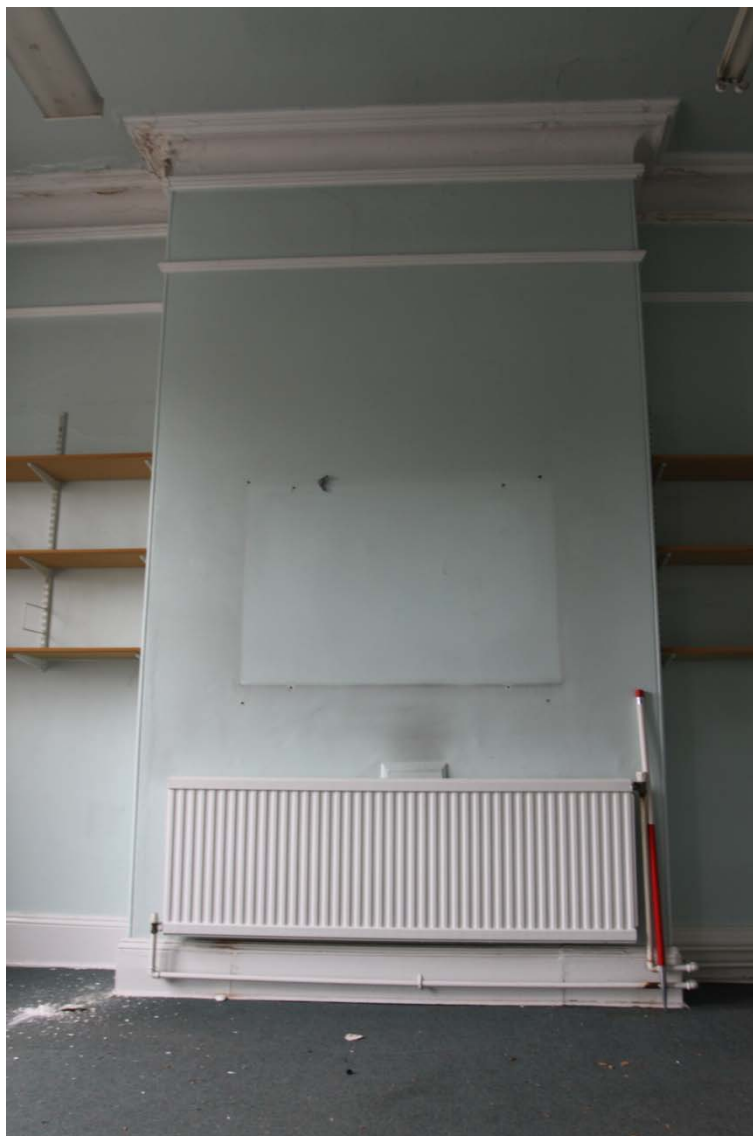
**Plate 10: Room 8, chimneystack, cornice and picture rail to north wall**

At first floor level the largest and grandest room is Room 8 (directly above Room 1). Room 8 has a pair of sash windows to the west wall with arched tops. There is a blocked-up chimneystack to the north wall. A cornice and picture rail extends around the room.

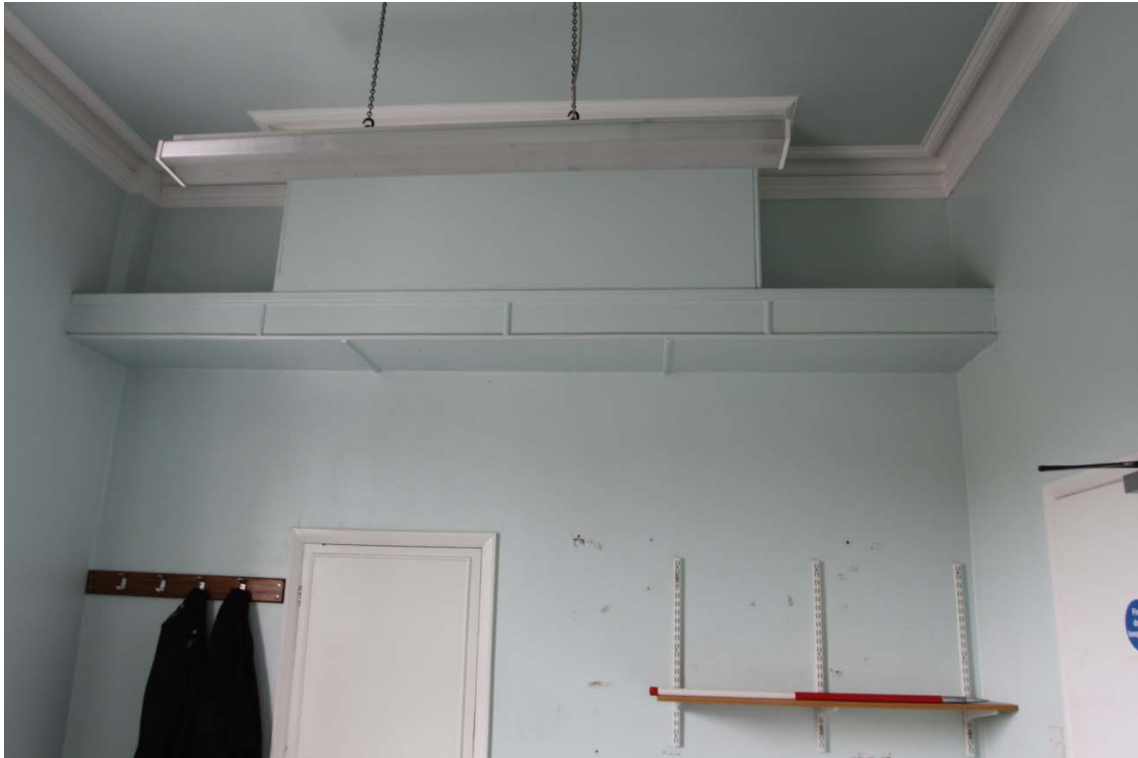
**Plate 11: Room 10 former chimneystack north wall**

Room 10 has undergone a number of alterations. The lower section of a former chimneystack to the north wall has been removed. The upper courses are retained by what appears to be a boxed-in joist. A door has been inserted in the north wall to enable the room to communicate directly with Room 8. A single arched topped window is positioned on the west wall. Cornicing runs around the perimeter of the room.

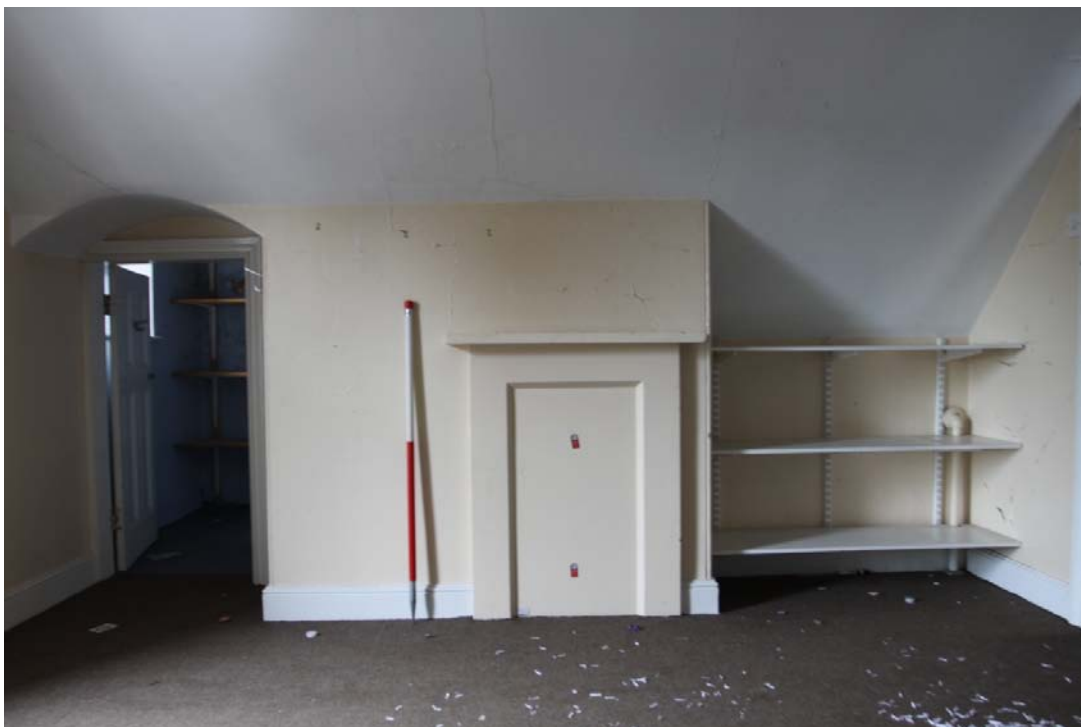
Plate 12: Room 16, south wall

There are two attic rooms at second floor level. Room 14 has a dormer window and Room 16 has a sash window. Both rooms have chimneystacks on the west wall with stone fireplaces in situ. There is a built-in cupboard to the north of the chimneystack in Room 14. A low-level doorway to the south of the chimneystack in Room 16 leads into the upper portion of the entrance tower. This has a thin lancet window and would have been used as a storage area.

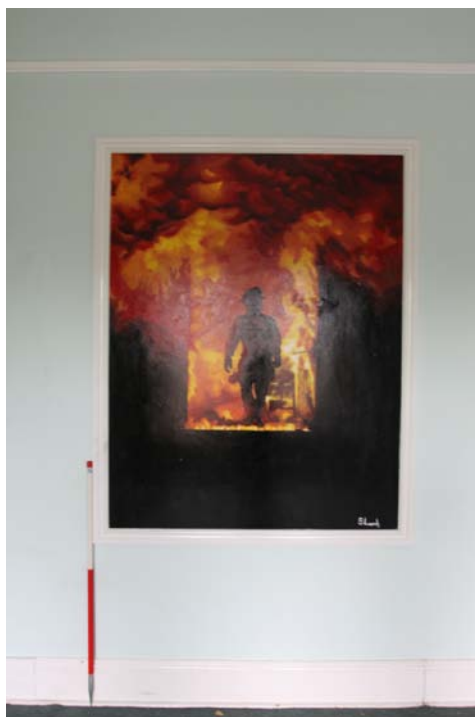
Plate 13: Room 8, fire fighter painting

On the east wall of Room 8 there is a large painting of a fire fighter emerging from a fire.
