Executive Summary

This Conservation Plan identifies the significance of the York City Walls, examines the issues and vulnerabilities and sets out policies for maintaining and enhancing the significance. The Plan is designed to inform management decisions especially regarding the development and use of the site.

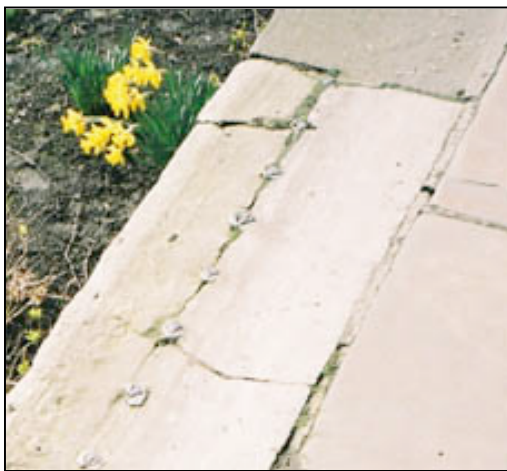
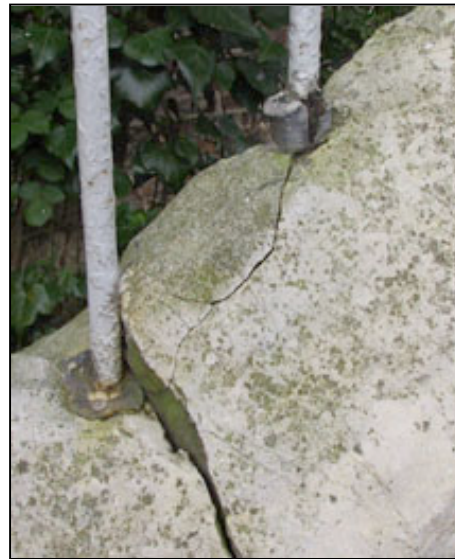
The damage that can be caused from railings can be seen here where the railings have been removed and in the picture to the right where railings are still in place near Micklegate Bar

along the inside of the Wall, although these provide security for those who are nervous of the height of the Walls and provide some form of health and safety provision they are often thought to detract from the appearance of the Walls and in some cases can cause damage to the fabric.

Retention and maintenance of the physical barriers, which are of historic interest and value, will assist with this provision. It is likely that these railings are made of cast iron, corrosion of iron is caused by the presence of oxygen and water. Good detailing, regular maintenance and quality paint application are essential to keep corrosion under control. The heat of the traditional use of lead to socket in metalwork can damage the paint system on the iron, therefore a compatible epoxy resin should be considered.

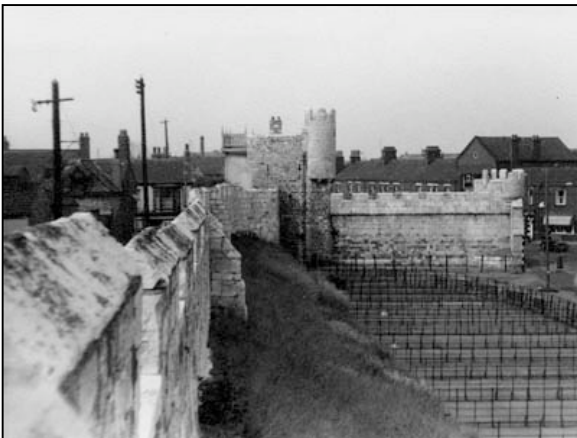
The creation of the cow pens for the cattle market in Paragon St involved the truncation of the City Wall ramparts²²

It has been noted that the embankments are likely to have been used for grazing in past centuries and a large cattle market was regularly held from 1827 until 1970 along the exterior side of Sections 15 & 17, with the ramparts being cut away to make space for the cattle pens.

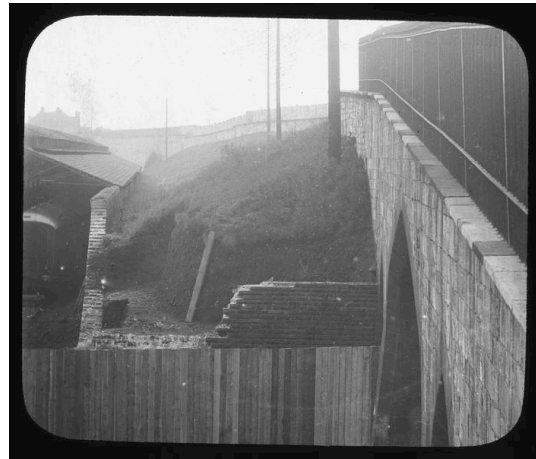
This part of the embankments of the City Walls was removed in 1923 to allow for the siting of a war memorial to the railwaymen who had died in the First World War. It was the site of the fire engine shed at the end of the Scarborough platform of the old railway station (which was inside the City Walls)²³

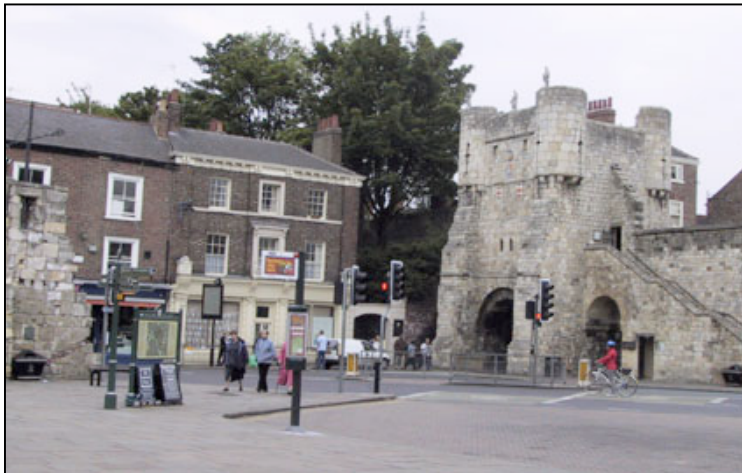
Street clutter at Bootham Bar

Bootham Bar is perhaps plainer than the other main medieval Bars, but nevertheless is a crucial part of the character of Exhibition Square and provides a highly appropriate focal point for the view up High Petergate. The signs and clutter of the junction and pedestrian crossings external to the gate **deduct** from this **aesthetic** value. However, it is a key access point for the Walls due to the many bus stops here.

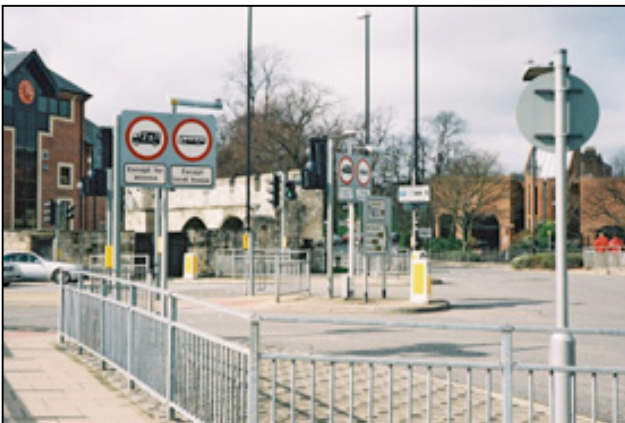
The street clutter at Layerthorpe Bridge affects views of and views from the City Walls

- *Context and setting.* The size and physical nature of the monument dictates that it is often viewed from a distance and that views out from the monument are integral to its historical purpose and current significance. In some instances the clutter of street signage, inappropriately sited modern amenities and the lack of good design for modern structures has an impact on views of or out of the monument.

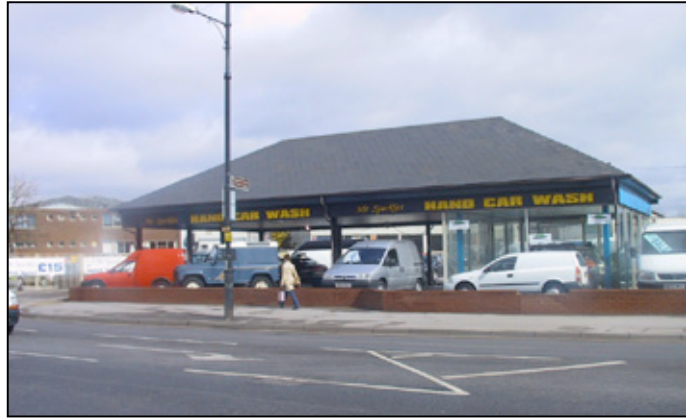
'Mr Sparkle' is indicative of the poor design of new light industrial units along Foss Islands Road

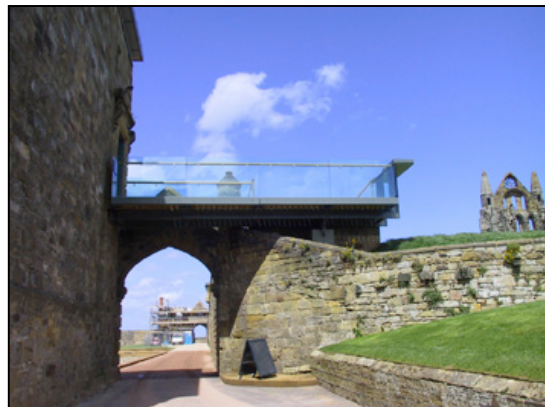
Physical barriers at Whitby Abbey

Good practice examples of appropriate physical barriers can be seen along Southampton City Walls and at Whitby Abbey, but there are also opportunities for using interpretive public art. There is a historical precedence for using local artisans for producing the small decorative sculptures on the Bars, which could be followed when commissioning new pieces.

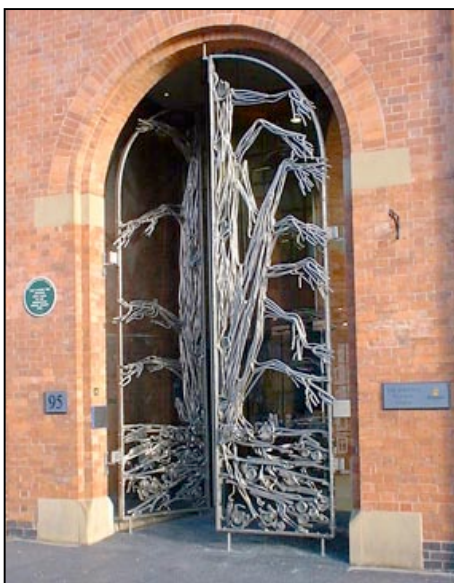
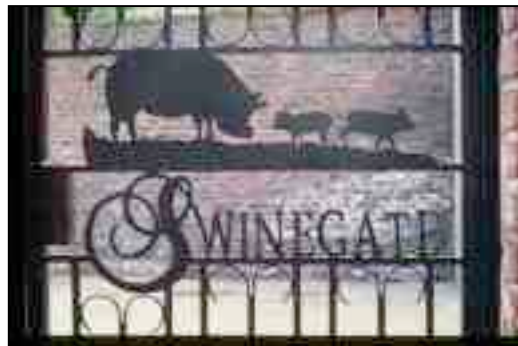
Barriers utilising interpretive public art, Swinegate, York (above) and in Birmingham's Jewellery Quarter (left)
