FORMER CARE HOME, FORDLANDS ROAD,
FULFORD, YORK.

AN ARCHAEOLOGICAL DESK BASED ASSESSMENT
OSA REPORT No: OSA17DT07 (DBA).

May 2017.

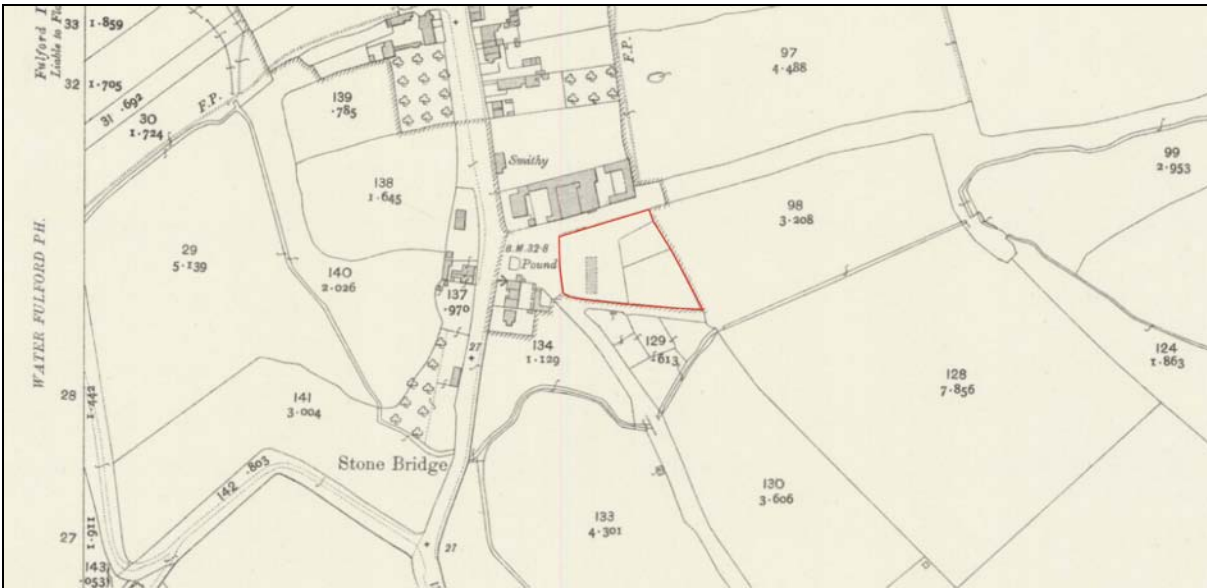
Figure 5. Extract from the 1909 Ordnance Survey map.

The earliest map to show any structures on the site dates to 1909 (Figure 5). Once again this map shows the site divided into the same three fields. A single long rectangular building had been built within the westernmost field by this date. The interpretation of this building is

uncertain, but given its location an agricultural purpose would seem likely. Relatively little change had occurred by the 1931 map (Figure 6) with the exception of the construction of a second, smaller structure in the western field. The final map illustrated dates to 1953 (Figure 7) which shows the site with no changes since 1931.
