FORMER CARE HOME, FORDLANDS ROAD,  
FULFORD, YORK

REPORT ON AN ARCHAEOLOGICAL EVALUATION.  
OSA REPORT No.: OSA17EV33

October 2017

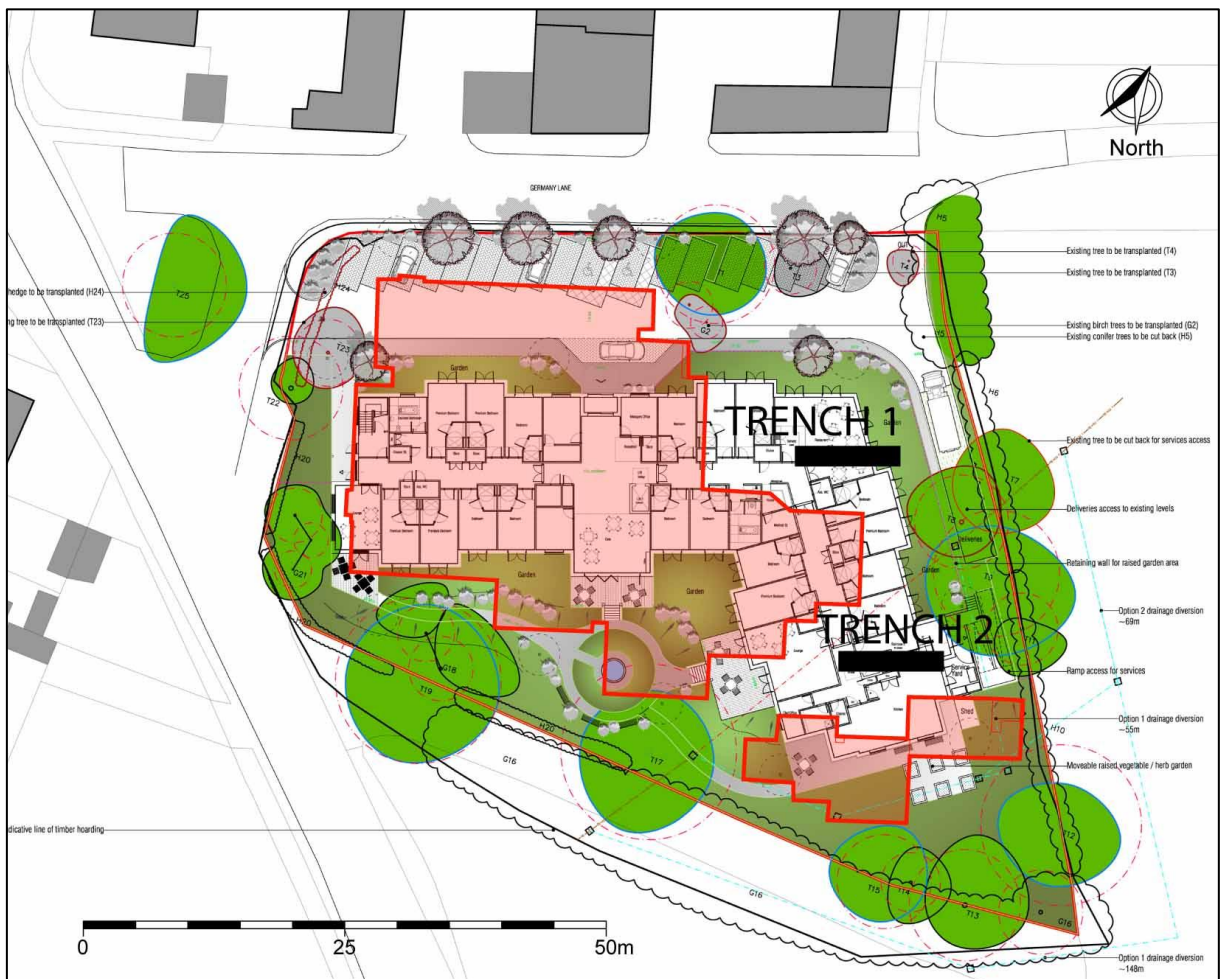
Figure 2. Trench location plan.

The evaluation comprised the excavation of two trenches (see Figure 2) as agreed with the City of York Council Principal Archaeologist and set out in detail in a Written Scheme of Investigation (OSA, September 2017). Originally it had been intended that the trenches would measure 10m in length. However, due to the presence of extensive live services, it proved necessary to shorten these to approximately 6m in length. This alteration is not deemed to be detrimental to the results of the evaluation.

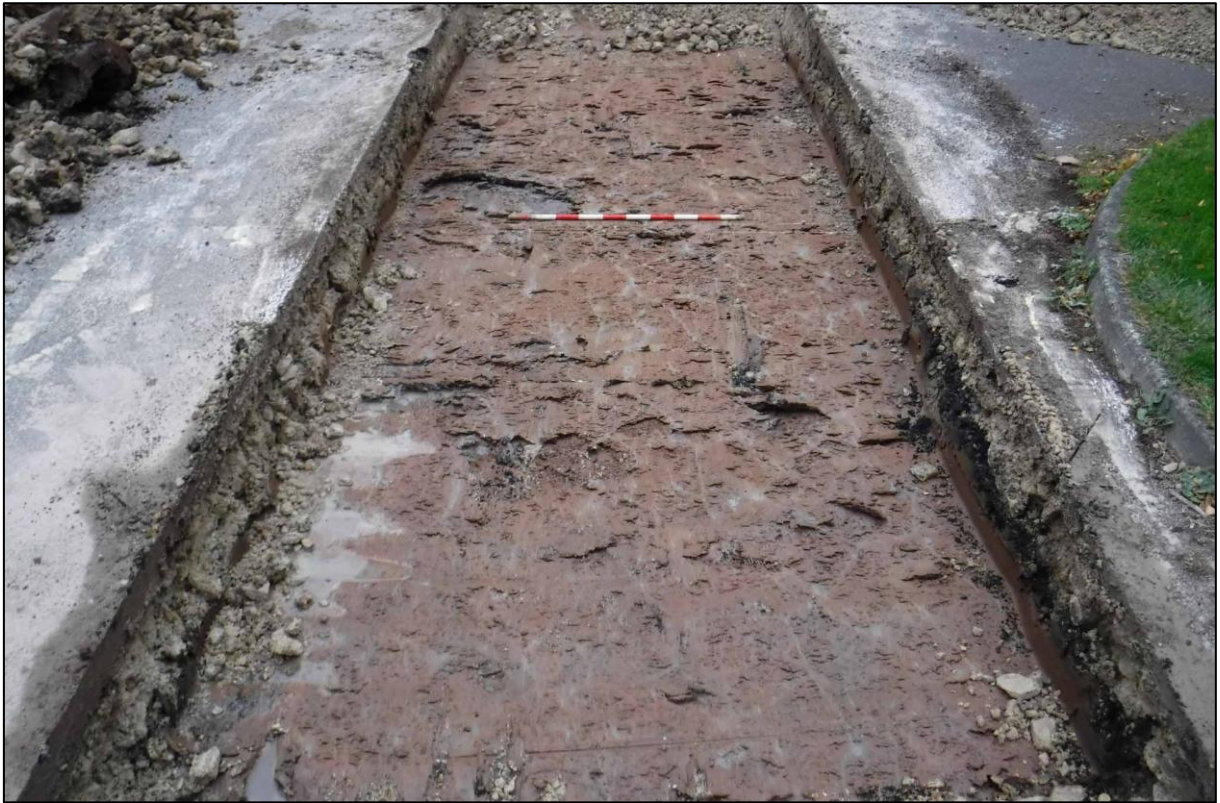
Plate 1. Trench 1, surface of truncated natural (103), looking east.

The earliest deposit encountered within the trench was the pinkish, orange brown clay natural (103). This was revealed throughout the trench a depth of 0.35m below the modern ground surface at a maximum height of 9.21m AOD (Plate 1). A sondage 0.70m deep was machine excavated into this deposit to confirm that it was in-situ natural (Plate 2). The surface of the natural was overlain by a thin (<0.05m) layer of black ashy silt containing frequent gravel (102). This layer appears to represent levelling prior to the construction of the current car park. The levelling was overlain by a 0.20m thick layer of crushed limestone hardcore (101) and 0.10m thick tarmac (100) forming the current car park. The surface of the car park was at a maximum height of 9.56m AOD at the western end of the trench.

The northernmost trench (Trench 1) revealed natural clay immediately below the make-up deposits for the current car park, presumed to have been deposited in the 1980s when the care home was constructed. A single borehole was sunk approximately 5m to the north of Trench 1 during a geotechnical investigation carried out in April 2017. This also revealed natural clay to be present immediately beneath the current car park sub-base. There was no evidence in either the evaluation trench, or the borehole for surviving subsoil deposits indicating that the surface of the natural was probably truncated during the car park construction. No archaeological features were present within the limits of the trench. However, the survival of the natural in this trench suggests that truncated, originally deep, archaeological features may still be present in this part of the site.

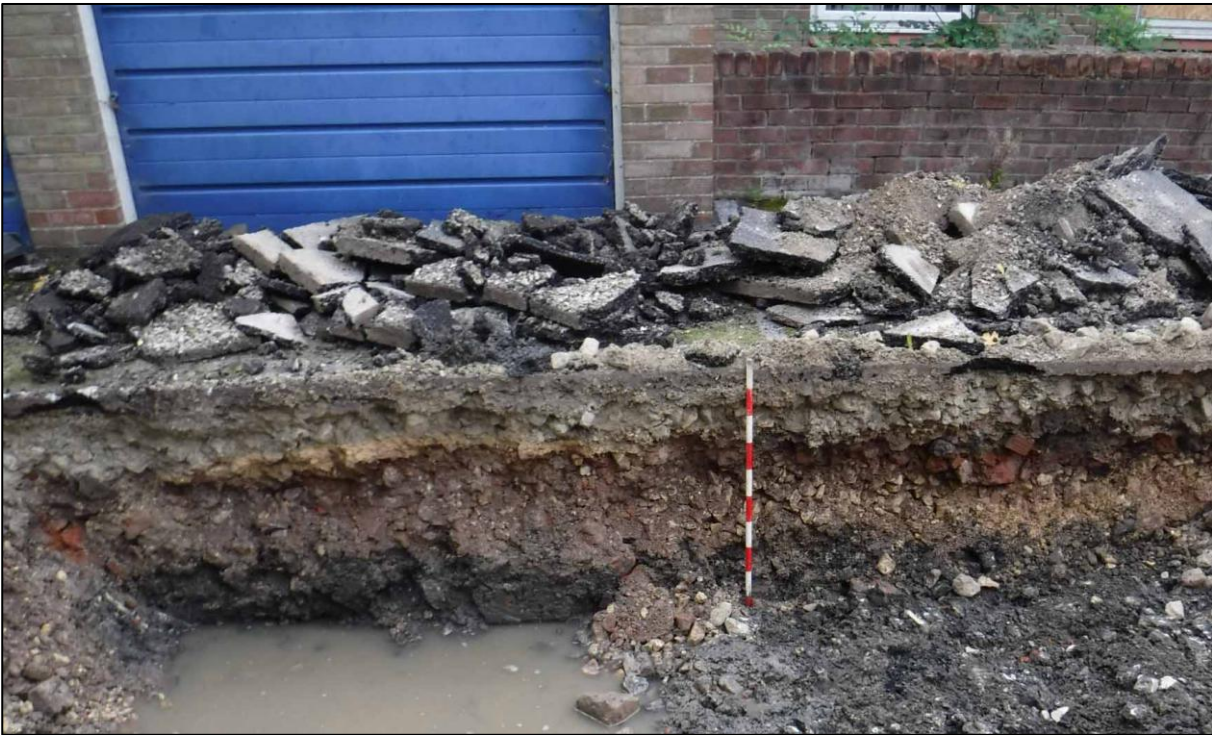
*Plate 3. Trench 2, north facing section.*

The earliest deposit recorded was a layer of friable dark brownish grey sandy clay silt (203) containing frequent fragments of brick, concrete and limestone rubble. This was recorded for a maximum thickness of 0.25m, and clearly extended below the basal limit of the trench, which lay at 8.30m AOD. This earliest made ground deposit was sealed by up to 0.60m thick layer of loose pale brown silty sand (202) containing frequent fragments of brick, concrete and limestone rubble. This deposit is likely to form levelling for the current car park, put down in the 1980s. The final two contexts recorded comprised the 0.15-0.20m thick crushed limestone hardcore (201) and 0.08m thick tarmac layer (200) forming the current car park surface, at a height of 9.34m AOD (see Plate 3 for the full sequence of deposits in Trench 2).

The southernmost trench (Trench 2) revealed deposits dating from the 20<sup>th</sup> century to a depth in excess of 1m below the current ground surface, to at least 8.30m AOD. These deposits are likely to relate to the mid 20<sup>th</sup> century rubbish tip recorded in evaluation trenches carried out in 1996 immediately to the east of the site (MAP, 1996).
