Bathurst House, 86 Micklegate, York

Heritage Statement

April 2018

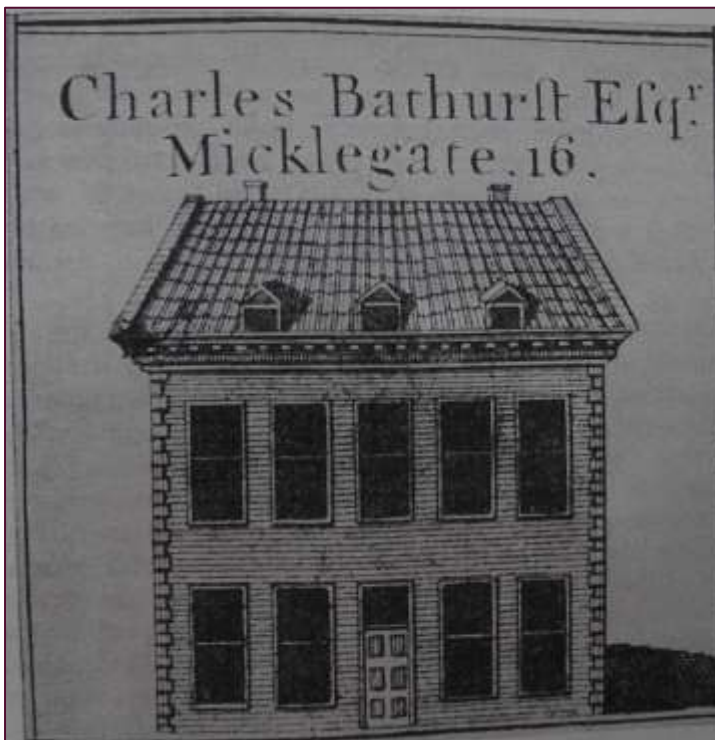
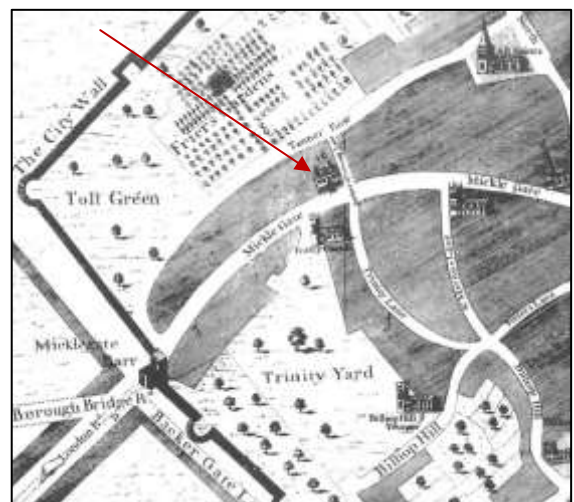
Figure 4: Bathurst House as depicted on Cossin's 1720s plan (right) as a two-storey townhouse with attics lit by dormer windows (left)

3.07 The house was originally two storeys with basement and attics, the latter lit by three dormer windows in a pantile roof as shown in the view on Cossin's plan (**figure 4**). There was a service wing to the

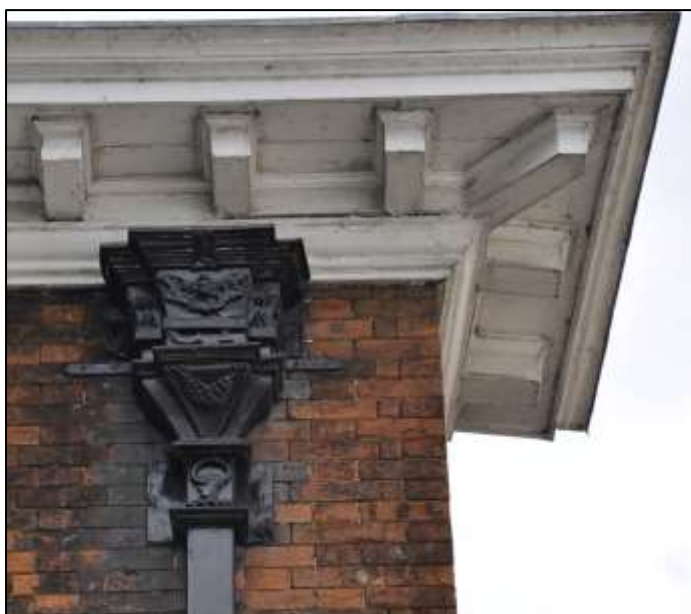
Figure 5: Original drain hopper and fall pipe detail with Bathurst crest and decorative detail with initials of the owners CFB i.e. Charles and Frances Bathurst

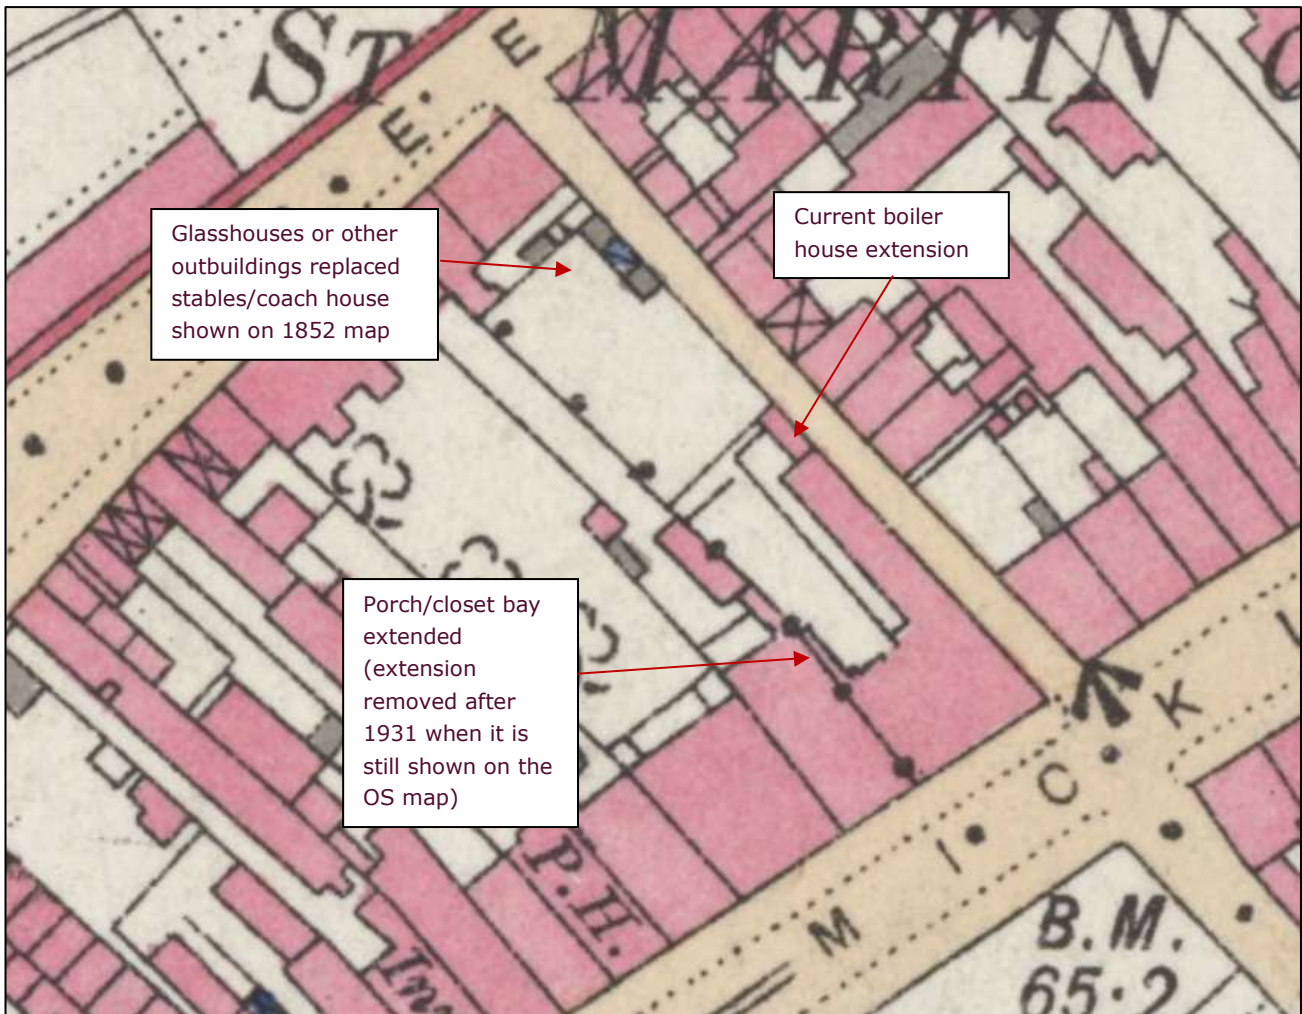
Figure 8: Ordnance Survey map, 1892; surveyed in 1889

- 3.13 Later extensions and alterations were made to the service wing at the rear and the stables (detached building) at the rear of the garden was removed. At least some of this work was done in 1873 for the North-Eastern Railway, which owned the premises in 1872–1879 and converted them into offices for the District Goods Manager, Southern Division (Title Deeds; information from British Transport Historical Records, York). This is captured on the 1892 Ordnance Survey map (**figure 8**).

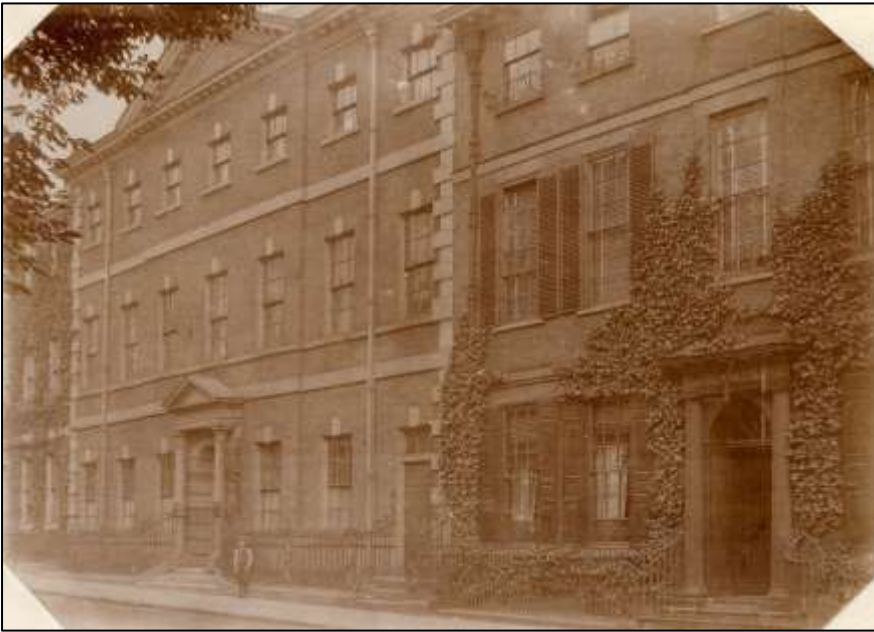
Figure 9: Bathurst House in the 1890s (© City of York Council – reference Local studies collection, y9_mic_383)

- 3.14 After the period of occupation as railway offices it again became a surgeon's residence from 1879 to 1909. During this time part of its frontage was captured in a photograph dated to the c.1890s (**figure 9**). At this date at least two of the first floor windows had timber shutters and there was ivy growing up the ground and first floor walls.

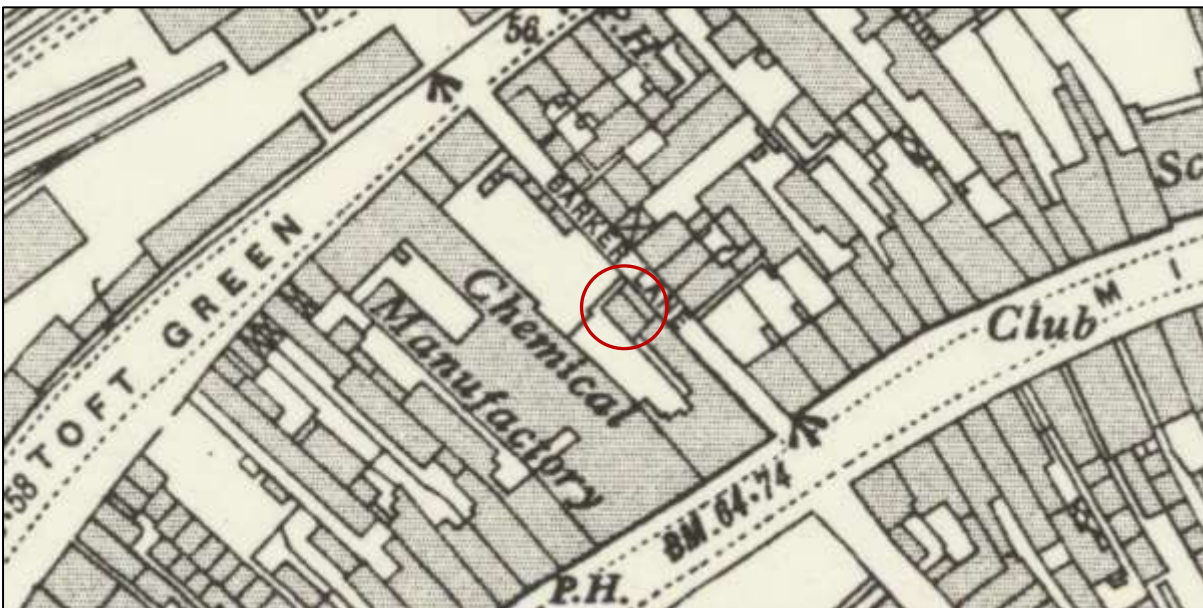
Figure 10: Ordnance Survey map, 1931 showing an extension to the former service/domestic wing

- 3.15 In 1911 the property was converted from a surgeon's residence to the Central Hotel, which it remained until 1921. For almost 40 years thereafter it was the York Y.W.C.A (charity providing support, accommodation and advocacy for women). The rear extension (currently a kitchen) to the service/domestic wing was erected between 1909 and 1931 based upon cartographic evidence (**figure 10**) and was presumably erected to serve the Central Hotel.

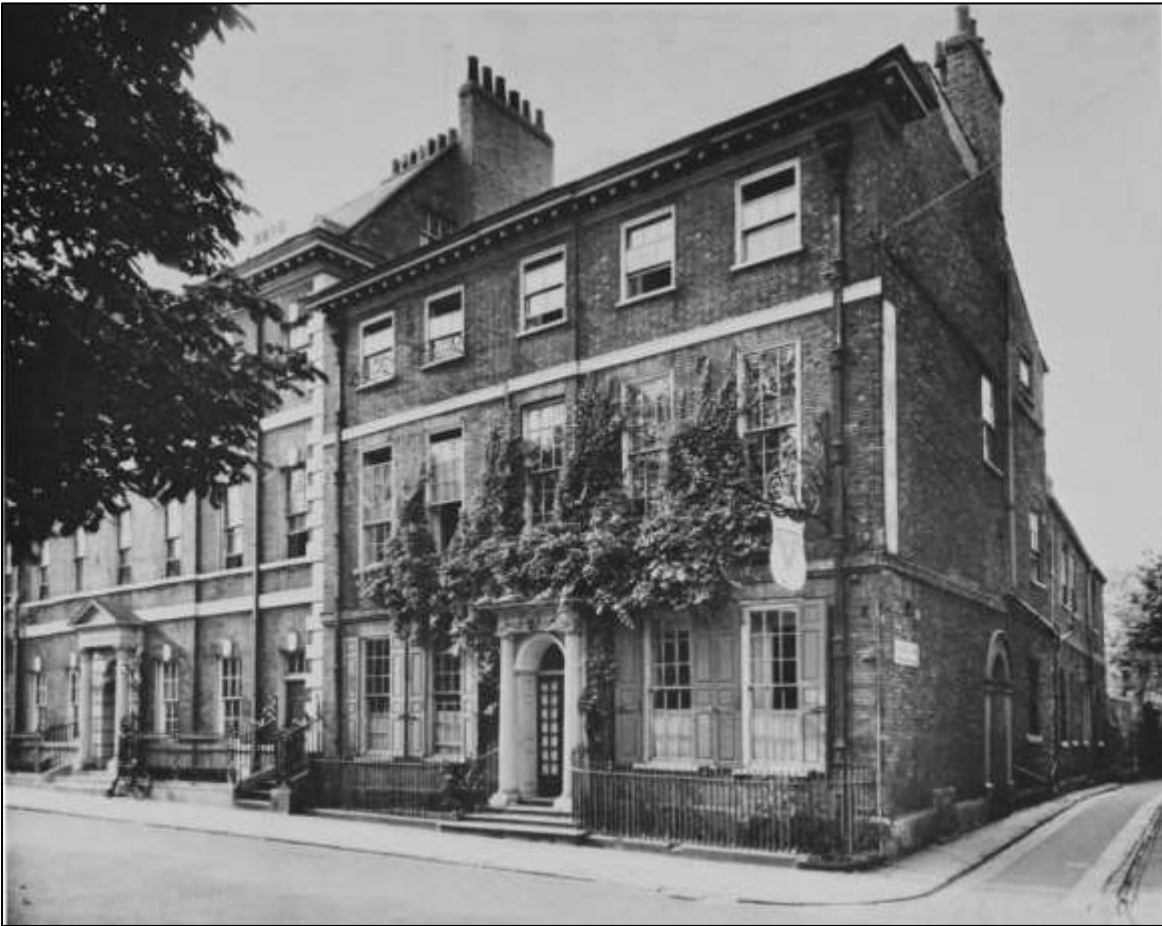
Figure 11: Bathurst House in c.1964 (© RCHME)

- 3.16 Bathurst House was purchased from the YWCA by the builder J. Yates and then by the University of York in 1963. When the RCHME visited in c.1964 the author reported in the unpublished site visit record notes that within the last three years the house had been converted into apartments with false ceilings inserted together with 'considerable hardboard partition walls. The service staircase in the rear wing has been boxed in and this has also happened to the staircase from the 1st floor to the 2nd of the main house (serving the original attics)'. A selection of drawings, phased plan and photographs produced by the RCHME are reproduced below (**figures 11-13**).

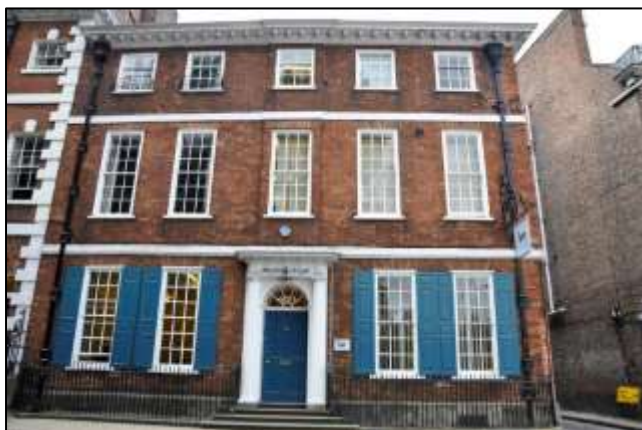
Figure 14: Street front (south) elevation

- 4.05 The street front facade (**south elevation; figure 14**) is in good quality red Flemish bonded brickwork, the early 19th century upper storey being of slightly larger bricks. When the upper storey was added, the original rainwater heads and cornice were re-employed and matching lengths of fall pipes were inserted. This elevation is of five bays and three storeys and is symmetrical. The Roman Doric surround to the entrance is of the second half of the 18th century, but the door is modern. In the windows, narrow glazing bars have replaced the originals, which presumably were thicker. All the windows are vertical timber sashes with flat brick lintels of gauged rubber bricks and most, if not all, are Regency in style and date. The ground floor timber framed sash windows have panelled shutters and ashlar sills. Above the entrance, the narrow central bay breaks forward some 3 inches, the upper part being slightly widened at the head of the central window. To east and west are large lead rainwater heads decorated with cherubs' heads and initials, 'B' above, 'C' and 'F' below; the fall pipes of square section have brackets enriched with the Bathurst crest. There is a moulded and modillioned timber cornice that breaks forward slightly in the central bay to follow the projecting central feature of this bay.

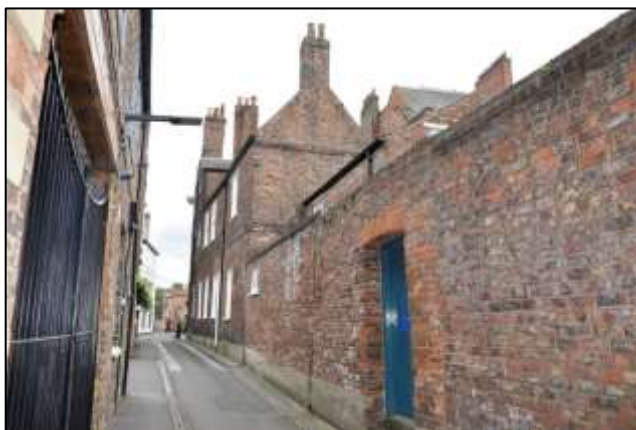
Figure 15: Side (east) elevation

- 4.06 The **east side elevation (figure 15)** faces Barker Lane. The good quality red brickwork of the front is returned about the southeast angle and there is a first-floor brick band that is continuous from the front elevation. There is a side entrance with a semi-circular gauged brick arch and painted stone imposts. The door case is reached via several stone steps and is probably 20th century in date. There is evidence in the brickwork of changes in the fenestration with various former windows blocked with brickwork but retaining their original lintels (mainly arched lintels with header bricks) or evidence of straight joints marking the blocking. There is a chimneystack of two phases.

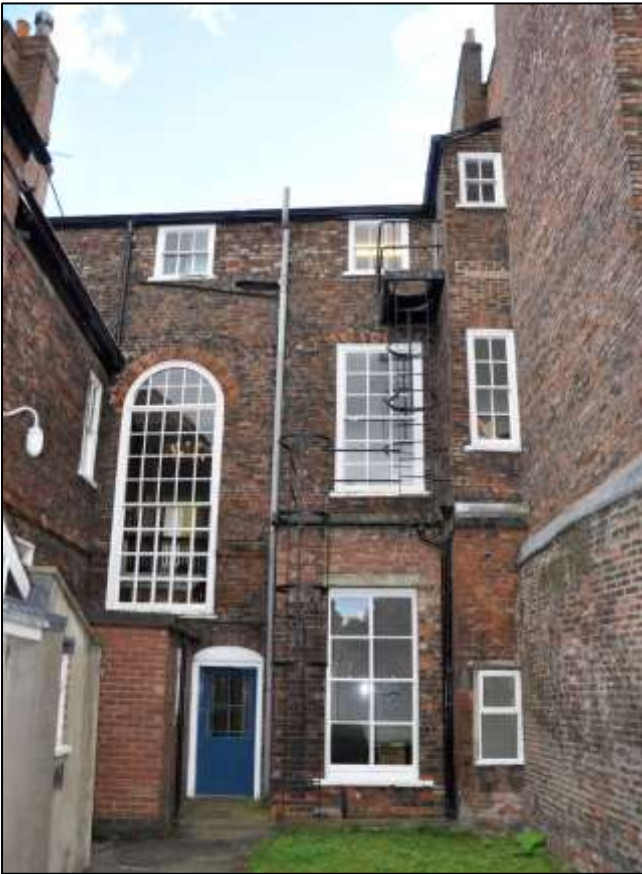
Figure 16: Rear (north) elevation with Regency door and large stair hall window

- 4.07 The **rear (north) elevation (figure 16)** is three storeys high with a small single bay three storey closet wing to the west and the two-storey service wing to the east. The RCHME contended that the ground floor of the closet wing was a porch during their visit and indeed this contains a blocked entrance on its eastern ground floor elevation suggestive of such a use. Both the top storey to the main building and that to the closet wing are early 19th century additions. A brick band again occurs at first-floor level. The wall head is an early 19th century cornice with simple paired brackets. The most noticeable feature is the large staircase window with a semi-circular head with gauged bricks. The upper sash here is a later replacement with narrower glazing bars. There is an early-mid 20th century single storey bay with a flat roof to the west of the rear entrance door and a mid-20th century single storey single room extension to the east of the rear door on the footprint of an earlier building. This had been built prior to the RCHME visit in the 1960s.

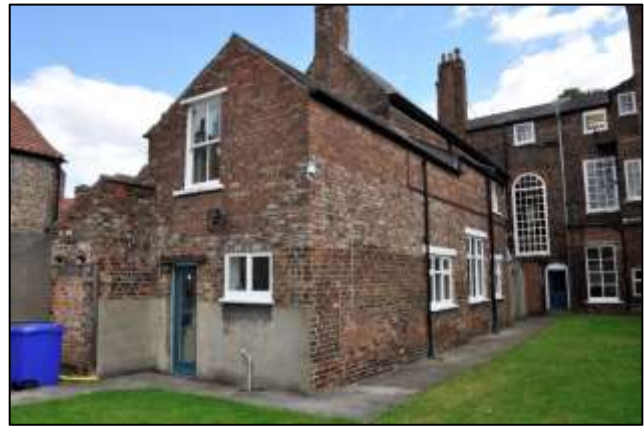
Figure 17: Service wing

- 4.08 The **service/domestic wing (figure 17)** to the building extends along the east side of Barker Lane to the rear of the east side of the building. Its east elevation continues that of the east gable end of the main house and forms a two-storey service wing, which continues the brick band below. There is an entrance with a flat brick lintel and 19th century door accessed via two stone steps from Barker Lane. There are four six-over-six ground floor sash windows with flat gauged rubbed brick lintels. On the first floor above the brick band are a further four six over six sash windows. All these windows are irregularly spaced and there is again evidence in the brickwork of changes in the fenestration with various former windows blocked with brickwork but retaining their original lintels or evidence of straight joints marking the blocking. On the west elevation the ground floor level is occupied by a mid-20th century single room WC at the south end attached to an early 20th century extension that forms a corridor (reusing some 19th century brickwork on the ground floor level). This continues to the north where it extends the northern end of the building (kitchen GF21). The main structure has a brick band at first floor level and a cornice of early 19th century date supported on simple paired brackets. On the ground floor are the remains of a blocked window towards the southern end and to the north of this a double large sash window of uncertain date – probably early-mid 20th century. There are the remains of an original window with a segmental arch of brick headers to the north of this and a blocked window at first floor level.

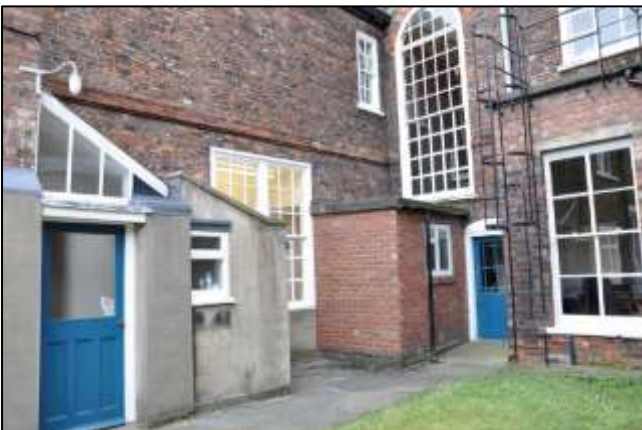
Figure 18: Mid-late 20th century single storey, single bay extensions to the rear of the north elevation of the house

4.09 There are several **later extensions** to the townhouse (**figures 18 & 19**) as mentioned above. Firstly is the early 20th century extension to the north and west of the service wing that extends part of this wing to a first floor level. Secondly, is a 20th century bay to the north elevation at ground floor level that truncates the blocked entrance door to the adjacent former porch and provides a large bay window to the ground floor room here. Thirdly, is a single storey 20th century building in the angle between the rear elevation and the service wing on the footprint of an earlier building. There is a further mid-20th century single storey brick workshop building to the rear of the garden at the north-east corner of the current plot, that has a corrugated sheet lean-to roof.

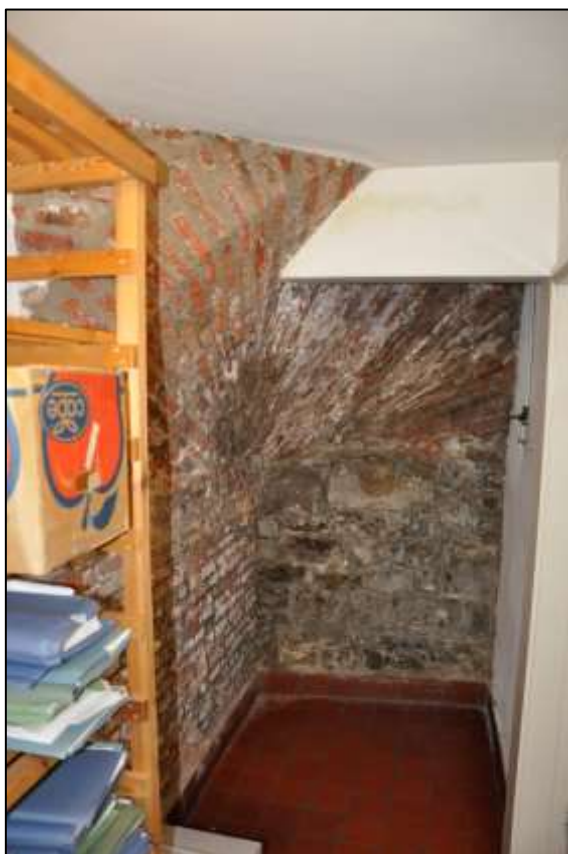
Figure 20: Medieval wall supporting later brick vaulting in basement

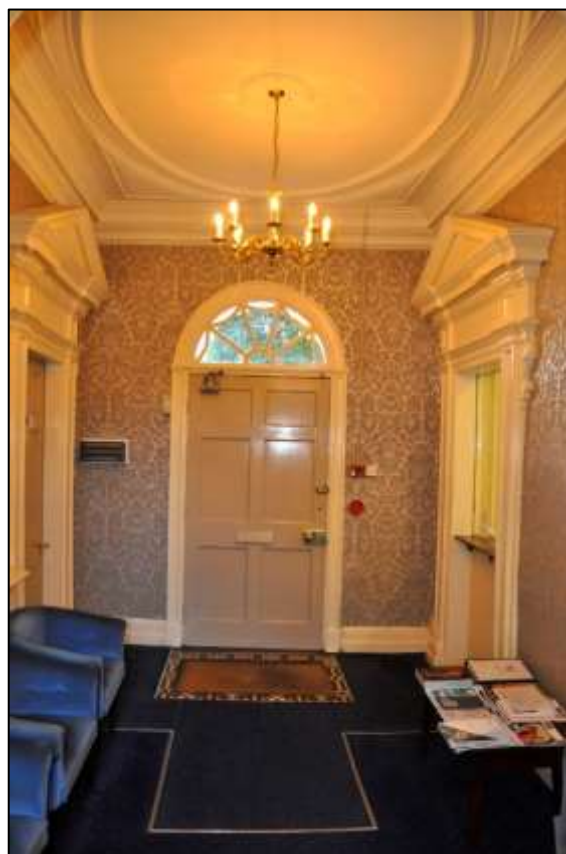
Figure 21: Ground floor entrance hall, GF1

- 4.11 On the **ground floor** the entrance hall (GF1; **figure 21**) has a simple plaster ceiling and cornice with doorways with pedimented door cases in the east and west walls. While the six-panel doors follow a 19th century pattern, the pediments are potentially 18th century elements. That to the west has been partially blocked and converted to a hatch in the late 20th century. There is a mid-late 19th century tiled floor. To the north is a round-headed archway with wood panelled responds and soffit and a fluted key-block; it opens to the stair hall (GF2) from which doors lead to all four ground floor rooms. In this stair hall is a door opening to the east to a secondary entrance passageway (GF4) from the door to Barker Lane and a modern door opening to the west providing access to the south-west room (GF9). Beyond the staircase is a door leading to the north-west room (GF7), to the passage to the rear service wing (GF6) and to the rear (Regency) door in the north elevation.

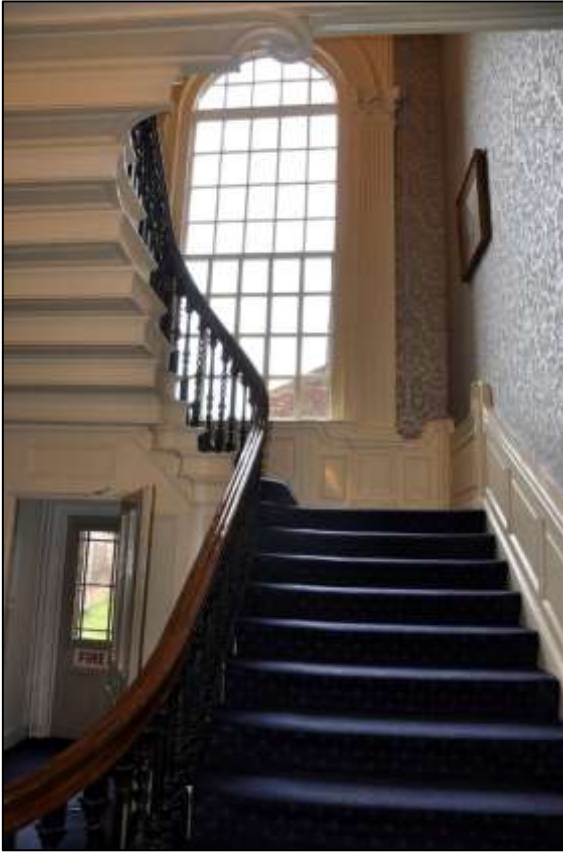
Figure 22: Staircase and window with detail of balusters (right)

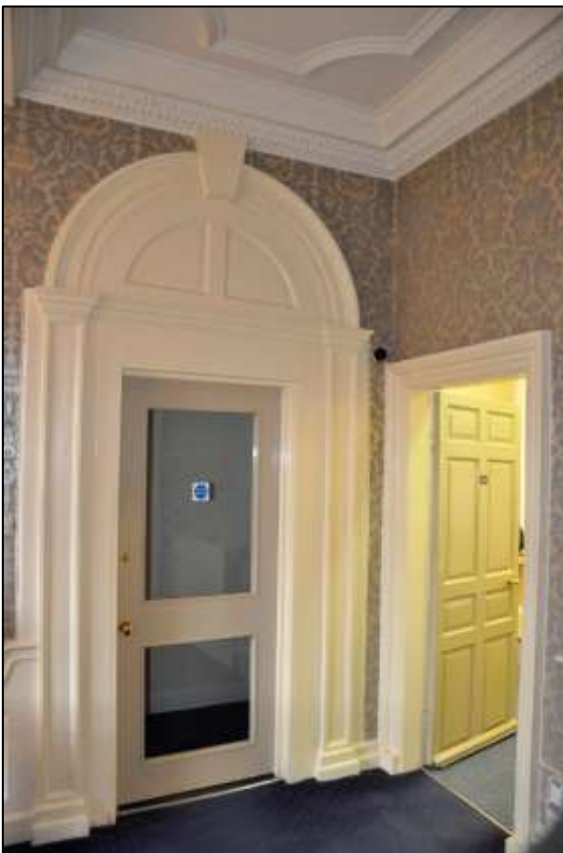
Figure 23: Doorcase in east wall of landing with modern door and 18th century eight panelled door to former saloon

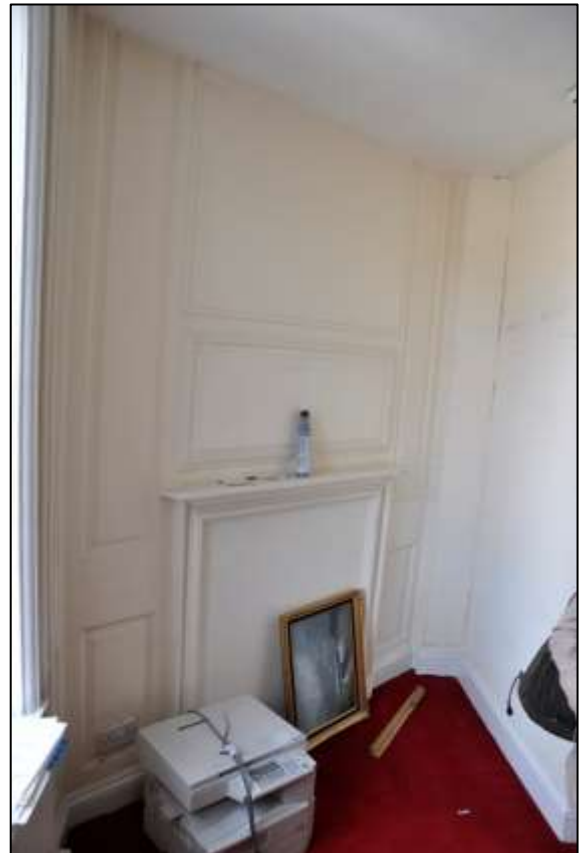
Figure 24: Early 18th wall panelling and chimney piece, FF9

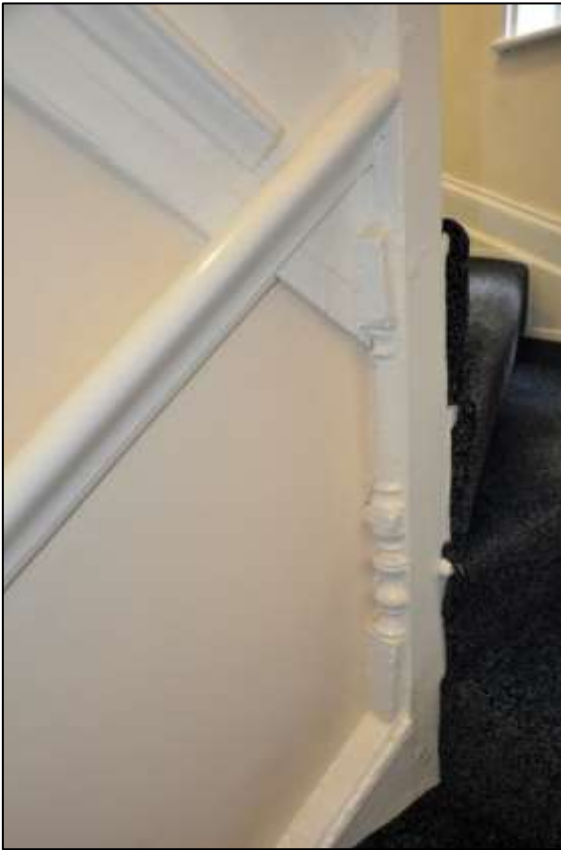
Figure 25: Example of surviving early 19th century baluster to stairs to second floor

- 4.19 The **second floor** is accessed by a staircase that has been much renewed but retains occasional early 19th century balusters (**figure 25**). A comparison of the floor plans produced in c.1963 by the RCHME and surveyed in 2017 shows several changes to the floor plan. Today there are three (rather than the previously four) rooms to the south front and three rooms to the rear; albeit one of the rooms – labelled c on the RCHME plan – was of recent creation. There is also the top storey to the closet tower adjacent to which is a modern fire escape. Timber stairs rise to the roof level. Within the rooms no fire surrounds survive, although the structures of these appear to survive in the gable ends. There are no cornices and the door architraves and doors are modern. The windows of the front rooms display simple sunk panelled reveals. The rooms themselves are plain and functional spaces.

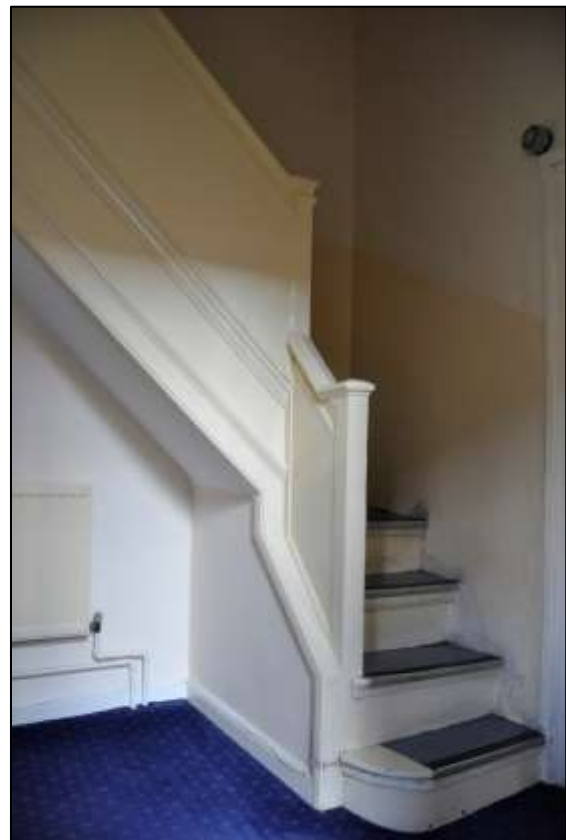
Figure 26: Stairs, circa late 19th century, within the service wing

4.21 Historical features in this service wing include a chimneybreast rising at the north gable end of the original wing i.e. rooms GF15 and FF18. Fire surrounds have been removed in the past. Some rooms, particularly to the first floor, retain moulded cornices likely to date to the late 19th century and the stairs (**figure 26**) linking the two floors rising from the hallway at GF16 have a moulded string, boxed-in balusters, square newels and flat moulded handrail that may be late 19th or early 20th century in date (with later boxing).

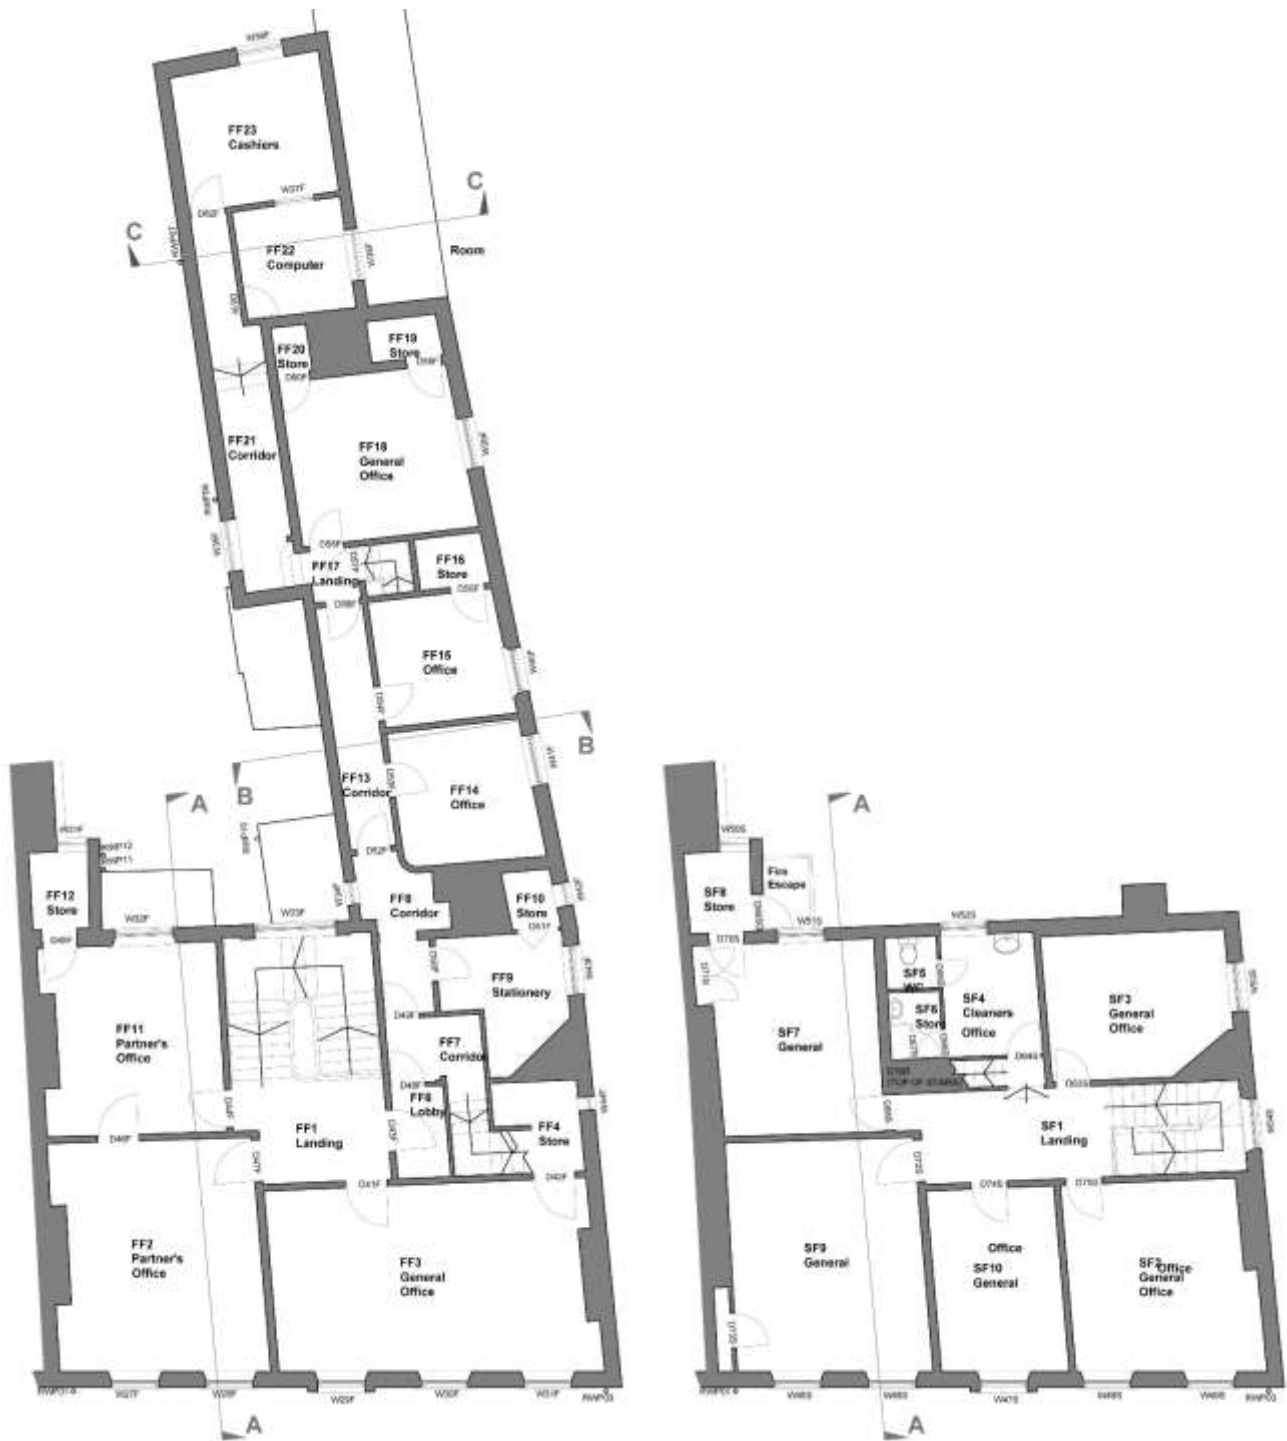
First and second floor plans as existing (© Charlotte Kitchen Architects)

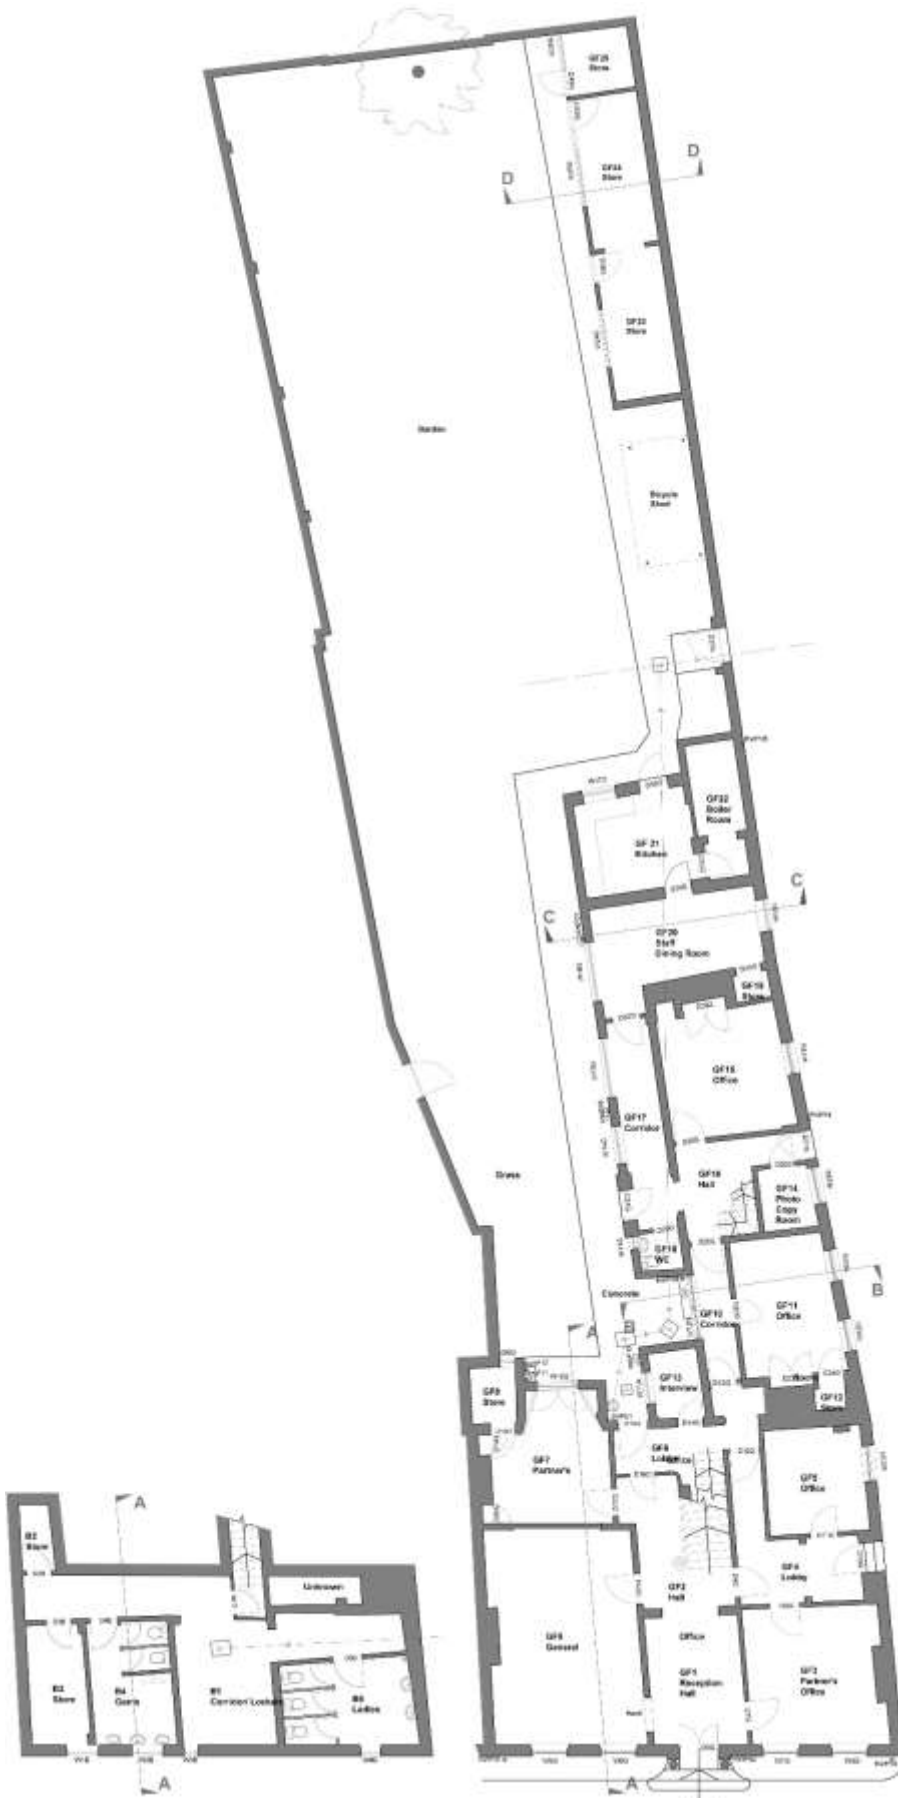
Basement and ground floor plans as existing (© Charlotte Kitchen Architects)
