# Old Post Office, Askham Richard

## Report on an Archaeological Watching Brief

| Development | Erection of building to rear forming ancillary residential and home office accommodation following the demolition of existing outbuilding | | |

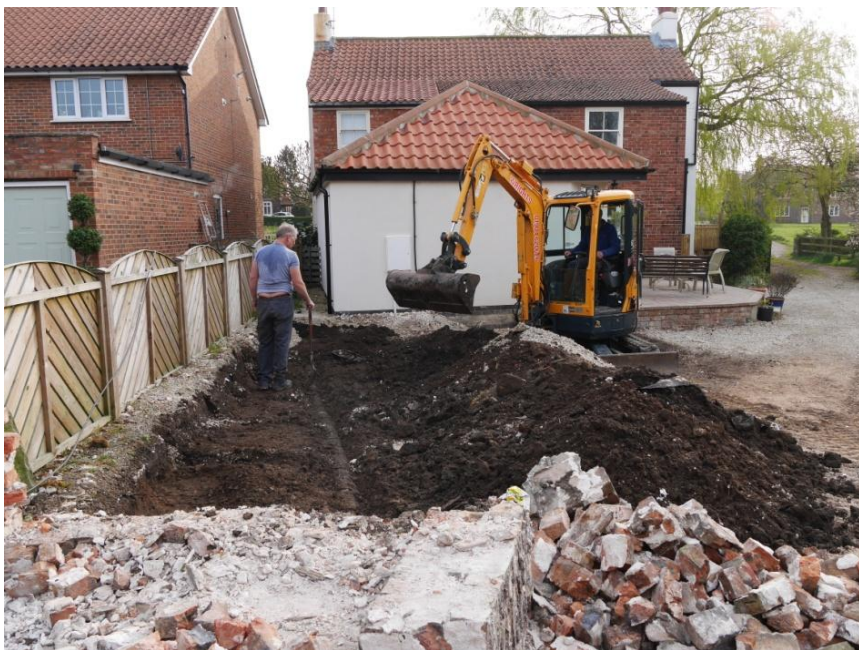
Figure 2: Image showing the excavation of the foundation for the new extension. Looking east

A back-acting mini digger fitted with a toothless bucket was used to strip during groundworks. The machine stripped in shallow spits to enable archaeological deposits to be observed (Figure 2). The watching brief revealed a north west -southeast aligned ditch and the contractor and all sub-contractors facilitated the archaeological recording of this feature.

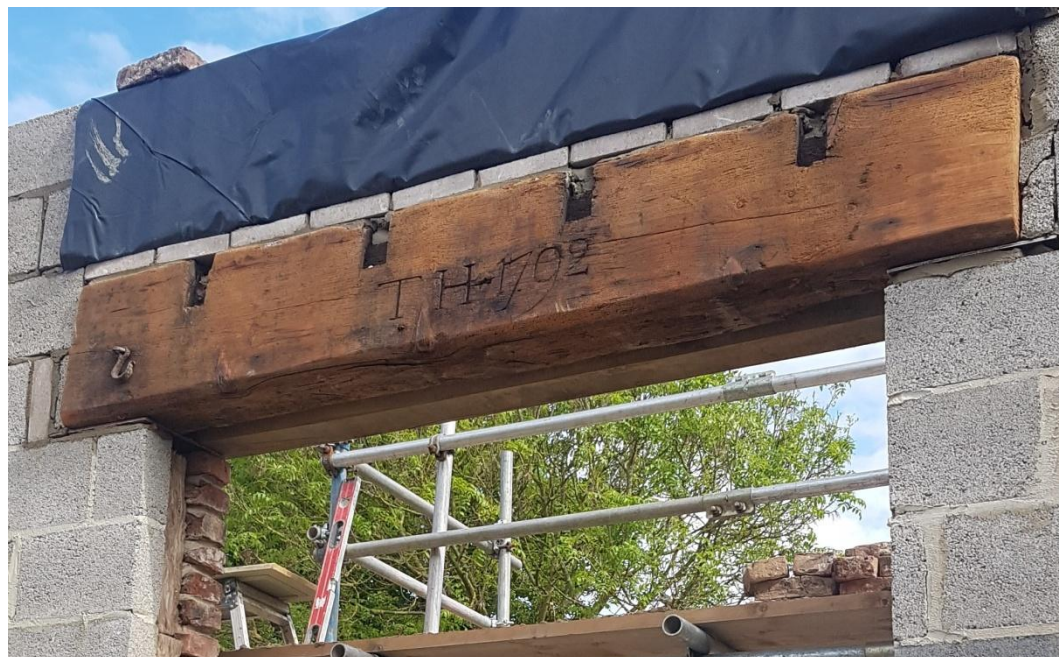
Figure 3: Original beam retained, by the owner, from the demolished 18th century outbuilding. Presently, repositioned as a window lintel, in the new build. Inscribed TH 1792- Thomas Hudson, Farmer residing at the plot during the late 18th to early 19th century.

The brick foundations of the 18<sup>th</sup>-19<sup>th</sup> century outbuilding were recorded. This building was demolished prior to the watching brief and is therefore not recorded in this document. The actual use of this building is unknown however it was noted by the owner that on one of the beams, the date '1792' was inscribed. This may indicate that this outbuilding was constructed in the late 18th century.

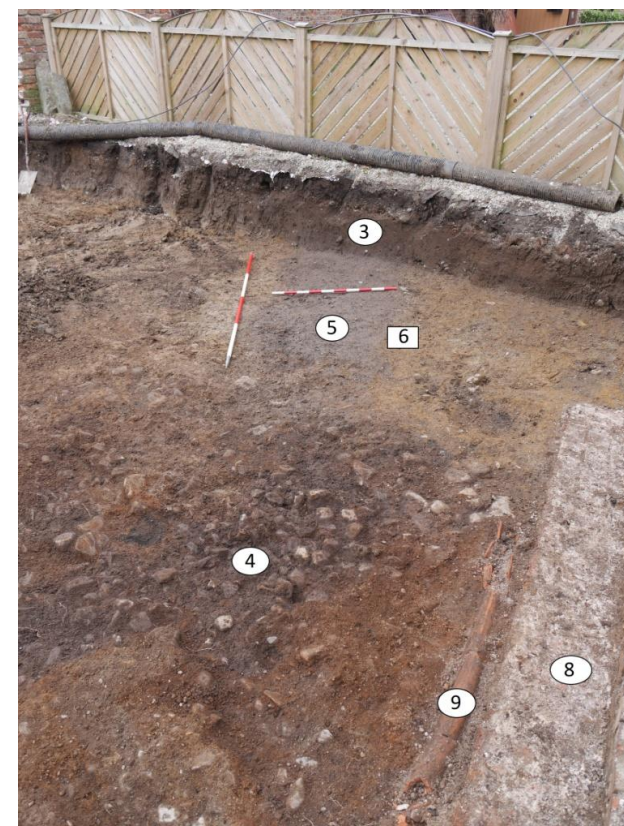
Figure 7: Post cleaning image of Contexts (3), (4), (5) and Features [6], [8] and [9]

The area impacted by the foundations of the new extensions consisted of approximately 50<sup>2</sup> m. Layers (1), (2) and (3) were removed using a mechanical excavator fitted with a tooth-less bucket. These made up ground (1) and garden layers (2) and (3) that were 0.80m, in depth sealed archaeological deposits, the base of the earliest archaeological feature (6) was 1.25m below ground level (Figure 7).

The ground surface impacted by the new extension consisted of two distinct layers. A layer of mixed rubble and gravel (Context (1)) formerly used as car park, which occupied most of the site. This rubble layer sealed a very dark grey silty clay material (Context (2)) identified as the recent garden top soil. The removal of contexts (1) and (2) revealed the presence of a dark brown clay silt material (Context (3)) and this measured 0.40m in depth. This context, identified as an agricultural layer, was predominantly observed towards the northern part of the development site and appeared to abut the rubble and cobble layer, Context (4).

Context (4) consisted of a layer of cobbles and rubble bonded with a very dark greyish brown silty clay material. This context measured 0.25m in depth and was observed covering most of the southern half of the development site, and was identified as a layer of rubble and cobbles; made up ground associated with the construction of the 18<sup>th</sup> -19<sup>th</sup> century outbuilding as the clay drain pie [9] is situated within (4) and (4) abuts the brick foundation wall [8] (Figure 6). Sealed under Context (3) and partly Context (4), was the remains of a linear feature [6] orientated northwest to southeast. This feature had a large U shaped profile with a concave base and measured 1.05m in width and 0.45m in depth. It was exposed to 1.80m. This linear was filled with a homogenous dark grey sandy clay silt. No archaeological remains were found during the excavation of this feature (Figures 8 and 9).

Abutting Context (4) along the northeast edge of the site were the remains of a red ceramic brick and cream/white mortar foundation wall Feature [8]. This structure was exposed for 4.00m and measured 0.30m in width. Adjacent to the foundation wall were the fragmented remains of a red clay pipe drain, Feature [9]. This drain ran parallel to the foundation wall and appears to have been positioned during the construction of the 18<sup>th</sup>-19<sup>th</sup> century outbuilding [8].

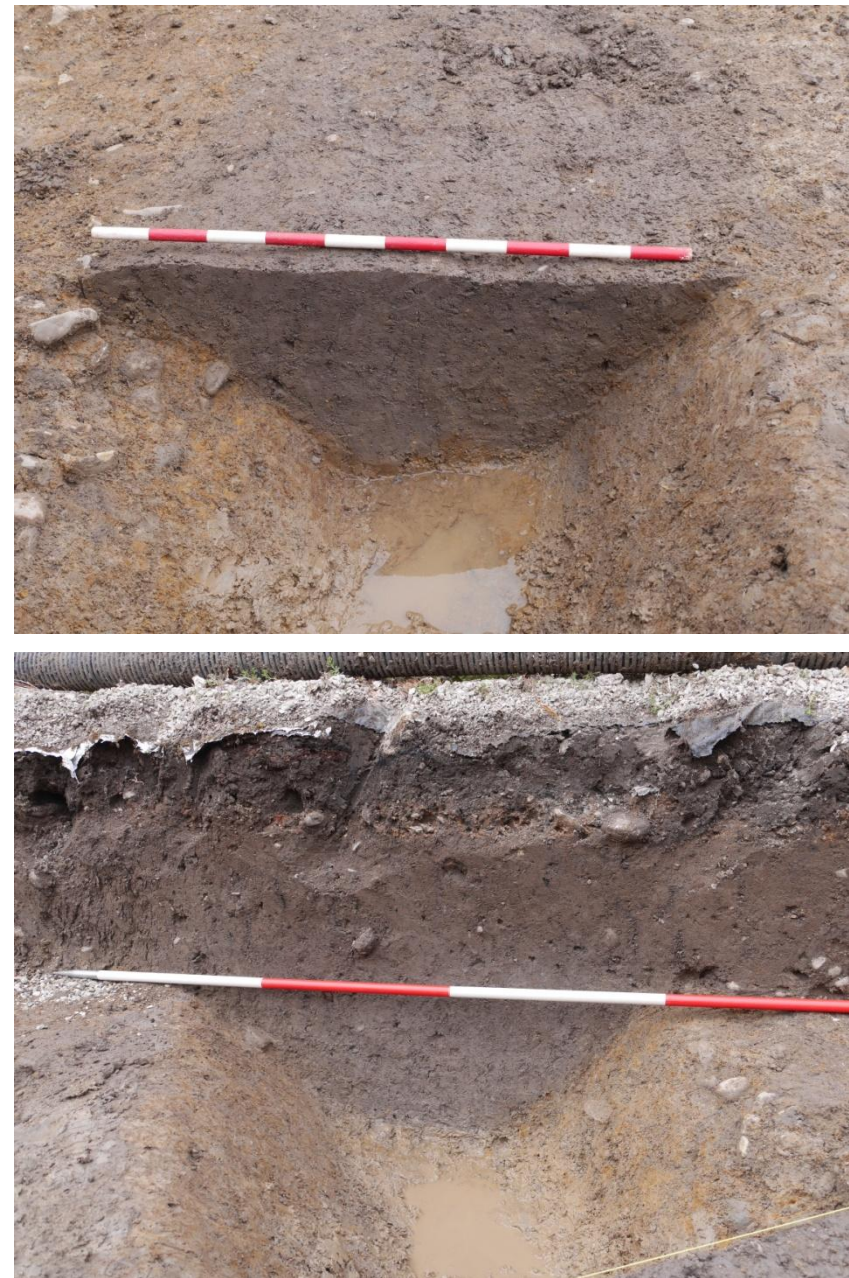
Figure 9: Feature [6] section photographs

A ditch [6], orientated NW SE was present and this contained a very sterile fill that yielded no dating evidence.
