**PIKING WELL,  
NEW WALK,  
YORK**

**REPORT ON AN  
HISTORICAL STUDY AND  
AN ARCHAEOLOGICAL  
EVALUATION**

**1999 FIELD REPORT  
NUMBER 49**

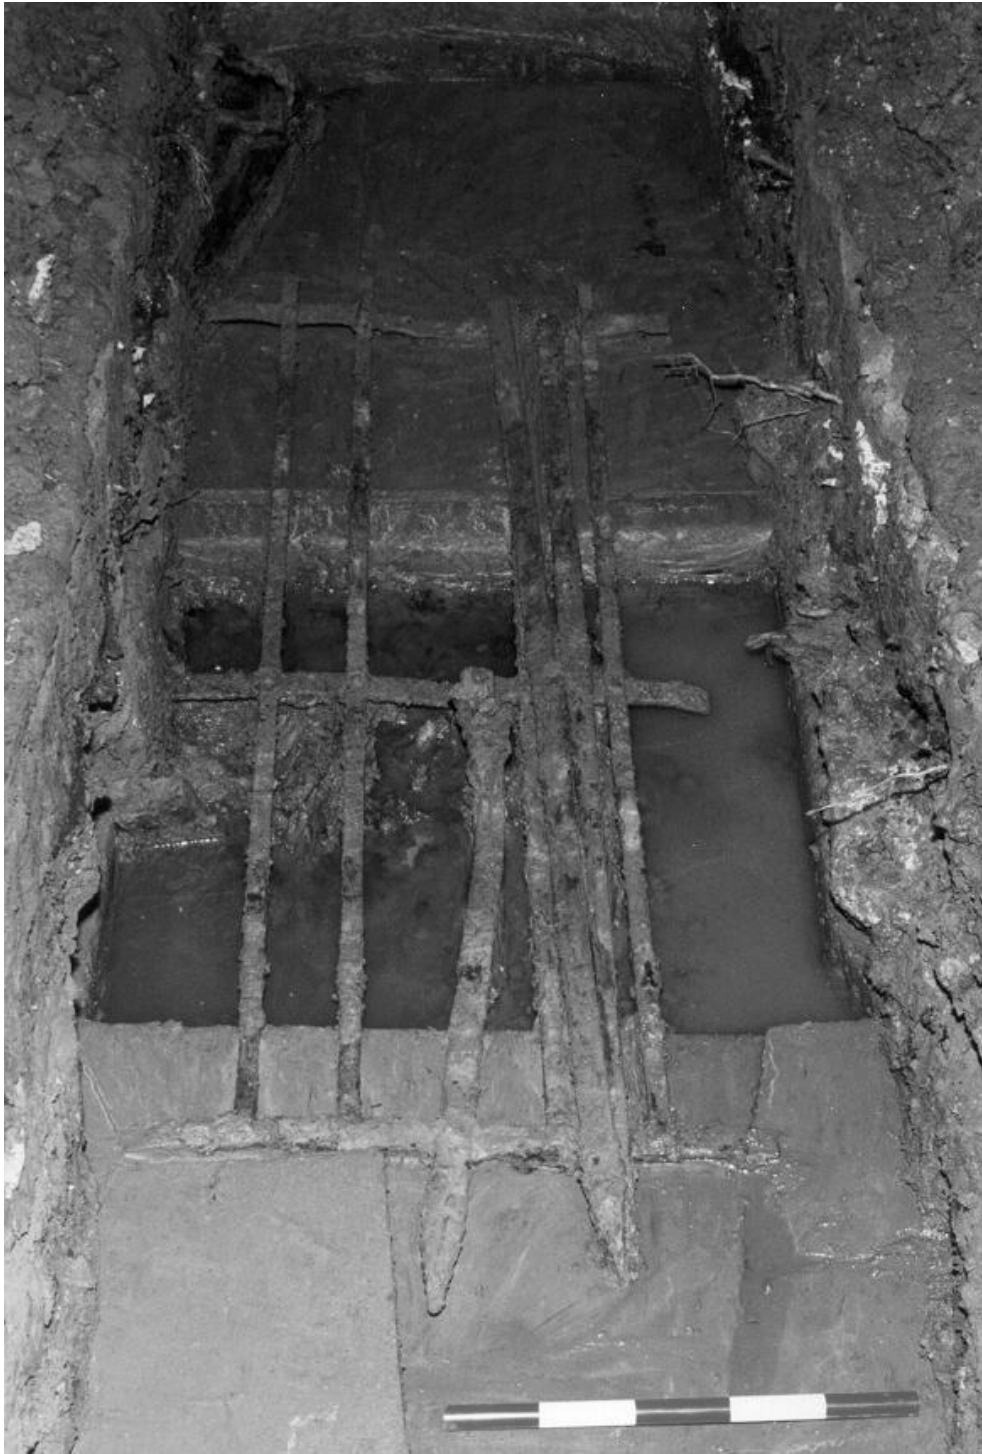
**Figure 14.** Photograph of context 1004 looking east

Sealing both contexts 1007 and 1006 was a section of wrought iron fencing which had been placed horizontally over the pool in order to block it (context 1004 see Figure 13). Context 1004 consisted of three iron bars which were clearly originally horizontal bars. These bars were 0.80m long, 0.04m wide and 0.015m thick, and were spaced 0.52m and 0.53m apart respectively. Four longer iron bars, 1.68m in length, 0.04m wide and 0.015m thick were attached to the 'horizontal' bars. The four longer bars extended 0.06m beyond the eastern-most 'horizontal' bar, but were exactly aligned with the western-most 'horizontal' bar. In addition there were two separate bars 1.74m long, 0.04m wide and 0.015m thick, each with one pointed end, and a shorter bar 0.90m long, 0.06m wide and 0.015m thick with one pointed end and the other end was broken and curved.

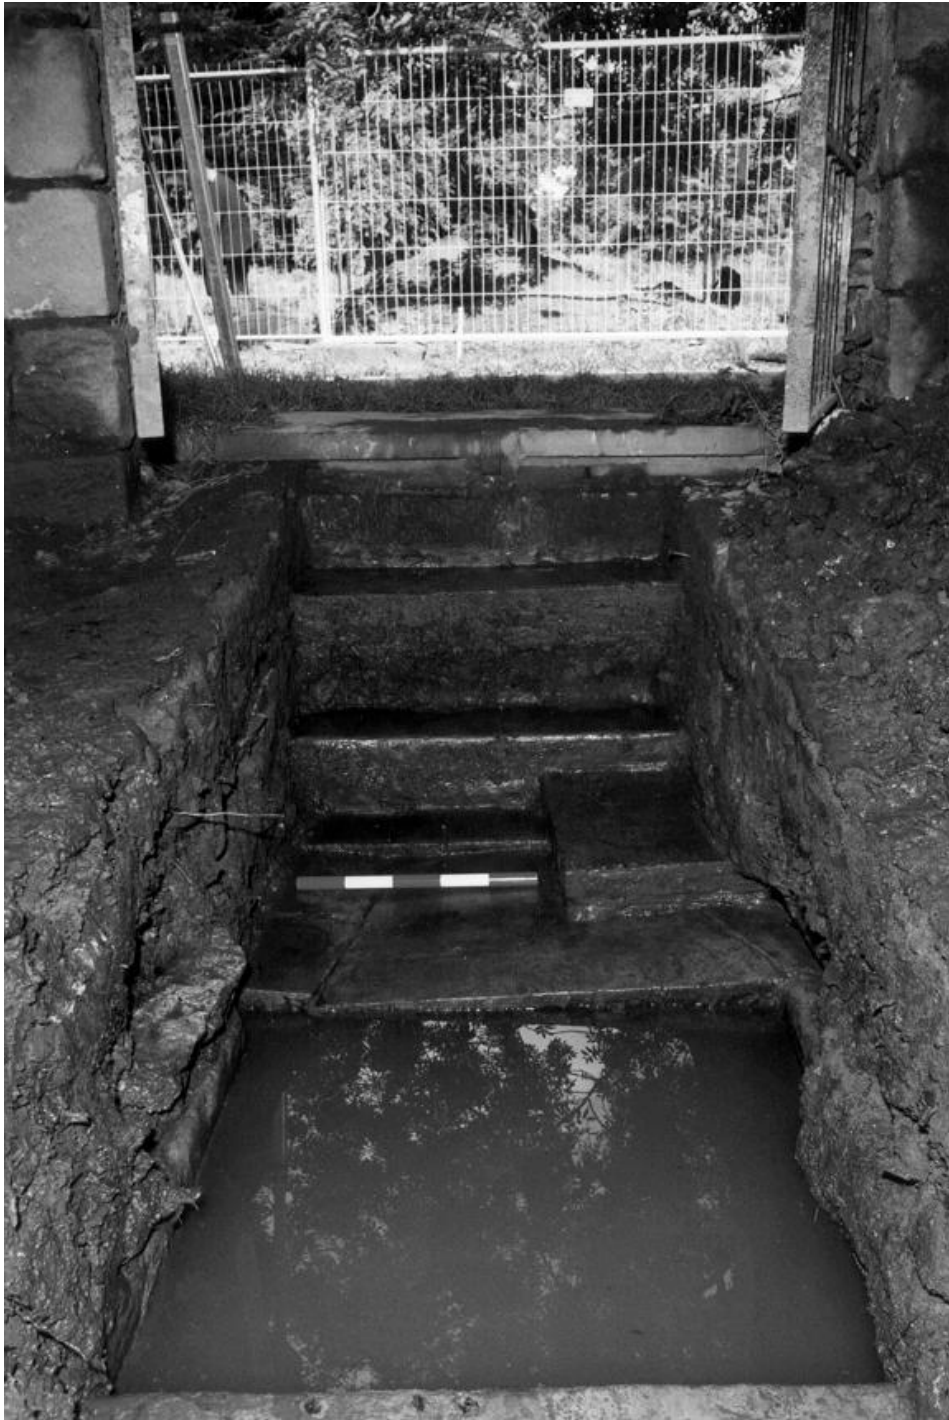
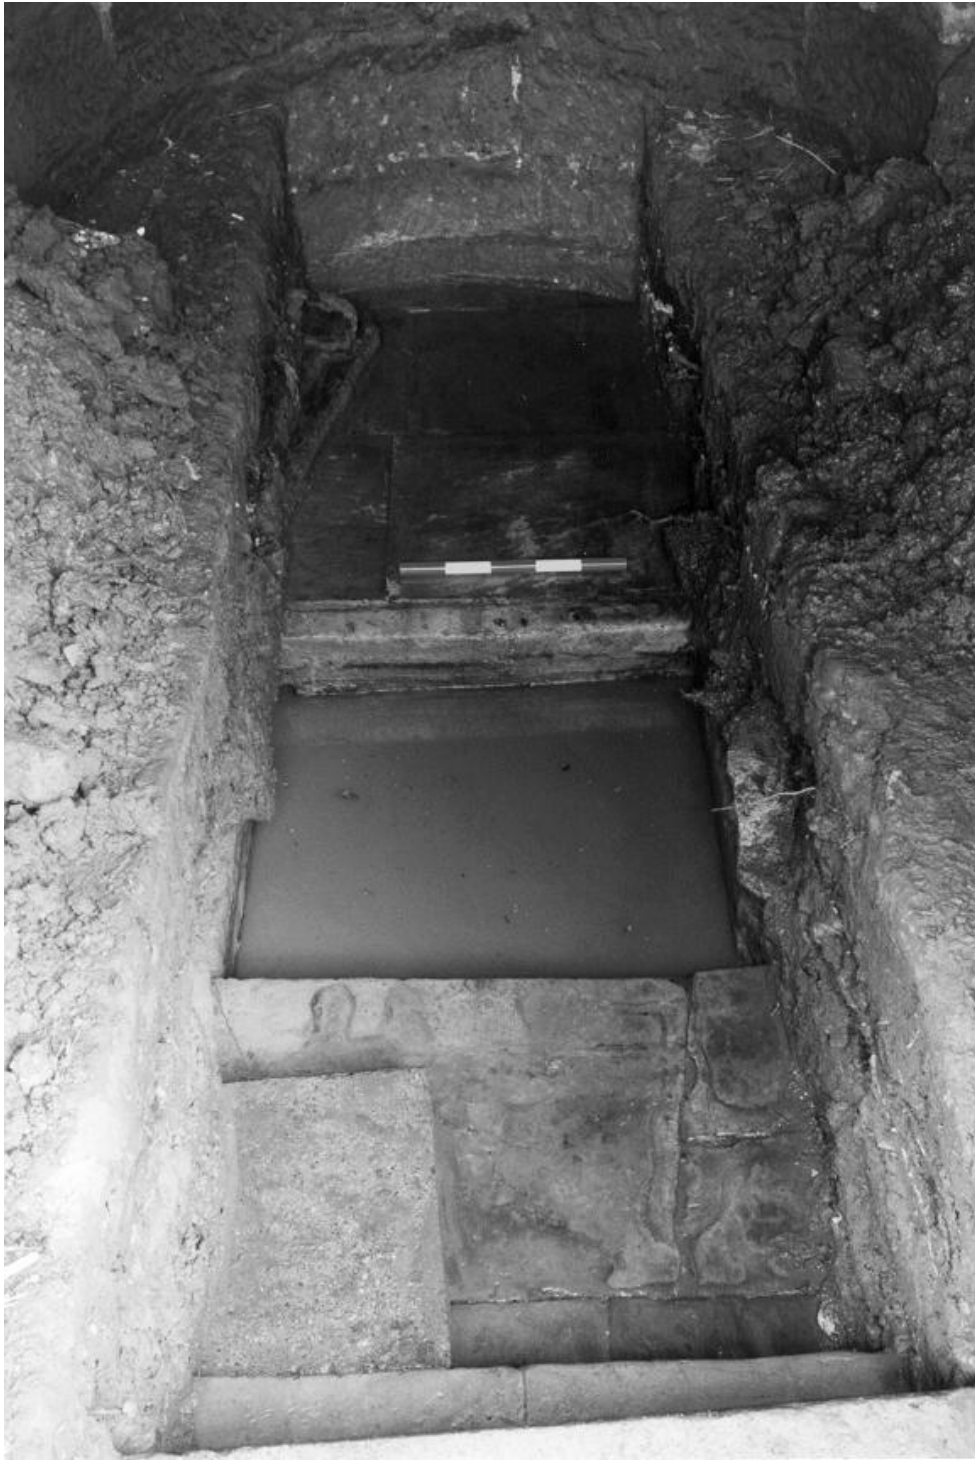
**Figure 15.** Photograph of context 1005 looking west

**Figure 17. Photograph of context 1005 looking east**

The earliest deposit in Trench 1 was a paved floor with a centrally placed stone-lined pool and an associated flight of four steps (context 1005). The water table was at 6.65m Above Ordnance Datum (AOD), only 0.05m below the level of the paved floor. The pool consequently filled with water to this level no matter how much infill material was removed. (Context 1005 is shown on Figures 9, 14 and 15).

The paved flooring (context 1005) within the well-house clearly represents the floor of the building, and is almost certainly the flagged floor which formed part of Thomas Pickersgill's restoration work of 1858 (see 3.2 above). It is strange that the stonework of the third step rests upon compacted earth rather directly on the step beneath and that the lowest step is so shallow. It is possible that when the well was re-erected by Pickersgill the original steps were carelessly re-laid giving a flight of steps with very uneven risers.

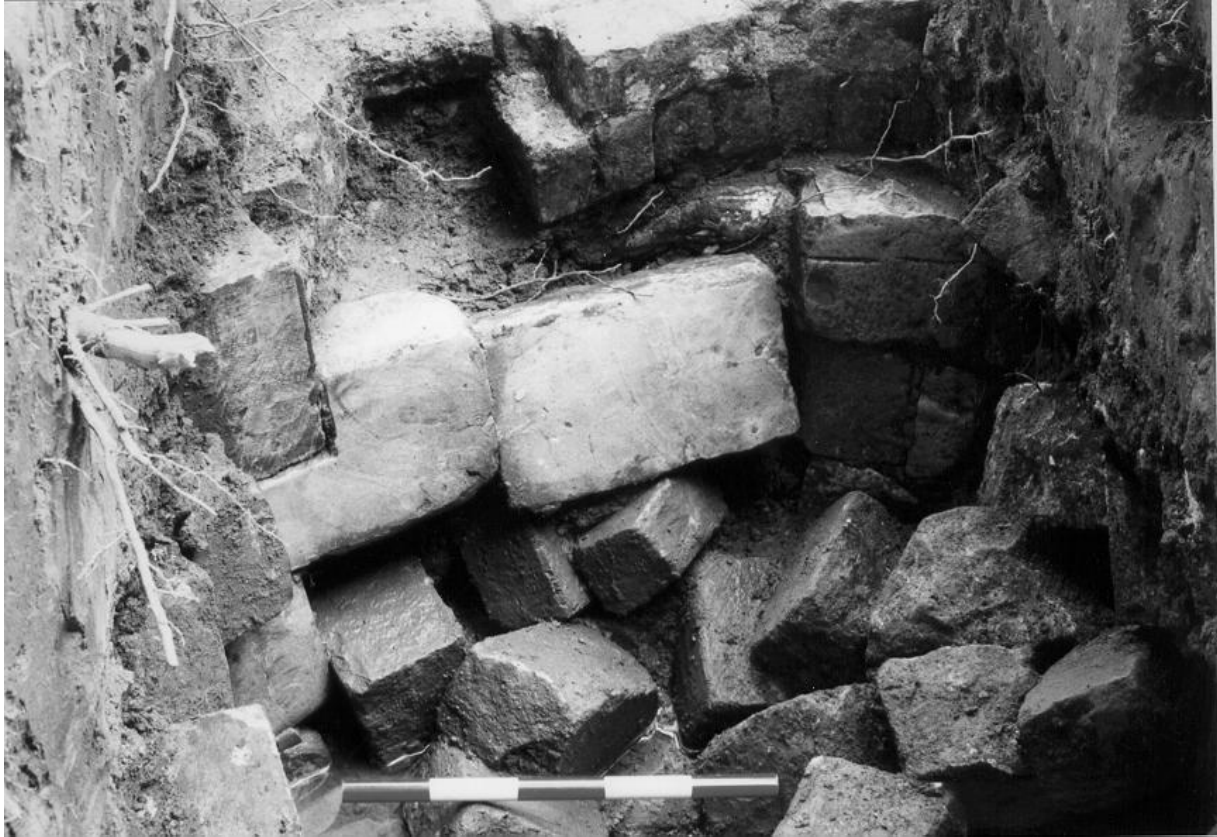
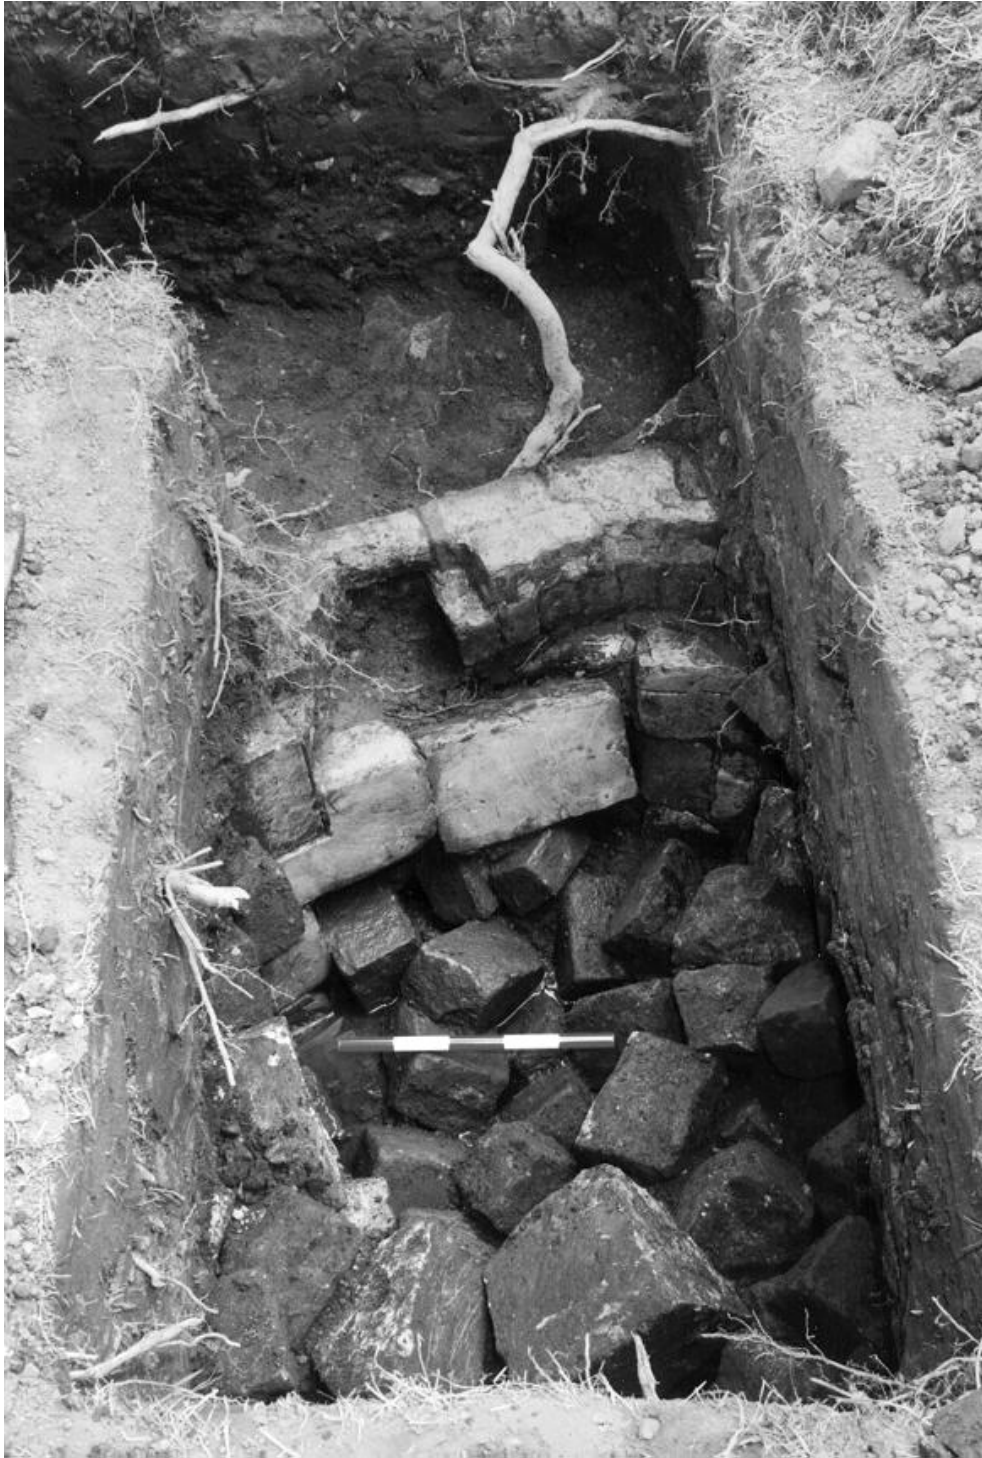
**Figure 17. Photograph of context 2012 looking east**

**Figure 18. Photograph of context 2012 looking east**

The earliest deposit excavated was a curving wall (context 2012 see Figures 12, 16 and 17). The eastern face of the wall (originally the outer-face) consisted of two courses of brickwork laid directly on soil. The bricks were all 0.24m x 0.12m x 0.09m in size and were mortared together. The upper-course was laid with the long axis of the bricks parallel to the wall face, and the lower-course with the long-axis of the bricks at right angles to the wall-face. To the immediate west of the brickwork there was a limestone wall 0.20m wide and in excess of 0.78m high. It was impossible to fully excavate this wall due to the presence of standing water and for safety reasons (the sides of the trench would have become unstable). The upper surface of the limestone wall corresponded to the height AOD of the base of the brickwork. There was no evidence of the brickwork continuing in depth below the top of the limestone wall. Water was encountered within this structure at 6.21m AOD (0.45m lower than in Trench 1 and 0.85m higher than the level of the water in the River Ouse at the time of excavation).

The wall (context 2012) located in Trench 2 clearly represents part of the 'open receiver' well
