Archaeological Watching Brief

Report no. 3497
November 2020

**9 King Street
York
North Yorkshire**

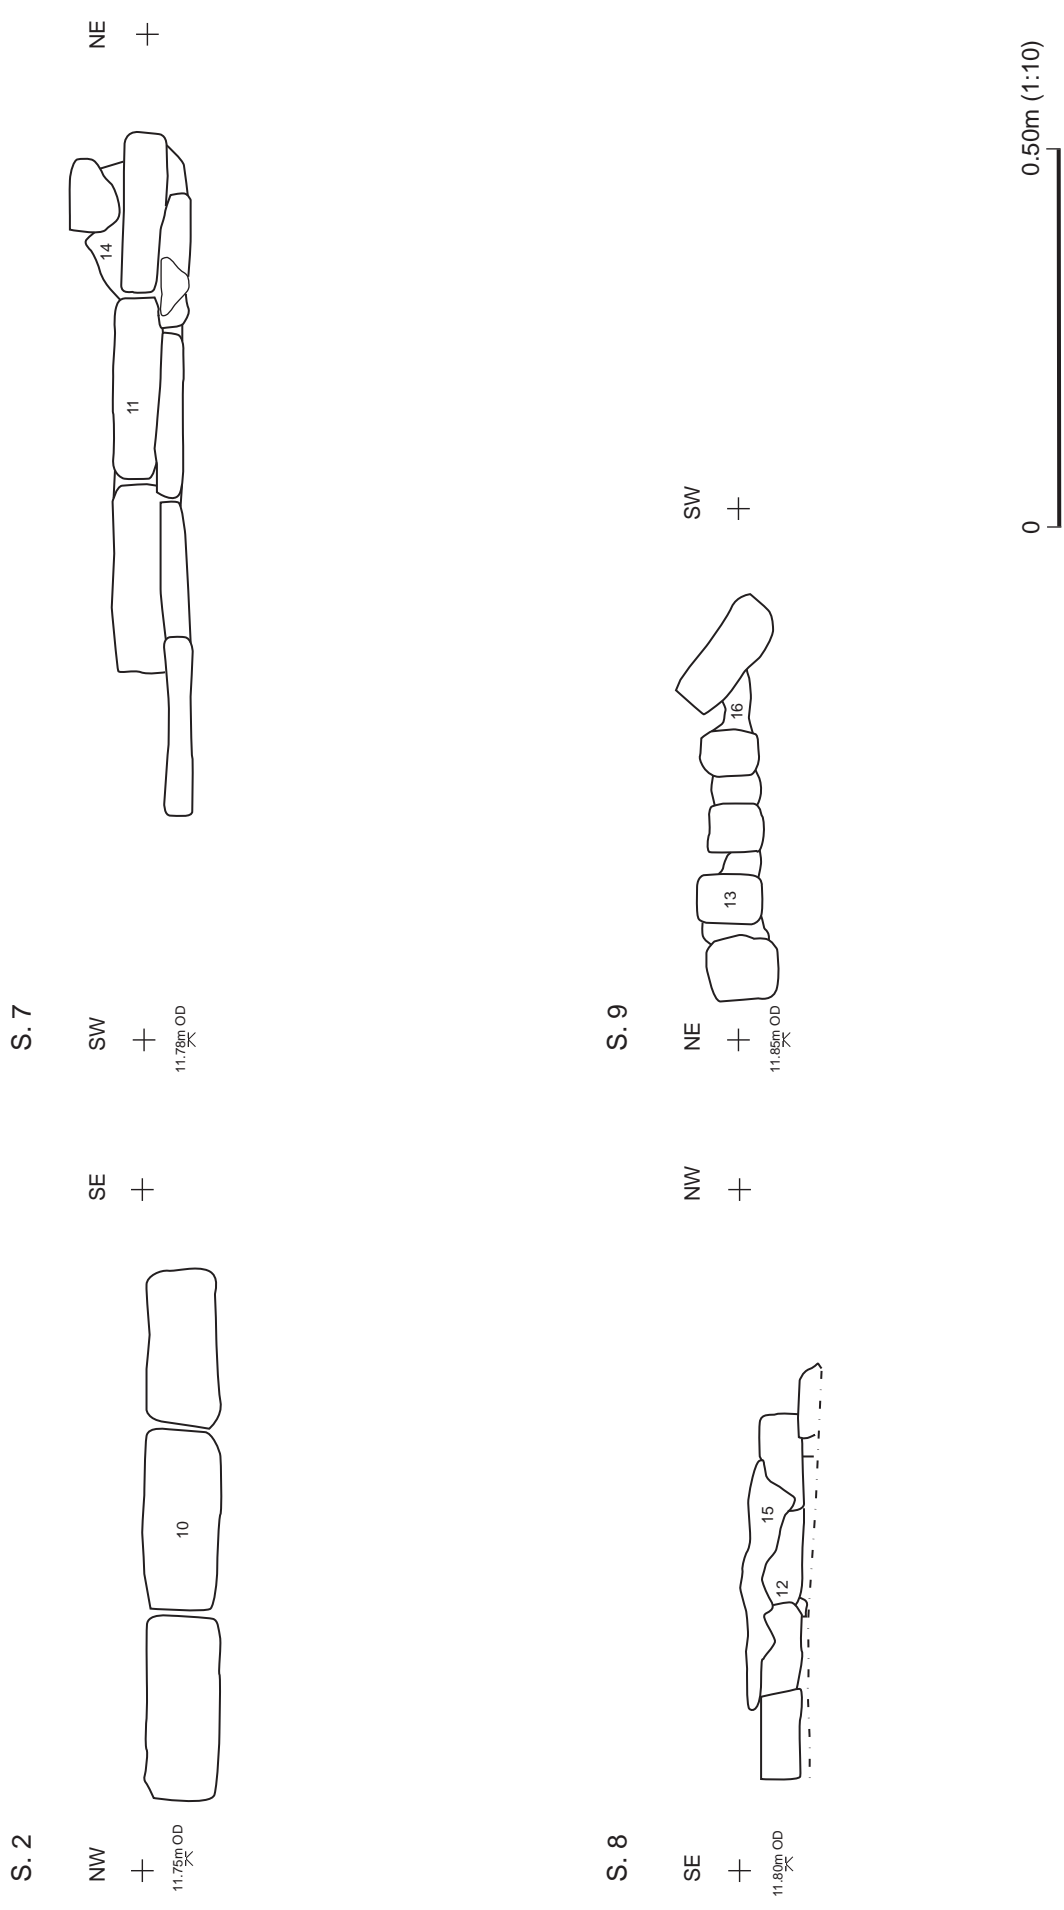
Fig. 4. Elevations of walls 10, 11, 12 and 13

large pieces of lime inclusions and occasional charcoal flecking (Figs 3 and 4; Plate 4 and 5). This wall was also identified in the north-western corner of the building. Wall 12, the southern return of Wall 11, presented the same characteristics as Wall 11. Together they presumably formed part of a small sub-rectangular outbuilding. Wall 13, of which only nine red bricks with greyish-white lime mortar survived, was situated in the north-eastern side of the building (Figs 3 and 4; Plate 6).

- Wall 10 - Two fragmented brick samples were presented for analysis from wall 10. One brick measures 120mm wide by 60mm thick, its full length is unknown. The second brick has a thickness of 45mm, its full length and width are unknown. The composition of the bricks appear alike and both have identical residual greyish-white lime mortar with charcoal flecking adhered to the faces. The bricks have a probable 17th-century date.

- Wall 11 - The fragmented brick sample from wall 11 measures 110mm wide by 68mm thick, its full length is unknown. The brick has an indentation on its bed face from the tool used to remove the brick from its mould. Adhered to its faces was a residual greyish-white lime mortar, the mortar has large pieces of lime inclusions and occasional charcoal flecking. The brick type is the same as the sample from wall 012. The brick has a probable 17th-century date.

- Wall 12 - The brick sample from wall 12 measures 235mm long by 120mm wide, it has a variable thickness of 55mm to 60mm. The brick was of identical composition to the brick sample from wall 12, and also has an indentation tool mark on its bed face. The brick has a probable 17th-century date.

- Wall 13 - The brick sample from wall 13 measures 220mm long by 110mm wide and has a variable thickness of 50mm to 60mm. The brick was heavily covered on all faces by a greyish-white lime mortar with lime inclusions and charcoal flecking. The brick has a probable 17th-century date.

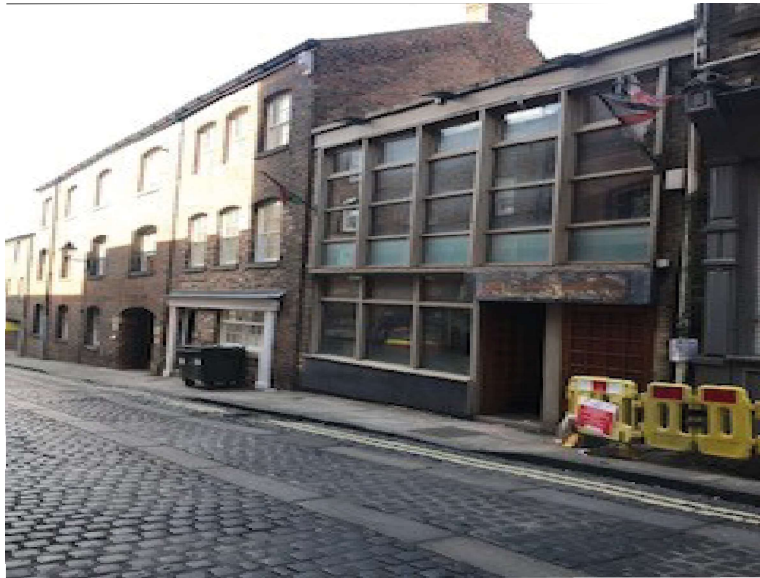
The ground-reducing works were mainly carried out at the rear of the existing building (Fig. 3, Plates 1 and 2). The modern wooden floorboards, linoleum and kingspan were removed and modern concrete deposits and rubble levelling layers were reduced by 0.50m. Four foundation walls associated with possible outbuildings were identified immediately below the levelling layers. Wall 10 comprised a single skin of red bricks laid as a single course of stretchers and bonded by greyish-white lime mortar with charcoal flecking (Figs 3 and 4; Plate 3). It was identified in the north-western corner of the building. The length of the wall surviving was 0.60m, and its width was 0.34m. Wall 11 comprised a double skin of red bricks surviving as two courses of stretchers, bonded by greyish-white lime mortar characterised by

Plate 1. No 9, King Street, looking south-west

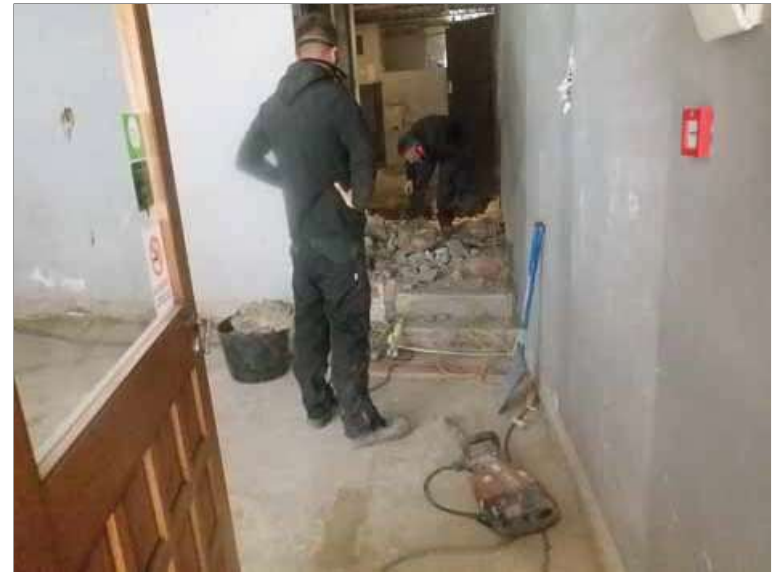
Plate 2. Inside the building, looking north-west

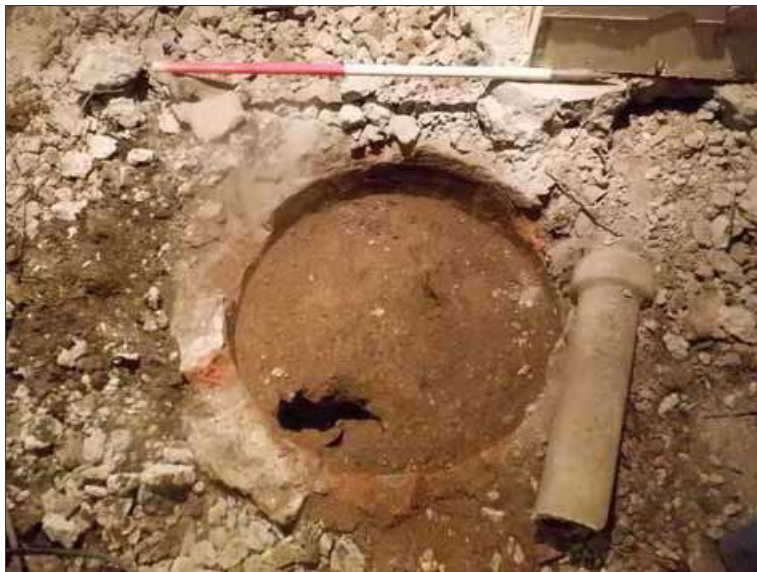
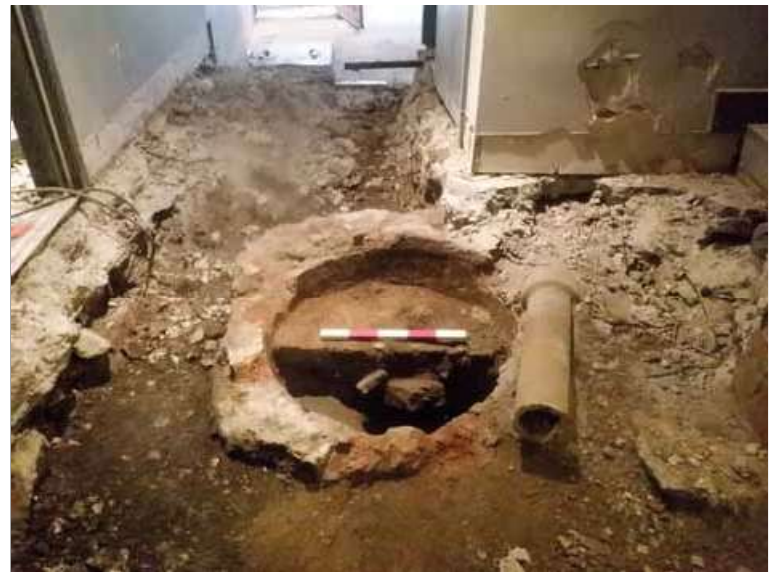
To the south-east of Walls 10, 11, 12 and 13, a well was identified immediately below the levelling layers and sand deposit 20. Well 17 (Figs 3, 5, 6 and 7; Plates 7 and 8) contained multiple deposits (only two fully visible) enclosed by a single skin of red bricks laid as a course of headers, and bonded by pale brown-grey lime mortar. Its diameter was 1m across. Its western side was disturbed by a later drain. As the well was left *in situ* and was not further disturbed during the ground works, only the two upper fills were investigated. Deposit 21, a mid-reddish brown sandy silt, represented the final backfilling of Well 17. Below deposit 21, was a dark greyish brown sandy silt (22), from which three metal object were found (see Section 7 below).

Plate 7. Well 17, looking south-east

Plate 8. Well 17, looking south-east

- Well 17 - The brick sample retrieved from well 17 measures 230mm long by 120mm wide and has a uniform thickness of 50mm. The brick has patches of residual pale brown-grey lime mortar. One of the header faces has a residual staining from organic material, which presumably relates to its use as a well. The brick has a probable 18th-century date.

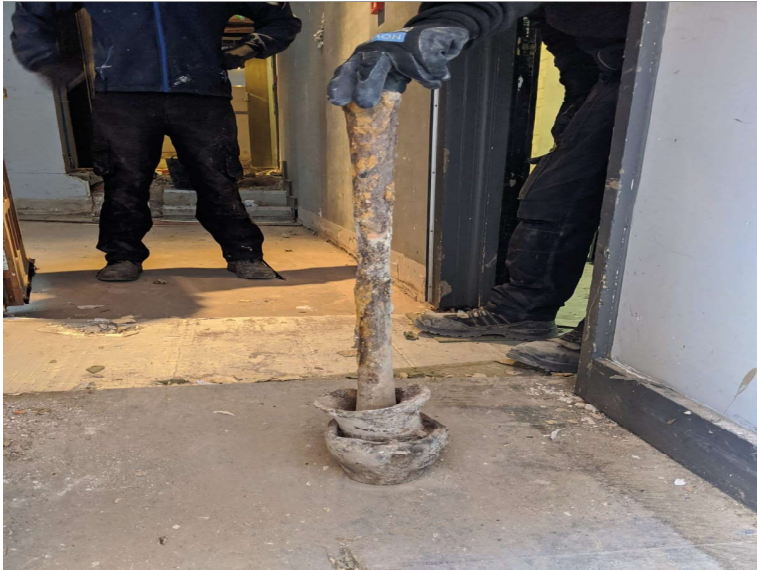
Plate 9. Object 1, pump

Object 1 (Plate 9) appears to be the internal elements of a positive displacement (or 'lift') pump used for raising water from a well. Such a pump comprised a piston and cylinder arranged vertically in the well, and a number of valves to control the flow of water. The piston would have been connected to the operating handle of the pump by a connecting rod. When the piston within the cylinder was raised by depressing the handle, water flowed under atmospheric pressure into the cylinder beneath the piston. Once this had occurred, a valve (standing valve) at the bottom of the cylinder would have closed preventing that water from flowing back from whence it came. When the piston was lowered again, the water trapped in the cylinder would have flowed past the piston by means of a further valve (travelling valve), into the pipe above the piston. Further action on the operating handle would have caused more and more water to enter the pipe until it overflowed into a spout located at the well-head.

In such a pump the cylinder, piston and valves could be located within the well-head pumping apparatus, or down, at or near, the bottom the well-shaft itself.

Whilst it is difficult to be definitive about the item, it would seem likely that this represents the remains of a bucket piston, lower valve and part of a connecting rod from a cylinder that

was once located at the bottom of a well (although one of the 'cups' seems to be upside-down on the shaft). This pump mechanism is difficult to date, however cast iron pump mechanisms only became commonplace from the middle of the 19th century onwards. Prior to this period, the pump cylinders, pipework and the well-head mechanisms were usually made of wood, often elm. Where ironwork was used in such pumps, it would have been wrought iron used sparingly, perhaps only for the bucket pistons, valve cups and connecting rod.

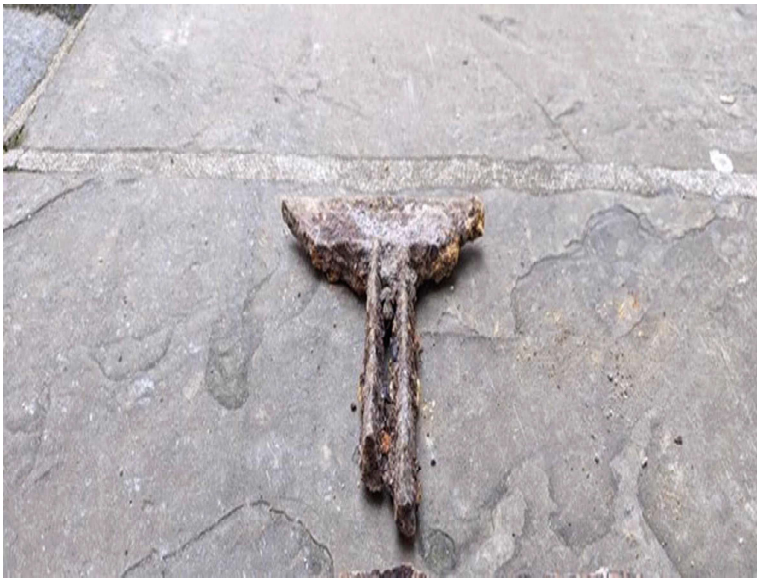
Plate 10. Object 2, knife edge pivot

Object 2 (Plate 10) could be part of a knife-edge pivot bearing or a tool of some description. If it is the former, it could have had some function as part of a well-head pumping mechanism.

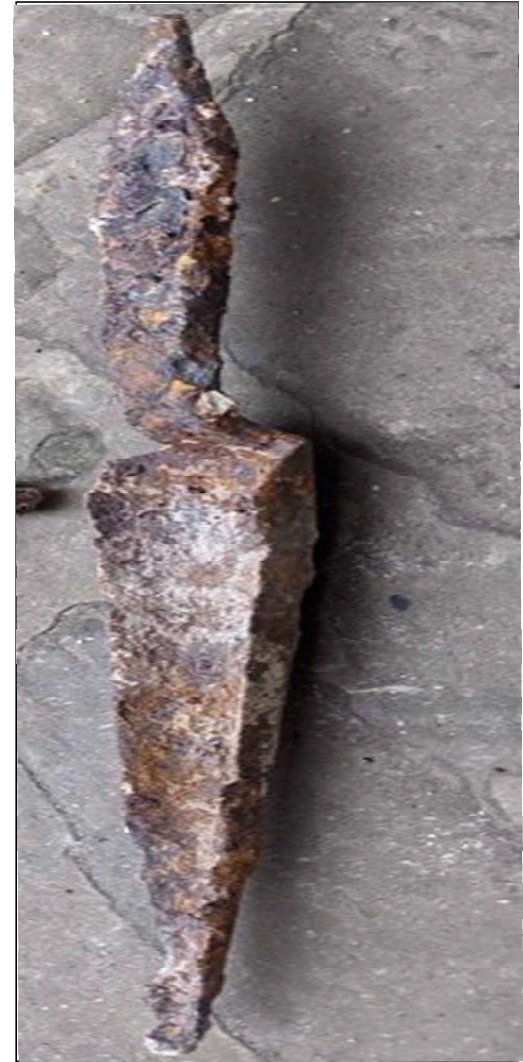
Plate 11. Object 3, bung borer

Object 3 (Plate 11) is a bung auger used for boring holes in casks or barrels to insert spiles (to control the flow of gas in or out of the cask), or taps (to draw off liquid). Such items have been used since the invention of the staved cask, and are still in use today.
