Church Cottage, Wheldrake

Archaeological Watching Brief Report

Site	Church Cottage, Main Street, Wheldrake, York YO19 6AA	
Site Code	CCW20	
County	North Yorkshire	
Location	National Grid Reference	SE 68258 44993
	Easting and Northing	468258 444993
	Latitude Longitude	53.896629 -0.96274808
Planning Reference	19/00589/FUL	
Development	Internal and external alterations including: re-roofing of Church Cottage, repairs to chimneys, reinstallation of chimney pots, repainting of brickwork, minor infilling of openings, internal reorganisation, installation of internal insulation & roof insulation, window repairs, removal & replacement of 1970's porch with an extension at the east end to provide a lobby, accessible WC, and a small store.	
Text, Images and Editing	LS Archaeology D. Signorelli, L. Signorelli, and F. Lawson-Jones	
Specialist Contribution	York Osteoarchaeology M. Holst and J. Ruiz Ventura	
Date of Issue	January 2021	
Work Commenced	November 2020	
Client	Ferrey and Mennim Ltd

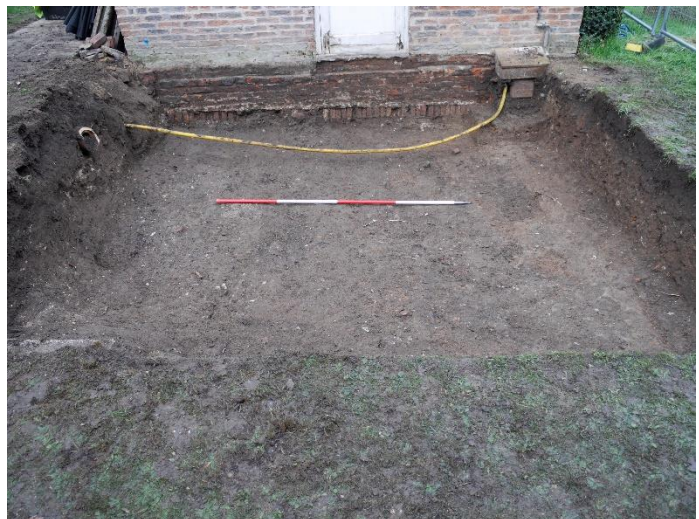
Figure 5: Level of excavation with slight staining, indicating grave cuts.

During the archaeological ground evaluation, a mini digger fitted with a toothless bucket was used to remove the existing turf and topsoil. The machine removed the soil in shallow spits of 0.1m. The monitoring archaeologist assessed any potentially significant features or deposits for further investigation, and the area was hand cleaned by trowel. This process was repeated until the first horizon of burials were reached at a depth of 0.75m below ground level, or 14.15 AOD (Figure 5). It was at this depth that groundworks ceased and all visible grave cuts were recorded in plan.

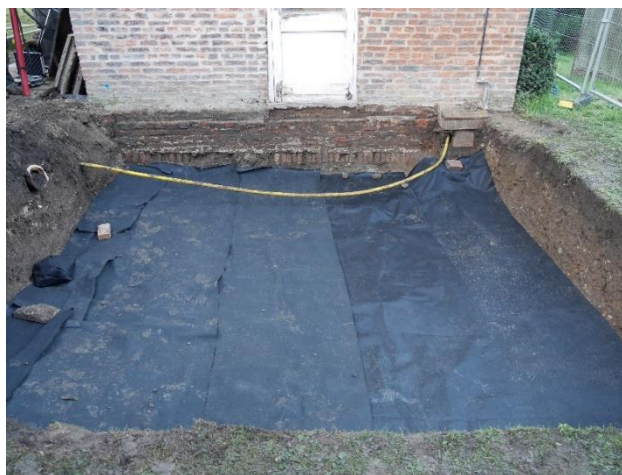
Figure 6: Excavation area sealed with the polypropylene fabric

It was agreed between all parties that the full excavation of the burials was not required to enable building works to progress. Adequate depths had been reached and mini piling would be used for the extension foundations. York Osteoarchaeology and the engineer working on behalf of Ferrey and Mennim Ltd mutually agreed the locations for fourteen mini piles. The ground was tested and the mini piles were positioned on a plan, in designated spots, identified as not affecting burials. After recording, the area was temporarily sealed with black polypropylene weed control fabric and backfilled with the excavated spoil until extension works commenced later in 2021 (Figure 6).

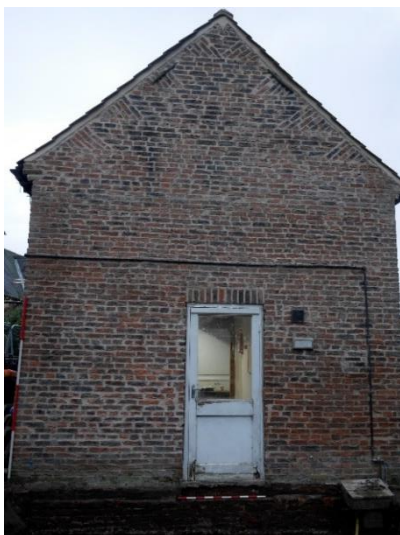
Figure 9: Tumbled brick gable detail as seen on the east facing elevation of the late 18th century range.

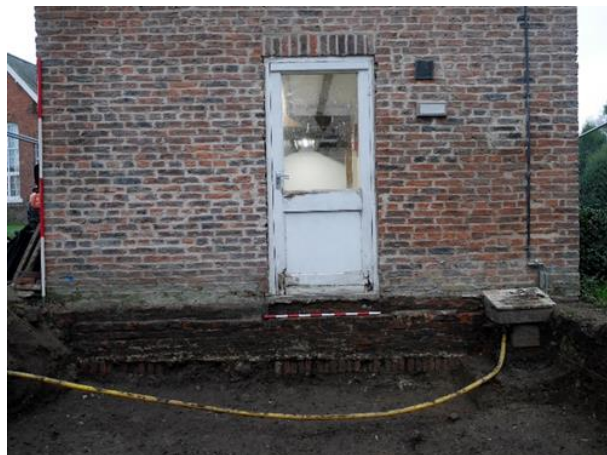
Figure 10: The exposed foundations of the late 18th century range comprised of a single course of bricks laid in rowlock, bonded with clay straight onto the ground. Above this row are six courses of brick laid in stretcher, bonded with light brown mortar.

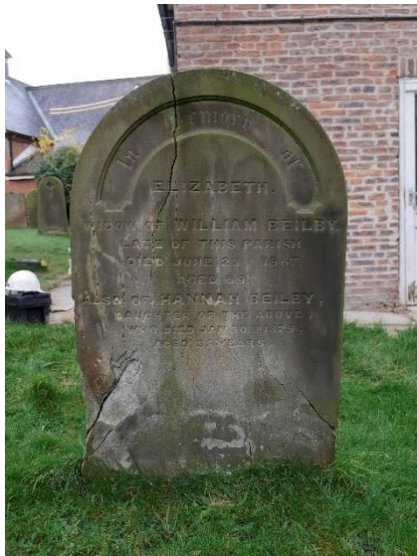
Figure 11: Beilby Family gravestone in situ, facing east.

The standing Beilby Family Gravestone (Figures 11-14) was removed due to its location within the footprint of the new extension. Cracked in places, the stone was inscribed:

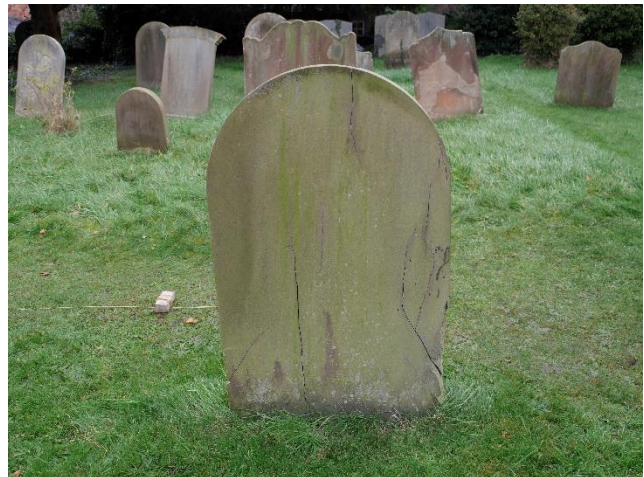
Figure 12: West facing Beilby Family gravestone with an oval top and straight ends facing west.

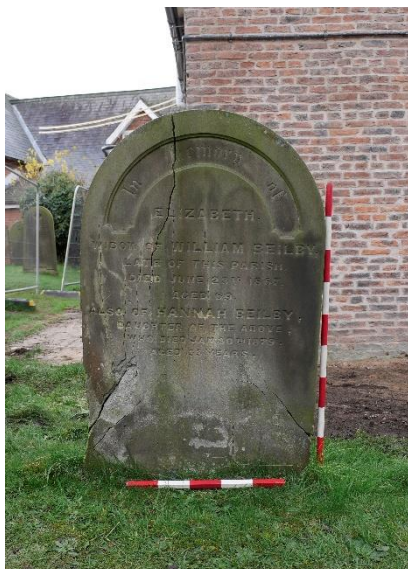
Figure 13: Beilby Family gravestone, Victorian inscribed carboniferous sandstone.

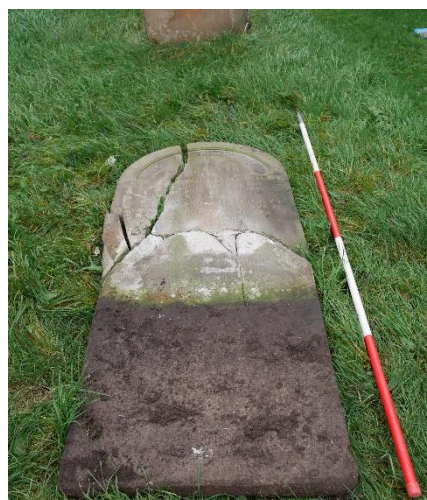
Figure 14: Gravestone measured approximately 0.72m in width, 1.7m in length.

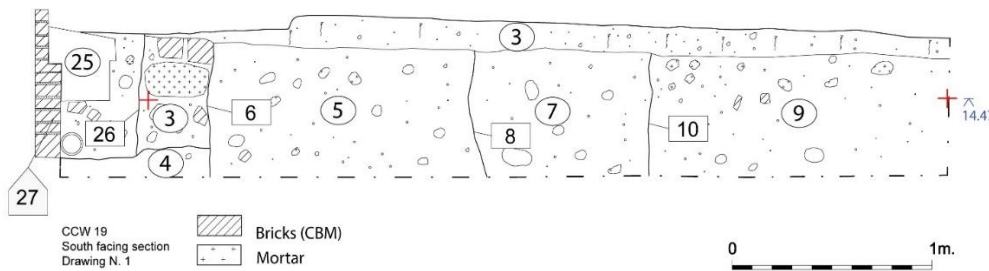
The vertical cuts for burials [6], [8] and [10] were recorded in the south facing section of the excavation limits (Figure 16).

Figure 16: South facing section of excavation limits.

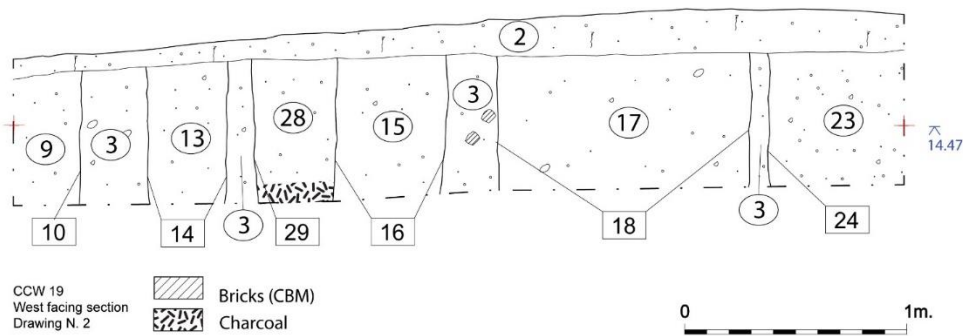
In the west facing section the cuts for burials [10], [14], [16], [18] and [24] were visible and recorded. Possible cremation [29] was noted located between cuts [14] and [16] (Figure 17).

Figure 17: West facing section of excavation limits.
