6-7 TOWER STREET & 1 PECKITT STREET,
YORK.

REPORT ON AN ARCHAEOLOGICAL WATCHING BRIEF
AND HISTORIC BUILDING RECORDING

OSA Report No: OSA20WB22

June 2021

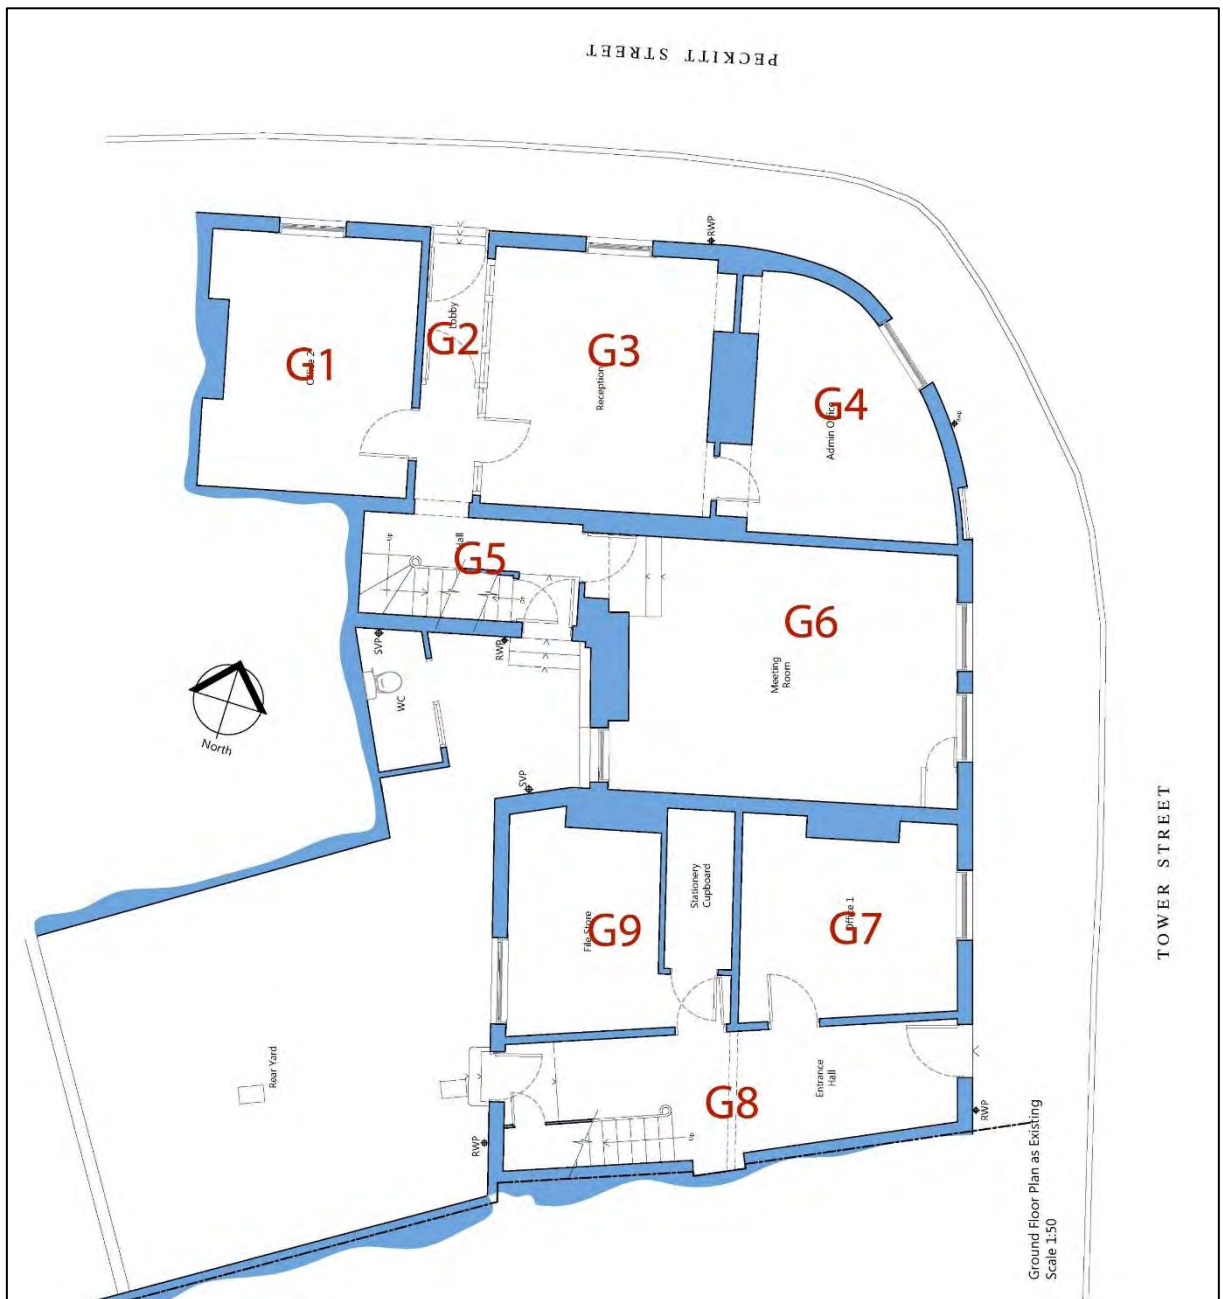
Figure 5. Plan of Ground Floor with rooms numbered.

A total of nine rooms were recorded on the ground floor across the three historic properties. Rooms G1 to G3 and G5 were located in 1 Peckitt Street, Rooms G4 and G6 in 6 Tower Street and Rooms G7 to G9 in 7 Tower Street. Within many of the rooms the only visible details related to the conversion of the buildings to form offices in the 20th century and these remained unchanged during the duration of the recording.

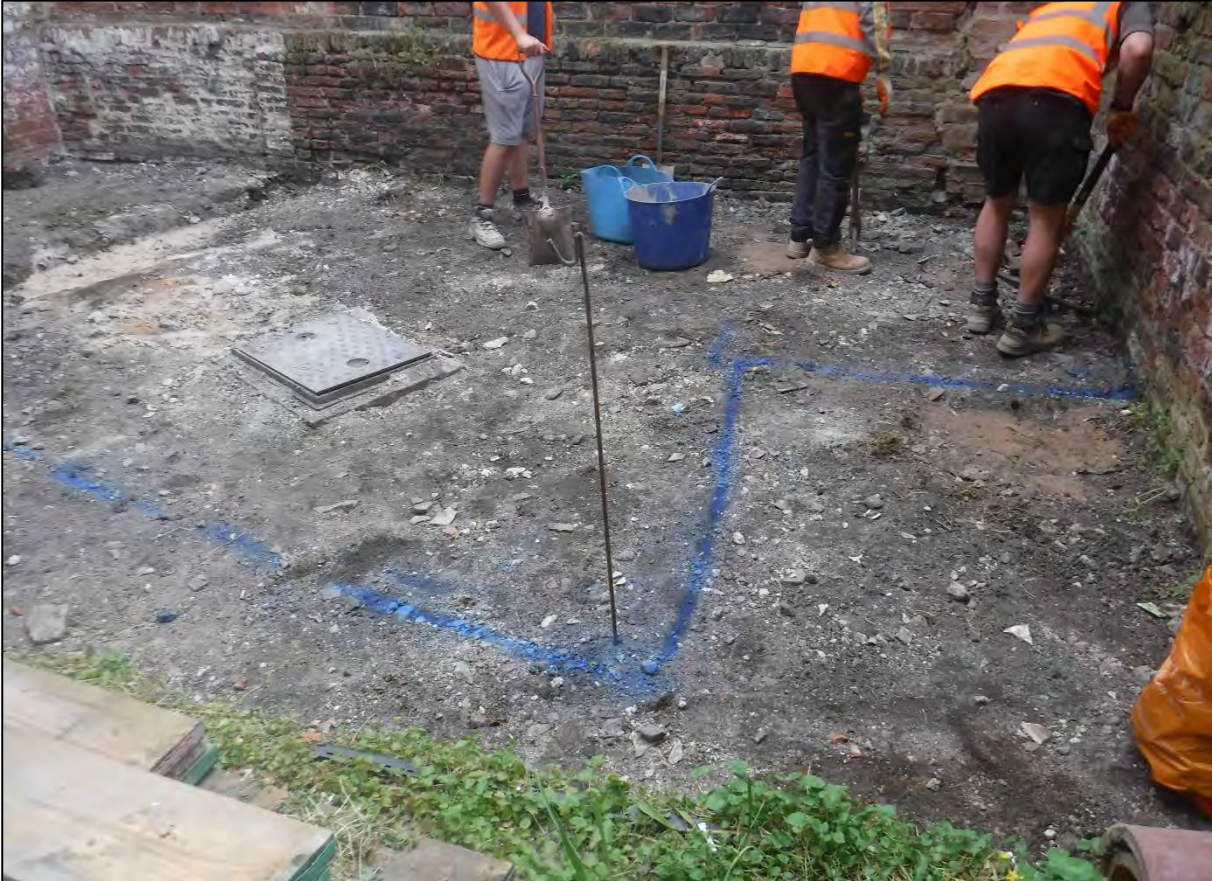
Plate 1. General view of excavation area following removal of yard surface concrete.

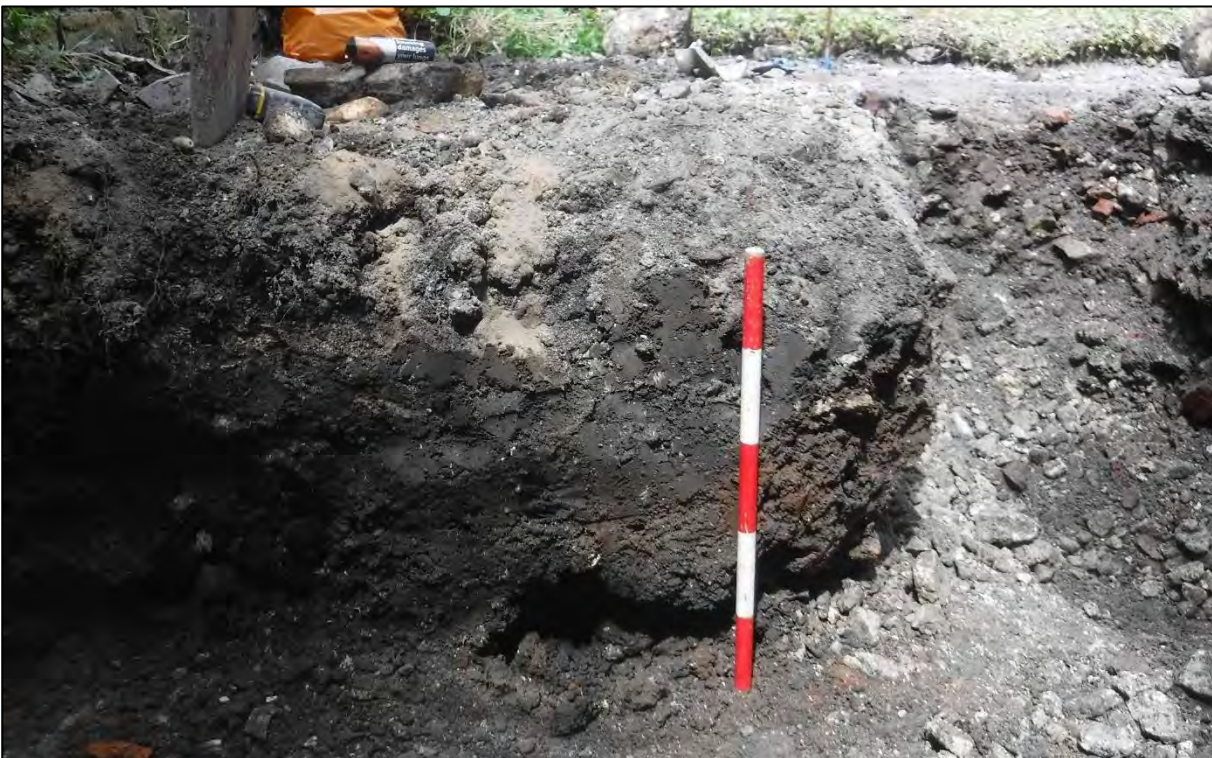
The earliest recorded deposit, encountered at the base of the excavation and for a maximum thickness of 0.25m above this was a layer of friable mid brown clay sand silt (101). This layer butted against the face of the existing brick yard wall (102) and is almost certainly a garden soil deposited within the 19th century yard. It was sealed by a layer of loose, mid brown sandy silt, containing frequent fragments of brick, mortar, concrete and stone (100) approximately 0.30m thick, which formed the make-up layer for the concrete yard surface (Plate 2). Throughout the area modern services were observed, including a manhole, which extended to below the maximum level of excavation.

Plate 2. Typical section illustrating excavated deposits.

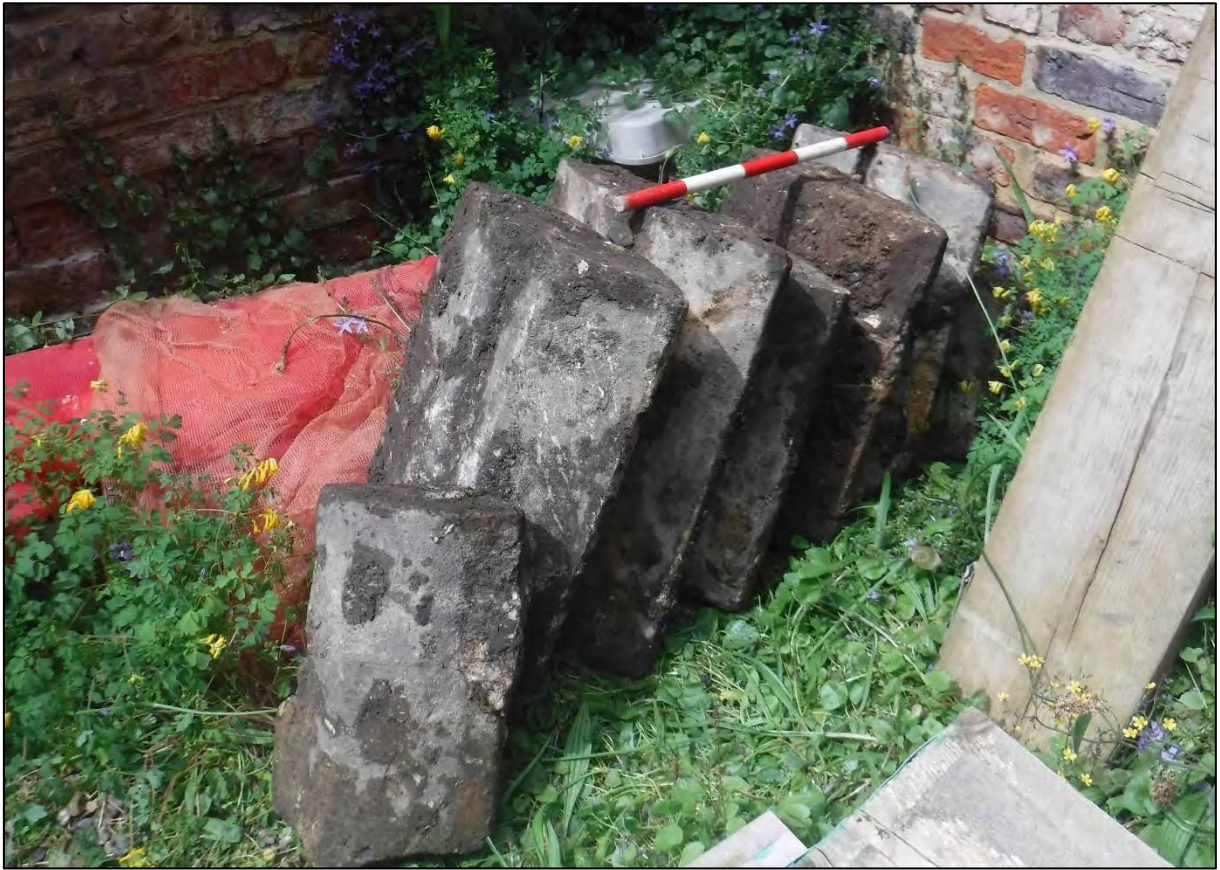
Plate 3. Assemblage of masonry window mullions.

The archaeological watching brief during excavations for the raft foundation of the new extension only revealed deposits of 19th and 20th century date. The earliest deposit was a garden soil, that butted against the extant yard wall which dates to the second half of the 19th century. The fragments of masonry window mullion were found within the garden soil and are likely to have formed part of a 19th century garden feature. It is possible that the fragments of masonry were originally recovered when the cellars for the Victorian houses were built, and were therefore potentially derived from the Franciscan Friary. However, they may have been brought onto the site from elsewhere. It is intended that the fragments of masonry will be retained within the garden as a feature.

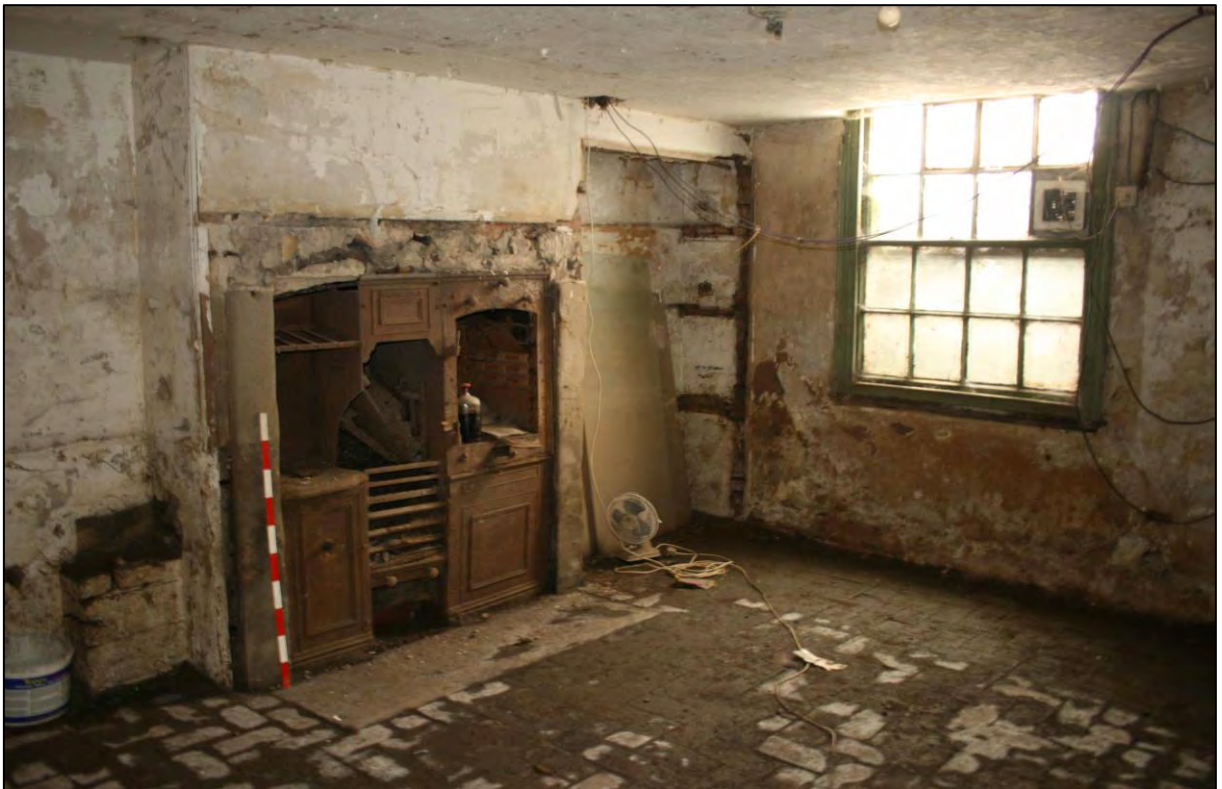
Room B1 was the largest, westernmost room within the basement (Plate 8). The walls were brick, covered in white paint/limewash and the floor brick setts. The western wall included a large iron cooking grange, set into a brick fireplace. The room was lit by a single sash window in the north (external) wall.

Plate 8. Room B1, showing grange and window.

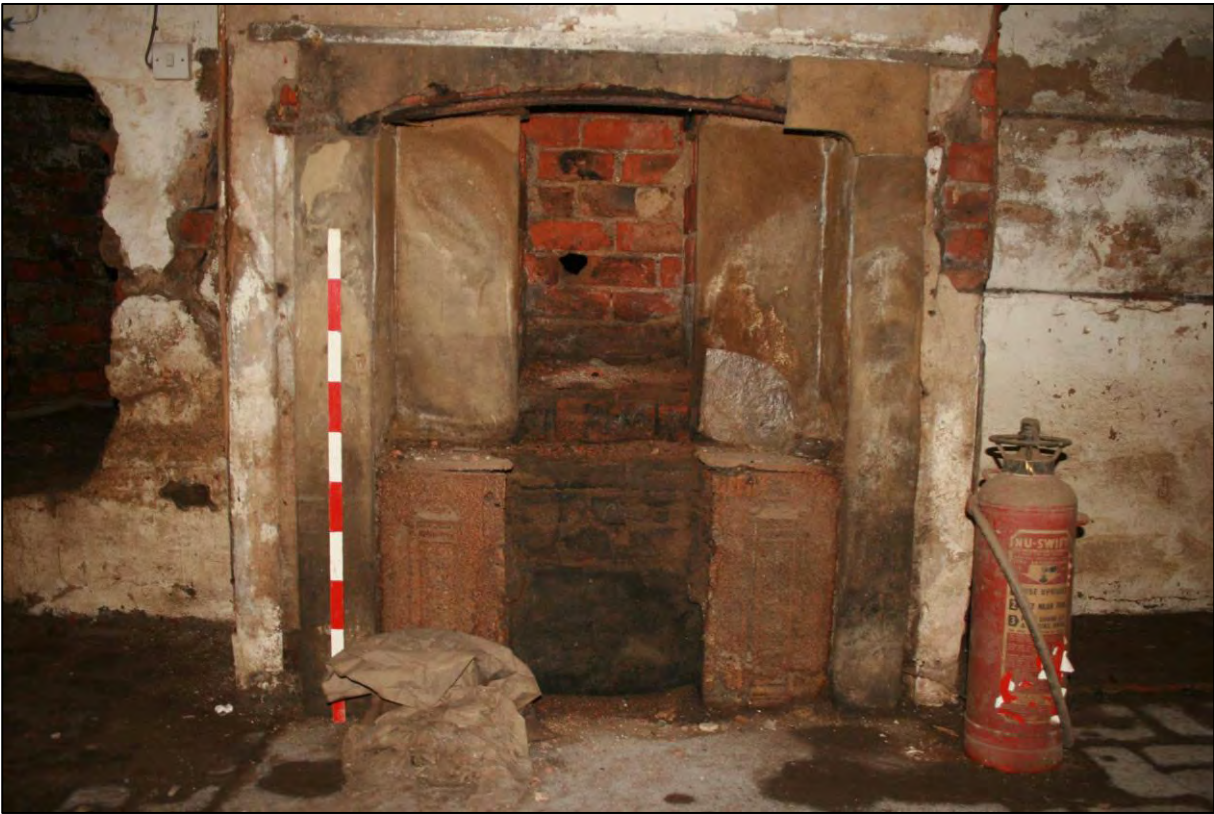
Room B2 was located to the east of B1 but was slightly smaller. It also included an iron grange, set in a brick fireplace on the eastern wall (Plate 9). The room was again lit by a single window in the north wall. Beneath the window was a raised, shallow fluted salt glazed sink, set on brick supports (Plate 10).

Plate 9. Room B2, grange.

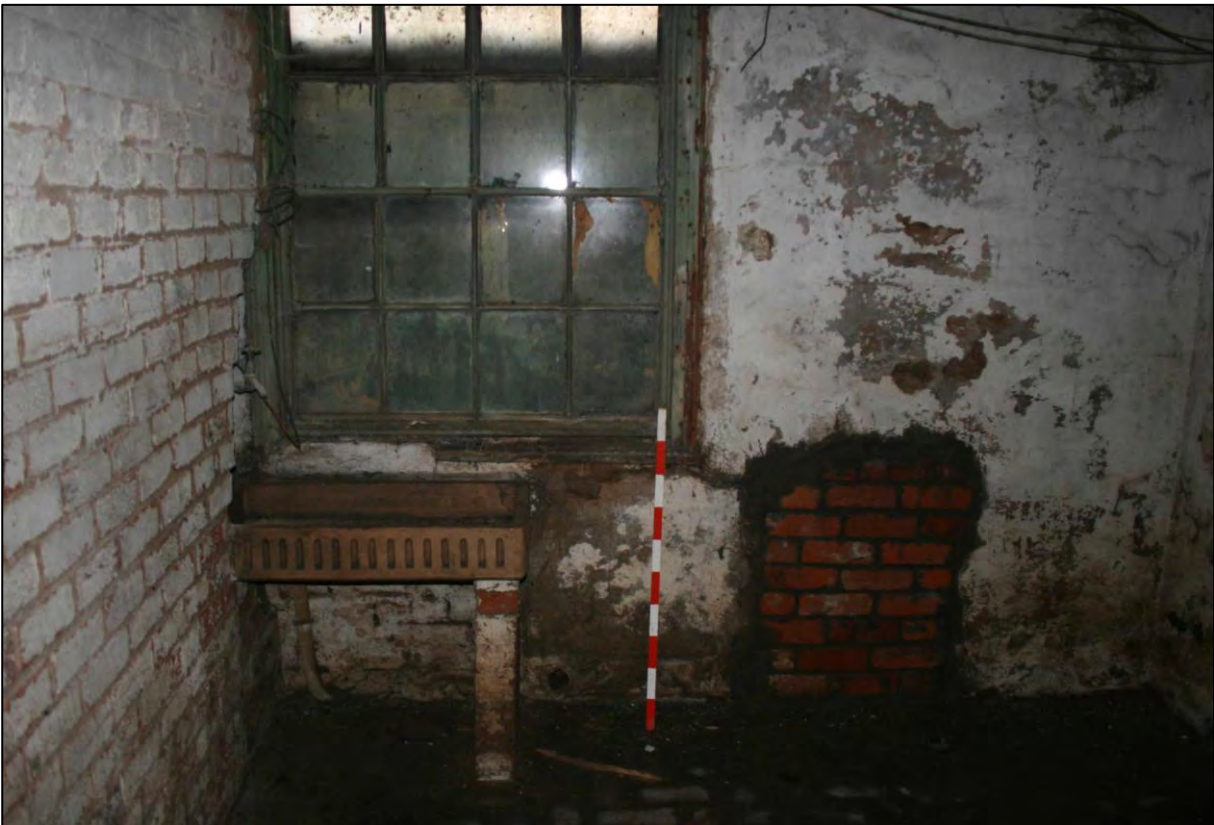
Plate 10. Room B2, window and sink, looking north.

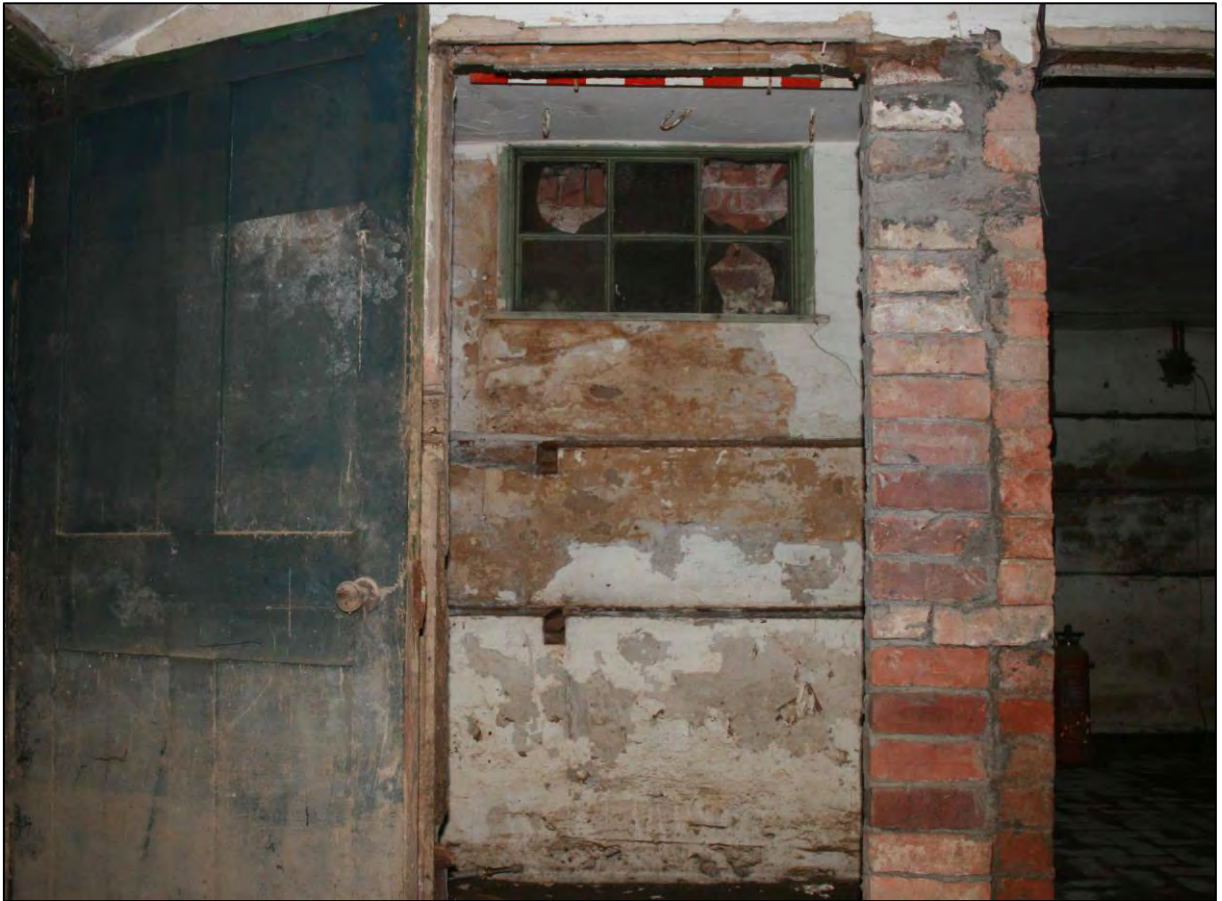
Room B3 was accessed from the northeast corner of Room B1 but had been formed by constructing a brick wall within the northwest part of Room B2. Room B3 comprised a small pantry or store and included several hooks in the ceiling, presumably for hanging meat. The single window at the top of the north wall had been bricked across externally and several panes had been broken (Plate 11).

Plate 11. Room B3, looking east.

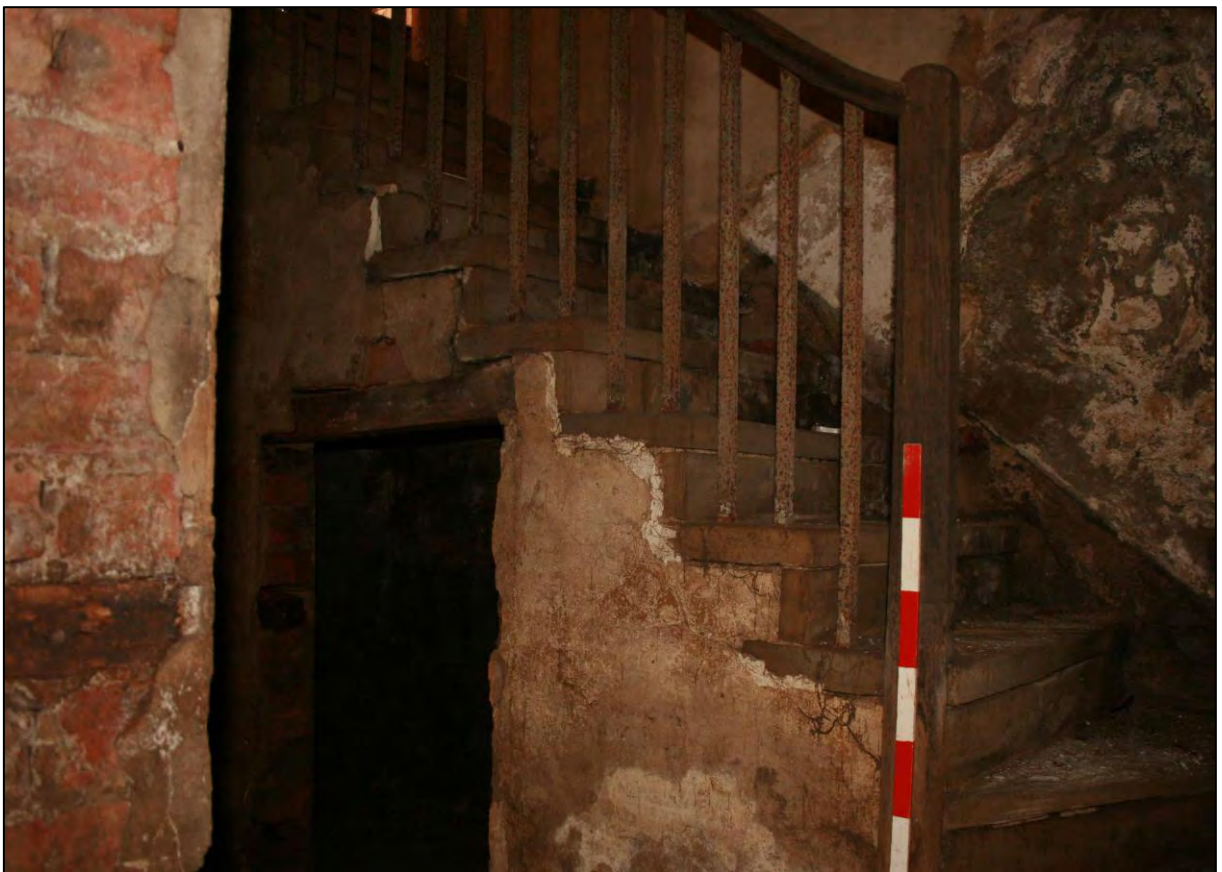
Room B4 comprised the stair access into the basement (into Room B1) from the ground floor. The stairs comprise stone slab steps, with the banister being of timber, with cast iron spindles (Plate 12).

Plate 12. Room B4, detail of stairs.

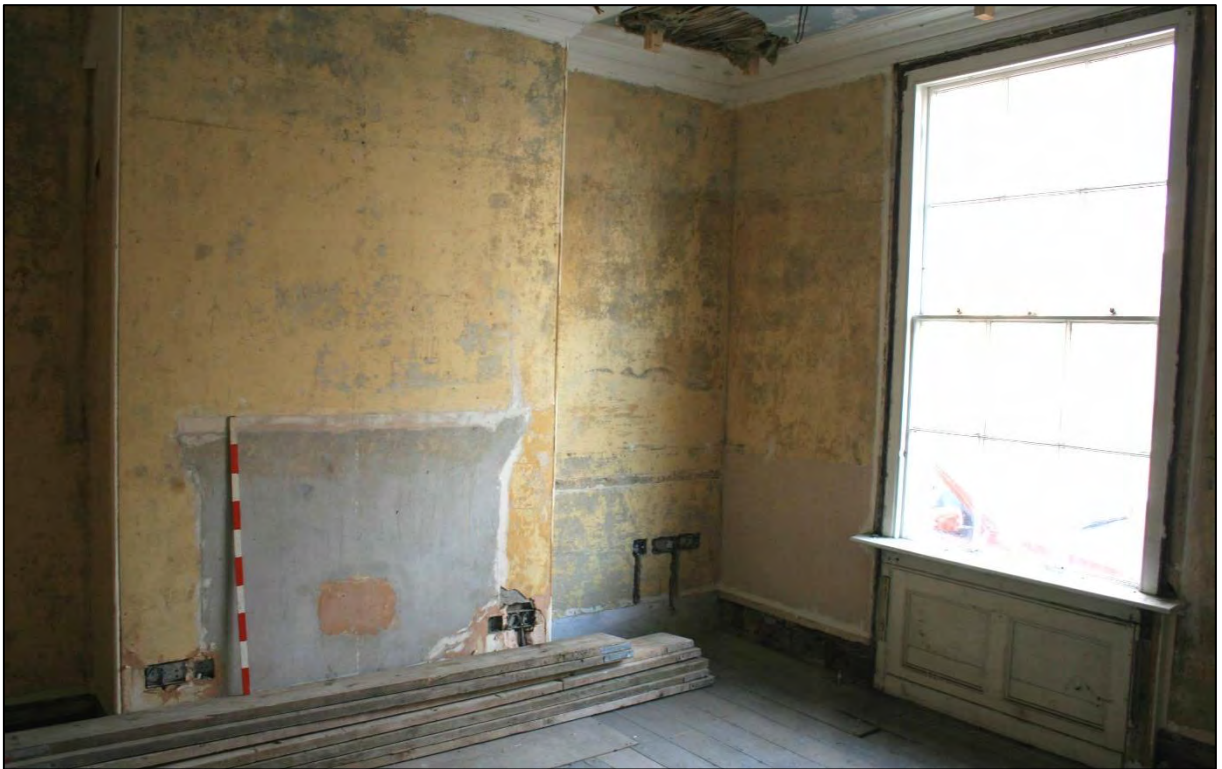
Room G1 comprised the westernmost room within 1 Peckitt Street. It had been decorated in the 20th century to form an office. The brick chimney breast was located in the west wall, but no historic elements of the fireplace were exposed (Plate 15).

Plate 15. Room G1, looking northwest.

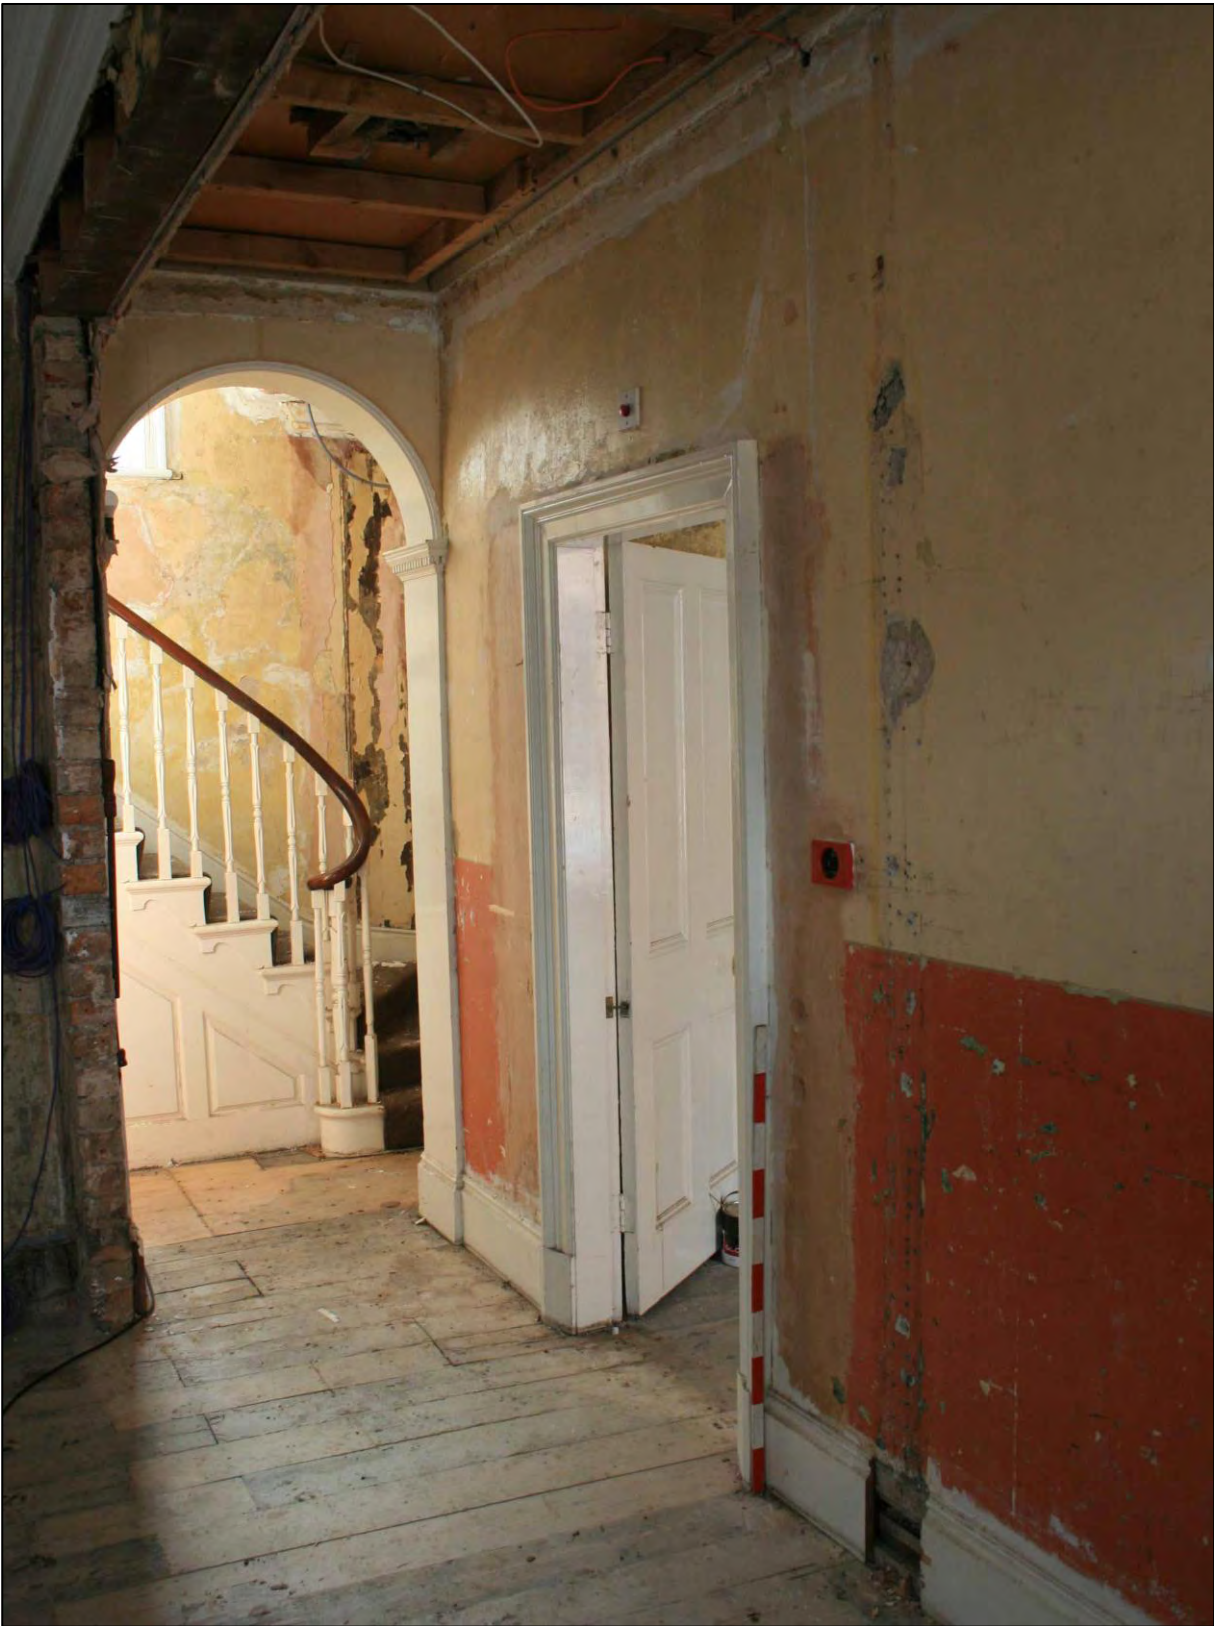
Room G2 was a narrow hallway entered via the main front door off Peckitt Street. It had been created in the 20th century by the insertion of a stud wall to divide it from Room G3. At the time of recording the stud wall had been removed thereby re-joining Room G2 to G3 (Plate 16).

Plate 16. Room G2, looking southwest.

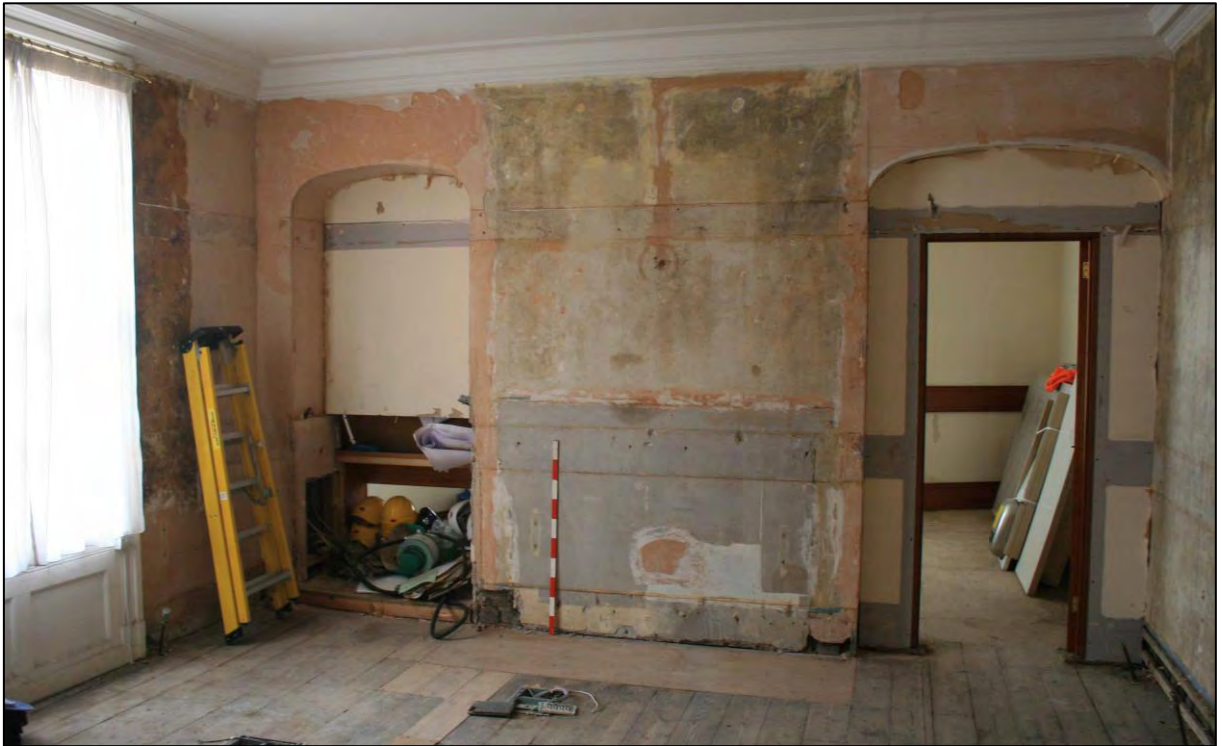
Room G3 comprised the central room within 1 Peckitt Street. It had been decorated in the 20th century to form an office. The main chimney breast was just evident between to modern alcoves in the east wall but no elements of the historic fireplace were exposed (Plate 17).

Plate 17. Room G3, looking east.

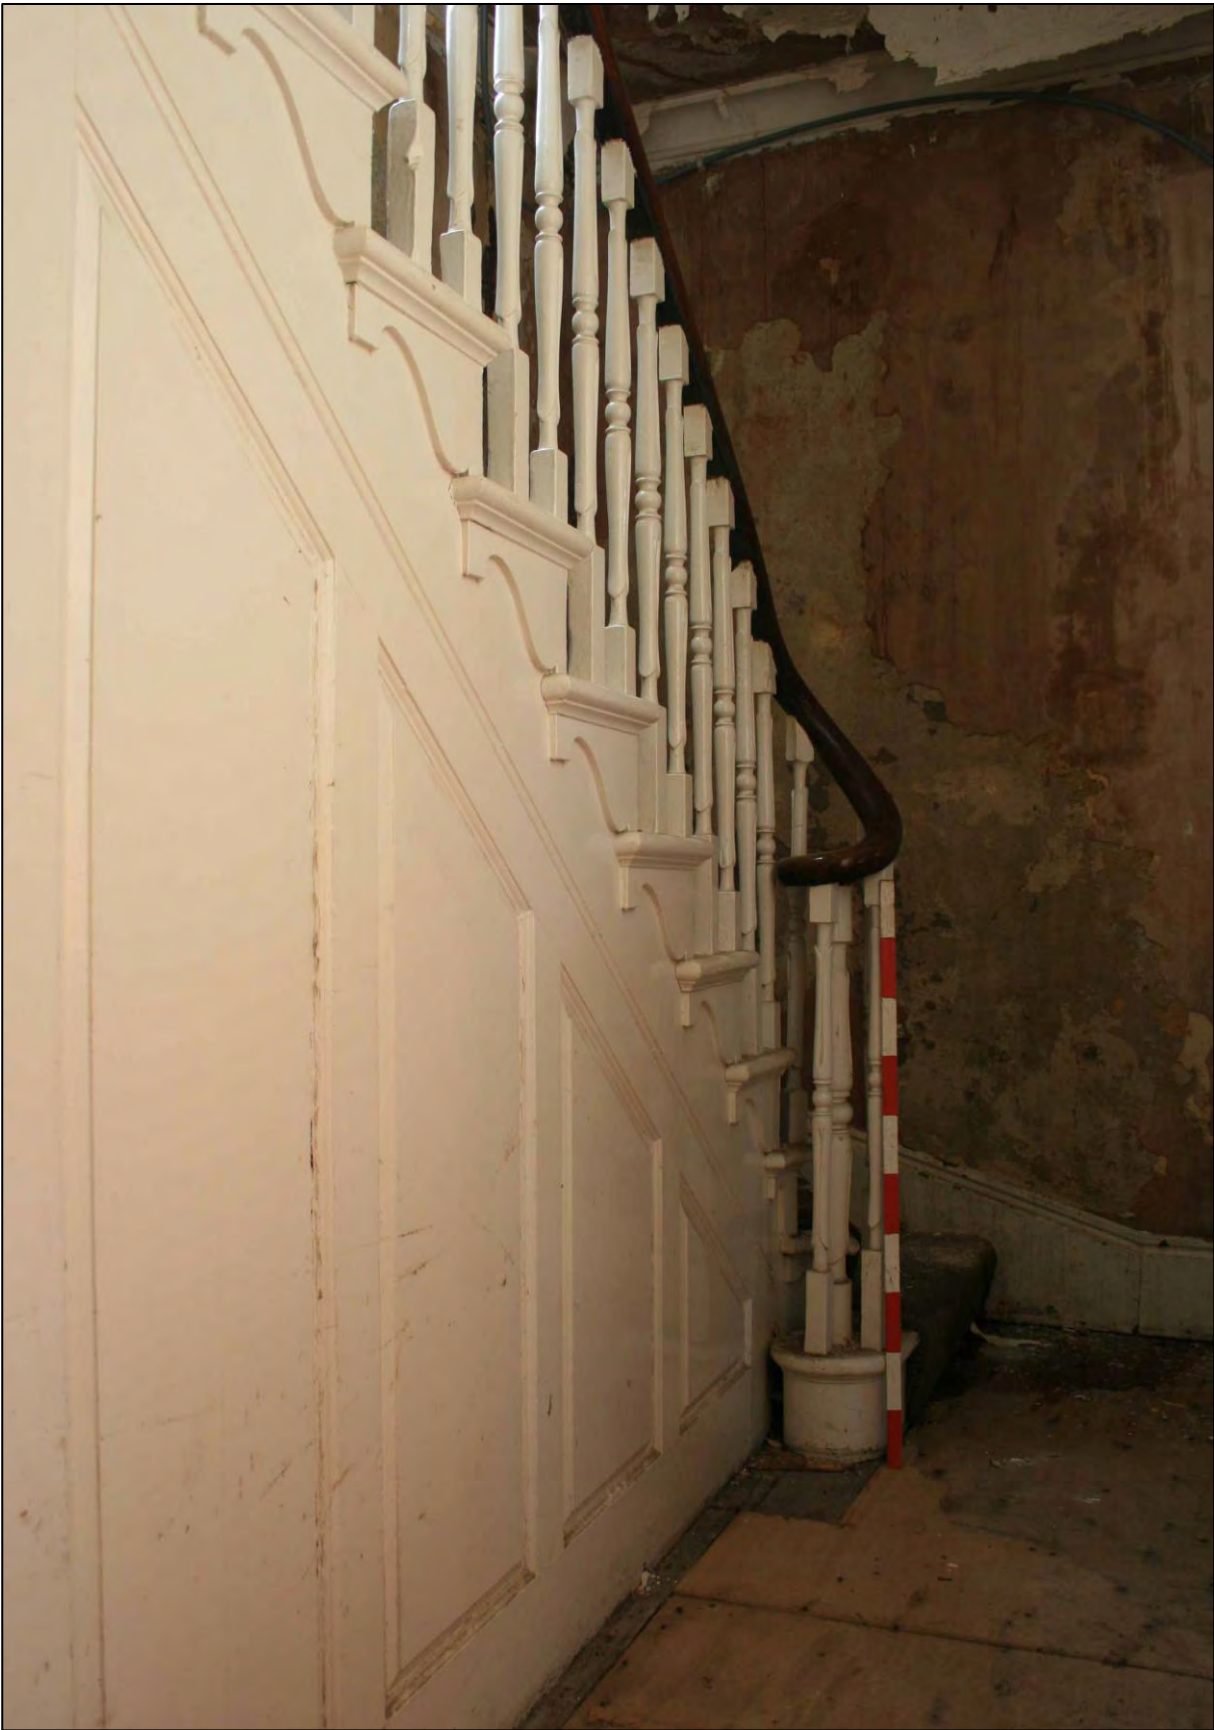
Room G5 comprises the rear stair hall for 1 Peckitt Street, although it is also linked to the rear of 6 Tower Street and provides access to the first and second floors of both properties. The original stairs are still present (Plate 19).

Plate 19. Room G5, stairs.

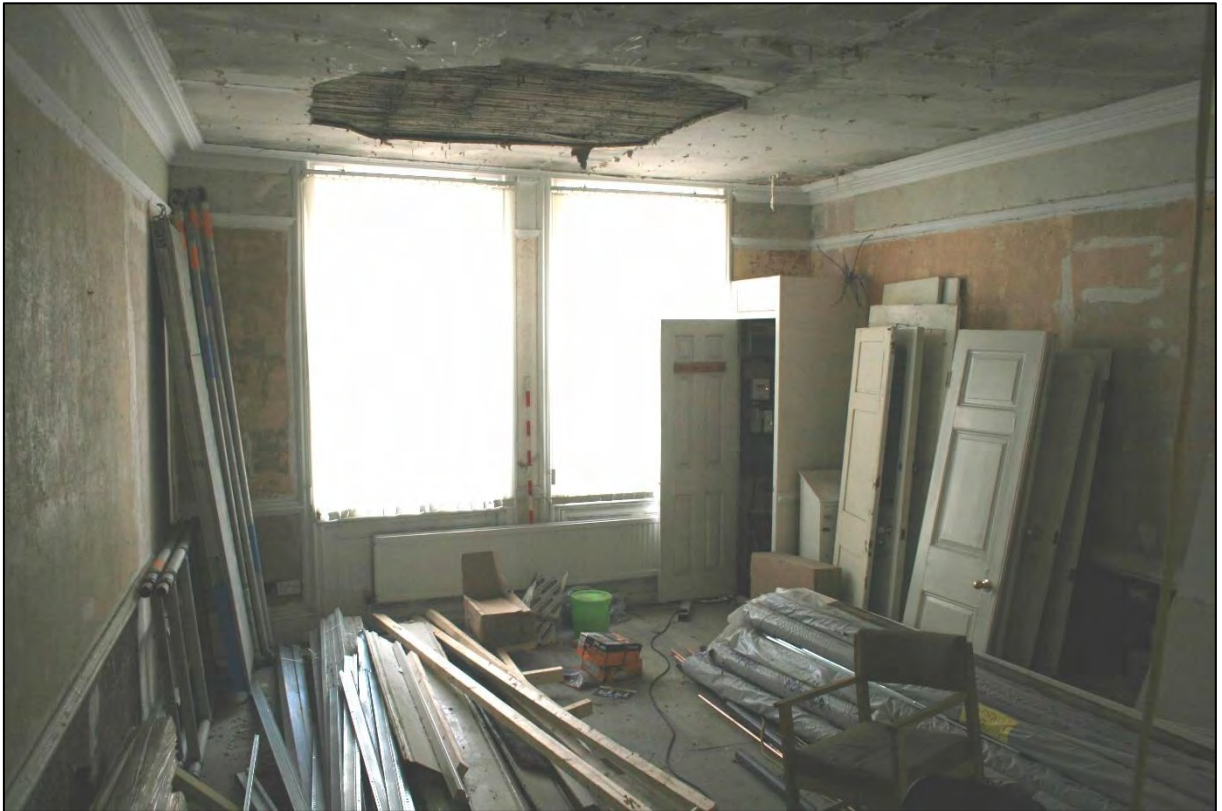
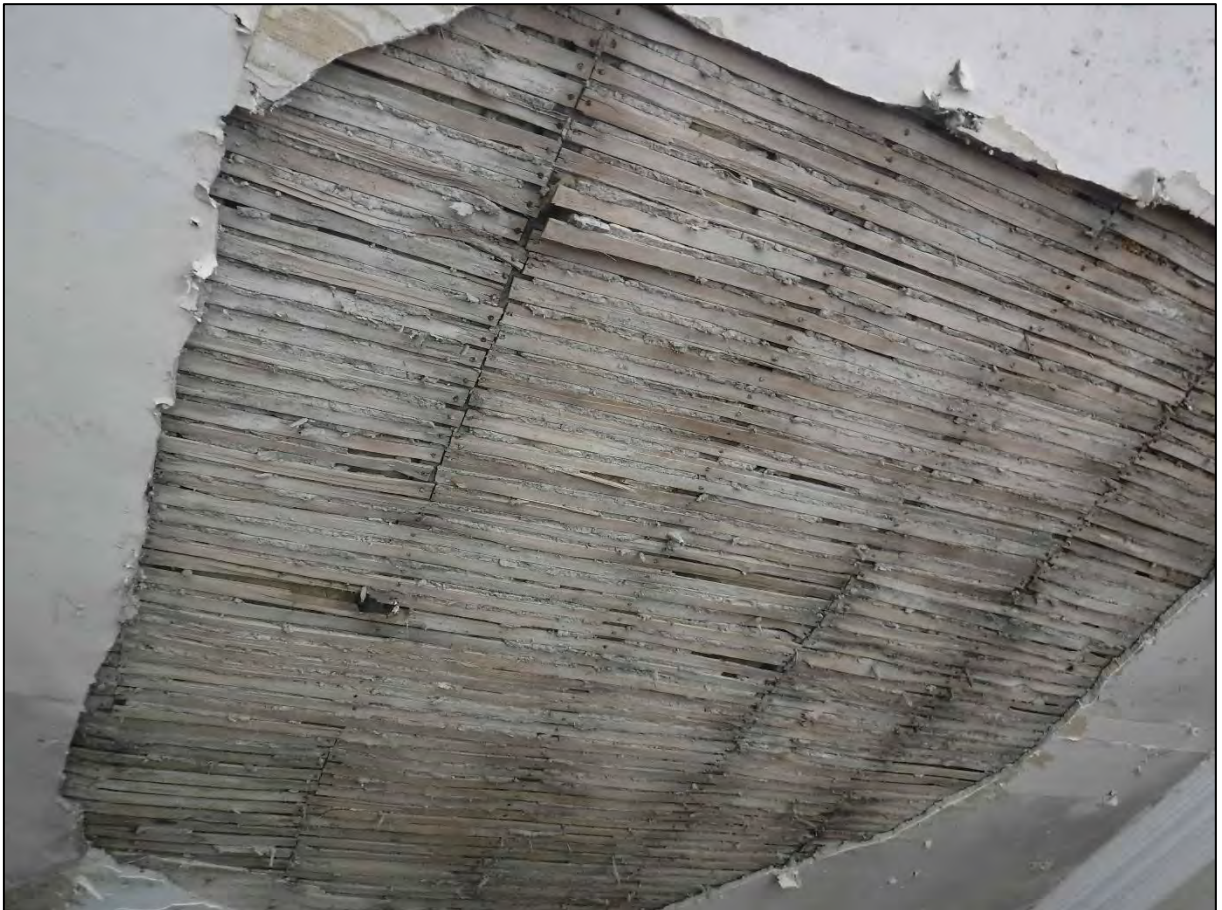
Room G6 comprises the southernmost room in 6 Tower Street and is accessed from the rear stair hall (G5). It had been decorated in the 20th century to form an office / meeting room. Part of the modern plasterboard ceiling had been removed revealing timber lathe structure (Plates 20 & 21).

Plate 20. Room G6, looking east.

Plate 21. Room G6 ceiling.

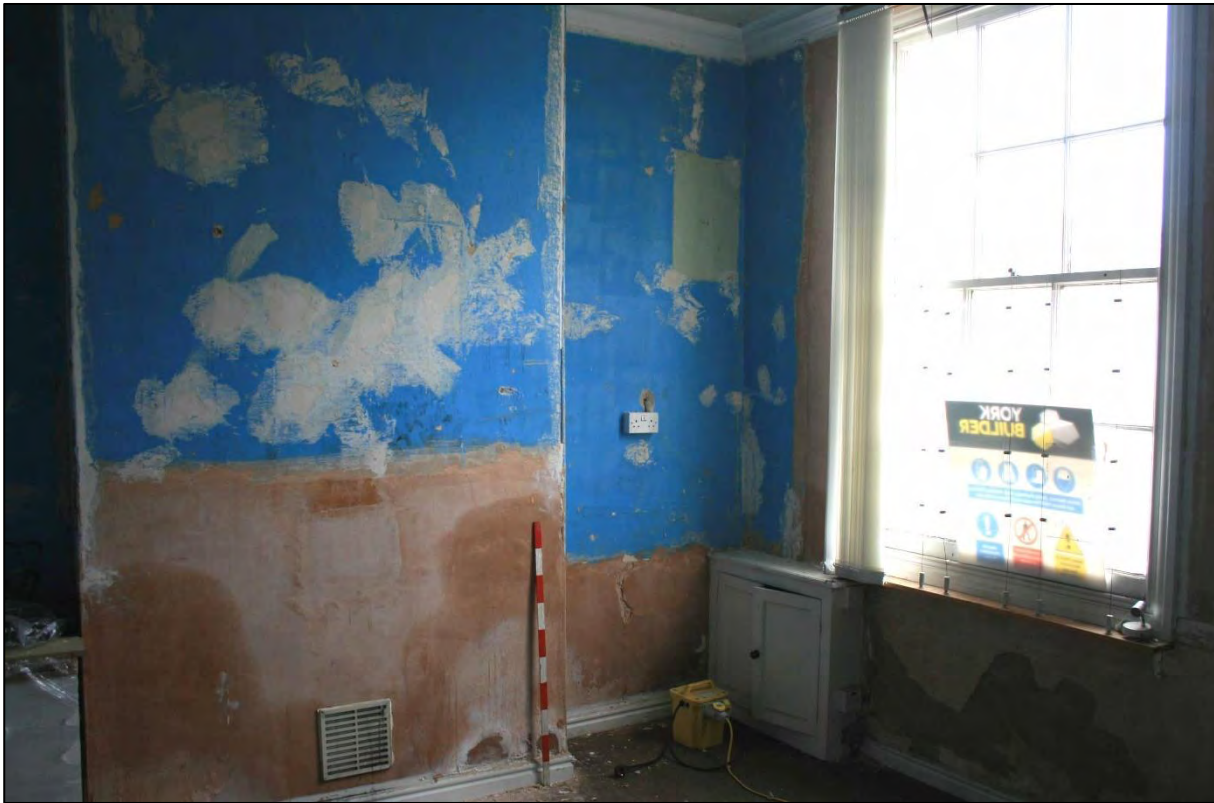
Room G7 was located towards the east of 7 Tower Street and had been decorated in the 20th century to form an office. The chimney breast was located on the north wall (Plate 22). During the course of the development selected areas of modern plaster were stripped from the lower parts of the walls. This revealed the original brick fireplace (Plate 23). Removal of the plaster also revealed the remains of a series of timber joists set into the brickwork along both the east and west walls, approximately 300mm above the level of the modern concrete floor (Plate 24). These suggest that the concrete floor is lower than the original timber suspended floor.

Plate 22. Room G7, looking northeast.

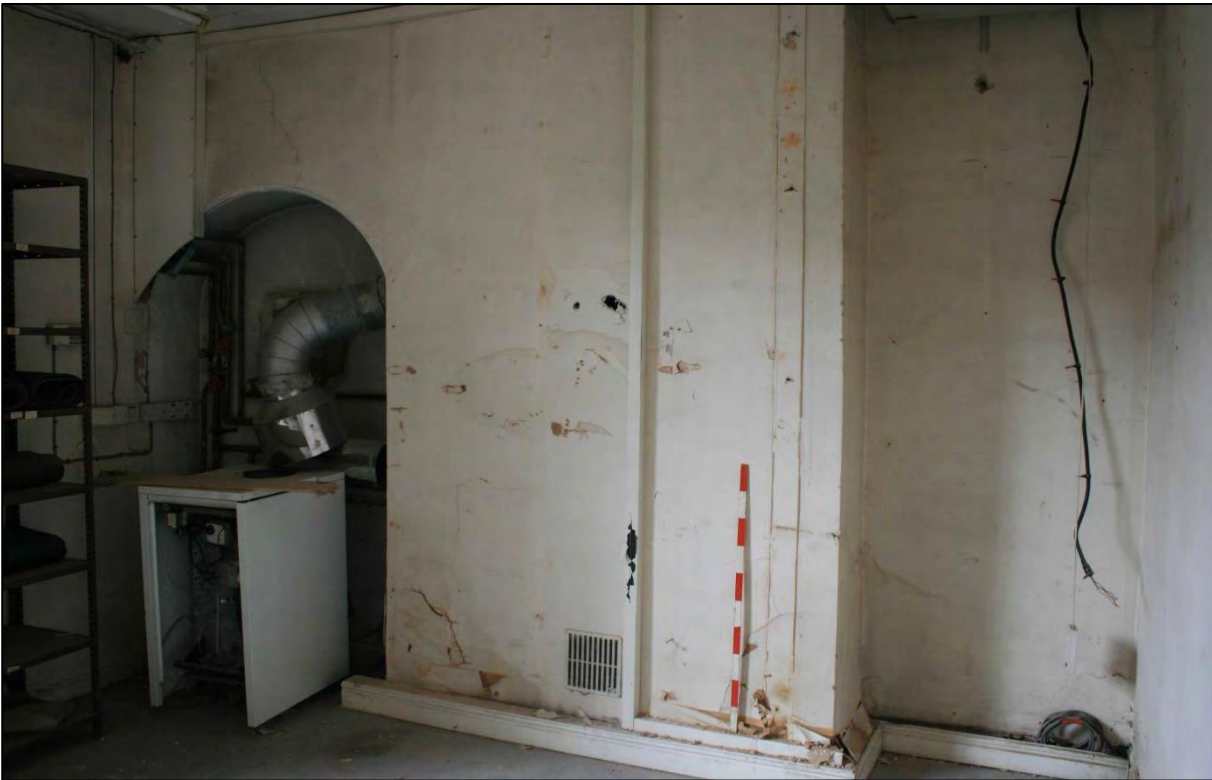
Room G9 was the westernmost, rear, room within 7 Tower Street. It had been recently utilised as a file store (Plate 27). Removal of modern fittings and plaster revealed a number of historic features including the original brick fireplace in the north wall (Plate 28). An area of modern breeze block infill in the western (rear) wall of the property appears to indicate the presence of a previously unrecorded door (Plate 29). Examination of the external face of this wall shows that the brickwork had been subject to rebuilding or repointing (Plate 30), and although the doorway is not obviously clear from the outside this is presumably related to the blocking shown on the internal face. As with Room G7 plaster removal had also revealed the presence of a series of sawn off floor joists (Plate 31) set in the brick walls, again at a height of c. 300mm above the modern concrete floor. Removal of plaster around the doorway into Room G9 (Plate 32) showed that the door had originally been positioned approximately 0.50m further to the west of the current door position in the corner of the room. The lowest identifiable part of the earlier, blocked doorway is also located approximately 300mm above the modern concrete floor level.

Plate 27. Room G9, as file store.

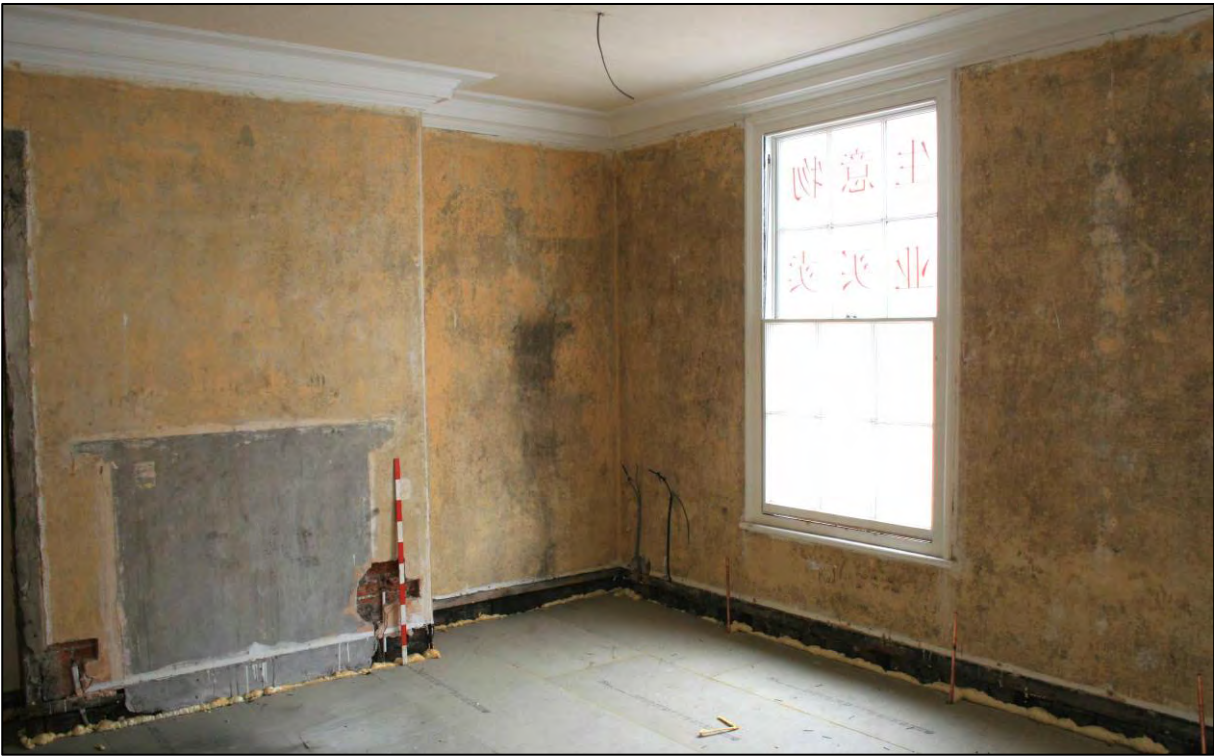
Room F1 comprised the westernmost room within 1 Peckitt Street. It had been decorated in the 20th century to form an office. The brick chimney breast was located in the west wall, but no historic elements of the fireplace were exposed (Plate 33).

Plate 33. Room F1, looking northwest.
