6-7 TOWER STREET & 1 PECKITT STREET,
YORK.

REPORT ON AN ARCHAEOLOGICAL WATCHING BRIEF
AND HISTORIC BUILDING RECORDING

OSA Report No: OSA20WB22

June 2021

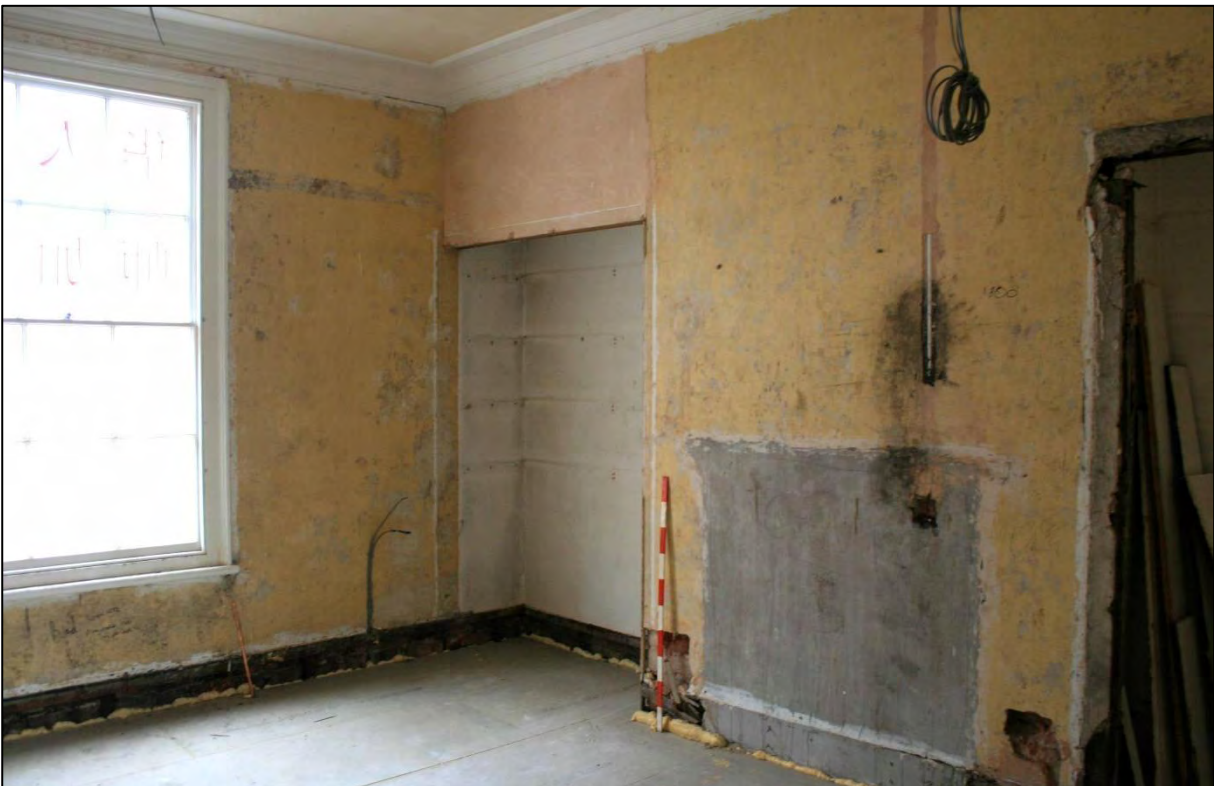
Room F2 comprised the easternmost room within 1 Peckitt Street. It had been decorated in the 20th century to form an office. The brick chimney breast was located in the east wall, but no historic elements of the fireplace were exposed (Plate 34).

Plate 34. Room F2, looking northeast.

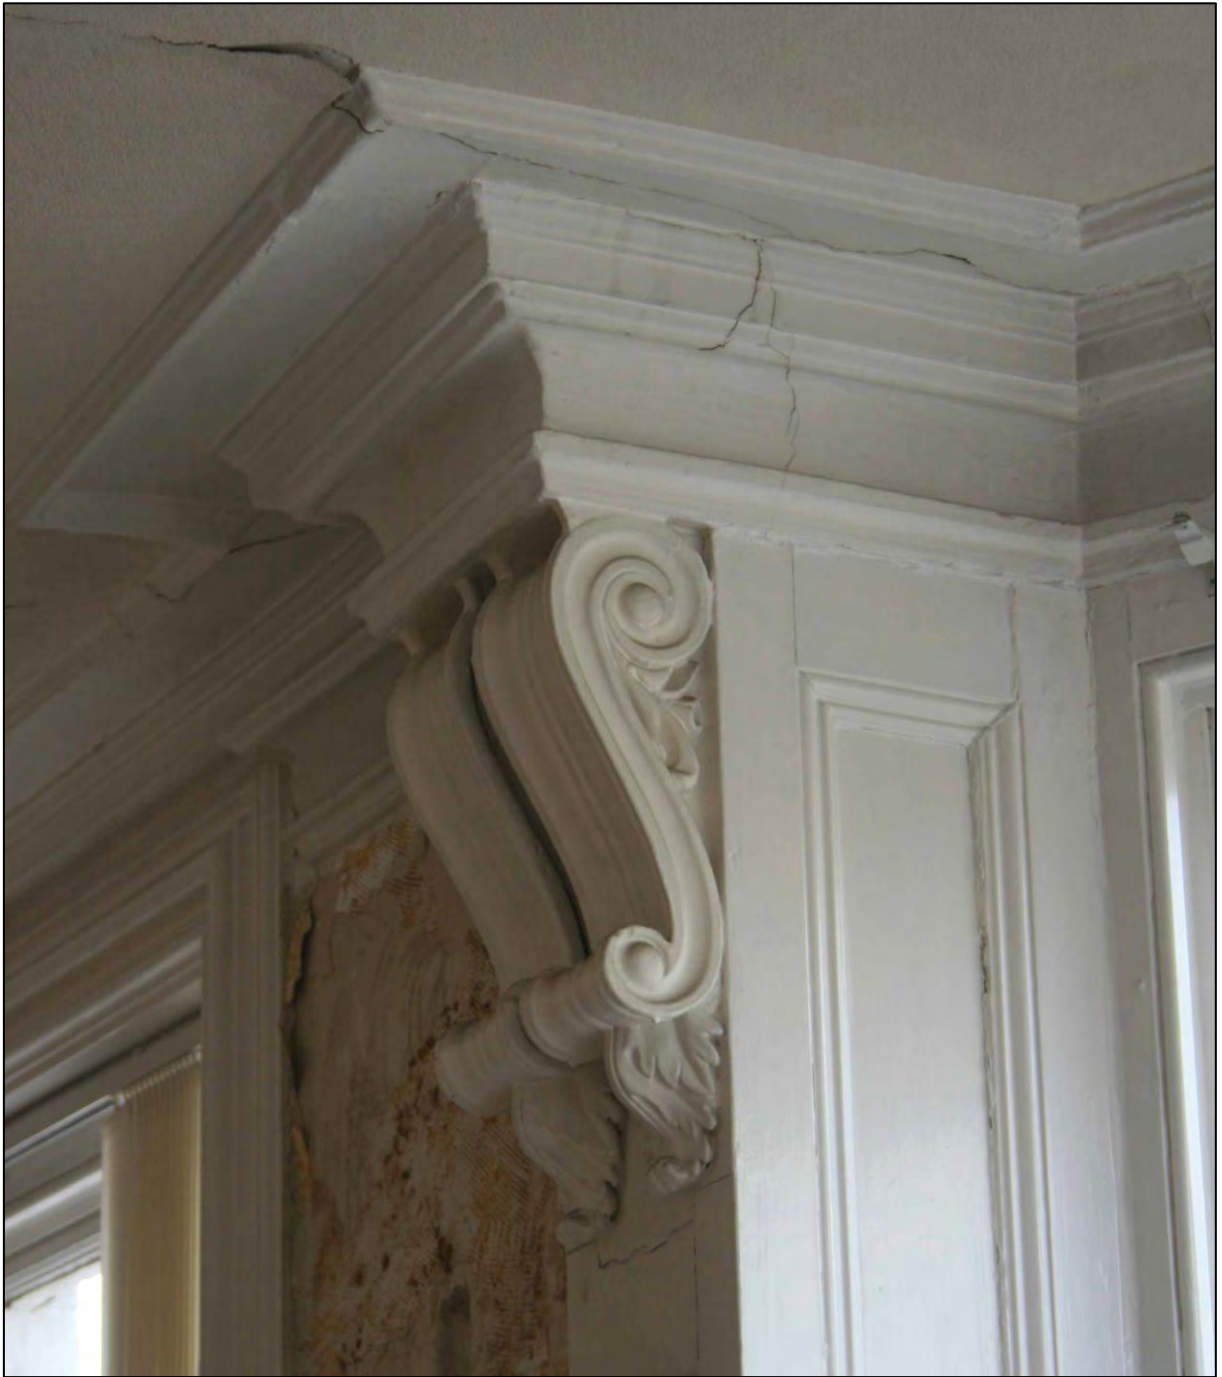
Room F3 comprised the northernmost room within 6 Tower Street. It had been decorated to form an office. The Victorian window surround is still present around the main east facing window (Plate 35).

Plate 35. Room F3 detail of Victorian window surround.

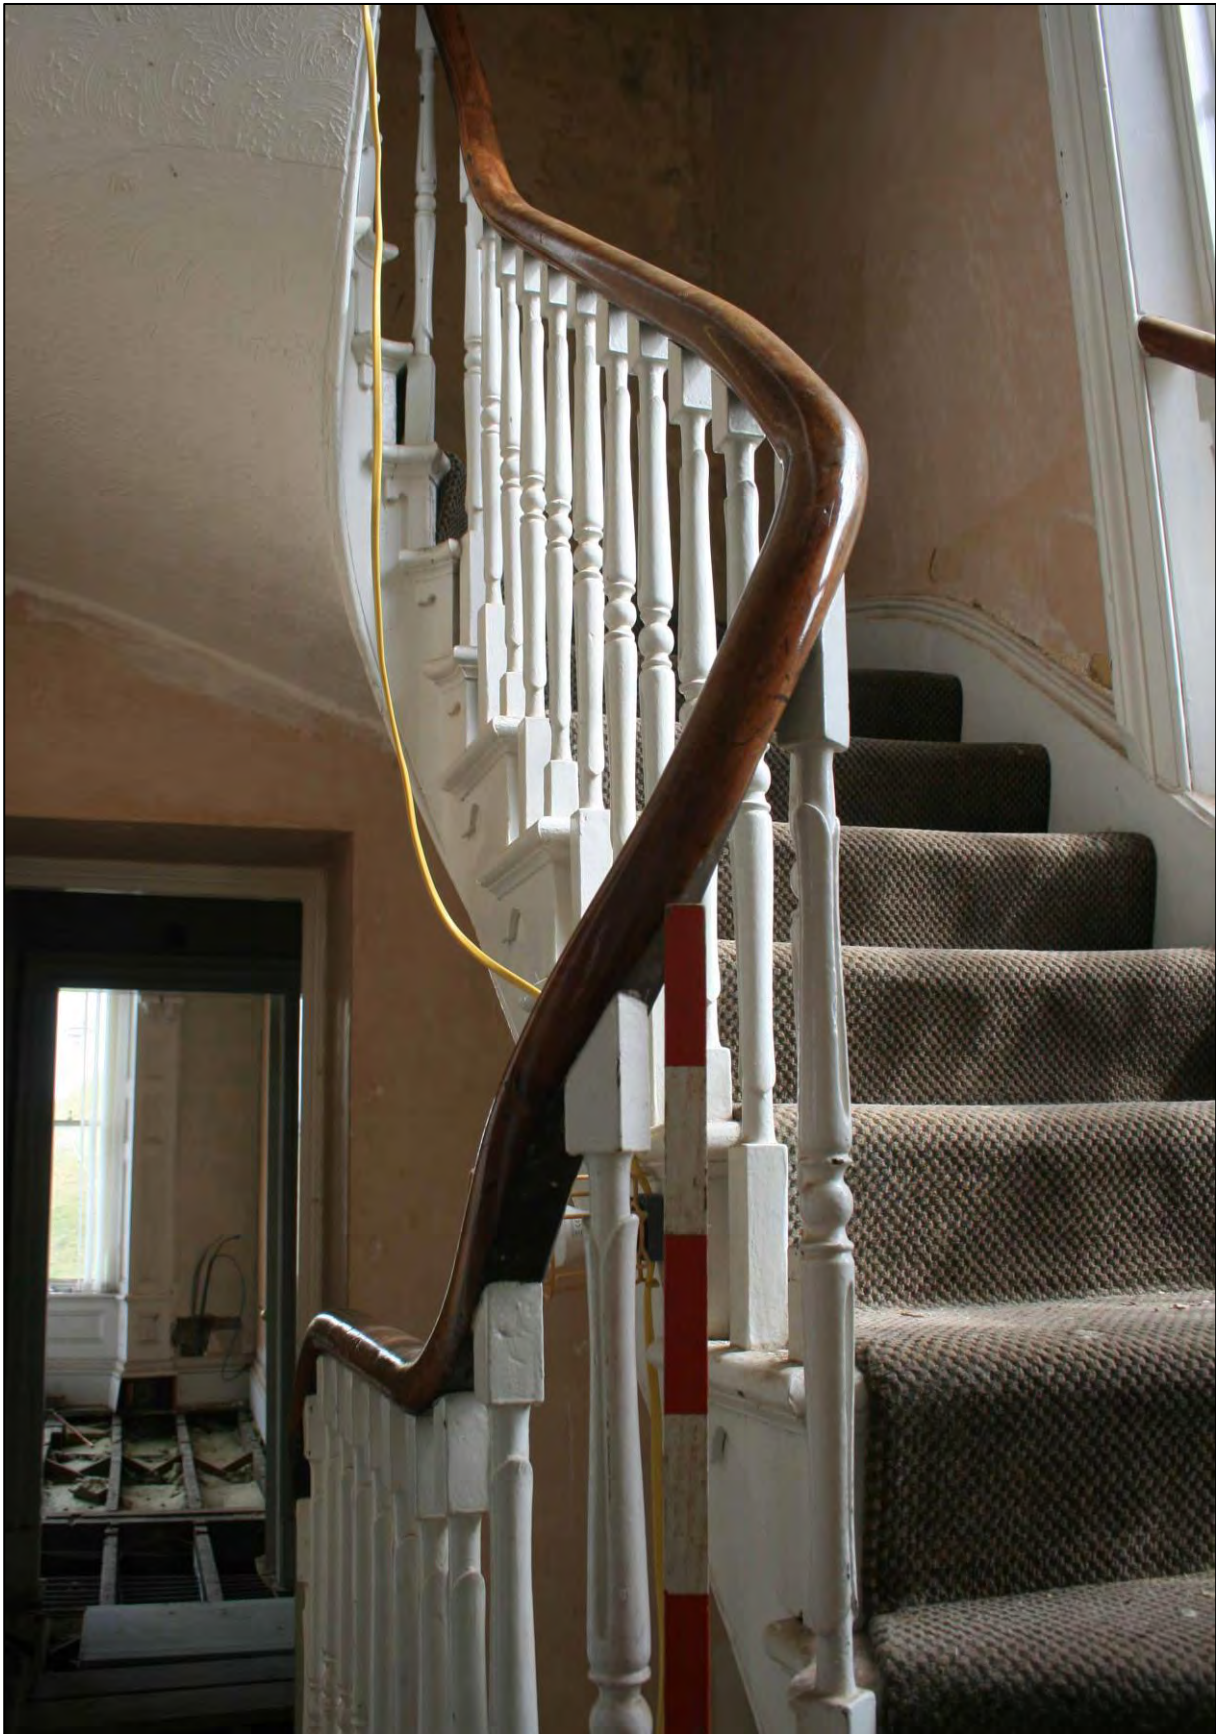
Room F5 comprised the stairs and small landing area providing access to rooms F1, F2, F4 and F6. The original wooden staircase has been retained (Plate 36) and the stairs are lit by an imposing arched window in the rear elevation (Plate 37). The scale of this window is best appreciated from an external perspective (Plate 38).

Plate 36. Room F5, stairs.

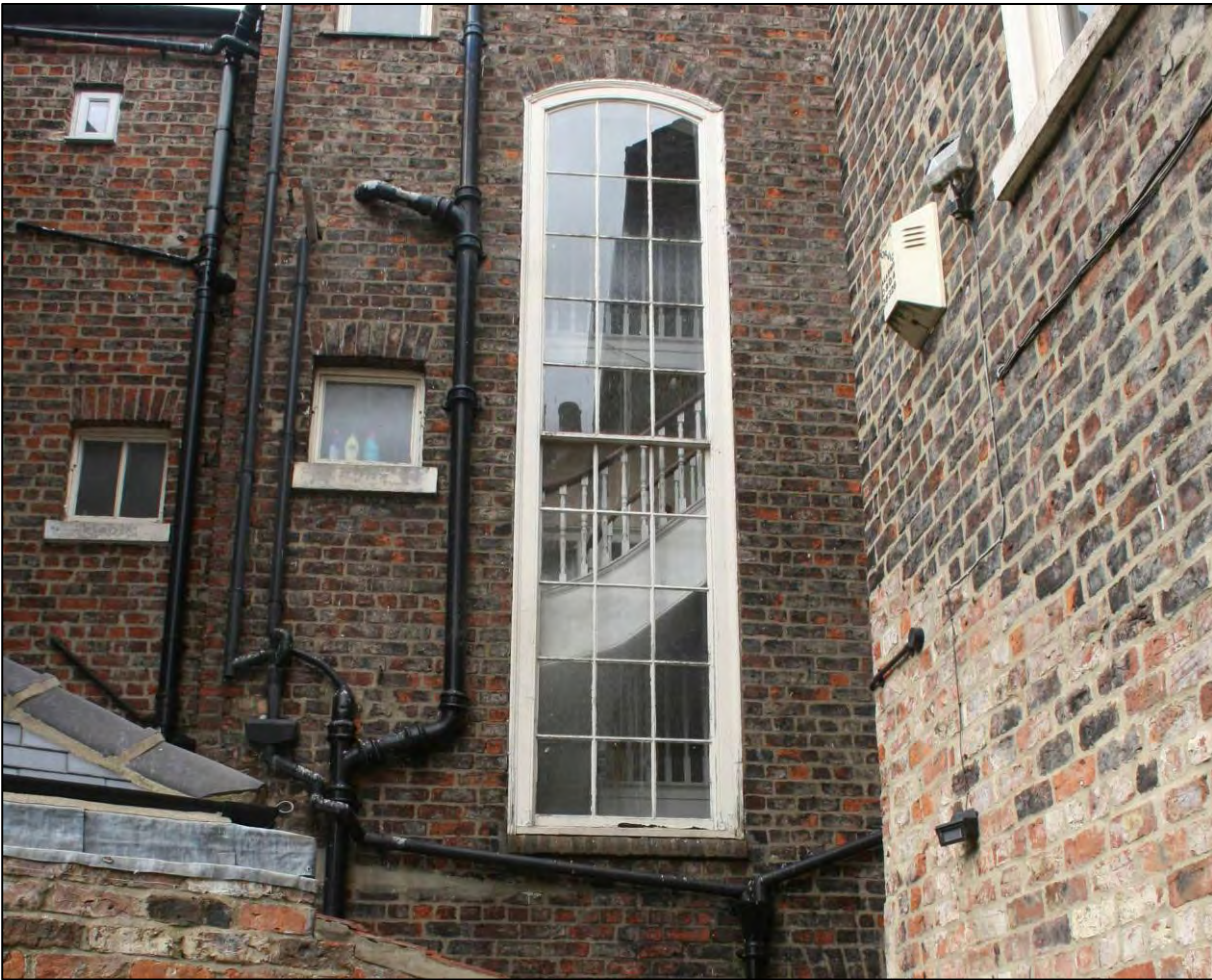
Plate 38. External view of stair tower window.

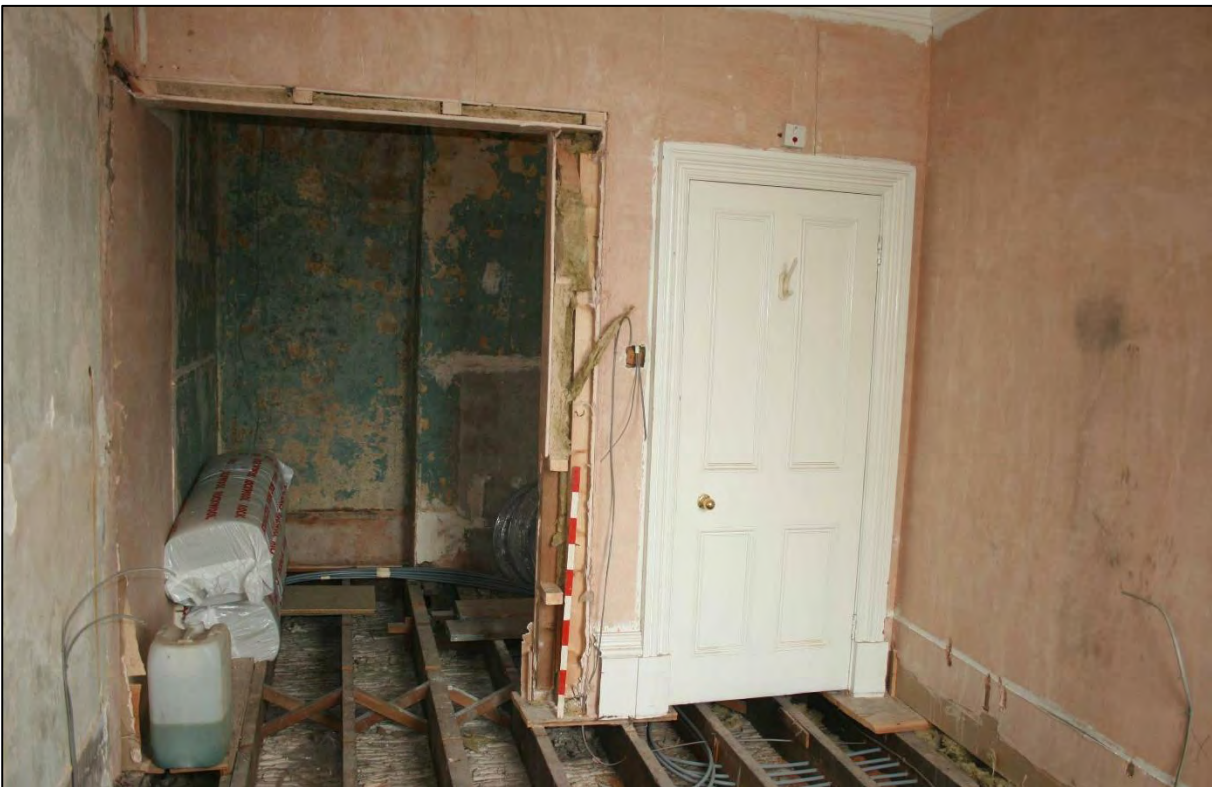
These two rooms are described together as they originally formed a single space and the division between them comprises a 20th century stud wall (Plate 39). The original chimney breast is visible in the west wall of F6 (Plate 40). The north wall of F6 includes the remnants of a patterned cobalt blue wallpaper (Plate 41) that may be late Victorian decor. The north wall of Room F7 however, appears to be a modern stud wall separating this room from Room F3 to the north (see Plate 39). Patches of the blue wallpaper are also present on the east wall of Room F7 (Plate 42).

Plate 39. Stud wall dividing Rooms F6 and F7, looking west.

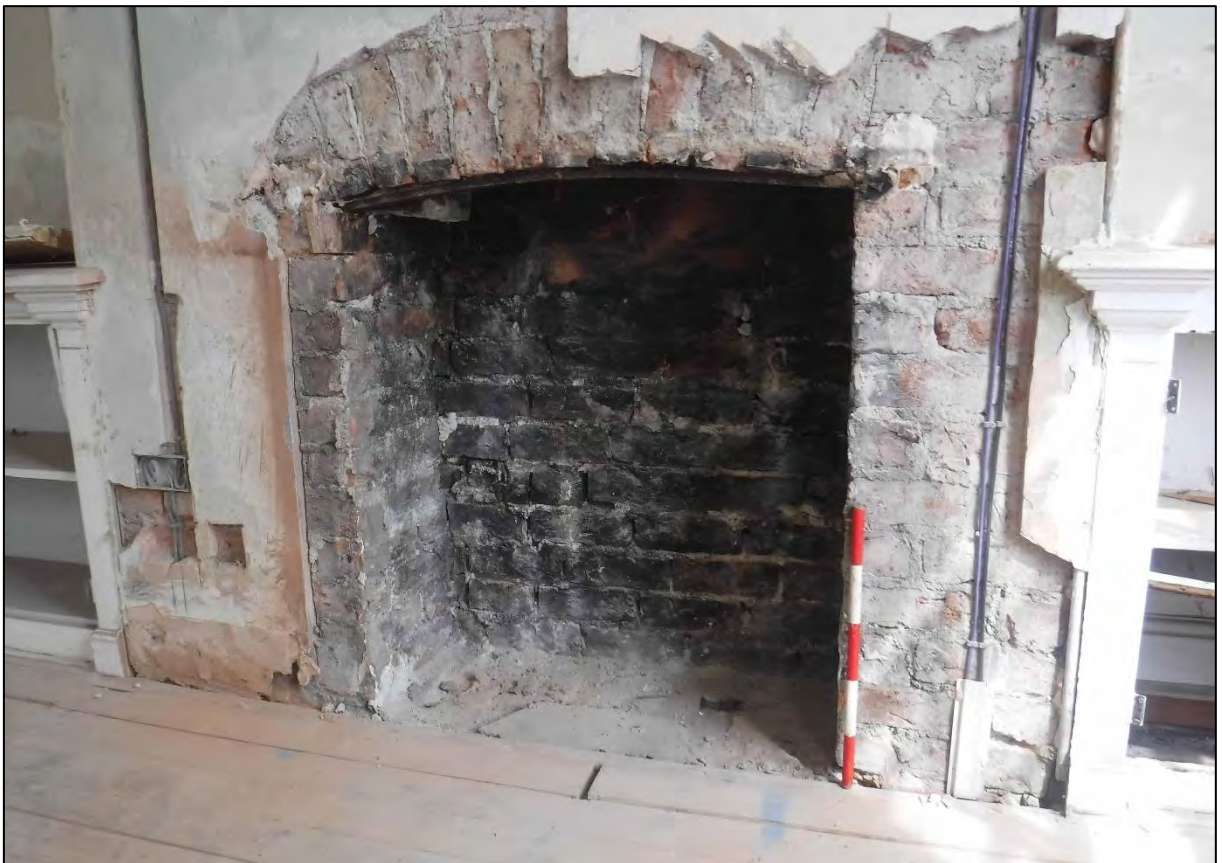
Room F8 comprised the eastern room within 7 Tower Street and had been decorated for office use in the 20th century (Plate 43). The chimney breast was visible on the north wall. Removal

of modern plaster revealed the original brick fireplace (Plate 44). The doorway in the northern half of the west wall has been blocked and a new doorway opened at the south end of this wall (Plate 45). Examination of the brickwork where plaster had been removed adjacent to the new doorway identified part of a possible brick lintel. If this is indeed a lintel then it would suggest that the original doorway into Room F8 was located immediately off the stairs and the new door has approximately recreated this entrance.

Plate 44. Room F8, fireplace.

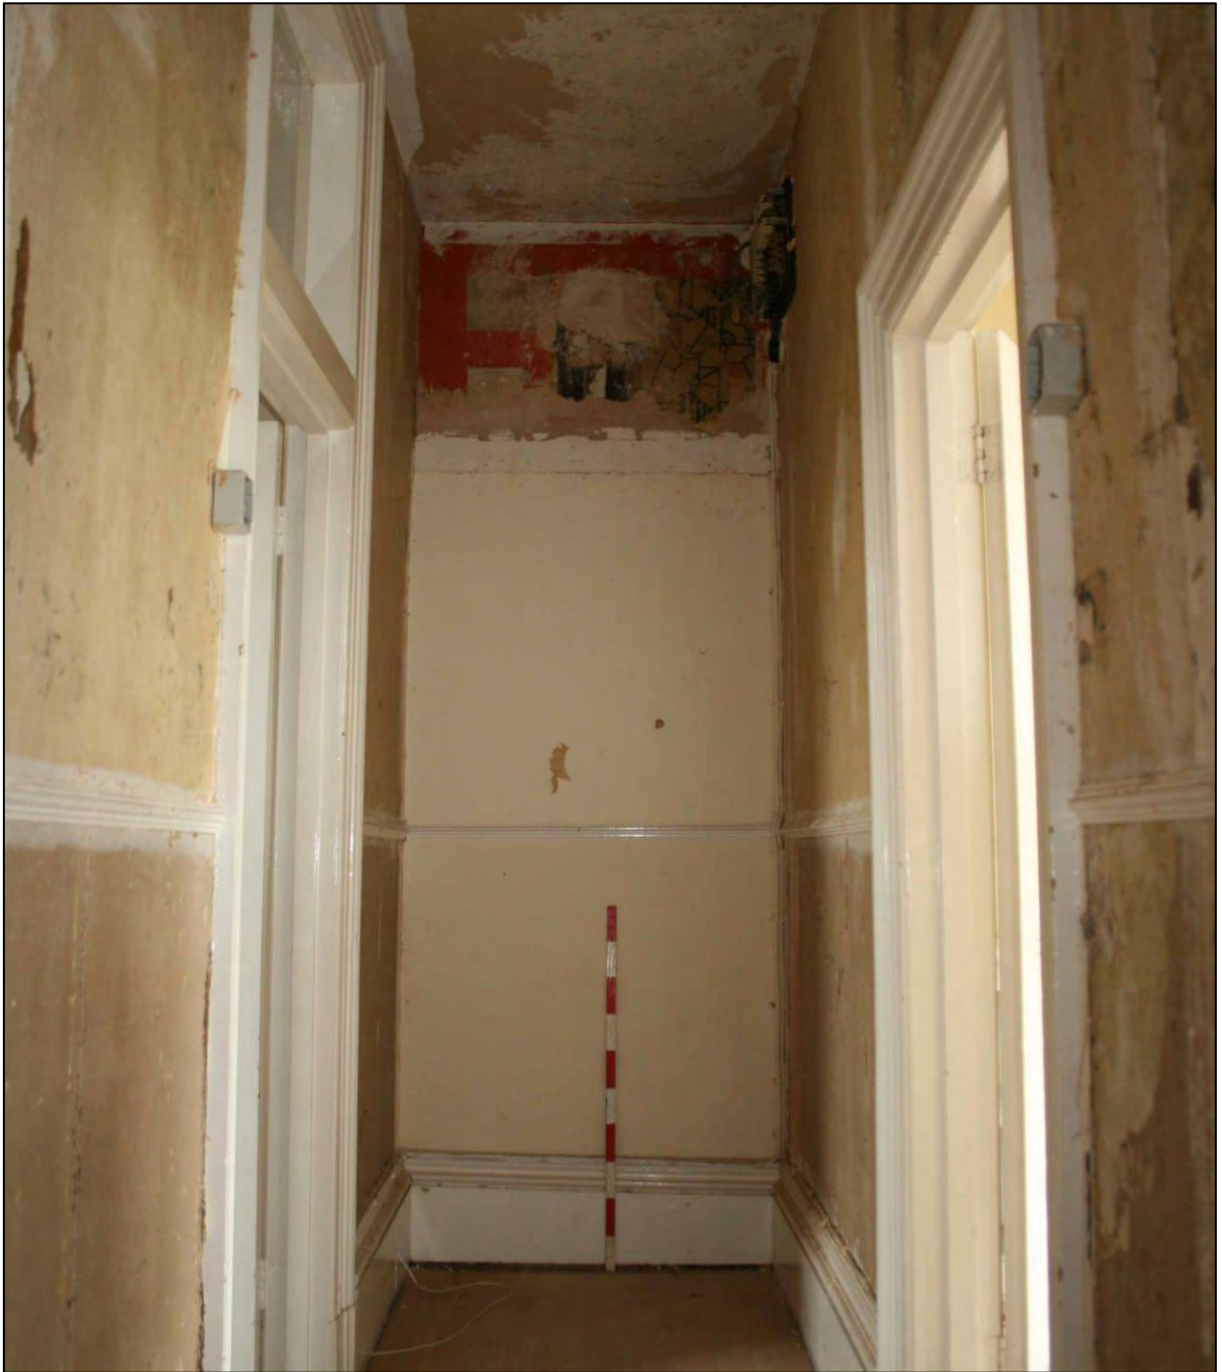
This comprised a hallway between Rooms F8 and F10 (Plate 46). Close to the ceiling, exposed by the removal of the earliest surviving wallpaper, was a small area of black painted decoration (Plate 47). This appears to be a geometric pattern, probably of early 20th century date, rather than relating to the original Victorian décor. Although this will no longer be visible it will be preserved within a service void.

Plate 46. Room F9, looking north.

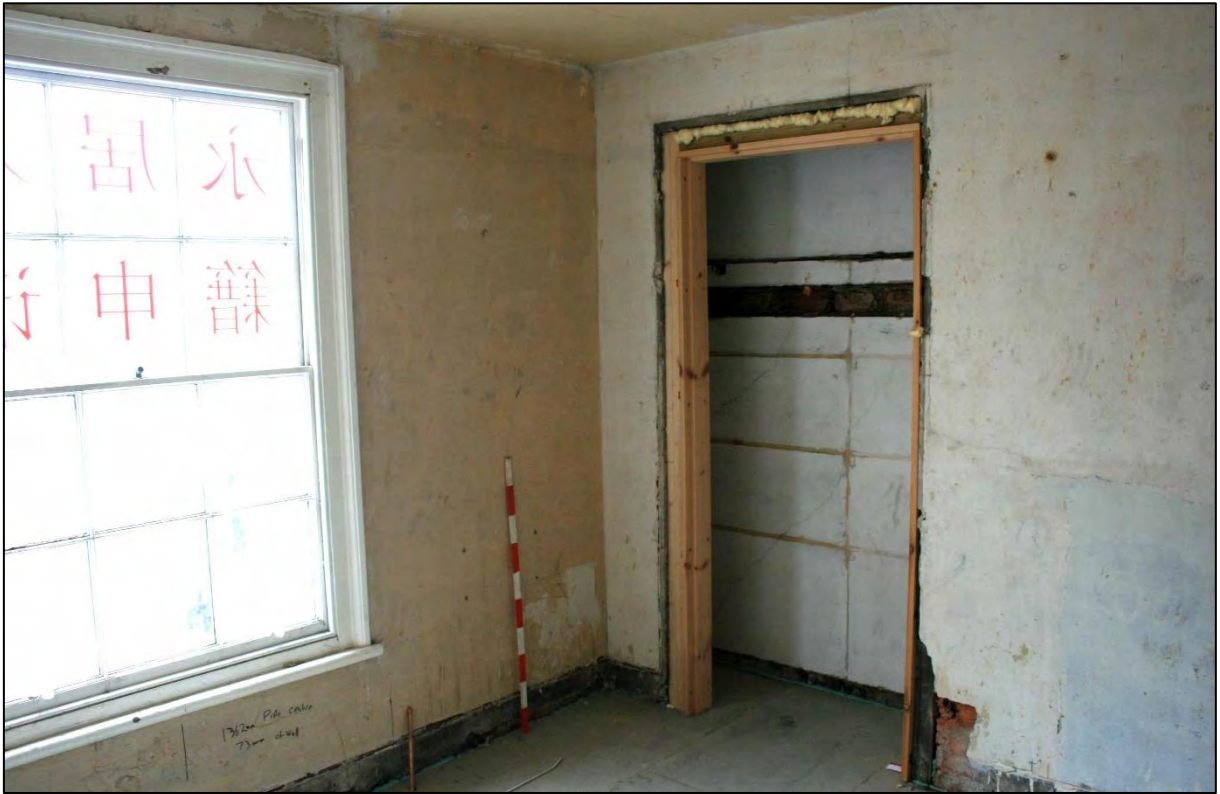
These four rooms were located in the northern part of site (in 1 Peckitt Street and 6 Tower Street) and had been converted to office use in the 20th century. No historic features were evident (Plate 50).

Plate 50. Room S3, example of 20th century office.

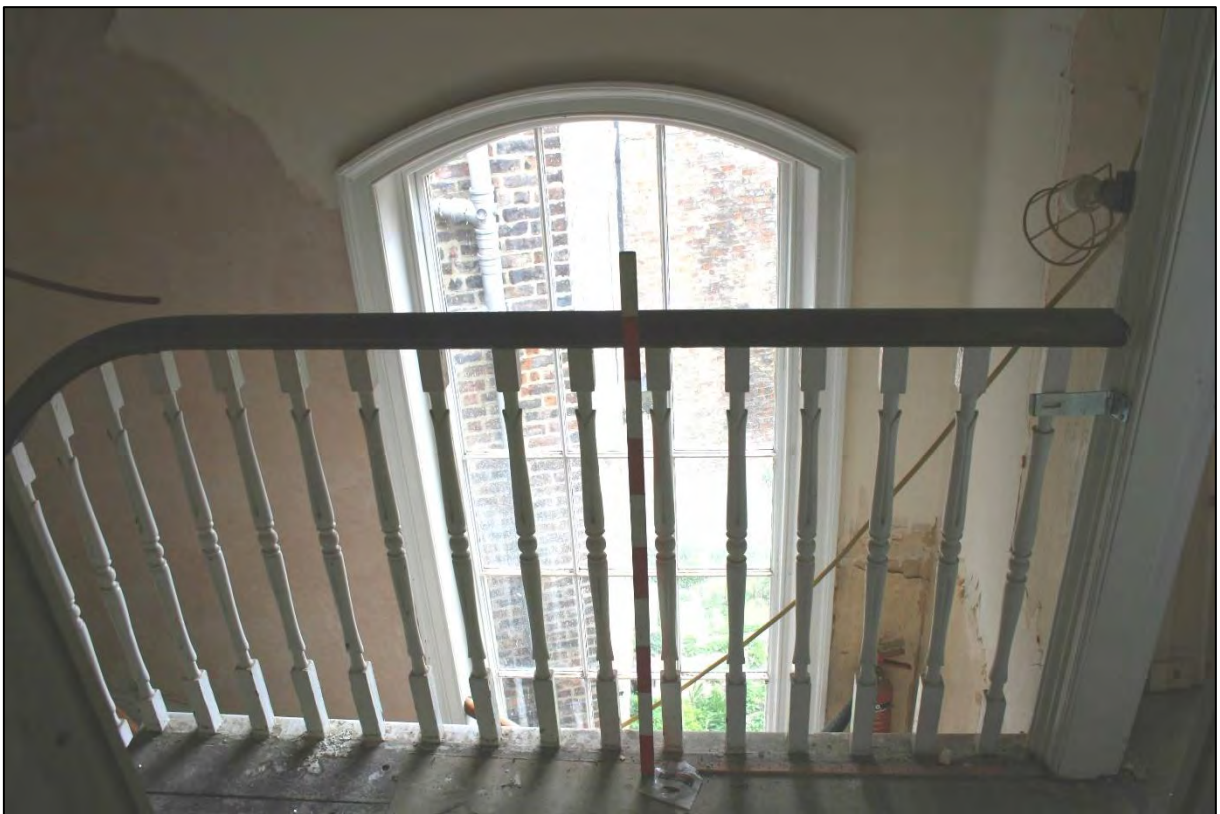
Room S6 comprised the upper landing and stairs to the rear of 1 Peckitt Street. The original wooden staircase is still present and the upper part of the large window described in F5 lights this landing (Plate 51).

Plate 51. Room S6, banister and window.

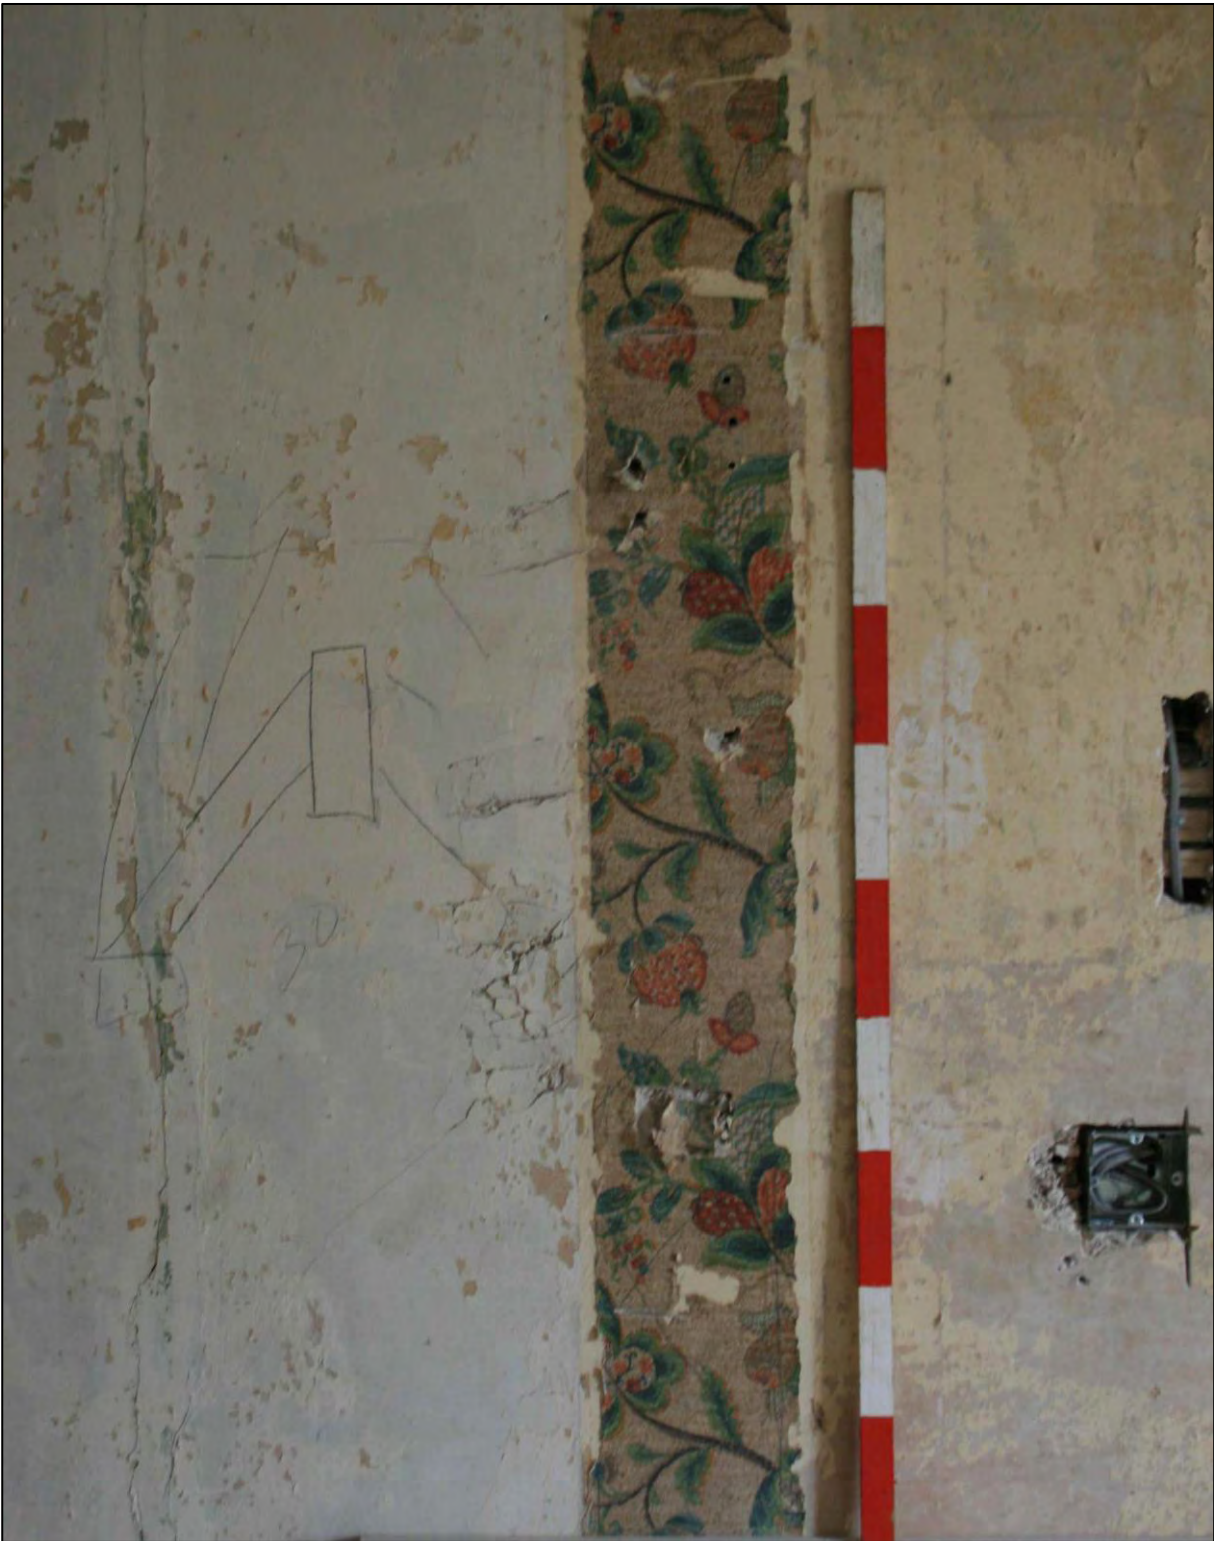
These two rooms were originally a single room within 6 Tower Street but had been divided by a modern stud wall to form an office and separate lobby. Removal of the stud wall had revealed a narrow strip of potentially historic wallpaper on the north wall (Plate 52). No other historic features were observed in these two rooms.

Plate 52. Rooms S7 and S8, wallpaper revealed by removing stud wall.

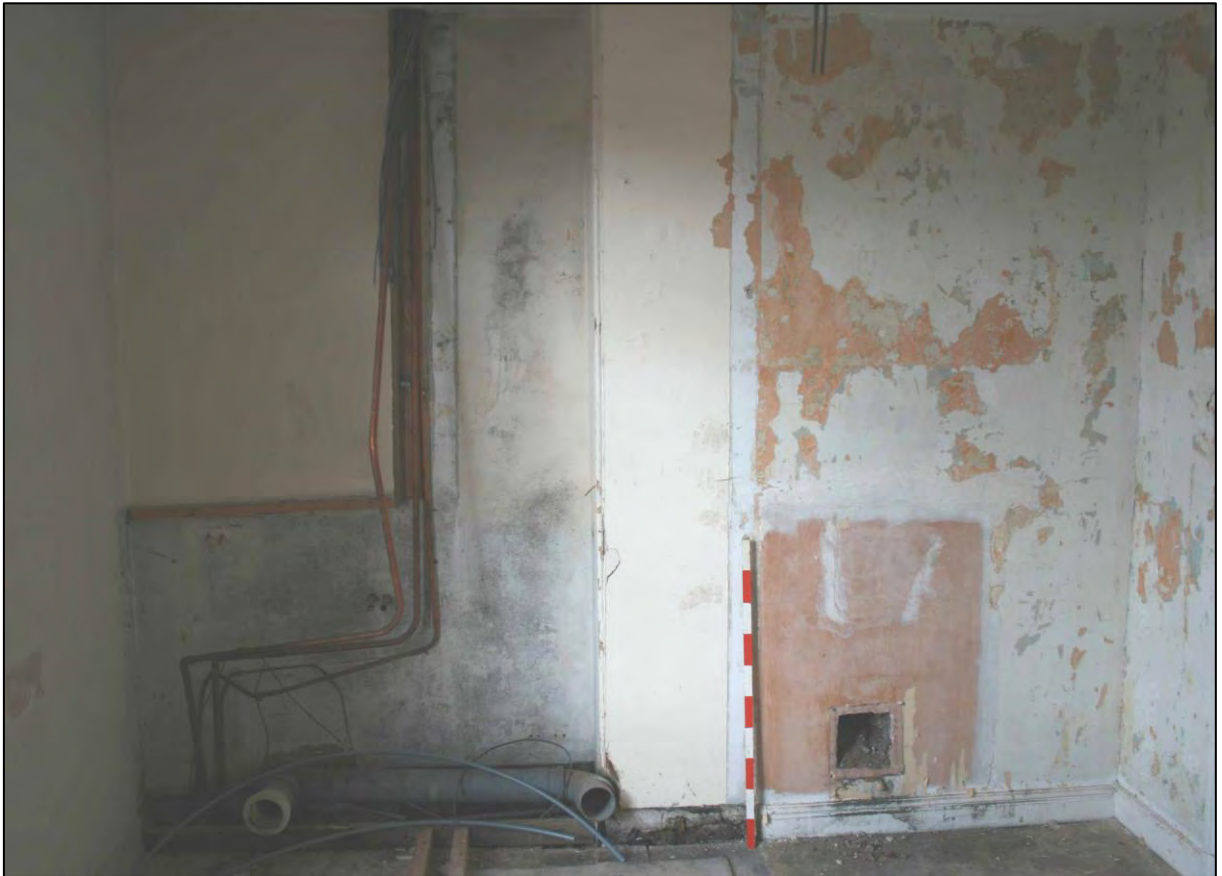
Room S9 was located in the western, rear part of 7 Tower Street and had been converted in the 20th century to a toilet, serving the offices. At the time of recording the room had been cleared. The location of the chimney breast could be determined on the north wall although no original fireplace brickwork was visible (Plate 53).

Plate 53. Room S9, location of chimney breast.

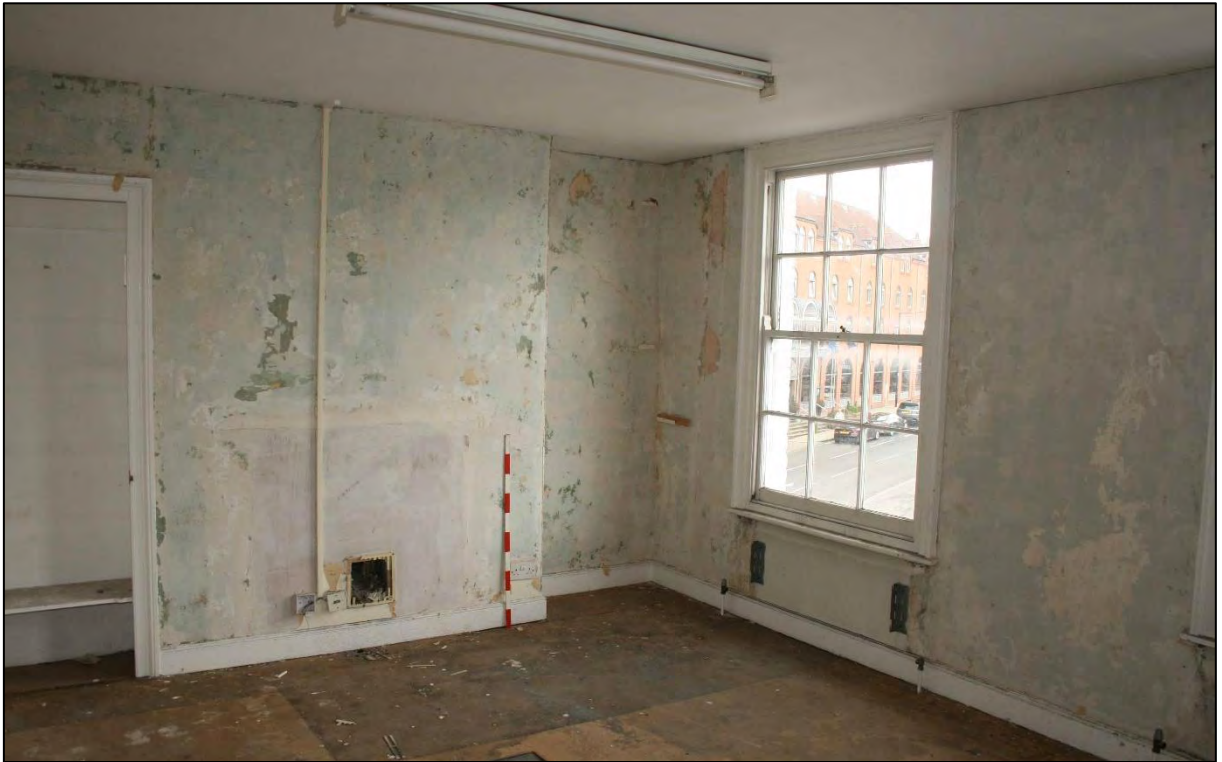
Room S11 comprised the eastern room in 7 Tower Street. It had been converted to office use in the 20th century. The chimney breast was visible on the north wall but no original fireplace brickwork was visible (Plate 55).

Plate 55. Room S11, looking northeast.

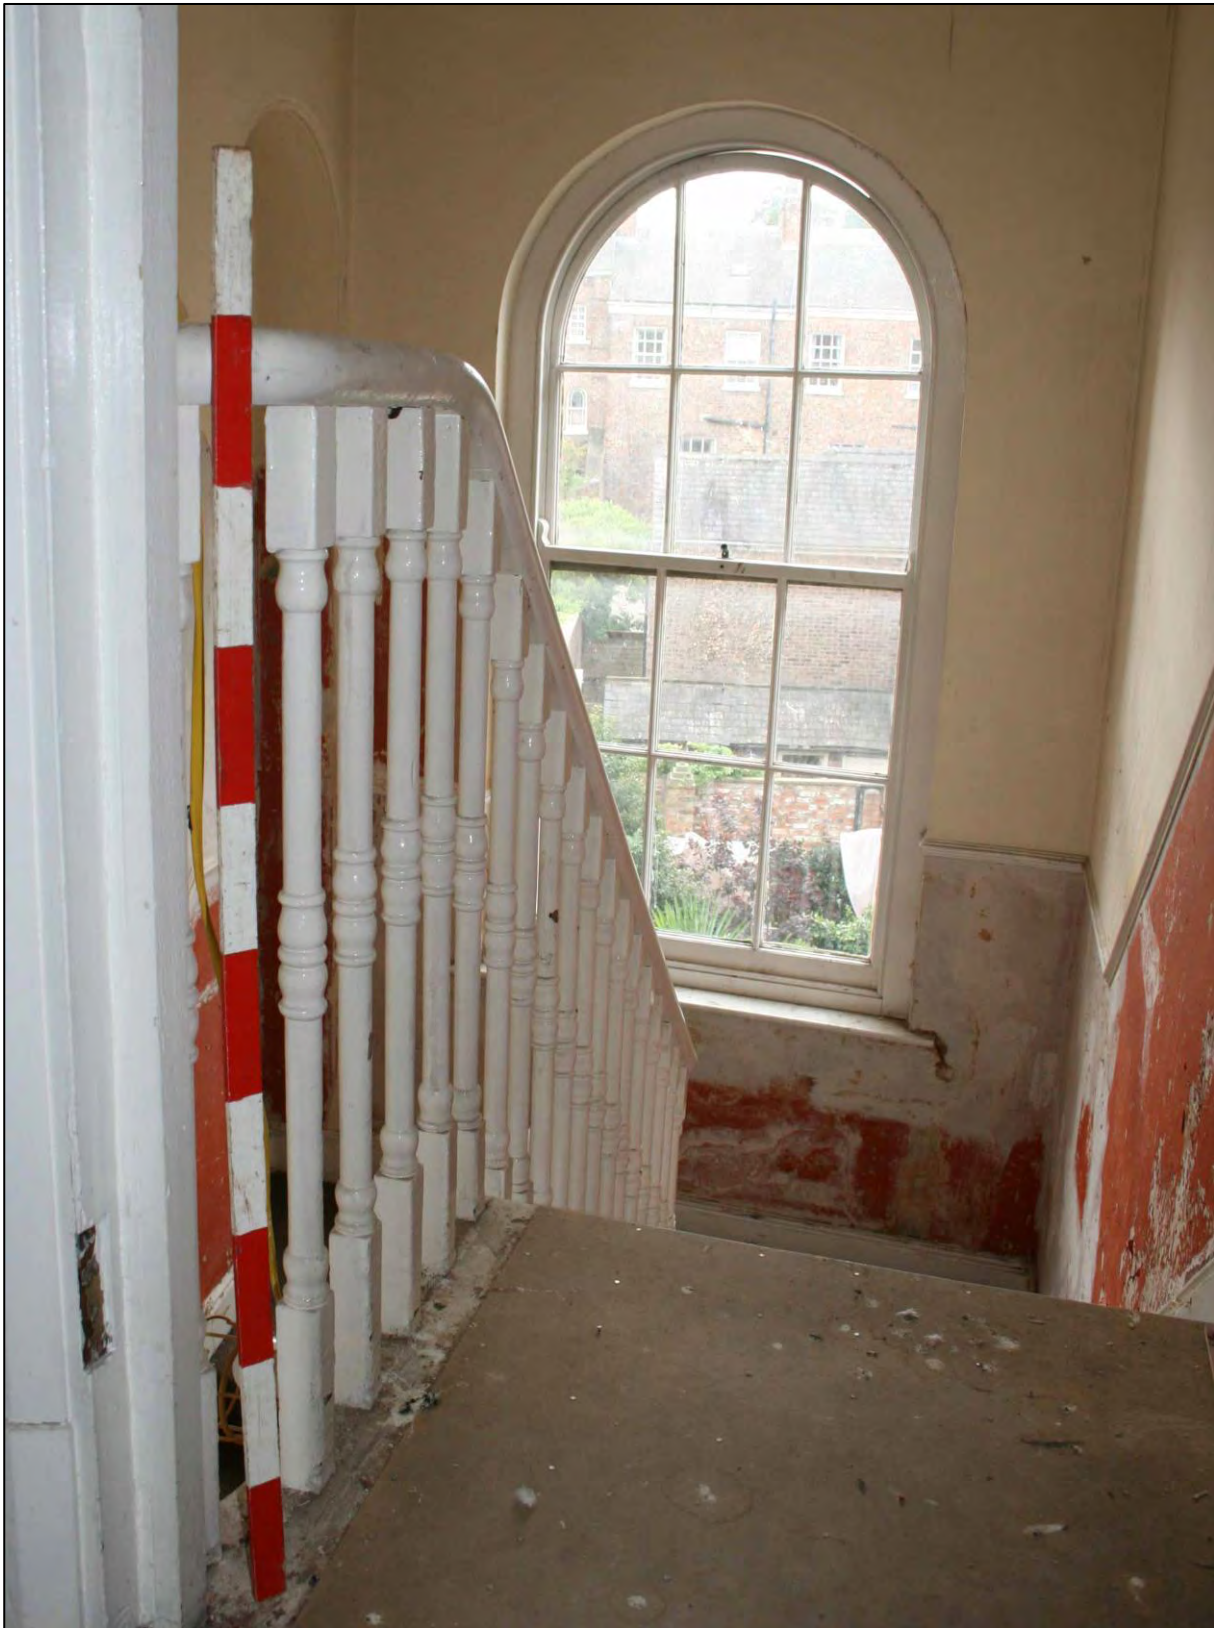
This comprised the upper part of the rear stairs for 7 Tower Street, which included the original wooden staircase (Plate 56).

Plate 56. Room S12, stairs.
