68-70 Walmgate, York

Heritage Impact Assessment

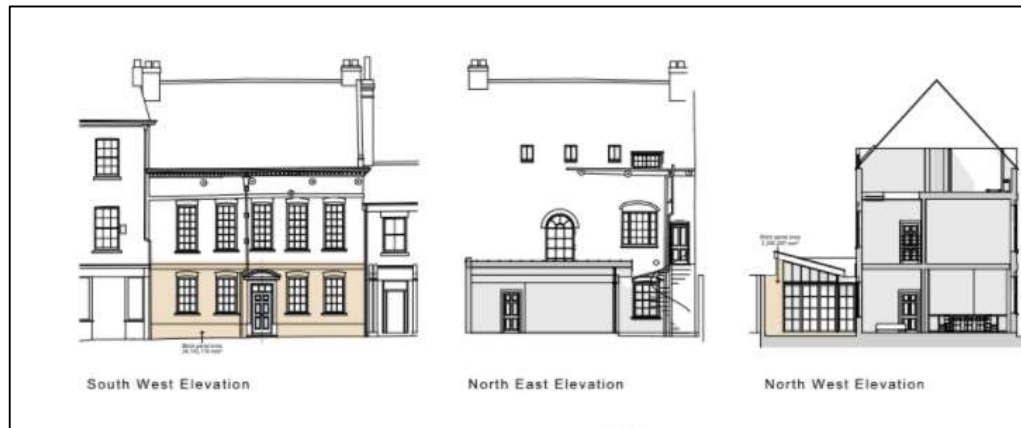
Fig 7 Original proposals for the front elevation were considered too conjectural

11. Key works include:
 - Removal of the modern shop front (Fig 29D) and reinstatement of an appropriately detailed, timber front door and surround and four, single-glazed sash windows to match those at first floor. The design below at Figure 7 was originally proposed but it was decided this was too conjectural. The brick plinth, for which there is no evidence, and the smaller pane windows have therefore been omitted. Proposed windows will be single glazed and match the existing. The door is based on the examples at Figure (34) which are located in eighteenth-century houses on St Saviourgate (Fig 24). It is assumed that there is a substantial, modern lintol behind the shop front. This will be cut out and the lintols to the new windows and door

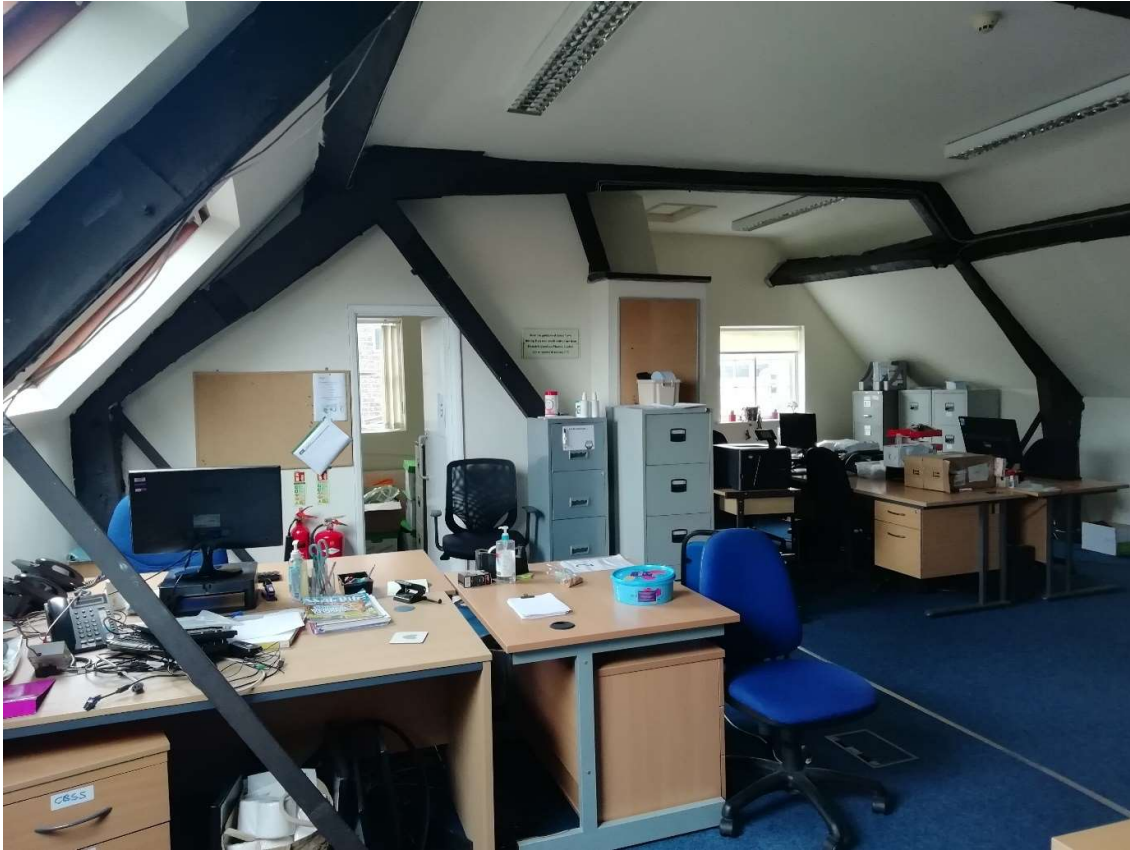
Fig 12 Attic (west to east) with gable windows and steel, strap ties

investment made in 2019 in strengthening the roof and the attic floor (Figs 12 and 13). To facilitate the use of the ground floor as retail space, new openings have been made and original doors blocked which has undermined the original plan form and 'flow' of the building (Figs 24, 25 and 29A). Two new doors have also been formed in the rear elevation to access modern, double pile, office extensions which have been formed in the yard (Fig 26).

- Lightweight, reversible stud walls will be fitted within the attic space to create 2 no. bedrooms and 2 no. bathrooms. This is one of the least sensitive spaces within the building due to extensive refitting works that took place in 2019 to strengthen the building. Stud walls will follow the line of existing trusses with stud work set within the extant structure so that it remains visible for purposes of legibility and visual character (Figs 12 and 13)

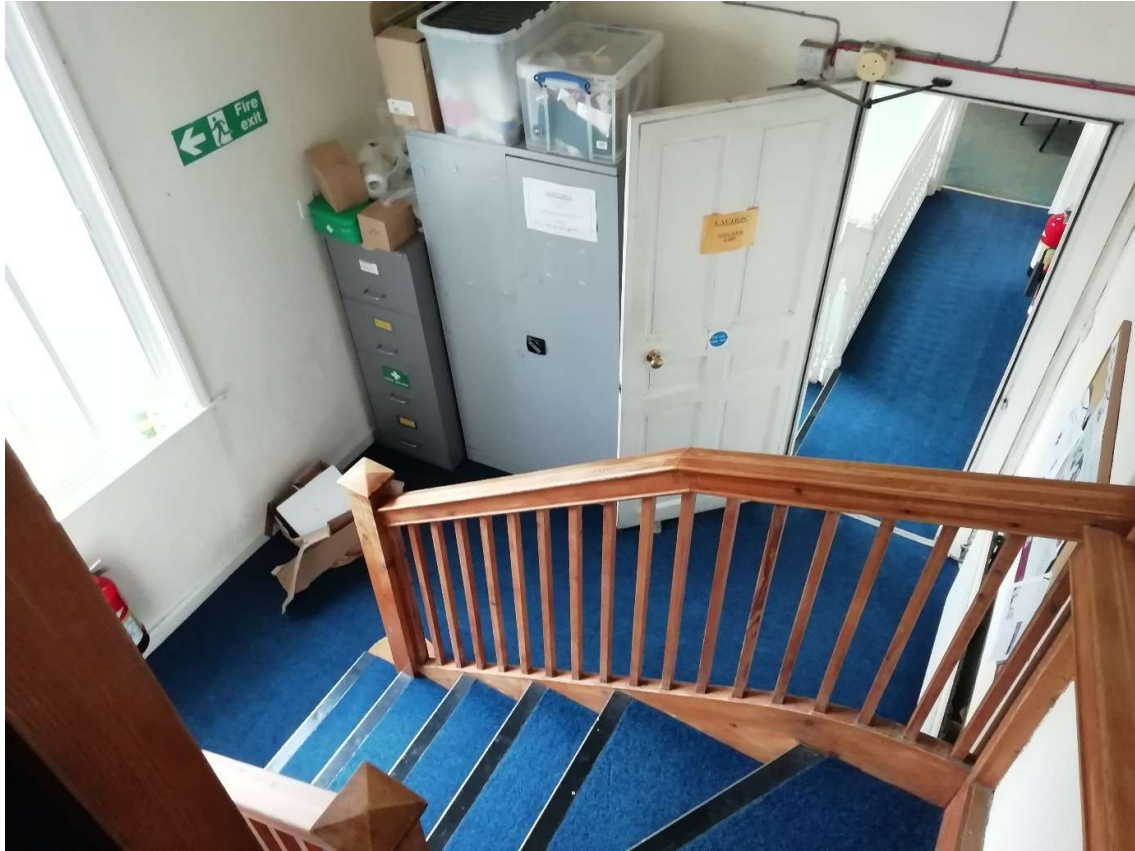
Fig 14 Second floor, left , rear room with new stair to attic and replacement window. Stair encases chimney breast and back stair.

- The missing back stairs which are evident in the Royal Commission survey will be reinstated and the unattractive, modern stair leading to the attic will be removed (Figs 14 and 15). It is suggested that the sectional detailing of this stair be conditioned to allow for sensitive exploration works to take place once the building has been purchased

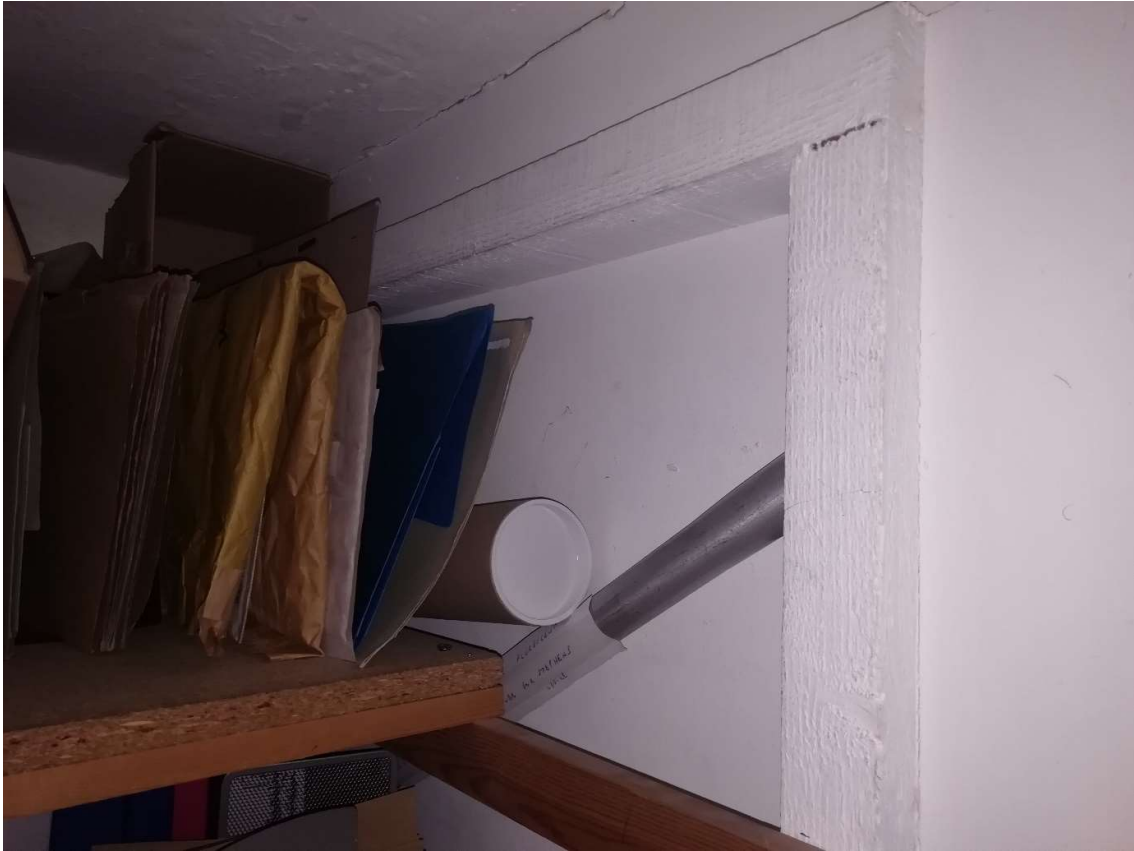
Fig 15 Blocked doorway from back stair to second floor, rear, lefthand room seen from cupboard (former back stair) off drawing room

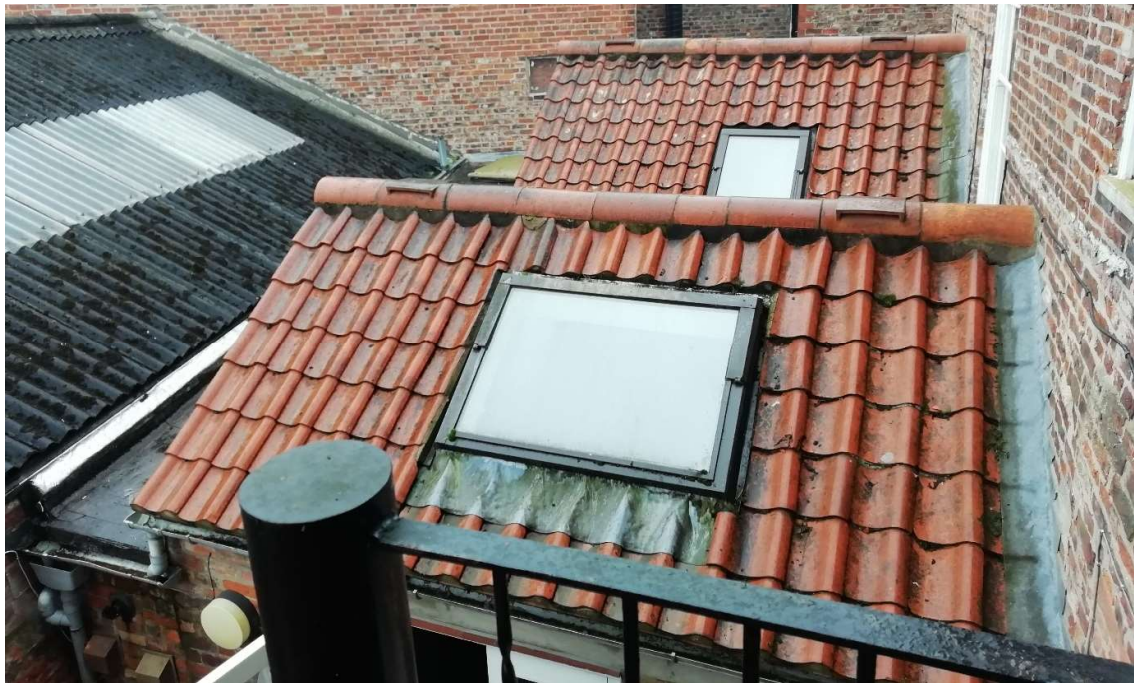
Fig 16 Double pile, rear extension with flat roof utility wing from fire escape

- The 2 no, large, Velux windows in the rear elevation will be replaced with 3 no. smaller, conservation rooflights
- The modern, double-pile, office extension to the rear which contains three rooflights, will be replaced with a contemporary extension of a slightly smaller footprint and of a more sympathetic design. The inverted mono-pitch will better reveal the rear elevation whilst the proposed roof lights will open up views from within this space of the stair window and the wider rear elevation (Figs 16 and 32)

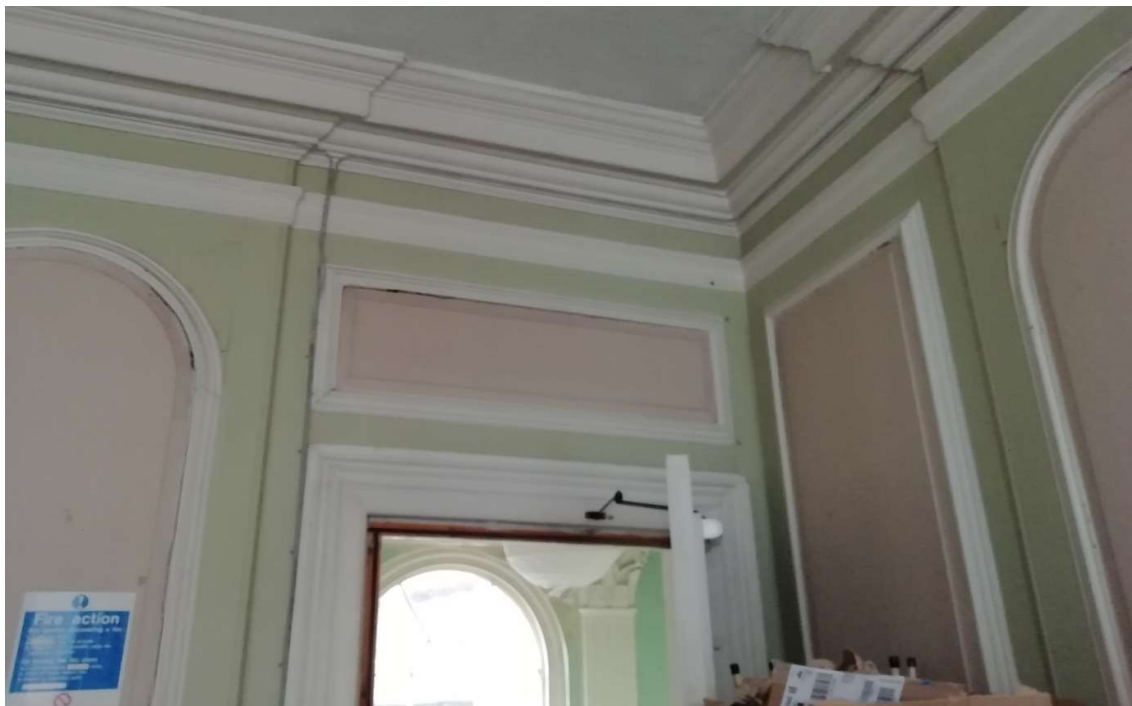
Fig 18 First floor, front, left room: bolection moulding and deep cornice

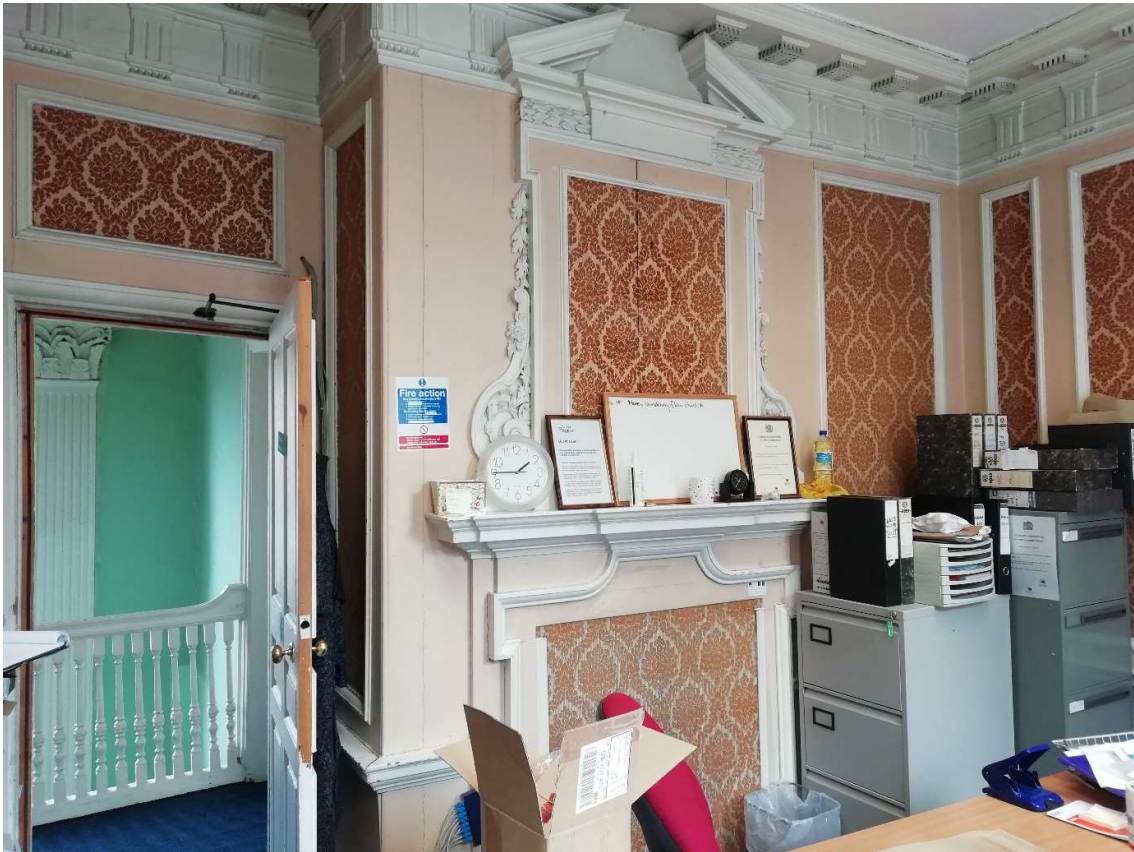
Fig 19A First floor, front, right hand room (fireplace to be re-opened & modern radiator replaced)

- The blocked fireplace to the first floor, front, righthand room will be re-opened (Fig 19A)

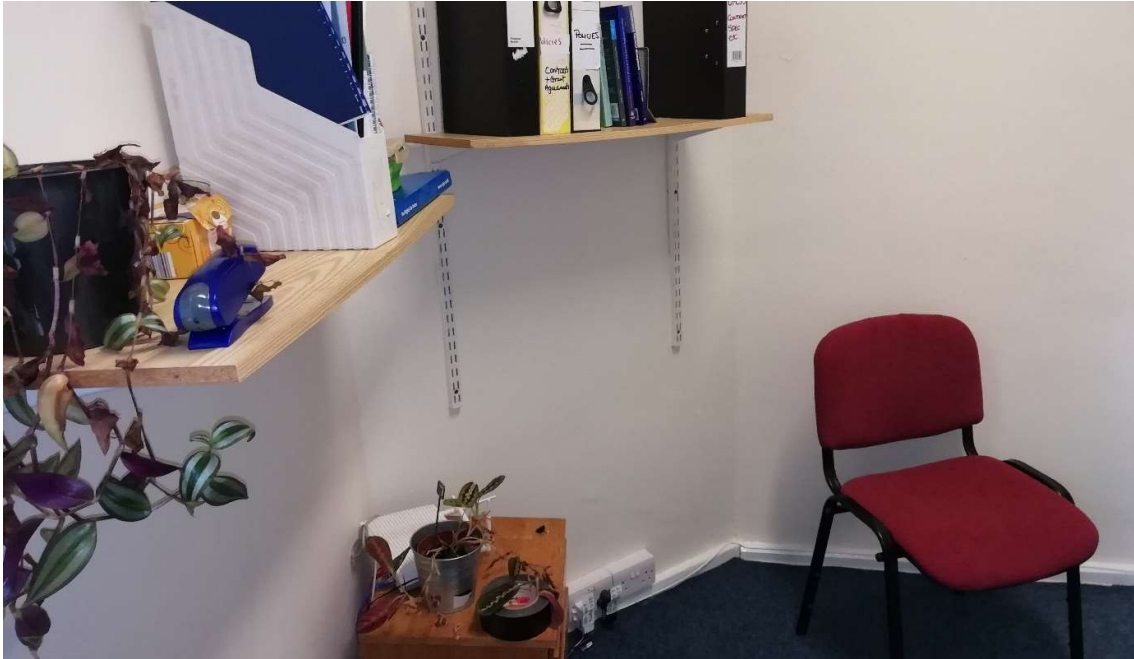
Fig 20 Blocked corner fireplace in first floor, rear, right hand room to be re-opened and fitted with reclaimed, Georgian fireplace shown at Fig IN

- The modern fireplace within the first-floor drawing room will be replaced with one of a more sympathetic design
- The blocked corner fireplace in the first-floor, rear, right hand room will be re-opened and fitted with the Georgian fireplace shown at Figure 21

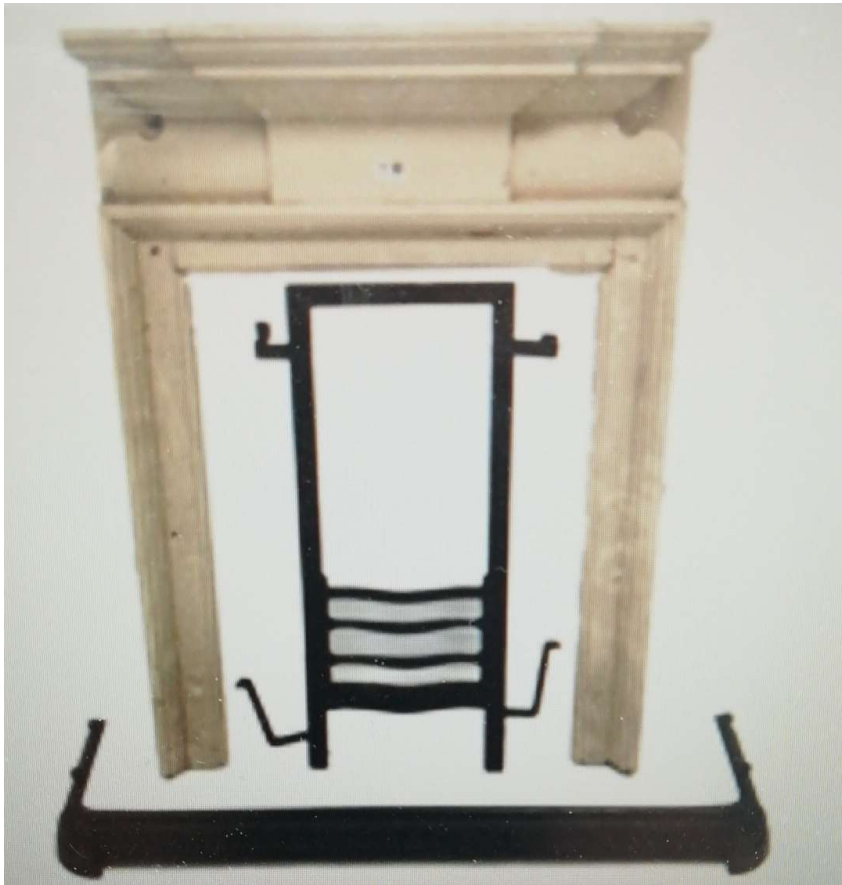
Fig 21 Proposed, reclaimed, Georgian fireplace to be fitted in first floor, rear, righthand room

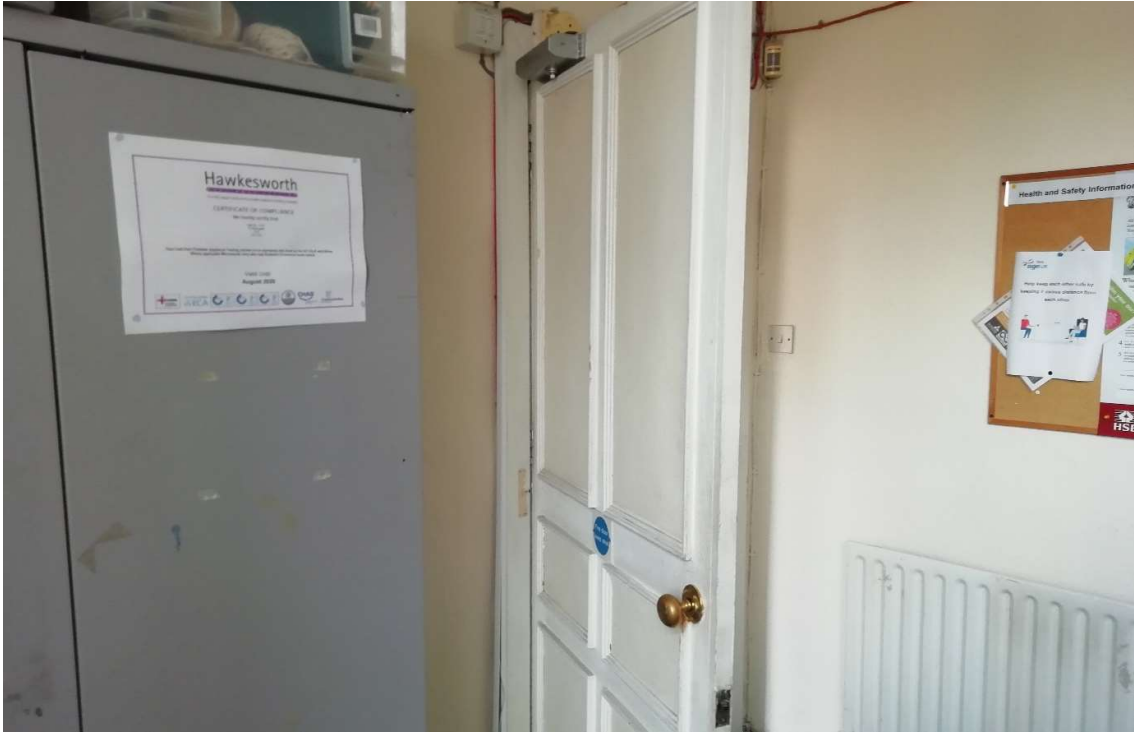
Fig 21A Applied fire panels and door closers to be removed from all first floor doors, fire resistance to be achieved using intumescent products

- All fire resistant panels that are fitted to the first floor doors will be removed (Figs 19A and 21A)
- Sensitive repair works will be carried out where necessary on advice from Mason Clark Associates who have also previously advised Age UK on the building. All new plasterwork will be carried out using lime mortar. The Mason Clark report is attached to this application

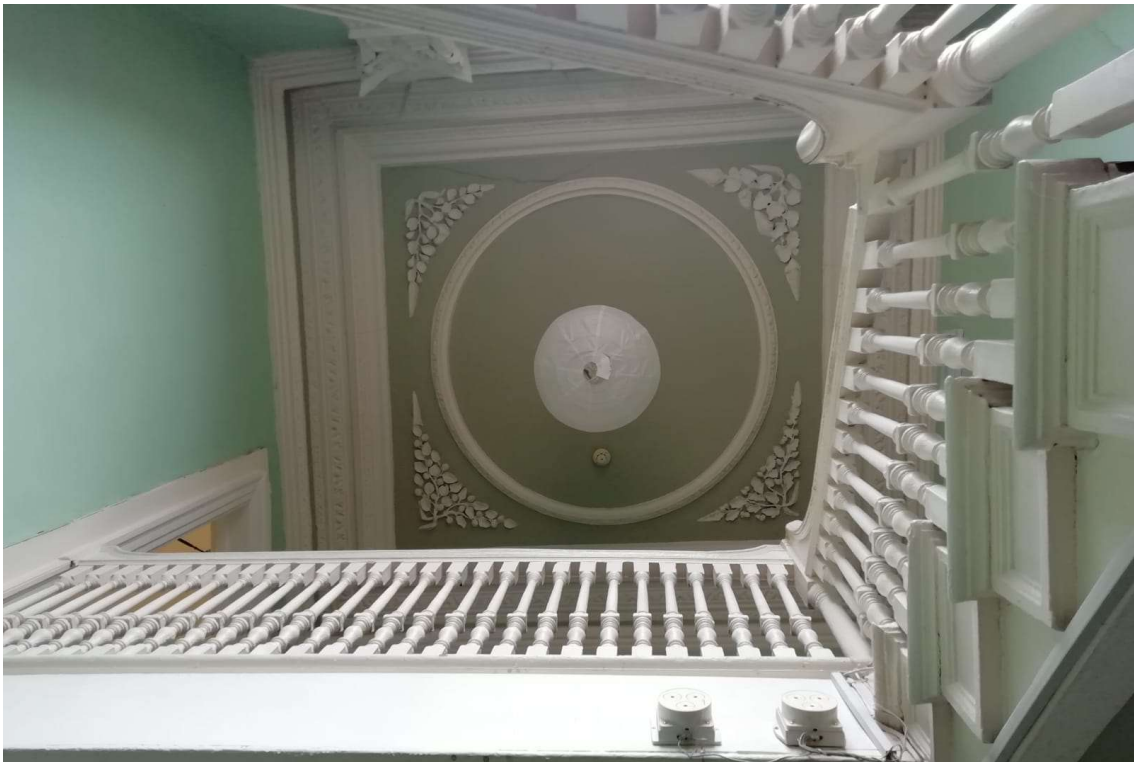
Fig 22 Decorative plasterwork above stair bay (wall mounted electrics to be removed)

- Surface mounted electrics, conduits, sockets and pipes of which there are many will be removed. Any new cabling/ pipework will be chased into walls and repaired using lime mortar. No services will be fitted into or behind historic panelling or decorative plasterwork

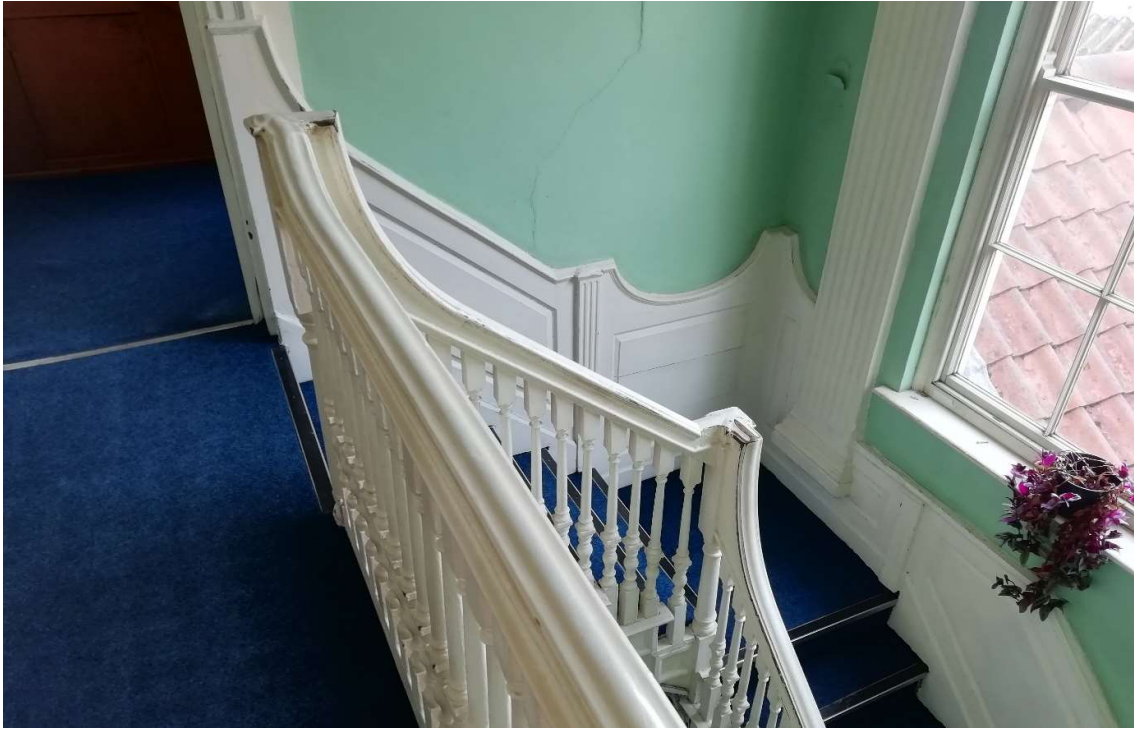
Fig 22A Stair (cracks in stair bay wall to be tied and modern doorway below infilled)

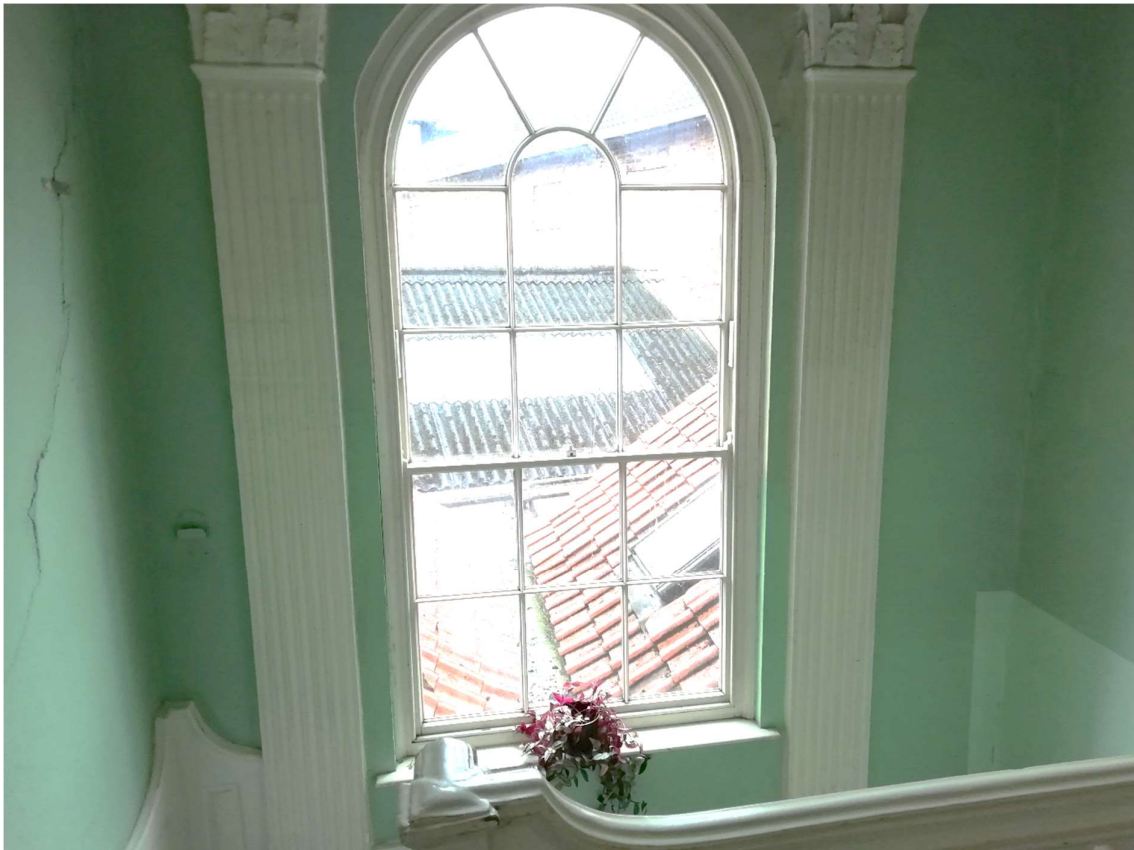
Fig 23 Elegant stair window flanked by Corinthian columns (cracks to walls to be tied and pointed)

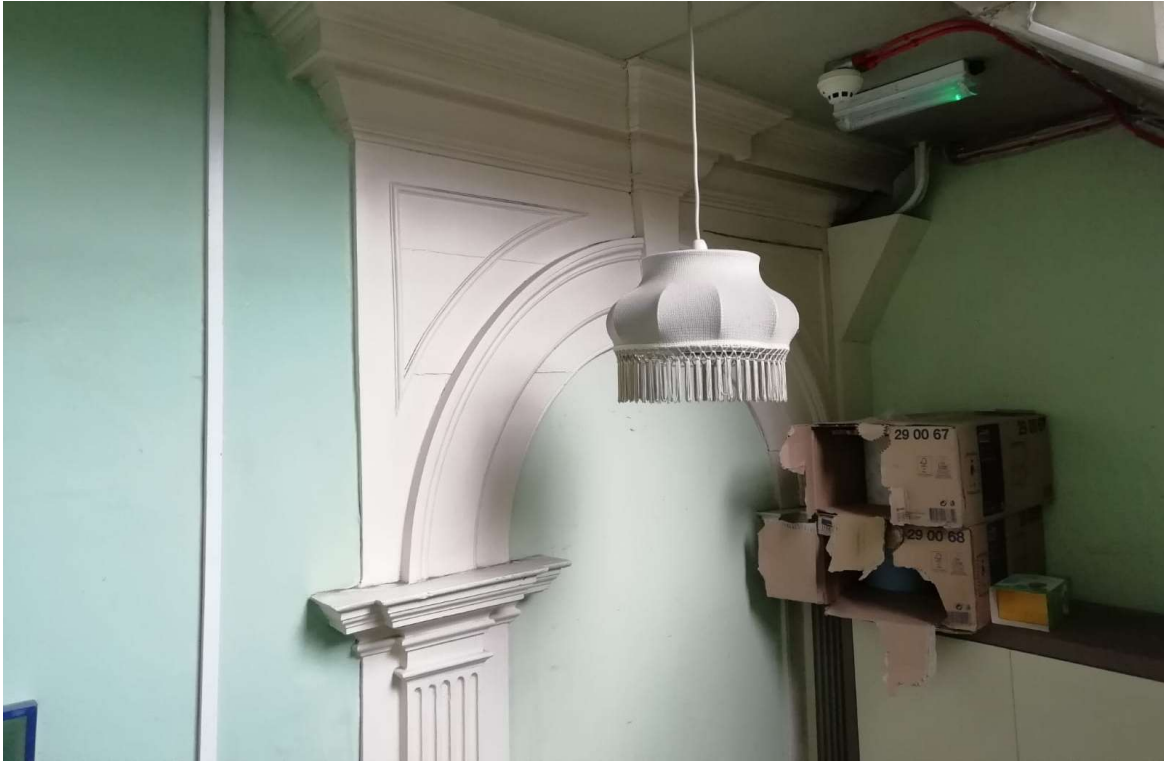
Fig 24 Looking from stair bay towards blocked doorway that originally led to a central hallway and on to the front door (door to be re-opened and trunking for electrics to be removed) Blocked door to rear, left hand room to right of this photo to be re-opened

- Use of matching, reclaimed bricks to make good the front elevation
- The blocked doorway opposite the front door, leading to the stair bay, will be re-opened to enhance the legibility of the original ground floor plan (Figs 24 & 29A)

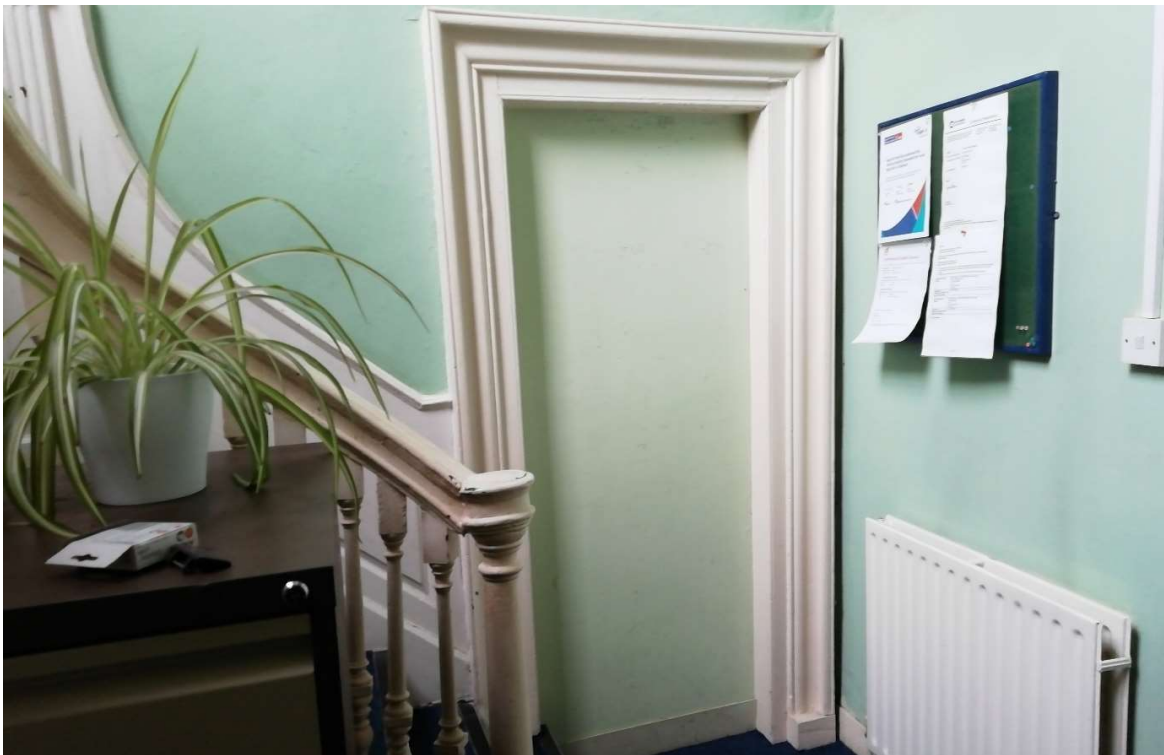
Fig 25 One of two blocked doors leading from stair bay hall to rear rooms (to be re-opened)

- The two blocked doors leading from the rear rooms into the stair bay will be re-opened (Fig 25)
- The suspended ceilings within the shop will be removed to expose historic floorboards to the first floor beneath and detailing to the stair bay door surround which is currently partially obscured (Figs 28 and 29)

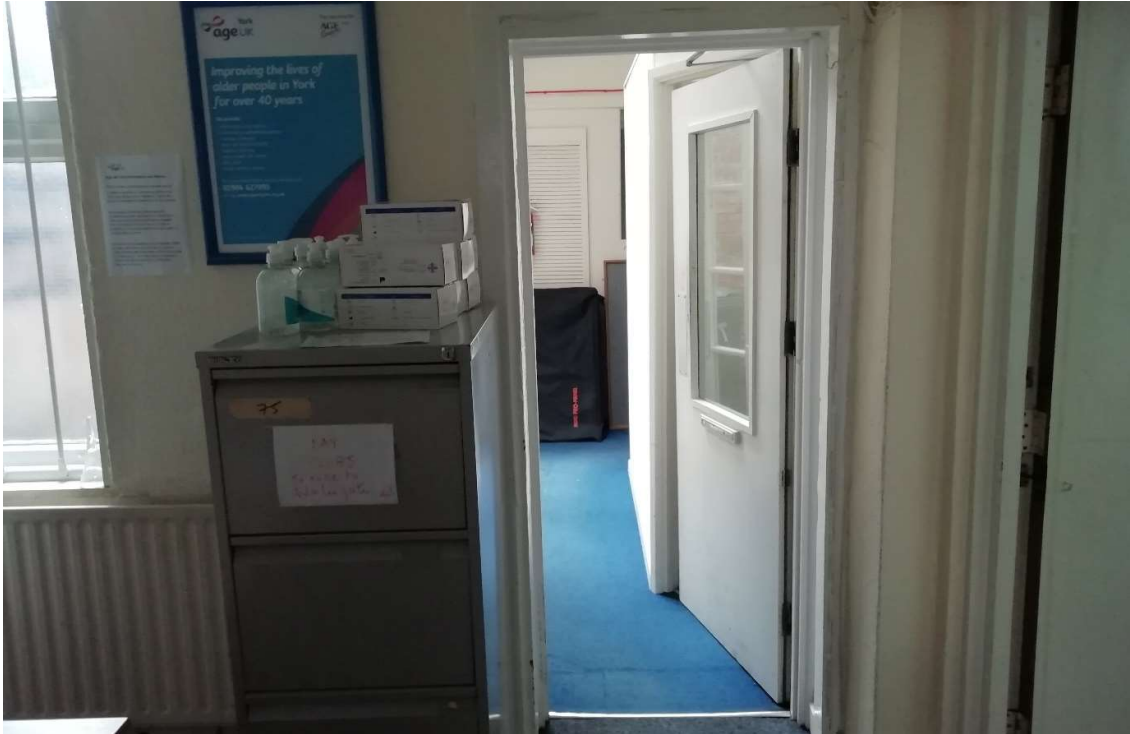
Fig 26 Ground floor, left hand, rear room. New door into rear extension and new door (to right) into stair bay to be blocked. The latter may also help address cracking in stair bay wall above

- Later doorways into the rear rooms from the shop will be blocked to help reinstate the original plan form (Fig 29A)
- The two new doorways that lead into the stair bay and into the rear extension from the rear, left hand room will be blocked (Fig 26)

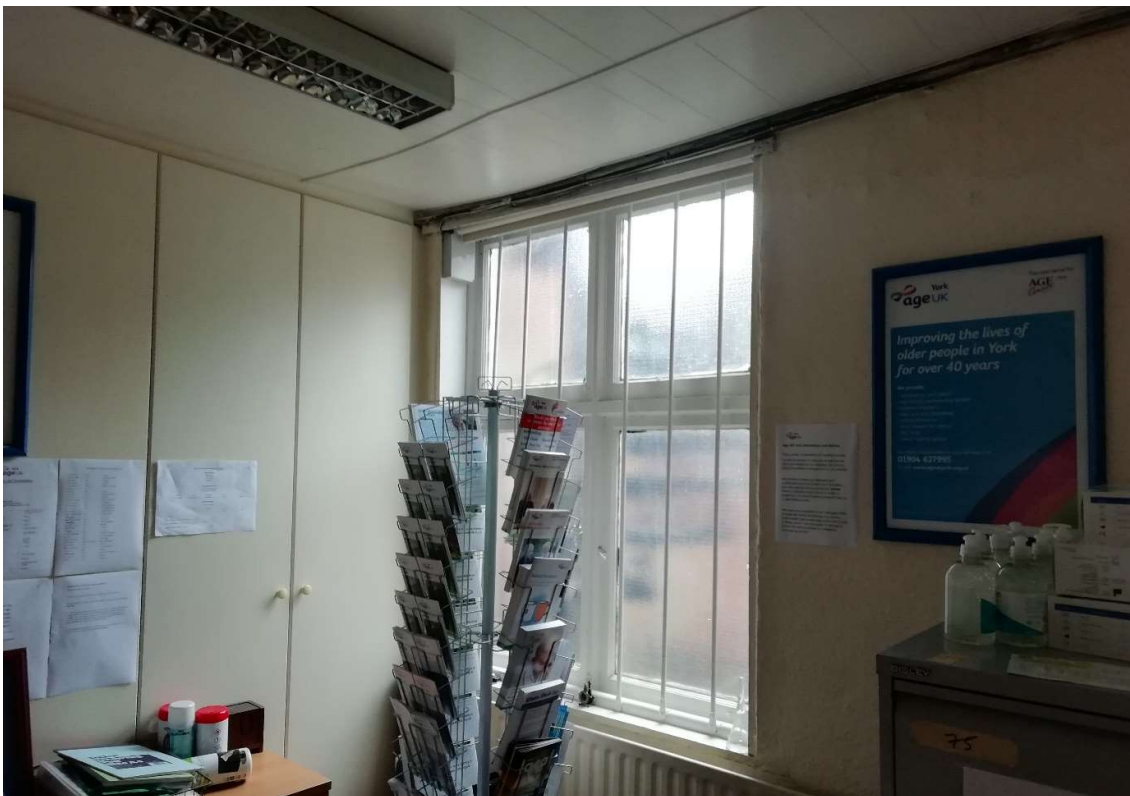
Fig 27 Ground floor, left hand, rear room. Modern cupboards, ceiling lining and window bars to be removed and window to be replaced with a vertical sliding sash window.

- Modern lining to the shop interior and to the ground floor, rear elevation will be removed to better reveal the historic surface below
- The modern storage units in the rear, left hand room will be removed to hopefully reveal the historic chimney breast. If this is still in situ, an appropriate fireplace will be fitted (Fig 27)

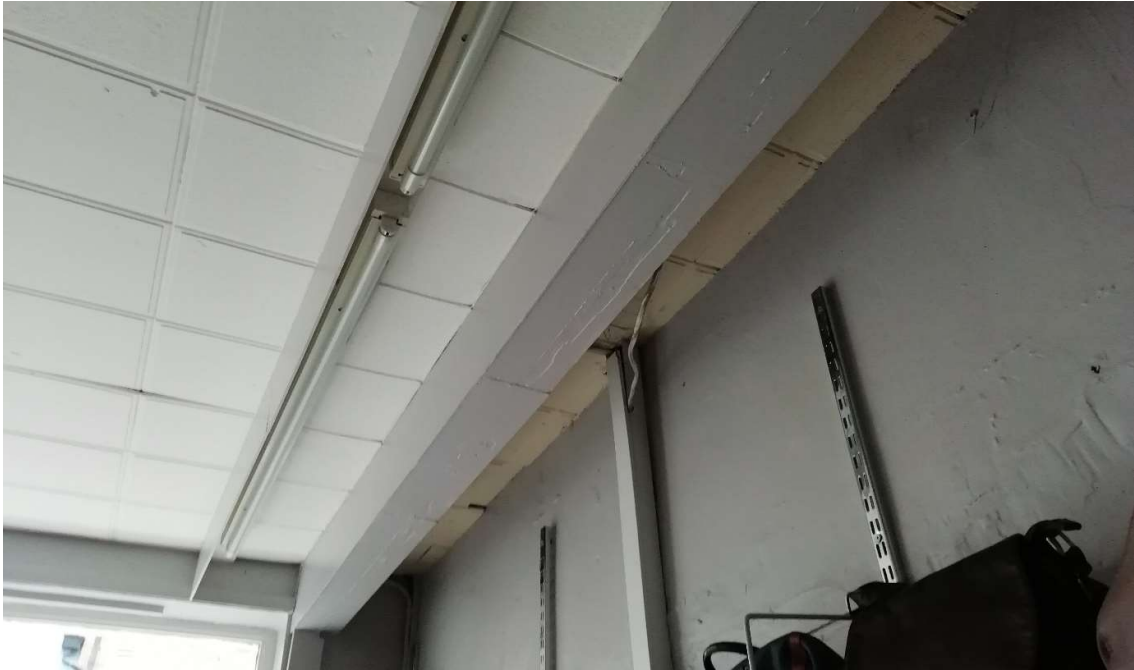
Fig 28 Modern ceilings to ground floor to be removed to expose historic floorboards behind and to better reveal the original proportions of the room

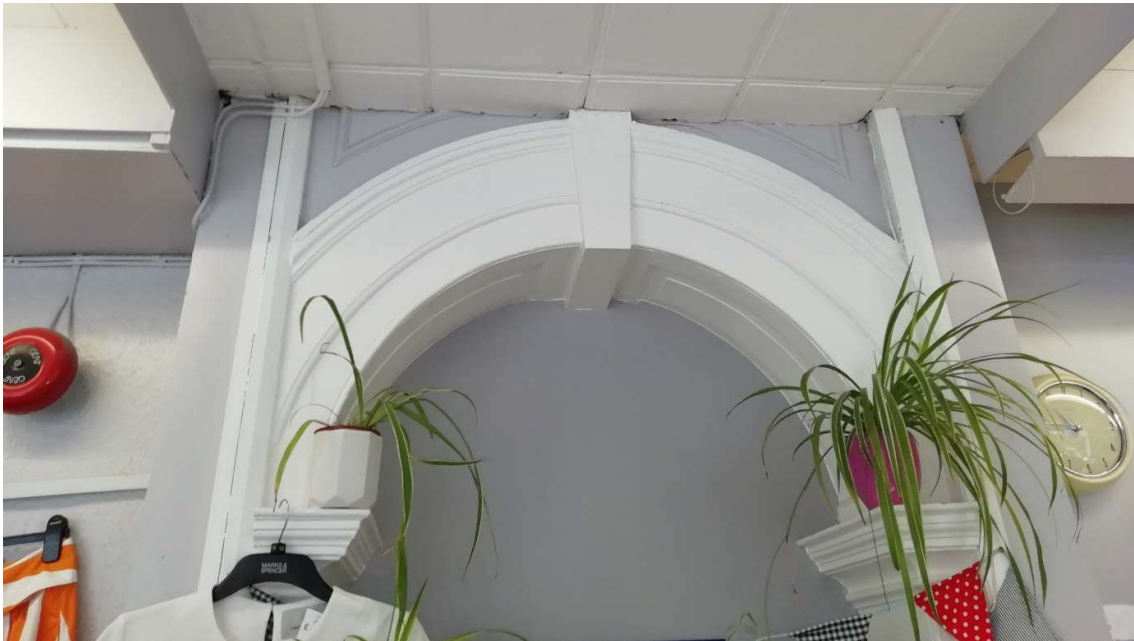
Fig 29 Ceiling tiles to shop bisect beading above blocked stair bay doorway-to be revealed

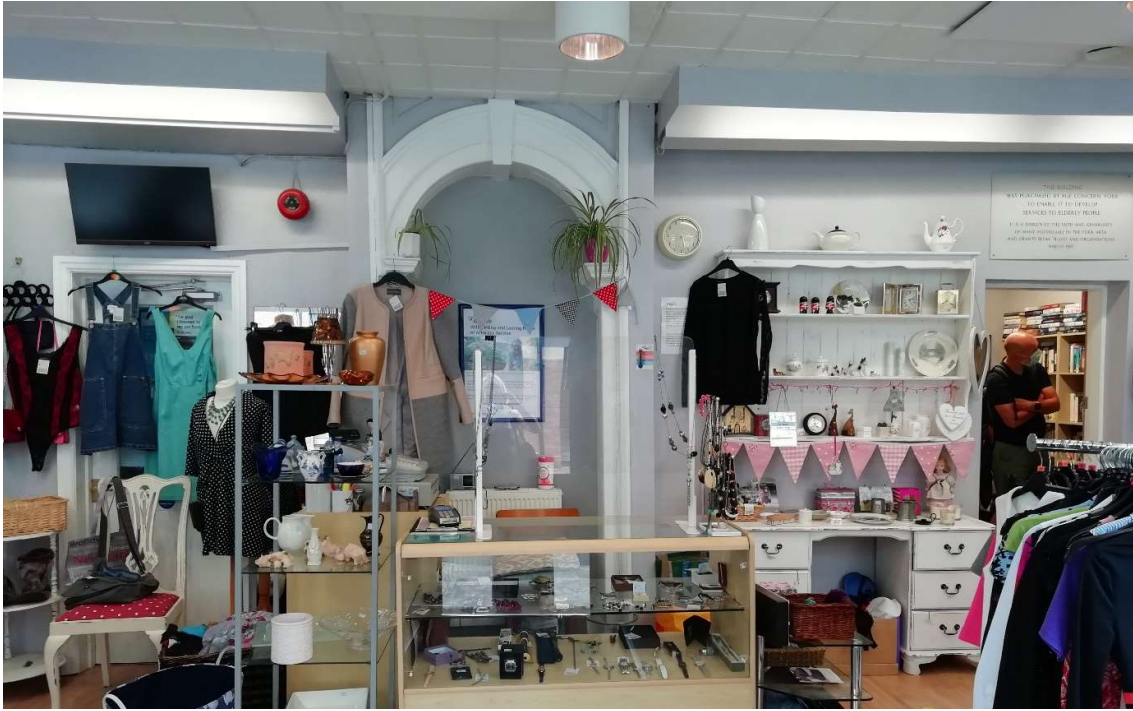
Fig 29A Two, modern flanking doors blocked and inner doorway re-opened to restore plane form

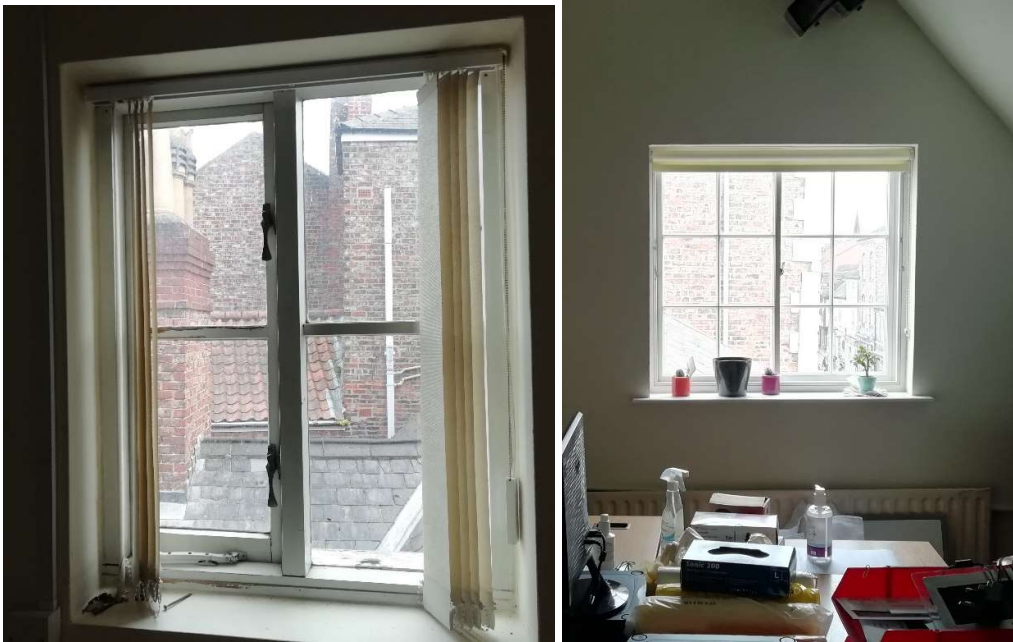
Figs 29B & C Modern, attic gable window replaced with Yorkshire sliding sash as per other gable window

- The modern, casement window to the attic gable will be replaced with a Yorkshire sliding sash as per the other gable window. This lower status window form is appropriate for the attic level

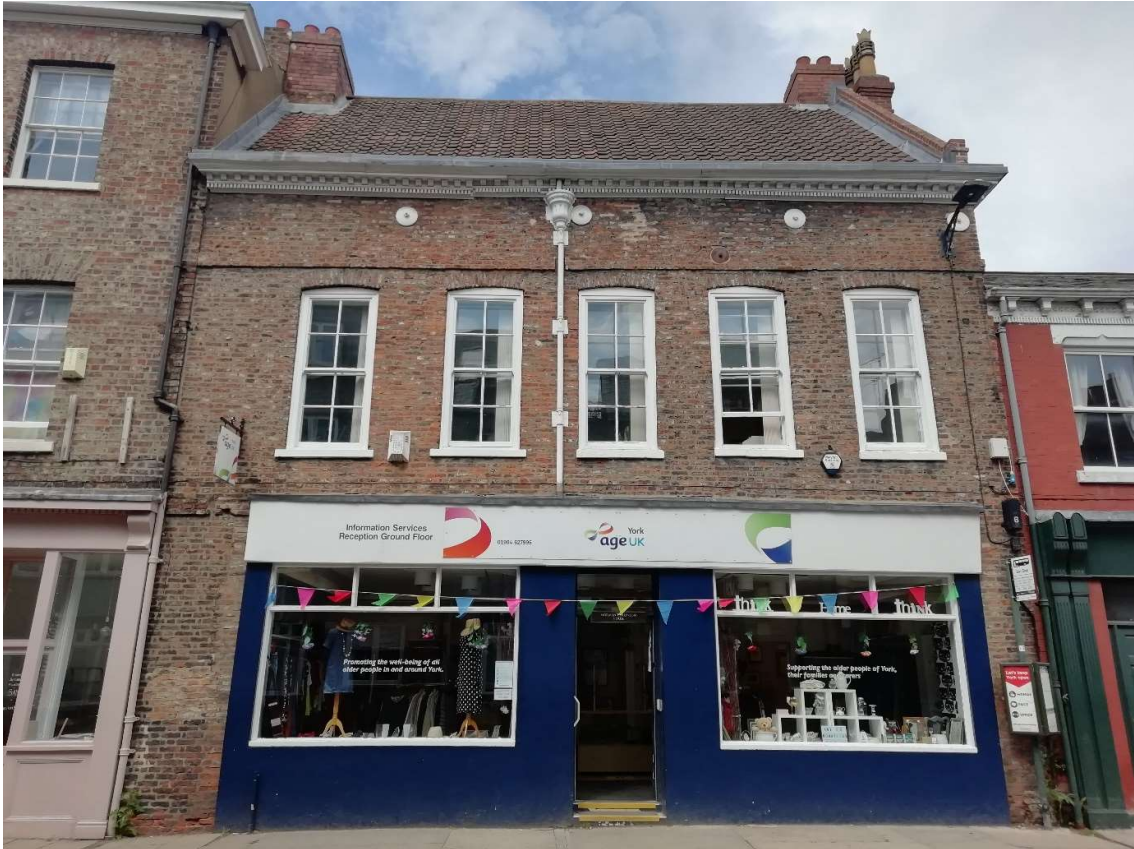
Fig 29D Modern shop front and lintol beneath to be removed and ground floor restored to residential use with four sash windows, a central doorway and reclaimed brick to match

formed from reclaimed brick as per the first floor lintols. The truncated ground floor string course will be restored (Fig 31). All pointing will be carried out in lime mortar.

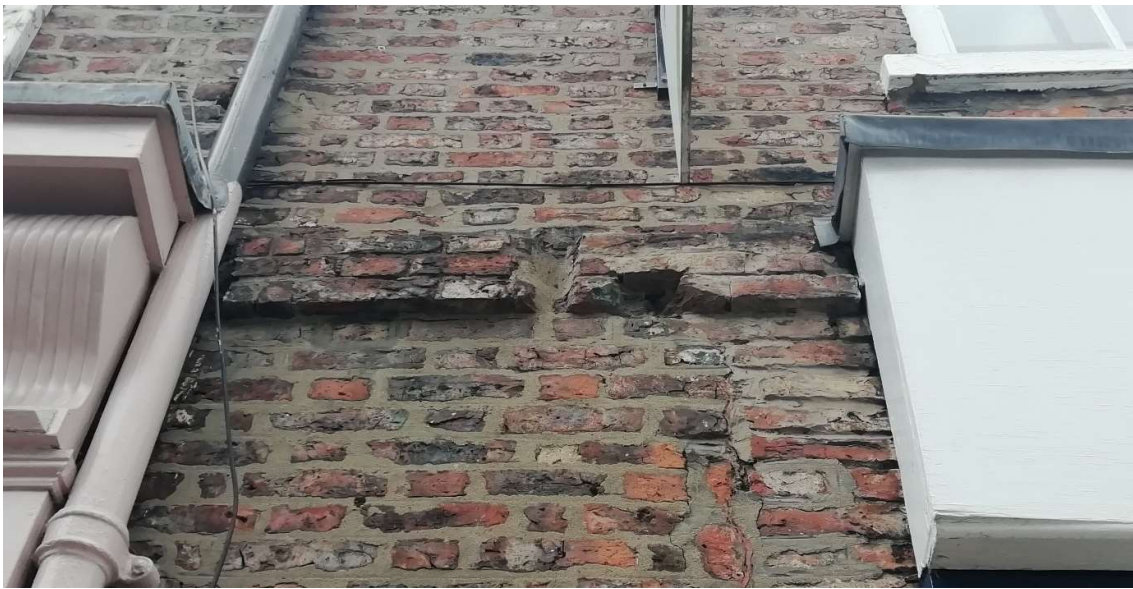
Fig 31 Brick string course above former line of first floor windows to be reinstated

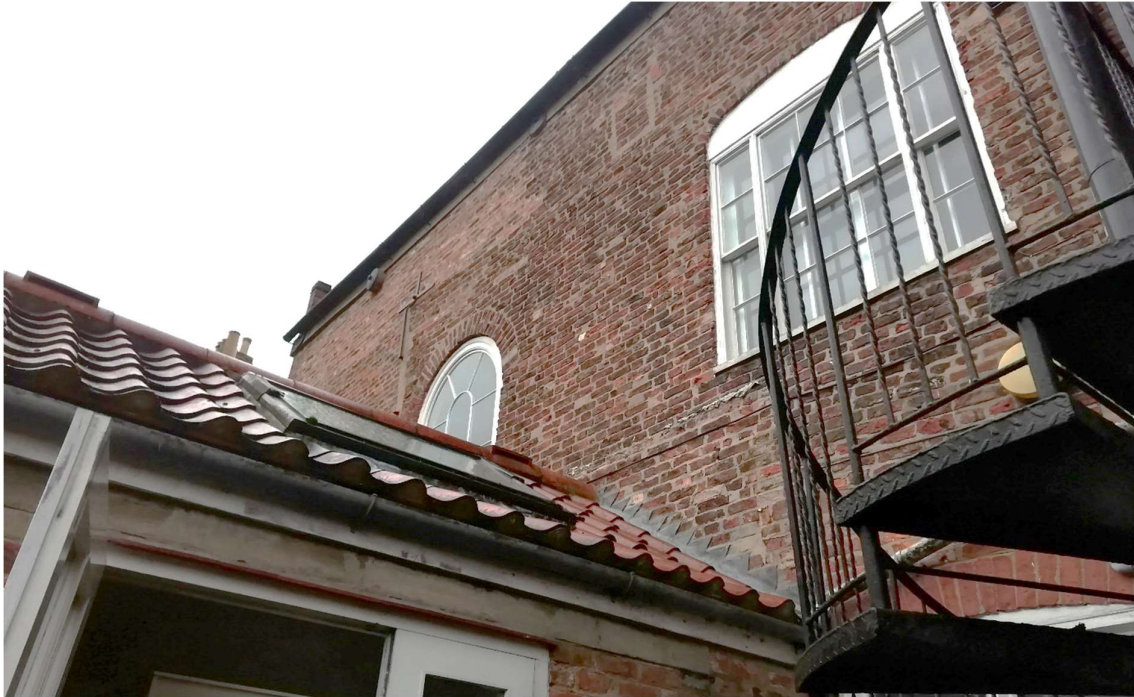
Fig 32 Rear elevation, stair window obscured by modern extension, replacement windows, fire escape and scarring to brick evidencing previous works

- The modern fire escape to the rear elevation will be removed (Fig 32), the modern doorway will be infilled with reclaimed brick and the resultant recess will be formed into a sink bay for the bathroom

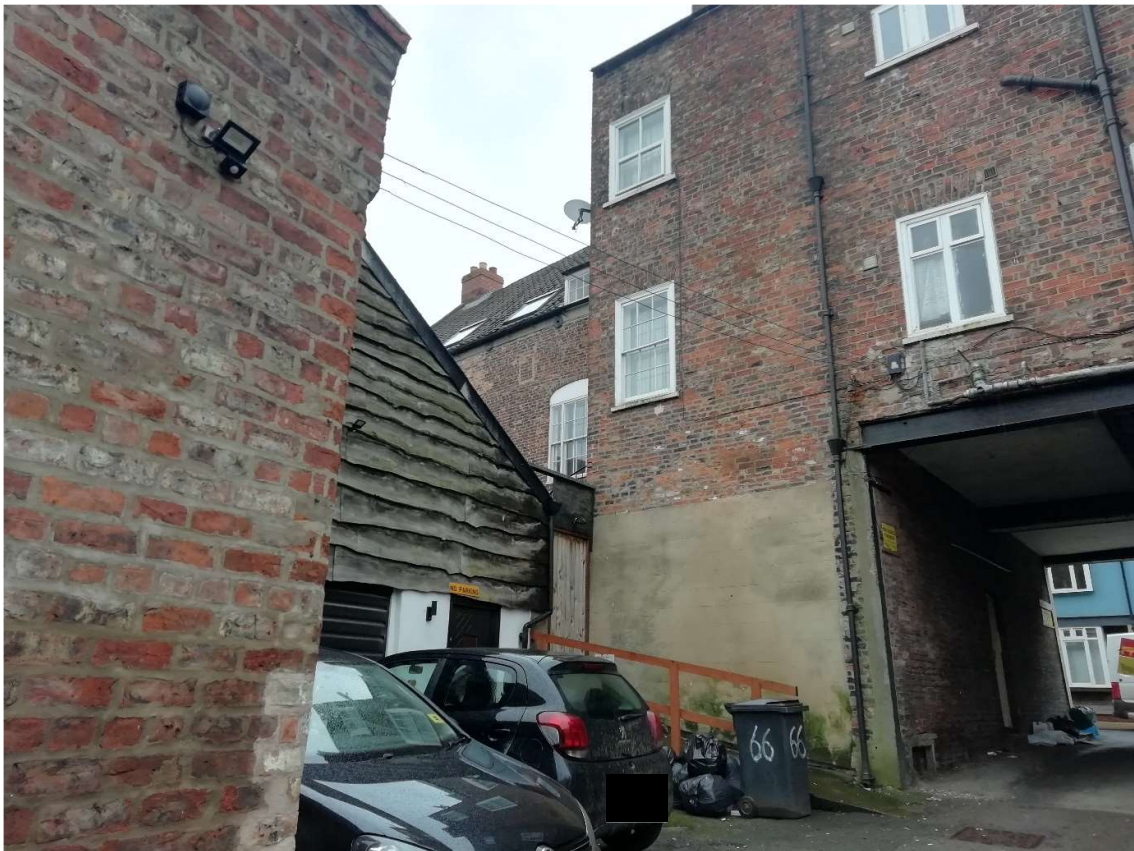
Fig 33 Limited view afforded of rear elevation from Melrose's Yard (note ramp/gate access to yard) Large Velux windows to be replaced with 3 no. smaller, conservation roof lights
