68-70 Walmgate, York

Heritage Impact Assessment

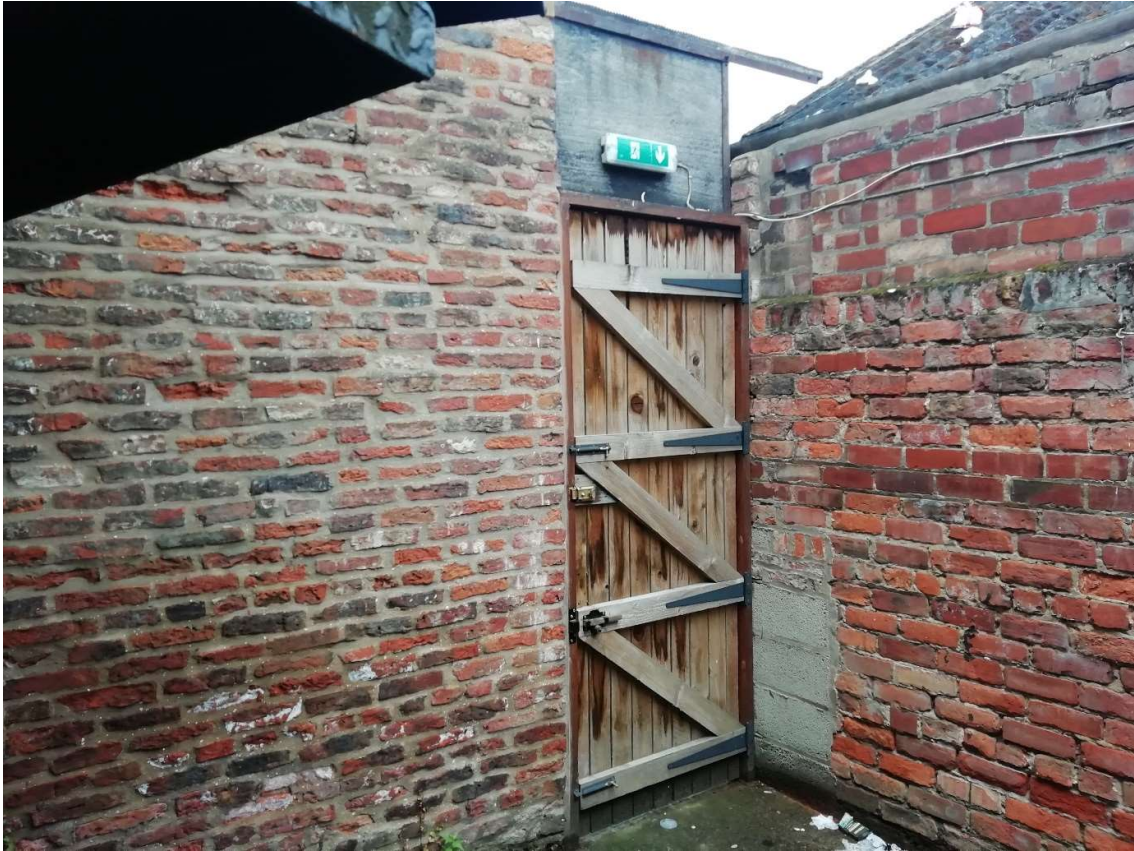
Fig 33A Barbed upper section removed, brick arch with coping to be formed over gate and gate replaced

- The low-grade, rear gate with the unattractive intruder deterrent above will be replaced with a brick arch and coping formed above and traditionally detailed gate to enhance the setting of the listed building to the rear.
