# **FORMER CO-OP WAREHOUSE NORTH STREET YORK**

## **A REPORT ON AN ARCHAEOLOGICAL WATCHING BRIEF**

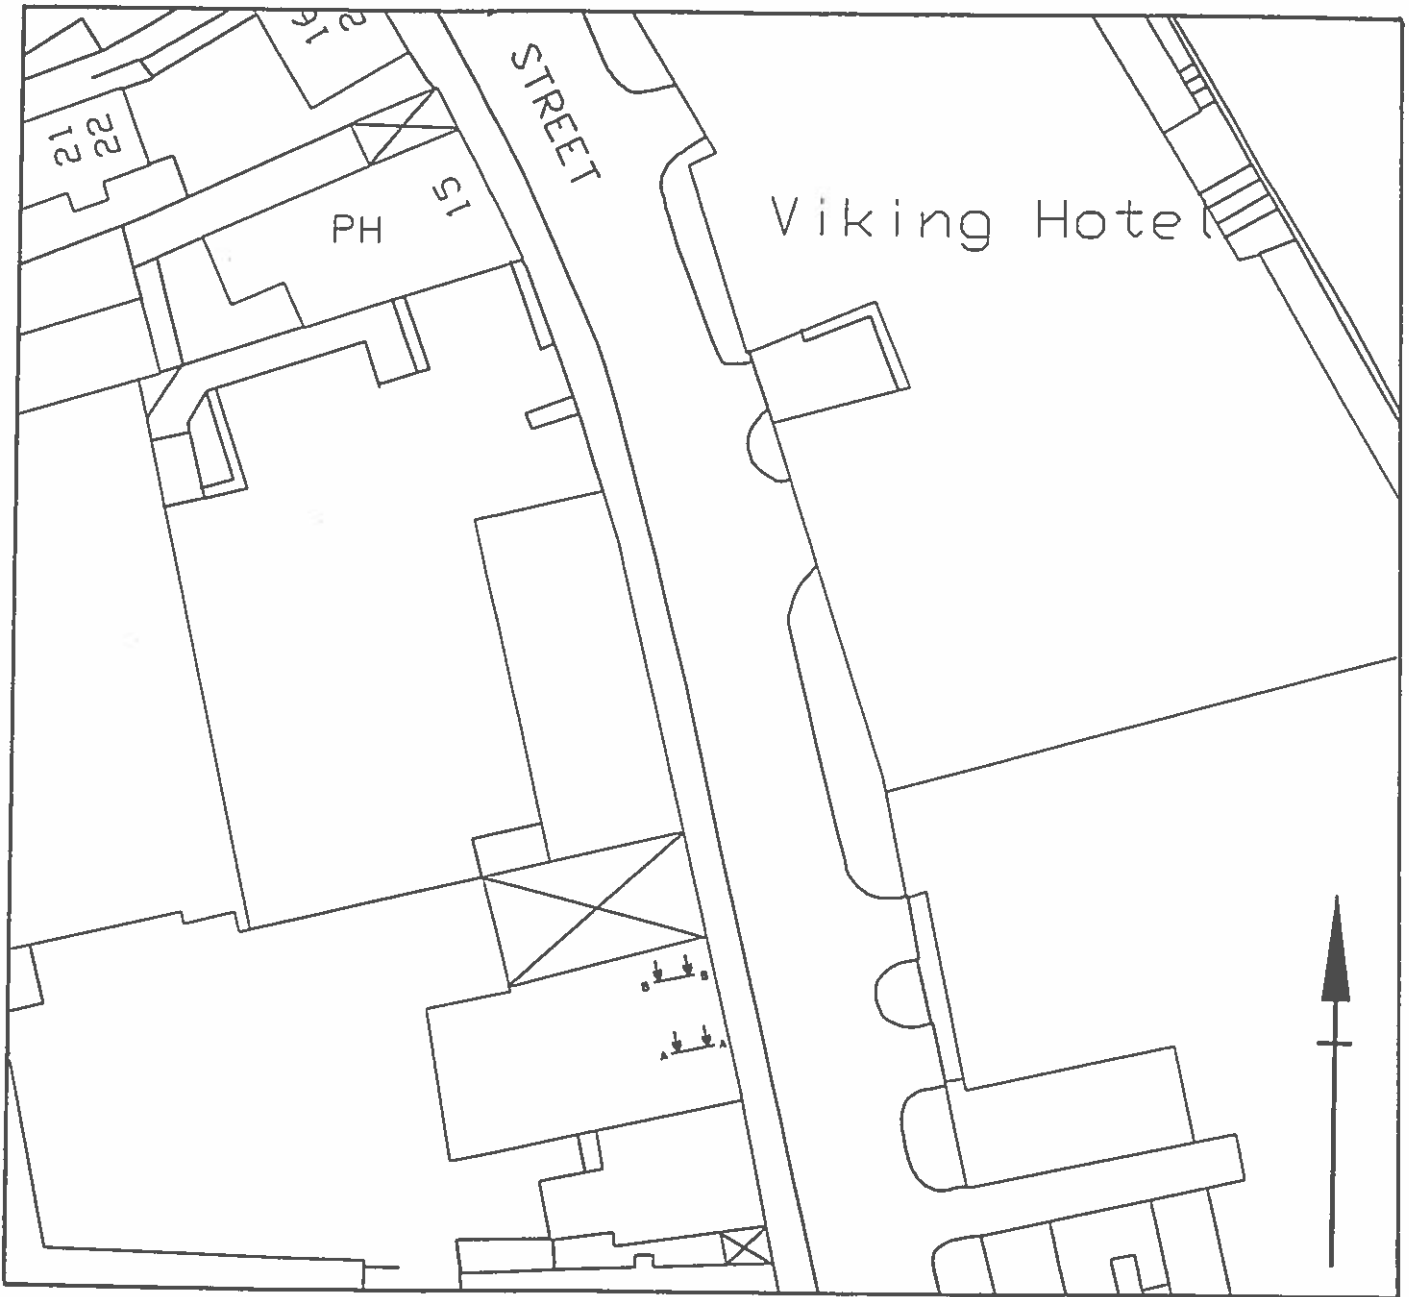
Figure 8. Location of recorded sections

The archaeological work to be undertaken was the recording of two north-west facing trench sections within the body of the warehouse (Fig. 8). The excavations however, were not observed archaeologically and material removed from the excavations was initially dumped outside the building and then transported away.
