## **ARCHAEOLOGICAL INVESTIGATIONS AT 24 FOSSGATE, YORK.**

*WATCHING BRIEF REPORT*

Report Number 2015/23    May 2016

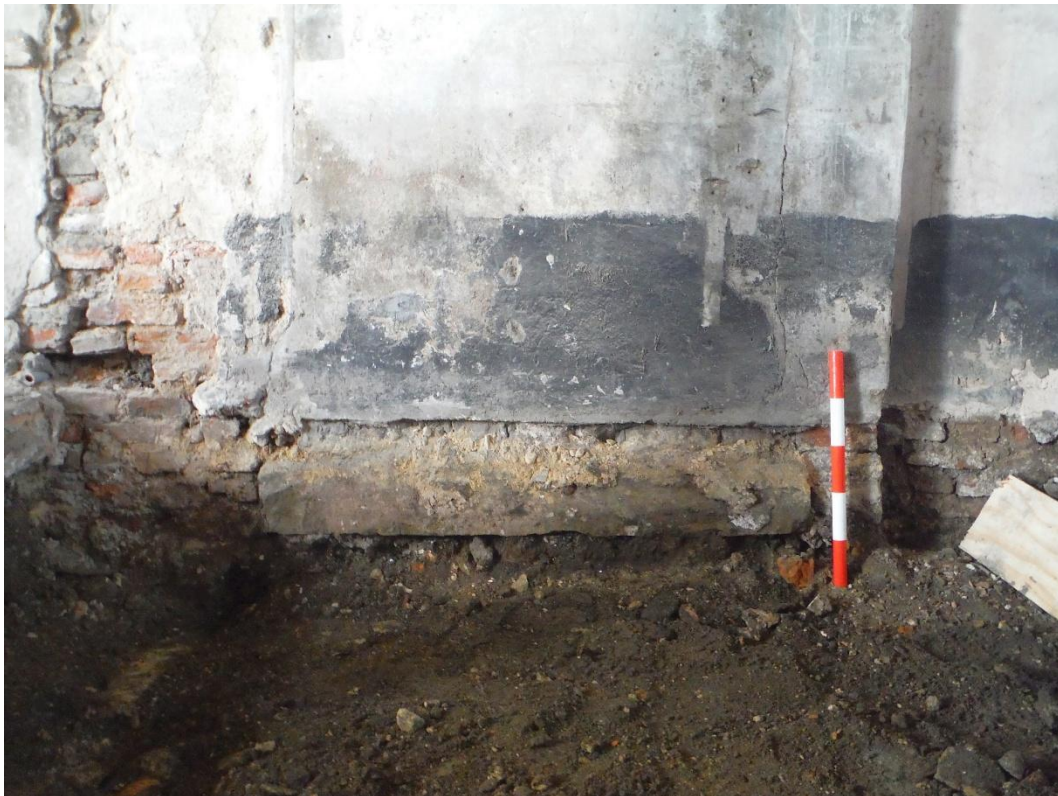
Cut into the dumping deposits were elements relating to the standing building. On the southeast side the standing wall of the building revealed a blocked up doorway threshold made from sandstone (Plate 1). Extending back into the property were traces for two brick walls which would have formed a corridor inside the entrance. At the northwest side a small area of brick paver flooring survived within the 'corridor' (Plate 2).

**Plate 1 Blocked doorway room 1. Facing southeast scale unit 100mm**

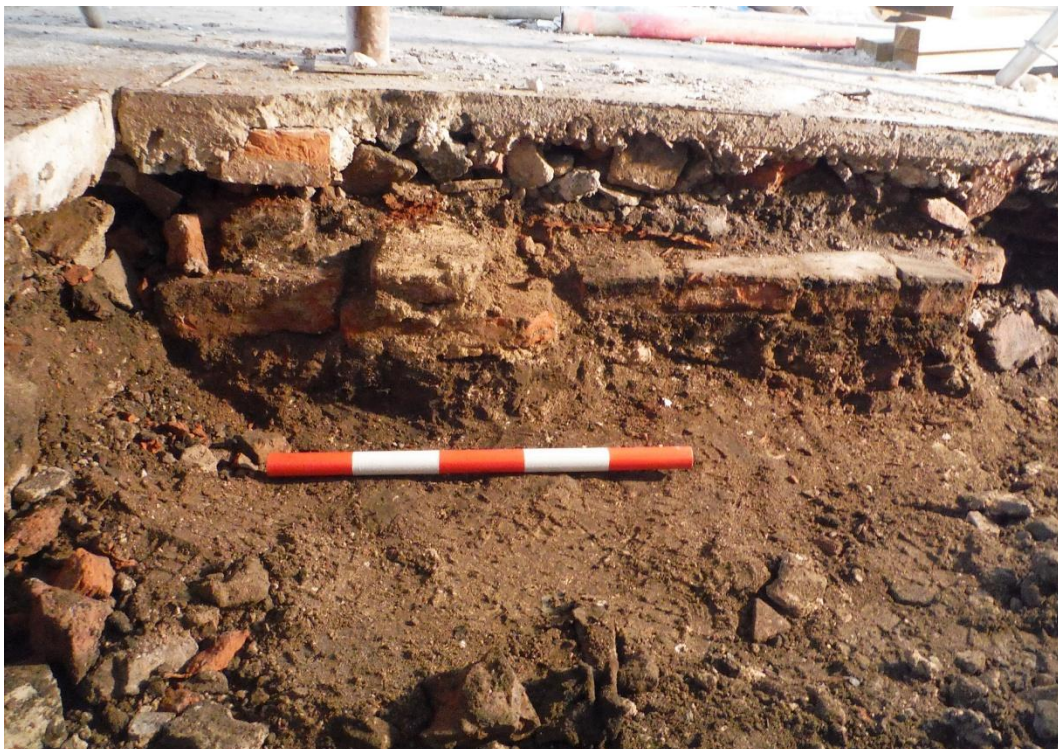
**Plate 2 Wall footing and floor detail room 1. Facing northwest scale unit 100mm**

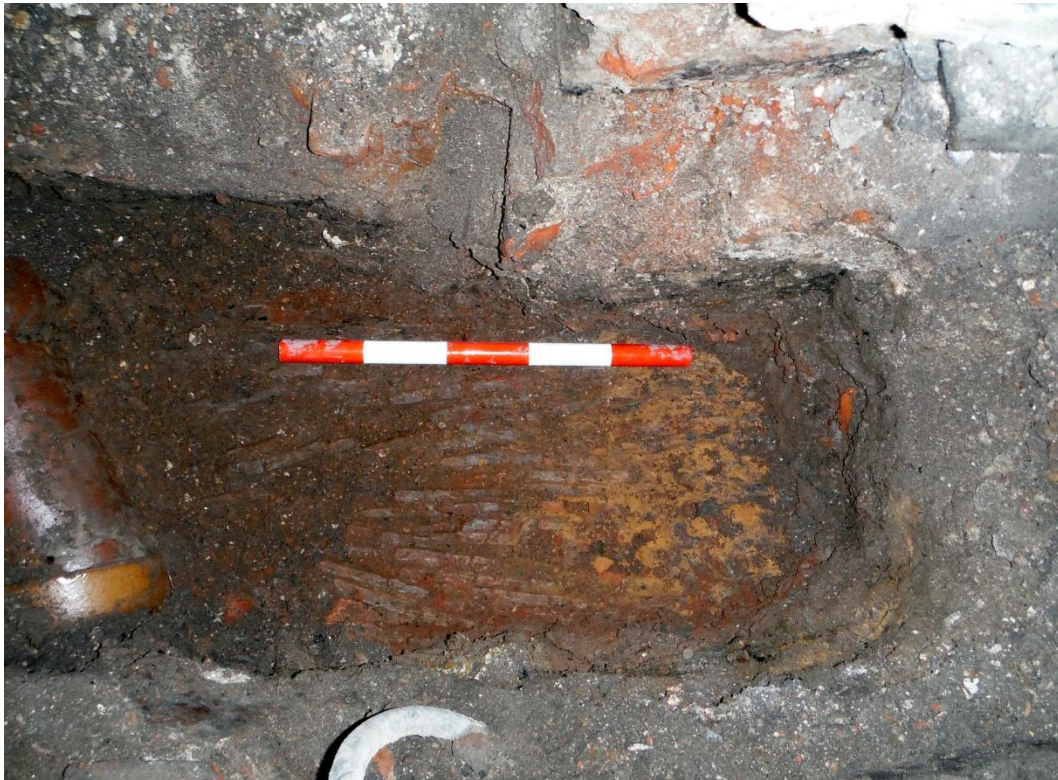
The archaeology changed considerably at approximately 5m back from the front of the building where the bottom of the services cut revealed a tile on edge hearth. This was encountered at c.800mm BGL and continued beyond the limits of the trench both north and south. Burnt material from this extended further to the west but it was not possible to determine precisely how far due to later disturbance. This can be seen in Plate 3 indicating the survival of the hearth in relation to a later drain. To the west of the drain, where it had not disturbed lower deposits, the hearth had been laid upon a flat limestone footing (Plate 4).

Once clear of the drain the hearth survived in better condition and the archaeological sequence became easier to establish. The northeast end of the tile on edge hearth appeared to have a deliberate border made up of medieval roof tiles laid flat. It is unclear as to how much of the whole hearth was bordered in this way.

**Plate 3 Tile on edge hearth room 1. Facing north, scale unit 100mm**

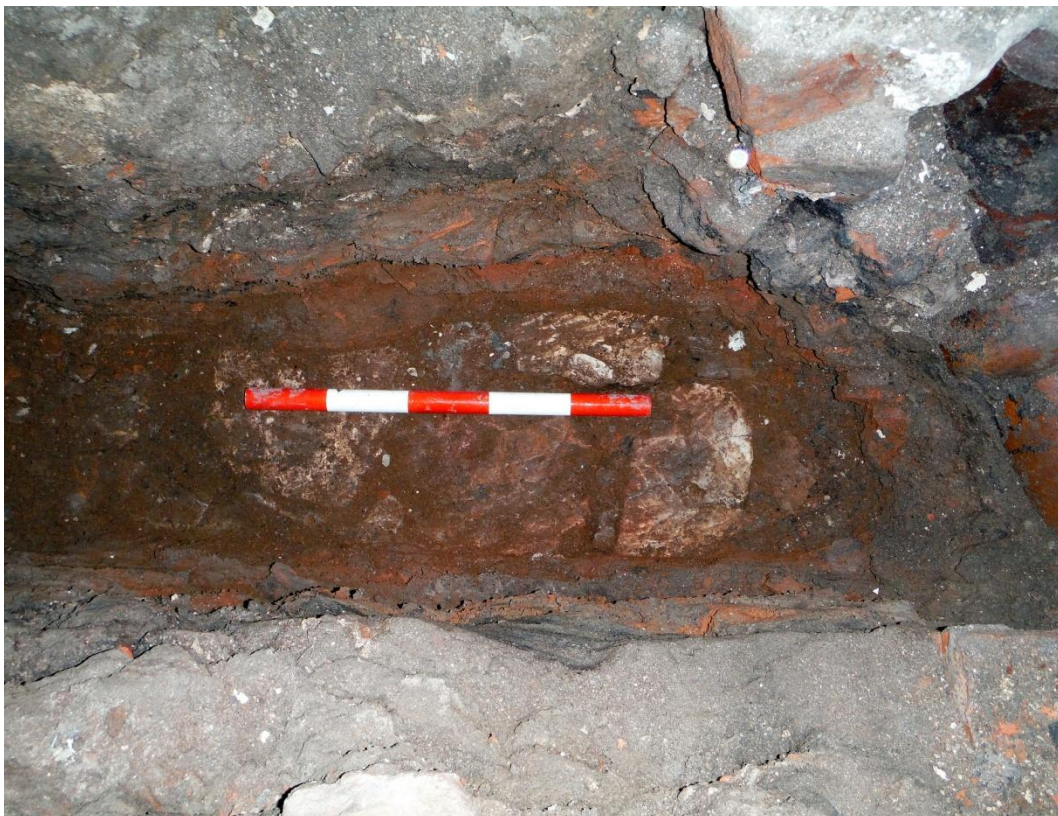
**Plate 4 Base for tile on edge hearth, room 1. Facing North, scale unit 100mm**

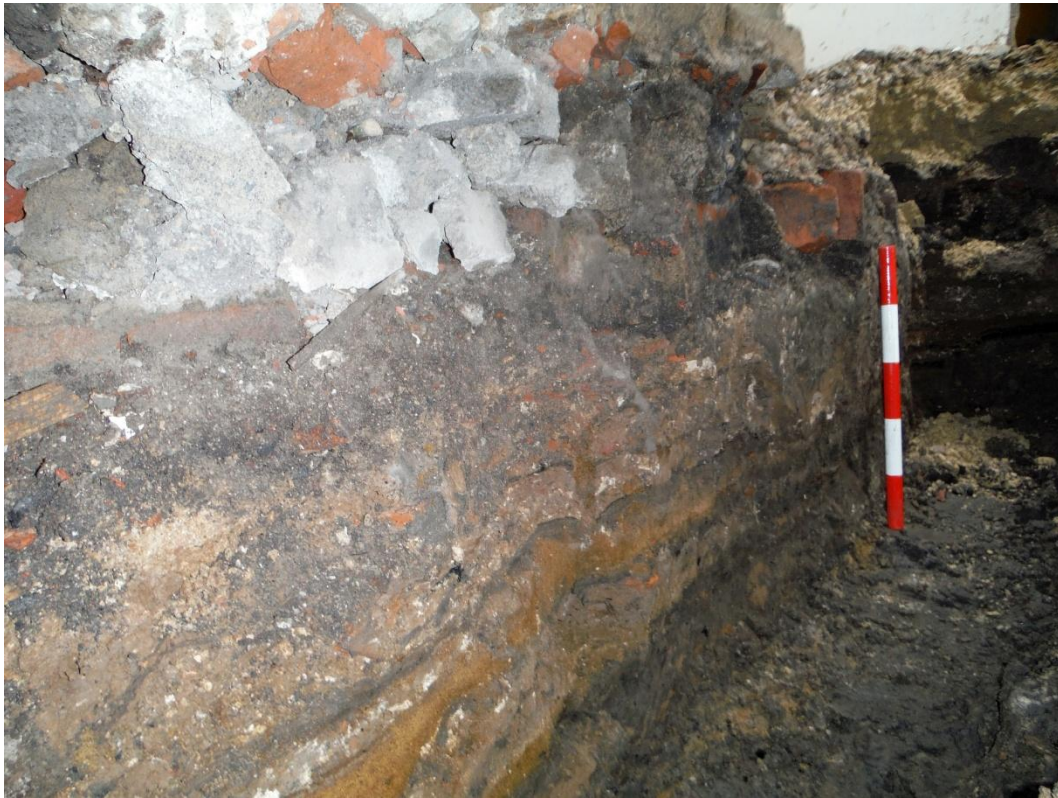
On top of this grey brown clay and silt a depth of 120mm was then taken up by a series of laminated deposits. These were characterised by thicker layers of sand, silt or mortar overlain by thin, black, occupation and trample layers (see Plate 5 for further detail). These continued up to and partially over the edge of the hearth described above. In one area there was a small (approximately 300mm wide) patch of in situ burning, perhaps linked with industrial activity, but no residues or waste were observed. These are likely to represent occupation contemporary with the hearth described above. No finds were recovered from these deposits.

Between 600m and 650mm a smaller sequence of occupation type deposits was recorded. This was obviously narrower than seen in room 1a, but also almost entirely black with only thin sand laminations between. It was uncertain if this was due to this being a different room or structure, or purely a different floor deposit further away from the hearth.

**Plate 5 Service trench section room 1b. Facing northwest, scale unit 100mm**

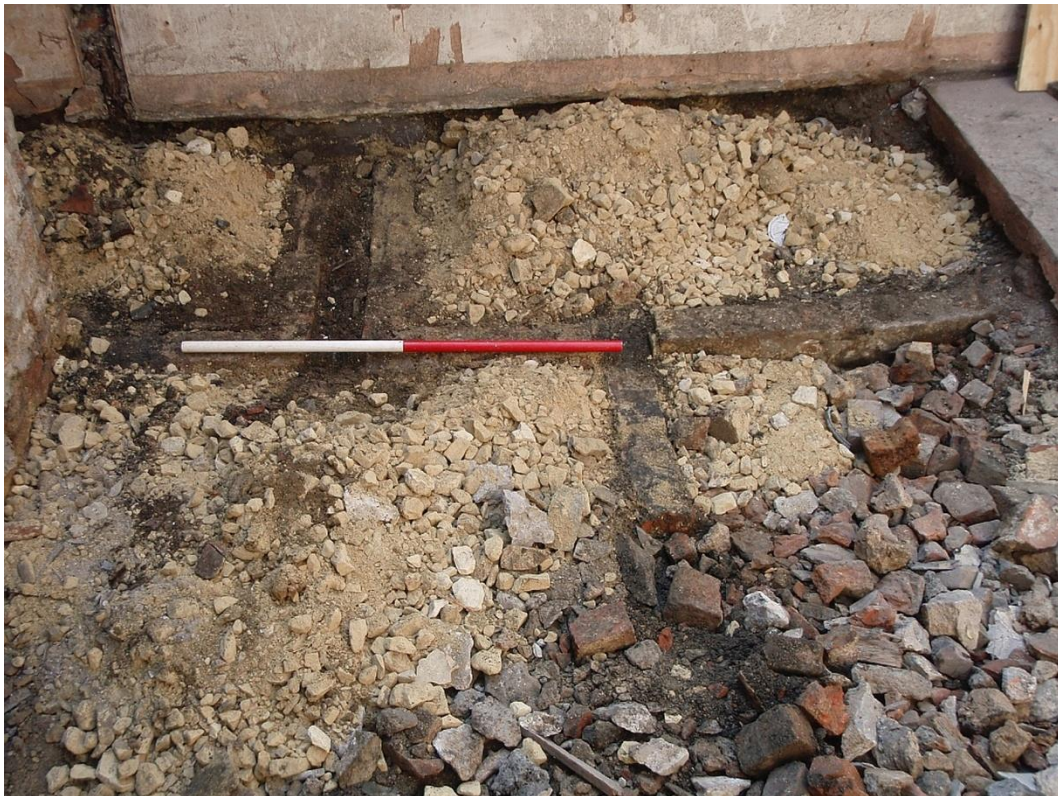
The excavation revealed a series of brick walls that appeared to form a possible boundary wall and two possible outbuildings, one with a doorway threshold still in-situ. These lime mortar bonded walls contained bricks consistent with the construction of the original property in the 1<sup>st</sup> half of the 19<sup>th</sup> century (See plate 6 for overall view).

**Plate 6 Walls and threshold in original yard, room 1b. Facing southeast, scale unit 500mm**

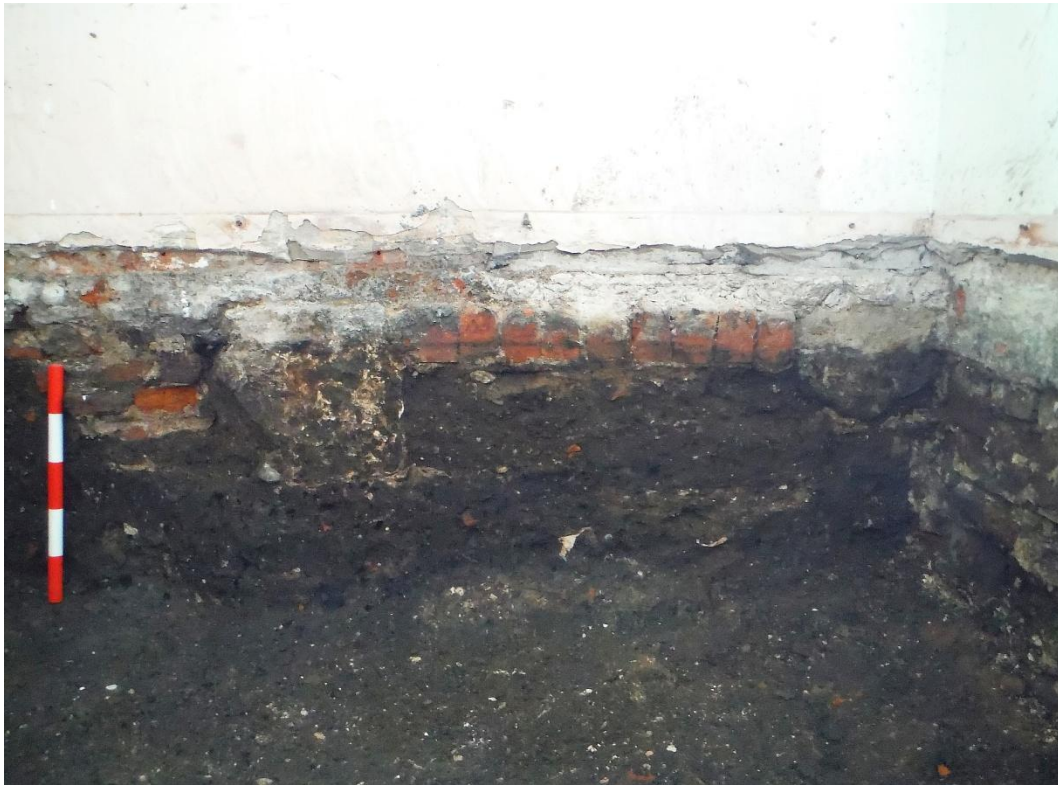
The most interesting features revealed were the foundations of the standing buildings and boundary wall. Within room 7 the original doorway to the southeast had been blocked up, however the footings showed the re-use of large limestone blocks on either side of the door (Plate 7). Further reused limestone was revealed in the foundations of the northeast boundary wall in room 8 (Plate 8).

**Plate 7 blocked doorway room 7. Facing southeast, scale unit 100mm**

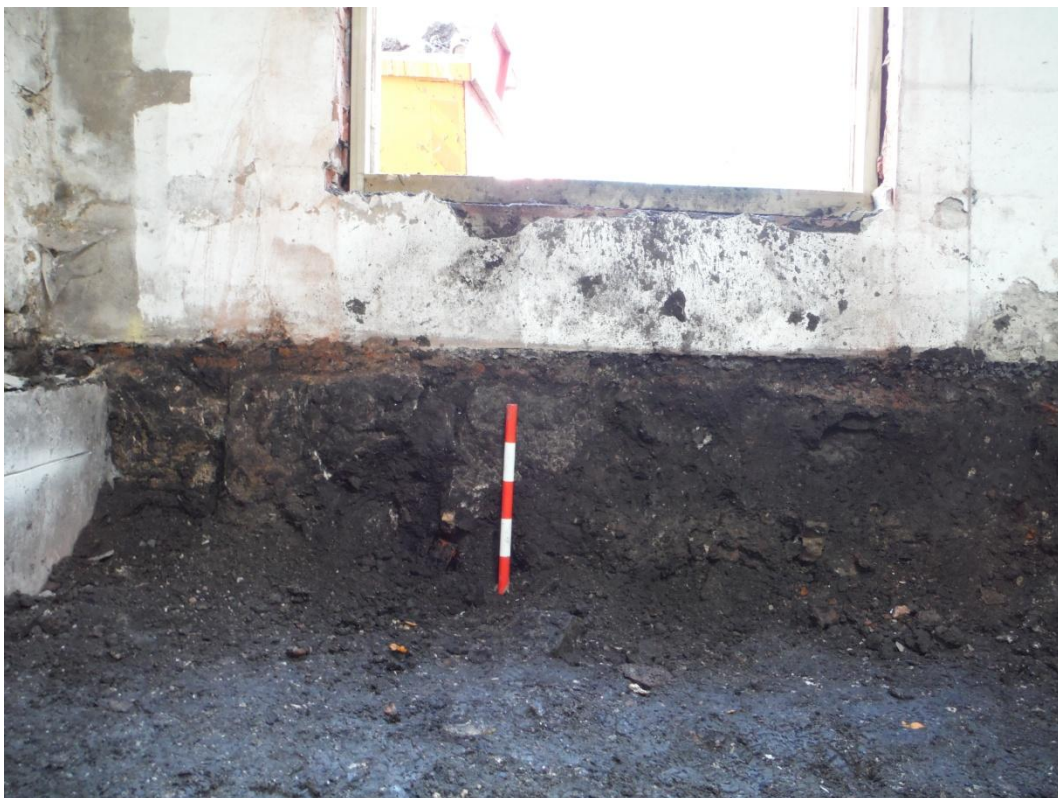
**Plate 8 Rear boundary wall, room 9. Facing northeast, scale unit 100mm**

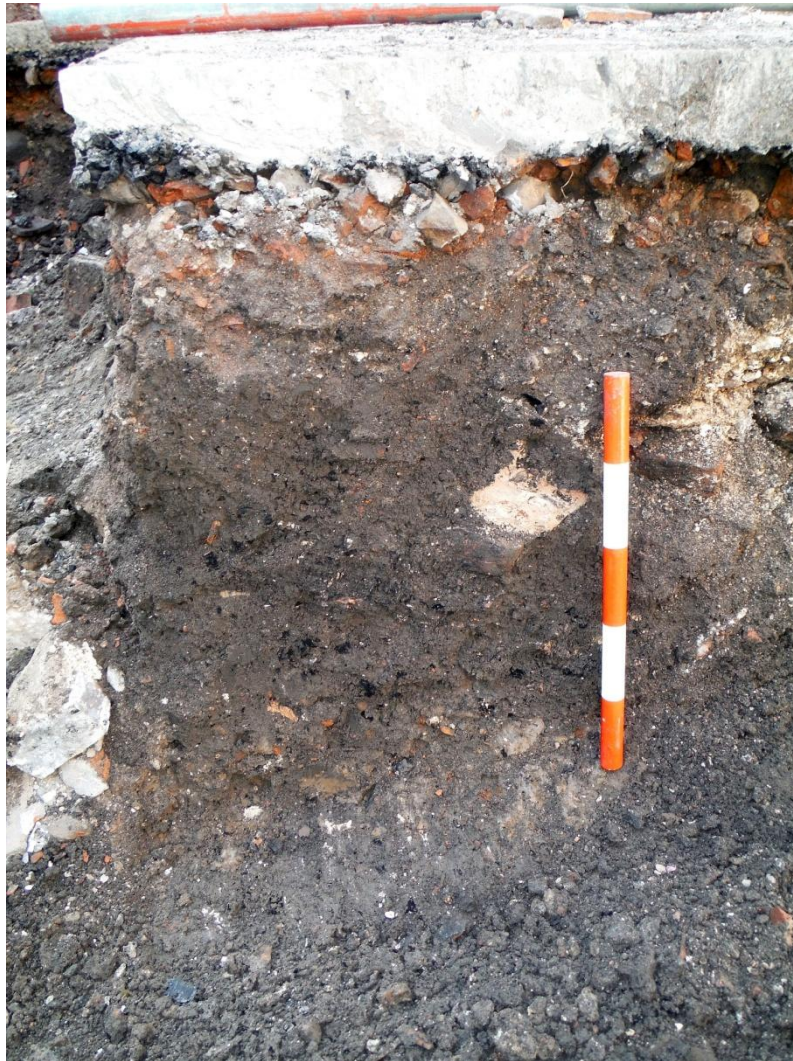
Above the horticultural soil the uppermost 350mm was comprised of 100mm of disturbance, possibly linked with 19<sup>th</sup> century construction, then 150mm of rubble make up for a 100mm concrete slab (the present day ground surface). See Plate 9 for full soil profile.

**Plate 9 Footing section through horticultural deposits. Facing south, scale unit 100mm**
