**Heritage Impact Assessment
Manor Farmhouse, Strensall**

29.10.2021

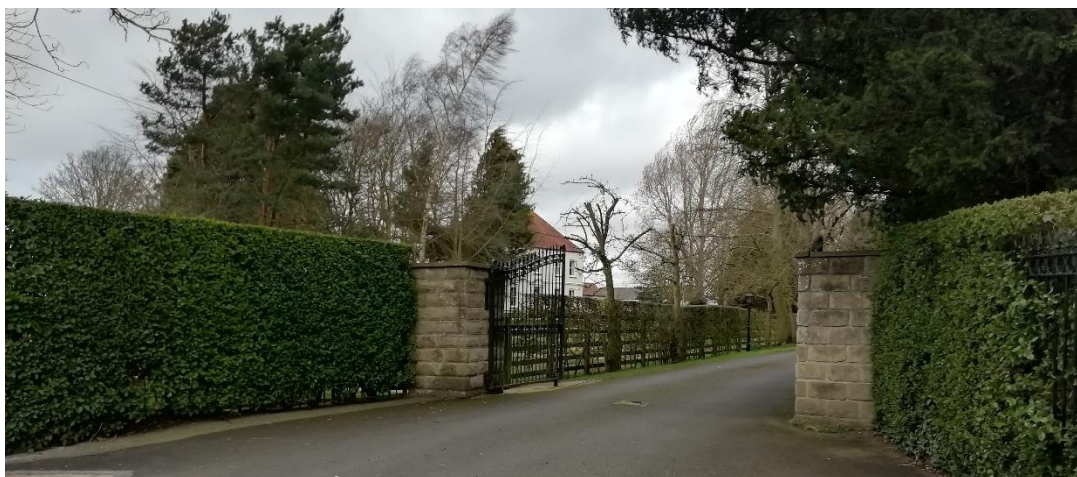
Fig 3 Suburban approach to Manor Farmhouse

- 5.1 Manor Farmhouse is located to the north of Strensall (Fig 2). It lies to the north of 'The Village', the settlement's principal east-west street, and is accessed via a tarmac drive which travels through decorative, suburban gates with modern stone piers. These piers are flanked by dense hedges and mature trees which make the former farm a hidden, high status enclave of which there are limited views from 'The Village' (Fig 3).

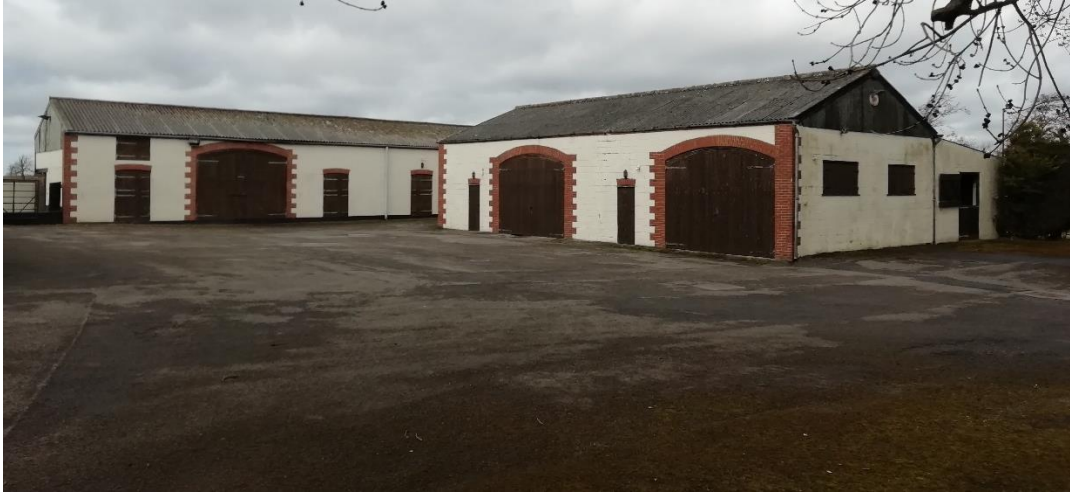
Fig 4 Former, modern farm buildings to north replaced with residential development

- 5.2 Manor Farmhouse is a seventeenth century house with eighteenth and twentieth century alterations constructed of white painted brickwork under a Rosemary tile roof (Fig 13). Beyond the farmhouse, to the north, and accessed via a shared drive, lies a modern housing development located on the site of a twenty-first century farmyard. The dwellings replace two, white painted, breezeblock farm buildings (Fig 4). These buildings were constructed on

a small section of the former dairy farm which was damaged by storms in 1999. The site was, until recently, in the same ownership as Manor House Farmhouse, which has an historic range of farm buildings attached to the rear enclosing a separate courtyard, and formed part of Manor House Farm. A new brick wall has been constructed to separate the farmhouse and its historic courtyard from the residential development beyond.

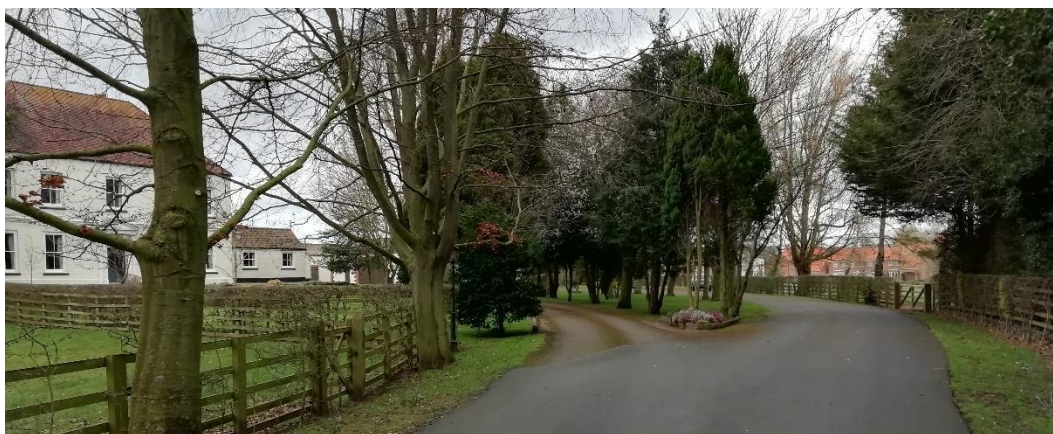
Fig 5 Tarmac driveway approach to Manor Farmhouse with access to dwellings to right

- 5.4 The more formal, front garden is set below the level of the house and is reached from the house by a short flight of steps. It bounded on the eastern and northern sides by the return stretch of the tarmac, loop drive. The return loop of this drive follows the line of the historic access to the moated site (see map regression below) whilst the ingoing section of the drive is new and associated with the modern farm and now the new residential development. The extensive, amorphous area of tarmac, which extends from the new access into the historic courtyard, undermines the setting of Manor Farmhouse, creating a visually weak, informal character.

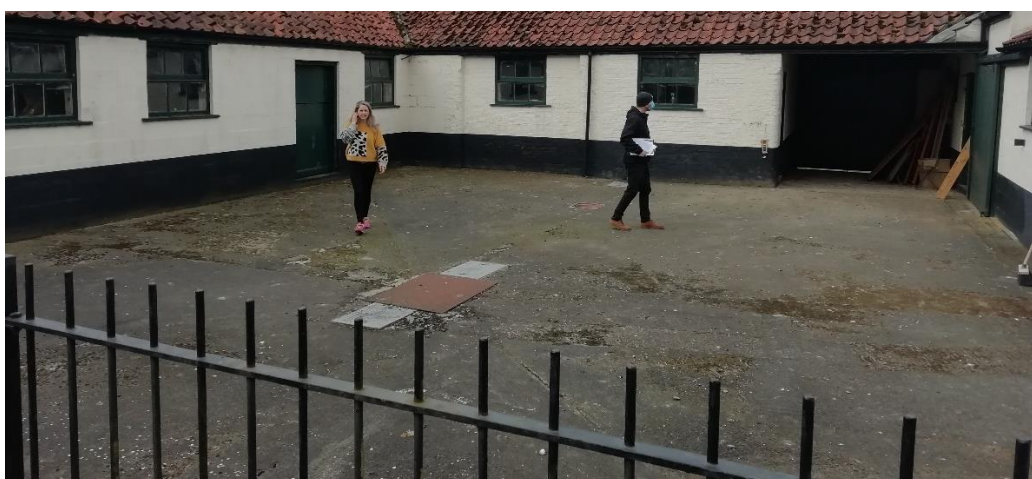
Fig 6 Split level tarmac foldyard bisected by modern steel fence

- 5.5 An historic range of farm buildings which are connected to the rear of the house form a 'U' shaped range to the north-west. This range encloses a former fold yard which is split level with the drop protected by a modern, steel fence which bisects the yard (Fig IN). The yard is covered in tarmac. The southern and western range are defunct but the northern range has been converted into a number of offices by the previous owners. Large, regularly spaced openings have been made without consent to form a number of doors and windows which are of a domestic design and constructed from plastic. The northern range dominates views of the house in the main vehicular approach to the house. The unauthorised works severely undermine the rural character of the dwelling's setting, a factor which is exacerbated by the tarmac covered yard (Fig IN).

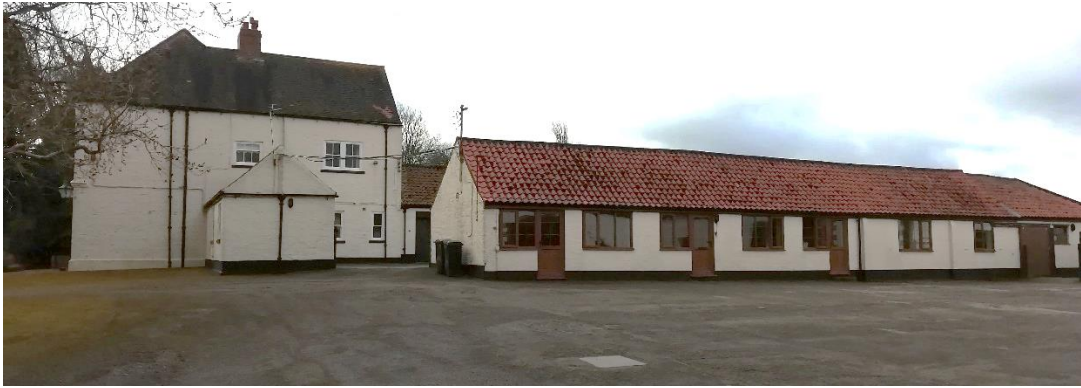
Fig 7 Office range to norther of house with modern openings and plastic fittings

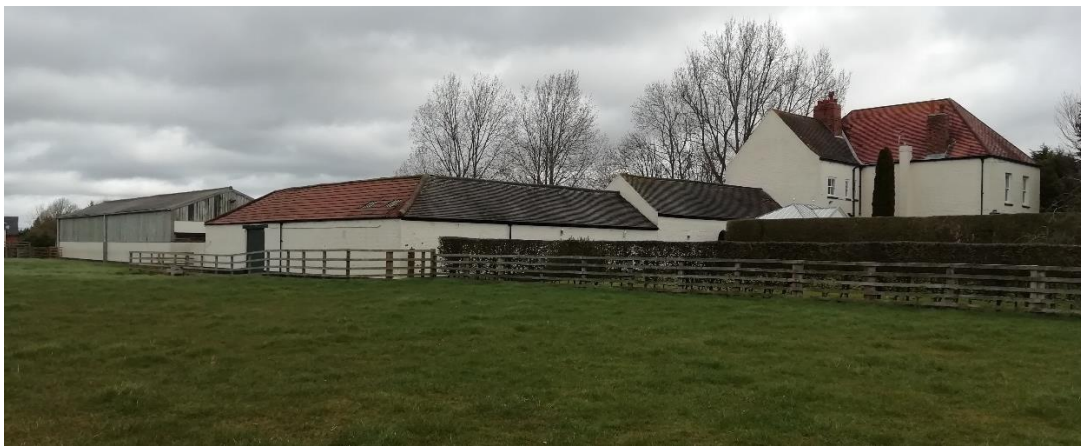
Fig 8 In views from the fields the white masonry unifies the farmhouse and the farmyard

- 5.6 The field to the west falls within the same ownership as the farmhouse. From here, the white painted masonry of the farmyard helps to reinforce the relationship between the yard and the house and aids the legibility of their relationship thus unifying the site (Fig IN). The diminishing ridge heights and associated status of the component buildings is best viewed from this angle with the hipped roof form of the dwelling stepping down to a pitched, two-storey service wing, which steps down to a garage block which in turn steps down to the former dairy. The southern side garden is contained by a mature hedge and the tip of the conservatory can just be seen against the rear service wing. In this view, it could be a free-standing greenhouse.

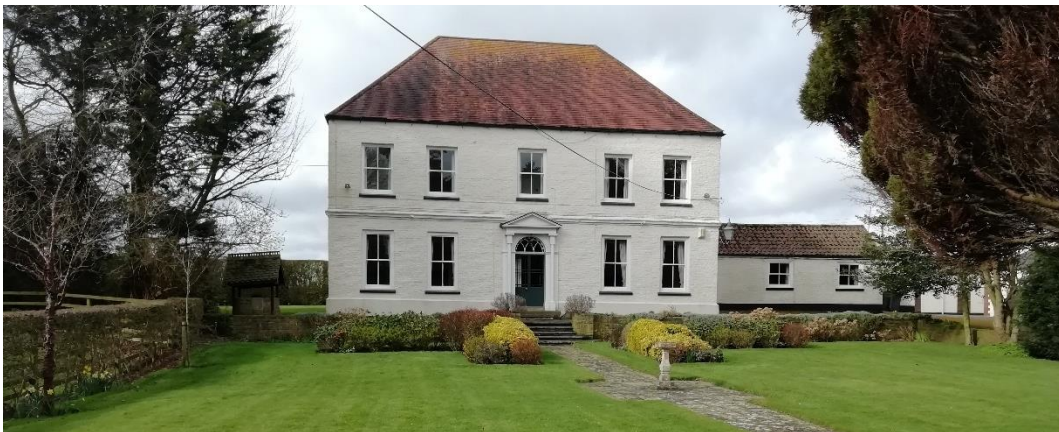
Fig 9 Manor Farmhouse viewed from the east

6.1.1 Manor Farmhouse is a Grade II listed building, the list description for which can be seen at Appendix A. It is built of white painted brick under a steeply hipped, twentieth century, Rosemary tile roof (Fig IN). It was built on the site of an early medieval, moated manor house and occupies slightly elevated land which gives it a commanding position and increases its status. It has a symmetrical, east facing principal elevation which was aggrandised during the eighteenth century through the addition of a portico, Doric columns and a fan light.

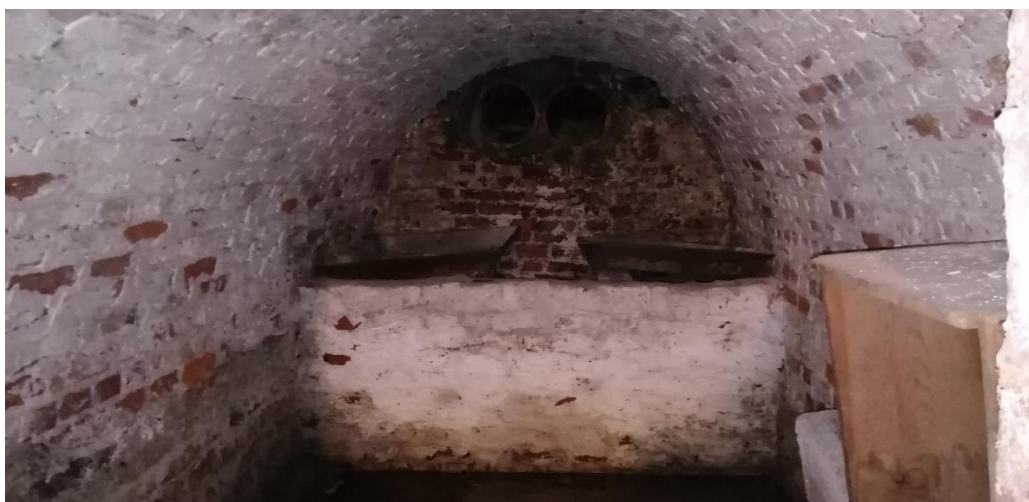
Fig 10 Former coal chute (now blocked) in current cellar

- 6.1.4 Pickard and Mitchell state that, 'the present Manor House dates from 1695 when Sir William Robinson, Lord of the Manor of Strensall, entered into a contract with John Etty Carpenter of York to build him a house here. Although Lord of the Manor, Sir William never actually lived at Strensall. He was twice Lord Mayor of York and an MP for York and Northallerton in 1685. The Robinsons had become lessees in the early seventeenth century and continued to be so until the late eighteenth century. The house seen today largely conforms to the plans of 1695 except for the cellars which are only thought to be eighteenth century, despite the presence of cellars in the earlier house. The coal chute to the existing cellar can be seen below at Fig 1N. The external access point, which is now blocked, would have been under the front elevation.

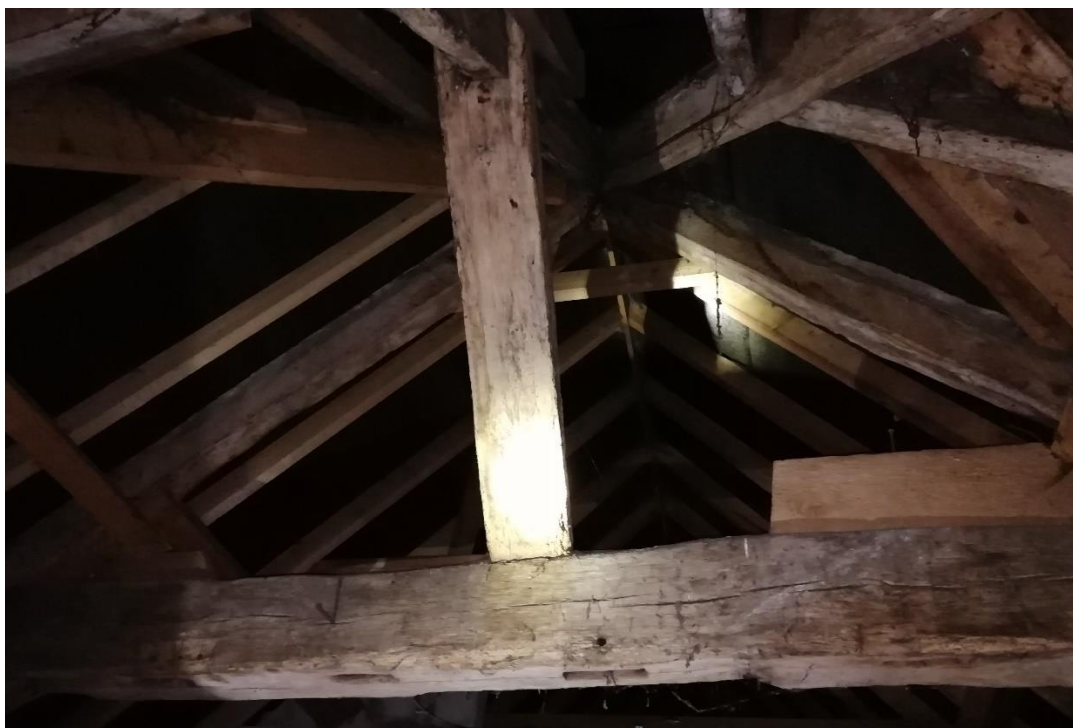
Fig 11 Roof structure with modern rafters and felt and breezeblock supporting wall

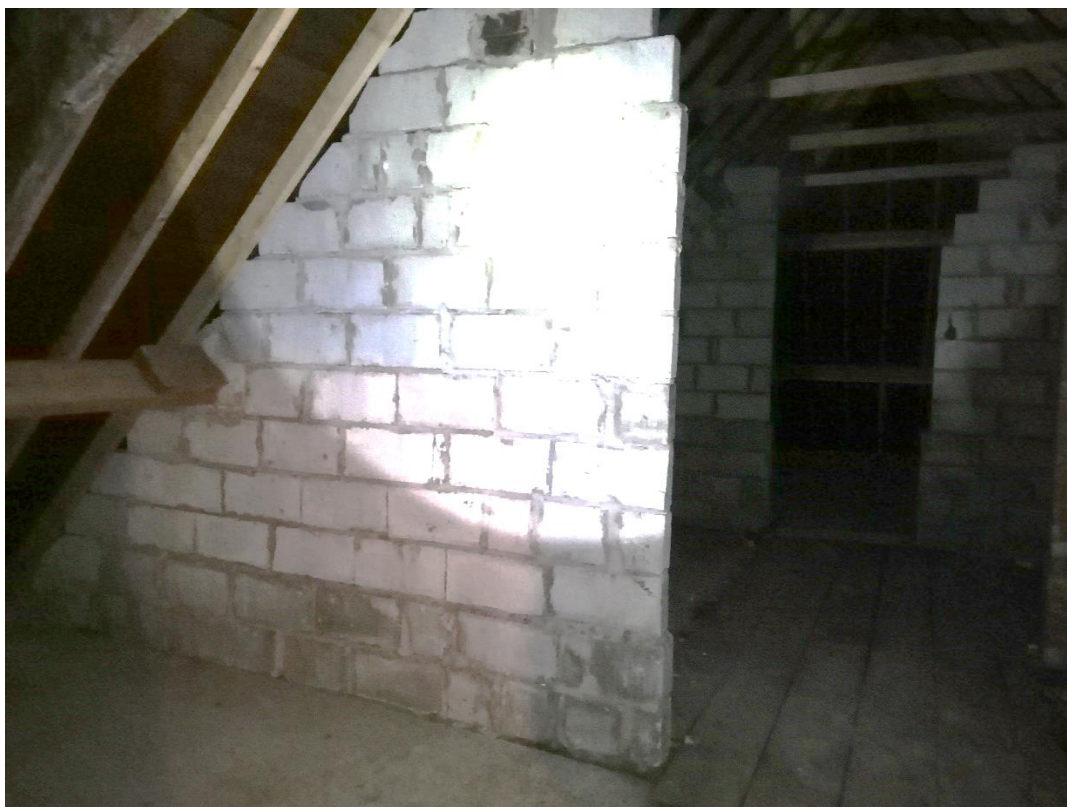
Fig 12 Breezeblock supporting walls within attic space with modern roof timbers

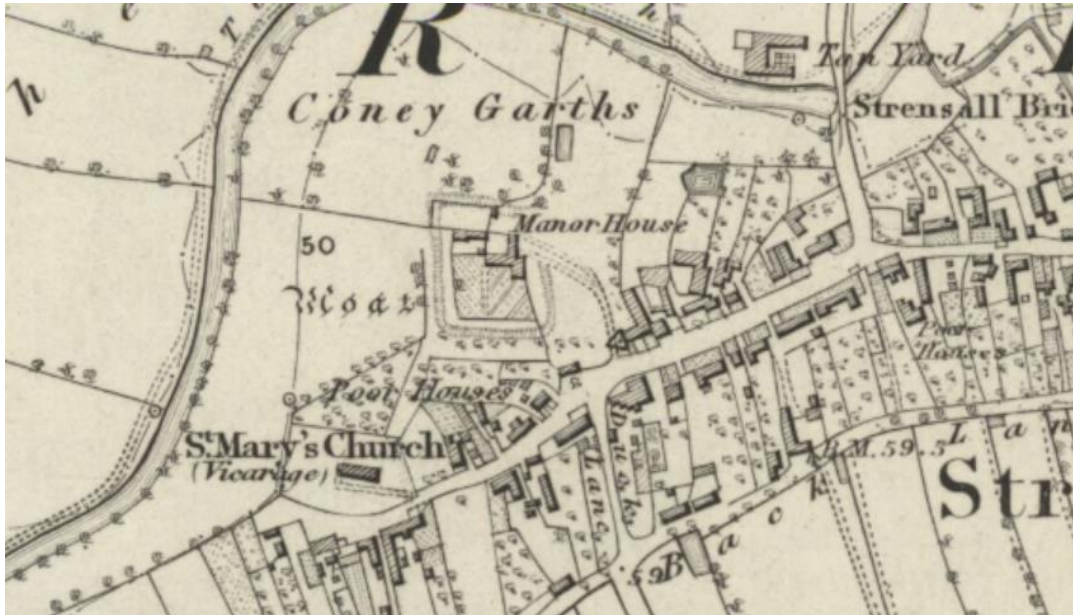
Fig 13 OS six-inch England and Wales Series, 1842-1952, published 1854

- 6.1.6 The earliest available mapping of Strensall found by the author dates to between 1842 and 1854 (Fig 14). This shows the Manor House with an area of domestic land which is bounded on all sides. This is, in turn, surrounded by a clearly identified moat on all sides. The only exception is at the north-east corner of the site where access is afforded to the house across the moat. This access comprises a path to the house and a track to the rear yard which follow much the same line as the current return driveway and path to the house. The area to the north-east of the manor is the only area where a boundary does not encircle the manor and the relationship with the land to north here is much more open. The northern arm of the moat, which appears to dogleg slightly rather than running in a straight line has been bisected by a fence enclosing Coney Garths with the moat taken into the field at this point. What appears to be a small structure has been built on the south-eastern corner of this arm of the moat. A very substantial structure is also visible in the field to the north-east of the Manor with a smaller structure evident in Coney Garths.

- 6.1.8 A boundary is also shown running perpendicular with the south-west arm of the moat which appears to terminate prematurely. This map also shows an historic building just south of the western part of current office which was later demolished. This building does not, as the Council has previously suggested, form part of the current office range, although this would be an easy assumption to make given their close proximity. 'Poor Houses' are shown between the church and Manor House, presumably built on land formerly associated with, and possibly donated by, the Manor with an orchard beyond. A triangular field with a tree lined boundary is evident to the north of the church which also appears to be used as an orchard. The southern moat is also reinforced by a line of trees to the south. These trees would have impeded views between the church and the Manor House although a thin spur of open land links the Manor House and the church between the orchards suggesting a possible 'short cut' and close relationship between the two structures.

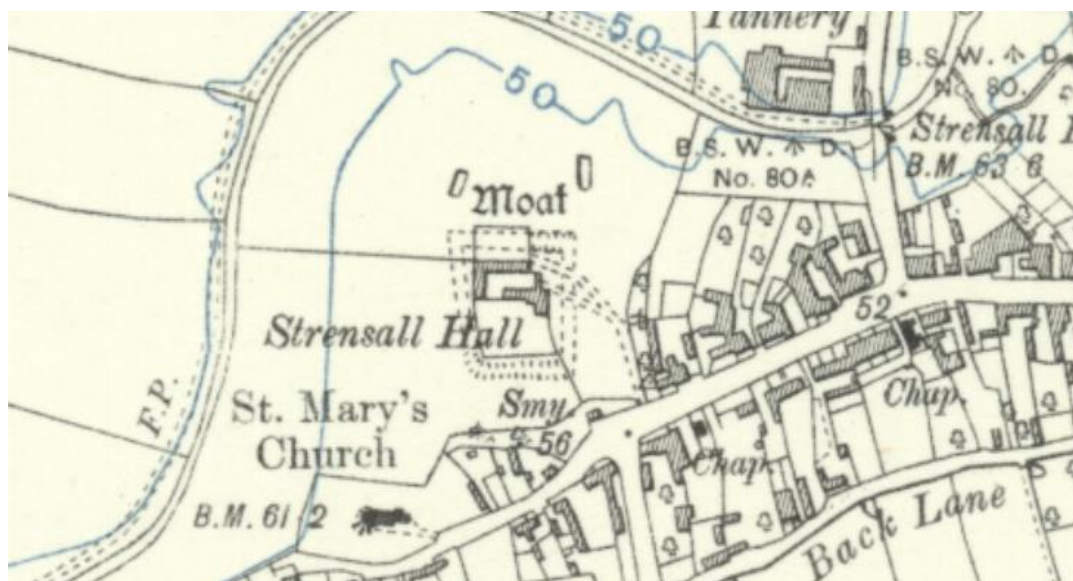
Fig 14 OS six-inch England and Wales Series, 1842-1952, revised 1909, published 1913

- 6.1.10 The 1919 OS map also shows that the building to the south of the current office has been demolished and rebuilt further to the north, closer to the moat. A range which extends to the south, to form an 'L' shape, has also been built which encloses the yard to the rear of the house. The boundary to the north of the site, evident in the 1854 map, has been realigned with the western side now running directly north from the apex of the northern range and the enclosure now encompassing the infilled part of the moat's northern arm. The structure at the corner of this enclosure has also been demolished. The field boundary to the south of Coney Garths has also been re-aligned to meet the apex of the new agricultural range which has resulted in a straighter field boundary. These alterations and structural development possibly imply a move to a more formal farm. Certainly, in the Bulmer's Directory of professions and trades of 1890, 'Warrener J.' of Strensall Old Hall is recorded as being a 'farmer (& joiner, &c.)'. As a joiner he may also have been involved in the funeral industry. This signifies a reduction in status of the building's occupants, from lord of the manor to farmers/ tradesmen.

- 6.1.11 The map also shows orchards between the church and Manor and the boundary to the east of the church had been removed, creating a larger, more open church yard and more open land to the south of the Manor House. The Poor Houses also appear to have been cleared and replaced with a blacksmiths (Smthy) with the result that the area to the south of the Manor is not only more open but less densely developed. The field boundary to the west of the moat and the eastern boundary to Coney Garths have also been removed creating a more open relationship between the Manor House and the surrounding landscape. The whole pattern of development in the area seems to eschew general norms where development becomes denser over time. The two field structures within Coney Garths remain, however, with the eastern structure appearing to have been augmented and a slim, tapered enclosure created along the eastern boundary of the demesne.

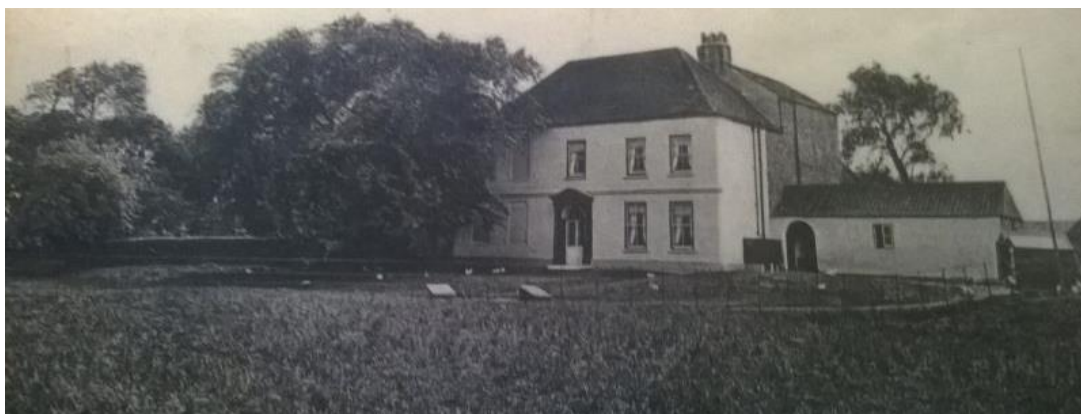
Fig 17 Undated photo showing shutters removed, blocked windows, arched doorway and shed to right with possible radio antenna

6.1.14 The historic photographs available are all of the eastern elevation due to the location of the primary access. Although they are all undated, Figures IN and IN are considered to be the oldest image as they show a mature tree to the rear of the building which is absent in the other photographs. Fig IN shows best the absence of the four windows to the left-hand side of the door prior to their reinstatement by the Halls in the late 1950s. The fact that they were blocked may explain why the tree here was allowed to grow to such a size. The arched door to the dairy, which was later blocked, is also best seen in this photograph. Both images appear to show two interpretation boards on the northern side of the estate fencing indicating that public access was afforded to these fields, even though no formal access is shown on the OS maps, and that there was a level of interest in the site. A shed is also visible, angled towards the entrance to the yard.

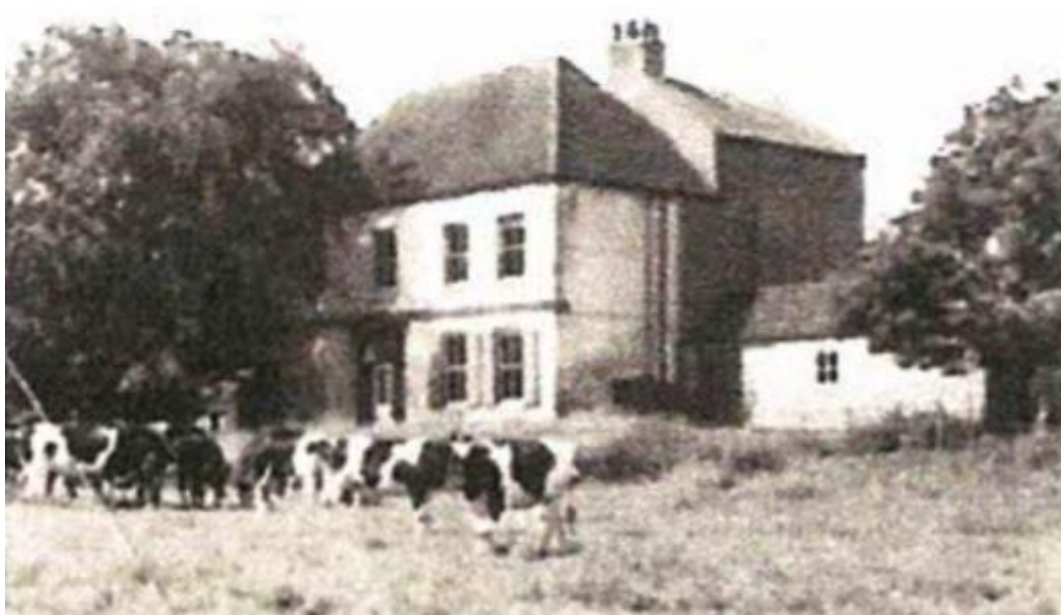
Fig 19 Showing former height of service wing & new dairy with cows evidencing a herd

6.1.15 Figures 20 and 21 demonstrate clearly the former scale of the service wing and its associated chimney. Figure 21 shows the very mature tree which fell onto the house, exposing the historic well to the south-east of the house and requiring the building to be re-roofed. It also

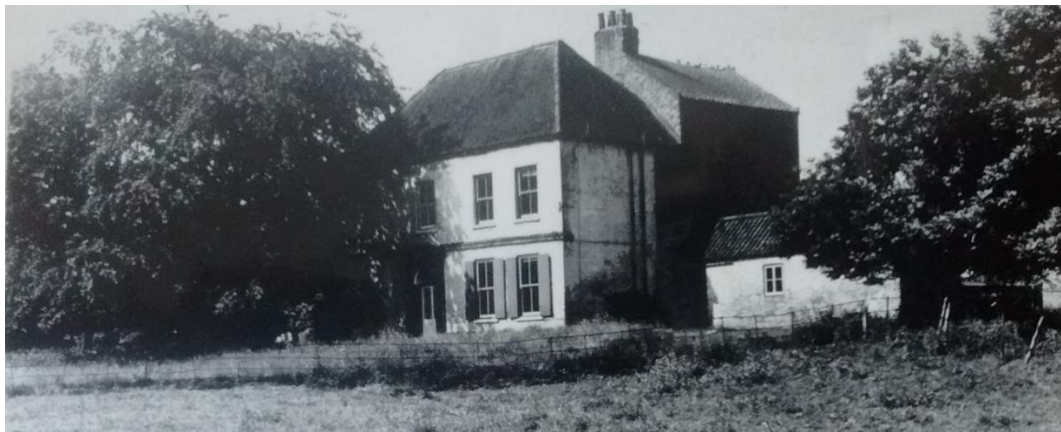
Fig 20 Undated photo with shutters to ground floor windows and estate fencing to drive

shows most clearly the estate fencing that was erected to separate the pastoral farmland from the domestic curtilage and the shutters that were briefly fitted to the remaining, ground floor windows on this elevation which are also most clearly evident in Fig 21. These shutters are likely to have been a late nineteenth or early twentieth century addition.

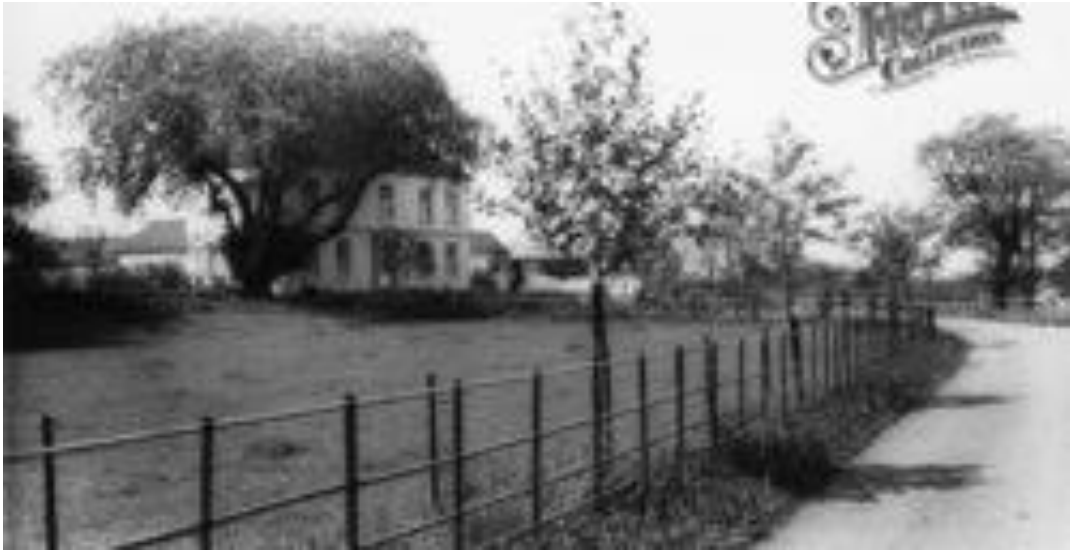
Fig 21 Approach to house c. 1960 with dairy farm evident beyond

6.1.16 Fig 22, copied from the Francis Firth collection, dates to the early sixties. The substantial tree appears to have been crown raised, probably as a result of the reinstatement of the four missing windows to the front elevation and an associated attempt to increase light levels in the corresponding rooms. It may have been this work that de-stabilised the tree and led to

its subsequent collapse. Some of the modern dairy buildings are evident beyond the listed range to the north.

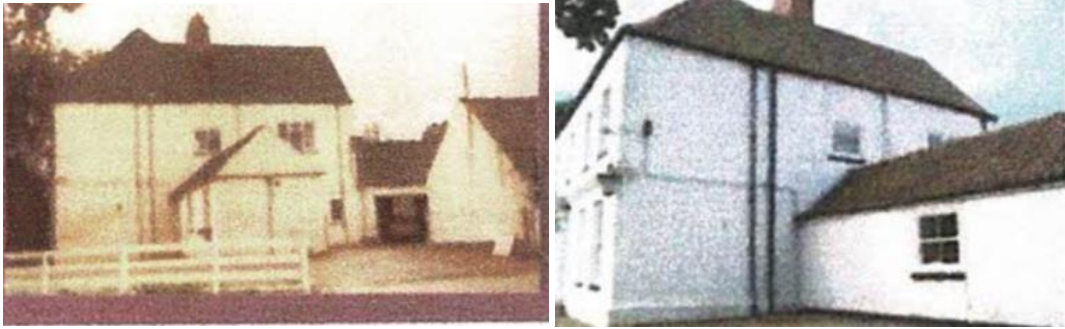
Figs 22 and 23 1975 photographs showing reduced service wing and chimney, covered access to south, post and rail boundary fence to domestic curtilage and blocked arched door to dairy

6.1.17 Fig 23 shows the much-reduced service wing with the windows of the bedroom and bathroom created in the attic space above the kitchen and the location of the former back stair respectively. A covered access is shown to the land to the south, in the location of the existing garage, and a post and rail fence is shown enclosing the domestic curtilage which has replaced the earlier estate fencing. Fig 24 demonstrates the blocking of the arched dairy door. A corresponding door was created on the western elevation. This alteration may have indicated the changing function of this space as the modern dairy was developed in new, purpose-built structures and this building became absorbed within the domestic dwelling.

- 6.1.18 These photographs evidence a solid boundary between the domestic curtilage and the wider agricultural setting. They also demonstrate the soft, pastoral landscape that formed the wider setting of the listed building and supported a small dairy herd prior to the establishment of the more intensive dairy farm in the latter part of the twentieth century. The front garden appears to be a relatively recent creation being preceded by what appears to be grass and trees which lent a 'parkland' character to the site.

- 7.7 An opening is proposed to connect the proposed day room with the conservatory. There are single doorways in the service range and, as highlighted above, the wall in which the door is proposed was previously a covered driveway and dates to the late twentieth century (see c.1970s photo at Fig 22 above). The masonry to be removed is therefore modern and the opening reflects the former connectivity between this space and the side garden. This is also therefore considered to be a neutral change.

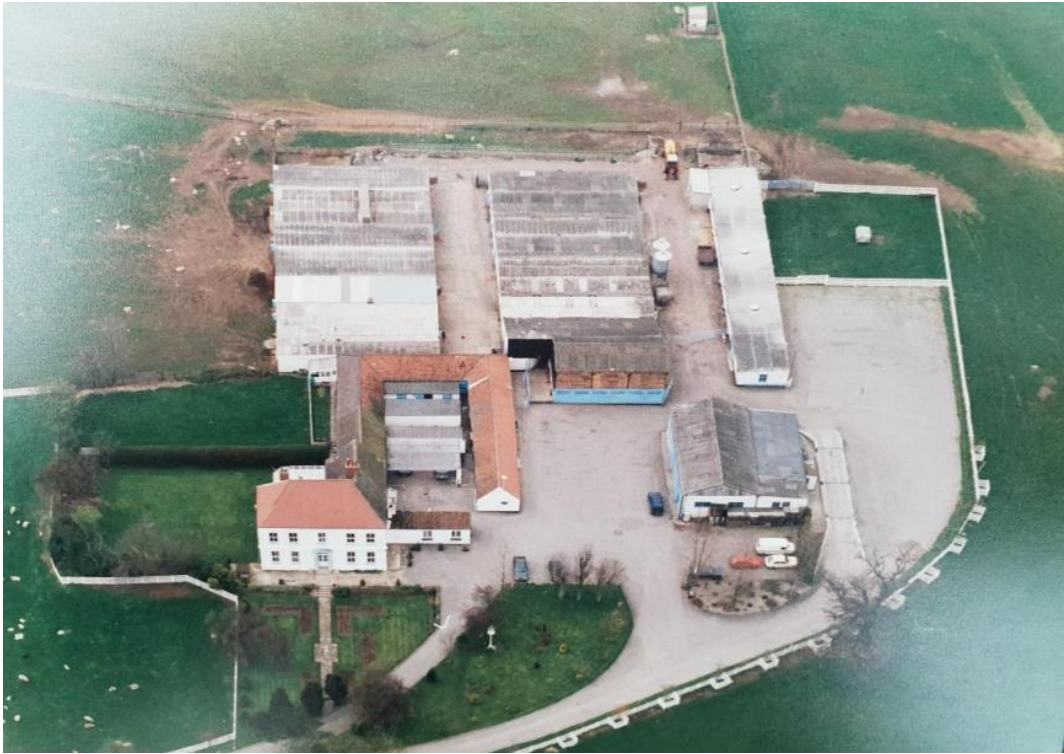
Fig 24 Peak extent of dairy farm in the 1980s eroded division between house and farm (note the presence of the conservatory)

- 6.1.19 The current ownership dates back to 1958 when the farm was purchased by Albert Hall. At the time of purchase the house was in a very poor state of repair and it took two years of restoration before the family could move in during 1960. For the following twenty years, the site was run as a dairy farm with a herd of forty milking cows. More buildings were constructed in 1975 to house calves. The herd continued to grow and further buildings were added in the following 10 years. Figures 25 and 26 show the dairy farm at its height with extensive and densely located, modern agricultural buildings constructed to the west and north of the listed building. The historic courtyard was infilled with modern sheds at this time and there was erosion of the grassland setting due to farm activity. Tree planting along the north-east boundary was carried out (note the white, rectangular protective cages) along a newly created boundary line. This boundary intruded into the formerly open manorial demesne, breaking down the pastoral setting of the listed building. The physical separation between the house and agricultural setting, that began with the moat and was then superseded, first by estate fencing and then by post and rail fencing, was removed, weakening the separation of the domestic curtilage and supporting landscape. This in turn blurred the distinction between land use and undermined the status of the dwelling.

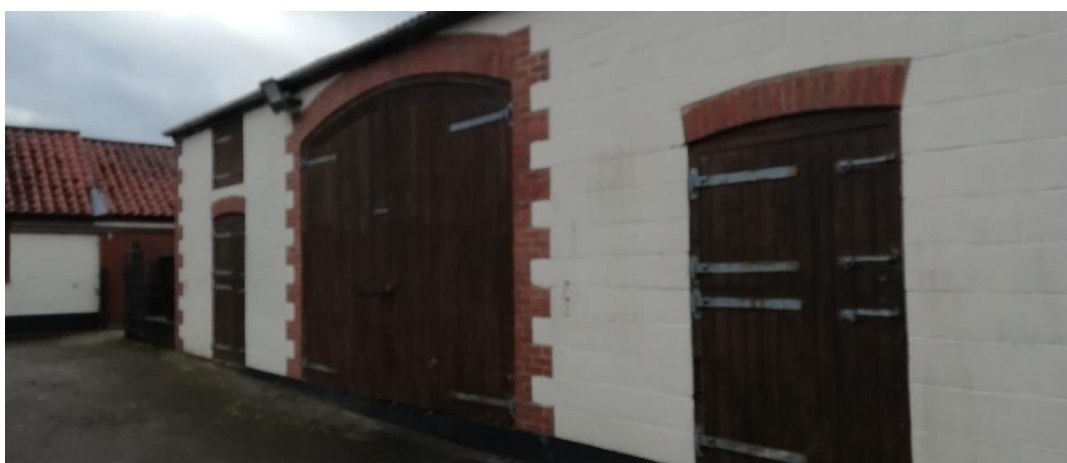
Fig 27 Arched openings, albeit on too large a scale, inspired by traditional cart openings

6.1.20 Following the BSE outbreak in 1996 the farm began to concentrate on beef production. The low height calf sheds were then no longer suitable and stood empty for the following three years. In 1999, the sheds suffered significant storm damage and the decision was taken to demolish them. The land on which they stood was returned to the adjacent field and reverted to pasture. This land is now largely outside the farm curtilage. Two breezeblock structures were constructed on or near the sites of former structures. Although thoughtfully detailed (Fig 27) these buildings were both one and a half storeys and so are higher than the historic, agricultural range. They incorporated arched, solidier course lintols which are not typical of vernacular farm buildings. The western block was also constructed over part of the former moat which undermined the legibility of the location of this feature and may have caused archaeological damage (Fig 28).

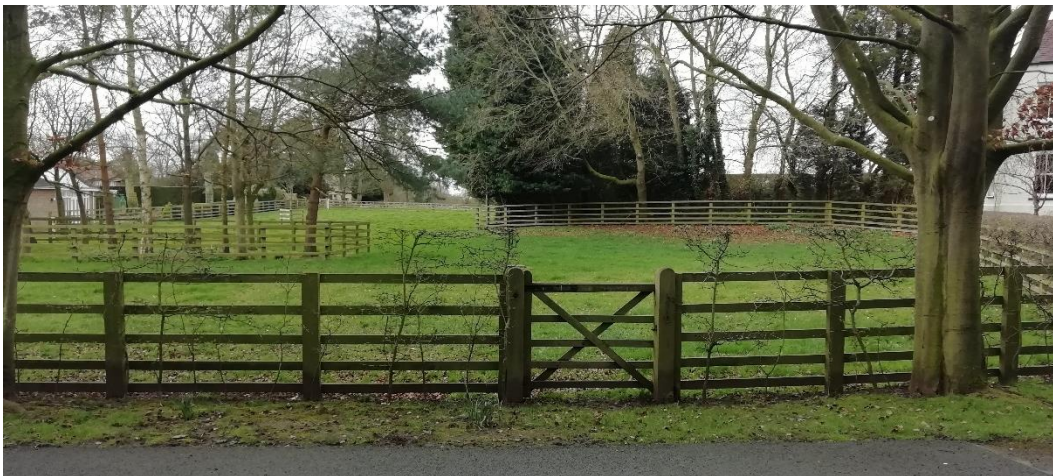
Fig 29 Open setting to south eroded by ring fence and suburban encroachment

6.1.21 Land to the south of the house remains in pastoral use although residential development along 'The Village' and the planting of conifers in the southern garden have suburbanised the setting of the listed building. The creation of ring-fenced enclosures of trees, whilst attractive, has also eroded the open setting of the former pastoral, manorial demesne.

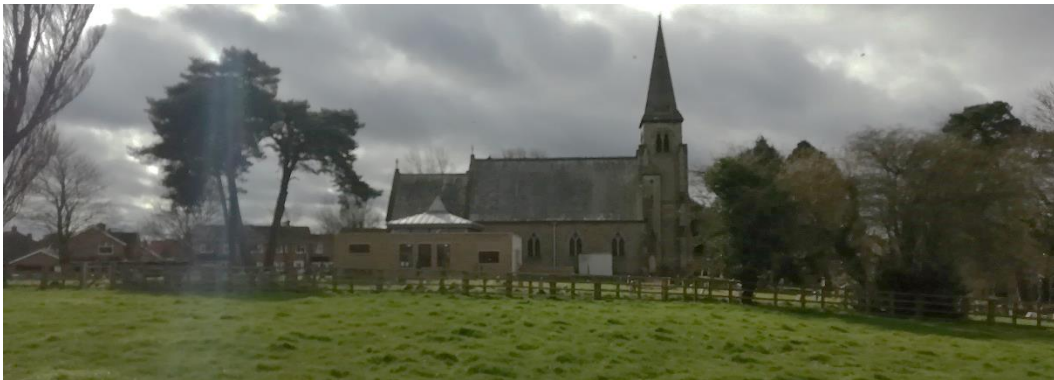
Fig 30 St Mary's Church from the north with geometrical extension

- 6.2.1 St Mary's Church is a Grade II listed church which was built on the site of an earlier, Norman church dedicated to St James, itself built between 1100 and 1150. It is known that in 1425 penitents visiting the Church of St. James in Strensall could receive indulgences. St Mary's was built between 1865 and 1866 in the decorated Gothic Revival Style from designs of Sir Gilbert Scott. It was designed by JB and W Atkinson and constructed from sandstone under a

Westmoreland slate roof. Its porch and principal entrance face south away from the application site. To the north, the church has been extended with a twentieth century, community room of a geometric design which the list entry states in not of special interest (Fig 30).

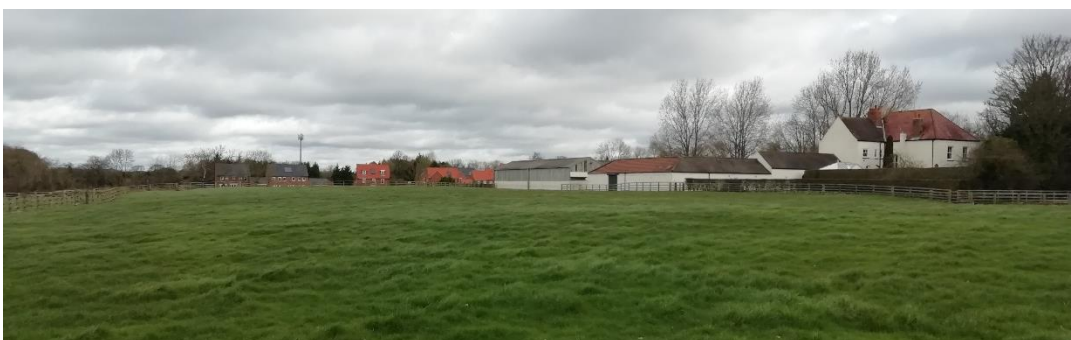
Fig 31 View north-east, taken from just beyond the graveyard

6.2.2 The application site is seen in views north-east from the churchyard, through trees planted in the churchyard and across a foreground of pastoral fields (Fig 31). In this view, the ridge of the conservatory is barely visible against the service wing. The large, square opening in the western range of the farmyard is visible as is the post and rail enclosure between this range and the field. The application site is also seen in views back towards the church from the north-west and north-east where the church spire is seen in silhouette against the skyline (Figs 32). In these views, Manor Farmhouse is concealed but the western, dairy range is visible.

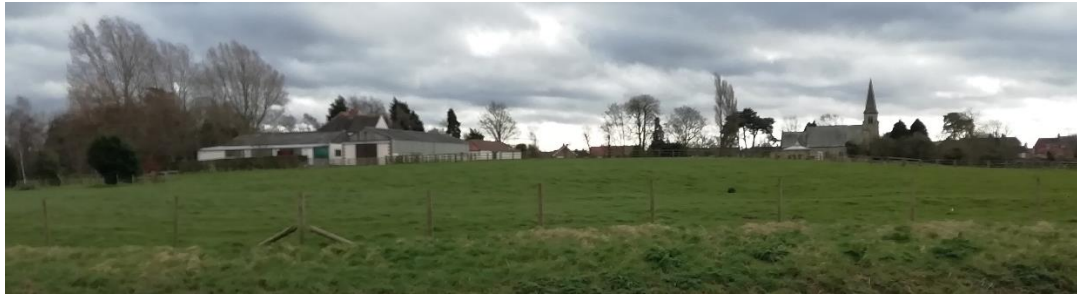
Fig 32 In views south towards the church the application site is visually intrusive

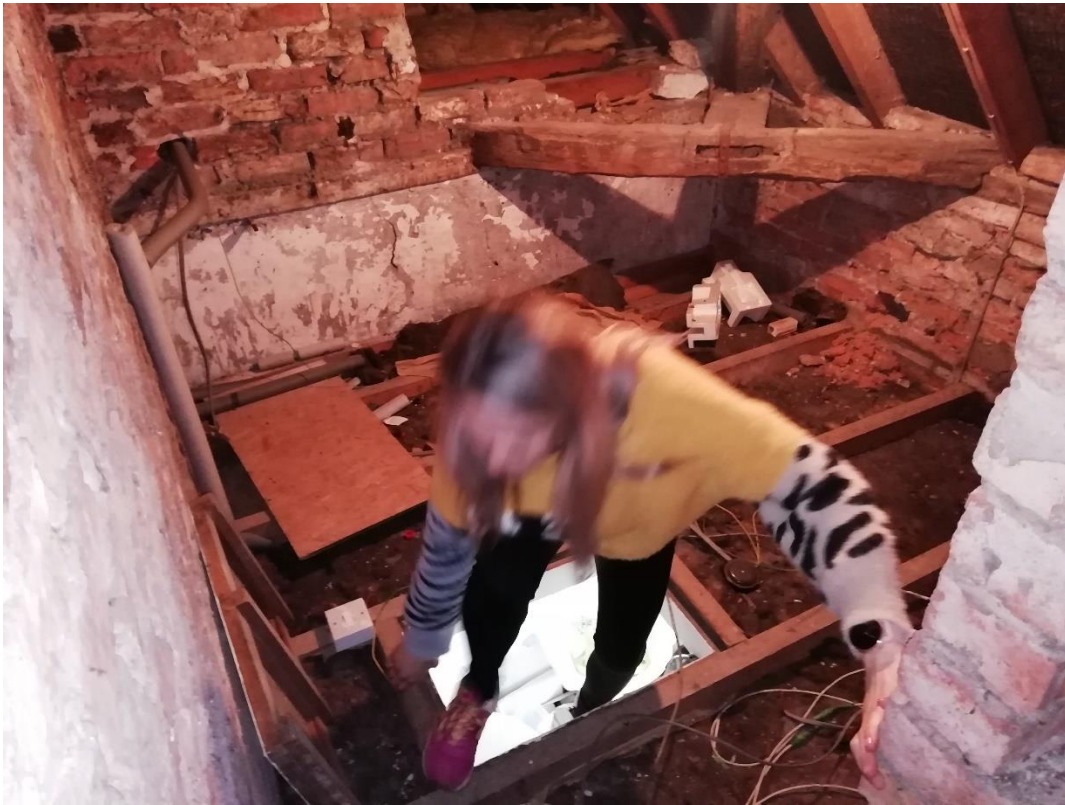
Fig 33 Plastered back stair bay with modern ceiling inserted and later, brick gable to the replacement service wing beyond

offset by the partial reinstatement of the back stair and the provision of access to the attics.

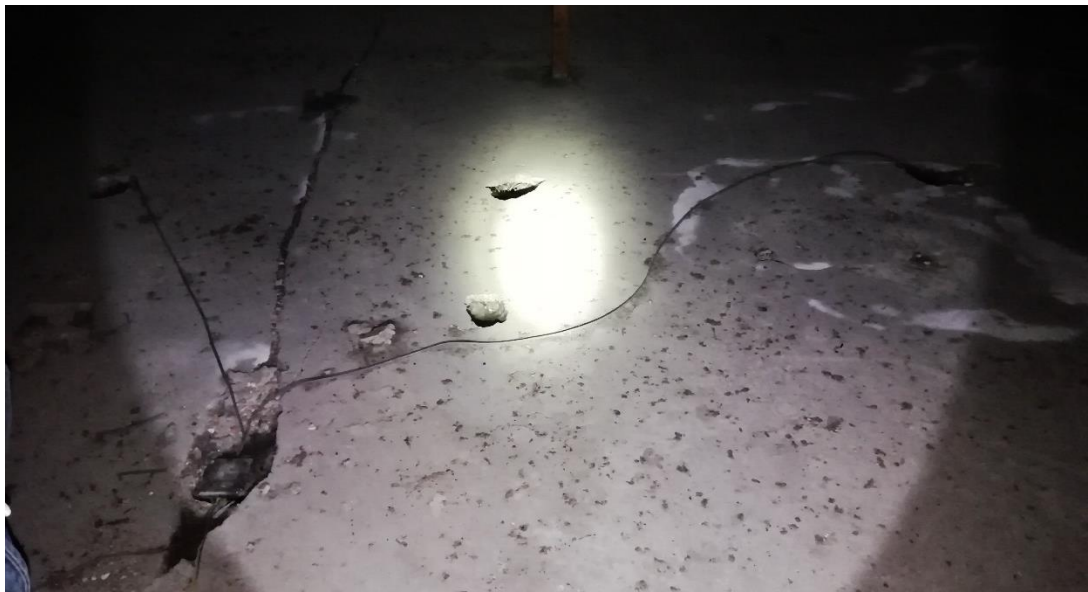
Fig 34 Limecrete floor referred to in original plans (Appendix D) to be conserved in situ

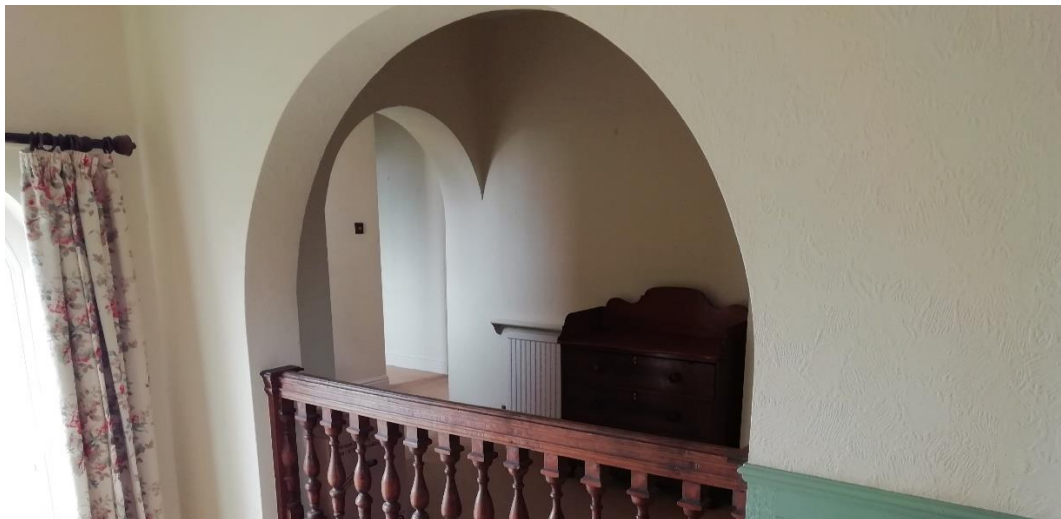
Fig 35 Two 1980’s arches formed from stud walling to be squared off

- 7.3 Two large, arched openings have been formed on the landing out of stud work (Fig 35) with modern balusters added within one of these openings. These have a very ‘eighties’ character. The applicants proposed to ‘square off’ these openings to better reflect the architectural detail of the original building. This will necessitate the loss of a limited amount of stud walling and is considered to be a neutral change.

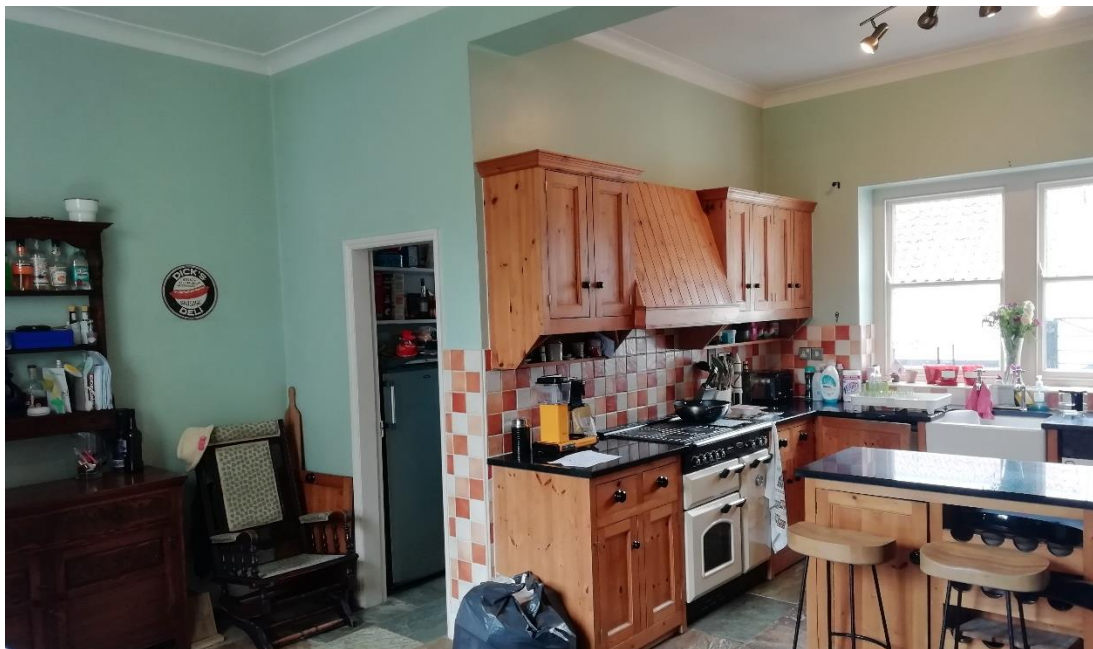
Fig 36 Pantry possibly formed from former Milk House shown on 1795 plans (Appendix D)

- 7.5 At pre-application stage, the removal of the pantry within the kitchen was discussed and received positive officer feedback. It has become evident however that this pantry is formed from what remains of the original milk house (Fig 36). On my advice, the applicants have decided to retain this pantry and omit their proposal to create a full width opening in this wall. A more modest doorway is proposed instead to connect the kitchen with the garage beyond which will conserve the pantry.

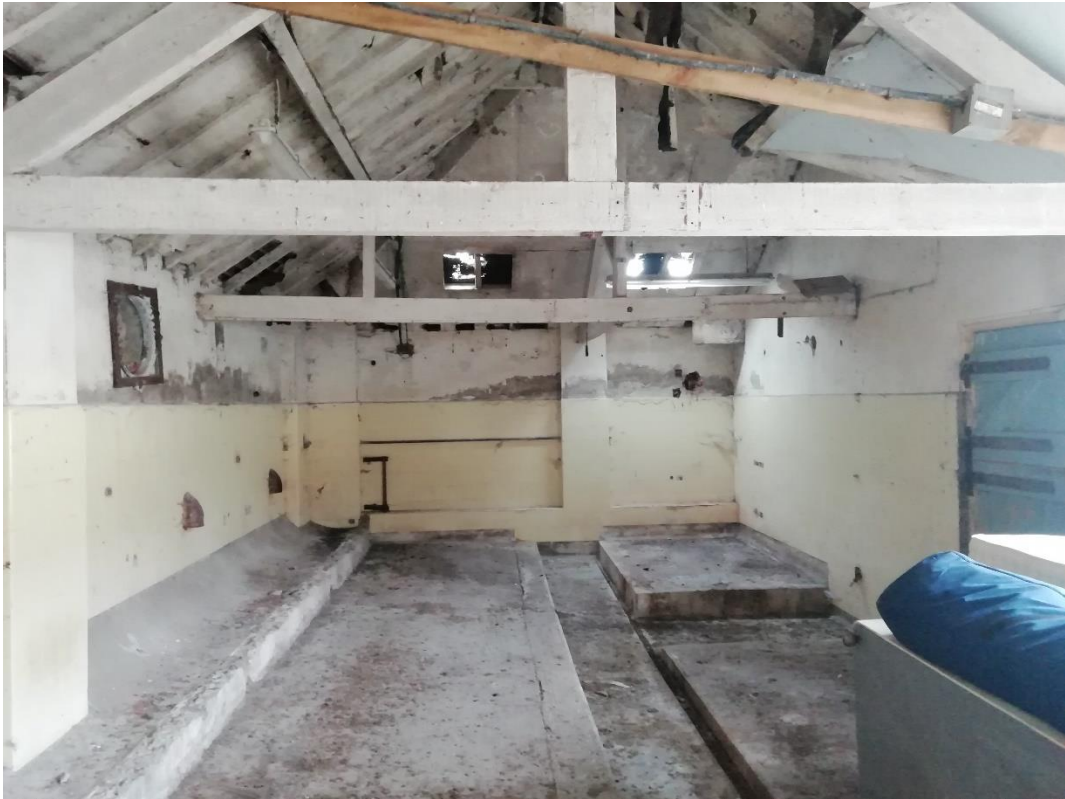
Fig 37 Southern dairy

- 7.10 The applicants propose to convert the southern dairy range into a gym and entertainment space (Fig 37). The map regression above shows that this is an early twentieth century structure. The conversion will be a low-key intervention and the tiled walls, roof trusses and purlins will be left exposed. The glass roof tiles, which are a vernacular approach to lighting agricultural buildings will be retained to conserve the external, agricultural character of the dairy but will be underdrawn and the external, Perspex covering will be removed. A new opening is proposed in the western gable. The design of this opening has been inspired by existing openings within the yard. It will be a square opening with a sliding shutter door which can be shut for security and thermal efficiency purposes when the gym is not in use. Glazing will be well set back in a deep reveal to minimise light reflection off the glazing. The loss of historic fabric and additional opening is considered to result in a low level of harm to historic interest, but this is mitigated by the considered design of the opening, the retention of the ephemeral tiles within the structure and other positive works being carried out within the site.

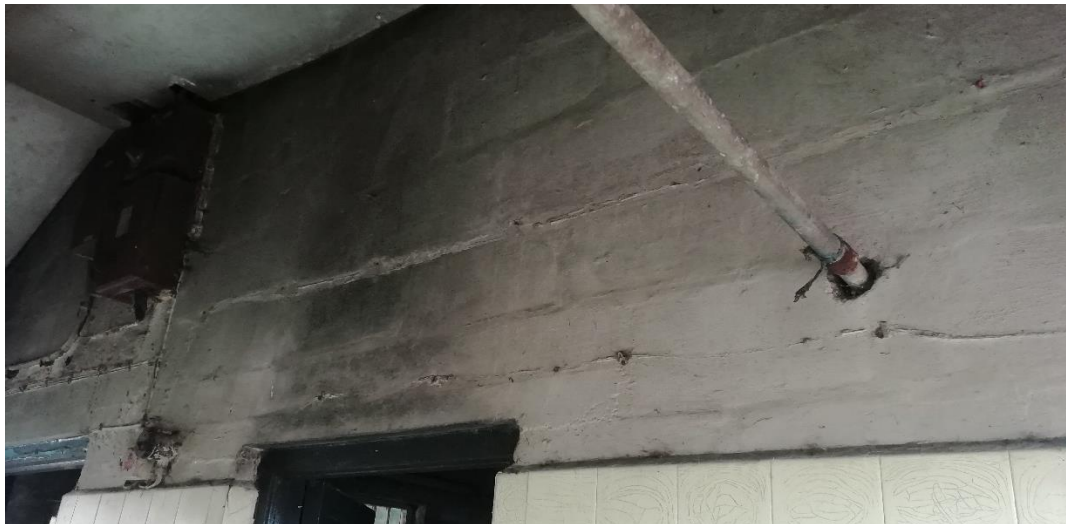
Fig 38 Proposed garage in section of range that is primarily constructed of breezeblock

- 7.12 A replacement garage is proposed in the northern range. This section of the range is primarily formed of breezeblock and as such this proposal received officer support at pre-application stage (Fig 38). The applicants originally proposed oak doors but this is not considered to be typical of this range or, indeed, of vernacular farmyards in the local area. As such the doors will be formed from vertical timber boards painted a dark, agricultural colour, with upper lights to reflect the garage doors currently contained within the building. Bifold doors are proposed given the tight access. Two personnel doors will be blocked as part of this work and a further door rehung to open outwards.
