**Heritage Impact Assessment
Manor Farmhouse, Strensall**

29.10.2021

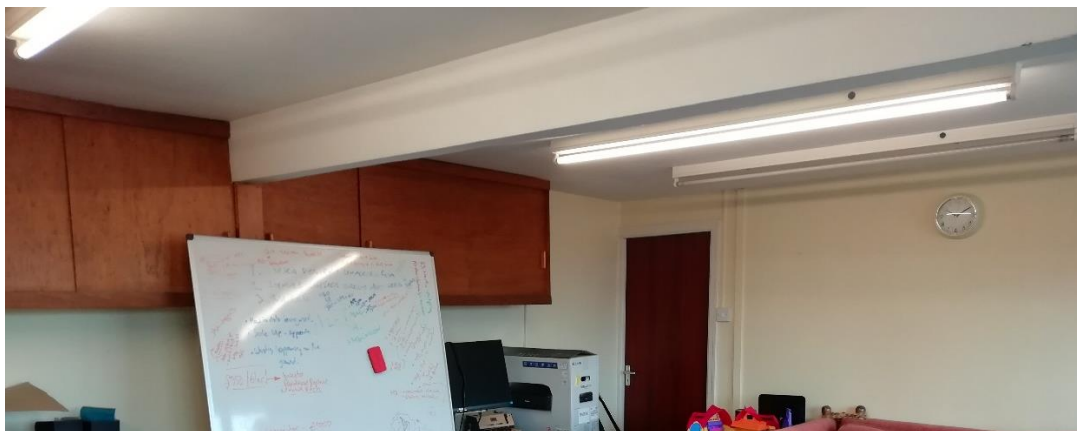
Fig 39 Downstand in northern range in location of proposed, internal wall

- 7.13 An internal wall is proposed within the northern range. This will reinstate a former wall which is evidenced by the downstand (Fig 39). This is considered to represent an enhancement as the proposal will better reveal the original floor plan. This work has already been carried out prior to the family decanting into the outbuilding during the re-wiring of the main house. No other works have commenced.

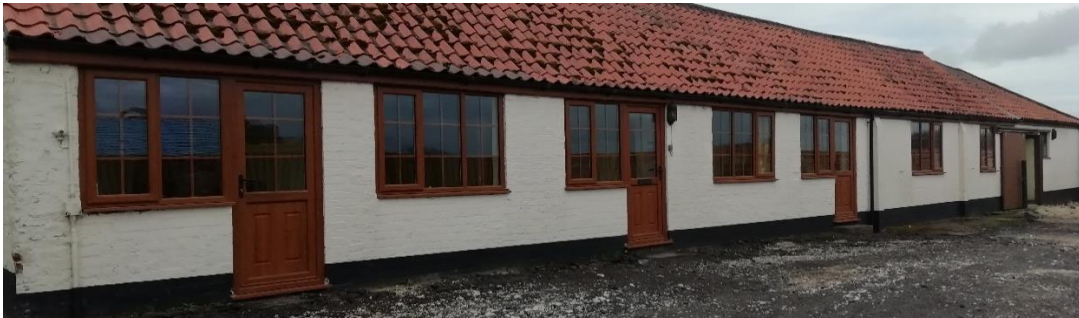
Fig 40 Left door & window and 3rd door from left to be blocked & fascia boards removed

- 7.14 One of the unauthorised office doors will be blocked up with masonry to match existing. This will enhance the appearance and historic and agricultural character of the northern range by increasing the masonry to void ratio. Personnel doors will be formed of vertical boards with a pencil mould to reflect existing doors within the range. Plastic doors and windows will be replaced with timber and painted a dark, agricultural colour to better reflect the agricultural character of the building. Plastic fascias and guttering will also be removed and replaced

with metal rainwater goods on gutter spikes. This work is considered to result in a significant enhancement to the historic and artistic interest of the listed building.

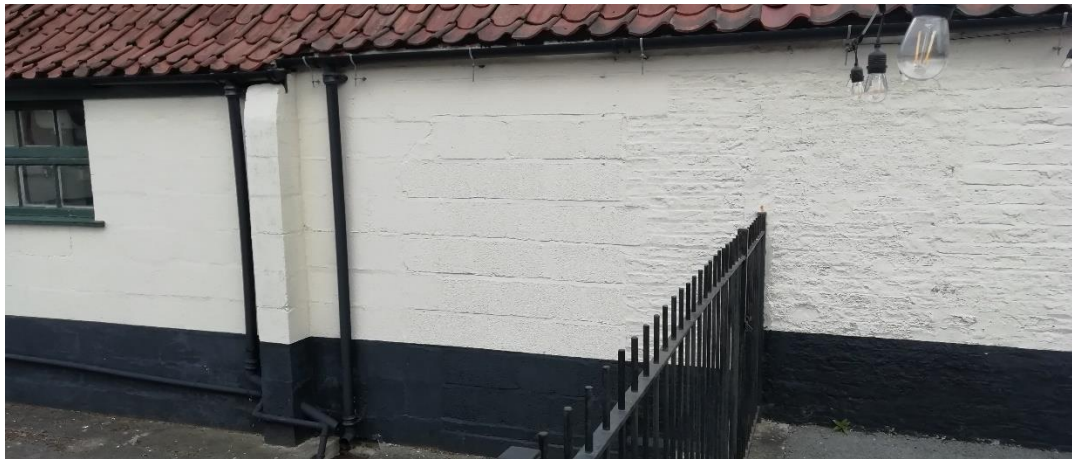
Fig 41 Blocked opening to be re-opened

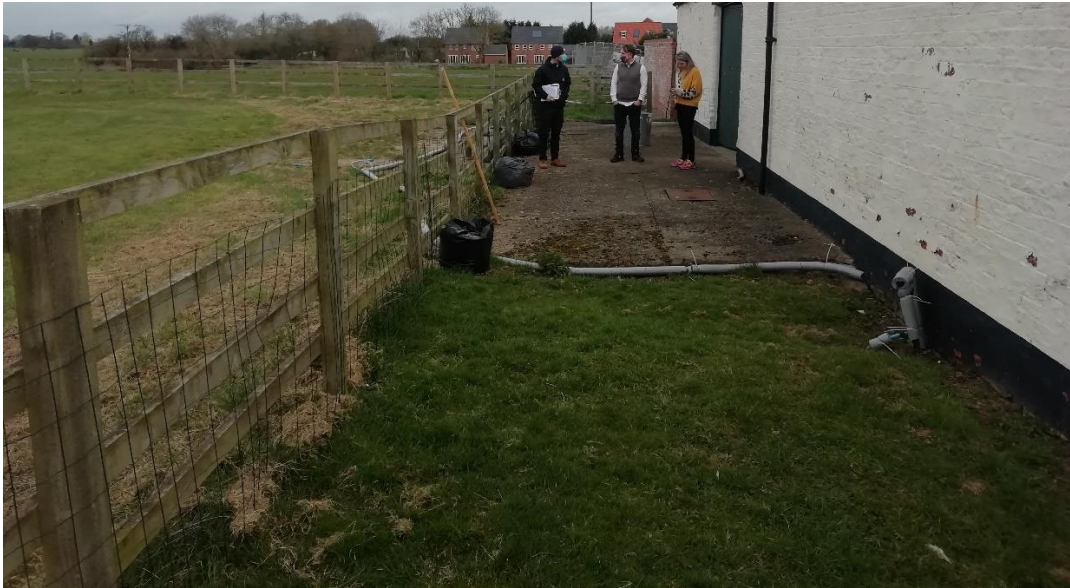
Fig 41 Concrete hardstanding and narrow, non-vernacular enclosure to be removed

- 7.18 Timber lintols are proposed above new openings rather than masonry lintols. This is a vernacular approach which will reduce the status of the proposed openings.
- 7.18 The unauthorised, foul water soak away cess pit will be replaced with a water treatment facility that complies with modern standards. This will have no heritage impact but will have an environmental benefit which is considered to represent public benefit that should be considered in the planning balance.
- 7.19 The applicants propose to remove the concrete hard standing to the west of the farmyard and the associated, narrow enclosure which is of non-vernacular proportion and adds visual clutter to views from and to the relevant heritage assets (Fig 41). This area will be turned to pasture which will enhance the rural setting of Manor Farmhouse, the church and the Conservation Area.

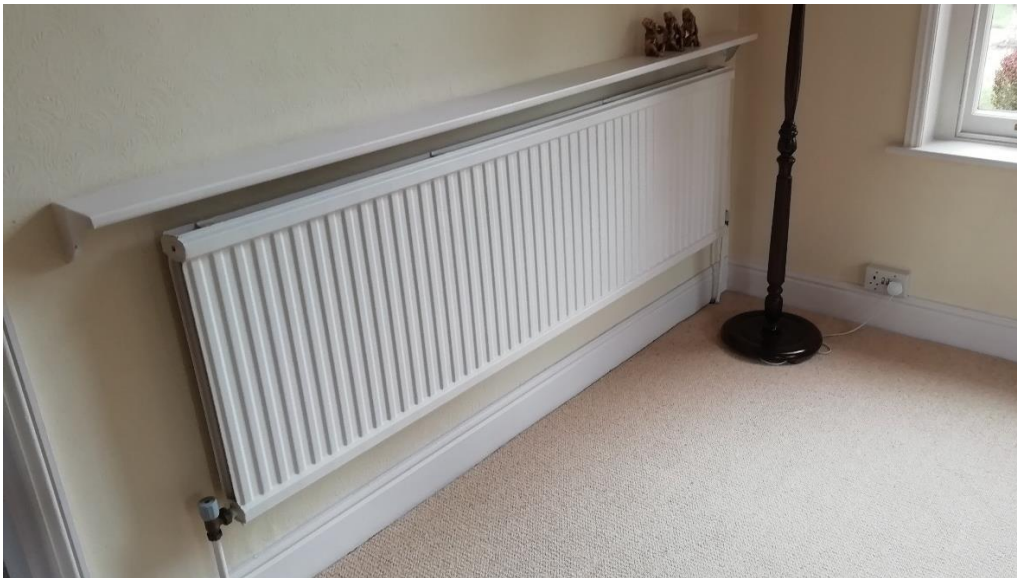
Fig 42 Modern radiators to be replaced with cast iron

- 7.20 The applicants propose to replace modern radiators with cast iron radiators which will enhance the historic character of the listed building (Fig 42).

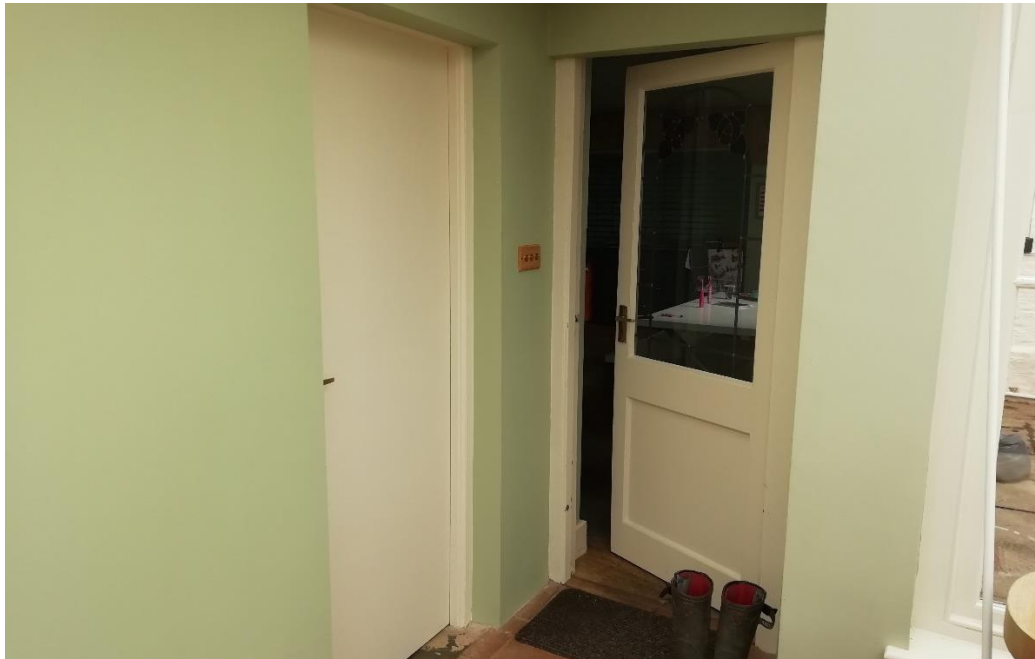
Fig 43 Two modern doors leading to conservatory will be blocked

- 7.21 Finally, the applicants wish to formalise the retention of the existing conservatory which has been in situ since the 1980s and which replaced a structure dating to the 1950s. There have been no complaints about the structure and officers visiting the site in the past have not raised it as an issue. Furthermore, the Conservation Area Appraisal specifically states that there are no negative factors within this part of the Conservation Area implying that the conservatory conserves the character of the Conservation Area. It is accessed via a modern

‘back’ door which will be blocked along with a further, modern personnel door that leads to the former garage (Fig 43). The conservatory is largely hidden in all key views towards the building, is subservient in scale and the steep gabled roof reflects to some degree the hipped detail of the main roof (Fig 44). The letter from the former owner at Appendix E demonstrates that there has been a structure in this location since the 1950s. Its removal will achieve very little other than to scar the building. Requirement of its removal now would therefore seem punitive.

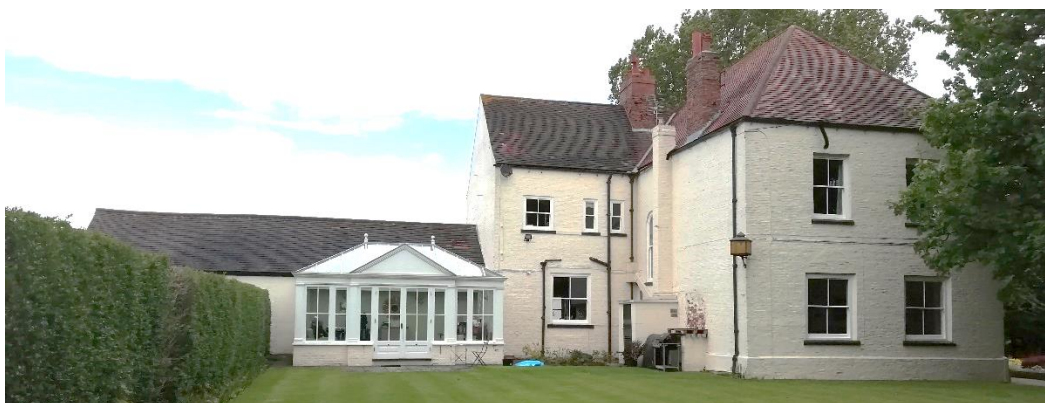
Fig 44 1980s conservatory which the applicants seek to retain
