<b>SITE</b>	Shambles Kitchen, 28 Shambles, York, YO1 7LX		
<b>CLIENT NAME</b>	PRH Electrical Limited		
<b>YAT PROJECT #</b>		<b>YAT REPORT #</b>	2022/126
<b>MUSEUM ACCESSION #</b>	N/A	<b>GRID REFERENCE</b>	SE 60451 51862
<b>PLANNING REFERENCE #</b>		<b>AAI OPS NOTICE #</b>	22022

## 1. INTRODUCTION

### 1.1 Project Background

York Archaeology was commissioned by PRH Electrical Limited to undertake an archaeological watching brief at Shambles Kitchen, 28 Shambles, York, YO1 7LX (NGR SE 60451 51862, Figure 1). The monitored groundworks comprised the excavation of a 3.1m long by 1.5m wide by 0.55m deep trench in order to locate an existing electric cable. Fieldwork was carried out on 19<sup>th</sup> of October 2022.

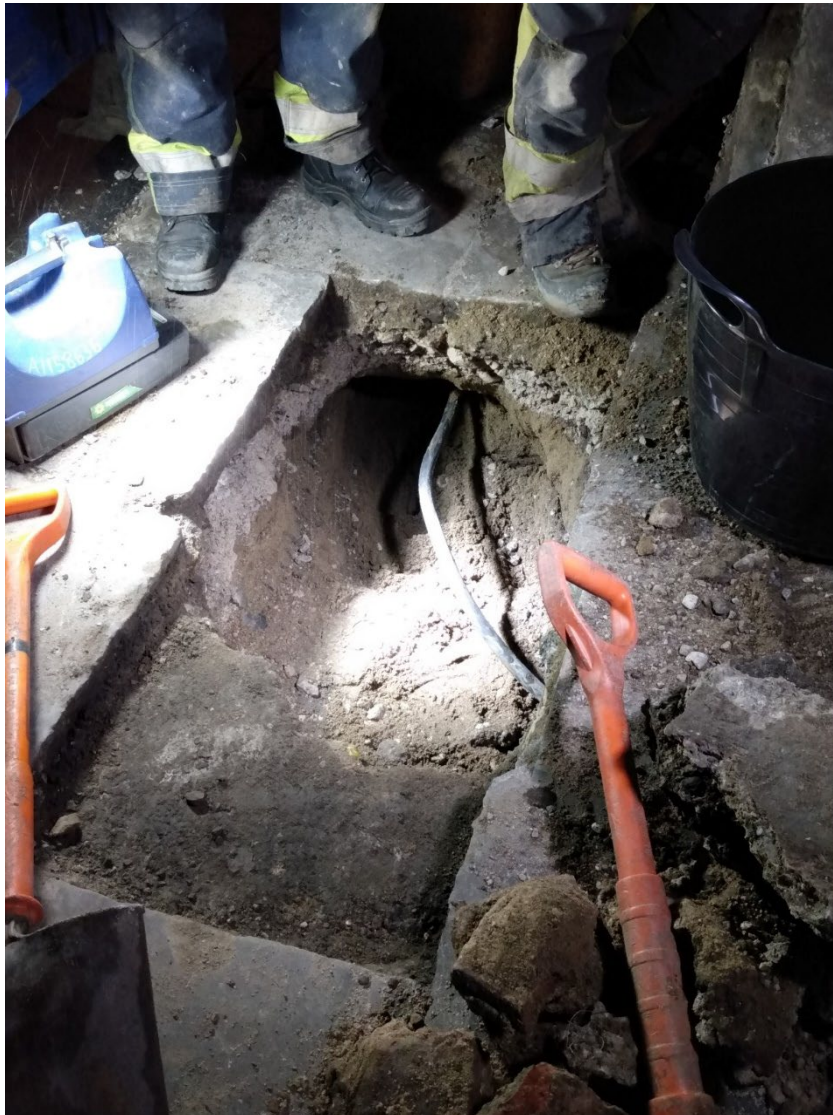
The natural geology was not reached during the watching brief. The earliest deposit encountered at 0.65m below ground level (BGL) was a mid-yellowish brown coarse sand deposit (1004). This measured 0.30m thick, and no finds or features were encountered. It is most likely that deposit (1004) is backfill for a modern service uncovered in the excavation area (Plate 1). Deposit (1004) was overlain by 0.15m thick deposit of compacted crushed concrete (1003) which had been deposited to level the latest phase of pavement and cover the modern services. Deposit (1003) was in turn overlain by 0.10m of loose pale greyish white concrete (1002) which had been deposited as a bedding layer for the pavement (1001). Paving slab (1001) measured 0.10m thick.

*Plate 1: Deposit (1004) and modern service, mid-ex, looking southeast.*

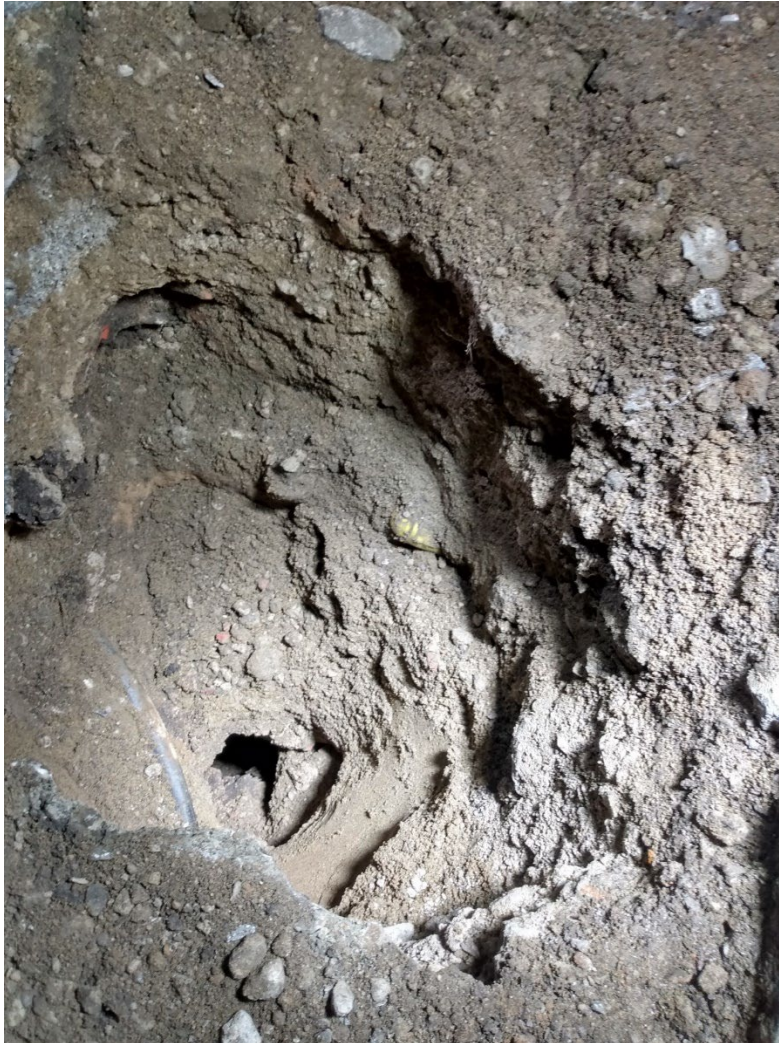
During the excavation works a small void was uncovered at 0.65m BGL (Plate 2). It measured approximately 1.4m deep and plastic service markers were visible suggesting that the area of the watching brief is further impacted by modern services.

*Plate 2: Void encountered at 0.65m below ground level.*

No archaeological remains were encountered during the watching brief at 28 Shambles, York. The deposits encountered were of modern date, deposited to backfill underground services and level the existing street surface. The void encountered at 0.65m BGL suggests that the depth of the modern service cut is deeper than the achieved depth of the watching brief. Data collected during the watching brief has minimal interpretive value and does not inform on any heritage assets located in the vicinity of the site.

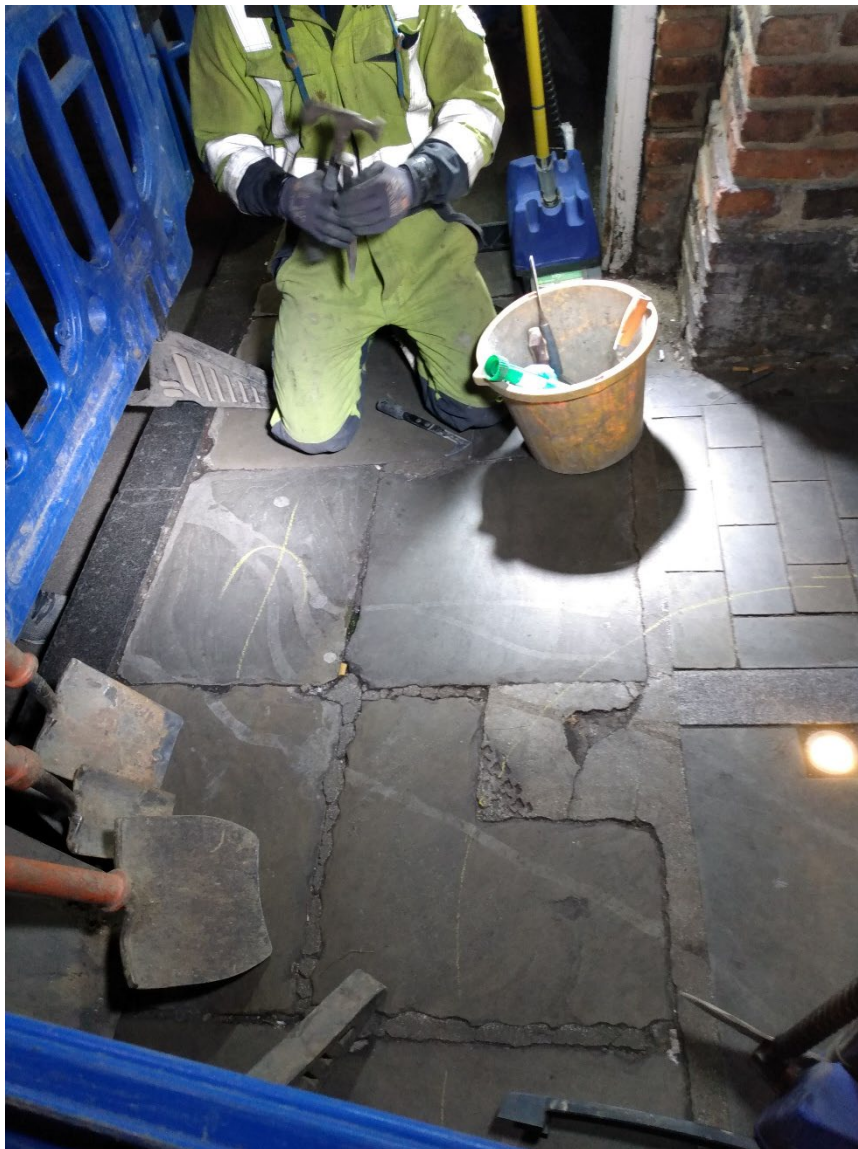
Plate 3: Watching brief area, pre-ex, looking southwest.

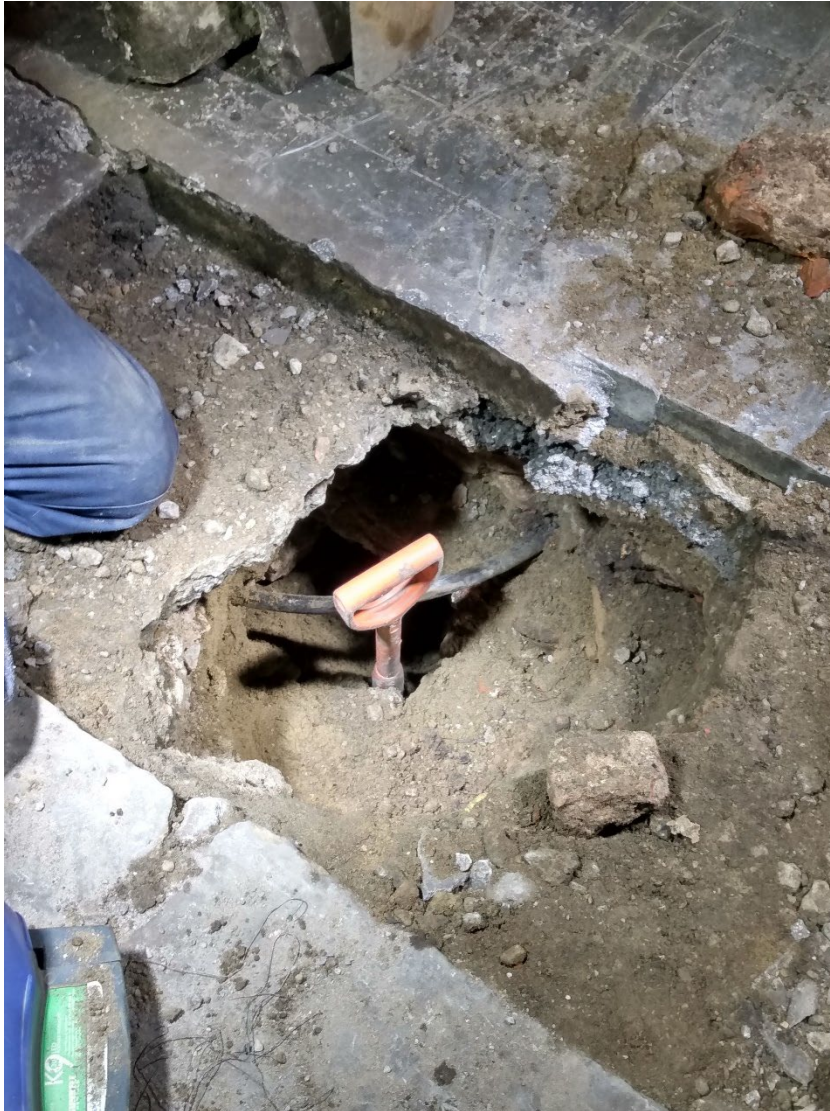
*Plate 4: Watching brief area and east facing section, looking southwest.*
