48 CONEY STREET / 8-10 MARKET STREET,  
YORK

REPORT ON AN  
ARCHAEOLOGICAL DESK BASED ASSESSMENT

OSA REPORT NO: OSA22DT06

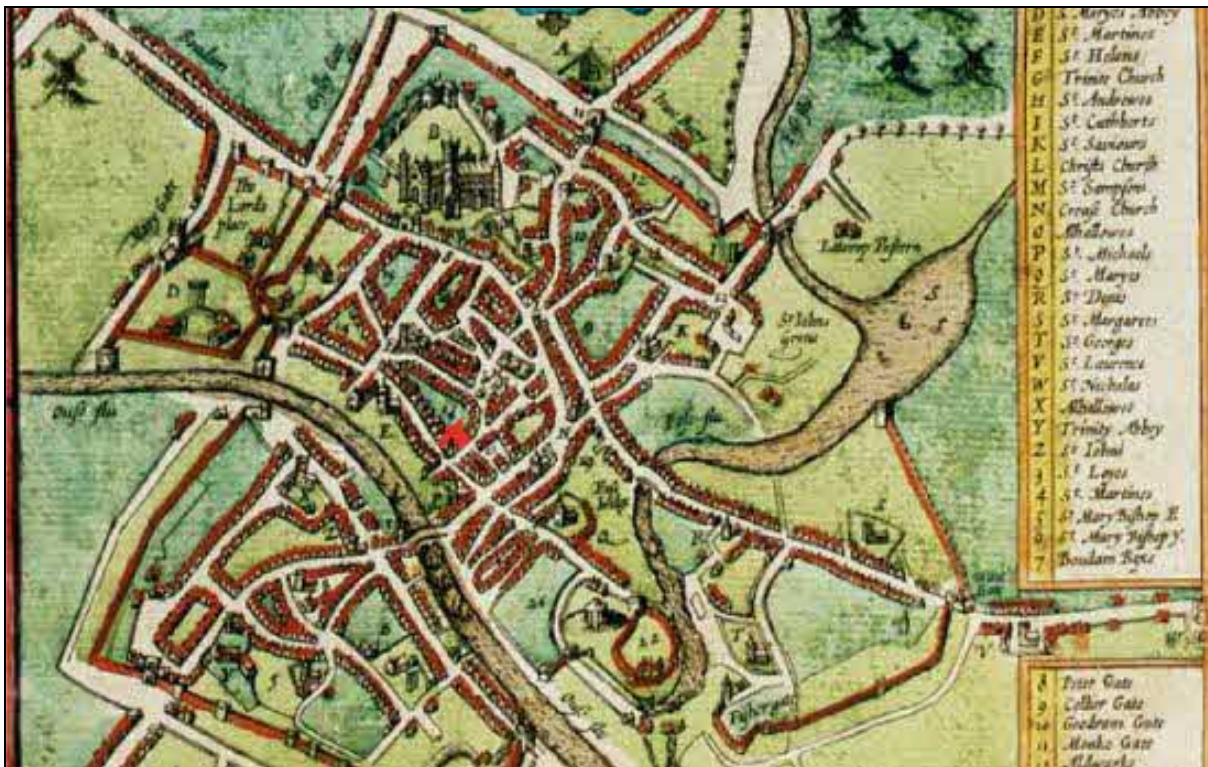
Figure 3. An extract from Speed, 1611, approximate site location shown in red.

The earliest map illustrated is the John Speed map of 1611 (Figure 3). This shows the location of the site within the historic core of the city. The street frontages of Coney Street and Market Street (previously referred to as Jubbergate or Jewbretgate in recognition to the proximity of York's medieval synagogue on the southwest side of Coney Street) were heavily developed at this date, probably a reflection of the situation in the medieval period, whilst the land to the rear of the developed frontages would have been open yards and gardens. The level of dense urban development is illustrated by the map produced by Cossins in 1748 (Figure 4) and by Jefferys published posthumously in 1775 (Figure 5).

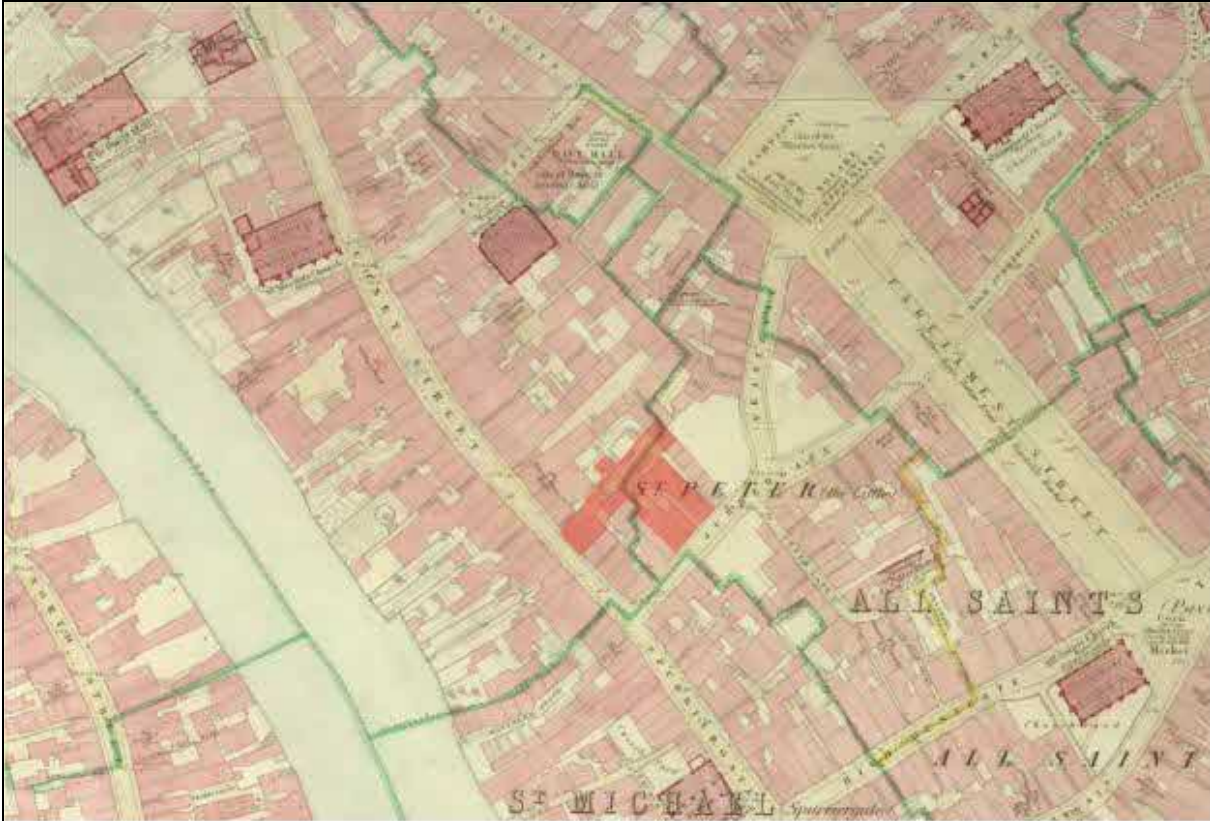
Figure 6. Ordnance Survey 1852, site area shown in red.

From the mid 19<sup>th</sup> century a much higher degree of cartographic detail is available, through the published Ordnance Survey maps. The Ordnance Survey map of 1852 (Figure 6) shows the entire Coney Street frontage as being occupied, whilst all of the frontage on Jubbergate, within the limits of the site, is also developed. Whilst the land to the rear of the street frontages does include some open spaces these are, by the mid 19<sup>th</sup> century only represented by relatively small yards and alleyways, as most of the area has been built upon.

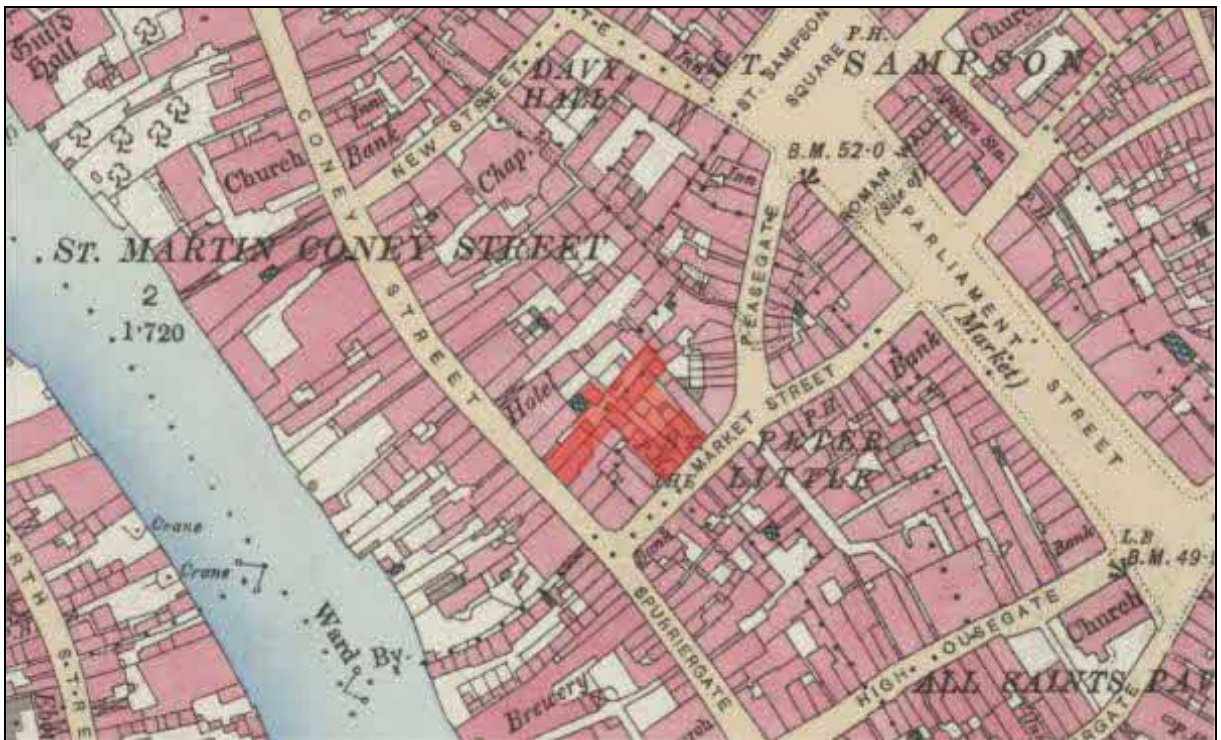
Figure 7. 1892 edition of the Ordnance Survey, site area shown in red.

A similar layout for the site is shown on the 1892 Ordnance Survey map (Figure 7). However, by this date the name Market Street is used. The southernmost building fronting Market Street is labelled as a Public House, which may indicate the presence of cellarage within this property. A broadly similar situation was evident on the 1909 Ordnance Survey map (Figure 8), with another of the buildings fronting Market Street also shown as a public house.

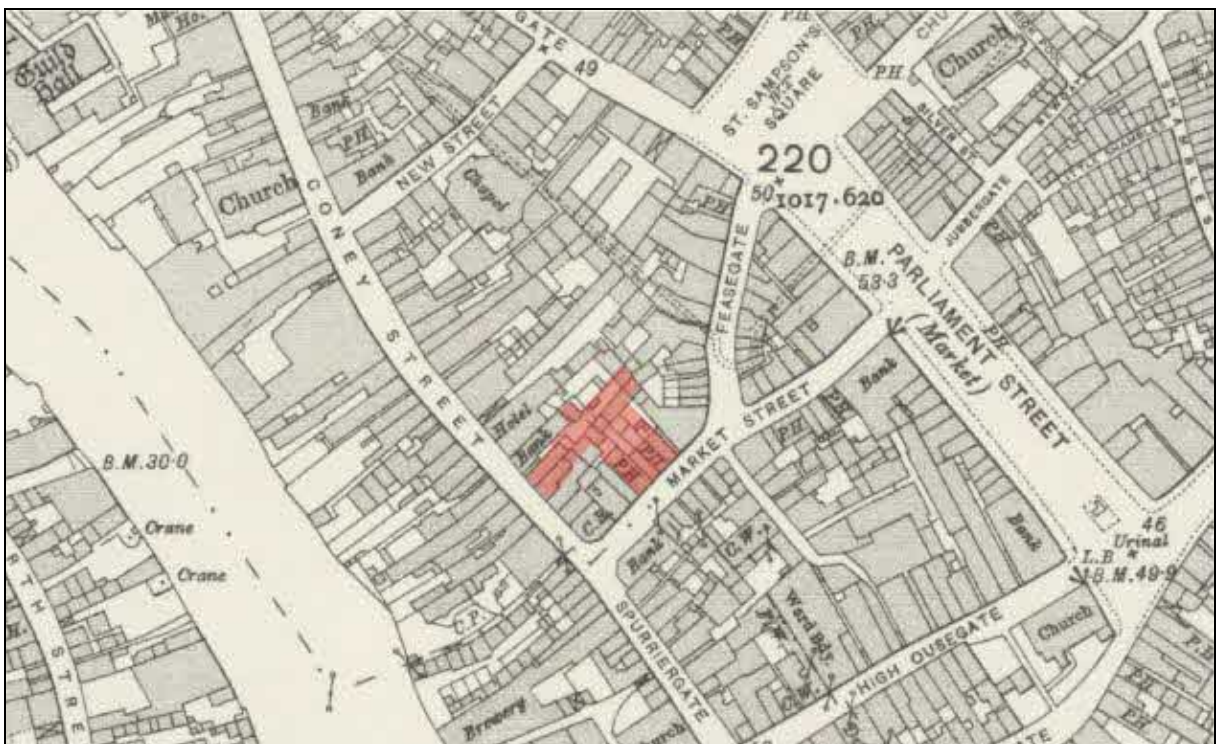
Figure 8. 1909 edition of the Ordnance Survey, site area shown in red.

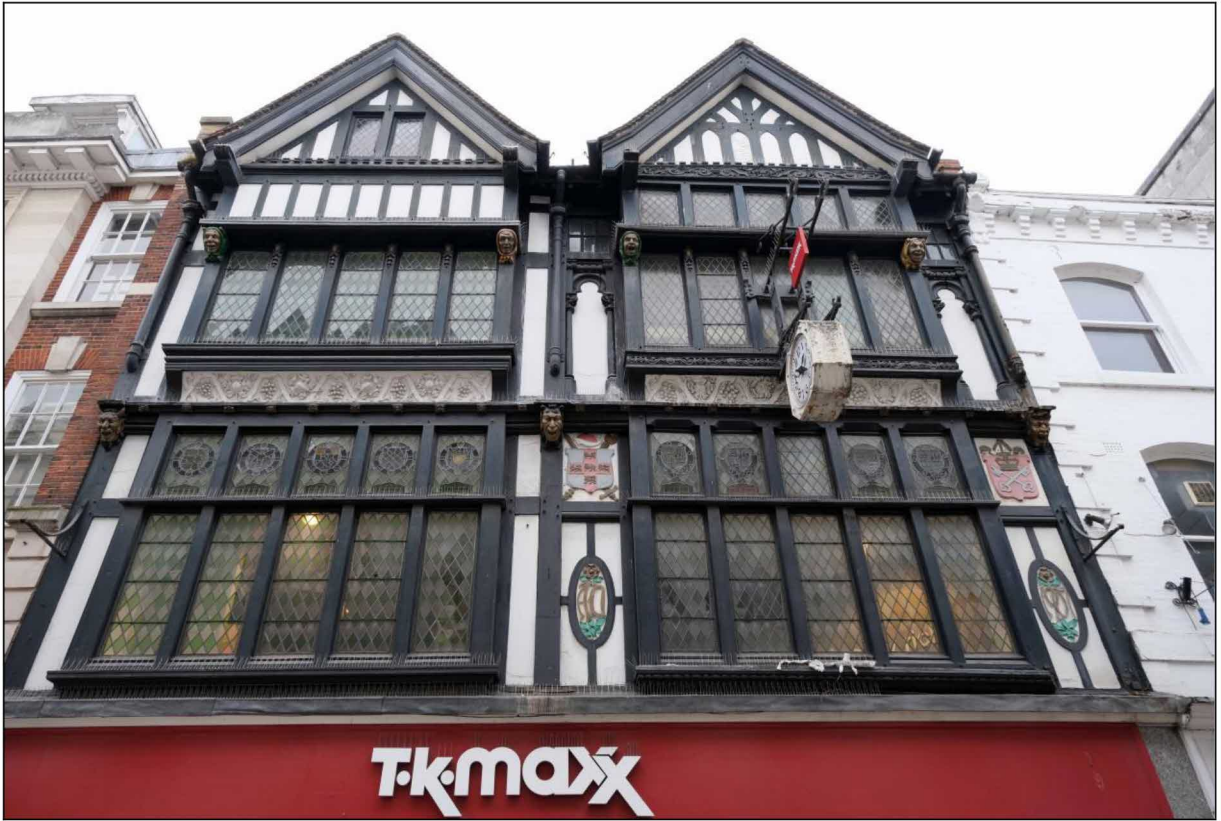
Plate 3. 48 Coney Street, detail of listed building frontage.

The site lies in the historic core of the City of York, centred at National Grid Reference SE 60270 51785. The site comprises retail property on the ground floor, fronting onto both Coney Street and Market Street, forming a rough L-shaped plot. The Coney Street frontage (No. 48) is a listed building, incorporating an early 20<sup>th</sup> century shop front, on the first and second floors, with a modern shop front on the ground floor (Plates 1, 2 and 3). The Market Street frontage (Nos. 8-10) is a substantial 3-4 storey later 20<sup>th</sup> century block, again with a ground floor shop front (Plate 4 and 5). The building includes a basement across much of its footprint (this was not accessed during the preparation of this assessment).
