EXCAVATIONS IN GRAY'S COURT,  
TREASURER'S HOUSE, YORK

OCTOBER - NOVEMBER 1989

ARCHIVE REPORT

MARK NEWMAN M.A. M.I.F.A.

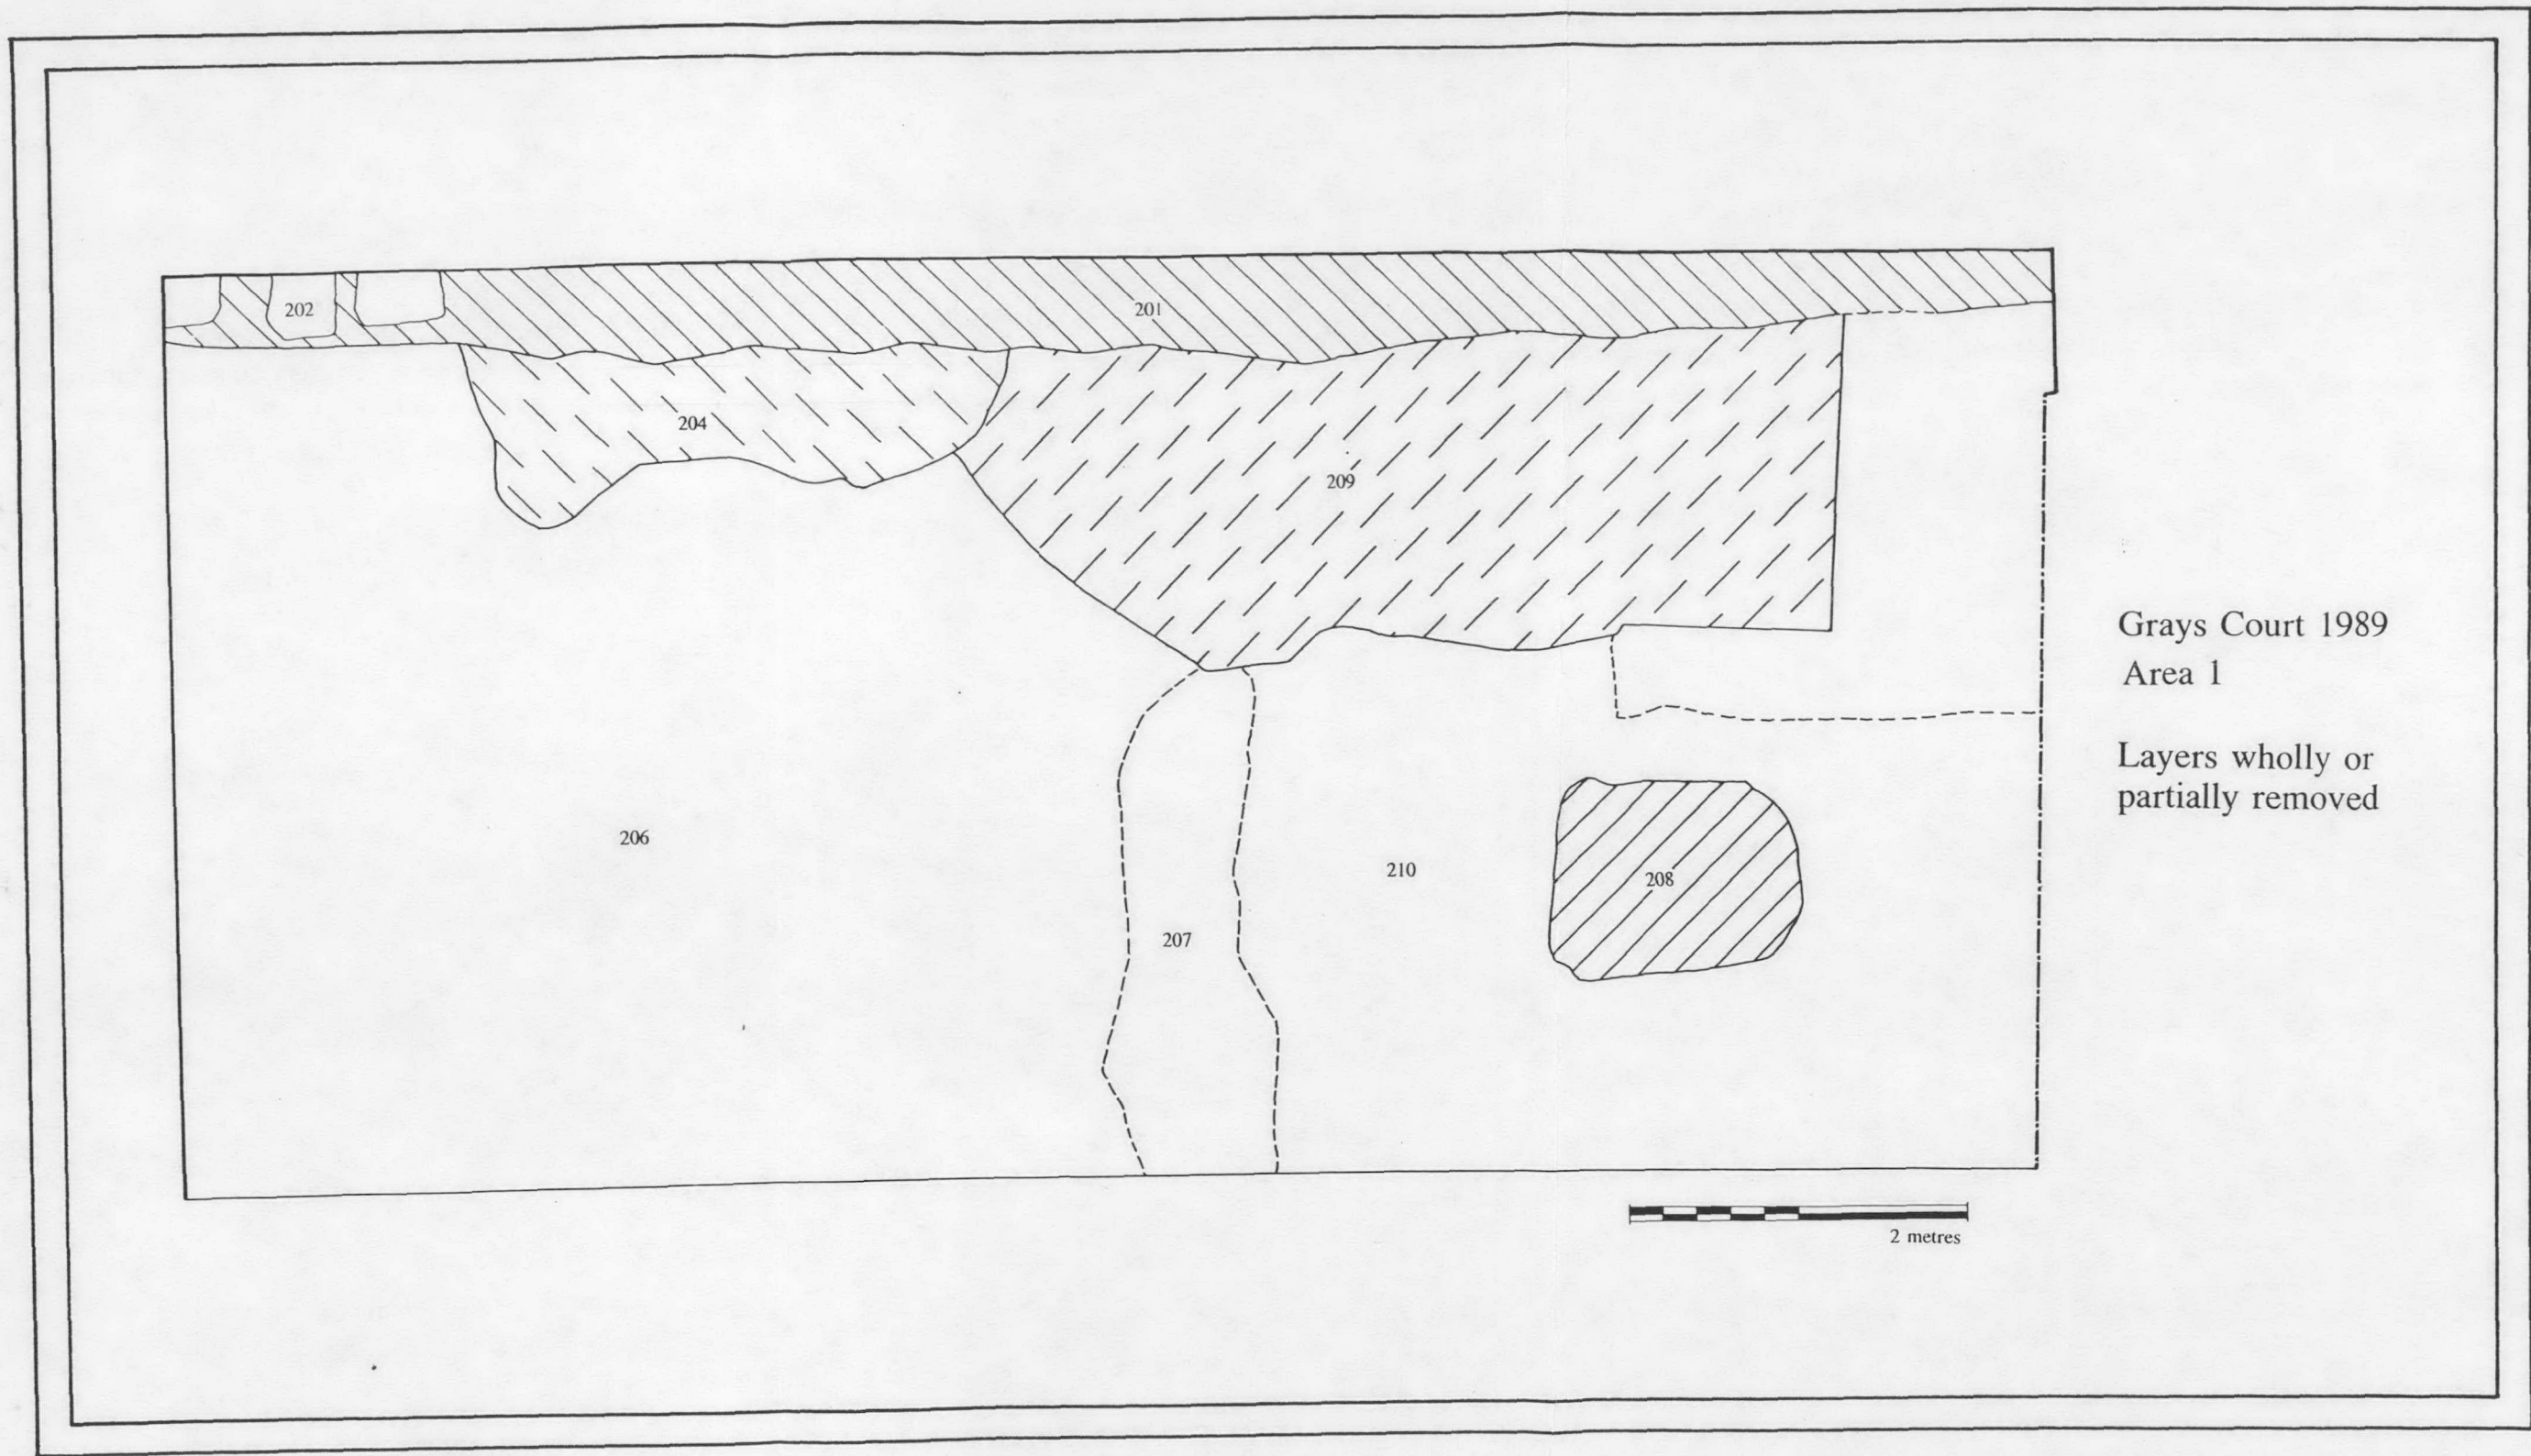
Figure 3.

3.1 AREA 1: Area 1 measured 5.3 x 11.6 metres consisting of the rectangle to the east of the projecting chimney foundation (fig. 3). The paving slabs were lifted, and then the bedding material [200] shovelled away. This was a black silty clay, with 30% clinker fragments and occasional pieces of building materials. The finds from the layer included residual pottery from the Roman period onwards as well as a fine Medieval buckle (fig. 23/1).

Once the 5-10cm of this material had been removed, the underlying deposits were cleaned. They consisted of rubble dominated layers close to the building contrasting with more uniform humic-based deposits further to the north. One of the rubble layers - 208 - proved to be a discrete deposit, but the others appear to be of a sequence of building-related layers and pit fills. The latest of these was layer 201 a deposit of pinkish-white mortar dominated rubble, averaging 55cm in width and extending along the full length of the exposed wall. This was removed for much of its length, and found to deepen closer to the house - indeed the deepest parts remained in situ at the conclusion of excavation. To the north of 201, 209 filled a right angle of exposed masonry [203] and extended further to the east. This layer consisted substantially of building waste - up to 80% of the context in places. Further east 204 was also overlaid by 201. 204 contained a number of brick fragments - from well 214 which the feature it filled had destroyed. Once 201 had been removed, it became clear that the feature containing 204 extended up to the foundations of the house [202].

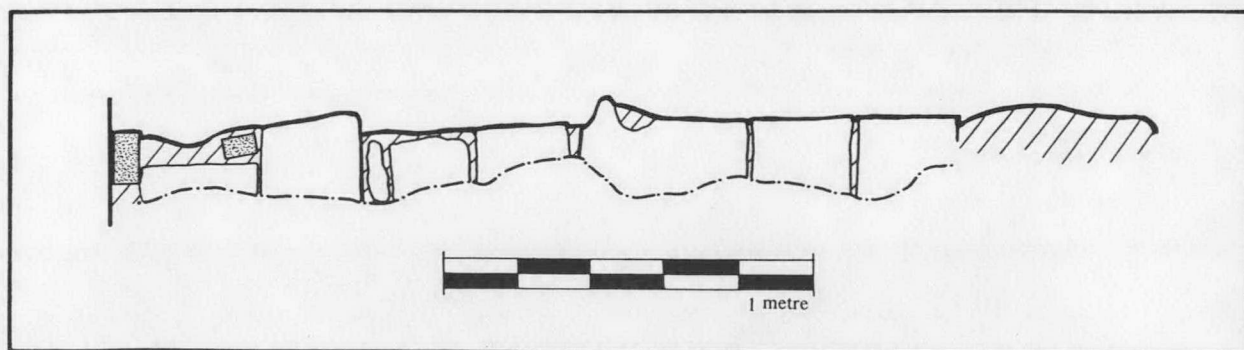
Figure 4 - Elevation of 203/1

thickness or in its external faces. The most complete stone face occurred in the western side [203/1] where there appeared to be an infilled gap in the masonry (fig. 4). The facing of 203/2 was rather less complete, while only the very top of 203/3 was exposed. At several points on the upper surface brick fragments were embedded, though these did not give the impression of being intrinsic to the original structure. 203 was infilled with a friable rubble layer [209] consisting of whitish mortar with fragments of stone and brick (with depths of 45 and 62mm).

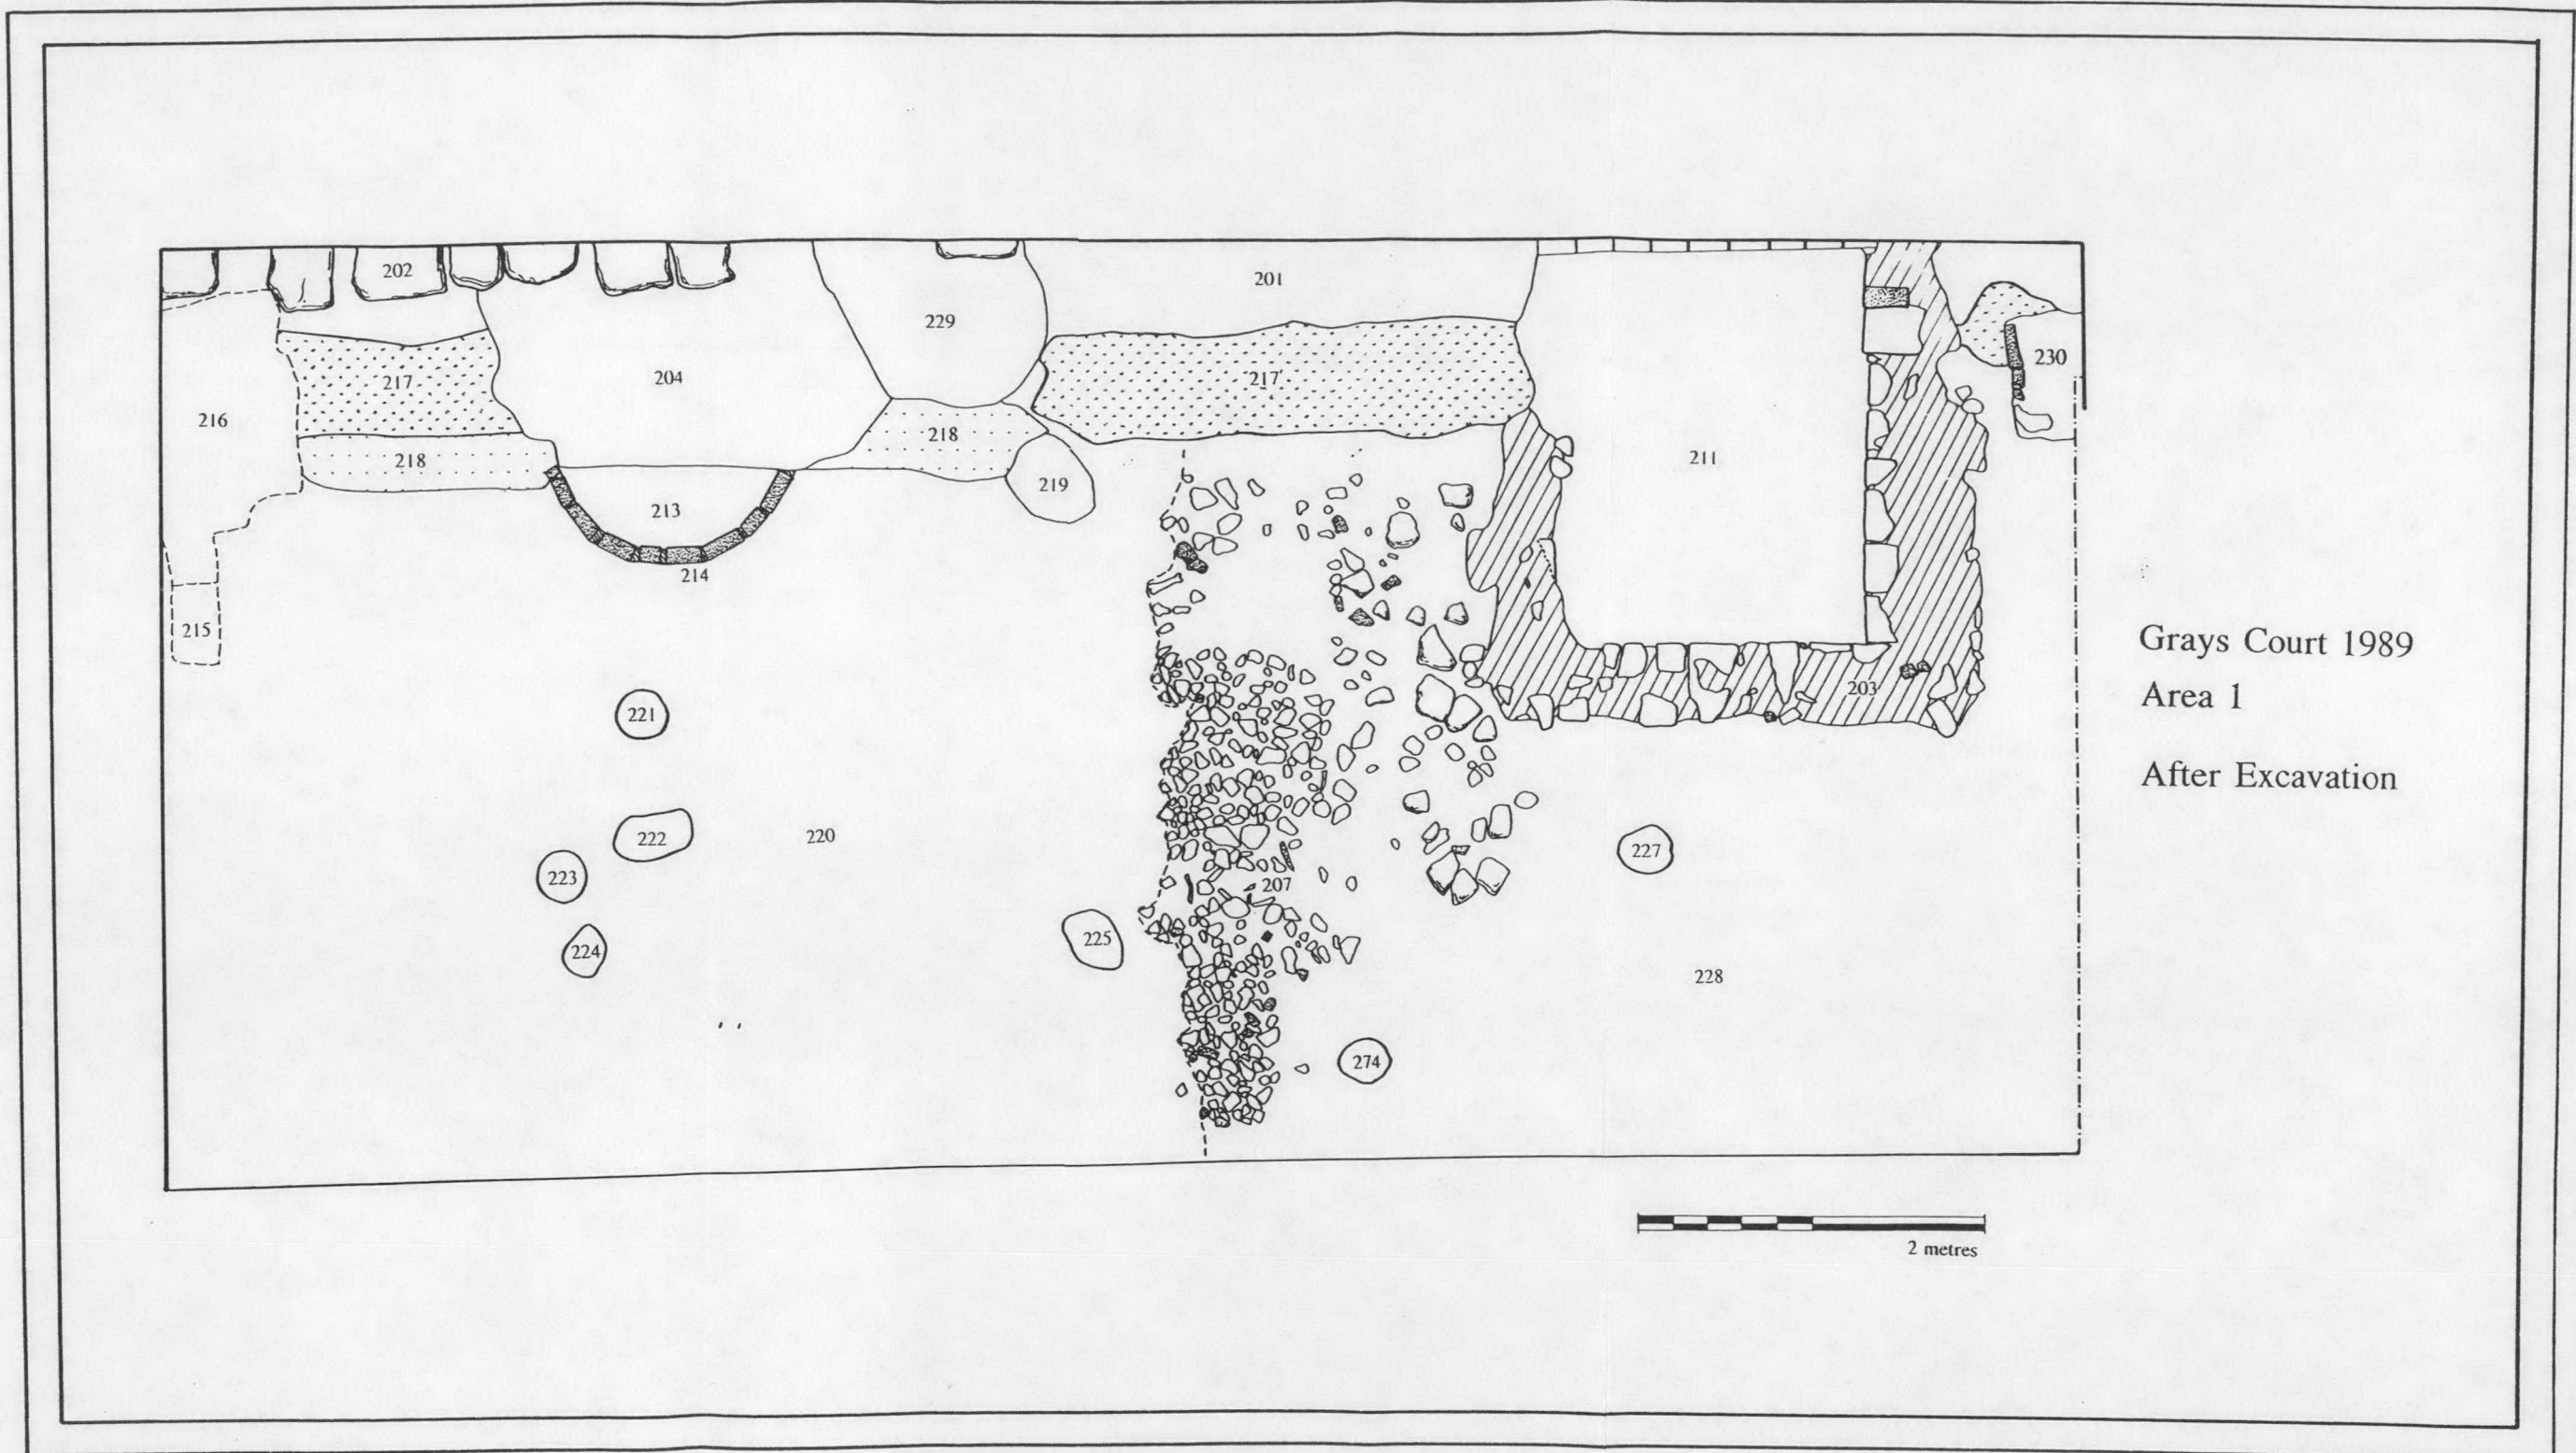
Figure 5.

The removal of 5cm of 201, 209 and 204 exposed several other contexts and features (fig. 5). At the western end of the site, a subrectangular brick lined pit [230] was exposed. Rather more of the masonry structure 203 was also uncovered. Exposed, the stone and mortar structure formed three sides of a square with sides of 2.80m (the fourth being formed by the house itself). This defined an internal space of 2.30m x 1.70m. The walls were formed predominately of off-white mortar, bonding an internal facing of York Stone blocks, with rather less evidence of stone through its

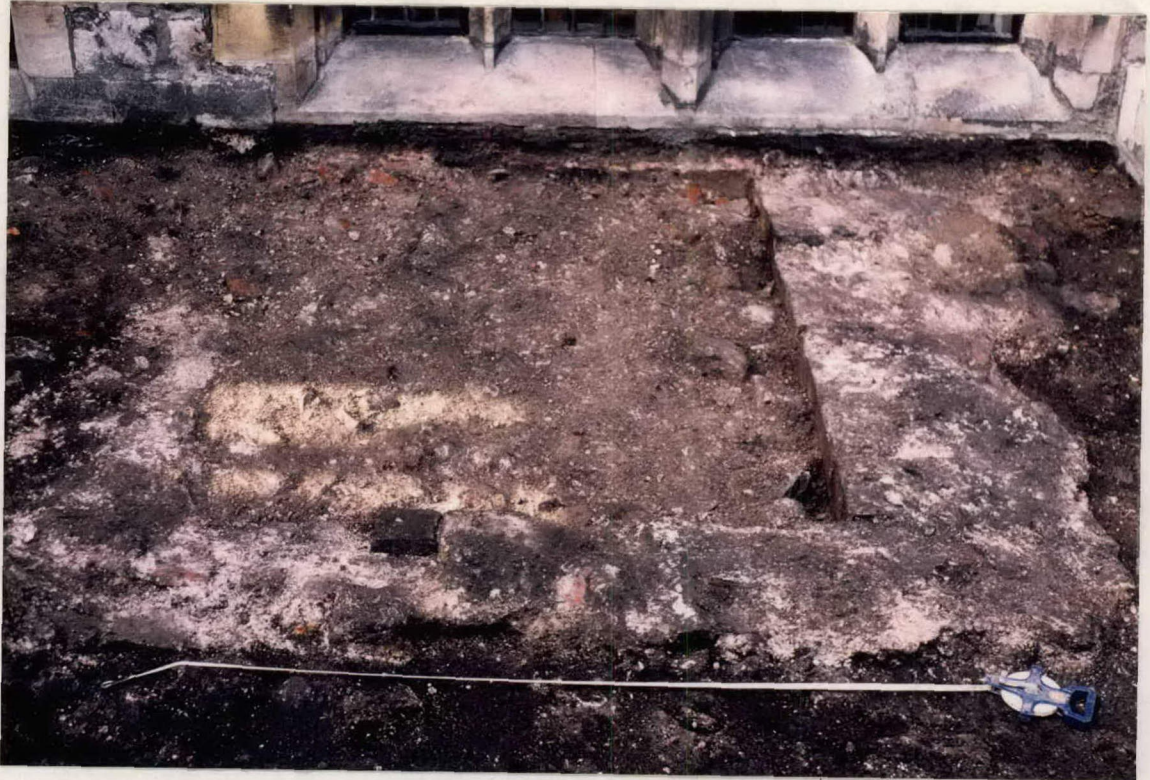
Figure 7 - Cellar Structure 203 [8/8]

5.3 EARLIER POST-MEDIEVAL:(fig. 20) A smaller selection of features predate the building work conducted by Elston and Dove. The most substantial of these was 203. The depth of this feature and its method of construction (with internal rather than external facing stones) strongly suggests that it was a cellar, either constructed as a wing off from - or more likely an addition to - the main cellar complex. The surviving masonry suggests that it had an aperture on its western side, indicating that it need not have been wholly subterranean.

The date of construction of this feature was not determined in the course of excavation. The presence of quite deep bricks (over 60mm) in its infill would suggest that it was not abandoned until the late eighteenth or nineteenth century - the most likely date being during the 1815 building programme. The fragments of brick in its construction probably indicate a post-medieval origin - though it is feasible that they derive from a superstructure rather than the cellar walls themselves.

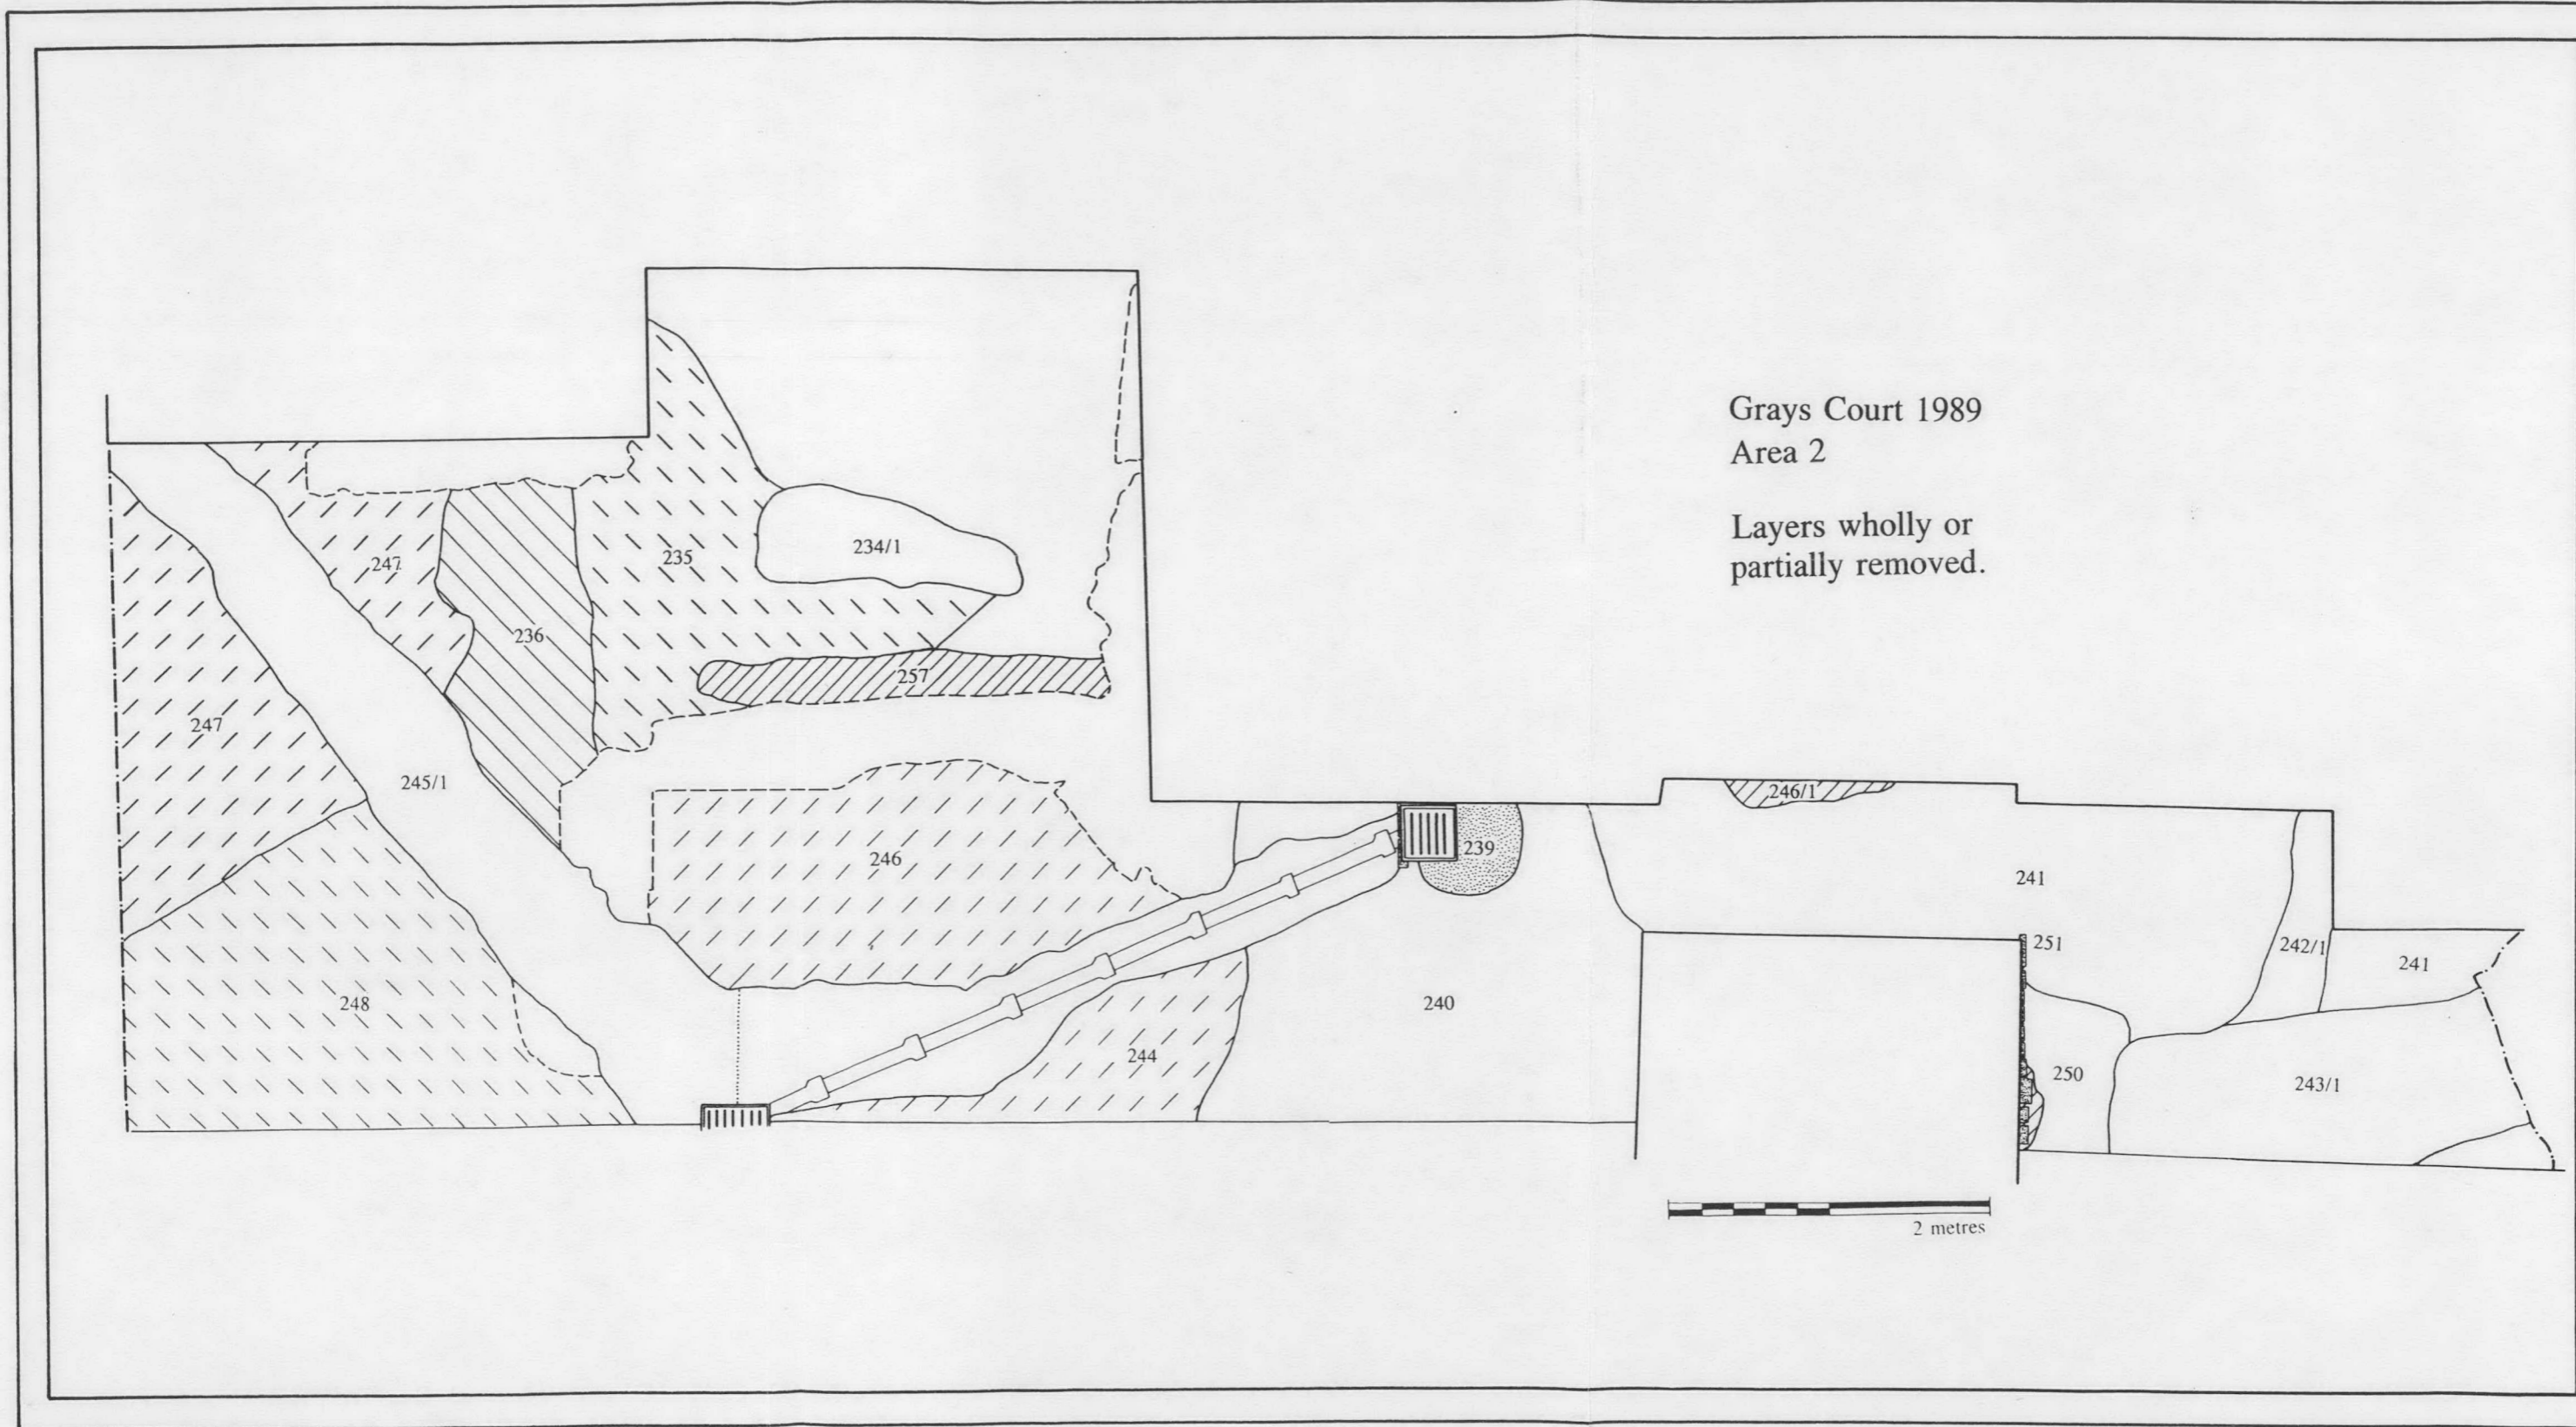
Figure 8.

The unexpected quality of the medieval deposits in area 1 whetted the appetite for what was likely to come in area 2, but these expectations were somewhat dashed when 200 was removed to expose a suite of comparatively modern features (fig. 8).

The most recent of these features were two twentieth century drains, 243 and 245. 243 lay in the narrow passage to the west of the door, and was not excavated. The solidity of its backfill, and the nature of deposits to the west of this feature, led to the abandonment of work in this area. 245, an "L" shaped cut crossing the main area, was cut for two drains, one running from near the chimney and the other from a down pipe near the cellar door, to a common outflow against the northern edge of the sunken area. The eastern arm of 245 [245/1] was probably butt-ended by 230 in the adjoining part of area 1, but this was not clearly demonstrated in the course of excavation. The southern end of the western arm [245/2] was marked by a drain corner, the

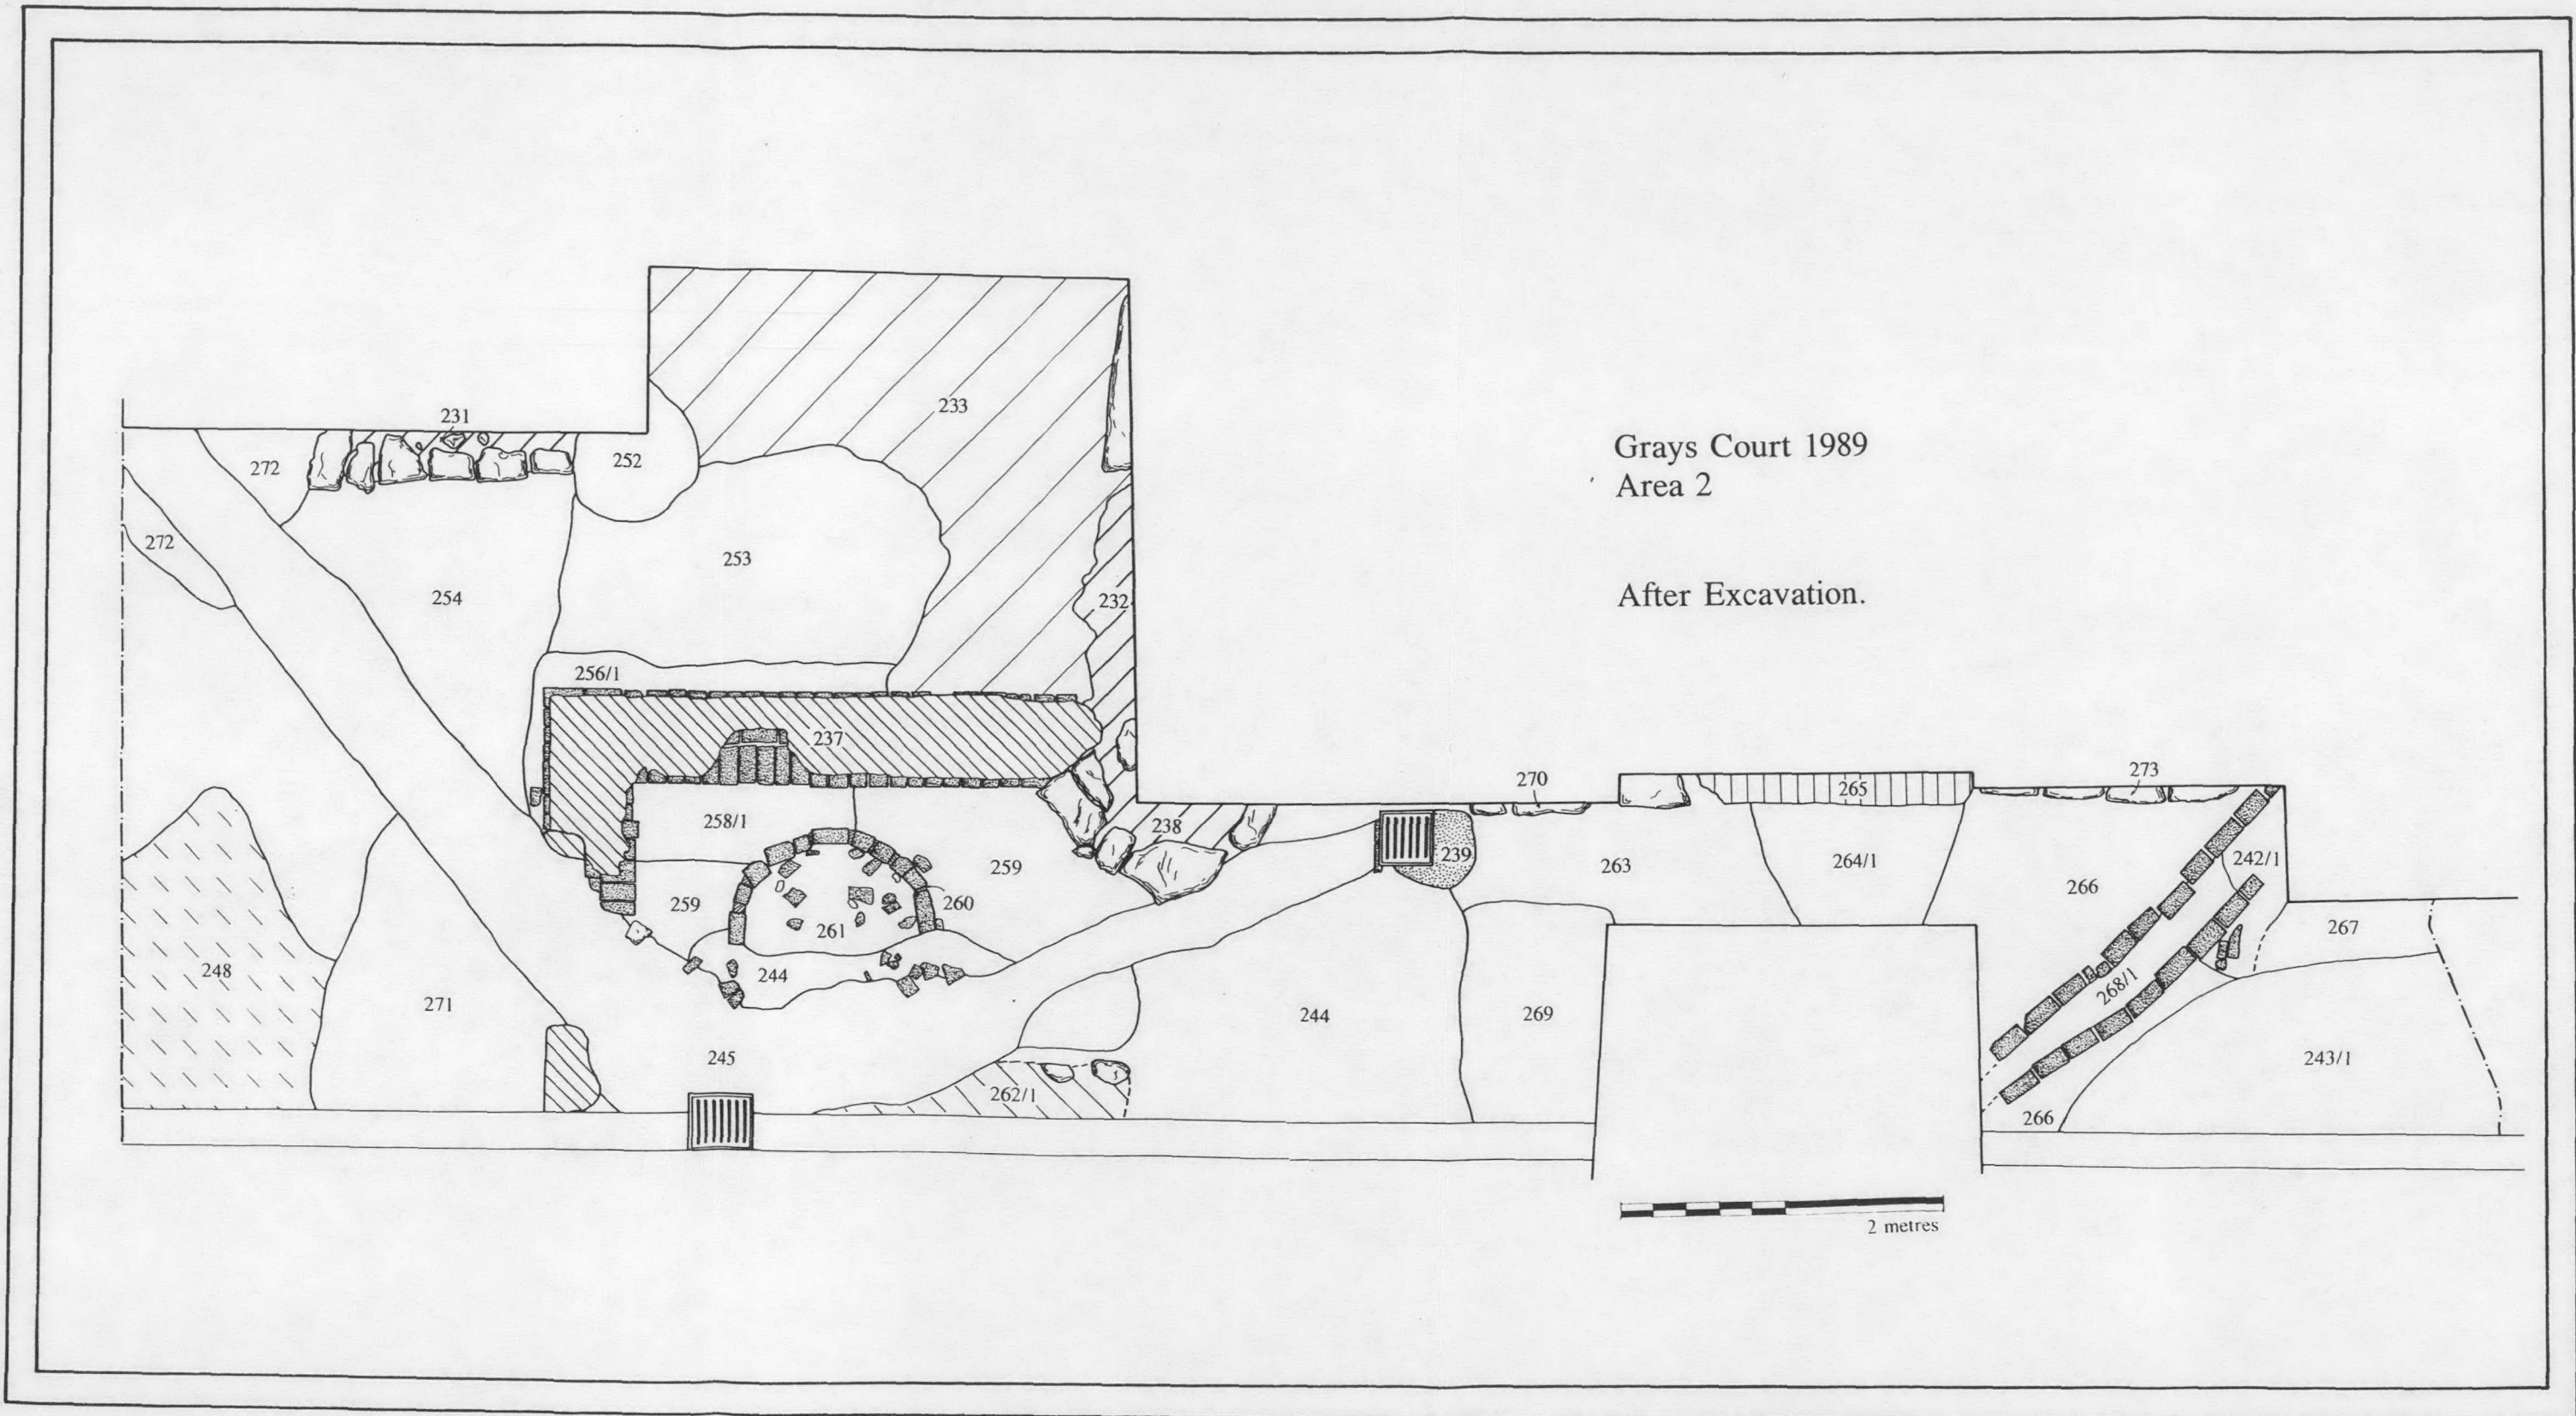
Figure 10

rich layer deposited at the bottom of the steps and extending most of the way to the next rebate. It had been cut by drains 243 and 242. 241 was also overlaid by a rubblier deposit, 250, but appeared to overlie the brick foundation for the stone steps [251]. Although the original brief called for the general reduction of the area by 8-10cm, the solidity of 237 and 233 negated the need for their removal, and excavation was ceased to the south of 237. Within that area, the removal of 234 and 235 exposed 253, a very dark grey, sandy loam with 20% crushed white mortar and 5% York Stone fragments, as well as 257, a rubble layer filling a foundation cut for 237 (fig. 10).

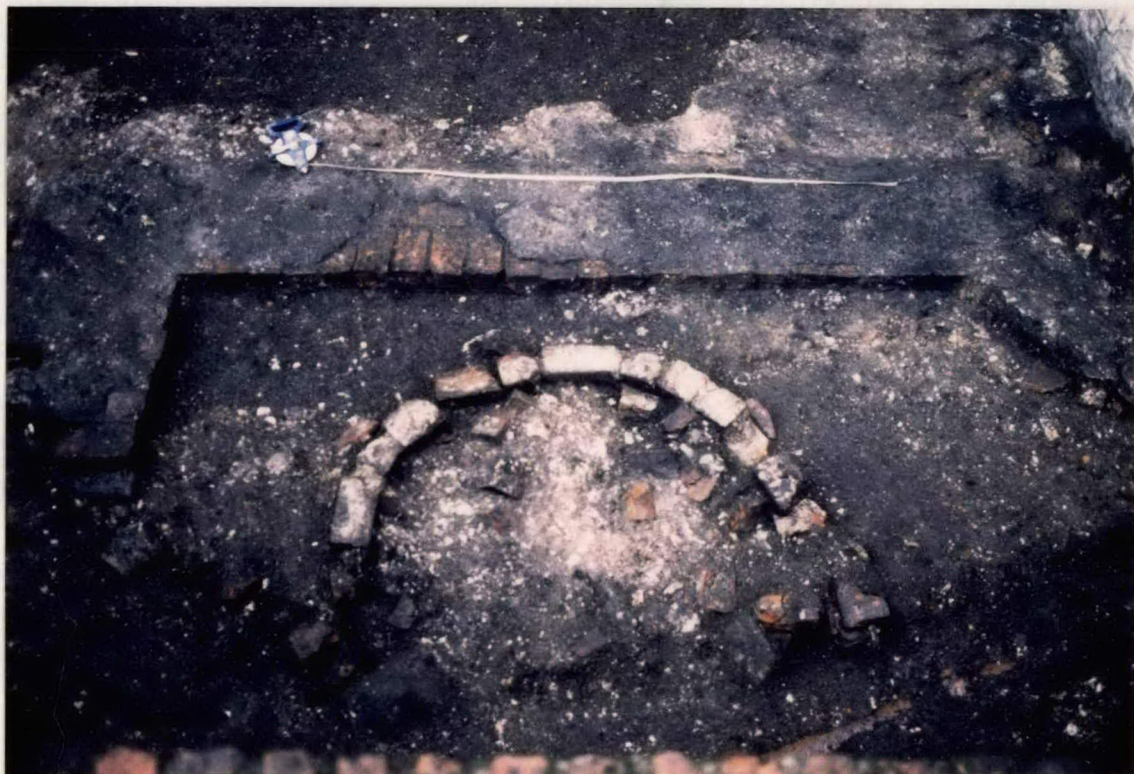
Figure 11 - Wall 237 and Well 260 [6/20]

The well 260, originally had an internal diameter of 1.10m. It was constructed using copious yellow/white mortar to bond reused bricks - with depths of 55mm. Pit 258 appears to have loosened the bricks on that side of the well, so it is presumably a later feature. After disuse, the structure was filled with assorted building waste [261]. Although the southern side of the shaft would have been intercepted by 245, it appears to have been damaged at an earlier date by a disturbance filled by 244.

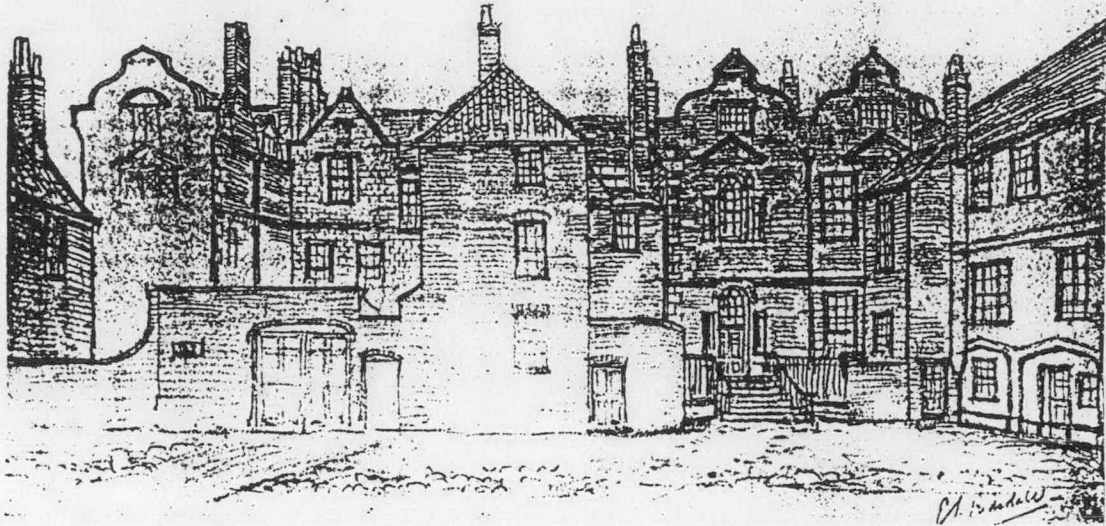
Figure 14 - Rear of Treasurers House, E.Scott Ridsdale, 1882

The appearances of the outbuildings was recorded in a sketch by E.Scott Ridsdale in 1882 (fig. 14), as well as several nineteenth century plans (fig. 17).

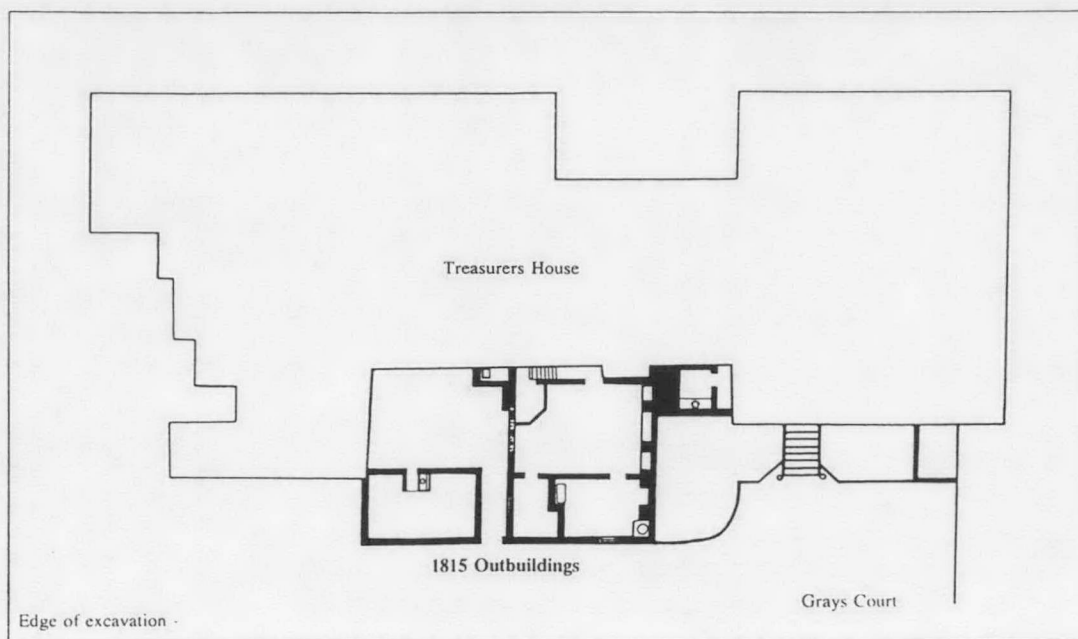
Figure 15 - Plan of 19th century outbuildings.

Frank Green's remodelling at the turn of the century brought many changes to the house - not least being the clearance of the cluttering outbuildings from its Grays Court side (fig. 15). He also reopened the cellars - an alteration of which he was particularly proud - and (presumably to provide a light source to them) extended the sunken area which had existed outside the medieval cellar door along the entire length of the building.

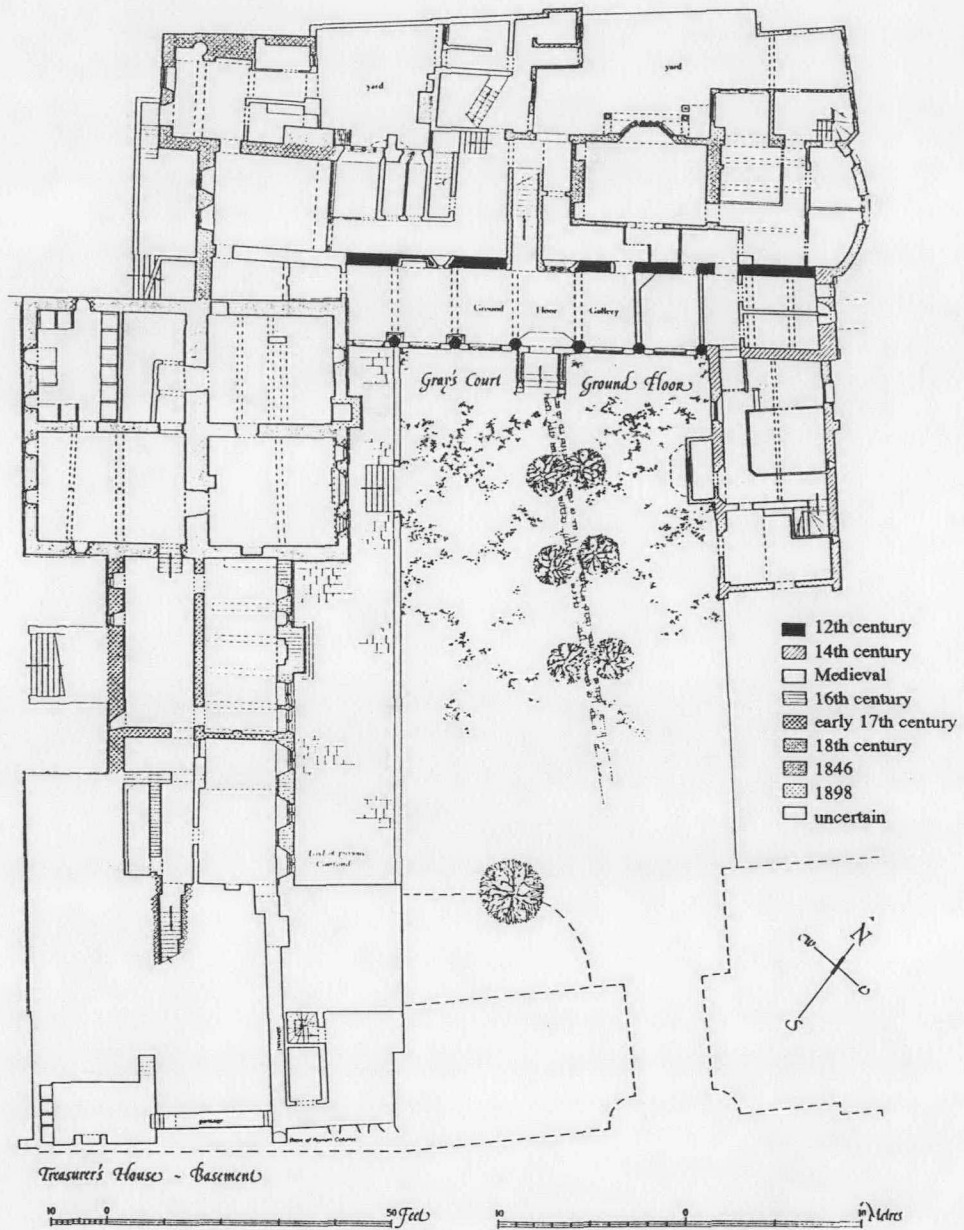
Figure 18 - Post 1900 features and deposits

5.1 POST-1897: (fig. 18) There can be little doubt that the current appearance of the northern side of Treasurer's House owes most to the alterations carried out by Frank Green, mainly between 1898 and 1901. The creation of the sunken area served both to expunge the early nineteenth century out-buildings, and to admit light into the cellars. The depth of this feature was probably established by the preceding out-buildings: their lowest level opened onto the same surface as the cellar door, and although this depth was only reached by the accommodation blocks, (see 5.2 below) Green continued at the same level across the whole area, truncating a considerable depth of medieval and post-medieval stratigraphy in the east of the site.

Evidence for post-1897 activity is therefore essentially negative. It is quite likely that rubble layer 201 belongs to this phase and possibly some of the other rubble filled disturbances. It is also possible that the churning that created 206 and 210 occurred at this time, but the absence of late nineteenth century material except glass (which is comparatively mobile in the soil) means that this conclusion cannot be confirmed.

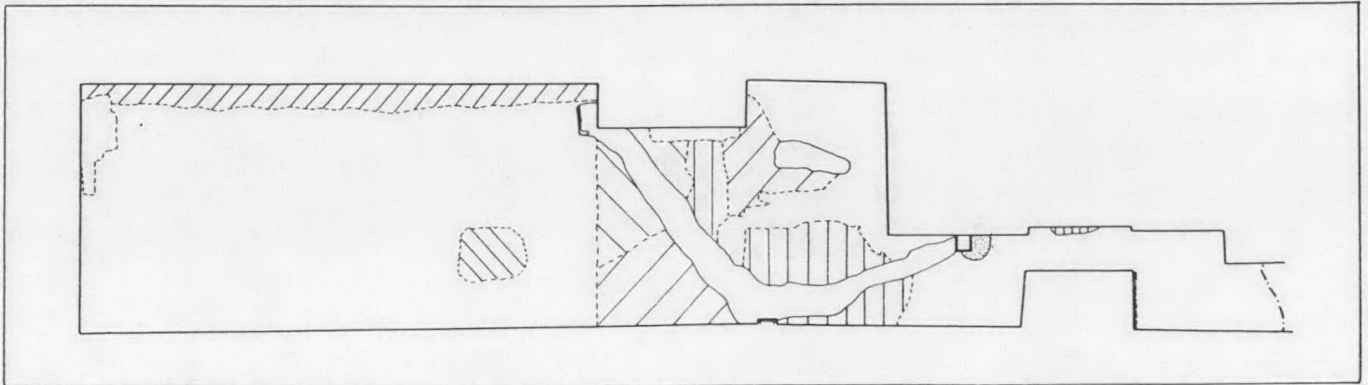
Figure 19 - Nineteenth Century Features and Deposits

5.2 NINETEENTH CENTURY: (fig. 19) The majority of the evidence for nineteenth century building activity comes from area 2. It was not possible to identify individual building phases in the evidence, but the documentary sources show that the buildings

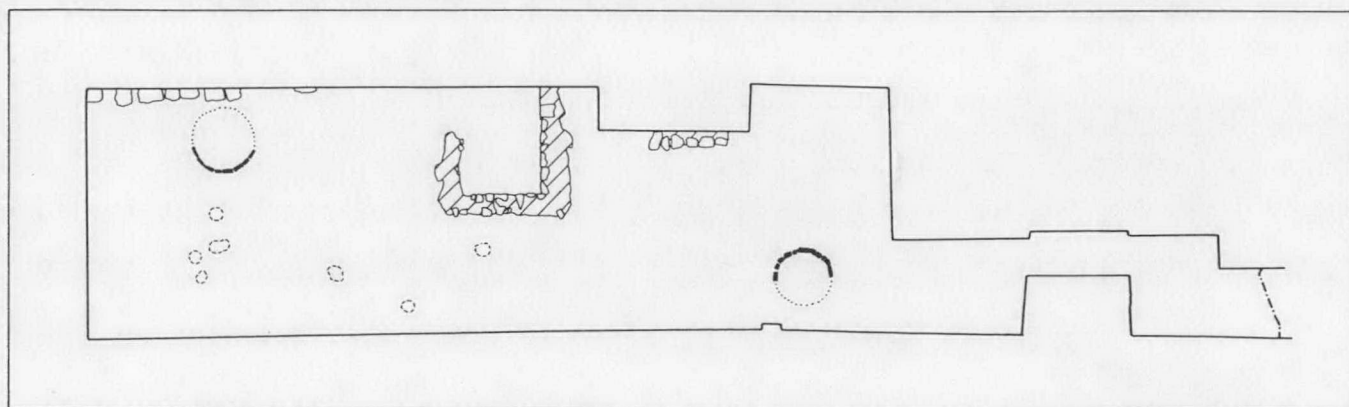
Figure 19 - Medieval Features and Deposits.

5.4: MEDIEVAL AND EARLIER: (fig. 21) The evidence for medieval activity, especially in area 1, was far better than had been hoped for. The truncation of deposits - presumably by Frank Green in 1898-1900 - exposed an extensive occupation strata consisting of contexts 220, 228 and 207. These may have been overlain by slightly later layers 206 and 210 (from which the bulk of the artifactual material was collected) but it is perhaps safer to see these deposits as an undated disturbance of the underlying layers. The excavation policy of absolutely minimal disturbance left a number of fundamental questions about the nature of these deposits unanswered. For example 220 and 228 were left undug, and so yielded no artifacts - precluding confirmation that 206 and 210 were indeed disturbances thereof.
