EXCAVATIONS IN GRAY'S COURT,  
TREASURER'S HOUSE, YORK

OCTOBER - NOVEMBER 1989

ARCHIVE REPORT

MARK NEWMAN M.A. M.I.F.A.

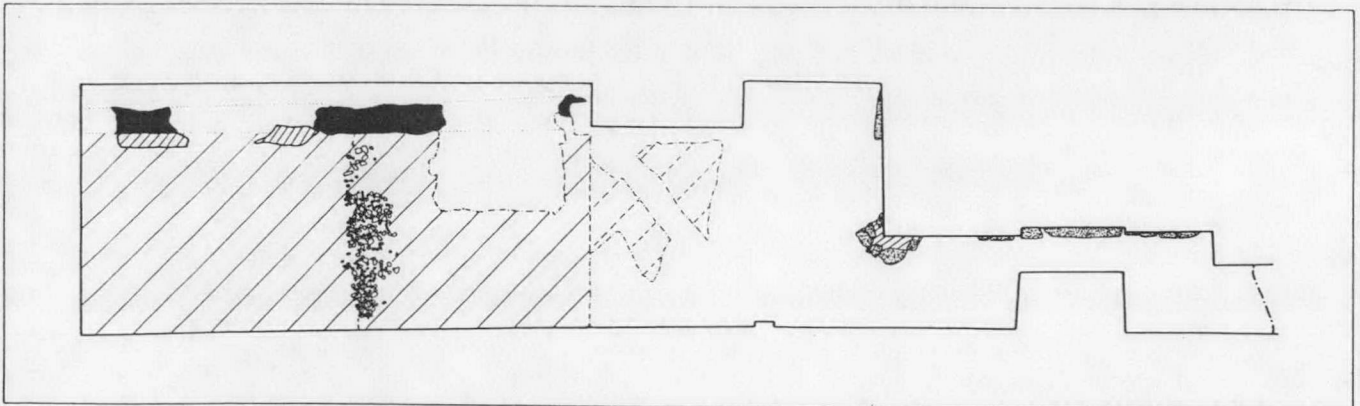
Figure 19 - Medieval Features and Deposits.

5.4: MEDIEVAL AND EARLIER: (fig. 21) The evidence for medieval activity, especially in area 1, was far better than had been hoped for. The truncation of deposits - presumably by Frank Green in 1898-1900 - exposed an extensive occupation strata consisting of contexts 220, 228 and 207. These may have been overlain by slightly later layers 206 and 210 (from which the bulk of the artifactual material was collected) but it is perhaps safer to see these deposits as an undated disturbance of the underlying layers. The excavation policy of absolutely minimal disturbance left a number of fundamental questions about the nature of these deposits unanswered. For example 220 and 228 were left undug, and so yielded no artifacts - precluding confirmation that 206 and 210 were indeed disturbances thereof.

Neither were the formation processes of the layers determined with any certainty. It is quite likely that 207 marks the remains of a partition of some sort separating 206/220 from 210/228. The substantial difference in artifact densities (over four times

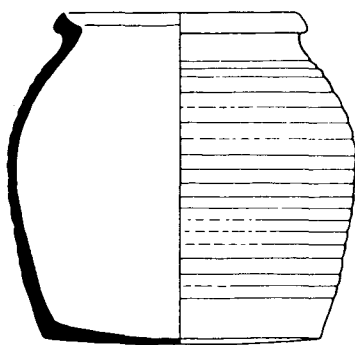
Figure 22/1 - Typical cooking pot, of the type found as fragments on site. (From Jennings, 1992)

Nearly all the utilitarian cooking and storage vessels are in either Gritty Ware or Red Sandy Ware. There is only one example of a glazed pitkin, from context 245/2. The unusual factor in this assemblage is the relatively large number of Red Sandy Ware jar fragments found in a number of the contexts. Typically in York assemblages of this period, small amounts of Red Sandy Ware are a consistent feature, but these are mainly fragments of jugs, and while the large globular bodied jars are known, they are far less common.

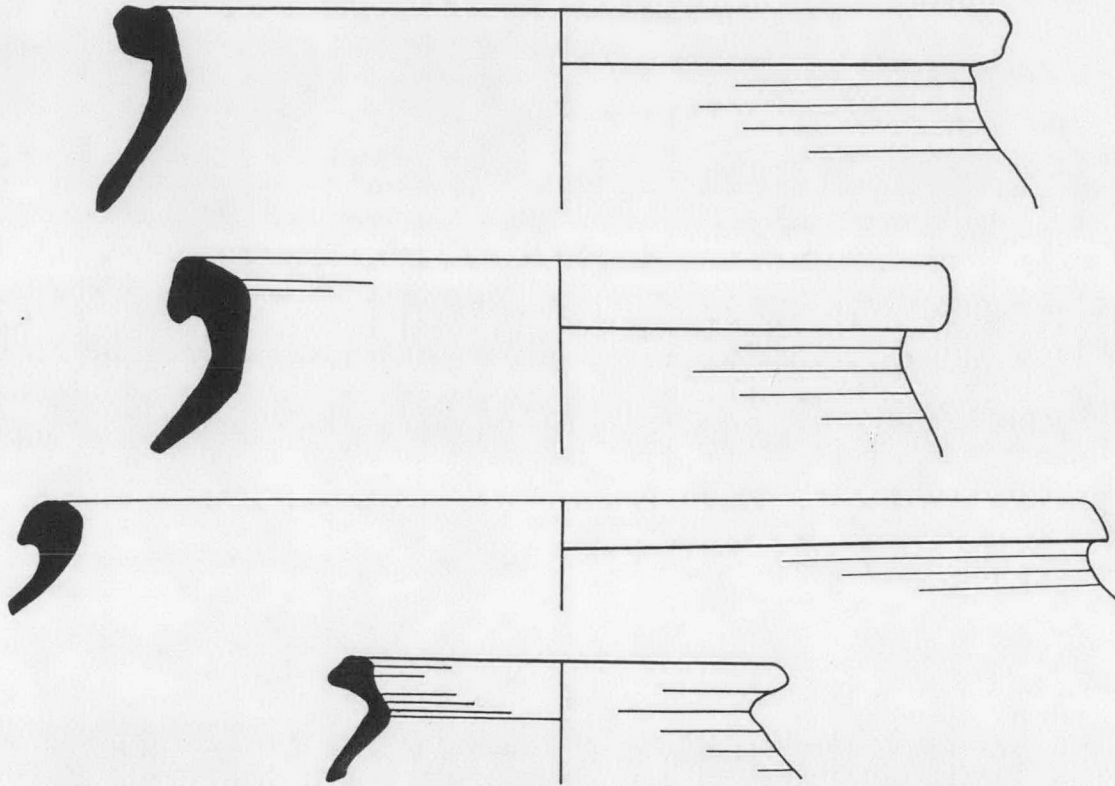
Figure 22/2-5 - Medieval Pottery (1:2) - a) Gritty Ware JARA rim [context 201], b) Red Sandy Ware JARL rim [204], c) Splash Glazed JARA rim [204], d) Stamford Ware CPOT rim.

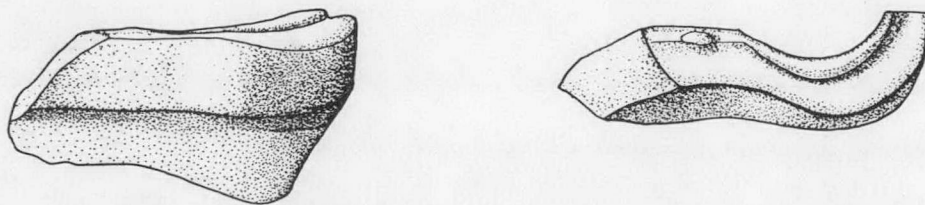
Figure 22/6 - Lip of a Splash Glazed Jug (1:2) [245/2]

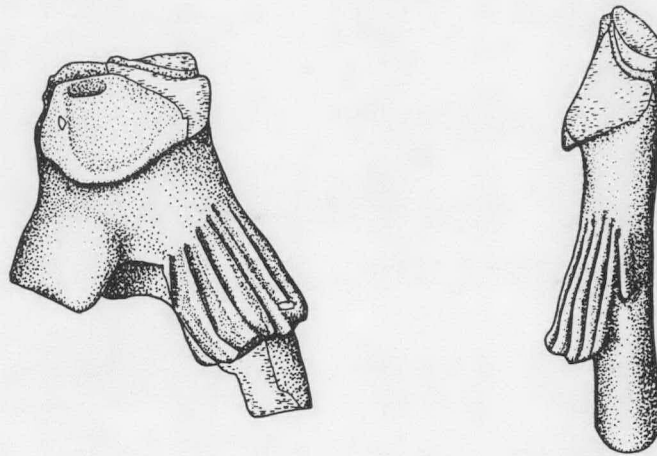
Figure 22/7 - Human figure (1:1) from a Scarborough (II) ware jug [249]

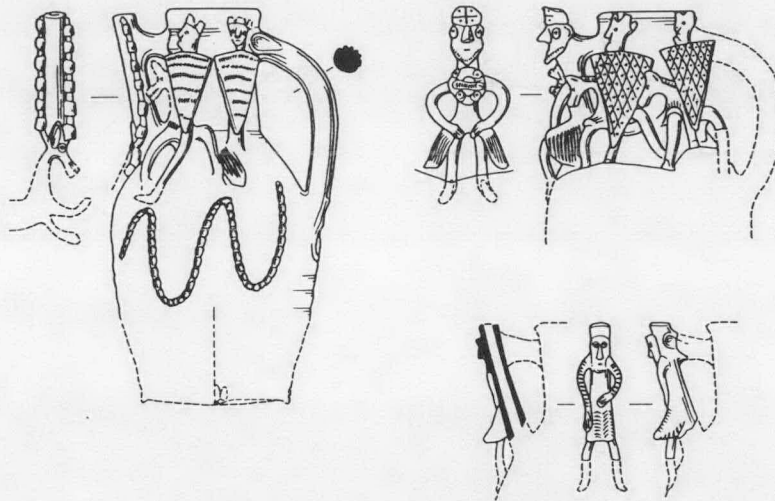
Figure 22/8 - Typical Scarborough Ware jug figures (from McCarthy & Brookes, 1987)

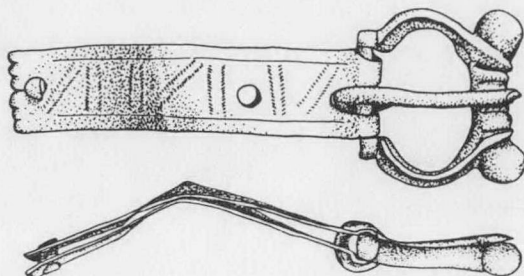
Figure 23/1-2 - Oval-framed buckle and strap-end (1:1) [200]

The recently published volume of medieval dress accessories from London (Egan and Pritchard, 1991) contains some fairly close parallels to the more complete example in its section on "ornate oval frames with plates". The London evidence suggests that the fashion for buckles of this sort was long lived and current from the late twelfth to late fourteenth centuries. There is some evidence to suggest that "knops" are more typical of the earlier part of this range, but this is not conclusive. The London material contains no close parallels for the fragmentary piece, which might as easily be post-medieval as medieval.

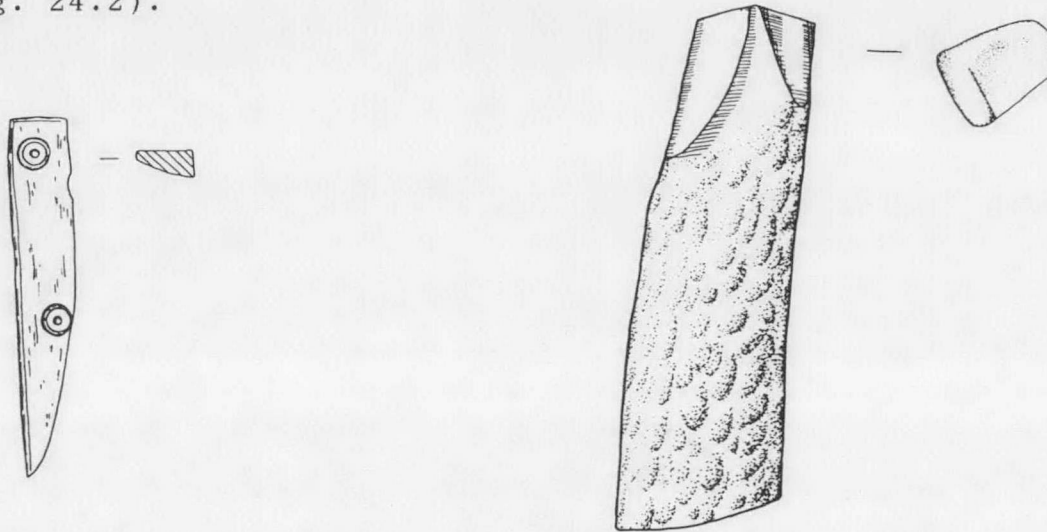
Figure 24/1-2 - Worked Bone: Antler "peg" (1:2) and decorative plaque (1:1)

determined, nor was its date: it could equally well be Roman or Medieval. The site also produced several fragments of antler as well as other deer bones. Several antlers had been sawn, and one further worked to produce a rectangular section at one end (fig. 24.2).

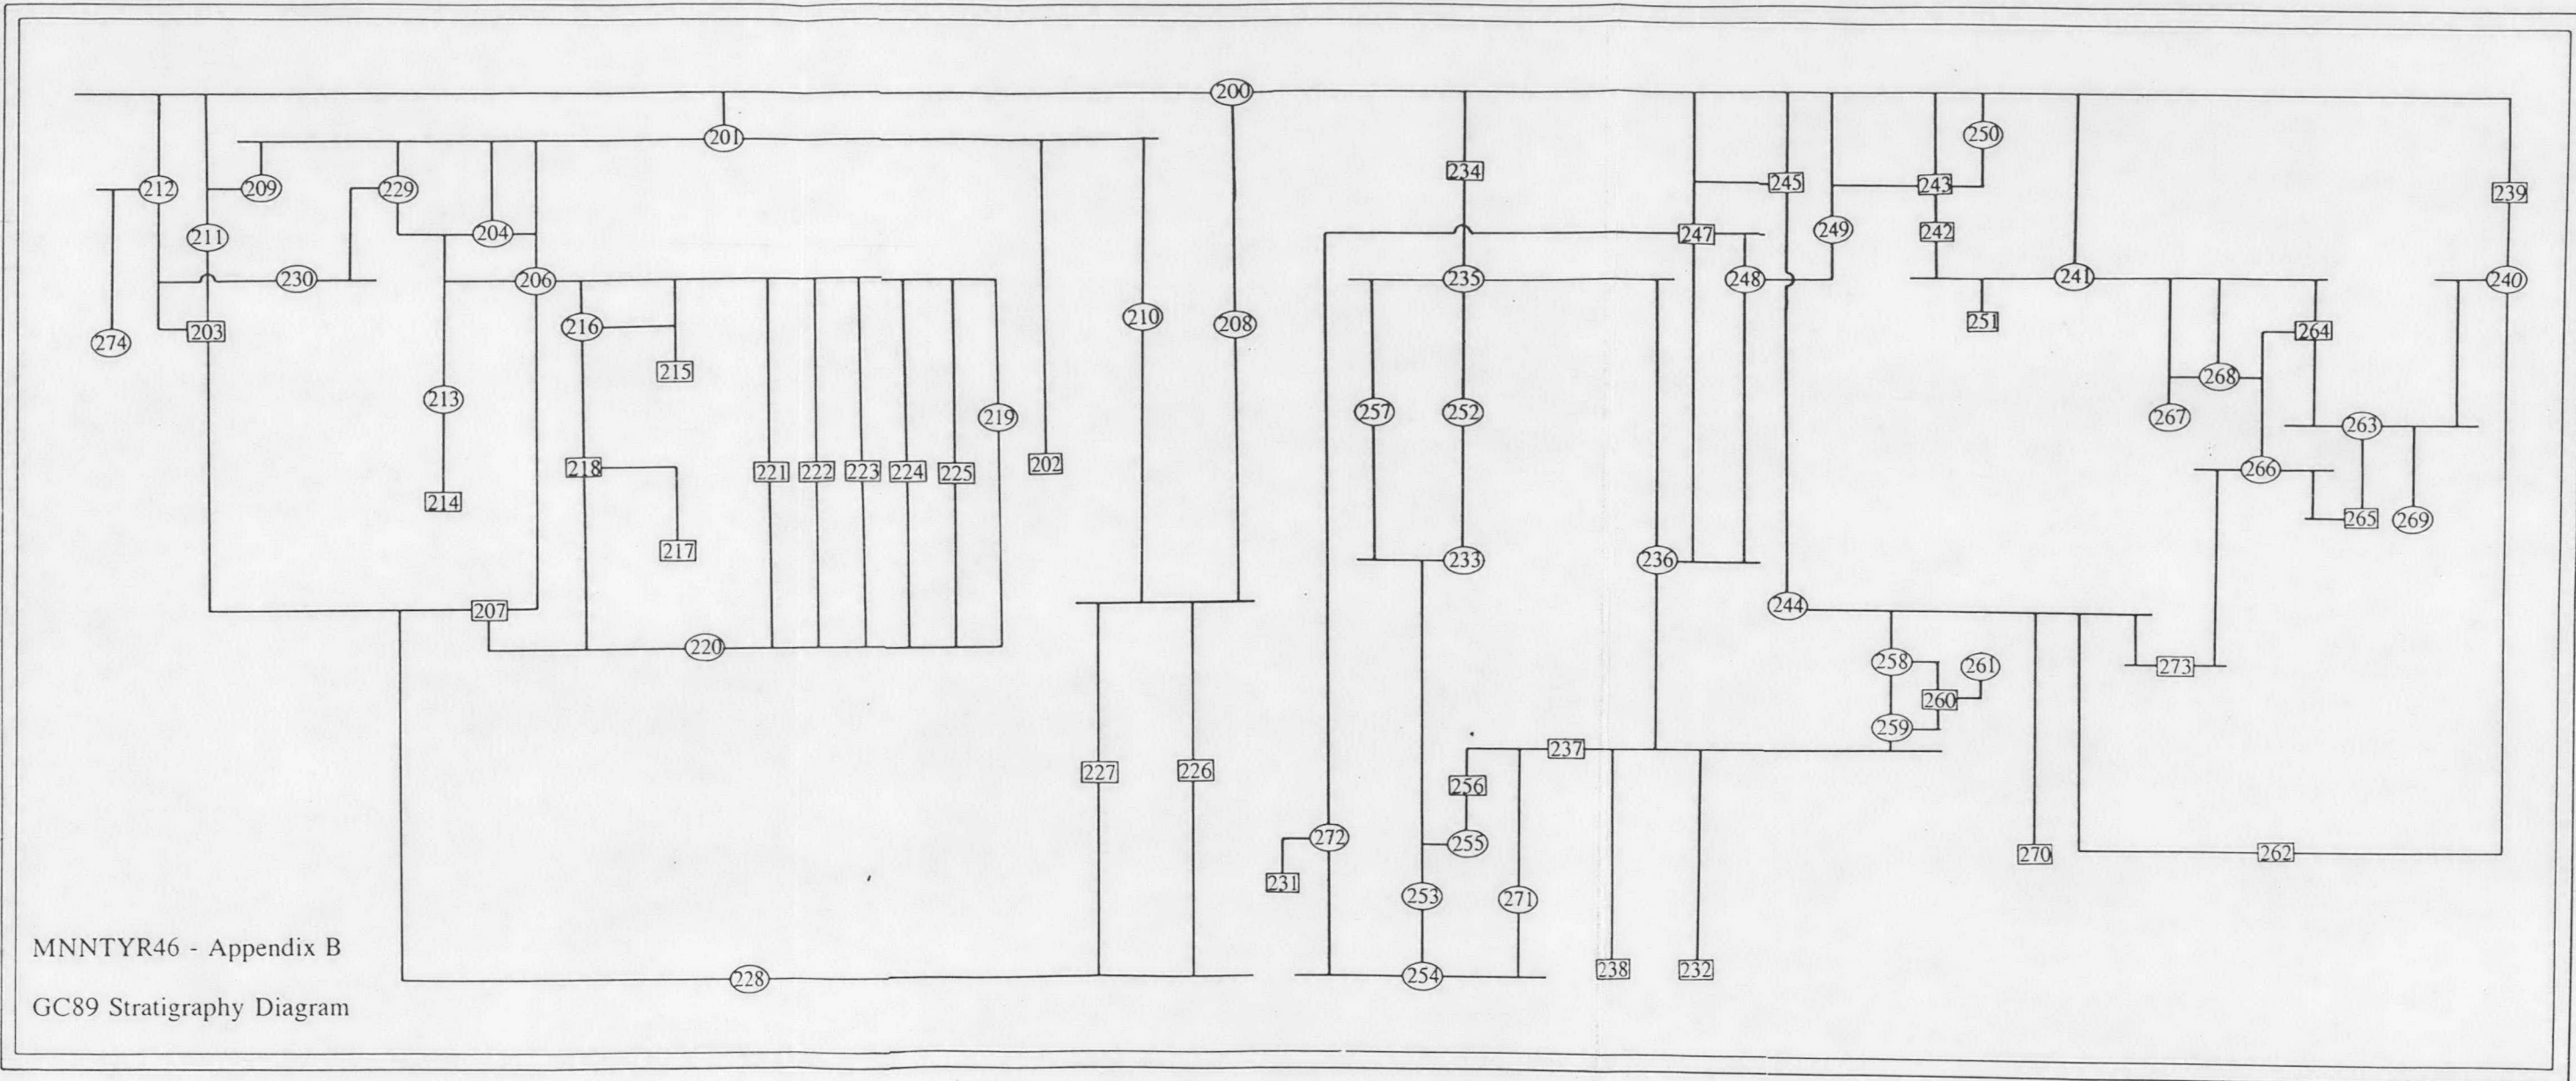
MNNTYR46 - Appendix B  
 GC89 Stratigraphy Diagram
