**1 VOYAGE LTD**

## **Heritage Impact Assessment**

**92 Micklegate, York**

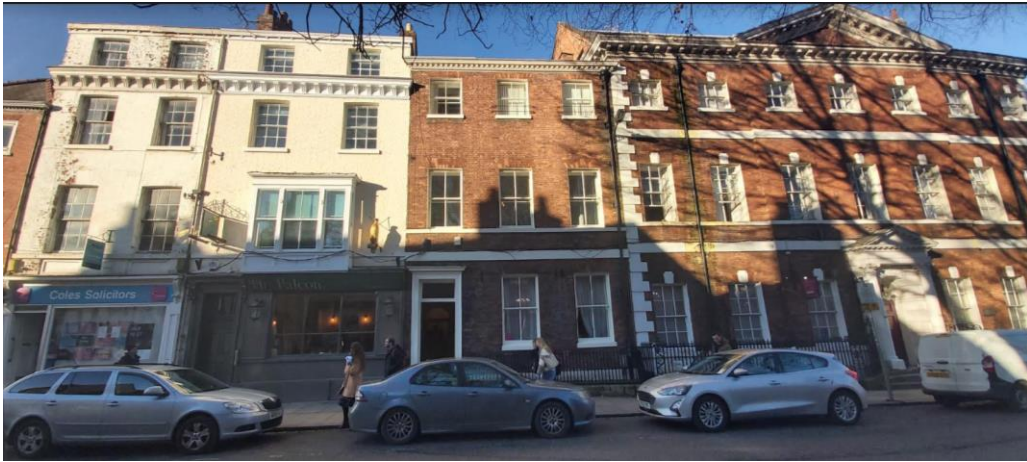
**Fig 2 92 Micklegate (centre)**

- 4.2 92 Micklegate is a late eighteenth-century, Grade II\* listed, three bay, three storey, mid-terrace building constructed of red brick under a hipped, Welsh slate roof (Fig 2). The building is pavement edge but occupies a long, linear plot which was, historically, a medieval burgage plot. Originally built as a dwelling, the building is now used as offices and land to the rear forms an associated car park. There is a rear, mono-pitch, single story, brick extension which was constructed during the 1980s. Fenestration is formed from diminishing, four pane, vertical sliding sash windows under flat arches of gauged brick. The second floor windows have external bars which indicate the historic use of these rooms as a nursery. The six-panelled front door is located to the left of the façade, under a moulded cornice and a fan light. Three steps lead to the entrance where a boot scraper is located. Both the front and rear of the building are bounded by iron railings which historically protected light wells serving the cellar; those to the rear also enclose a set of external steps leading to the cellar. The front elevation incorporates a modillion and dentil cornice, painted stone bands at first floor and first floor sill level and a painted stone plinth. Sills at ground floor and second floor level are also painted.

- 6.1.11 In terms of the actual building, the RCHME record describes 92 Micklegate stating that, '*The main front ... [Fig 2] is in red brick, with stone dressings, and has a slated roof. The windows have deep flat arches and stone sills, and the modillioned and dentilled cornice overlaps the adjacent Micklegate House ... [Fig 9]; to E. is a moulded rainwater head with a fall-pipe secured by holdfasts decorated with opposed fleurs-de-lis. The iron railings are original.*'

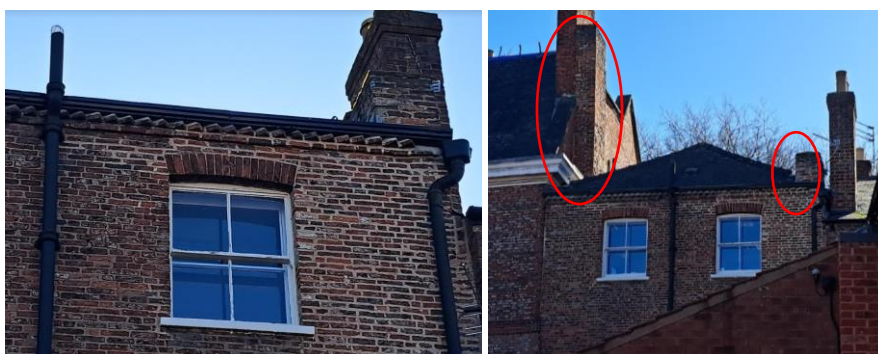
- 6.1.12 The rear elevation does not incorporate a cornice although there is a decorative string course of projecting bricks with a course of coggled bricks above at eaves level (Fig 9A). The rear elevation is largely symmetrical with the exception of a former first floor door, now additional window on the right side. Windows on this elevation have been enlarged and sit under brick, relieving arches rather than the flat arches found on the front elevation. A tall, brick chimney emerging from the eastern gable is evident from the rear, as is a truncated, corner chimney at the north-west corner (Fig 9B). Neither retain pots.

**Fig 9A Eaves band & enlarged window Fig 9B Tall gable and truncated corner chimney**

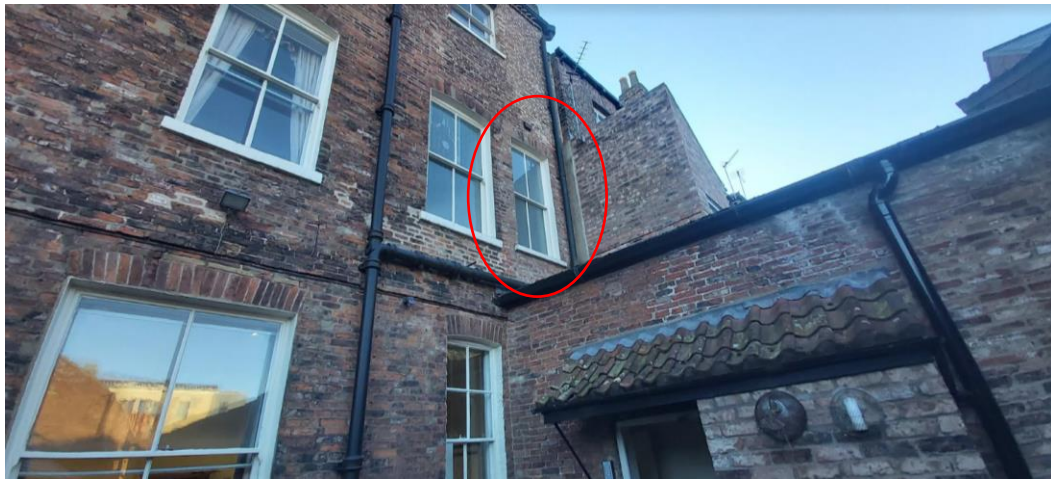
- 6.1.13 The RCHME records, 'A two-storey range at the back, possibly of the first half of the 18th century, [which] was modernised in the 19th century, when a first floor was added to the vestibule joining it to the main building.' This range would have pre-dated the main house which was built at the end of the 19th century. It has now largely been removed and replaced with a late, twentieth century, single storey extension. A small area of historic fabric remains within the ground floor link (Fig 10). The right hand, first floor window, which has a much thinner sill, and which upsets the symmetry of the rear elevation, is thought to be the location of the nineteenth-century door which connected the house to this range at first floor (Fig 10).

**Fig 10 Location of former, two storey range, ringed window likely location of former door**

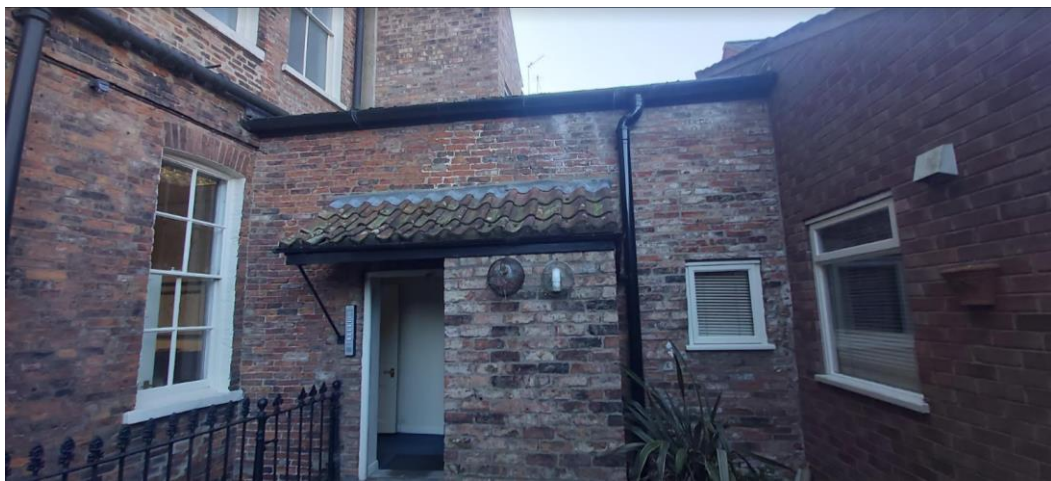
**Fig 11 Historic fabric to the ground floor link with later porch**

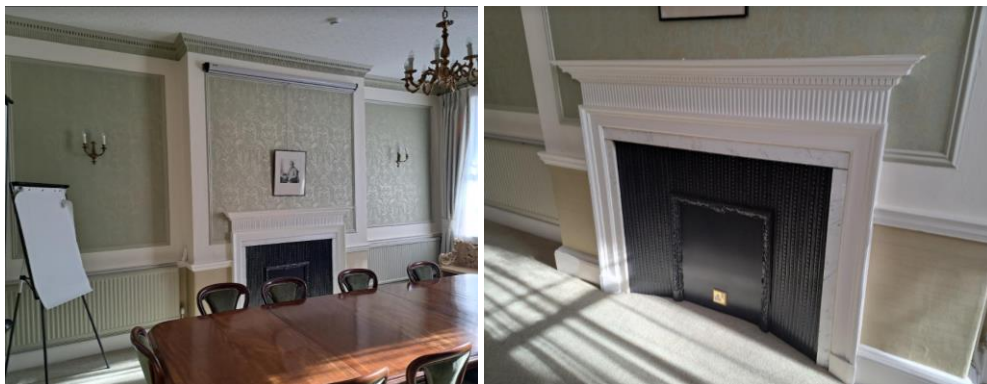
**Fig 14 Dining room cornice, dado & applied plaster mouldings Fig 14A Repro fireplace**

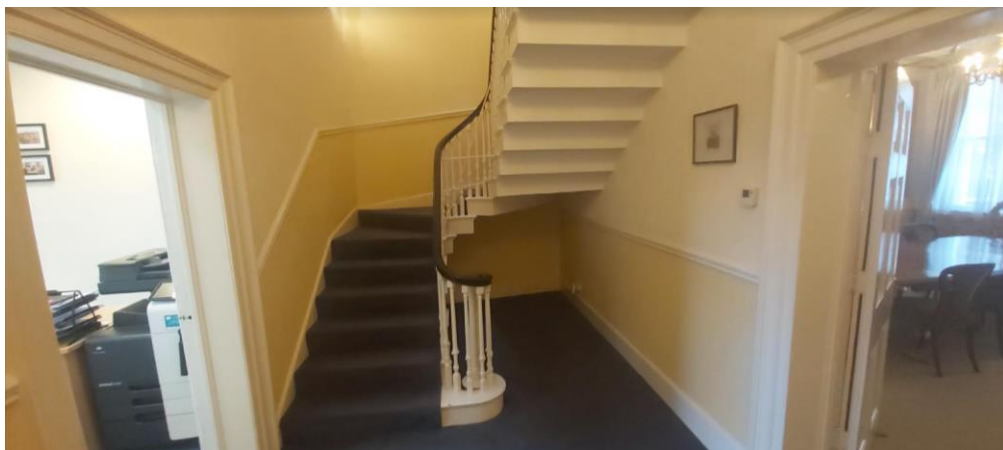
**Fig 15 Cantilevered staircase, swept handrail, slender balusters and dado rail**

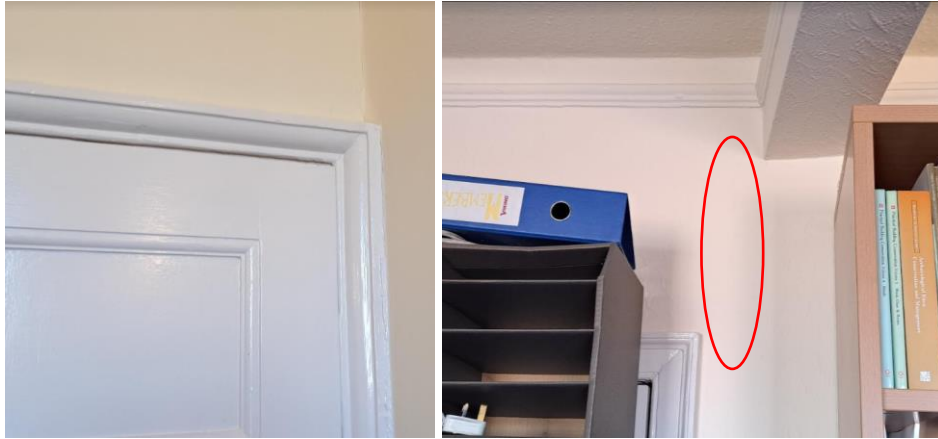
**Fig 28 FF wall built up to architrave Fig 29 Gap between sf wall & architrave above**

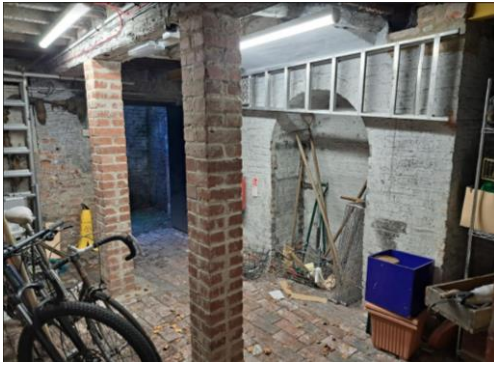
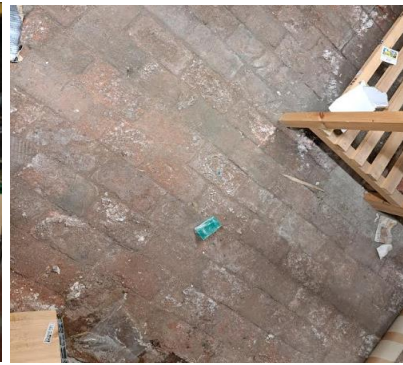
**Fig 35 Niche in right gable & modern pier Fig 36 Original brick floor**

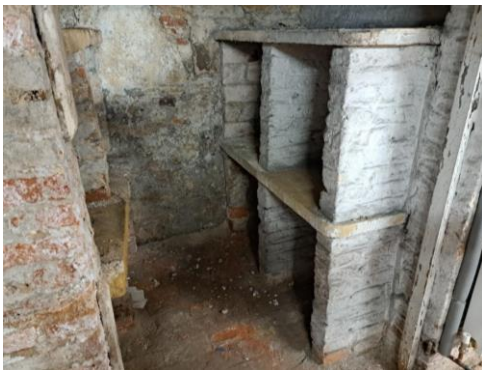
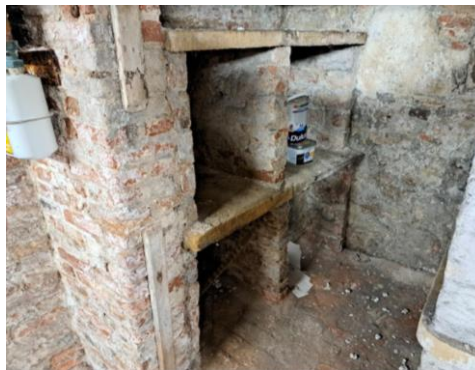
**Figs 37 and 38 Opposing brick and stone stores on the left gable**

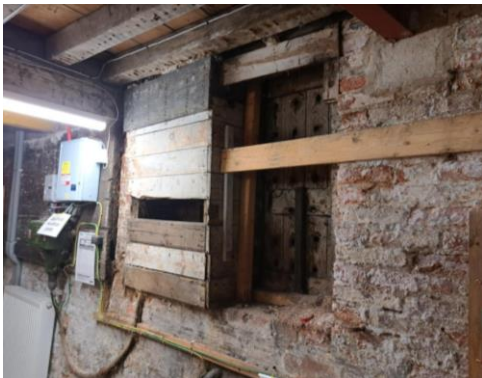
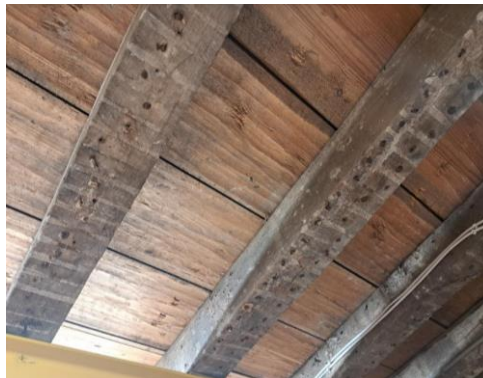
**Fig 39 Blocked opening in front elevation Fig 40 Evidence of former cellar ceiling**

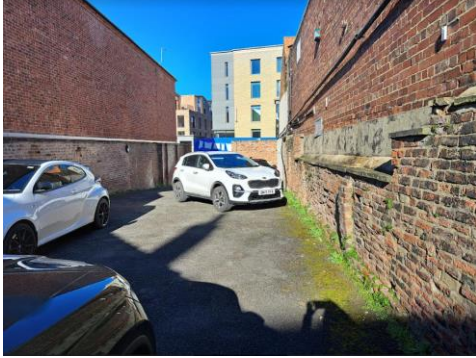
**Fig 41 Eastern boundary to right**

has consent to remove and replace the extant outbuildings. The applicant therefore has no control over the eastern boundary (right wall at Figure 41). The eastern boundary is formed from a mix of new and old bricks with sections formed from historic bricks likely to be re-built (Fig 42).

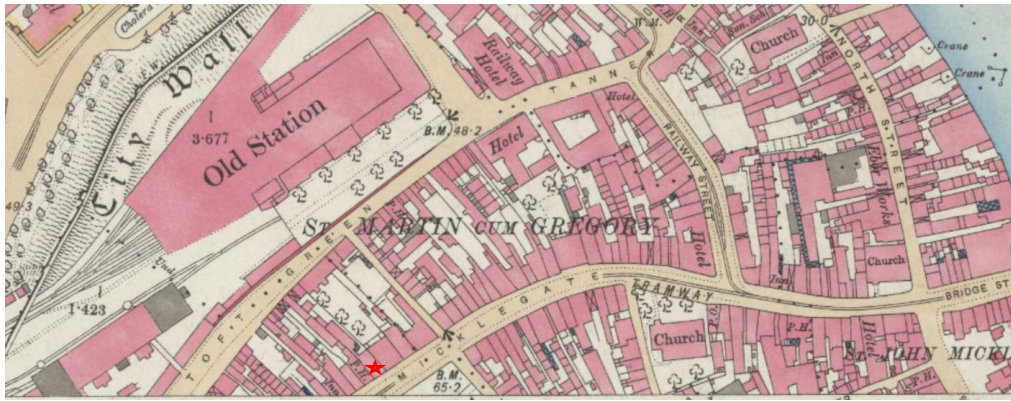
Fig 48 OS 25-inch England and Wales 1841-1952 (surveyed 1889, published 1892)

6.2.8 The 1889-92 survey at Figure 48 shows the structure occupying the rear boundary incorporated a covered access on its western side (indicated by the attenuated 'x'). A separate structure of square plan is also shown between the boundary structure and the dwelling's rear extension demonstrating that the rear curtilage of the application site was dominated by outbuildings at this time. The 1907 survey shows the increasing industrialisation of the area with the letters 'C.W.' and 'F.W.' on land to the east which had previously been recorded as formal gardens (Fig 49). The letters indicate the presence of chemical works and factory works and are indicative of a decline in status and industrialisation of the area which was associated with the arrival of the railway. There are little changes of note in the 1929 and 1937 OS surveys shown at Figures 50 and 51. At some point during the latter part of the twentieth century, the various outbuildings within the rear yard have been demolished and the rear extension to the dwelling has been replaced, during the 1980s, with a single storey, mono-pitch extension formed from dense, modern bricks. A modern boundary wall has been formed to partially enclose the rear yard, utilising reclaimed bricks, whilst leaving sufficient space for vehicular access.

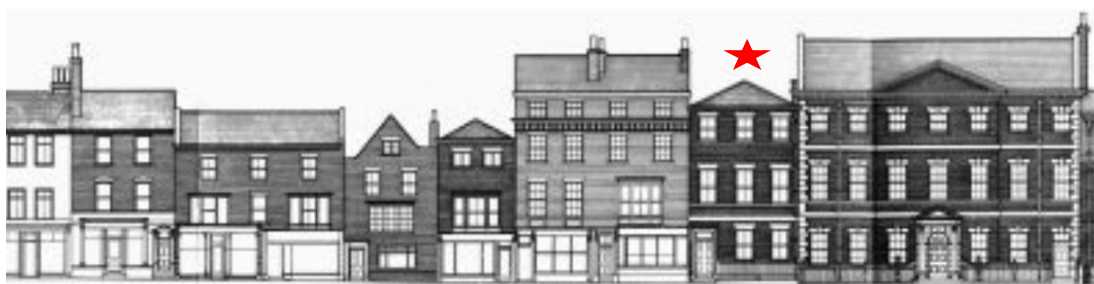
**Fig 52 RCHME drawing of site and wider streetscape c. 1972**

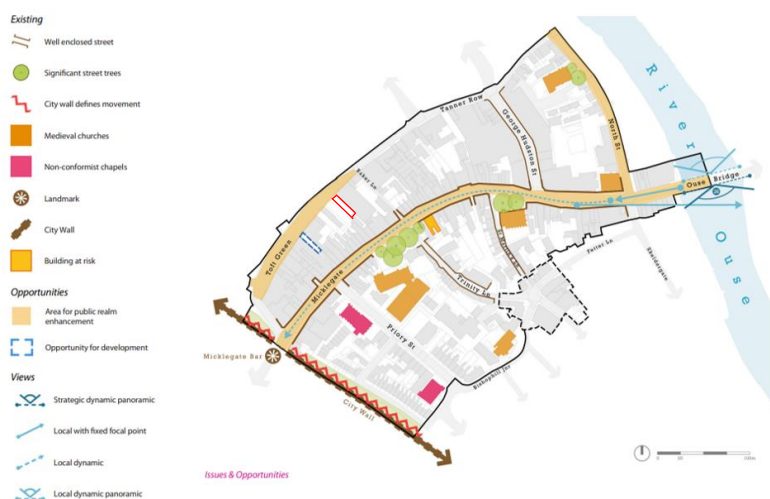
**Fig 53 'Opportunity for development' identified in the CAA by a dotted blue outline, application site outlined in solid red line**

6.2.12 The CAA adds that, *'there is a small development opportunity next to the York Brewery, Toft Green. Any new building should respect the existing building line and be no higher than neighbouring rooflines.'* The map at Figure 53 is taken from the CAA and identifies the 'development opportunity' by a blue dashed outline and the photograph at Figure 54 shows this site as seen from Toft Green. If one compares the application site (Fig 55) with the land identified as a 'development opportunity' within the CAA, it is clear that the two sites share very similar characteristics although the application site is considerably wider. While both sites provide brief, glimpsed views towards the rear elevations of historic buildings fronting Micklegate, both sites are, in themselves, visually, low-grade sites, with non-historic boundary treatments. As such both undermine the strength of the streetscape and could accommodate a new structure. It is assumed that the only reason the application site was not identified as a development opportunity when the CAA was produced was because it was in active use as an office car park.

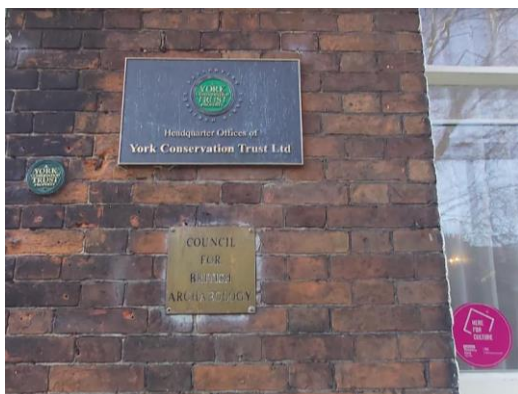
**Fig 56 Four signs to be removed**

- 7.2 Externally, four signs on the front elevation, which advertise the presence of the various office users, will be removed, thus removing visual clutter from the front elevation (Fig 56). The blue plaque which refers to the building's historic association with James and Thomas Backhouse, and helps reveal the heritage significance of the building, will, however, be retained (Fig 8 above). The modern, tarmac finish and municipal bike stands to the rear yard will be replaced with stone flags which will both enhance the setting and better reveal the domestic character of the building (Fig 58) and the missing finial on the cellar gate will be replaced on a like-for-like basis (Fig 57).

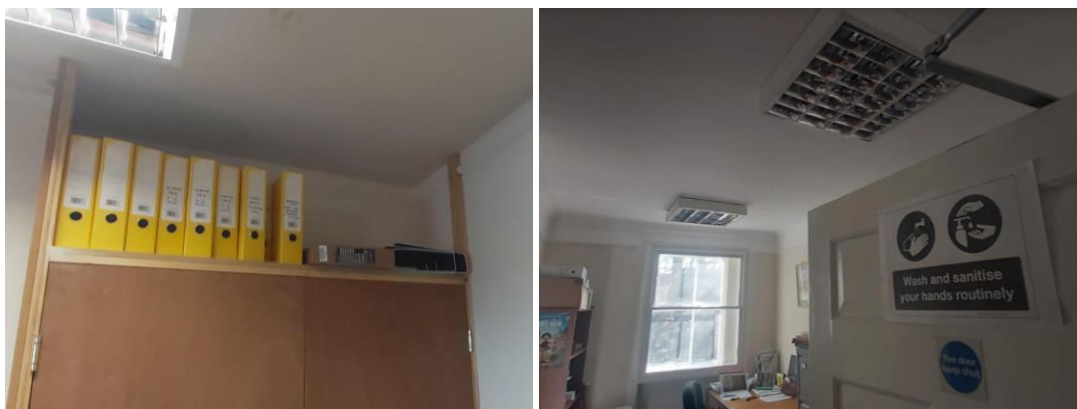
**Figs 59 & 60 Commercial fittings, lights, signage & furniture to be removed**

- 7.3 Internally, a plethora of commercial fittings and harmful interventions relating to the current use, ranging from substantial, modern light fittings, surface mounted conduits, commercial grade carpets and low-grade fitted cupboards to commercial toilet facilities will be removed and or reversed in line with the proposed change of use from office to dwelling (e.g.s at Figs 59 to 62). Blocked and missing fireplaces will be re-opened and/ or reinstated. Walls that have been removed, and a doorway that has been blocked, to create open plan offices, will be reinstated to better reveal the original plan form. The change of use proposed and associated works will reinstate the building's original and optimum viable, use and will better reveal its historic plan form and its architectural and historic interest.

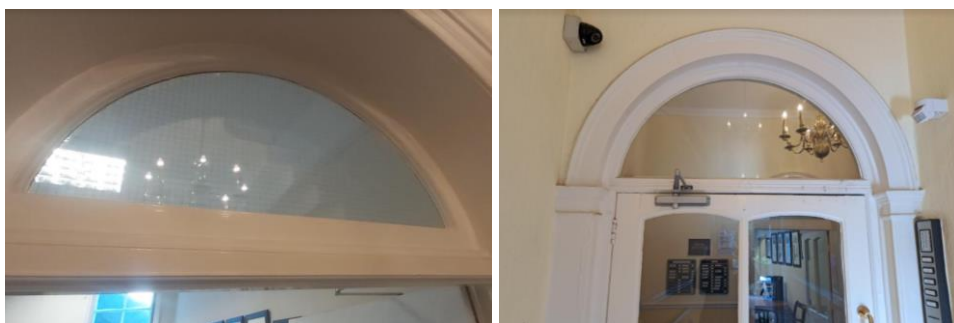
**Fig 64 Wired glass to gf rear hall fanlight to be replaced with clear glazing to match porch**

therefore a simple, contemporary handrail which reflects the low status of this stair is proposed. Modern fire-glass in the fanlight above the door leading to the rear corridor, which contains visible wires, will be replaced with clear glazing to match the fanlight in the entrance hall thus enhancing the historic interest of the building (Fig 64). The blocked fireplace in the ground-floor rear room will be re-opened and an appropriate fireplace fitted which will also enhance the historic and architectural interest of the building (Fig 65).

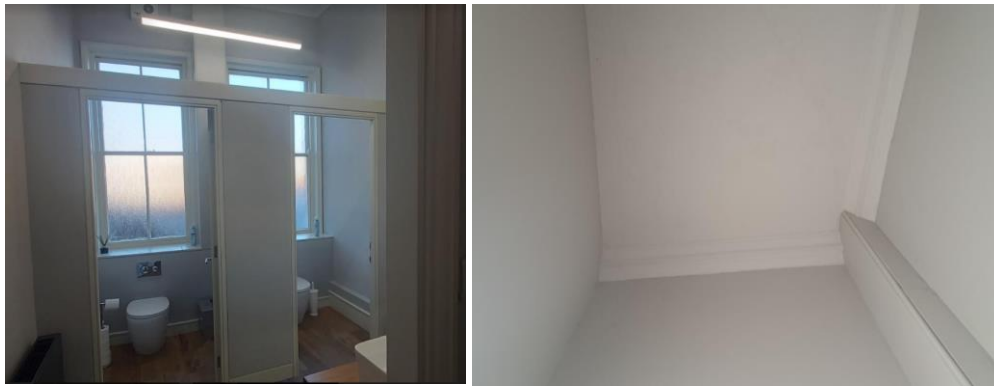
**Figs 66 & 67 Modern w.c. stalls and conduit to ff, rear, left room to be removed**

- 7.5 At first floor, the modern toilet stalls, surface mounted services and cupboard (Fig 66, 67 and 69) will be removed and opaque glazing in the two windows in this room will be replaced with clear glazing (Fig 68). This will better reveal the historic plan form and character of the building. It is assumed that this room historically contained a fireplace which was possibly removed when the first-floor link was created to the rear range. Careful investigation at strip out stage will determine whether or not it would be appropriate to reinstate a fireplace to this room. The missing fireplace to the rear, right-hand room will be reinstated (Fig 70).

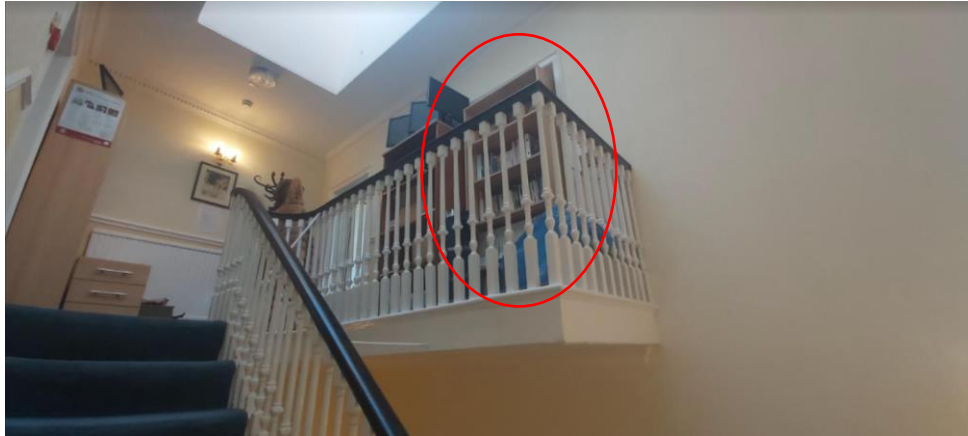
- 7.6 At second floor the blocked door leading from the landing to the rear, right-hand room will be re-opened to better reveal the original plan form (Fig 71). The missing partition wall which would have originally bisected the rear space, now an open plan office, will be reinstated to re-form two separate rooms. This will make more sense of the two doors leading from the landing and better reveal the original plan form (Fig 72). The blocked fireplaces, historically the only source of heat for these rooms, will be re-opened and appropriate fireplaces fitted to better reveal the historic and architectural interest of the

**Fig 71 Functioning but blocked doorway to be reinstated**

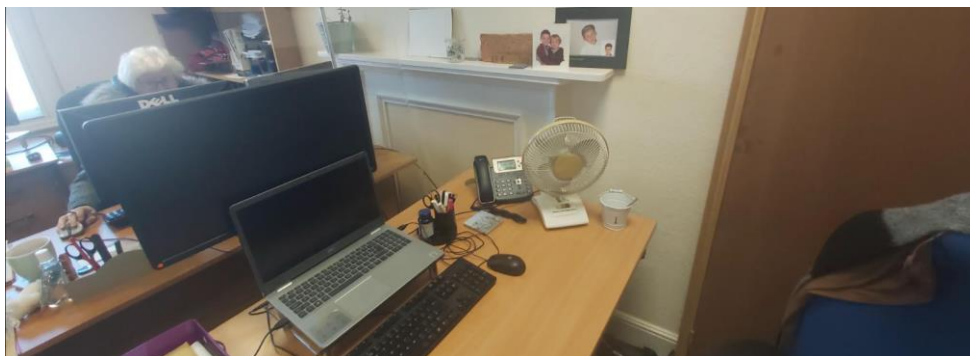
**Fig 73 Fireplaces to sf, rear, right room to be reinstated**

building (Figs 73 & 74). The new opening between the two front rooms will be infilled which will bring the lobby back into meaningful use and reinstate the original plan form thus better revealing the significance of the building (Fig 75). The two, blocked fireplaces will be re-opened (Figs 76 and 77).

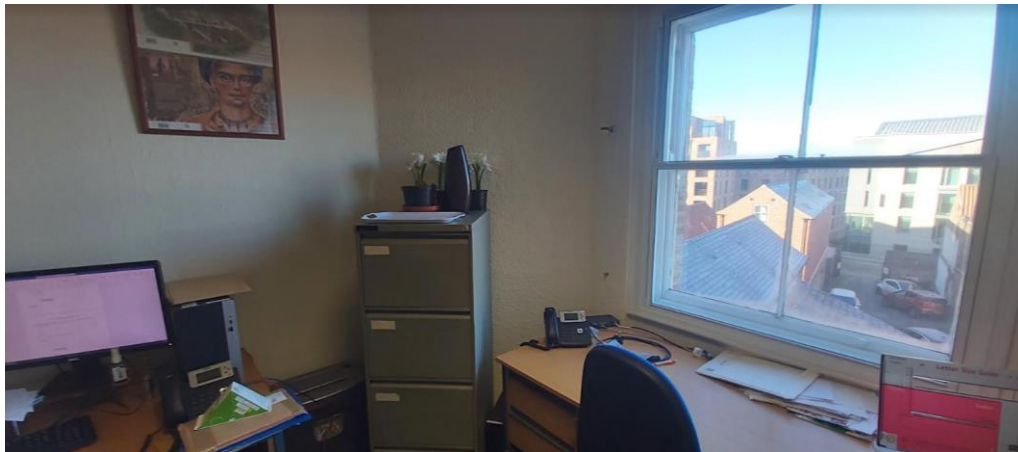
**Fig 74 Corner fireplace in second floor, rear, left room to be reinstated**

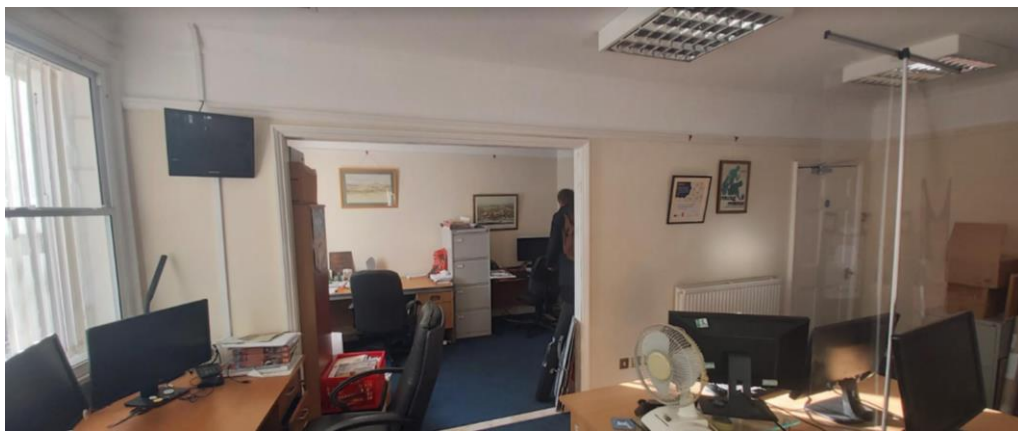
**Fig 75 Modern opening between sf, front rooms will be infilled & modern lights removed**

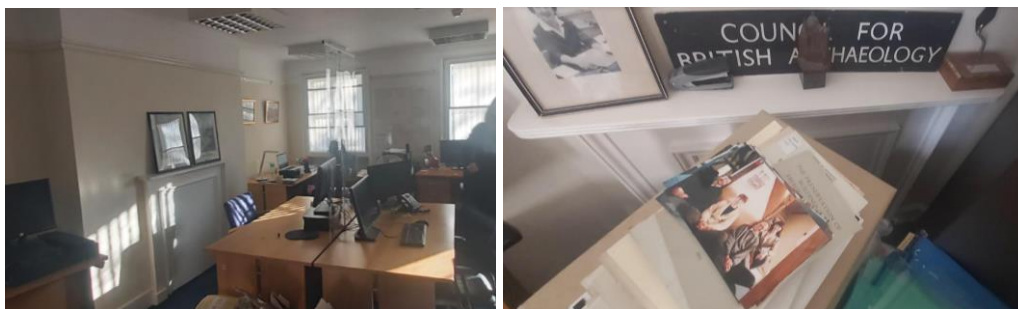
**Figs 76 & 77 Fireplaces to sf, front rooms will be re-opened**

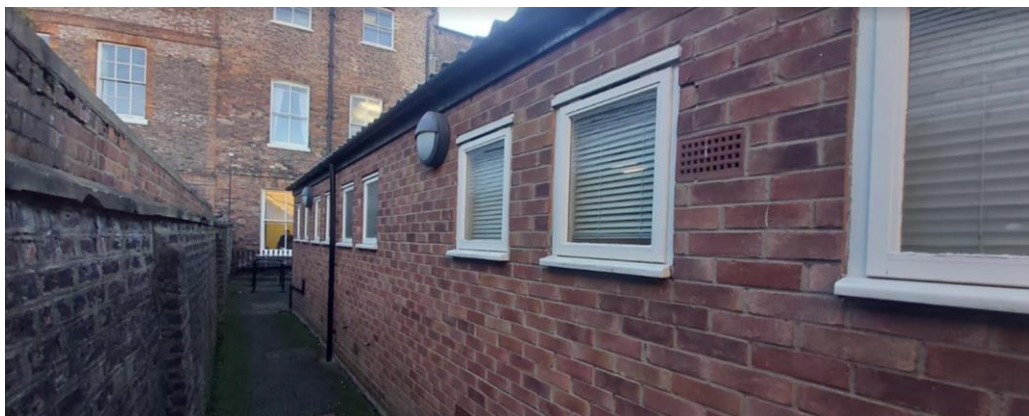
the side yard and the attached conduit and the removal of the metal blinds and municipal lighting within the extension will further enhance the building's setting (Figs 79 and 78).

**Fig 78 Unattractive rear extension to be rendered and windows and lights replaced**

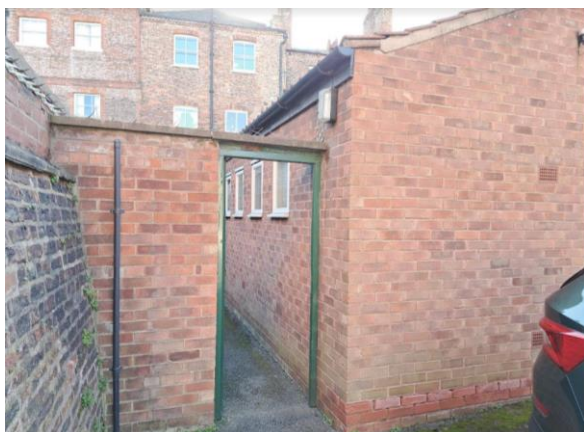
**Fig 79 Dense brick wall & conduit to be removed**

- 7.7 The modern, rear extension is constructed of a dense, unattractive brick with square, storm proof windows and municipal, external lighting. This will be covered in render, which is typical of some outbuildings in the area and a more traditional material. This will enhance the setting of the listed building (Fig 78). The removal of the modern brick wall that bisects

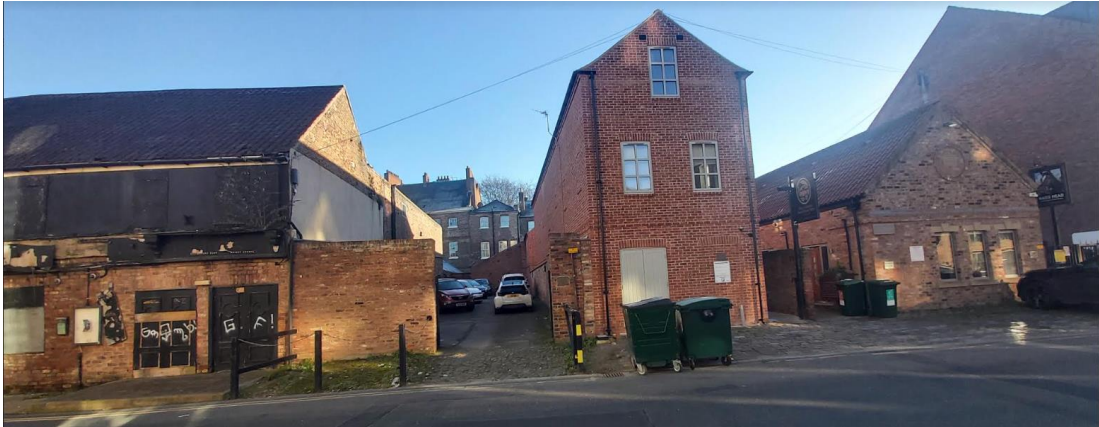
- 7.8 A new, pavement edge dwelling is proposed to the rear of the site which will replace the historic outbuilding evident in the historic photos and map regression above. This dwelling is of contemporary design but is inspired by what appears to be the historic coach house at Figure 44. It incorporates the outline of a snowdrop thus referencing and better revealing the site's connection with James Backhouse and its associated historic interest. Its height and mass reflect the structures on neighbouring sites and its colouring will reflect and compliment the tones of adjacent brick work (Fig 80). Its construction will infill a modern gap thus adding strength to the streetscape. The ground floor, shared passageway will enable the surface of the brick, boundary wall between the site and 'Fibbers' to remain legible, if indeed the owners of Fibbers retain this wall during redevelopment, whilst the modern design will also reference the contemporary nature of architecture on the northern side of

**Fig 80 Application site viewed from Toft Green and location of proposed dwelling**

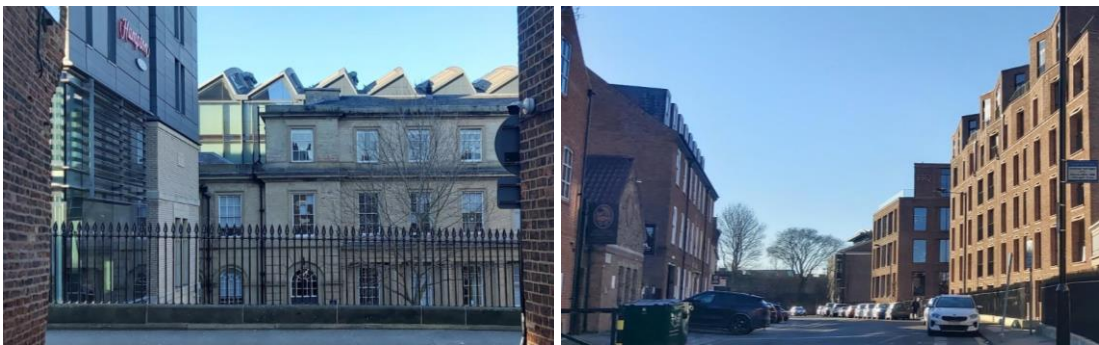
**Figs 81 & 82 Contemporary design on north side of Toft Green**

Toft Green (Figs 81 and 82). The combination of sensitive scale mass and colour scheme and contemporary design and materials is considered to result in a high-quality piece of architecture which will contribute to and enhance the streetscape.

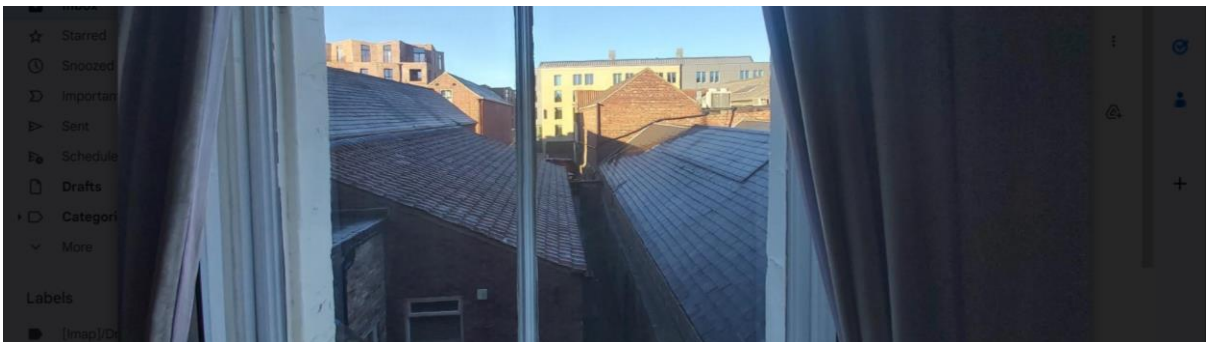
**Fig 83 View from rear window of modern extension and development on Toft Green**

- 7.9 The proposed, new dwelling will combine with enhancements to the modern, rear extension to further provide a more attractive outlook from the rear windows of 92 Micklegate thus enhancing, albeit it in a minor way, its artistic interest (Fig 83).
