YORK ARCHAEOLOGICAL TRUST

Archaeological Investigations at City Walls, Micklegate Bar, Chainage 0690-0700

YAT Watching Brief Report YA/2022/133, December 2022

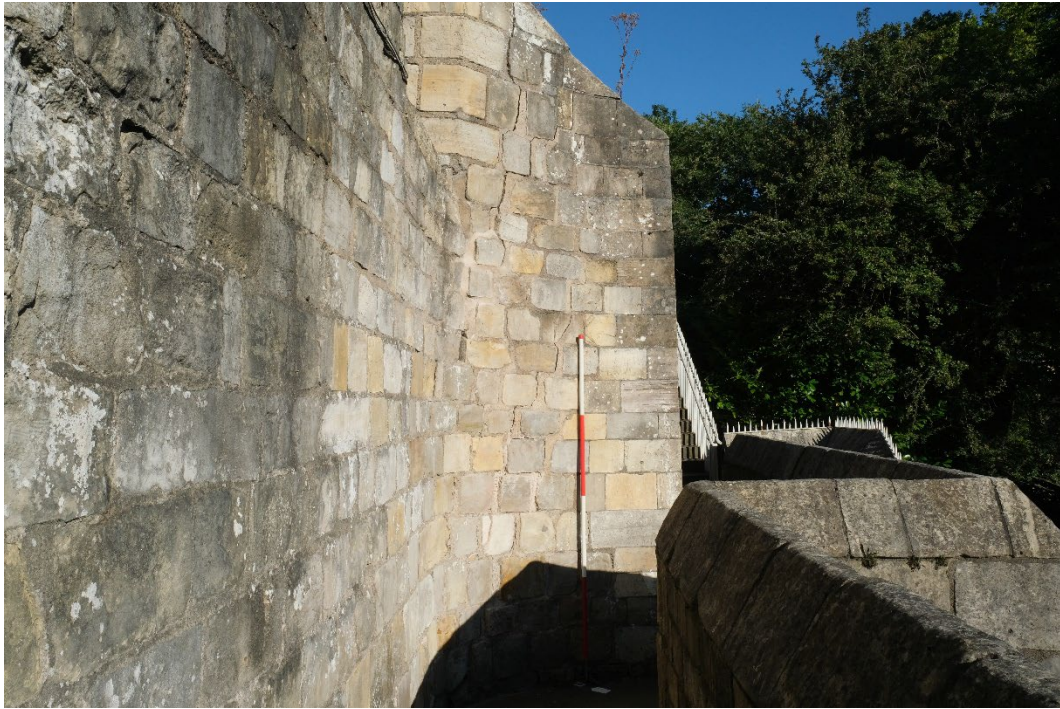
Plate 1 Parapet Wall (2m scale).

The parapet wall (Plate 1) is constructed of medium to large-sized rectangular and sub rectangular limestone pieces. Visually, the corner section of the wall appears to be of a later construction, the stones here being less weathered, more regular in shape and size and more closely bonded together. Visible within this section is a large crack leading up the wall between the bonding material (Plate 2). Trench 1 was placed directly below this crack. Rectangular in shape, the trench was placed in the area where the walls turn to investigate the extent of the wall crack and the strength of the wall foundations here, measuring 1.30m x 1.37m and 0.80m at its shortest end (Plate 3).

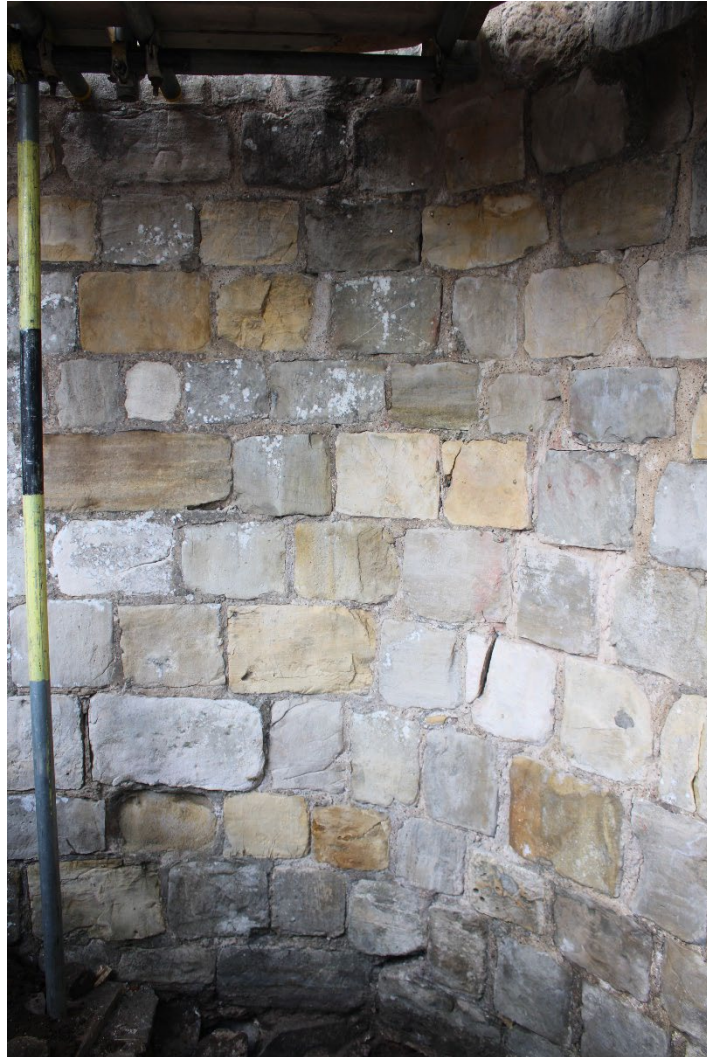
Plate 2 Close up of crack in parapet wall.

Furthermore, the 19th century reconstruction and adaptation of the walls may have resulted in the wall cracking and weakening. In the parapet wall a large crack was visible along the corner of the wall. In a similar example, in Trial Pit 2 at Tower 32 a crack was visible running down the face of the medieval tower wall, around the point that it is bonded to an 18th/19th century extension built to support a widened wall walk (Johnson 2017, 9). A weakness in the bond between new and old at Micklegate, combined with this section being built on a clayey-silt foundation, may therefore explain the crack appearing in this section.

Stonemasons removed a section of stones and metal ties were inserted into the core to strengthen the stonework. The planned remedial works comprised a deep rake-out and repoint

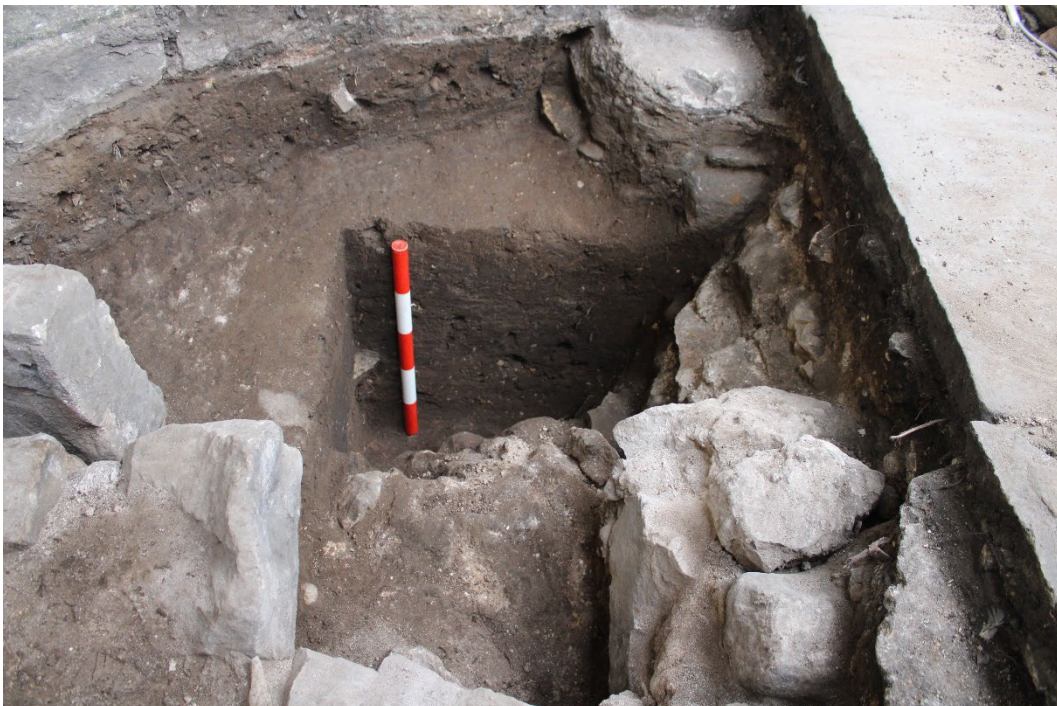
Plate 3 Trench 1 sondage (0.5m scale).

The earliest deposit seen within the sondage was rampart deposit 1010. This was a friable, mid greyish brown silty clay with orange clay patches, interpreted as a levelling deposit within the rampart. This was found at a depth of 0.54m extending to the LOE at 0.90m. Above rampart 1010 was structure 1005 (Plate 3). This was a north-east/south-west aligned wall under the present walkway located 0.50m from the south-eastern edge of the trench. A construction deposit 1004 was associated and built against the wall and consisted of a cream white lime mortar. Overlying the construction deposit was redeposited rampart material 1003, which was 0.30m in thickness. This was a compact to friable, mid orange-brown, clayey silt with occasional large angular sub rounded limestone fragments. A stone post-pad 1008, was found above redeposited rampart material 1003 (Plate 5). This was 0.006m in thickness. This may have been a support for the city walls 1009, when they were rebuilt in the 19th century. Overlying 1003 and built against 1009 was 1002, a bedding for the walkway slabs. This was 0.10m in thickness. Cut through the bedding deposit 1002 was drain base 1007 and drain 1006. Sealing the whole sequence was the present walkway flagstone 1001.

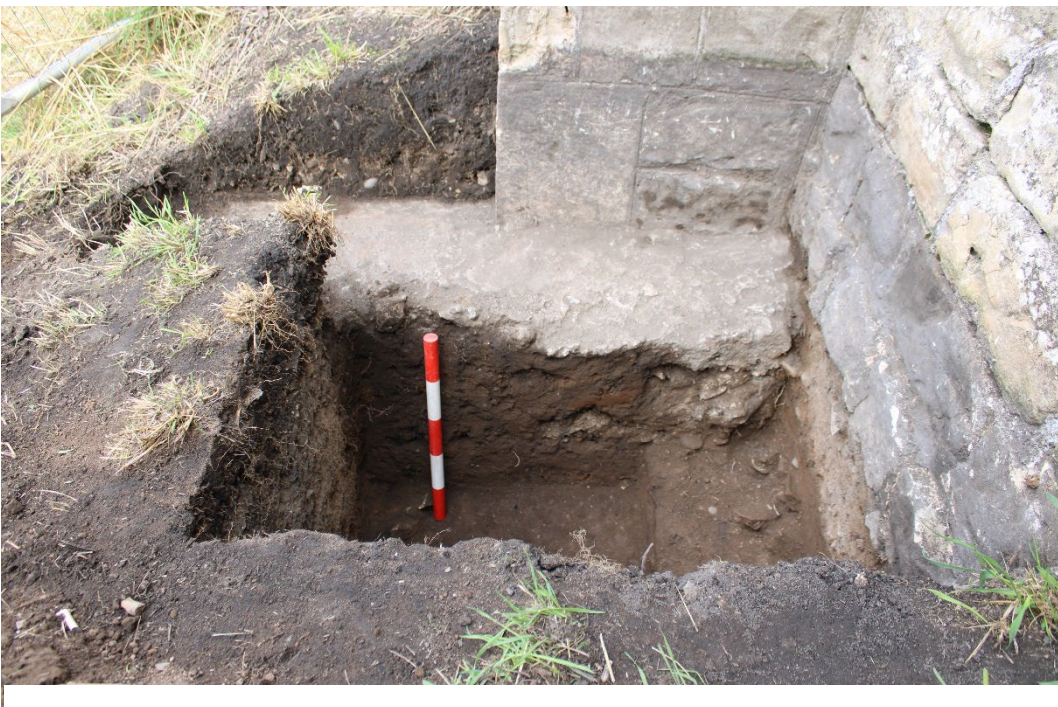
Plate 6 Trench 2 (0.5m scale).

Trench 2 was a square trench measuring 1.00m x 1.02m excavated to a depth of 0.80m BGL (Plate 6). The trench was located on the city wall rampart, immediately against the city wall and buttress. The intention was to investigate whether the foundations of the city wall were visible and whether the rampart material was from the original medieval rampart or a later addition.

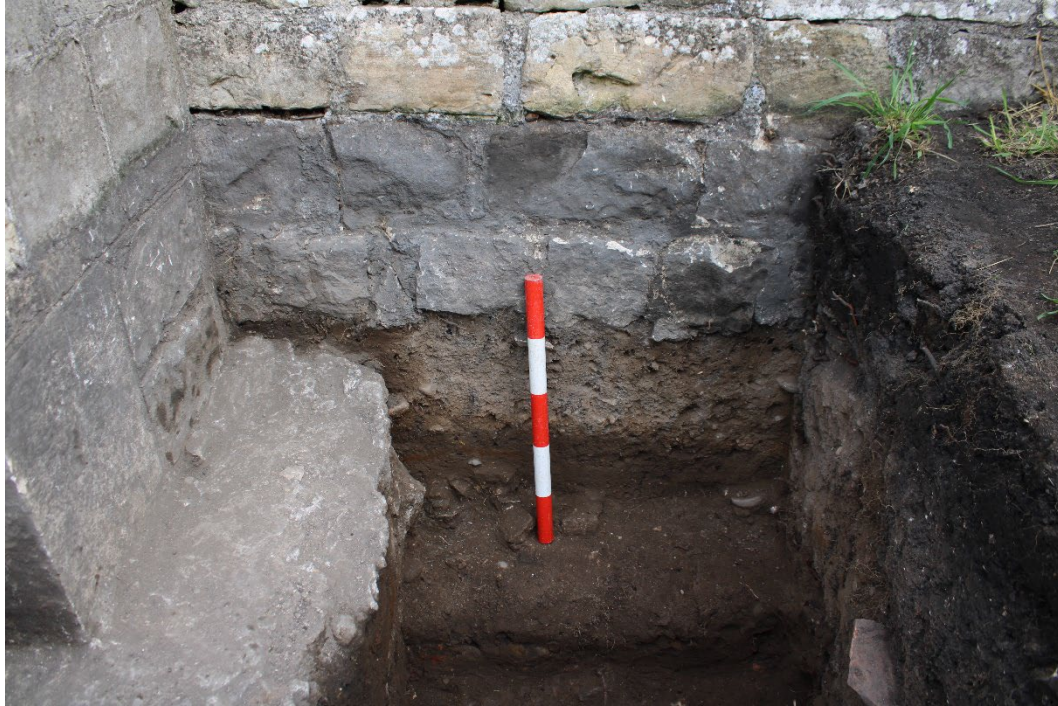
Plate 8 Trench 2 against wall (0.5m scale).

Once the wall face was removed, this section of wall revealed a disintegrating wall core. This was causing the two wall façades to separate, causing the cracks seen in the rampart wall (Plate 8). The core was composed of angular, sub angular and broken fragments of small and medium sized limestone, packed together in a disorganized manner and reinforced with modern concrete from 20th century works. As a result of this large gaps were visible through both faces of the wall. Once the stones were removed the wall core was strengthened by the city wall masons using metal ties.

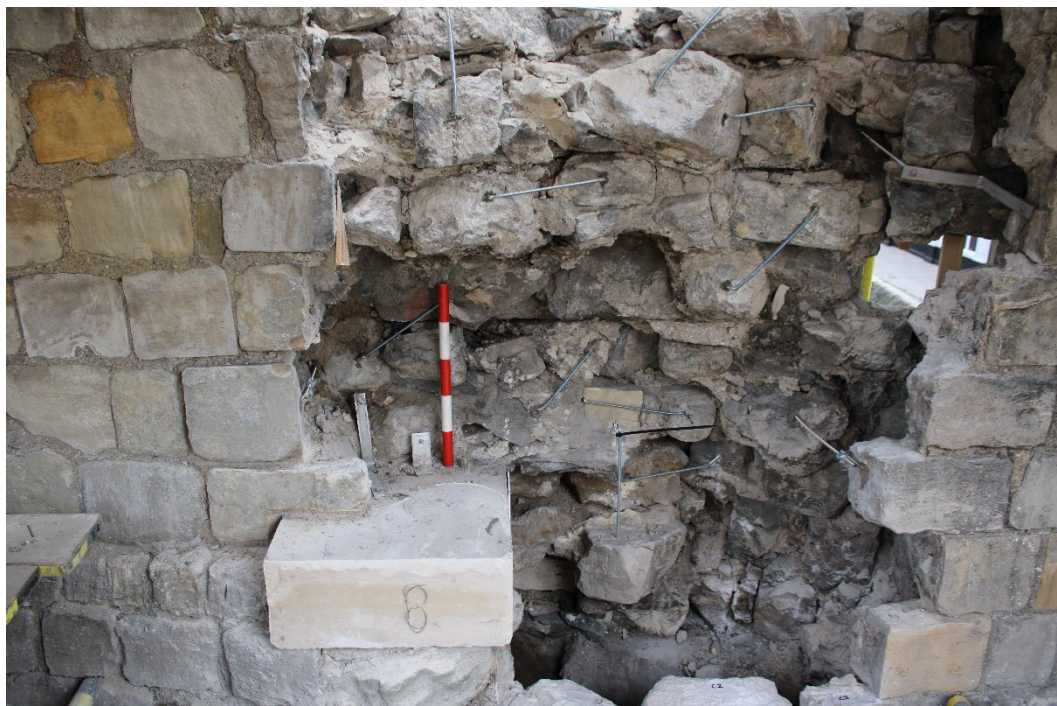
Plate 7 Wall core (0.5m scale).

Within Trench 2 the earliest deposit seen was deposit 2002. This was a friable, greyish orangey brown clayey silt, interpreted as a foundation deposit for the walls above it. Immediately above this was the city walls 2003 (Plate 7). Built up against wall 2003 was deposit 2001, which was a loose, greyish brown, silty sand that made up the rampart in this area but is unlikely to be medieval in date due to its loose consistency and the high level of disturbance. Above this was layer 2000, similar to Context 2001 but containing modern inclusions such as glass fragments. This deposit formed the topsoil. Concrete support 2005 was added in the 19th century to support buttress 2004; the deposits around this area had been disturbed during this repair work and the area was subsequently backfilled with deposit 2006, which was likely to consist of redeposited material from layer 2000.

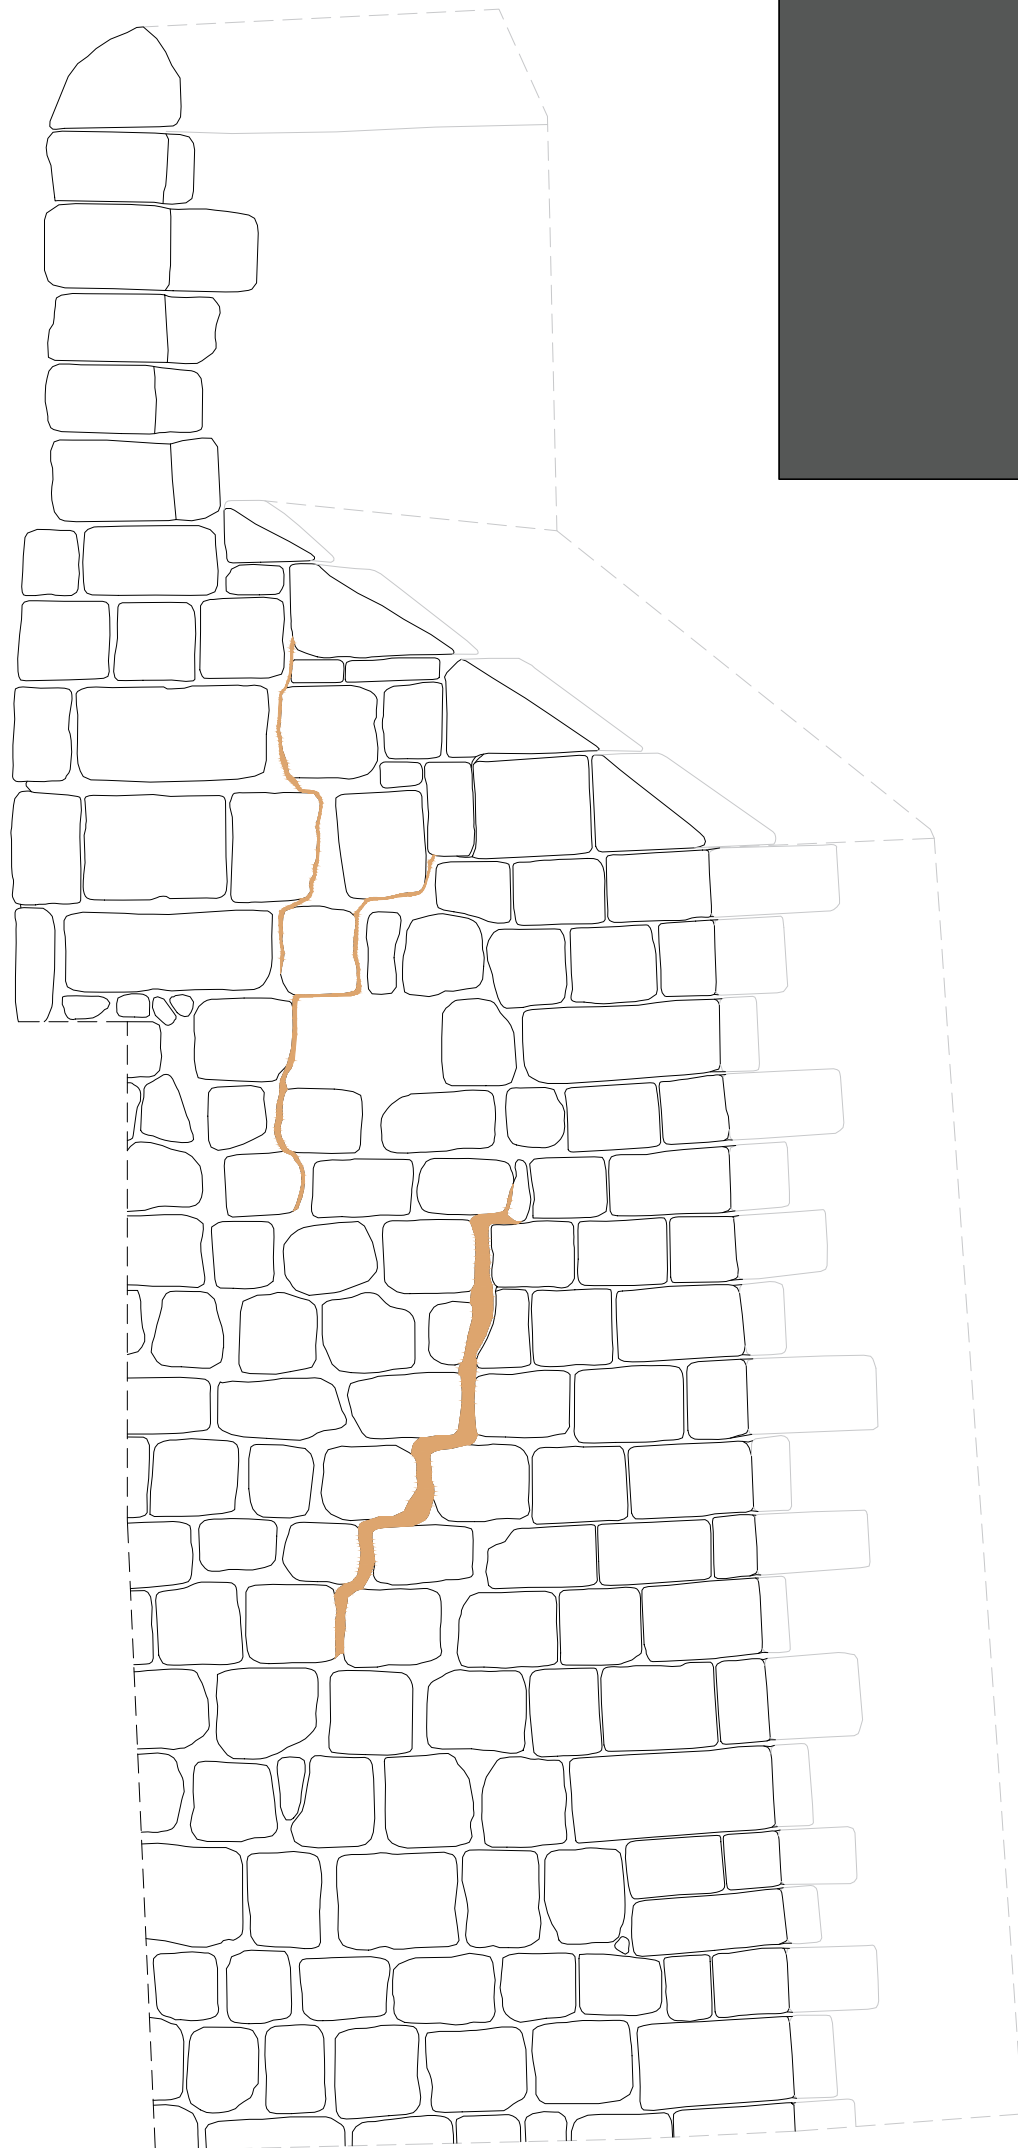
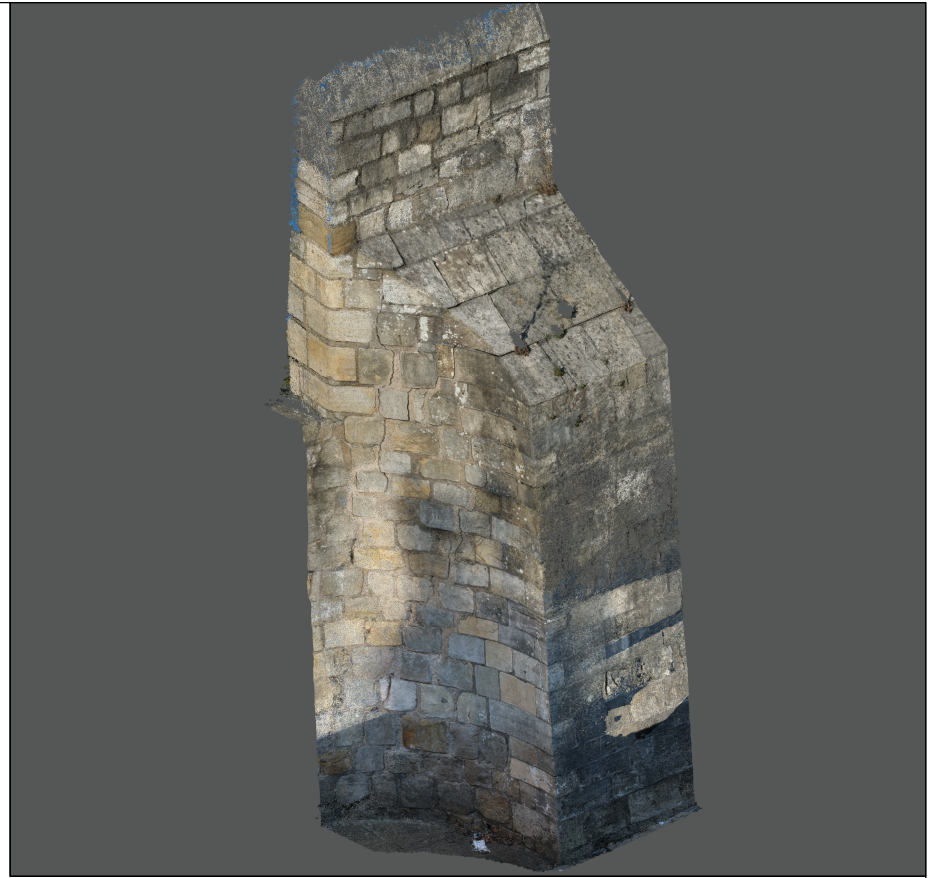
Figure 06 - North East Facing (Curved Part of Inner Walkway) City Wall Elevation
6323 - City Walls, Micklegate Bar, York

Key
Crack Highlight
