39 TANNER ROW, YORK YO1 6JP
HERITAGE ASSESSMENT

Report no: 2022/674.R01v2
Version: Final
Date: February 2023
Author: Ed Dennison & Shaun Richardson

**HERITAGE ASSESSMENT,
39 TANNER ROW, YORK YO1 6JP**

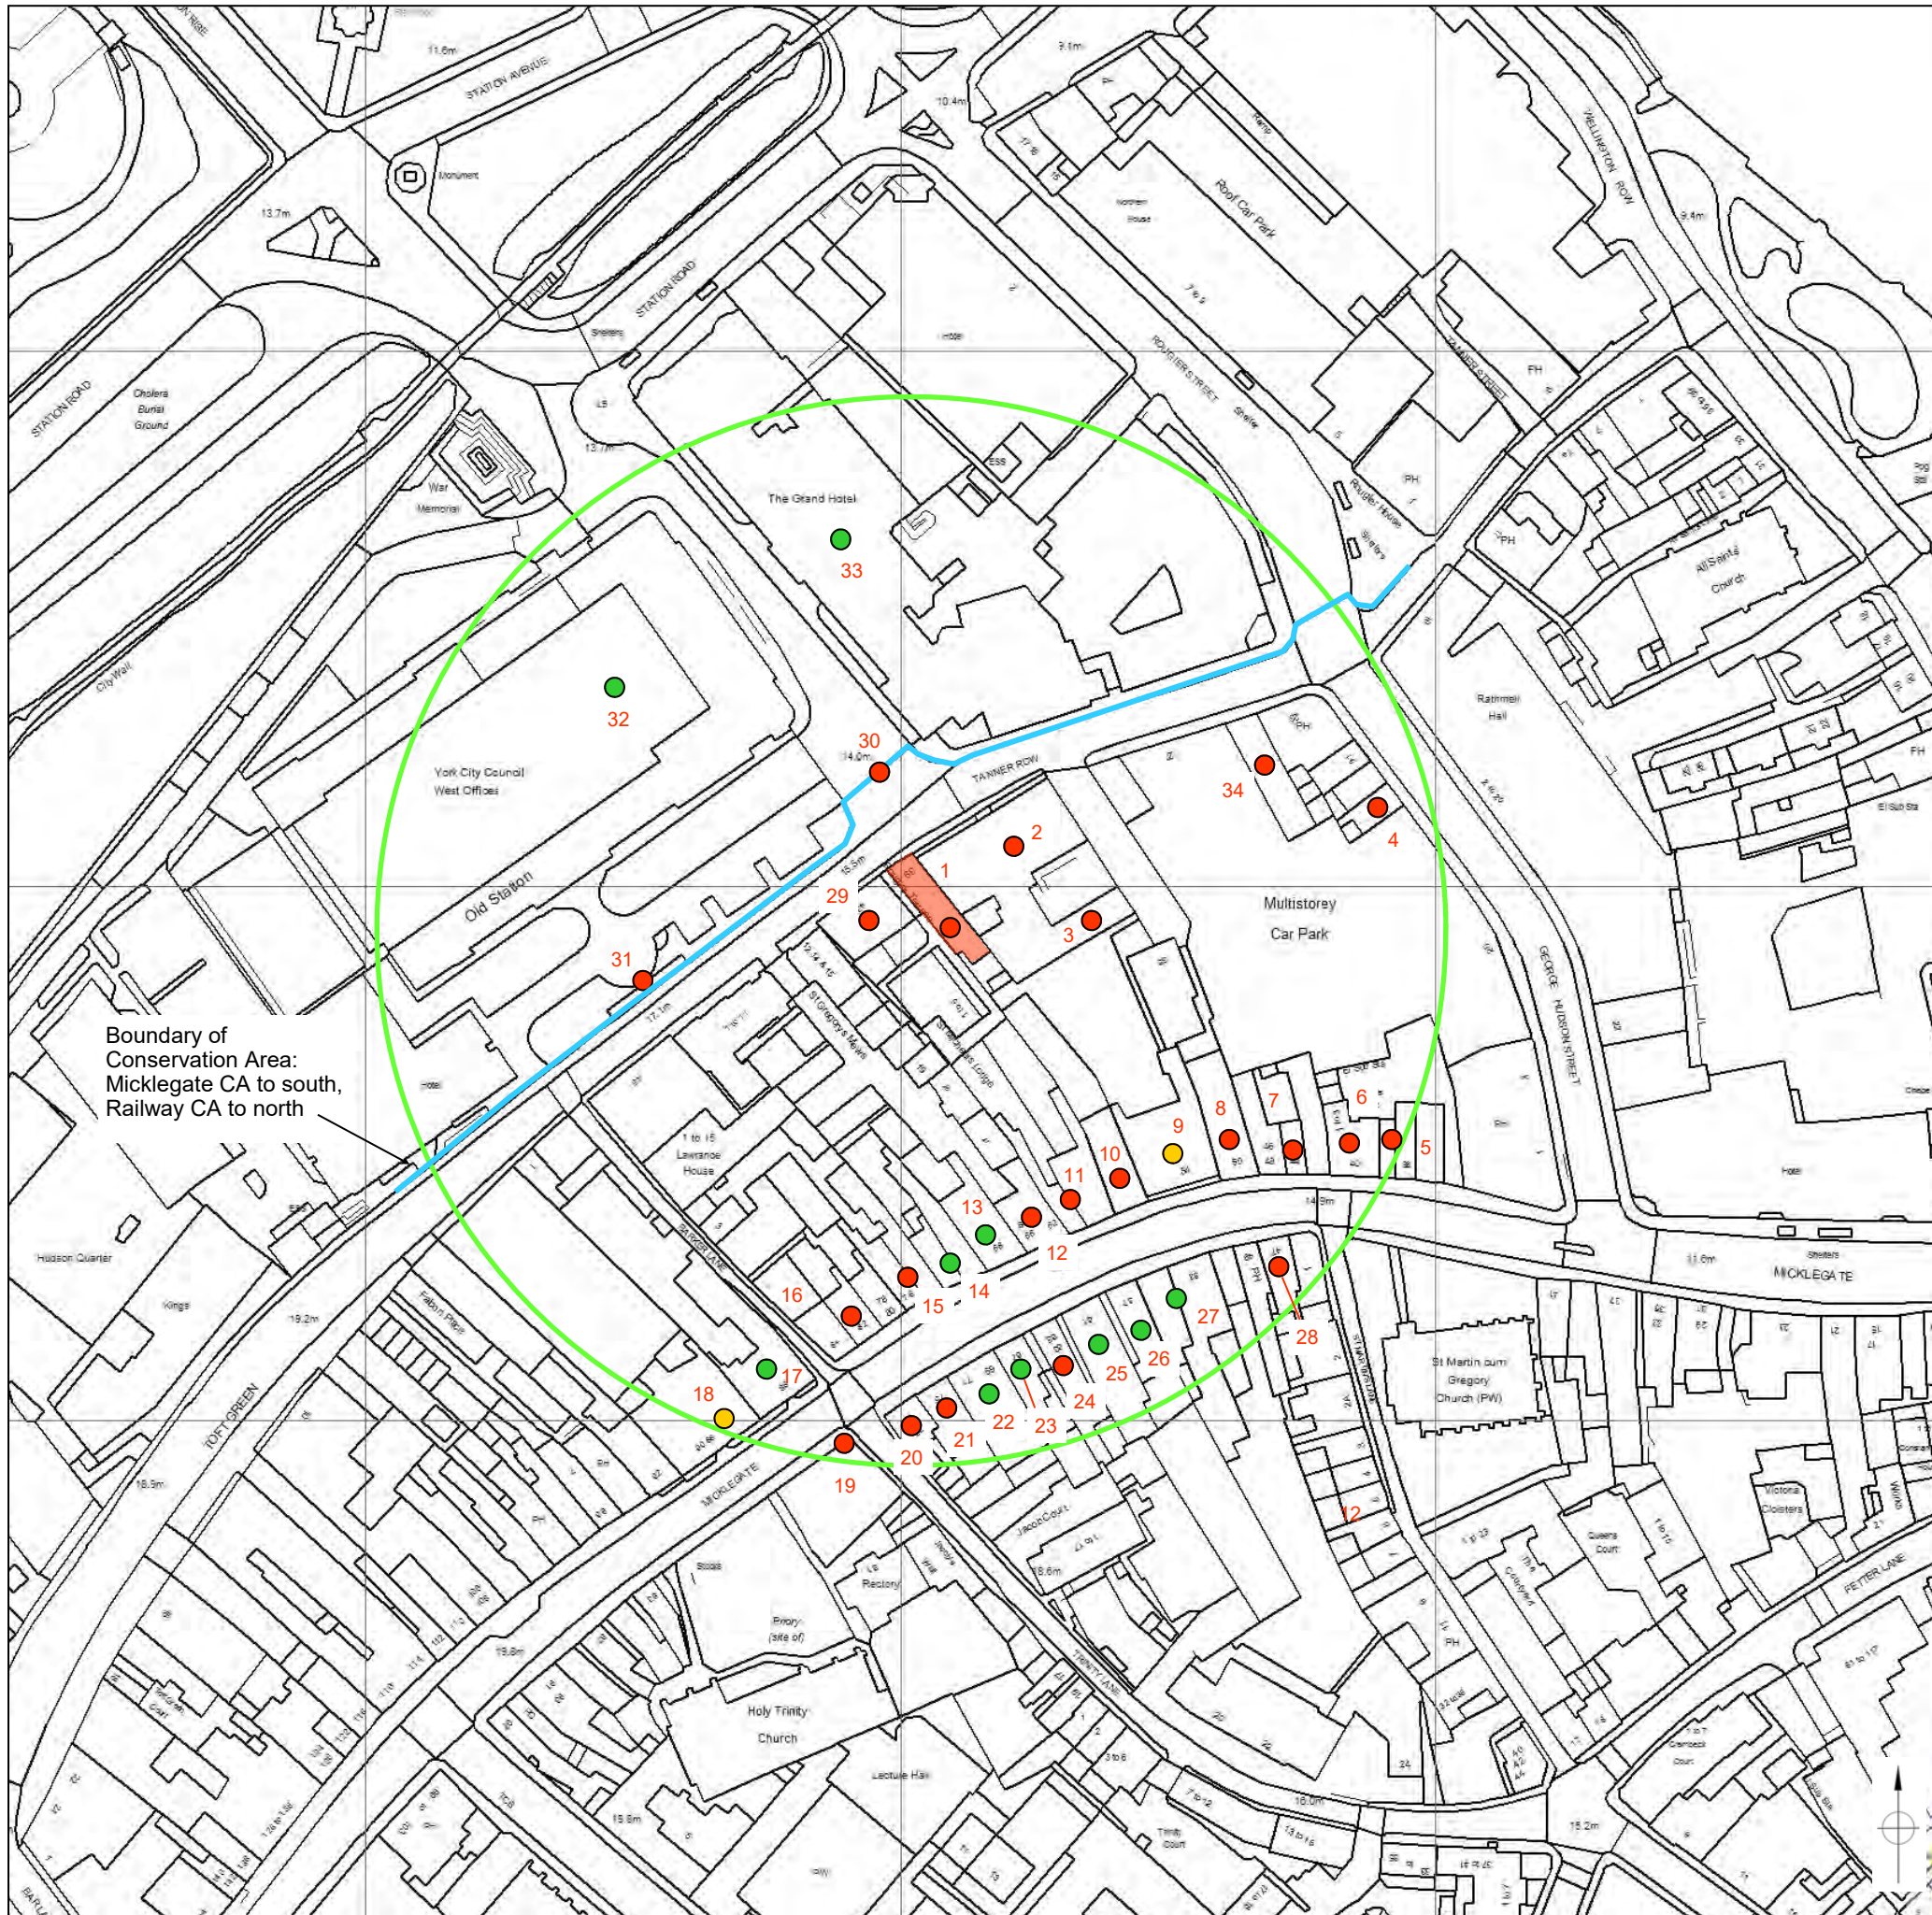
| EDAS | | FIGURE | 3 |

- Designated Assets
- Grade I Listed Buildings
 - Grade II* Listed Buildings
 - Grade II Listed Buildings
 - Boundary of Conservation Character Areas
north - Railway Area (Area 22)
south - Micklegate (Area 22)

- 3.7 As noted above, 39 Tanner Row is a Grade II Listed Building. A number of other Listed Buildings lie along Tanner Row and within the defined study area, as shown on figure 3 and listed in Appendix 1.

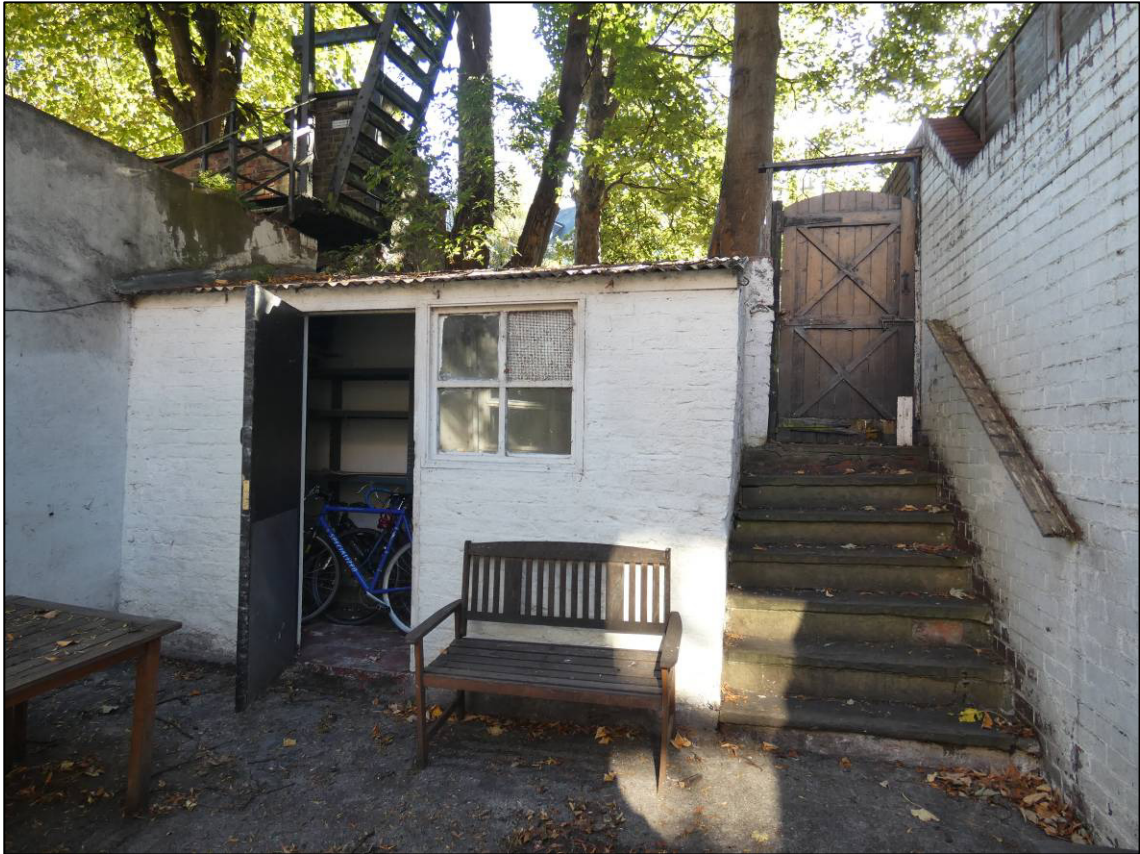
Plate 8: External store in courtyard, north elevation, looking SE (photo 1/829).

- 5.29 On the south side of the yard, there is a small detached store or shed [1/829, 1/830] (see plate 8). A building is shown in this location with the same footprint in 1891 (see figure 7B), and it may originally have housed outside W.C.'s. It replaced a similar structure shown further to the north-west in 1852 (see figure 7A), which was demolished when the rear of no. 39 was extended sometime between 1852 and 1891. It is a single storey structure, rectangular in plan, brick built and with a single pitch corrugated sheet roof sloping downwards from south to north. There is an inserted doorway and window in the north elevation. The brickwork appears to have been subject to much alteration, but has been painted, obscuring much of the structural detail; the older bricks used in the structure are handmade (average dimensions 220mm by 100mm by 65mm) and not laid in any particular bonding pattern. The interior of the structure has a concrete floor and the walls have been boarded out or rendered.

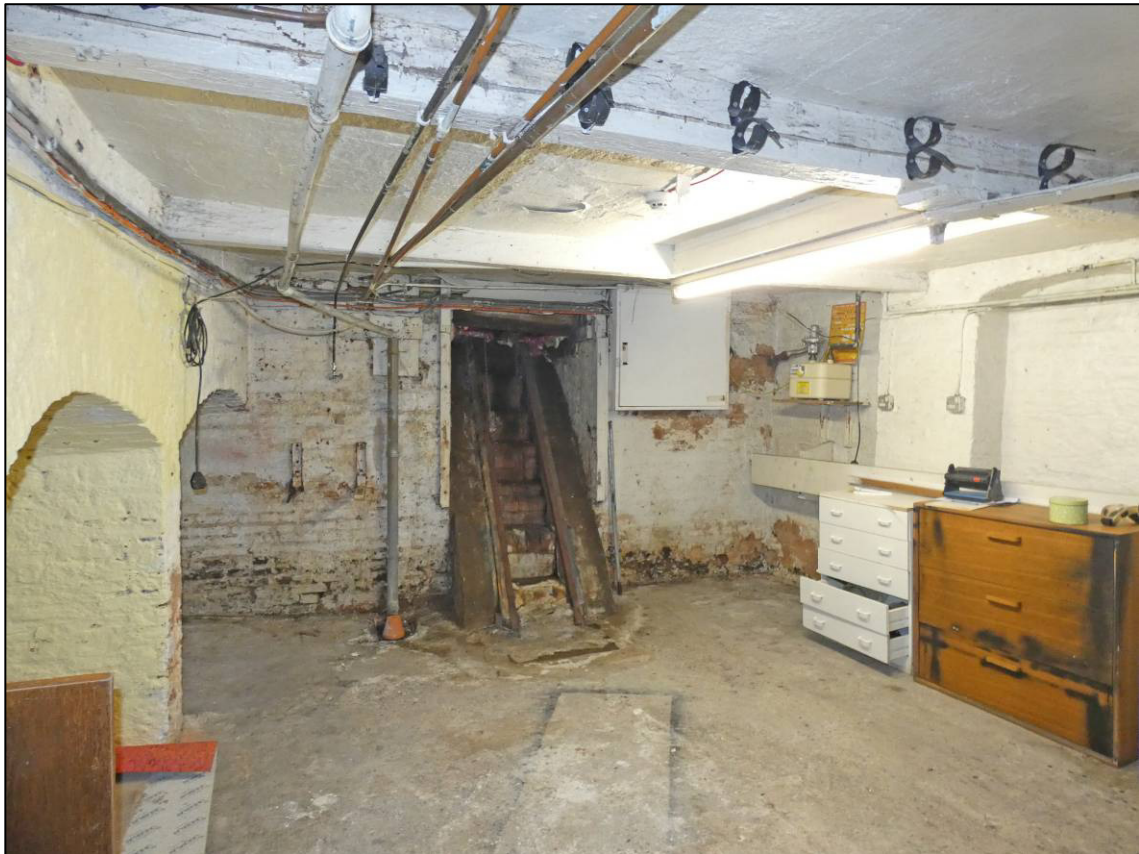
Plate 12: Cellar room B2, north wall, looking NW (photo 1/845).

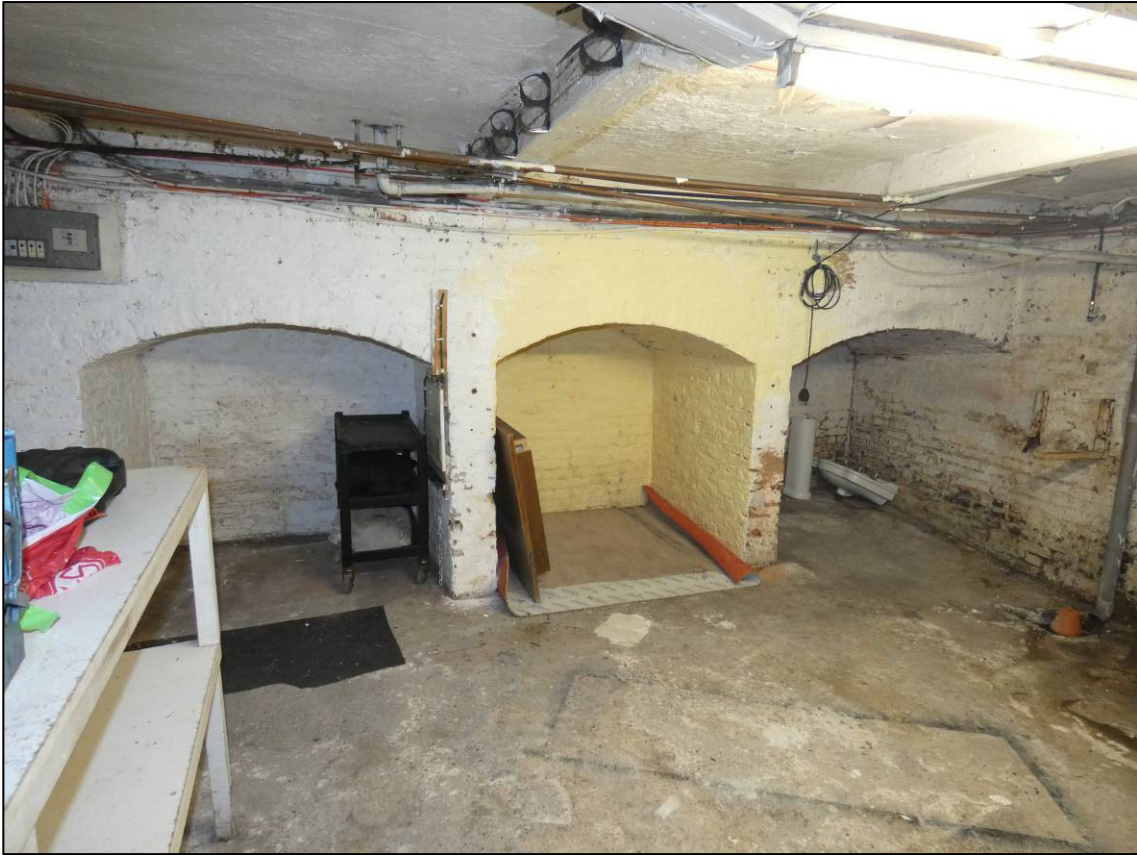
Plate 13: Cellar room B2, storage bins in west wall, looking W (photo 1/847).

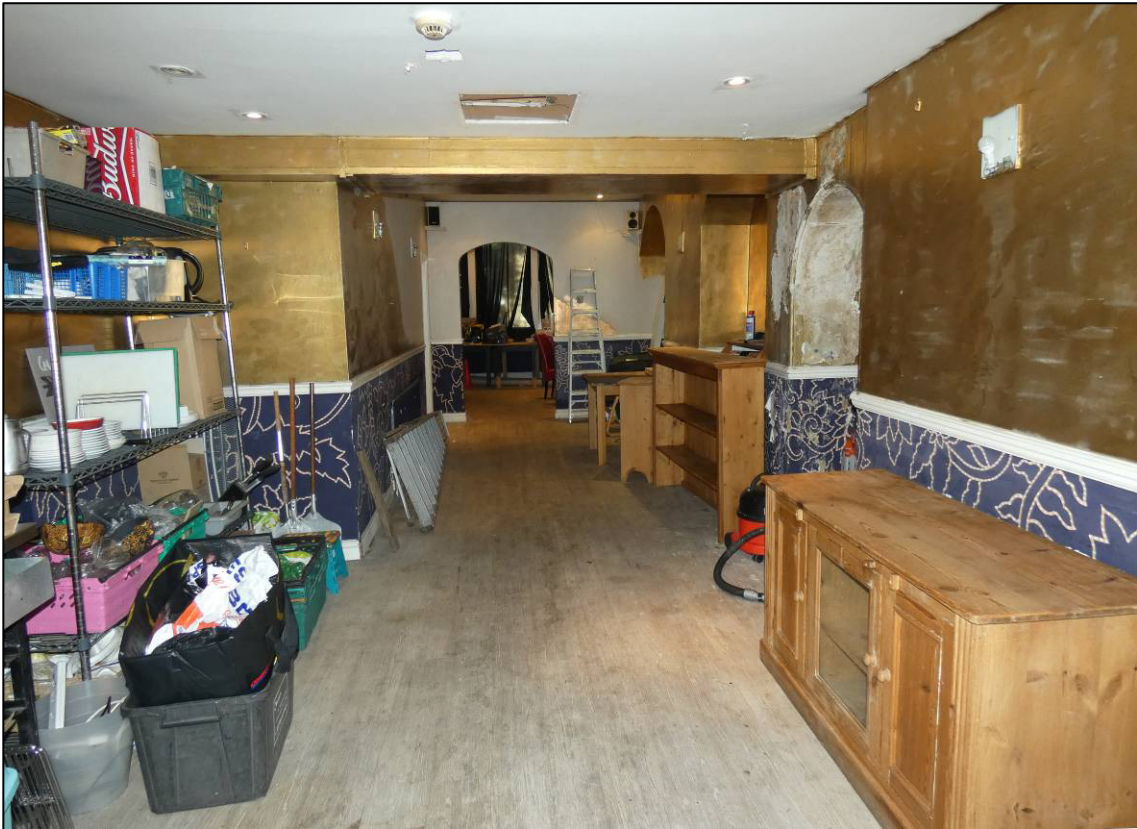
Plate 19: Room GF2, showing central ceiling beam, looking NW (photo 1/821).

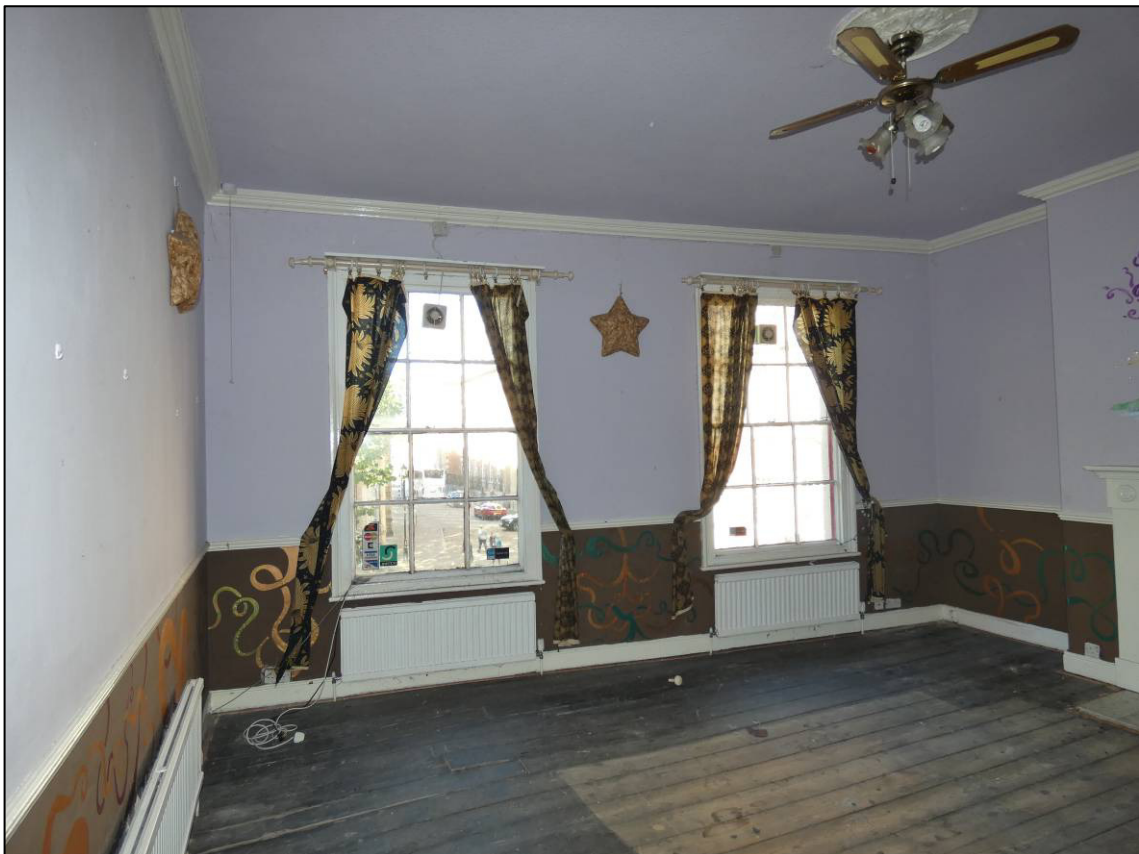
Plate 28: Room 1F2, north wall, looking N (photo 1/865).

- 5.42 The larger, north, first floor room (**1F2**) is entered through a doorway on the north side of the hall; both the doorway architrave and the door itself are modern replacements. The room is floored with east-west softwood boards (average width 0.18m) and retains its original skirting boards, dado rail and ceiling cornice [1/866]. The room was heated by a fireplace in the east wall, which retains its mid-late 19th century wooden chimney piece, comprising jambs with corner blocks (including a circular bulls-eye detail to the upper blocks) and a moulded mantel shelf [1/863] (see plate 26). A polished stone surround survives to the fireplace, within which there is a cast-iron surround to the grate [1/864] (see plate 27). However, the tiles between these two features have been painted over recently and the existing grate appears to be modern. The fireplace is flanked to the south by a low cupboard of late 19th century appearance. The room was lit by two windows in the north wall, each fitted with an original 12-pane (six over six) sash frame [1/865] (see plate 28).

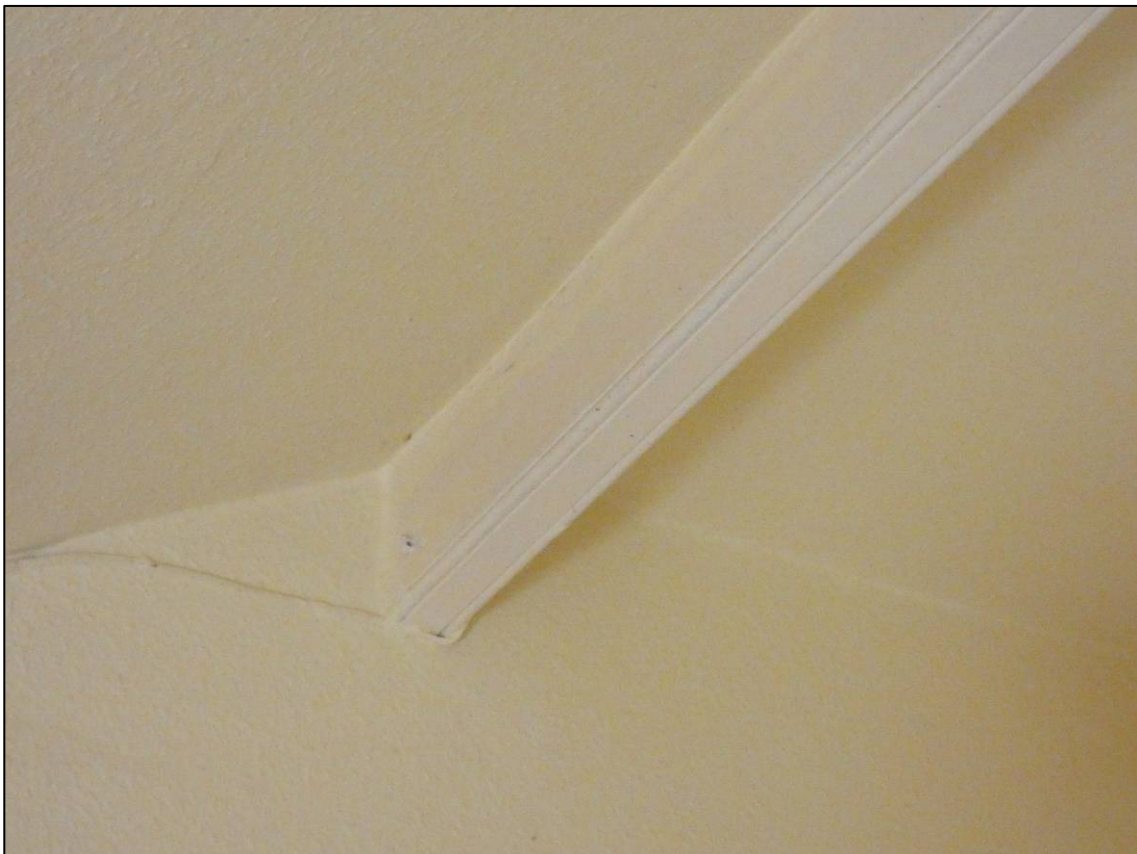
Plate 42: Room 3F4, visible part of roof truss over, looking NE (photo 1/888).
