77 Walmgate | Repairs & Alterations

Design, Access & Heritage Statement

Prepared for: York Conservation Trust
Prepared by: Dr Dav Smith, MCifA, of Maybank Building Conservation LLP
July 2024
Proposal number: 2371 - 001
Revision: REV 01 LBC

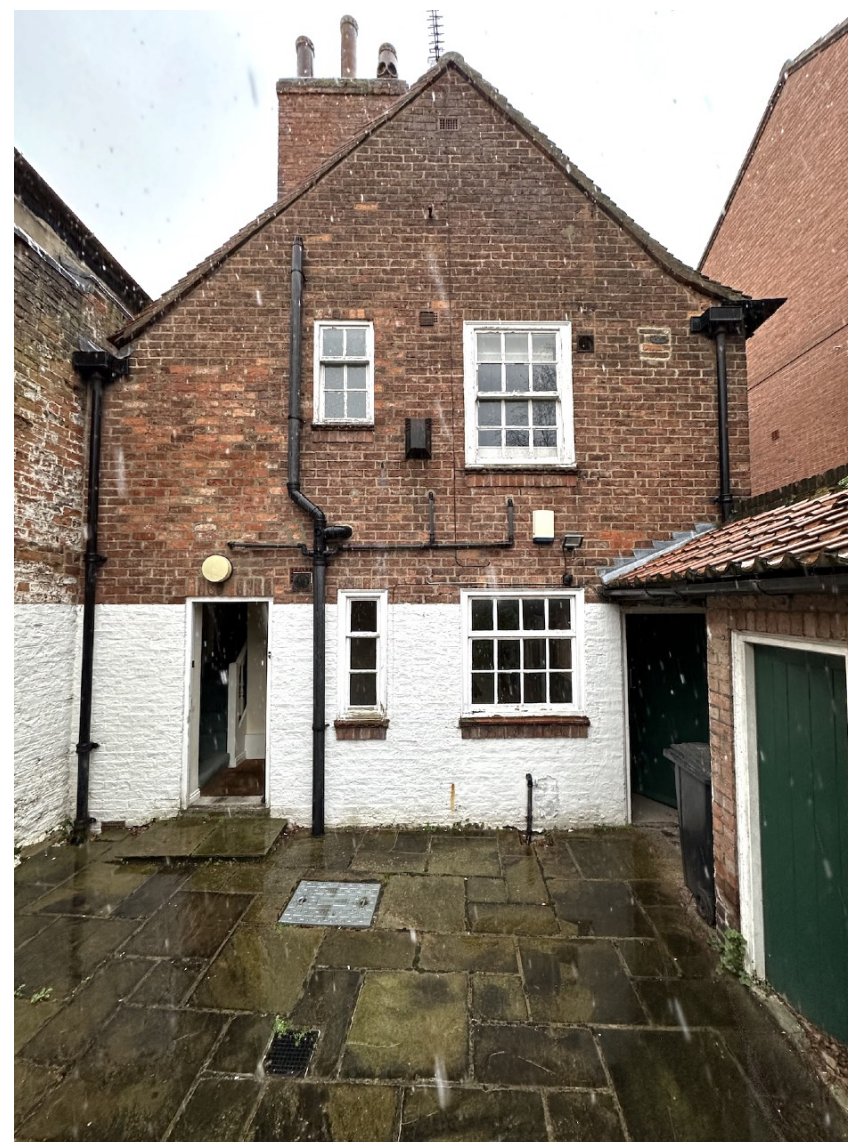
Figure 1 Existing rear elevation of no.77 Walmgate., with yard and outbuilding seen to the right.

A new gallery corridor and kitchen room extension are proposed in the rear courtyard of the site, which would connect onto the existing historic structure (fig. 1). The proposed new development would occupy an additional ~26m² of new footprint onto the existing ~59m² ground floor plan. The proposed new extension has been carefully designed to sit comfortably within its historic setting, and to be subordinate to, and clearly differentiated from, the listed building.

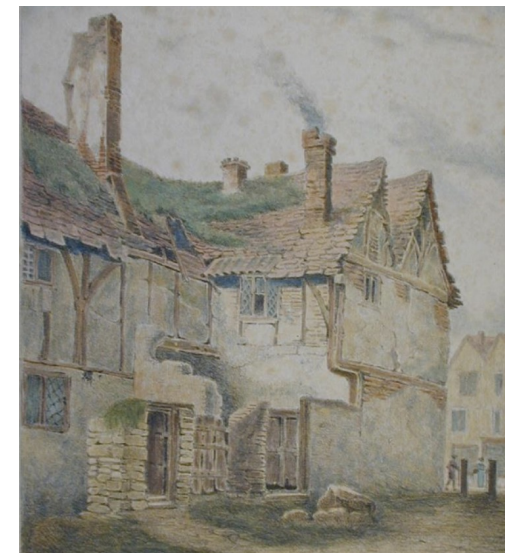
Figure 6 Example of a lost timber-framed building on Walmgate, by Henry Cave (1823) - showing its dilapidation and a common L-shaped plan with yard © YMT

- From the late 1950s there were widespread clearances along Walmgate, resulting in the loss of many of the street's historic buildings, including almost all of its timber-framed buildings (fig. 6).

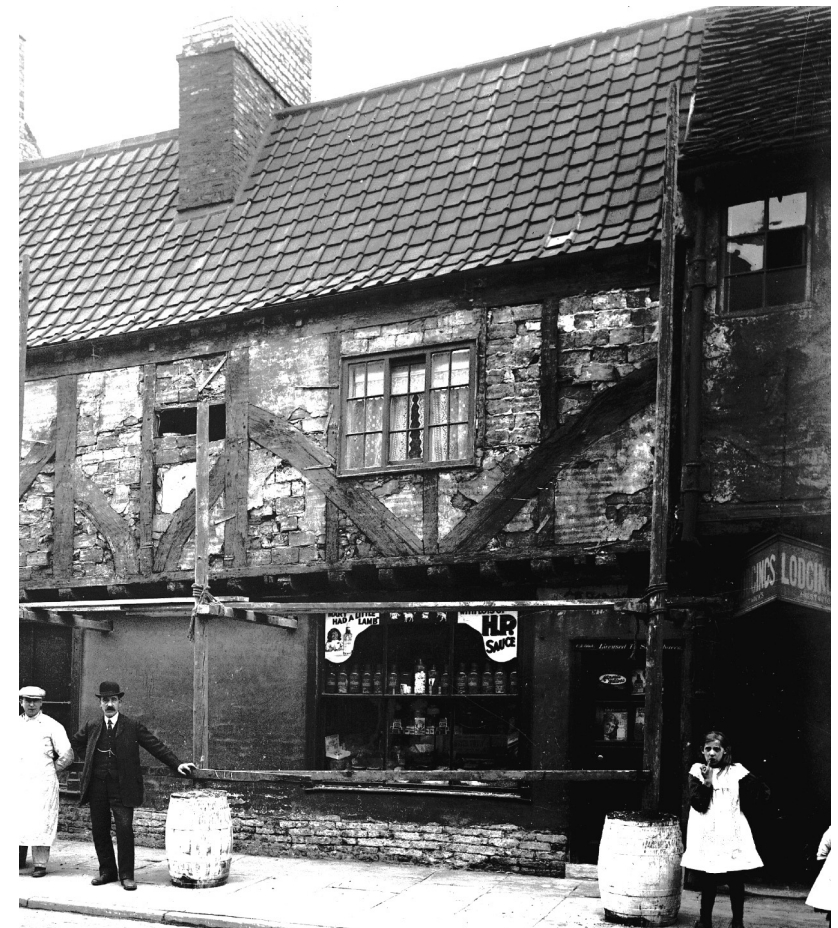
Figure 7 Photograph of 1905 showing 77-81 Walmgate, with the site seen to the far right with two girls standing outside. The timber-framed building to the left has now been demolished © York Explore 1000191

- Figure 7 is the only known image of the site prior to its C20th restoration. Seen on the far right, it reveals that the upper timber-framing had been covered with poor quality render and contained a small 6-pane casement window, seemingly with one pane missing. The front roof pitch was covered with clay tiles and there was no gutter. A sign advertising it as Hustwick's Lodging House projected above the door. Although difficult to discern, the door and doorframe appear different from those in later photos.

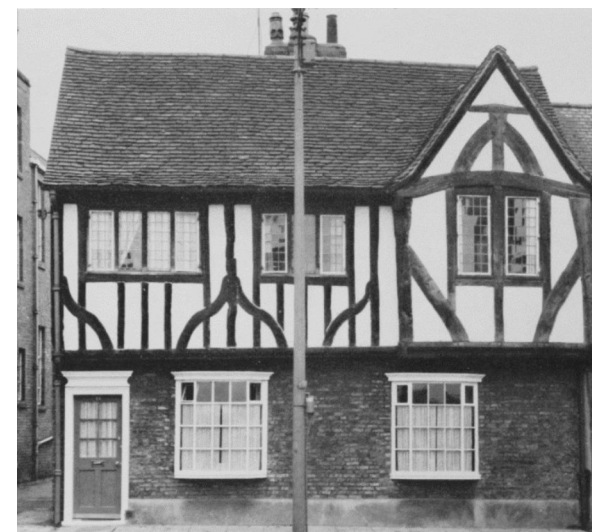
Figure 9 1970s photo showing the building following its 1930s restoration, including the new doorcase and two canted oriel windows at ground floor © RCHME.

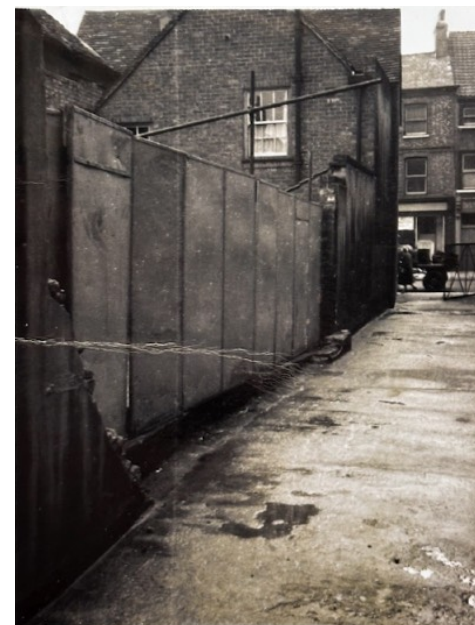
Figure 10 Photograph from June 1965 showing the side boundary wall showing the metal gate which was replaced by the existing brick wall. Photo labelled “Wall to be repaired”.

- In 1965 the boundary wall separating the rear yard from the passage to the east was rebuilt, removing a large metal gate, likely dating from the early C20th (fig. 10).

<p><i>The redundant outbuilding constructed against an earlier boundary wall.</i></p> <p>The section of boundary wall proposed for demolition dates from 1965 (see fig.10) is utilitarian in design and detailing, and does not contribute to the site's heritage values. Its replacement would not adversely affect the site's significance.</p>

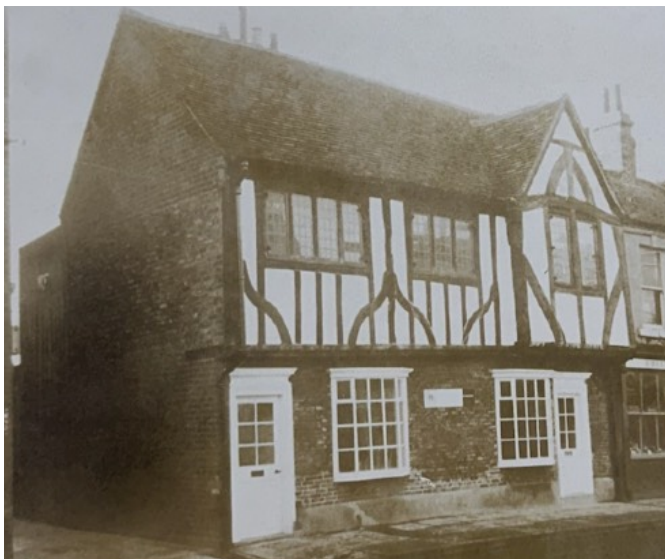
Figure 13 Photograph showing the front elevation following the 1980 alterations to form 2no. shops.

- In 1980 no.77 Walmgate was altered significantly to form 2no. shops with an upstairs flat (fig. 11). These works included alterations to the staircase, and the addition of a new doorway through the western end of the front elevation. Other works to the ground floor included the insertion of concrete floors, the addition of a stud wall with door to form a separate kitchen and passageway, and alterations and replacement of the rear entrance door. At first floor a new bathroom was added, an existing first floor rear window was infilled and a new bathroom window inserted (fig. 12), the lean to roof was replaced at the rear, and a new internal doorway was inserted through the rear timber framing to the new kitchen.
- The site following the 1980 alterations can be seen in a photo taken that year, showing the inserted western door (to far right) (fig. 13).

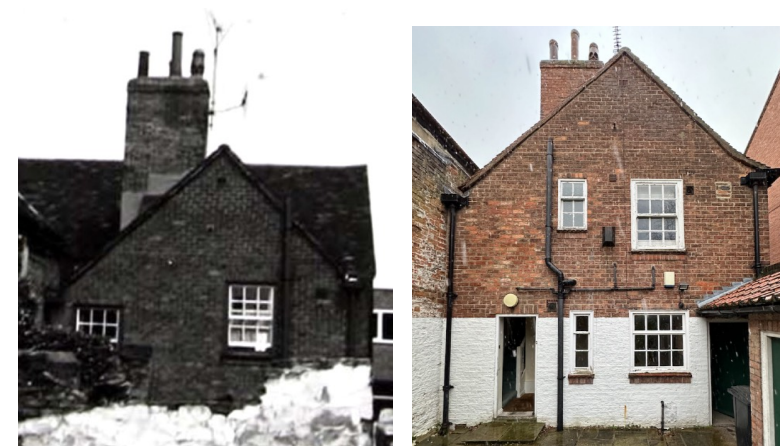
Figure 12 Left - 1971 photo showing the rear elevation and yard. Note the 1935 stair window on the left, prior to its infilling and creation of new bathroom window in 1980 (seen on current photo right).

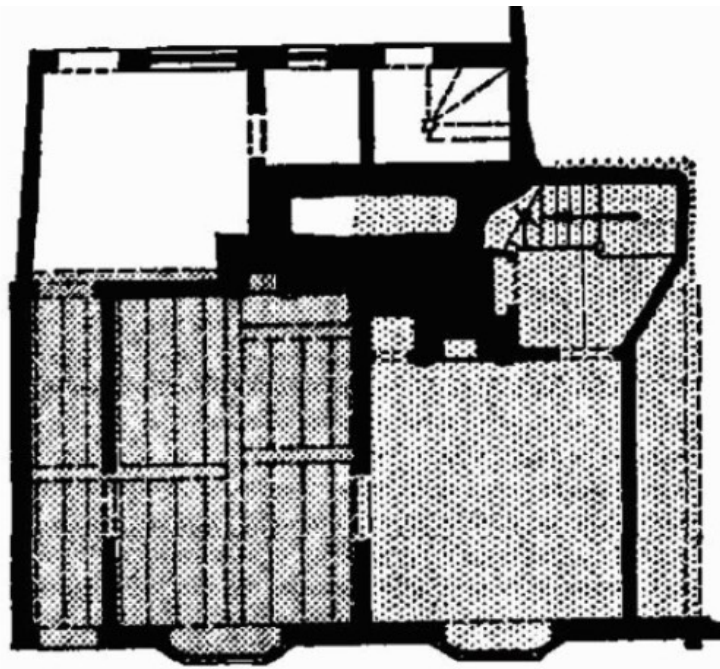
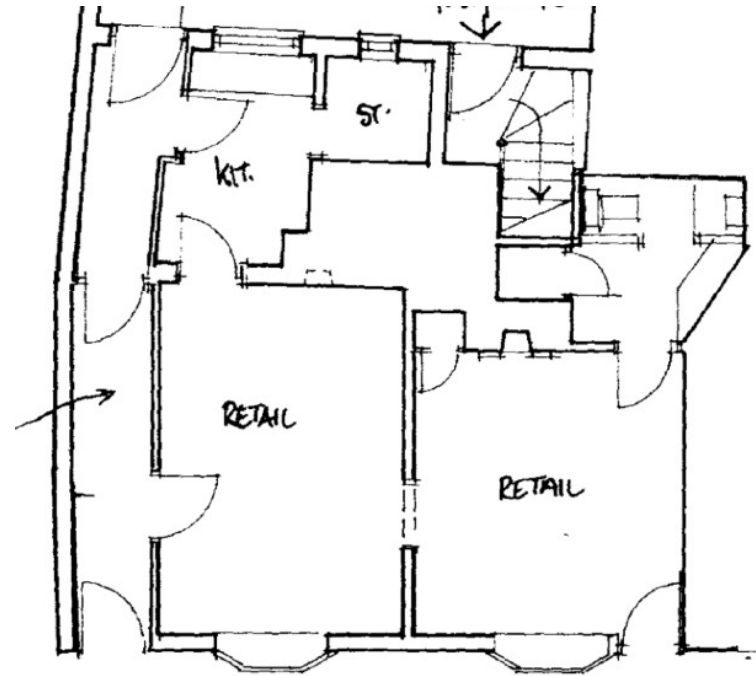
Figure 14 Left - RCHME ground floor plan of c.1971; and Right - 2003 floor plan showing evolution of the ground floor plan across the later C20th, including the enclosing at the rear to form the present passage.

- In the later 1980s the plain tile roofing was replaced, with the works being partially funded by the City of York Council.
- Consent was granted in 2003 (03/02013/LBC) to convert the ground floor retail space to a domestic flat, with the work being carried out in 2005. These works included the infilling of the western doorway (inserted in 1980), the replacement of the ground floor canted oriel windows with new oak oriel windows. Minor internal alterations were made to provide a new kitchen and bathroom for the ground floor flat. The doorway between the ground floor kitchen and passage (inserted in 1980) was removed and infilled (fig. 14).

The stepped partition wall proposed for removal was inserted in 1980 and its doorway was infilled in 2005, when the present kitchen was created (see figs. 11 & 14). This space is today poorly lit, awkwardly arranged, and no longer fit for purpose. The small wall separating the stairwell dates from 1935-36, although the stairwell was substantially altered in 1980. The opening up of this area to create a new Dining Room will allow this space to be more effectively utilised without adversely affecting the site's heritage values.

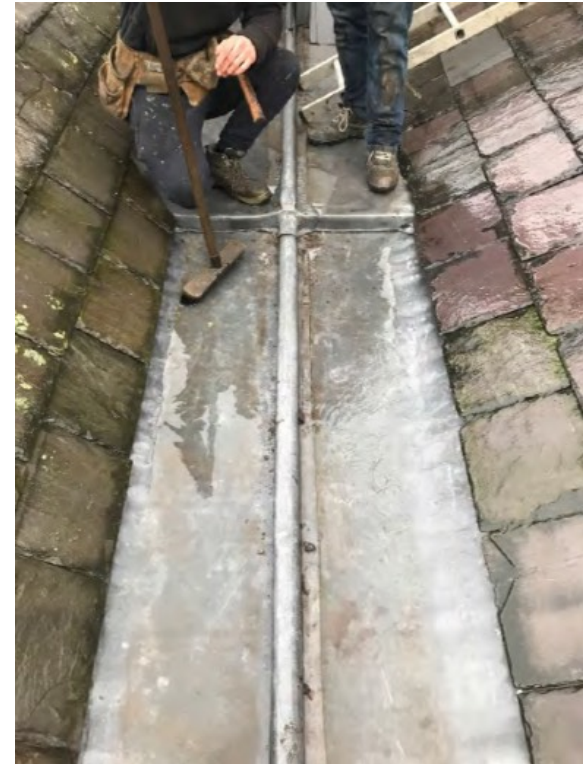
MAINTENANCE Example of valley gutter cleaning at York Theatre Royal, this needs to be undertaken on a 3-month cycle.

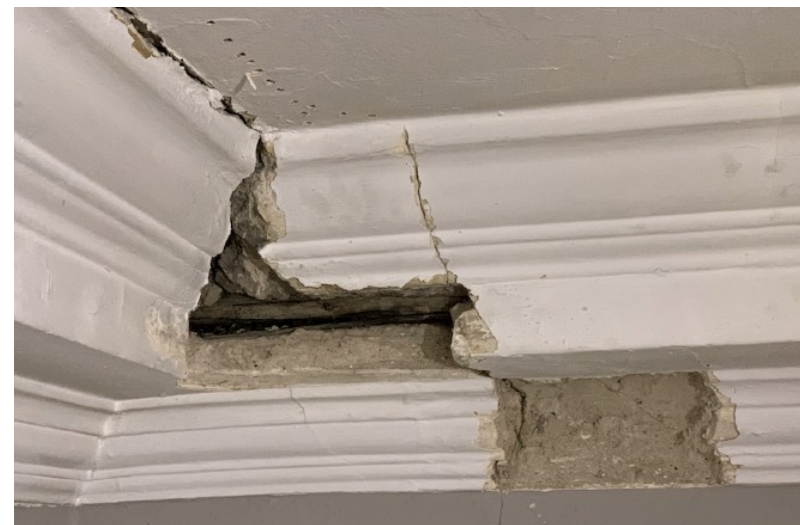
REPAIRS Example of plasterwork repairs to the North Anteroom cornice and ceiling in the Assembly Rooms. Damage has been raked out ready to hand run new lime hair plaster.

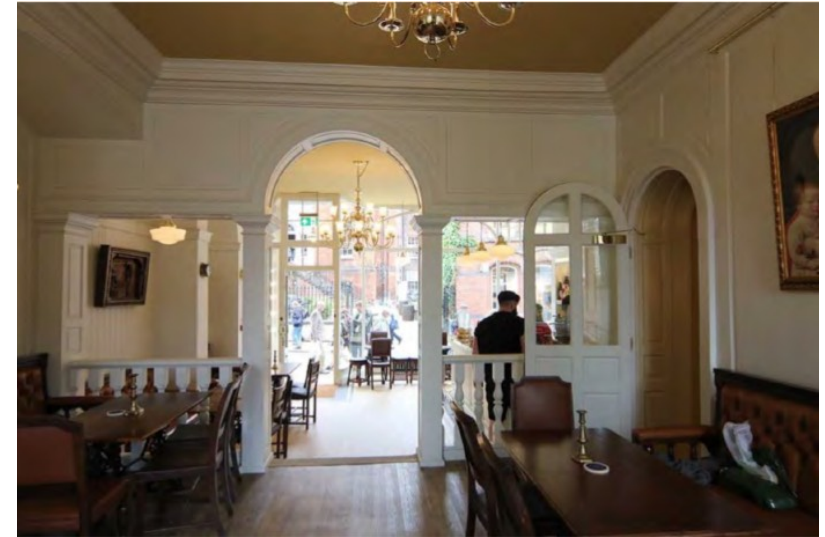
RESTORATION Archway restored to ground floor of 14 Lendal. New timberwork made to exactly replicate the original fabric by tracing their outline in the original paintwork

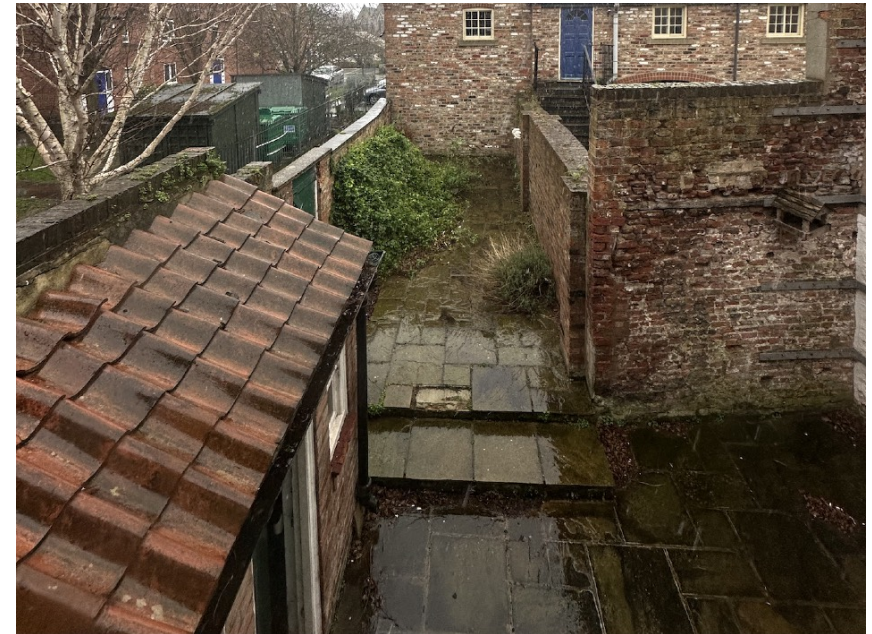
Figure 15 Rear yard with its raised steps to back portion, and lean to outbuilding.

0.02	Lower ground level in rear yard, replacing existing drainage system Lower rear courtyard surface level by approx. 180mm, and excavate proposed new internal floor levels to a maximum depth of 700mm below existing. Pave new external courtyard space with 'Marshalls' Tegula 60mm block paviors in Pennant Grey (fig. 16), and provide new semi-mature ornamental tree. Replace rear external drainage system, providing new stainless steel manhole cover with paving block infill.

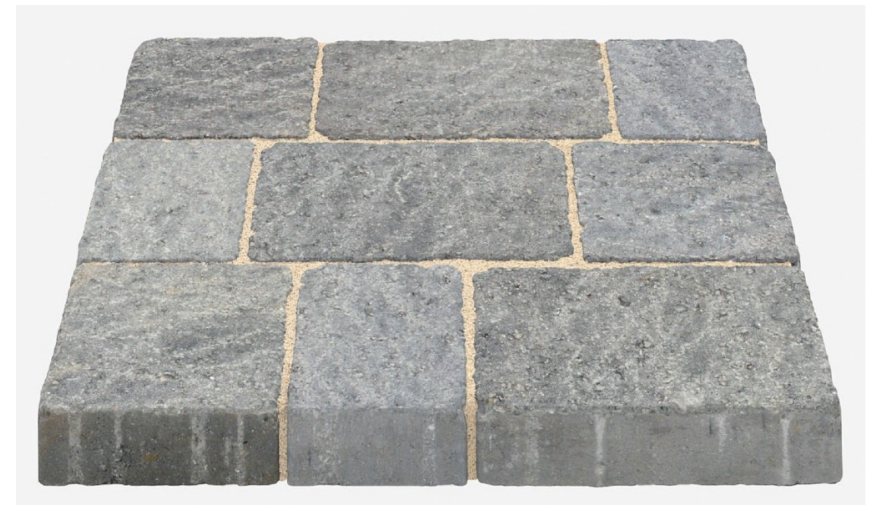
Figure 16 'Marshall' Tegula 60mm block paviors in Pennant Grey

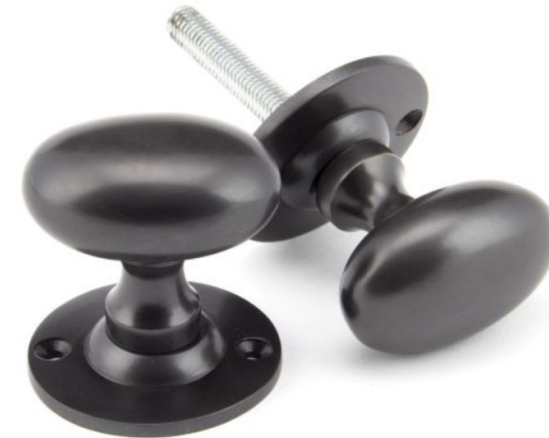
Figure 17 Proposed 'Anvil' Beeswax Regency Aged Bronze Oval door knob (91976).

1.03	Redecorate internal doors / change ironmongery
	Existing internal doors DG04 - 10 and DF01 - 04 to be prepared and redecorated. Doors to be provided with new door furniture as required, all from the 'Anvil' Aged Bronze range (fig. 17). See door schedule for proposed works.

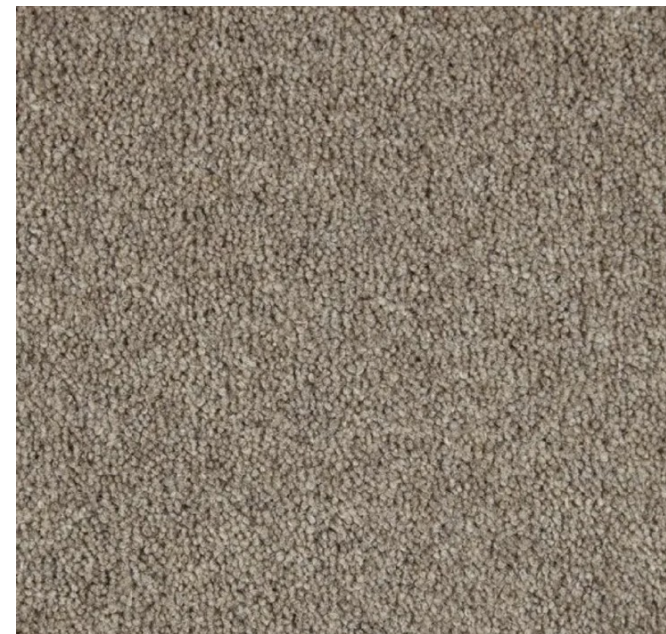
Figure 18 'Kingsmead' Wool Twist Weald Park carpet, colour Ash.

1.04	Provide new floor coverings
	New floor coverings, including 'Kingsmead' Wool Twist Weald Park carpet, colour Ash (including FF bedrooms, dining room & hall) (fig. 18), and 'Polyflor' Polysafe PUR range non-slip vinyl flooring to kitchen / bathrooms.

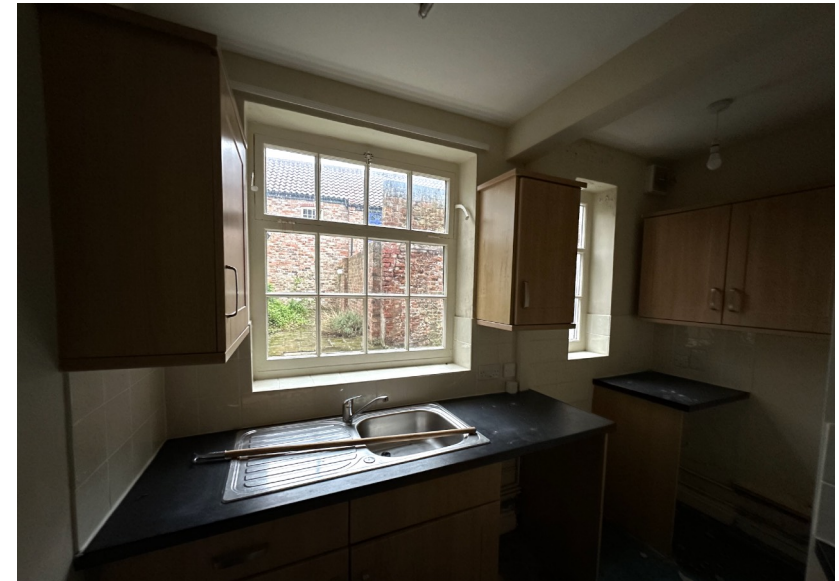
Figure 19 Present GF kitchen and 1930s windows in rear elevation proposed for removal.

2.03	Form new opening in GF rear wall
	Remove existing kitchen windows (VWG03 & 04) together with surrounding GF brickwork wall to form new large opening in rear wall. Opening to be filled with new 'Touchstone' Steelyte powder-coated stainless-steel double-glazed double doors with side lights (fig. 20). Lintels to be pre-stressed concrete internally, and soldier brick with stainless steel L-strip lintel externally.

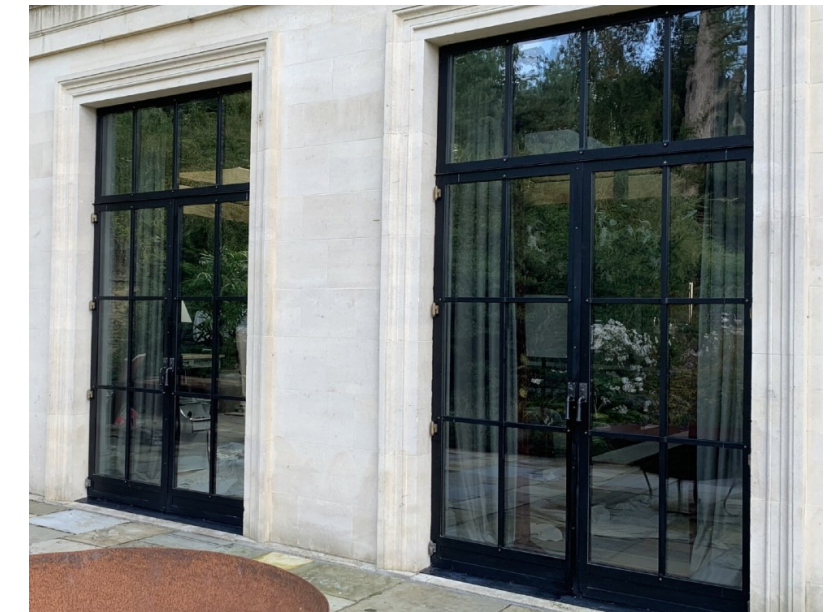
Figure 20 Examples of 'Touchstone' stainless steel double-glazed doors.

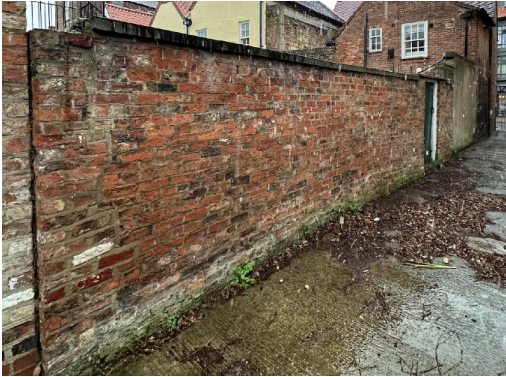
<p><i>The present side boundary wall, viewed from the lane and dating from 1965.</i></p>

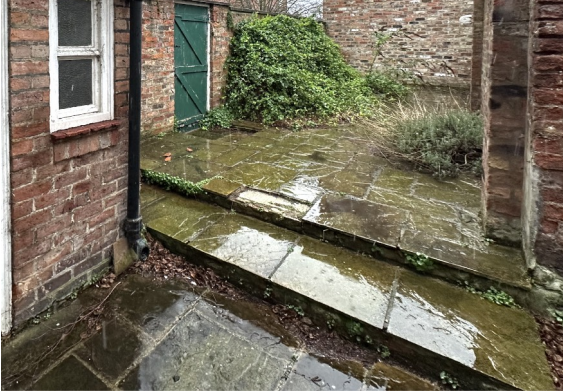
<p><i>The present un-utilised rear yard with its C20th paving and varying levels.</i></p>
<p>0.03 Construct new gallery corridor and rear extension range to form courtyard</p>	<p>Low Underutilised rear yard with 1965-1980 paving</p>	<p>Major New development infilling part of the yard</p>	<p>Slight / Moderate</p>	<p>Presently empty, the owners have been informed by their estate agents that the first floor 1-bed flat is now untenable due to inadequate safe egress in the event of fire. Considerable efforts have been made to design an improved fire safety solution within the present footprint, however all were found to represent significant harm to the Grade II*.</p> <p>The property has undergone numerous changes since its restoration in the mid 1930s, driven by changing ways of living and the challenges of occupying the building. The conversion of the site from residential to retail, and then back to residential, were prompted by difficulty finding tenants, and the limited viability (both commercially and residentially) of the location following the C20th slum clearances along Walmgate.</p> <p>The character of the street has, however, changed in the past decade and this site now stands as one of the finest historic frontages in an up and coming area of the city. The opportunity therefore exists to convert this site into a high quality family home that can make full use of the historic spaces. Such a change is deemed necessary to ensure the long term optimal viable use of the site, by securing good residential tenants at a rental income that will help maintain the historic fabric. The proposed rear extension has been very carefully designed to have minimal impact on the historic fabric, and would be clearly subservient to the listed building. The new work has been designed to have minimal visible impact within the wider streetscape. Further, the creation of a new kitchen</p>

<p>0.02 Lower ground level in rear yard, replacing existing drainage system</p>	<p>Negligible Mid C20th paving and levels</p>	<p>Moderate Loss of paving and lowering of levels</p>	<p>Neutral / Slight</p>	<p>The present arrangement of the rear yard largely dates from 1965, when the boundary wall was reconstructed and earlier gates removed. The yard was further altered in 1980, when two outbuildings were demolished, and the step to door DG03 was added. The lack of stratigraphy suggests the current paving post-dates or was part of that 1980 work. The below ground surfaces are likely to have been heavily disturbed by the various C20th alterations, although an archaeological watching brief during excavation works would enable documentation of any surviving archaeological finds or features.</p>

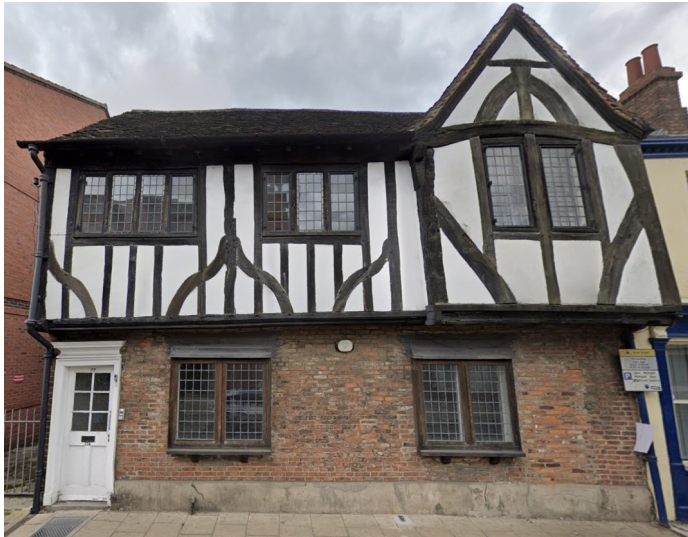
<p><i>Front elevation showing the exposed timber framing and infill panels at FF level.</i></p>

0.04 Redecorate external timberwork	<p>High Late medieval / early modern timber framing, and 2005 windows</p>	<p>Negligible Redecoration only (beneficial)</p>	<p>Slight</p>	<p>The unpainted C15th-C16th timber framing was exposed and extensively restored in 1935-36, while the GF oriel windows date from 2005. All have been previously treated with wood stains. The proposed redecoration is required as part of ongoing cyclical maintenance, and would help ensure the long term preservation of the timberwork. This proposed work would help maintain both evidential and aesthetic heritage values, and is argued to be beneficial.</p>

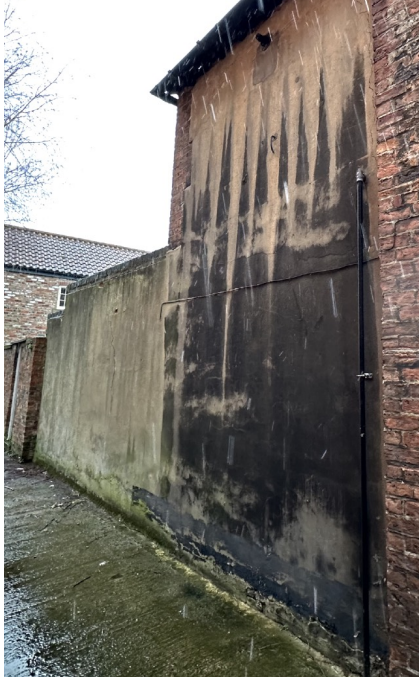
<p><i>The 1930s cementitious render has been badly stained by pollution and is an inappropriate material for historic buildings.</i></p>

<p>0.06 Replace external cementitious render</p>	<p>Negligible / Intrusive Undecorated C20th render</p>	<p>Minor Positive change</p>	<p>Neutral / Slight</p>	<p>The present undecorated cementitious render is unsightly, being increasingly stained by pollution. This is an inappropriate material for an historic building, which is helping to trap moisture within the fabric. Its replacement with traditional 3-coat 'Hot Lime' plaster would help preserve the fabric behind (evidential value). The proposed render would be finished raw, with aggregates carefully selected to achieve an authentic and appropriate 'honey-coloured natural finish'. It is argued that this change to a more appropriate material would improve the site's aesthetic value, thus helping to better reveal the site's significance.</p>

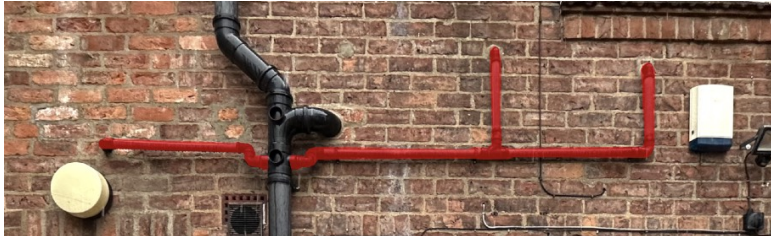
<p><i>Redundant ancillary pipework (red) proposed for removal.</i></p>
<p>1.01 Redecorate Internal Walls and Ceilings</p>	<p>Low Plain C20th plasterwork, apart from historic moulded cornice in GF bedroom.</p>	<p>Negligible Redecoration only (beneficial)</p>	<p>Neutral / Slight</p>	<p>The proposed redecoration is required as part of cyclical maintenance. The use of good quality paints in an appropriate heritage colour would improve the appearance of the historic interiors, better revealing aesthetic heritage value, and thus is argued to be beneficial. Please note that no work is proposed to the historic panelling in the GF Bedroom, or to the painted fireplaces, or unpainted timber framing.</p>

<p>0.08 Remove redundant pipework</p>	<p>Negligible / Intrusive Redundant 1980s ancillary pipework</p>	<p>Negligible Positive change</p>	<p>Neutral</p>	<p>The smaller ancillary pipework associated with the present 1980 FF bathroom and kitchen would no longer be required. Its removal and quality repair of the brickwork is argued to have a beneficial impact on the site's aesthetic value and would thus be a positive change.</p>

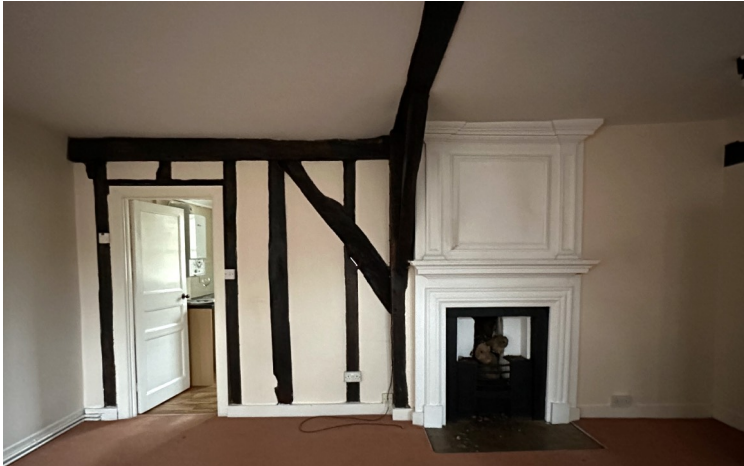
<p><i>FF Room requiring redecoration of plasterwork to walls and ceiling.</i></p>

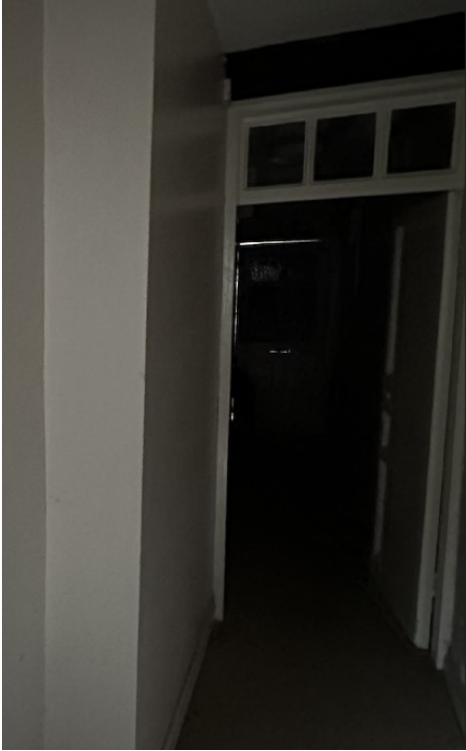
<p><i>Looking down the current hall through door DG04 towards the front door.</i></p>

<p>2.01 Form new Cloak Room</p>	<p>Medium Historic passage through the C16th hall range</p>	<p>Moderate Subdivision of historic space</p>	<p>Moderate</p>	<p>The proposed dividing of the current front hall with 2no. stud partition walls is required to create a working floor plan within the proposed layout, providing a much needed cloak room and boiler cupboard. These add functionality to an otherwise dark and underused area, and will provide new storage spaces in which modern servicing can be hidden, including the combi-boiler, distribution board, meters etc. The historic plan would still be readable through the exposed ceiling joists running through above, reducing harm to the legibility of the historic arrangement. Having served numerous purposes and having already had its plan form altered numerous times over the past century, it is argued that this intervention represents less than substantial harm. The requirement to create a working layout within a comfortable family home is essential to secure the optimal viable future of this building, which requires significant funds for its long term maintenance.</p>

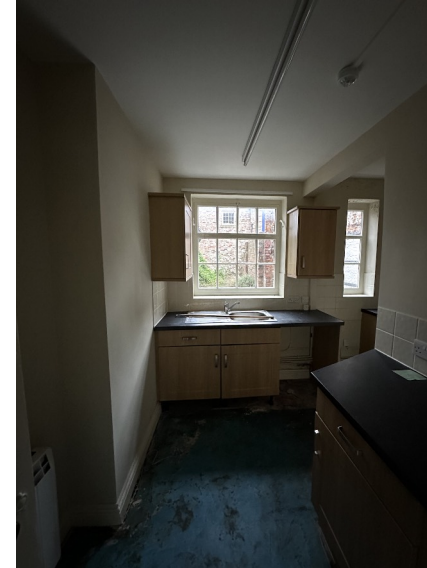
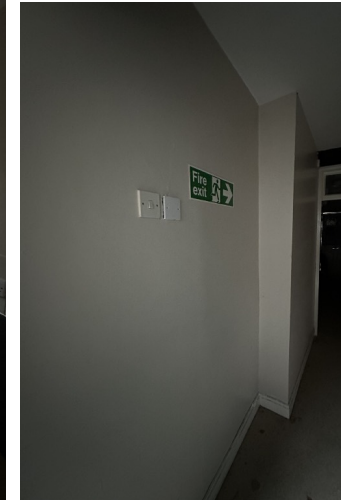
GF flat kitchen with 1980 stepped partition wall seen on left; and the same wall seen from the hall, where the line of the infilled doorway can be seen below the fire exit sign.

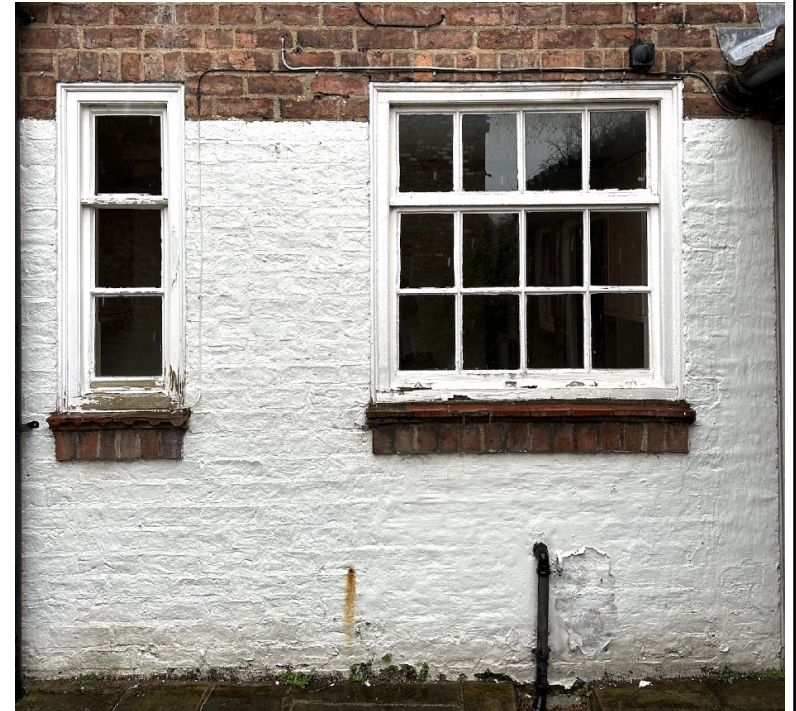
The 1935-36 rear cavity brick wall with deteriorating GF casement window.

The present rear brick wall dates from the 1935-36 remodelling, and at ground floor includes a 4/8 casement window with top opening light and a 3-light fixed casement window. The painted wall has suffered from damp ingress and both windows are now in poor condition, with significant rot to both frames. The internal floor plan has changed significantly, and improved natural lighting is now required to better utilise the space. The proposed new doors would provide illumination and access, while retaining good thermal values. It would also provide views into the proposed new courtyard, and represents an important design element of this high-quality family home. It is argued that this small loss of 1930s fabric represents less than substantial harm and is required to facilitate the optimum viable use of the property.

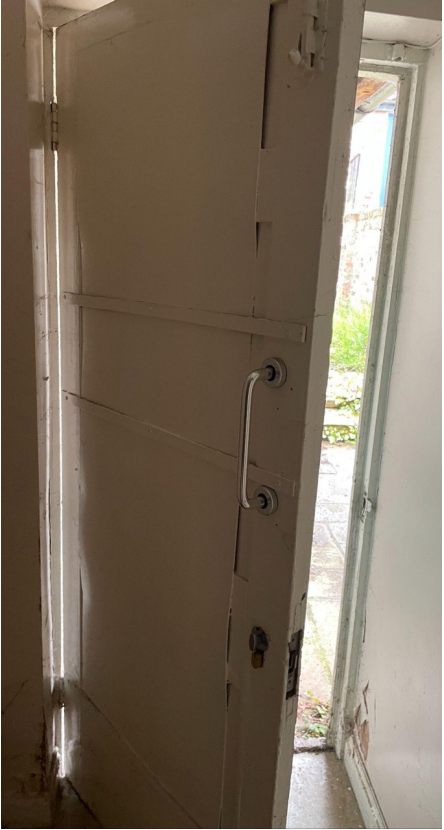
<p><i>Door DG02 dates from the 1930s restoration. Note the internal straps and overboarding, as well as later door furniture.</i></p>

<p>2.04 Remove external door (DG02)</p>	<p>Low Three-panel exterior door from 1935-36, now in relatively poor condition</p>	<p>Major Removal of door and frame</p>	<p>Slight / Moderate</p>	<p>This three-panel door (DG02) dates from the 1935-36 restoration work and does not sit within a proper frame with architraves. The door is not in good condition and has been cheaply boarded and strapped internally. With the proposed gallery extension, this door would become redundant, and it is argued that its loss represents less than substantial harm to the significance of the site. A matching adjacent internal door (DG04) is to be retained. This harm is required in order to achieve the optimal viable use of the site in order to preserve its long term viability.</p>

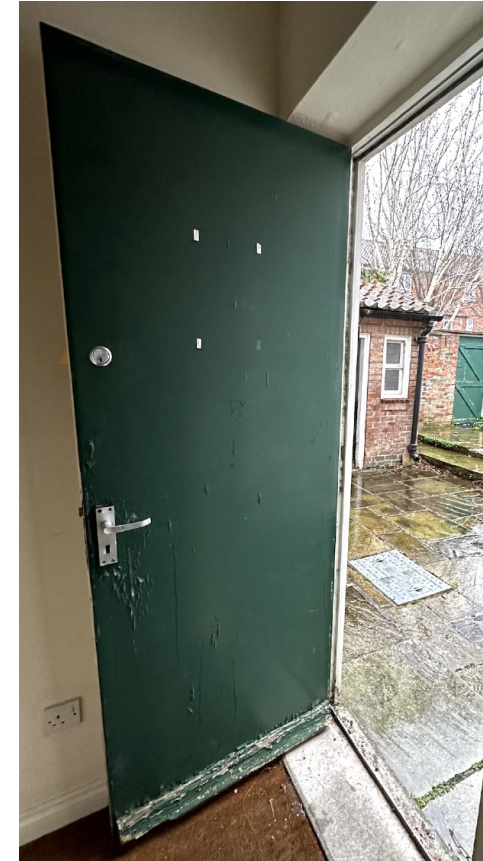
A poor-quality and inappropriate flush panel door installed in 1980.

This is a modern flush-panel door and frame (DG03) installed in 1980, which is inappropriate to the significance of the historic building and is reaching the end of its lifespan. Its proposed replacement with a new double-glazed stainless steel door is argued to represent a visual improvement. A double-glazed door would also improve the site's thermal performance and increase the provision of natural lighting into the staircase. Although the proposed new door is of modern design, it is proposed to be located within a C20th wall, and would help bring cohesion to the proposed rear courtyard design.

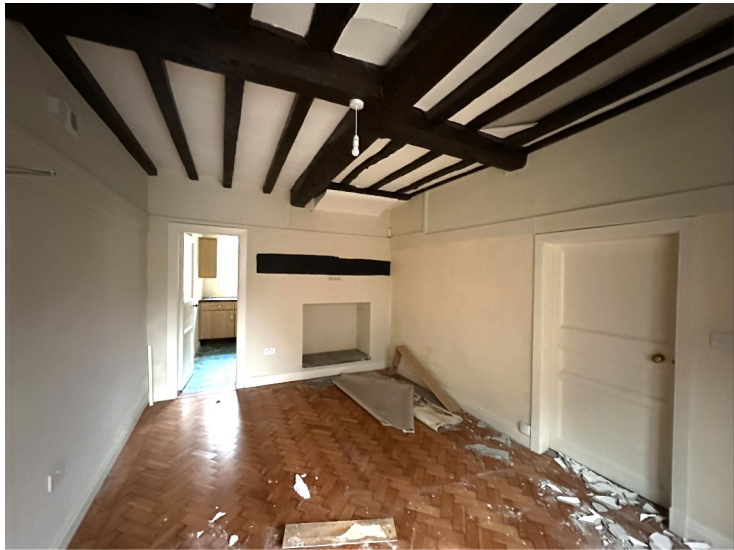
<p><i>Failing plasterwork between ceiling joists, with fallen plaster seen on the floor below.</i></p>

2.07	Replace plaster ceiling to Living Room
	Remove existing modern plaster skimmed finished between timber joists. Re-line between joists with 10mm 'Gyproc' Glasroc F board cut to fit and securely screwed in place before being finished and decorated as per Item 1.01.

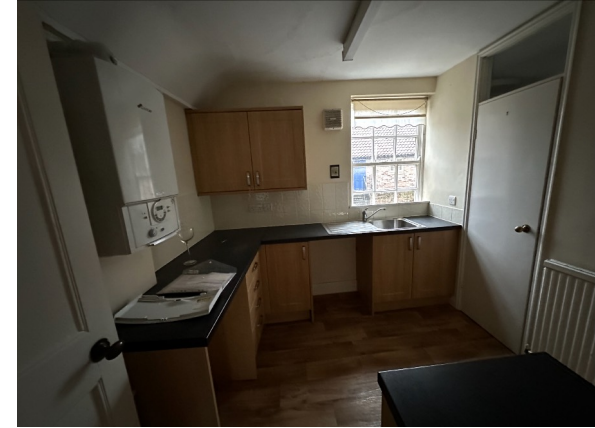
Redundant FF kitchen with bathroom beyond - a spatial arrangement created in 1980.

The present FF kitchen and bathroom arrangement result from the 1980 remodelling of the 1930s rear extension. These were formed when the site was altered to provide a separate FF flat, but the kitchen would become redundant under the proposed conversion to a single family home. The proposed removal of the 1980 partition walls and bathroom extension over the historic staircase, would reinstate earlier spatial layout, and is argued to be a beneficial change.

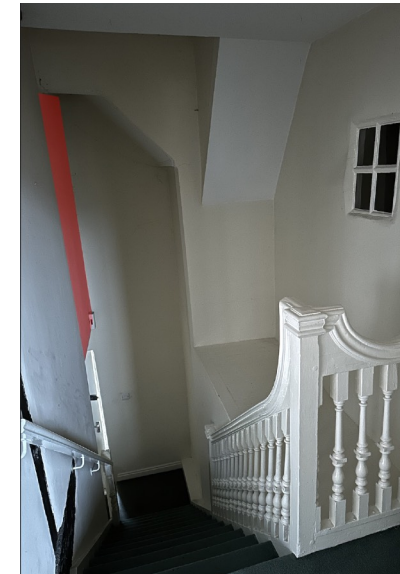
Bathroom extension over historic stairs (highlighted in red) - inserted in 1980 and proposed for removal to reinstate full height of stairwell.
