22 Lendal, York
Archaeological Monitoring and Recording Report

Project name	22 Lendal, York
Type of project	Monitoring and recording
YA archaeological code financial code	9114 9114
National Grid Reference	SE 60135 51935
OASIS ID	yorkarch3-525378
Planning Reference	23/01599/FUL
Client	Togel Contractors
Report version no. and status	V1 final report
Author Illustrator Editor	P Howlett B Price K Smart
Report approved by date

Four trenches required archaeological excavation and a total of 15 piles/geotechnical interventions were monitored during the planned drainage and sub-station foundation groundworks (Figure 2).

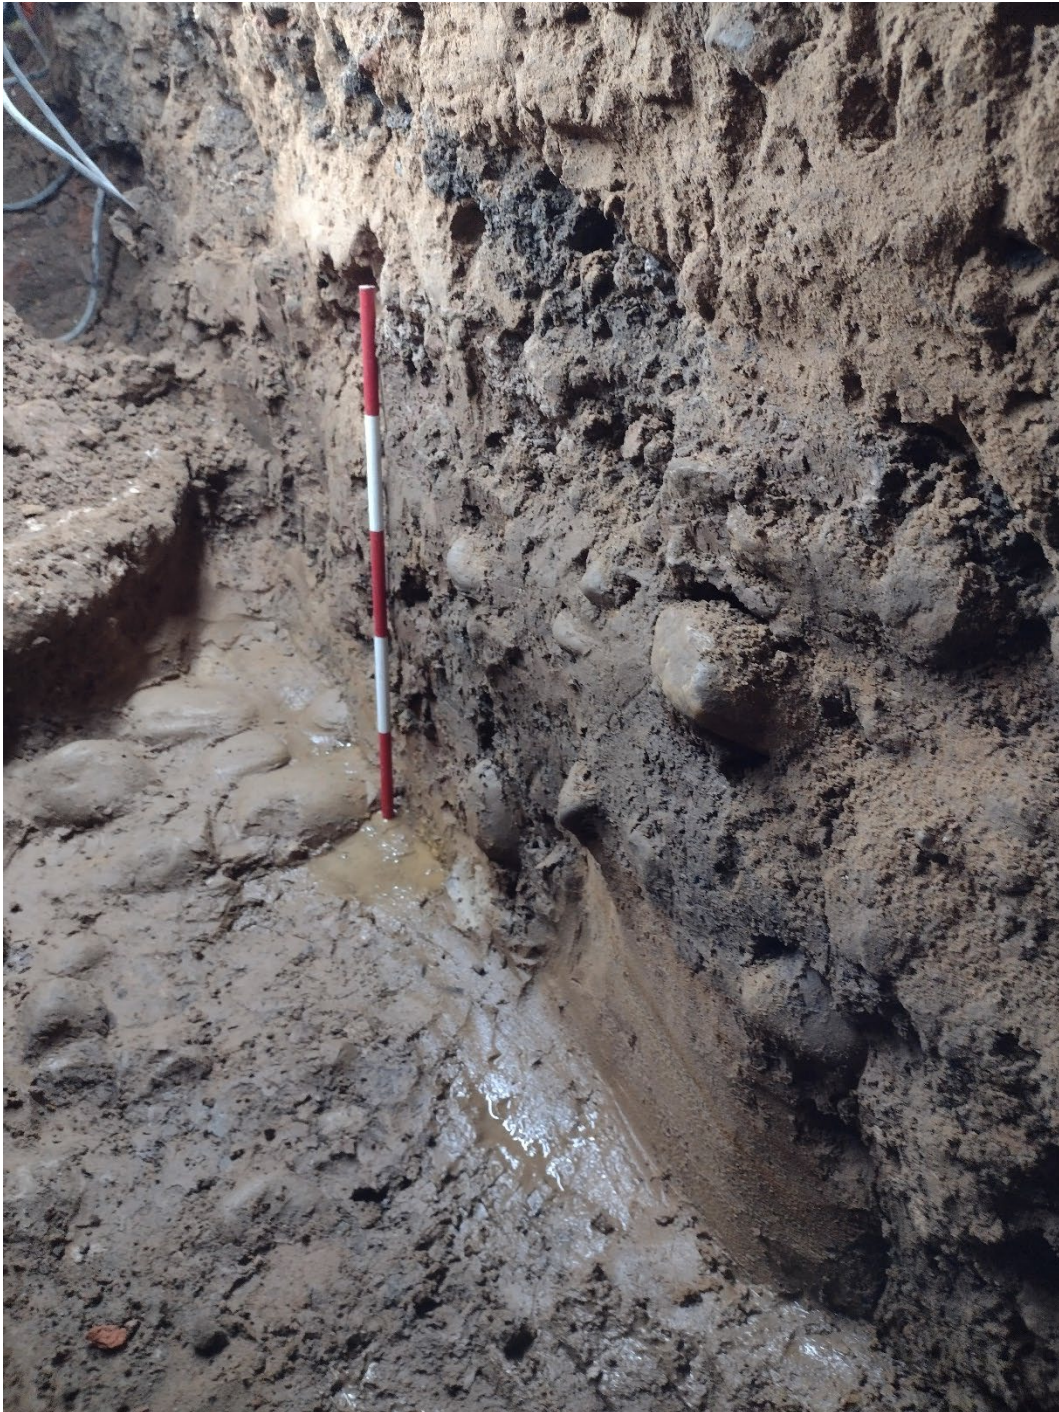
Plate 3: Trench 1 oblique view of south-west facing section, post hole [C1009] cutting natural C1012 at 9.55m AOD, scale unit 0.10m

5.2.2 The earliest deposit seen was a small 0.50m by 0.50m area of medium sized cobbles C1011 in a clean yellow sand matrix in the base of the trench at 1.00m BFL, 9.30m AOD having been cut through by the wall foundations. These cobbles were deemed to be natural and were covered by a 0.25m thick, firm mid yellow-brown striated sterile sand of geological fluvioglacial origin C1012, whose upper horizon was 0.74m BFL c 9.66m AOD (Plate 3).

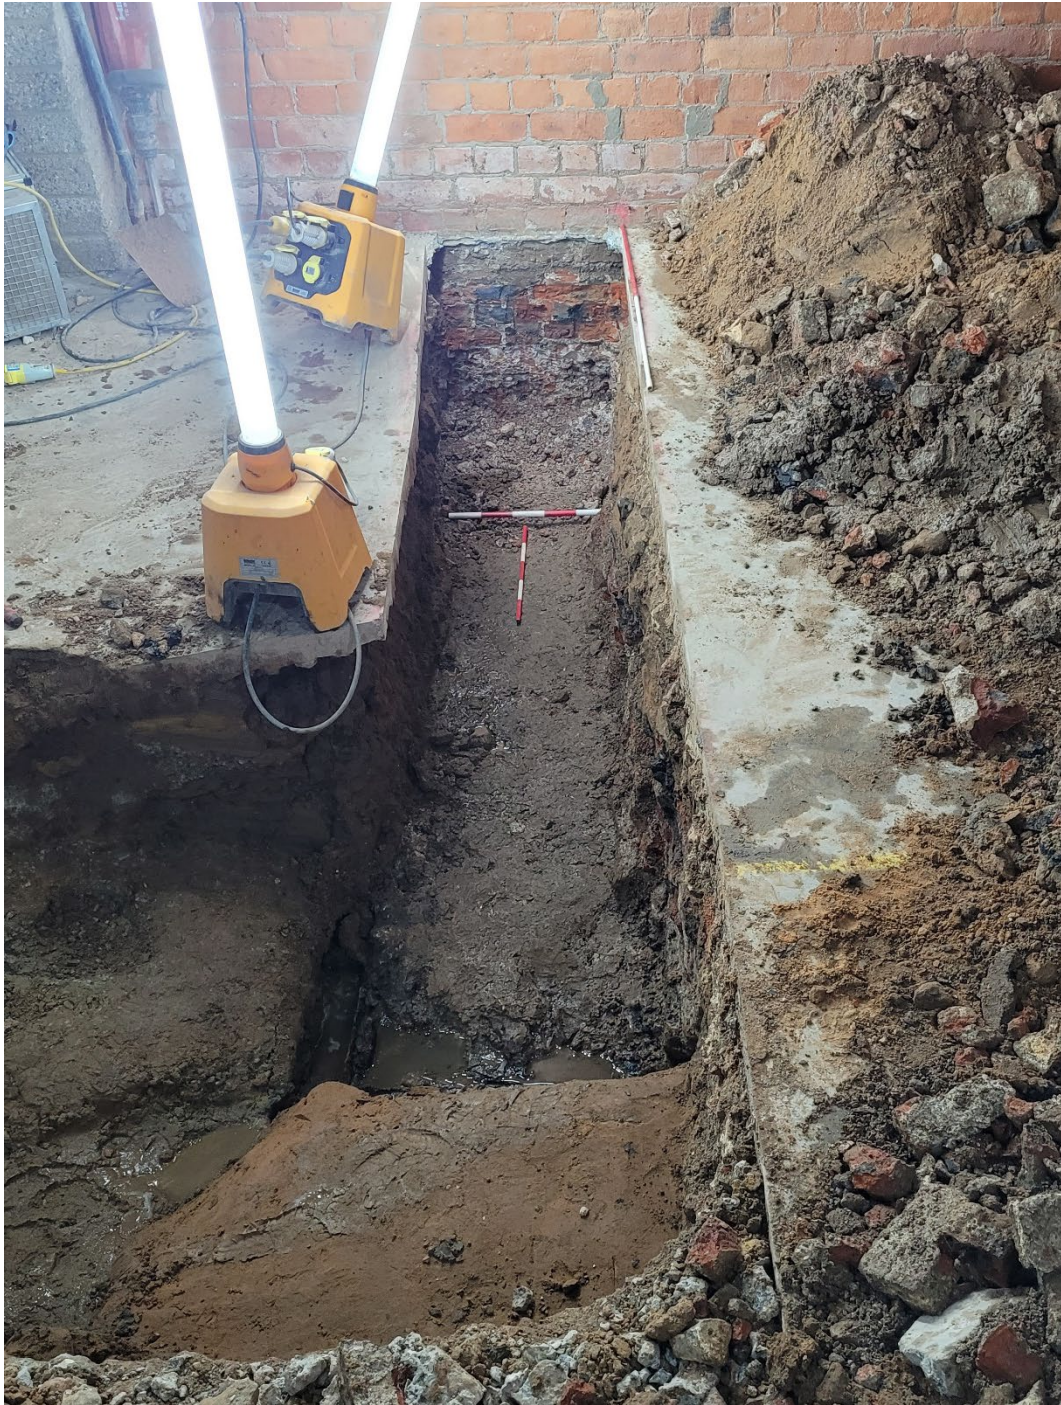
Plate 4: Trench 2 base looking south-west, scale unit 0.10m

- 5.3.4 The construction cut [C2023] for a post-medieval wall footing C2021 was not fully excavated, but was exposed down to 0.85m BFL, 9.45m AOD, the limit of excavation (Plate 4). This wall was on the same north-east to south-west alignment as Trench 2. At the northern end of the trench the wall end was seen and may have been the corner of a return to the north-west direction. C2021 was approximately 5.50m long and continued below the foundations of the corridor walls which cut into the upper surface (Figure 4, Plate 9).

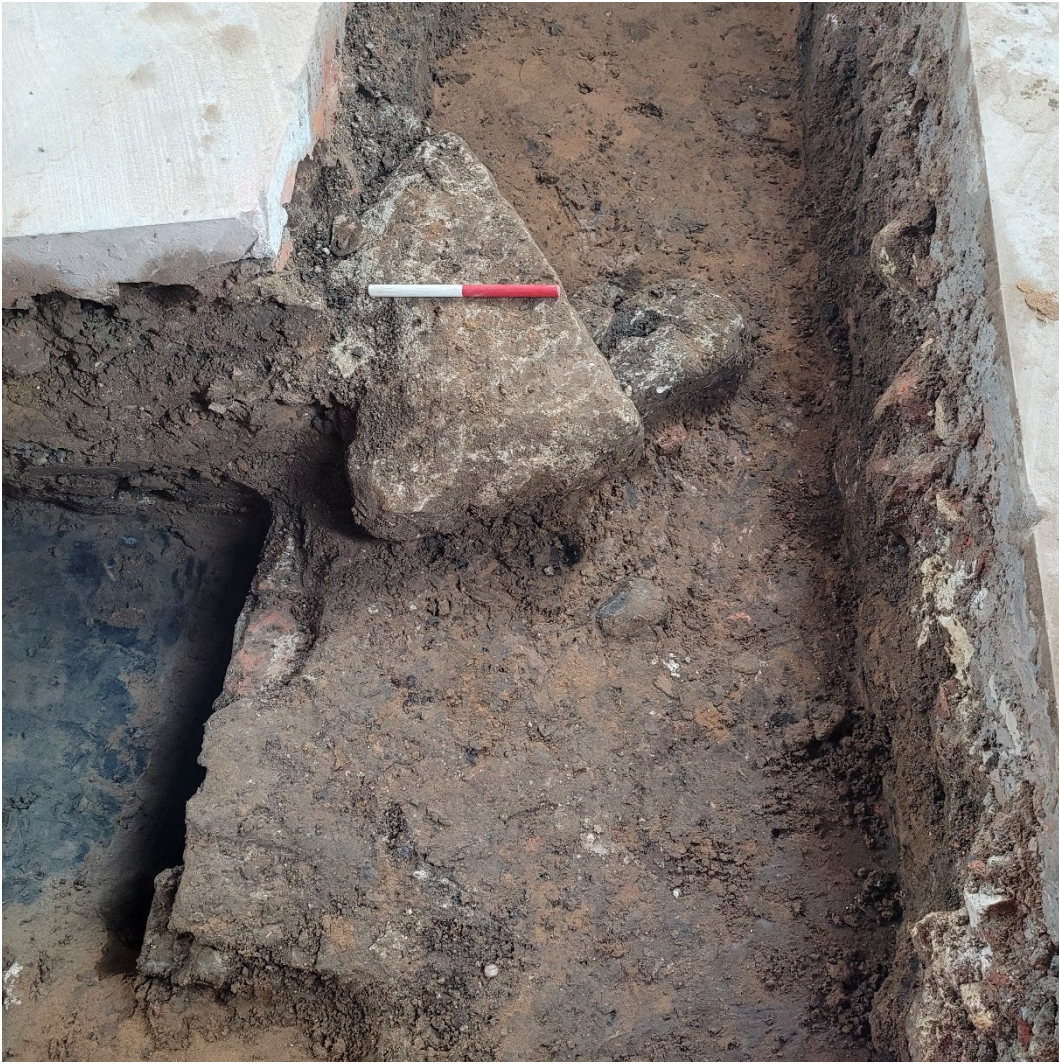
Plate 7: Trench 2 Limestone block C2019 in demolition above wall C2021, looking south-west, scale unit 0.10m

- 5.3.7 Above the partially demolished wall a series of post-demolition trample C2020 and levelling deposits C2017, C2018 with an overall thickness of 0.35m extended across Trench 2. In these deposits a triangular fragment of roughly dressed magnesian limestone C2019 was found (Plate 7). No tooling was evident and its origins or date could not be determined.

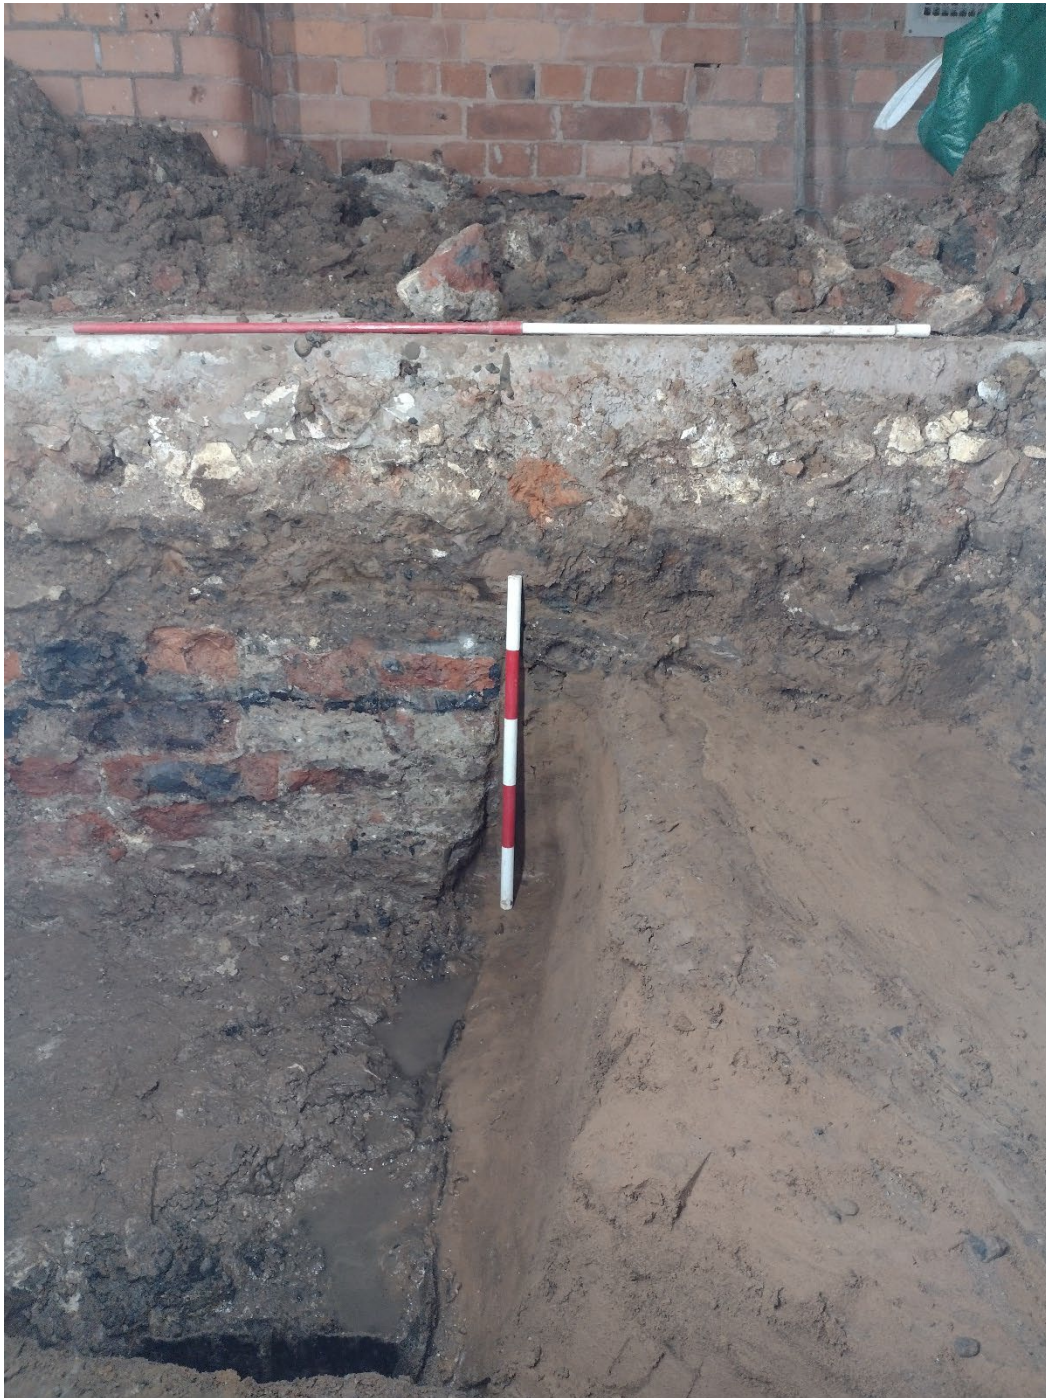
Plate 8: Trench 2 south-east facing section of wall C2021 and construction cut [C2023] with shuttering C2024 and bedding C2027, scale units 0.50m, 0.10m

- 5.3.5 At the base of the wall cut [C2023], wooden shuttering C2024 could be seen and had been used to retain the broken brick and cobble wall foundation C2027 within the soft sand. These were left in situ as they were below the level required for the new drainage pipework (0.80m BFL) (Figure 5.5, Plate 8).

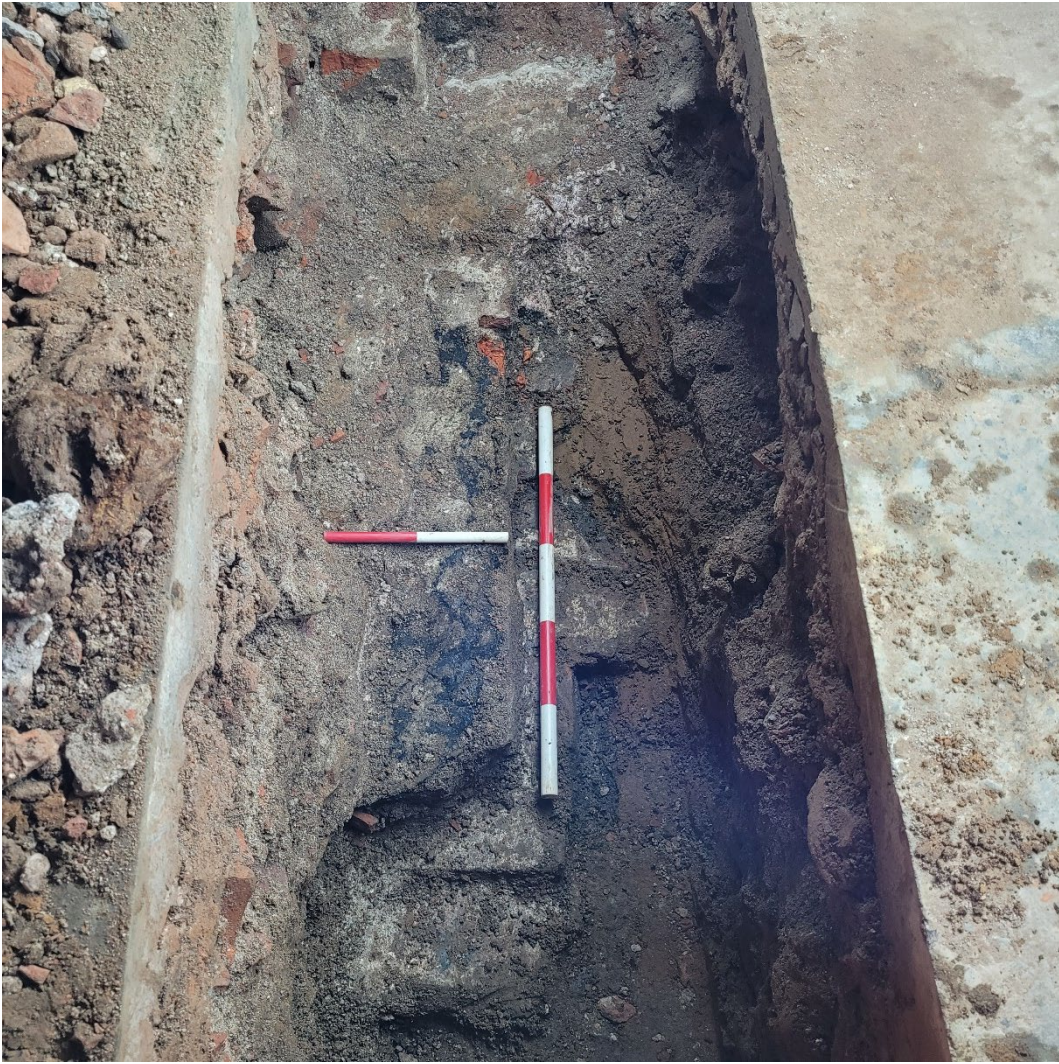
Plate 9: Trench 2 the south-west end of wall C2021 showing bitumen DPC and limestone foundation, scale unit 0.10m

- 5.3.6 On top of this foundation sat wall footing C2021 which was made up of four courses of brickwork and occasional small cobbles followed by a 10mm thick bitumen damp proof course and another brick layer before it had been truncated by the construction of the Post Office. At the south-western end the wall sat on re-used limestone blocks (Plate 9). The backfill C2022 of the wall construction cut consisted entirely of re-deposited natural sands.

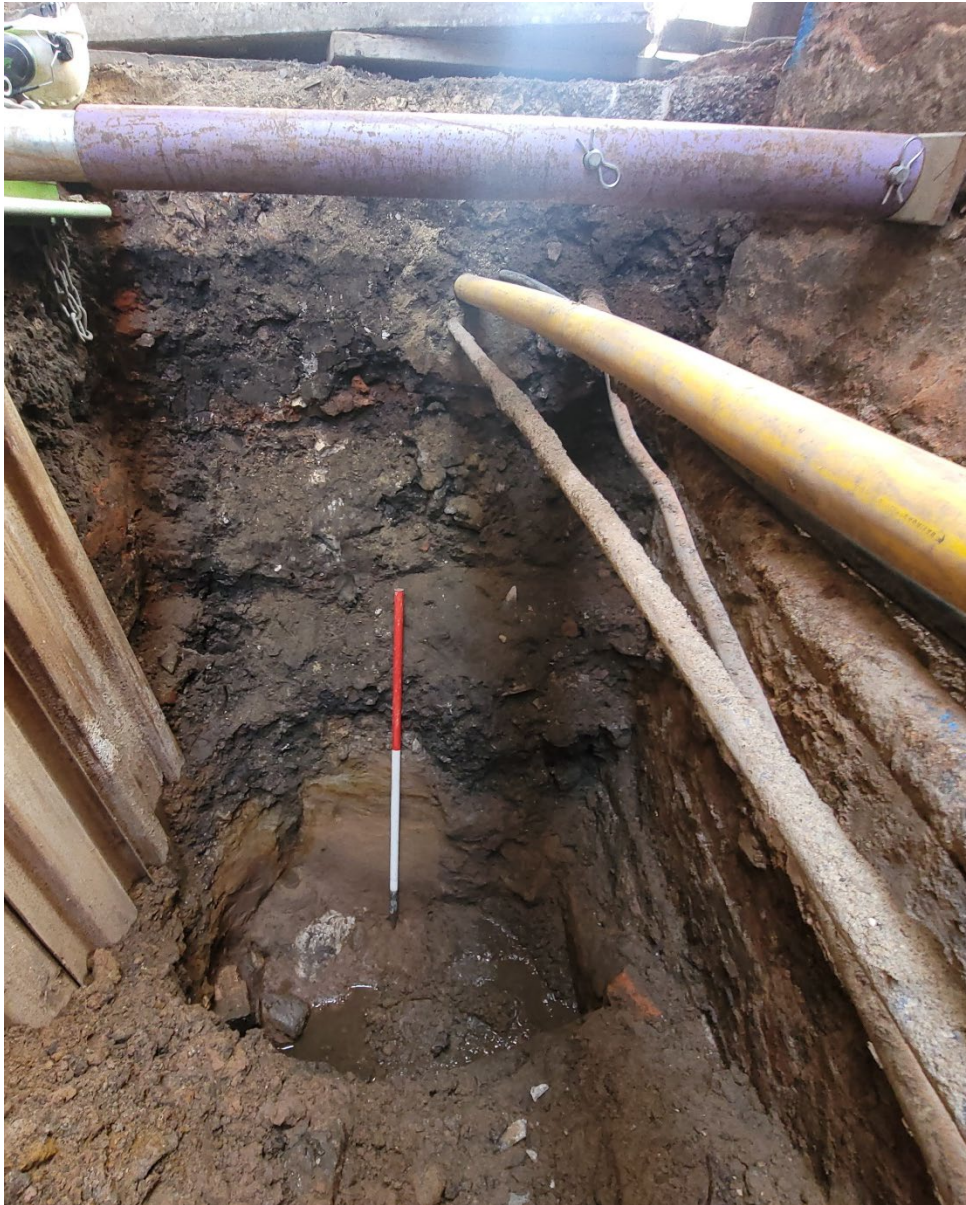
Plate 11: Trench 3 north-east facing section, post hole cutting natural at 9.60m AOD, scale unit 0.50m

- 5.4.4 Truncating C3013 was a posthole C3015 0.40m at the top and cutting down through C3013 and C3016 to a depth of 0.76m. Health and safety concerns regarding the depth of the trench meant that the fill C3014 could not be sampled. However, it was seen to be a soft orange-brown clayey silt with traces of wood fragments. No dating evidence was found and this archaeological horizon was interpreted as a possible continuation of that seen in the basement Trenches 1 and 4 at 9.75m AOD (Plates 11 & 12).

- 5.4.7 The construction cut and fill [C3012] C3011 of the outer wall foundations for 22 Lendal were themselves truncated by the 1.15m deep and 0.88m wide cut [C3007] of a service trench running the length of the alley containing pipe work and cabling for a number of modern services including a lead water pipe, plastic gas pipe and high voltage electric cables. The loose backfill C3005 of this service trench contained large quantities of broken brick and small to medium sub-angular stones and limestone fragments as well as modern bottle glass fragments (Plate 11).

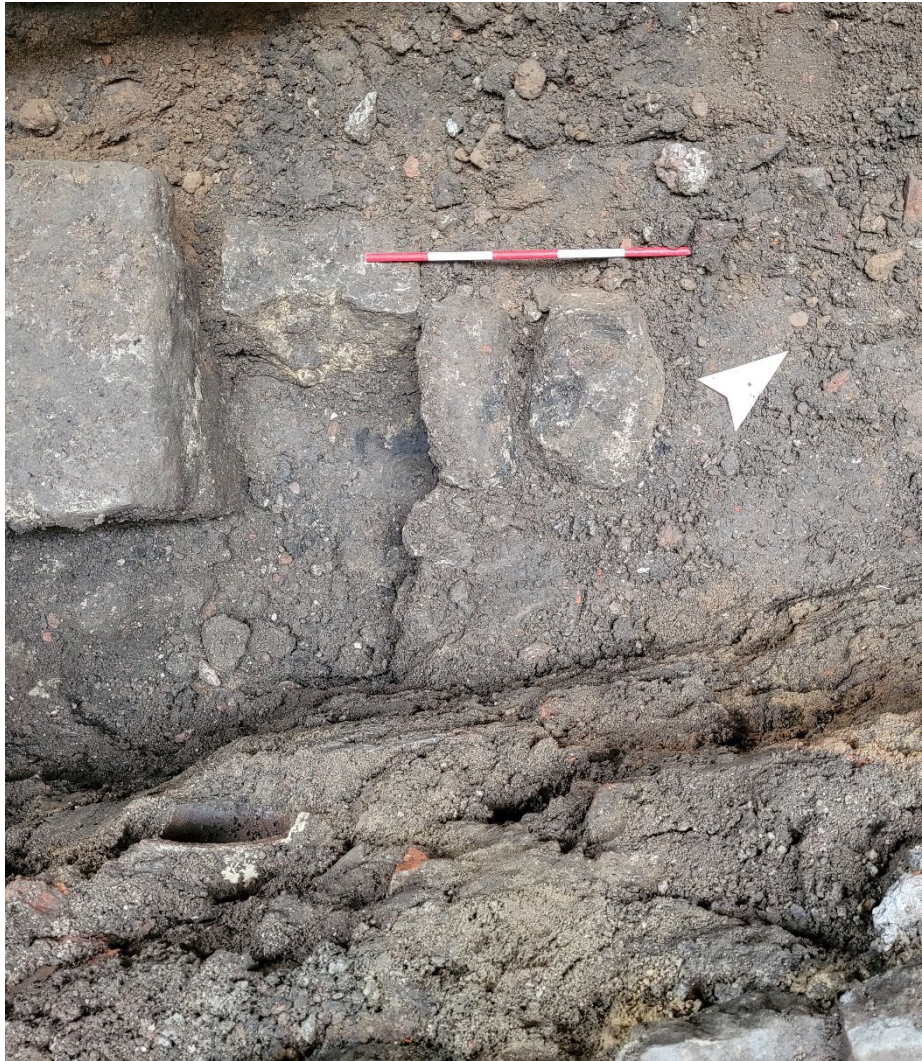
Plate 13: Trench 3 looking north-west, re-used medieval limestone blocks C3004, scale unit 0.10m

- 5.4.6 Above C3008 was a loose un-mortared layer of magnesian limestone blocks of varying size C3004. These were roughly tooled with traces of residual original mortar on them (Plate 13). They were interpreted as robbed out and re-used wall blocks from the nearby medieval Augustinian friary, acting as foundations for a post-medieval brick-built wall C3003, aligned in a north-east to south-west direction and diverging slightly from the outer wall line of 22 Lendal. Six courses of C3003, three bricks wide (0.36m) and roughly mortared were exposed in the centre of the trench at 0.55m BGL (11.10m AOD) (Plate 14).

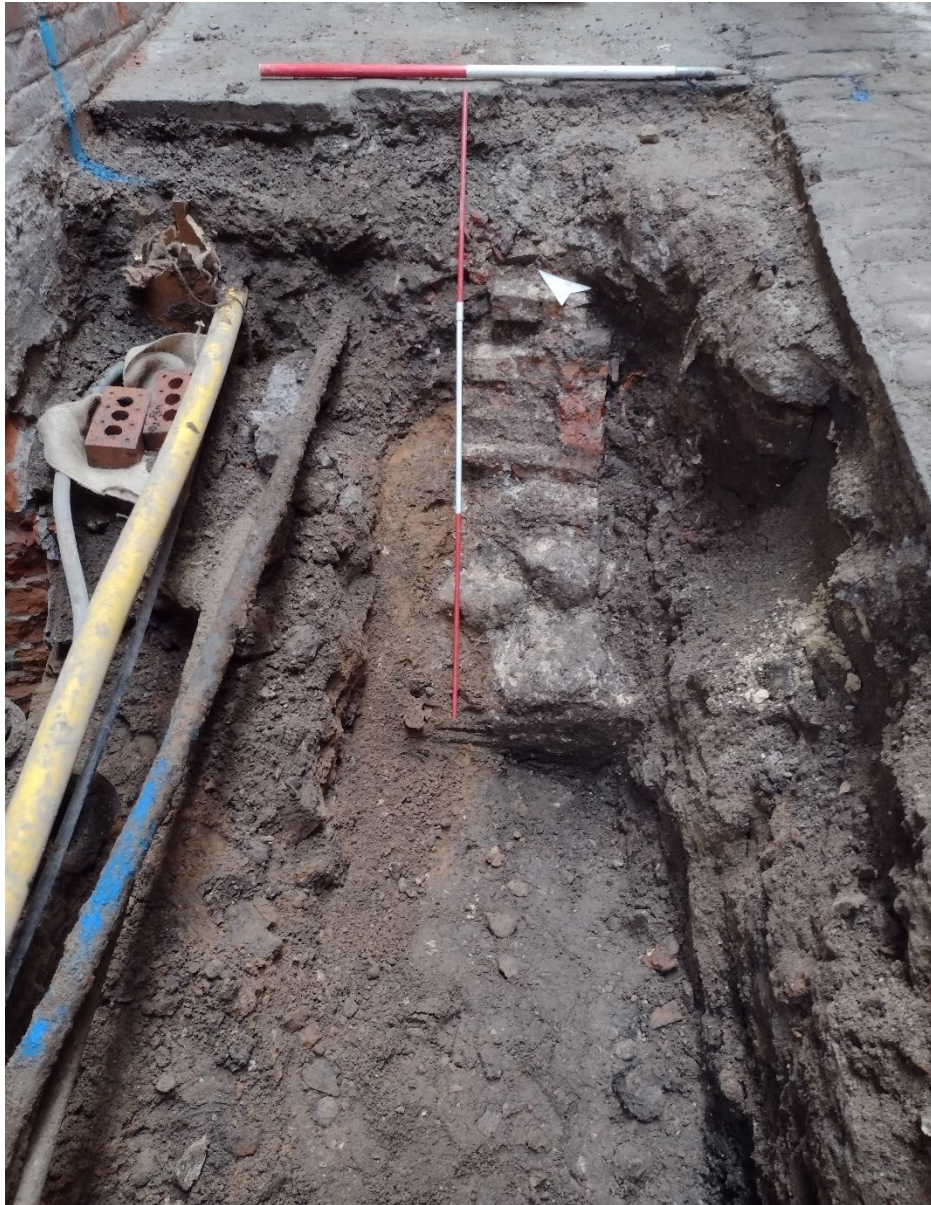
Plate 14: Trench 3 looking north-east, re-used medieval limestone wall blocks below post-medieval wall, scale unit 0.50m

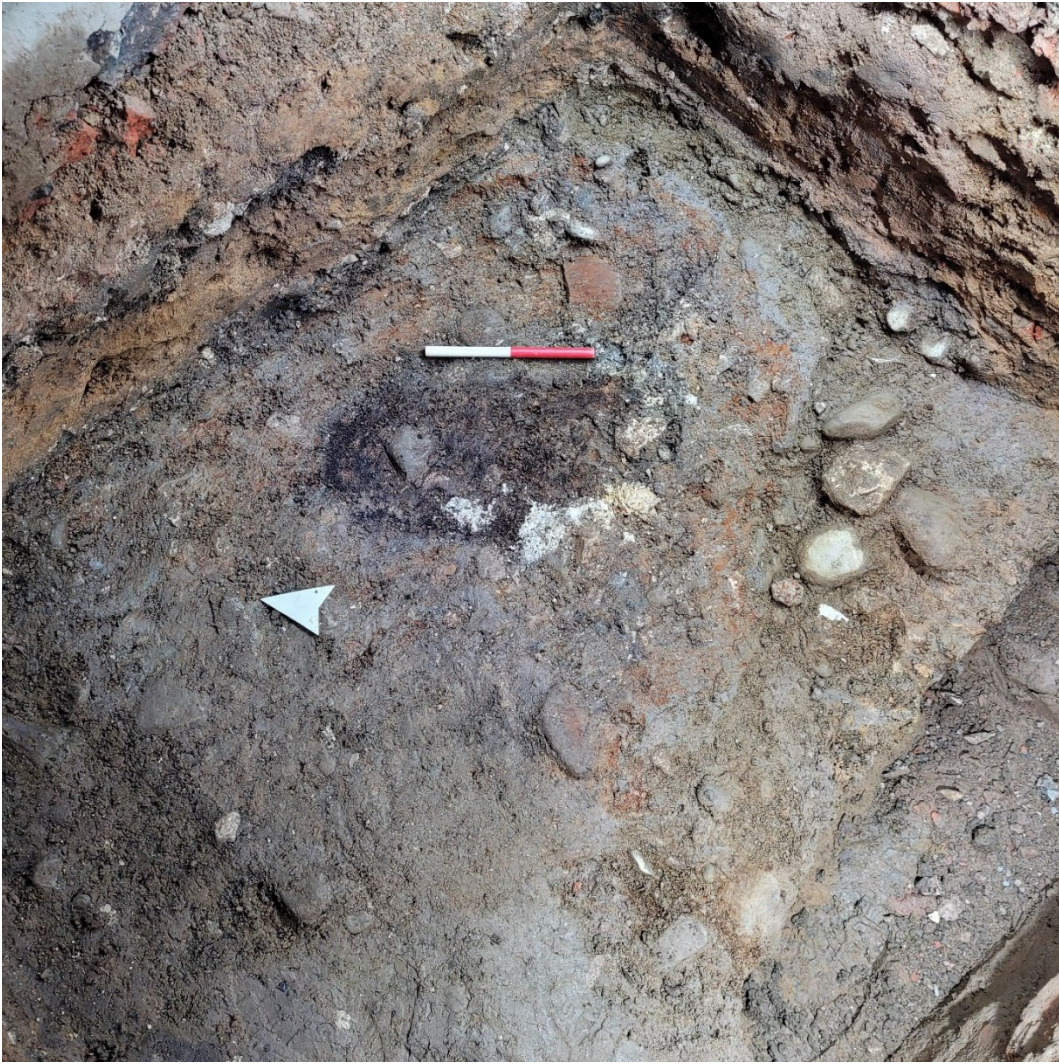
Plate 15: Trench 4 looking east, archaeological horizon at 9.80m AOD, posthole [C4013], cobble surface C4017 cut by pit [C4010], scale unit 0.10m

- 5.5.12 Unlike the above small post and stake holes the flat base of a larger 0.40m long and 0.23m wide rectangular post hole [C4013] was seen to cut through surface C4017 to a depth of about 0.10m. The fill C4012 was sampled (SA4) and contained two Roman pot sherds as well as fragments of oyster shell and burnt limestone (Figure 4, Plate 15).

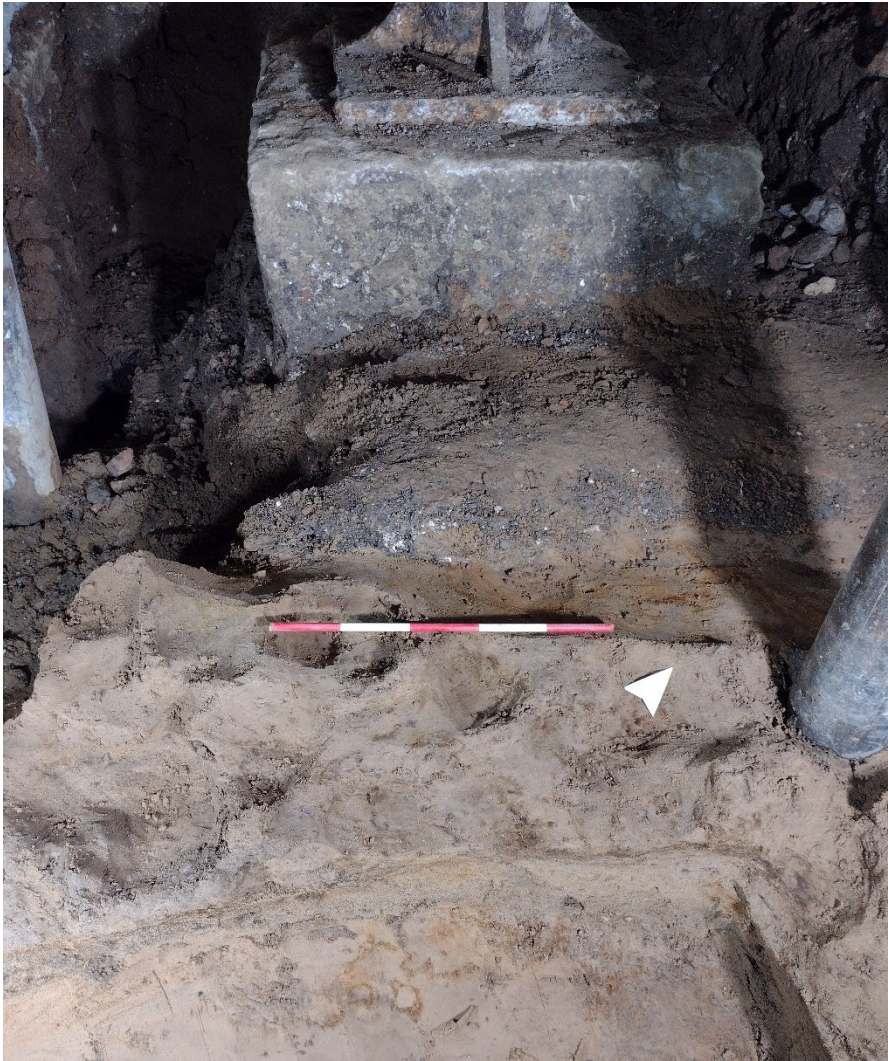
Plate 20: Trench 4 pitted natural below the dump deposit C4019, looking north-west, scale unit 0.10m

- 5.5.15 It was also noted that 1.00m to the west of Trench 4 the basement foundations, below a basement roof support column, consisted of a re-used, large 0.94m² chamfered Roman or medieval architectural magnesian limestone block (Plates 20 & 26).

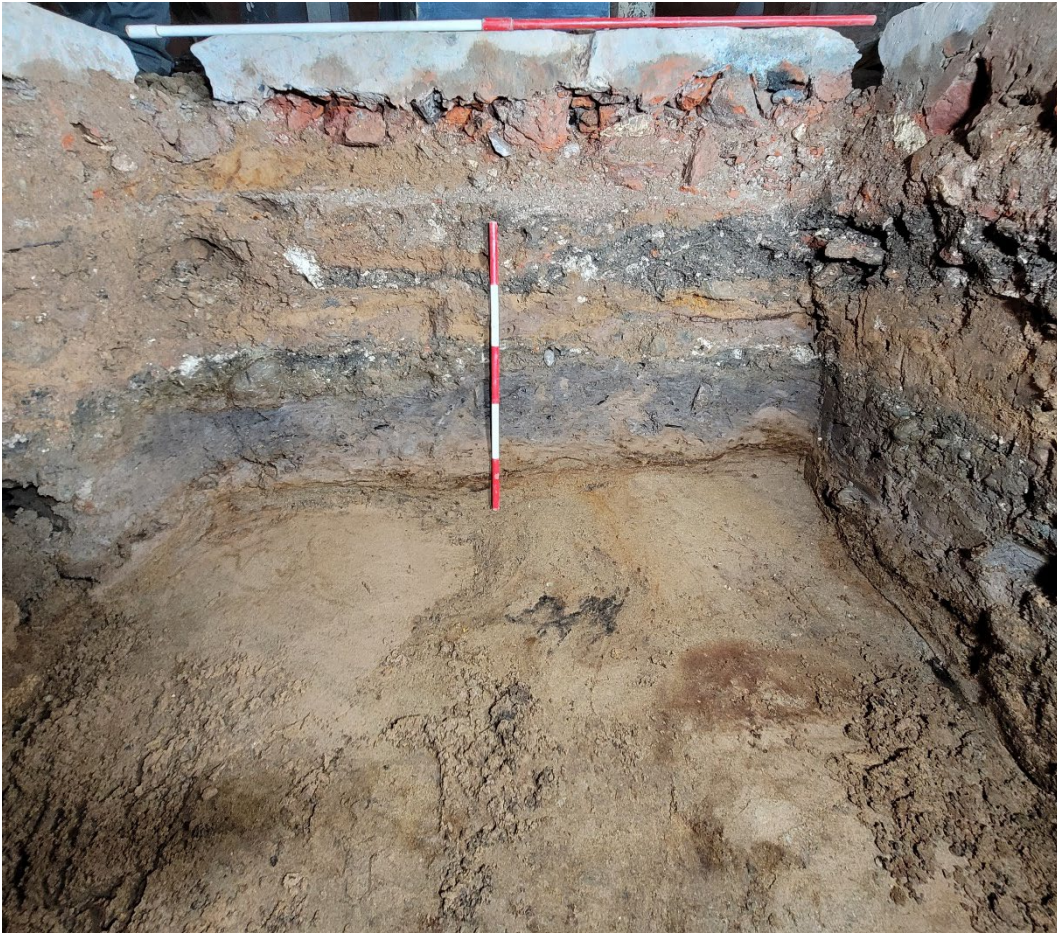
Plate 21: Trench 4 south-east facing profile, Iron panned natural C4022 in base, thick grey layer is dump C4019, Scale unit 0.10m

5.5.4 Above C4006 was a distinct thin (0.05m) concreted and laminated layer of iron panned sand (Plate 21). This layer was covered by C4021, a 0.10m thick layer of 'dirty' and disturbed sand. There were no features in this material and it was understood to be the interface between the archaeological horizon and the superficial geology. The presence of iron panning suggests intermittent periods of waterlogging, which may account for some of the preservation noted in the environmental samples taken from layers above. The possibility of periods of waterlogging was also observed and noted in the laminated deposit C1014 in Trench 1.

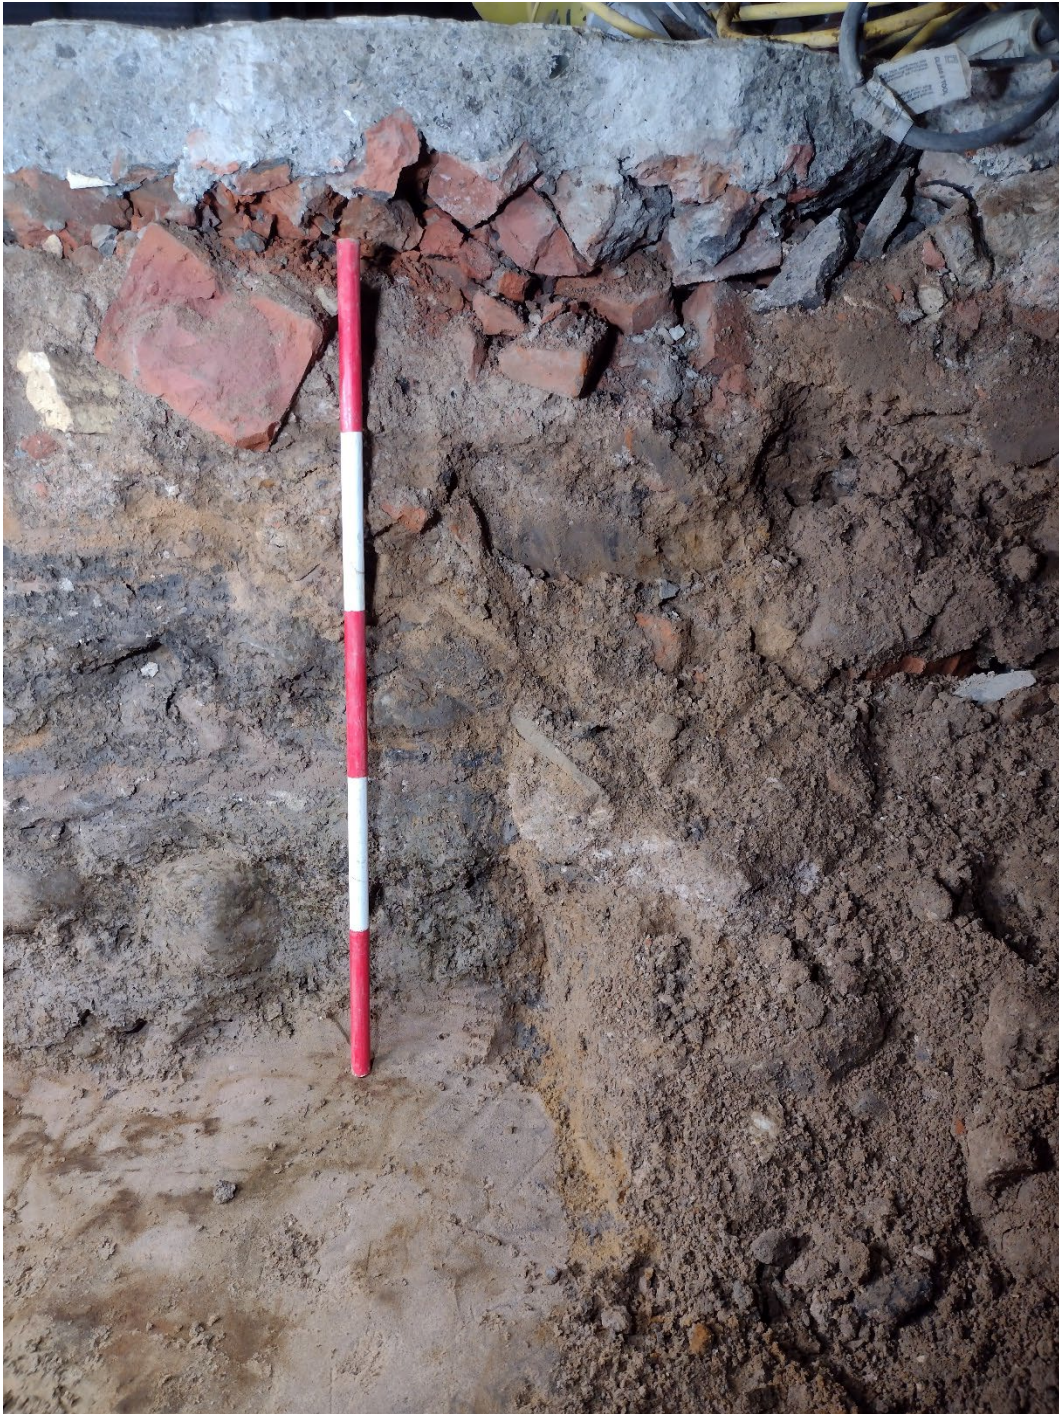
Plate 22: Trench 4 south-west facing profile Archaeological deposits truncated by eastern construction cut of Post Office wall, scale unit 0.10m

- 5.5.14 To the south-east the archaeological deposits were truncated by the Post Office foundations (Plate 22). The southern and south-eastern sides of the trench, and all of the deposits noted above on that side, were truncated by the construction cut [C4004] of the brick-built manhole (Figure 4, Plate 19). The overlying layers of basement floor foundation C4001 and concrete floor C4000 were as described in the other trenches.

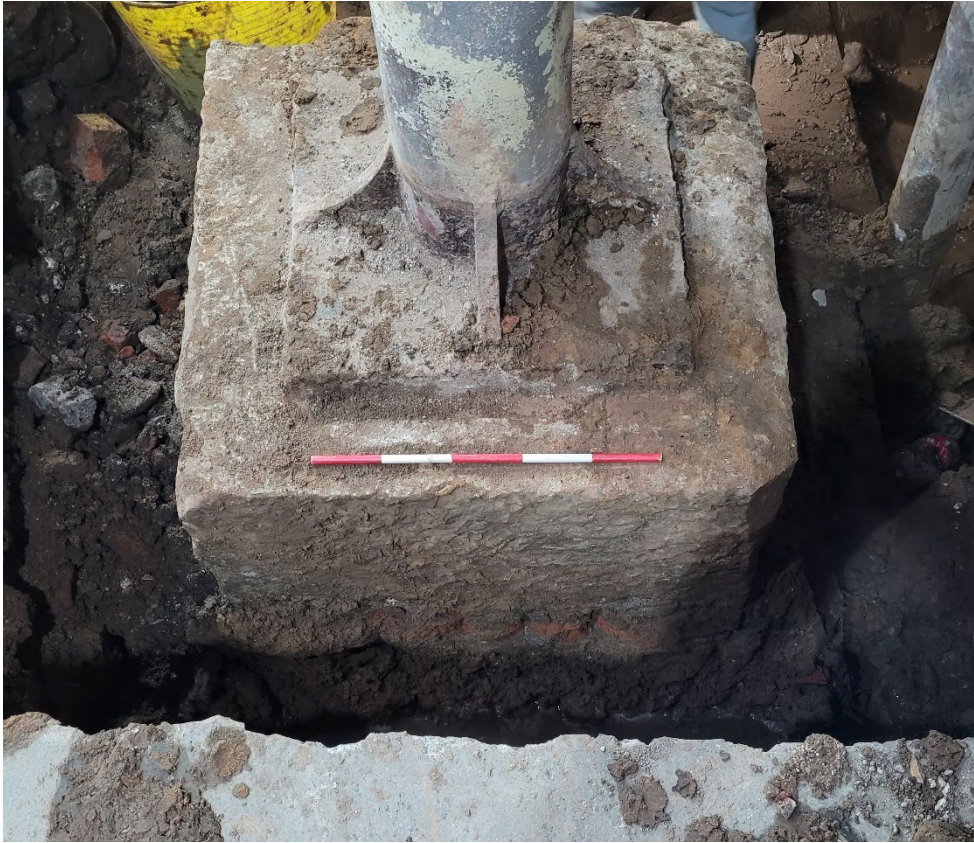
Plate 26: Re-used medieval limestone block in basement column foundation, looking east, scale unit 0.10m

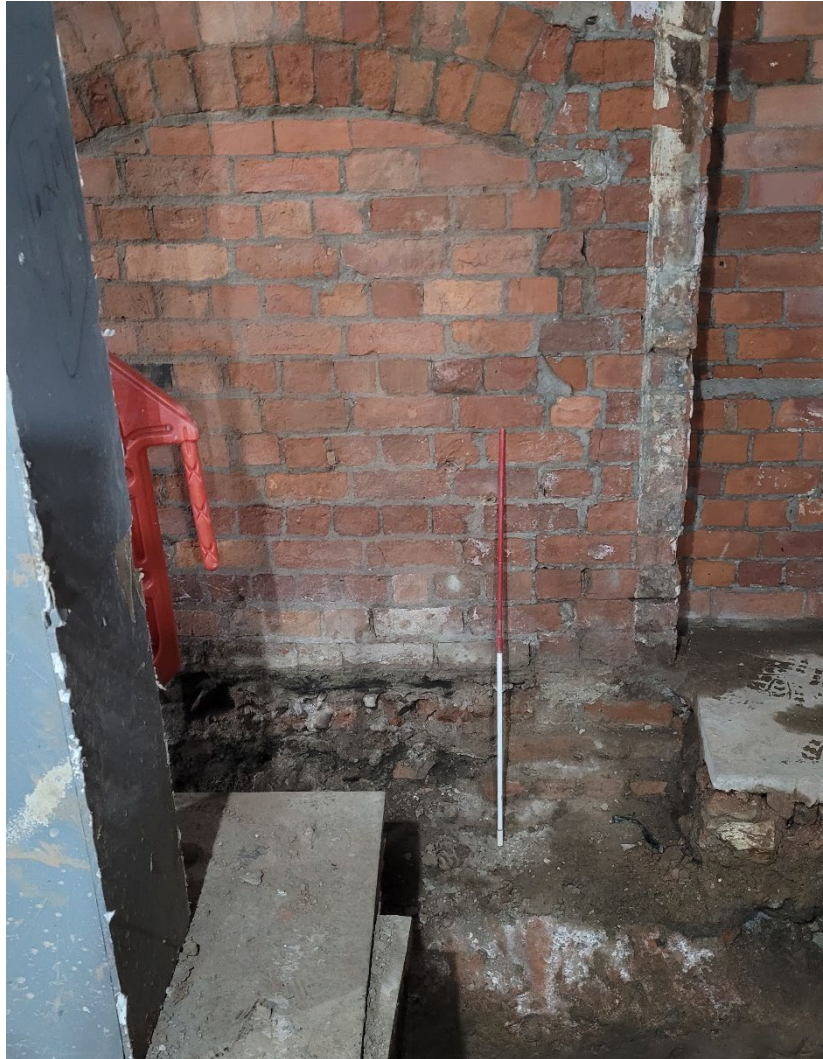
Plate 27: Blocked fireplace arch in south-western basement wall, scale unit 0.50m

concrete wall foundations 1.20m deep at the south-western end below a bricked-up arch or fireplace obstructing the proposed pipe run (Plate 27).

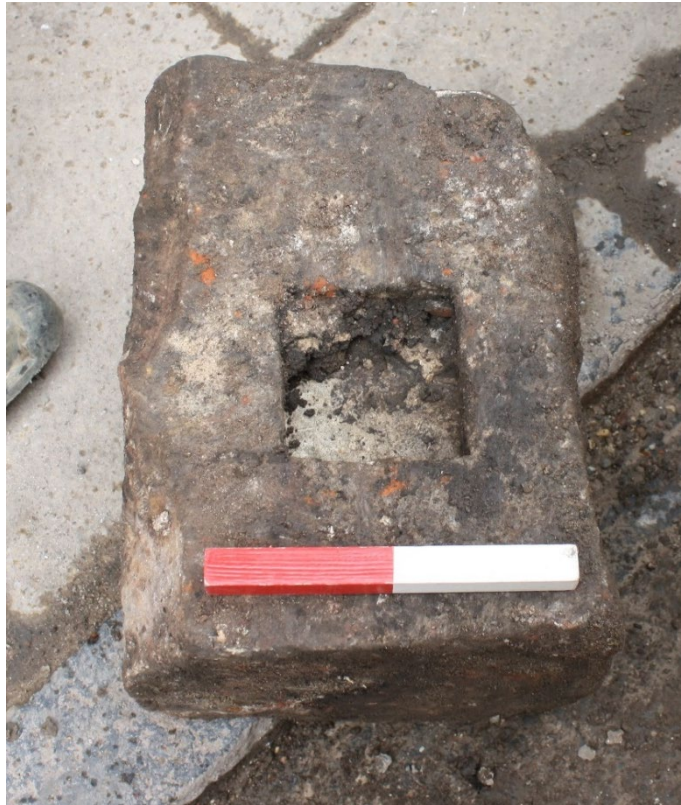
Plate 29: Re-used, medieval limestone masonry retrieved from the extended alley way trench, scale unit 0.10m

The interpretation was the same as that arrived at for the features observed in Trench 3, in that they were robbed out and re-used wall blocks from the nearby medieval Augustinian friary acting as foundations for post-medieval brick-built walls.
