1 Museum Street, York YO1 7DT

Heritage Statement
January 2025

1 Introduction

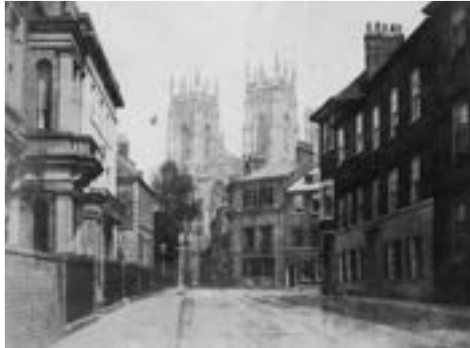
Museum Street in 1853 showing previous Royal Hotel (York Archive)

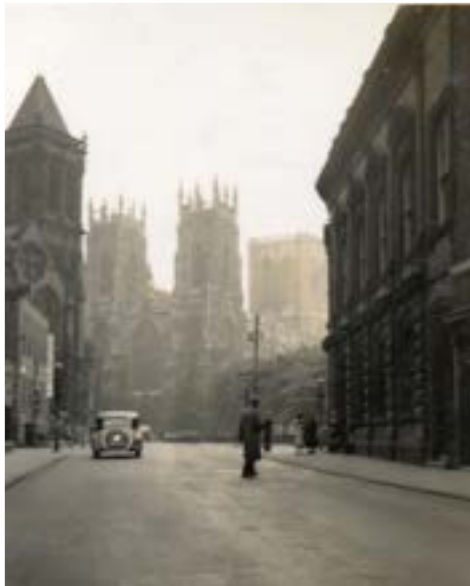
Museum Street in 1939 showing current building on right (David Lovell)

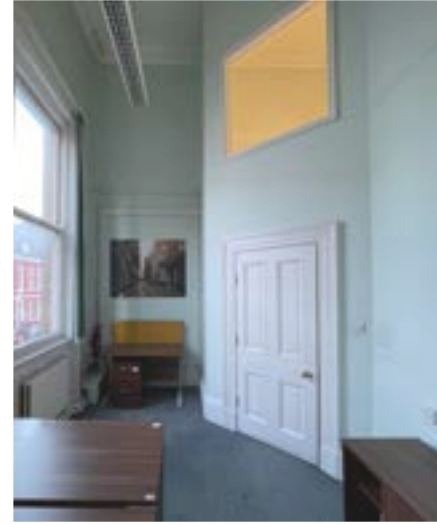
R104 Office formed from modern partition walls

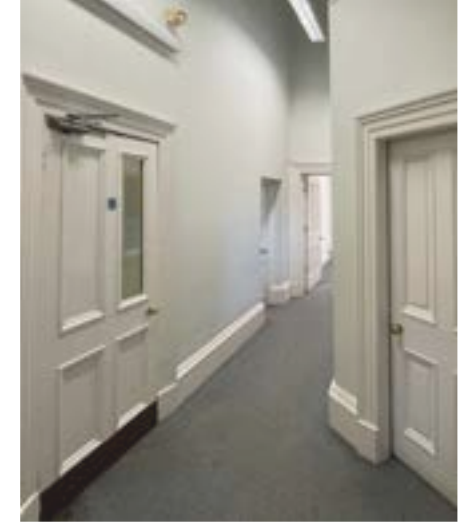
R105 Fire corridor created with modern partitions

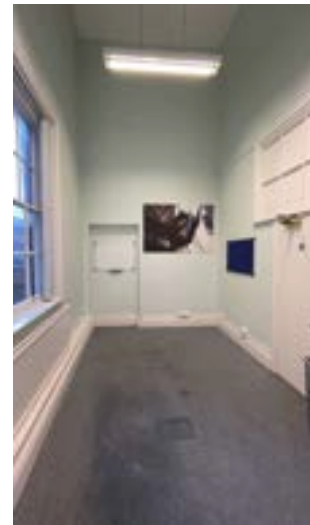
R111 Office with original door infilled

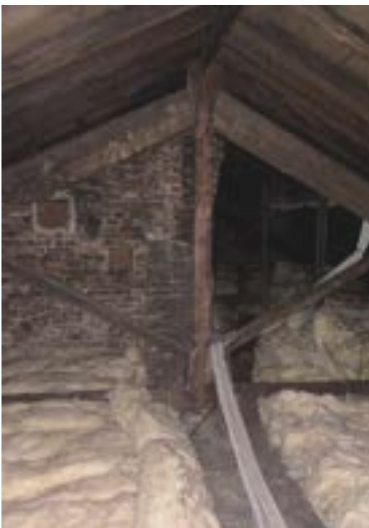
Roof void

On the roof, the natural slate tiles and ridges appeared to be in good condition with the bituminous underlay generally intact. The small area of roof space observed appeared to be dry however the crawl boards around the brick chimney stack were damp.

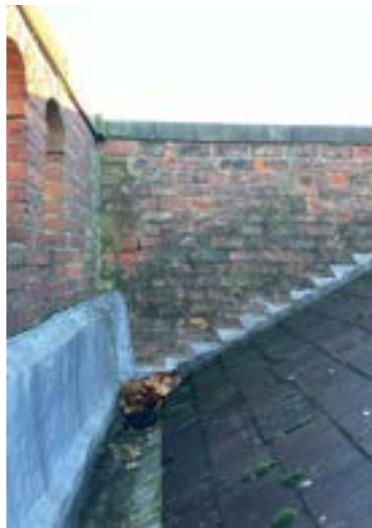
Parapet and associated lead work

The rainwater outlets in the parapet gutter will need to be cleared regularly to prevent blockages.

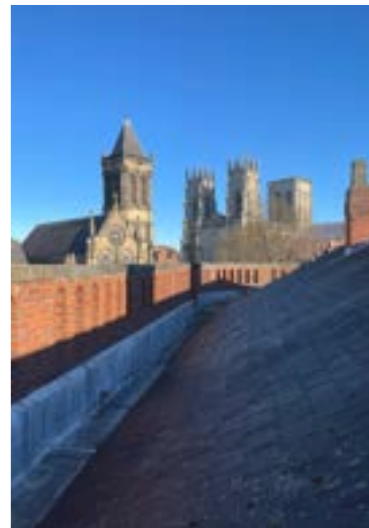
Parapet Roof facing Museum Street

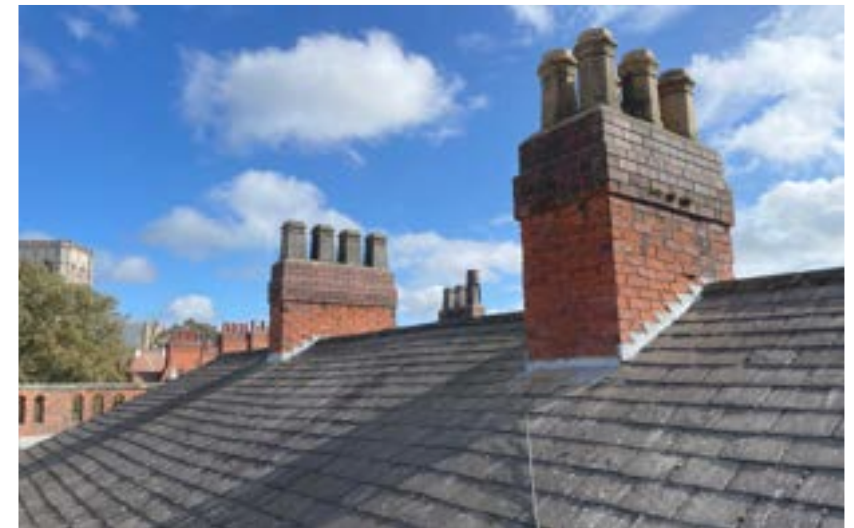
Brick chimneys

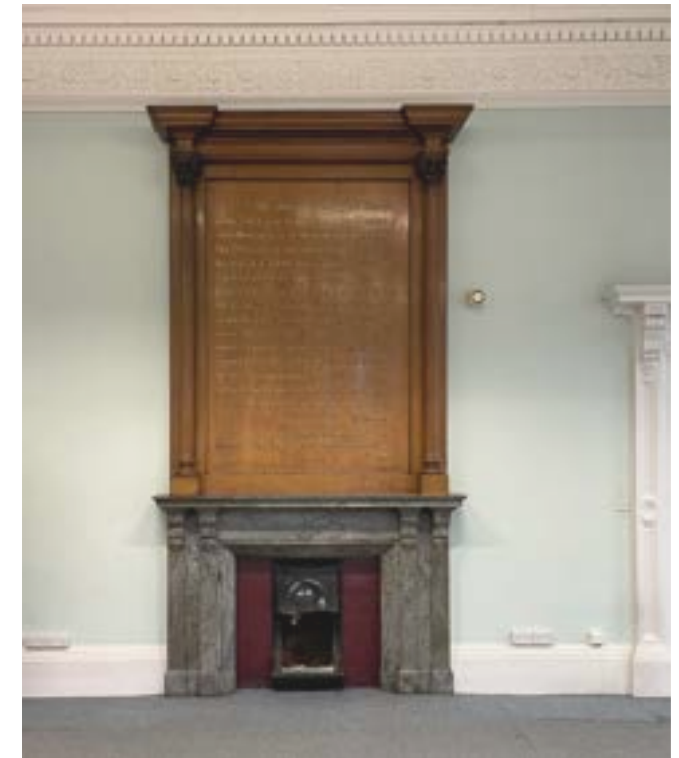
Wooden tablet situated within the principal room at first floor level with examples of the detailed plaster cornice and timber joinery.

Internally the building benefits from its original plaster cornices and ceiling roses as well as examples of detailed joinery work surrounding doors. The original principal staircase also retains its original ornate cast iron balusters.
