**WALKER'S IRON FOUNDRY  
DIXON'S YARD  
WALMGATE  
YORK**

**AN ASSESSMENT REPORT ON AN  
ARCHAEOLOGICAL EXCAVATION**

April 2006

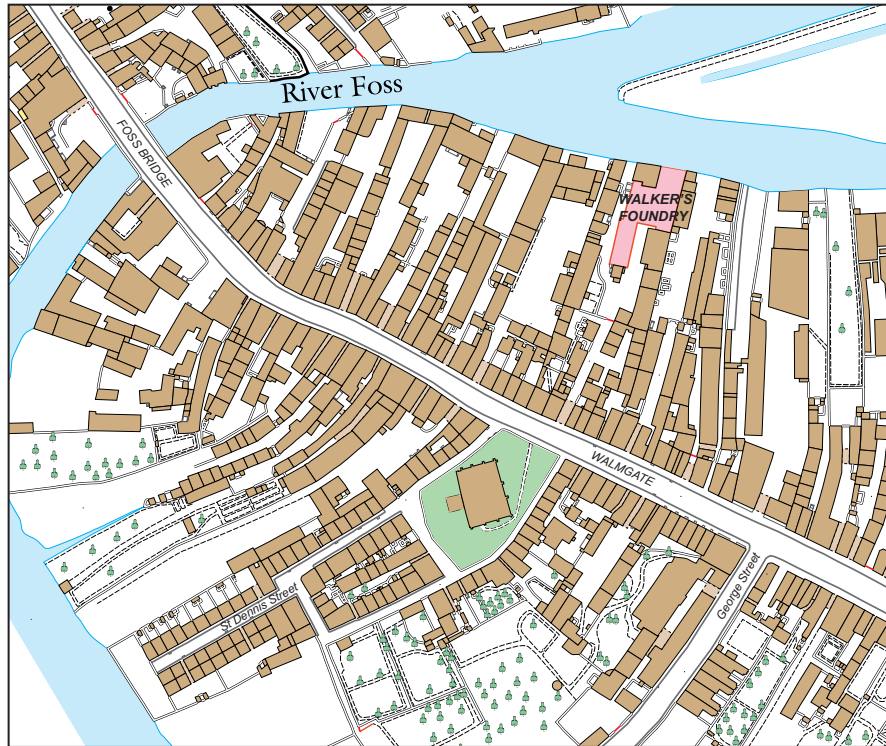
Fig. 3 Part of the 1852 Ordnance Survey showing the location of John Walkers' Foundry

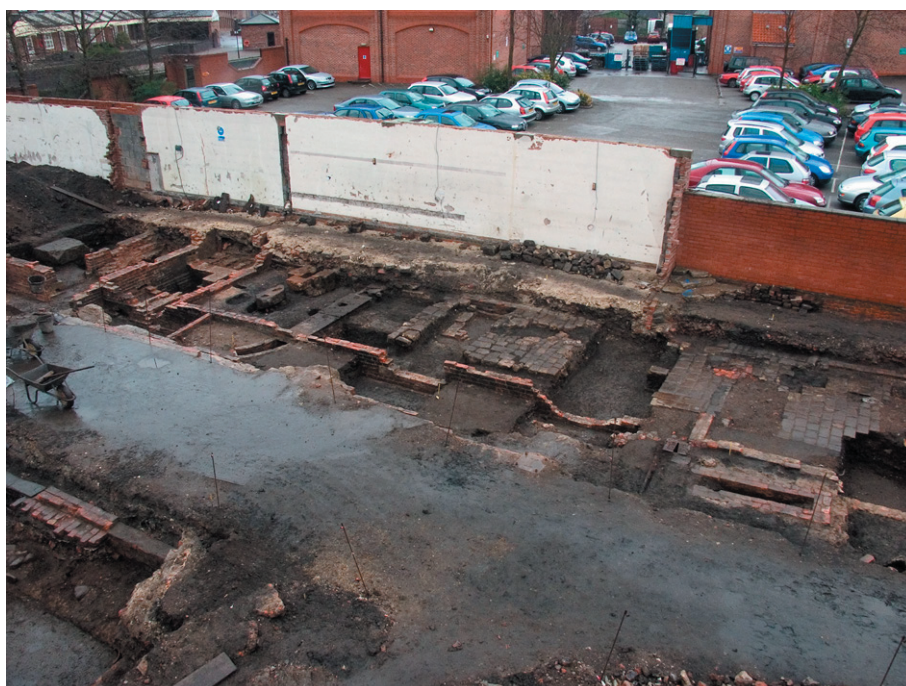
*Plate 1 General view north-east of Trench 4 with floor of stone setts 4136 / 4254 beyond north-south Wall 4238*

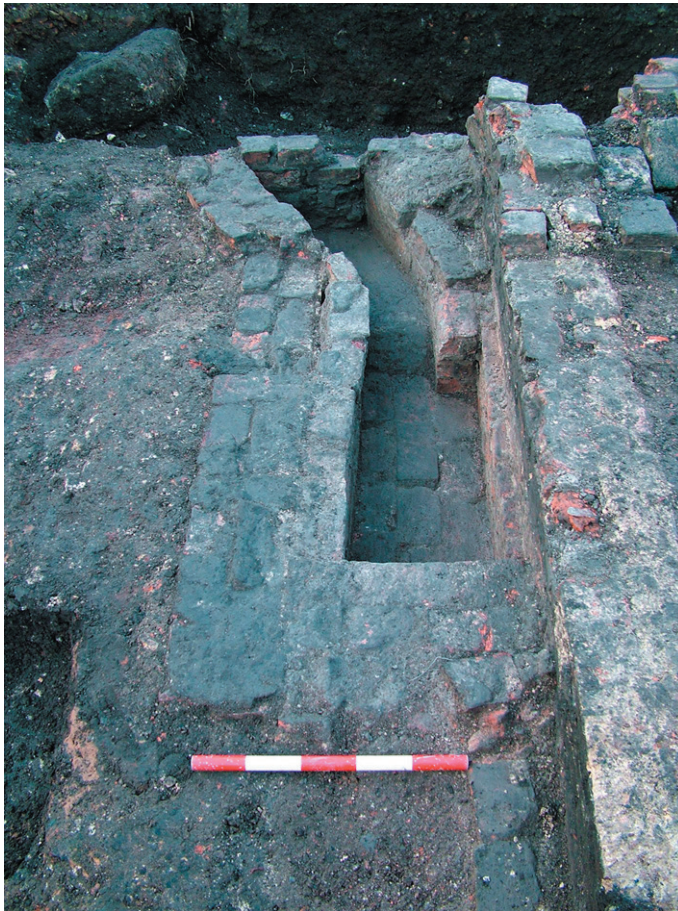
Plate 2 View west of drain 4266 (Area A)

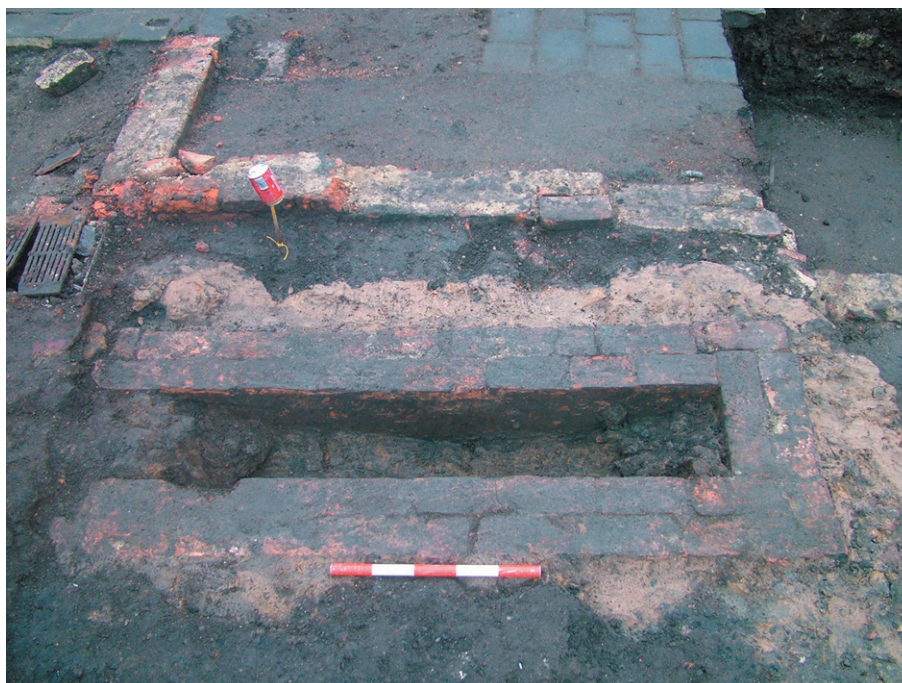
*Plate 3 View east in Area K of Pit 4159 associated with grinding wheel and east-west Wall 4156 with return to east at top*

West of Wall 4156 was 4159, a brick structure (Plate 3), which had probably been located below a grinding wheel. It was sited within a cut (4160), visible in the north side of the evaluation trench dug by On Site Archaeology in Areas B and K, which had a gradual break of slope at surface, leading to straight vertical sides and a flat base. Housed by 4160 was a narrow structure (4159), rectangular in plan with walls on both sides and at one end, which measured c.1.60 x 0.8m. Within the cut the bricks were surrounded by a densely compacted, very clean and pure, light brownish yellow clay backfill with very occasional building material small fragments and occasional pockets of yellow-brown sandy silt (4161). The walls were two courses of bricks wide, and the bricks were laid on bed. Contained by the walls of 4159 was a very hard, dark reddish brown slag (4312) which dipped in the middle, probably as a result of the use of a wheel. Above 4312 and filling 4159 to the top was a hard, dark grey brown, mixed deposit of slag and industrial waste with pockets of clay sand (4162). Partially sealing this structure was a hard, dark grey silty slag deposit (4168).

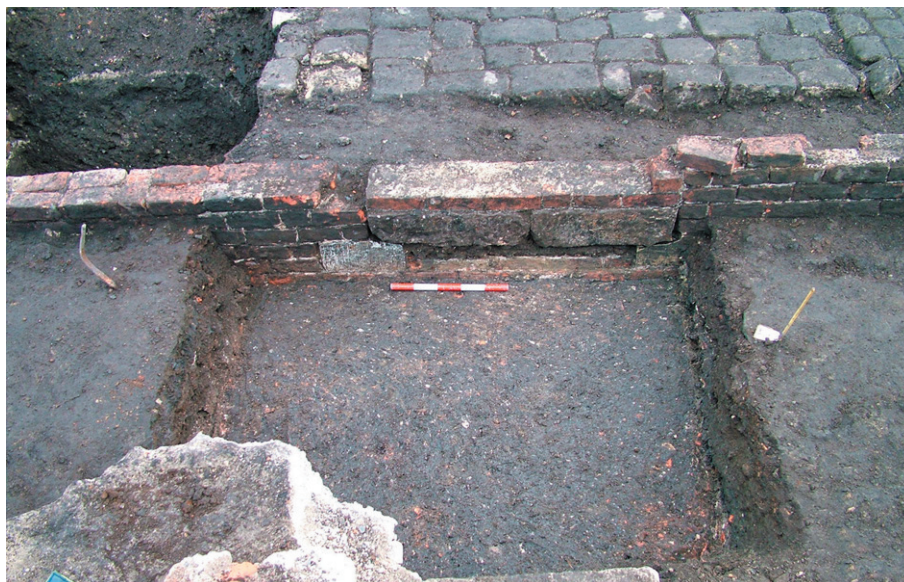
*Plate 4 Test Pit 1 (Area D) view east showing Wall 4238 and blocked doorway*

Cutting through 4438 was the north-south wall 4238 (see above) in which there had been a doorway, later blocked. Above 4438 was a compact, mid orange brown slag layer (4437), probably used to level and raise the ground level, prior to the insertion of 4412 and 4417 (see below) into Wall 4238. Stratigraphically above 4437 was a friable, mid red brown sandy silt accumulation (4436). After this deposit had accumulated the threshold of doorway was raised and two sandstone blocks (4417) with sockets for a door frame put in place.

Subsequently the doorway was blocked with a brick wall (4416), measuring 1.45m north-south and 0.22m east-west. Each brick measured 0.22 x 0.11 x 0.07m and the bonding material was a hard, light yellowish white sandy lime. Immediately north of the was an area of sandstone slabs (4412), which measured 0.6 x 0.5m; each slab measured 0.2 x 0.3m, and they may have been contemporary with Floor 4411 (see below).

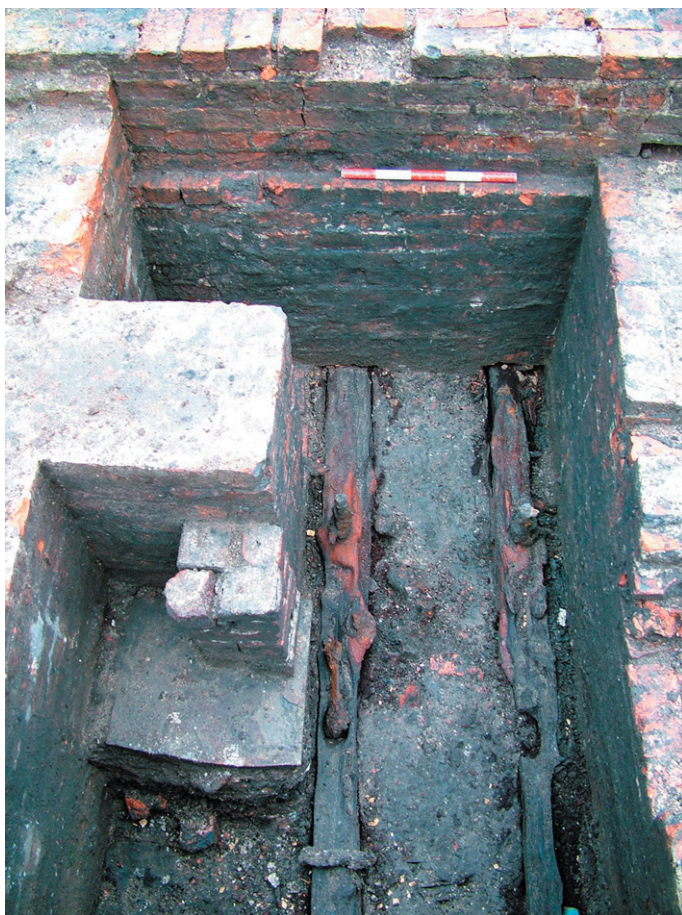
Plate 5 Area E: view south of timber beams 4112 and 4113 in chamber; Wall 4242 on left with structure 4087-8 left of scale

Above 4110 was a pair of timber beams (4112 and 4113) lying north – south, 0.40m apart (Plate 5). Both timbers measured a maximum of 2m long x 0.17m wide and 0.13m thick. They passed under the walls on the north and south sides of the chamber (4239 and 4240) in which there were small slots to accommodate them. In addition, there was also a slot built into the base of the eastern wall (4242) possibly to hold part of this machinery in place.

Both timbers had iron fittings attached to them. Timber 4112, on the west, had an upright fitting 0.65m from the south wall and a socket for a missing iron fitting 0.75m from the north wall. Timber 4113, on the east had an upright iron fitting 0.65m from the south wall and a flat protruding iron fragment at 1.05m from the north wall.

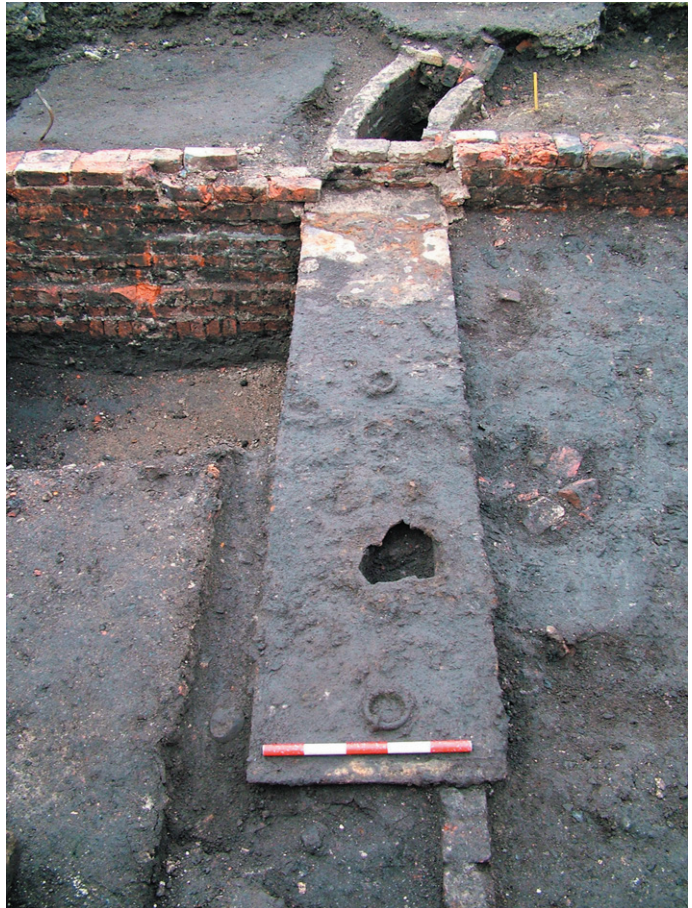
*Plate 6 Area D: view west of Drain 4306 showing iron covers 4451-2 and north-south Wall 4238 top*

East of Wall 4328, cutting through 4253, the drain (4306), aligned east-west, was 3.30m long and 0.40m wide. It was not fully excavated (the construction trench was numbered 4340). The drain was lined with two walls consisting of a single line of bricks, bonded with white-yellowish mortar. Filling the construction cut around the walls was 4452, a loose, mid to dark brown sandy silt with occasional building material and mortar fragments (4451). Covering the drain were three iron sheets acting as lids (4453). The smallest one measured 0.60 x 0.30m and it was located under Wall 4238 (see above). The other two measured 1.20 x 0.30m and both had a central circular ring handle on their east edge. The three sheets were 0.04m thick and very corroded.

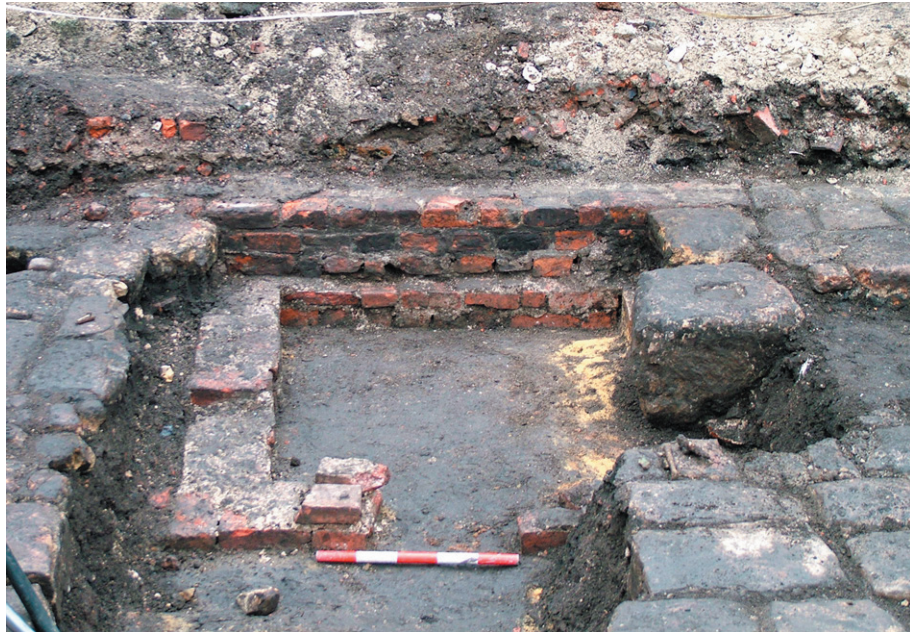
*Plate 7 Area D: view east of brick-built structure 4522 set in stone sett floor 4136*

Built into 4136 was a brick structure appearing as a small chamber (4522; Plate 7). It was square in plan, with two courses of surviving bricks. It measured 1.25 x 1.40m, with two possible entrances, one in its west wall and the second in its south wall. The bricks measured 0.22 x 0.11 x 0.07m and were bonded with pink-orange mortar.

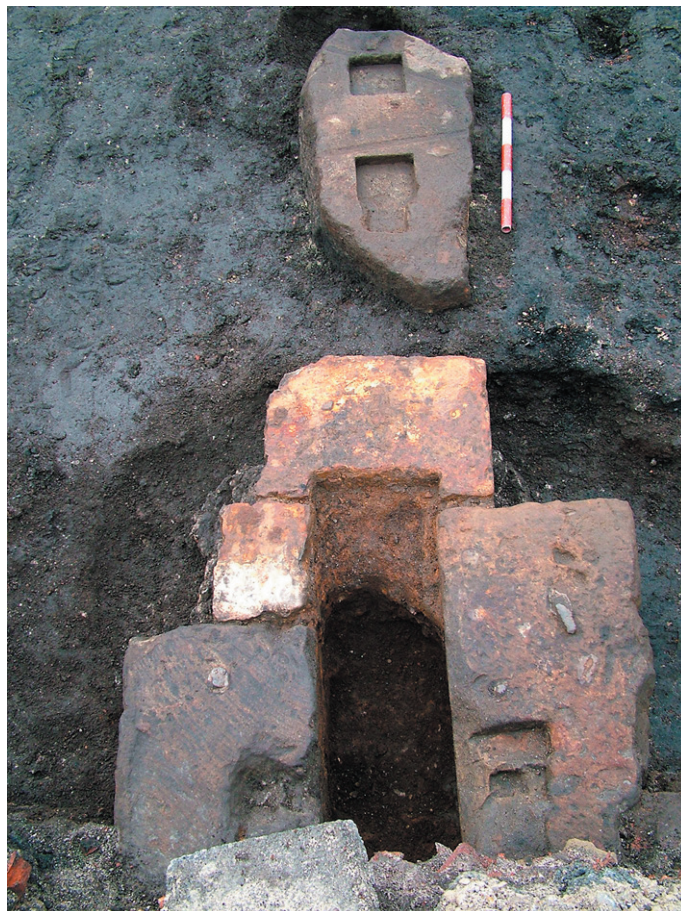
*Plate 8 Area E: view west of stone settings 4137-8*

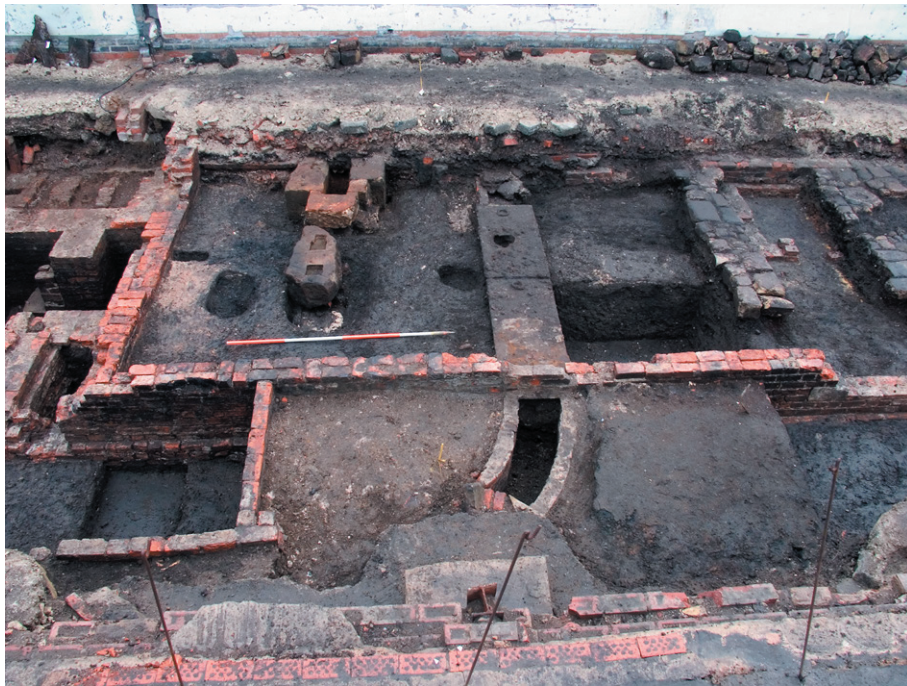
Plate 9 Areas D, E, M and N: view east showing north-south wall 4238 running left to right (centre) with Drain 4306/4309 (as 4306 centre foreground, as 4309, centre top) with iron sheets (4451-2) used as cover. Chamber in Area E is top left, left of Wall 4239. Lower left, east-west Wall 4229 and brick drain lining 4219. Left of centre top: stone settings 4137-8 after excavation of brick floor 4139

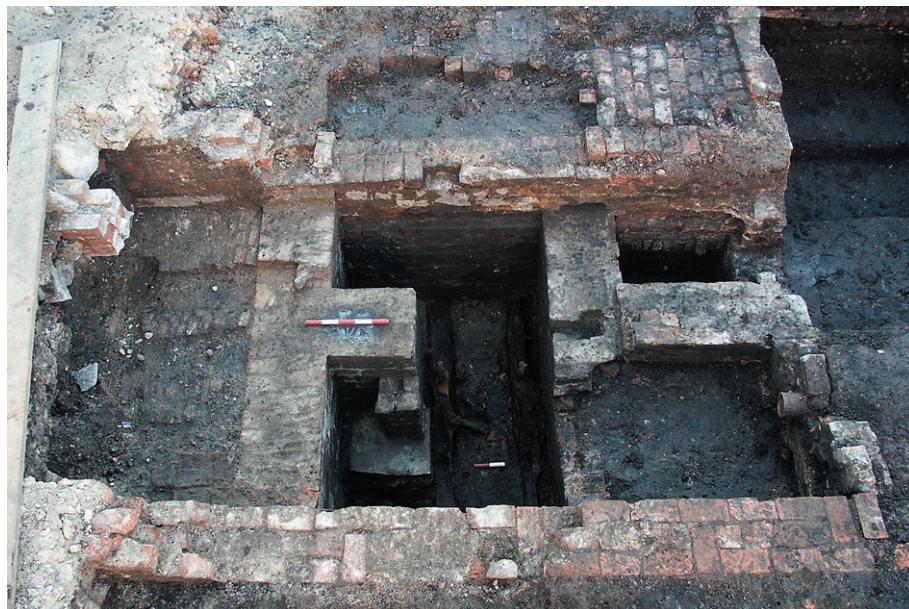
Plate 10 Area E: view south of chamber with Wall 4240 at base, walls 4241 and 4243 on right and Wall 4242 left of scale

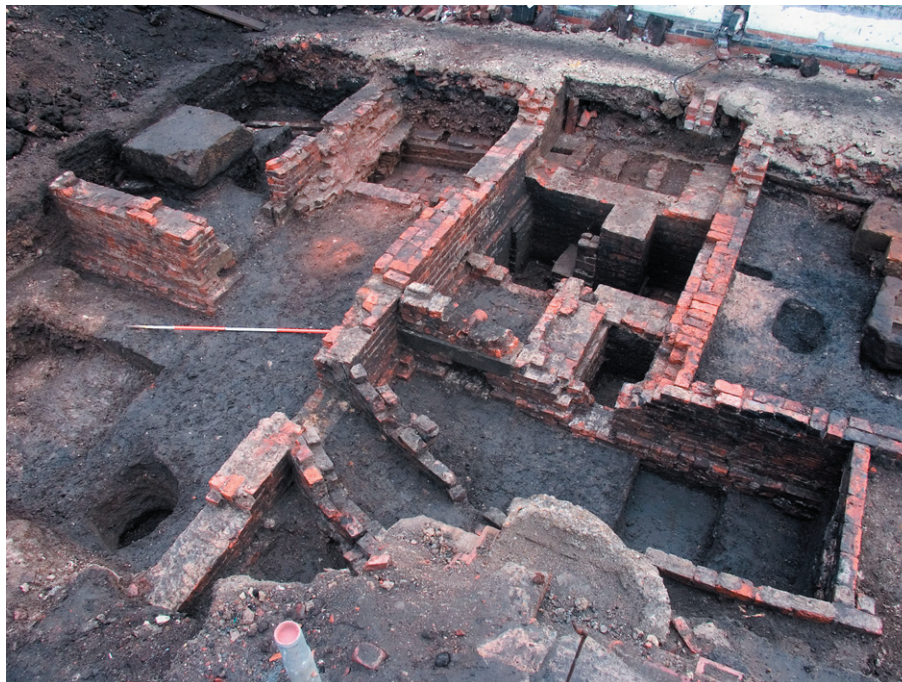
*Plate 11 Areas E, F, and N: view north-east with the chamber (Area E) in centre, east-west Wall 4240 running down the centre, and room defined by Walls 4034 and 4215 at top left. Drain lining Walls 4219 and 4230 centre foreground*

Above 4225 was a spongy, mid grey blue clay (4231). Cutting 4231 was a brick-lined drain (Plate 11) 2.5m long x 0.15m wide x 0.46m deep, probably linked to 4309 (see above 5.2.6). It was cut through Wall 4240 at its north end beyond which it was truncated by a service pipe cut. The lining 4219 and 4230 stood seven courses high, and the walls were one course wide, but two courses wide at the north end. The bricks were of various dimensions: the most typical measuring 0.13 x 0.12 x 0.07m, the biggest 0.22 x 0.13 x 0.07m, and the smallest 0.10 x 0.09 x 0.05m. The bonding material was soft, light brown sandy lime mortar and a small amount of crushed concrete.

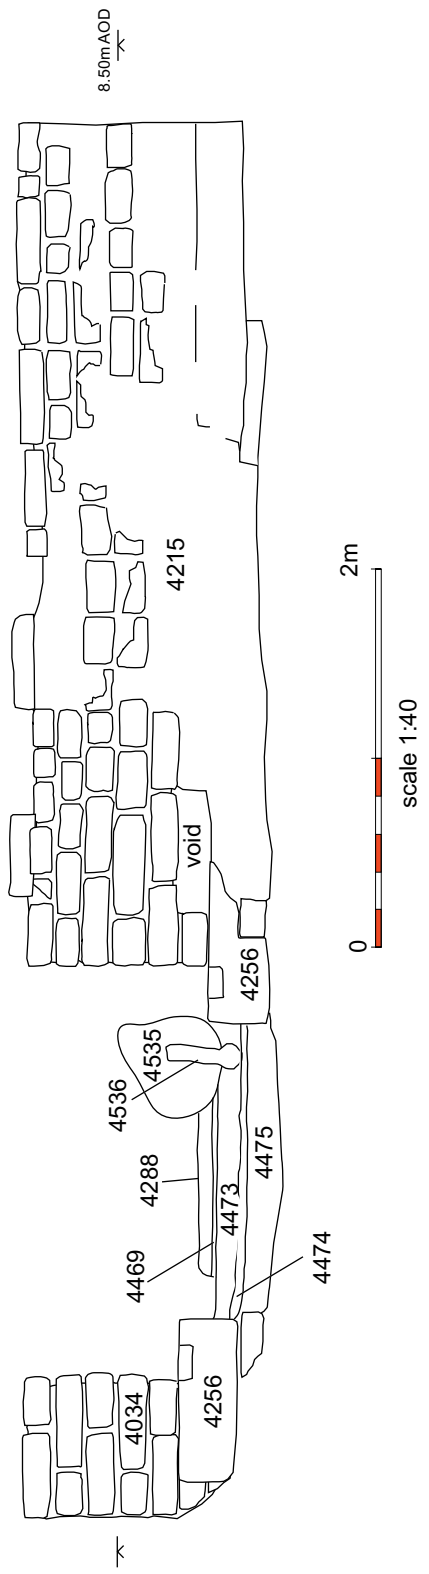
Fig. 5 South facing elevation, Wall 4215

Running east-west was Wall (4215) which was two courses wide and had six surviving courses of bricks (Fig. 5). The bricks were laid vertically and horizontally on bed, measured 0.23 x 0.11 x 0.06m, and were bonded with greyish white mortar.

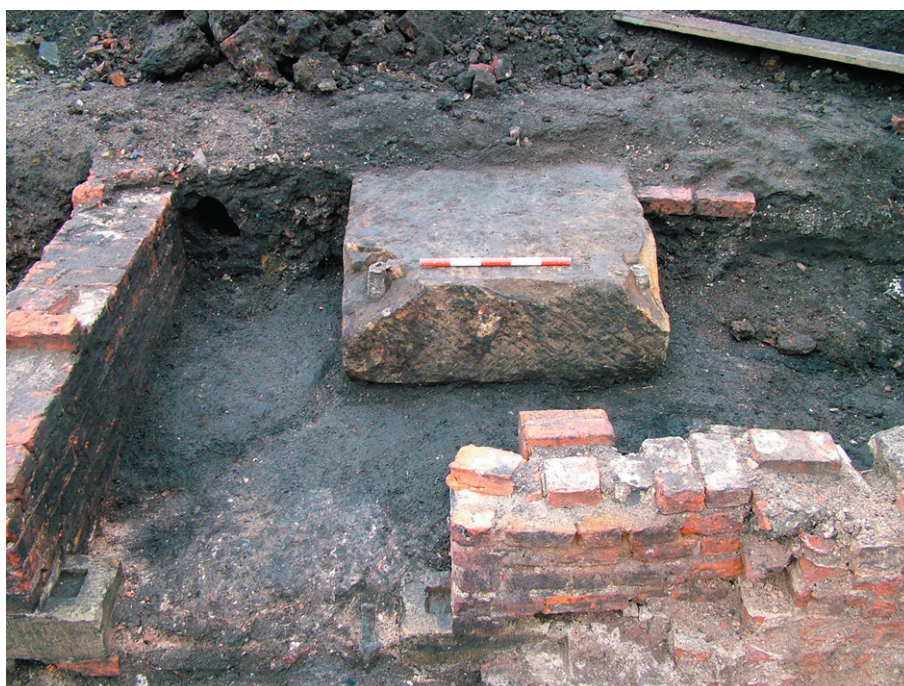
*Plate 12 Area F: view north, Wall 4215 foreground and Wall 4034 left and stone block 4205 at top*

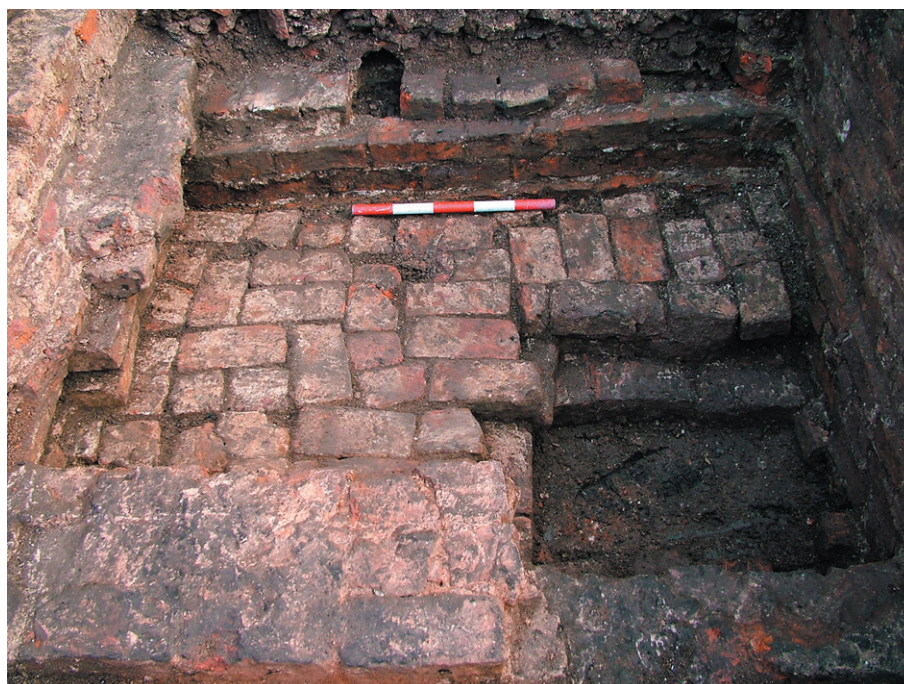
*Plate 13 Area F: view east of brick floor surface 4501*

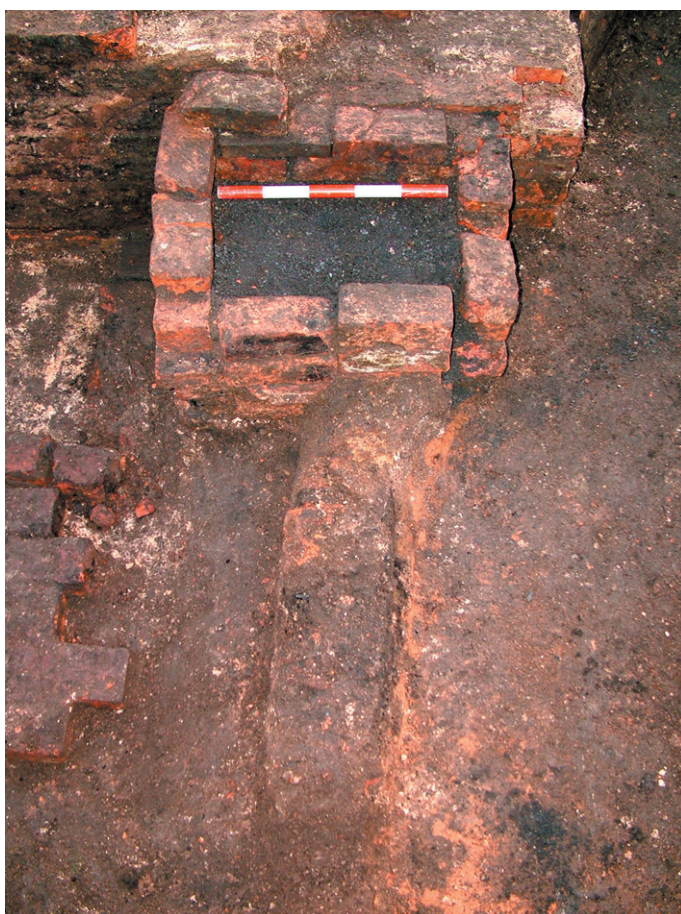
*Plate 14 Area F: view south of the brick walled structure 4237 with Wall 4240 above*

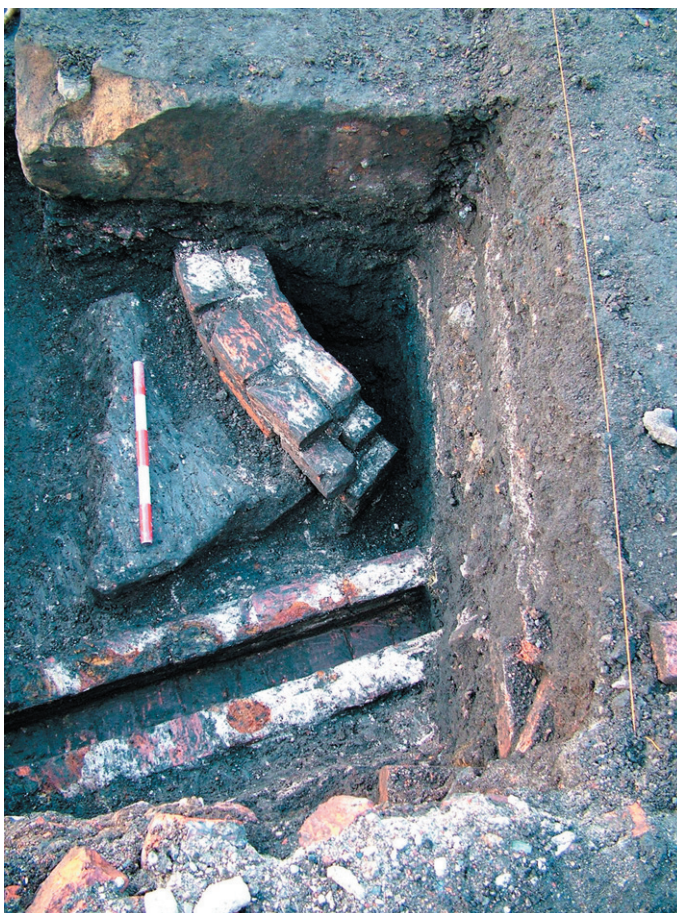
*Plate 15 Area F: view west of drain 4485 (base) and Wall 4526*

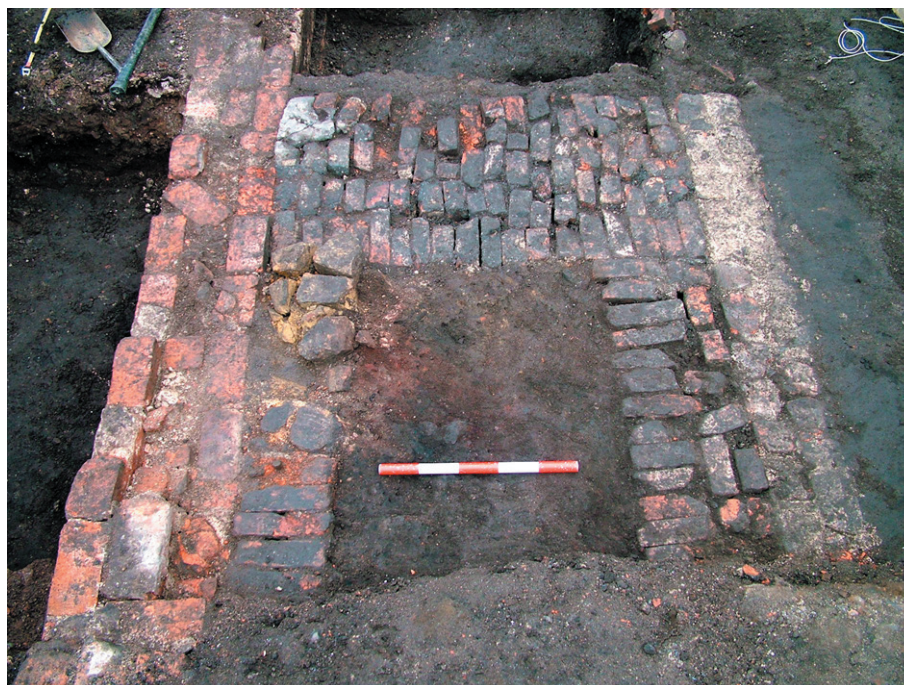
Plate 16 Area G: view north of Hearth 4032, Wall 4026 (right) and Wall 4034 (left)

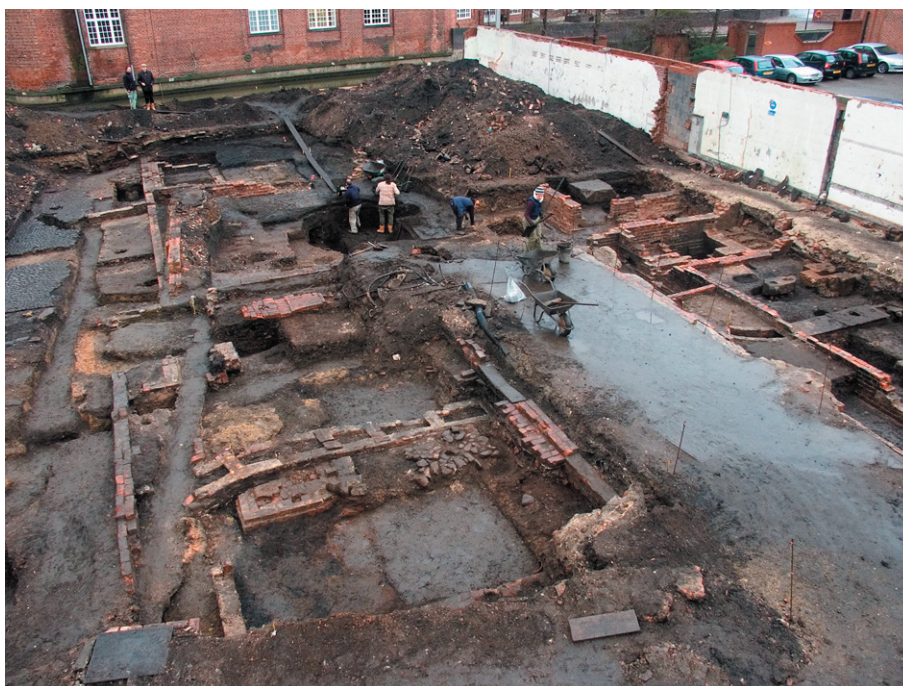
Plate 17 General view north of part of Trench 4 (right) and Trench 5, the figure in the pale jacket (top centre) stands in the Casting Pit 5116

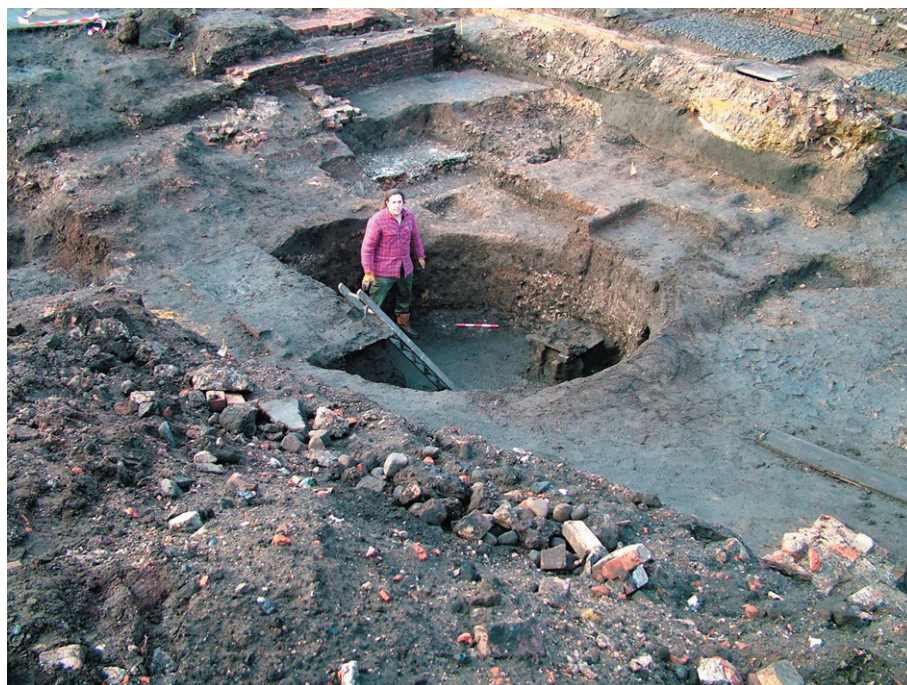
*Plate 18 View south-west of Casting Pit 5116 with east-west Wall 5106 (top)*

Cutting through 5253 was a large pit circular in plan (5116), (Plate 18), 4m in diameter and 1.68 deep. It had sharp break of slope at the top, vertical sides, a sharp break of slope at the base which was flat. This was probably the principal casting pit for the foundry and may have had a chimney standing above it of which no trace has survived. A ventilation shaft or flue (5254) was found on the north - west side, near the bottom. This had a brick lining, and an arched top. It was almost 2m long, but the complete length could not be estimated due to a collapse inside the flue. At the base of Pit 5116 was a flat iron platform (5251) mounted on a base of bricks. The brick structure was square in shape and five courses high.

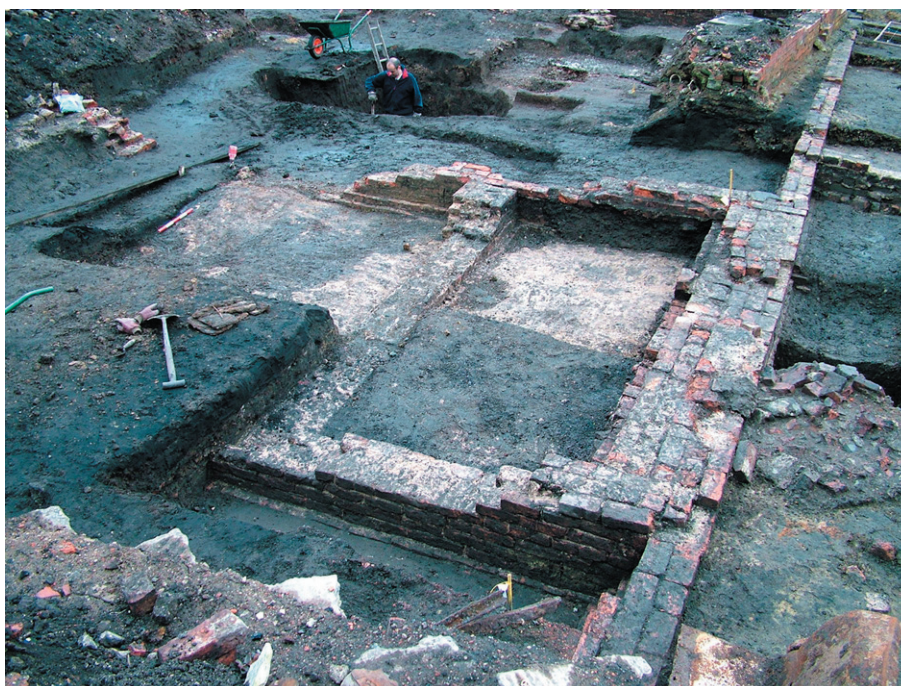
*Plate 19 Area U: view south-east of room defined by Walls 5039, 5132 (right), 5079 and 5195. Top of the concrete base (5021) on right of Wall 5132*

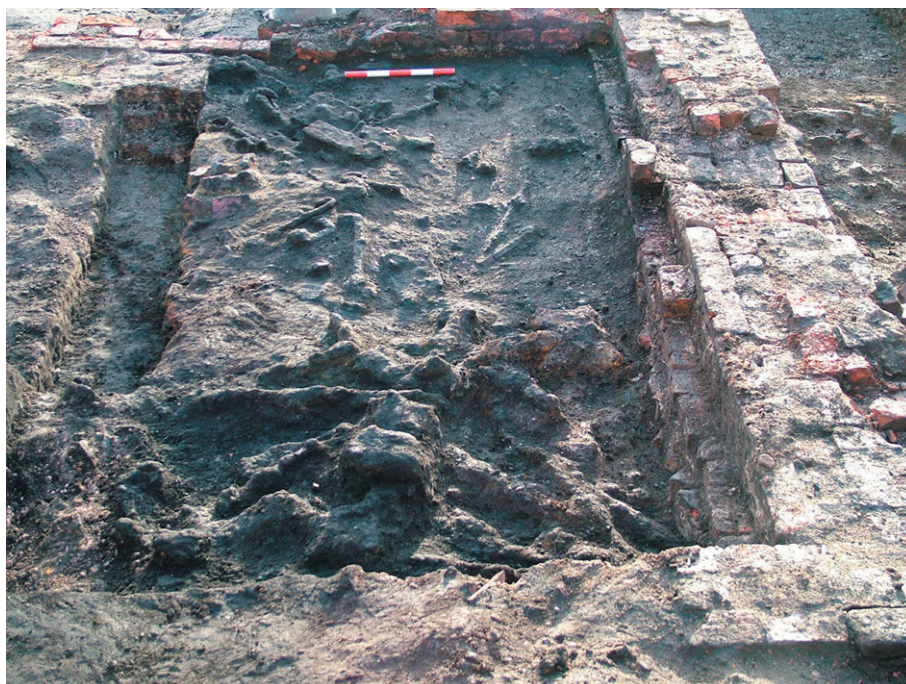
*Plate 20 View south of Deposit 5164 containing iron objects with Wall 5132 on right*

Above 5165 within the room described above, was a soft, black casting sand deposit (5164). This contained a large number of iron objects (Plate 20). Above 5164 was a soft casting sand which was dark black with grey flecks, with occasional small coal fragments (5118). This deposit also contained some iron fragments. Above it was a moderately compact, light greyish purple sandy silt with occasional small to medium coal fragments (5076). Above 5076 was a soft, bright yellow sand with a moderate amount of broken bricks (5075) which was succeeded by a soft, black casting sand (5117). Within this deposit were numerous iron objects (see Section 9), the locations of which were recorded on plan.

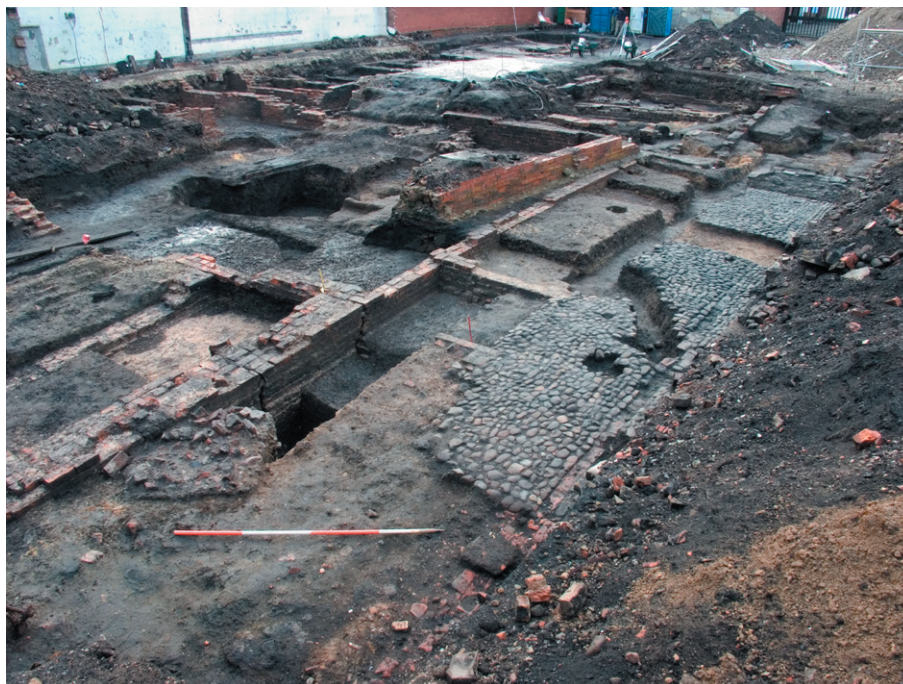
Plate 21 Trench 5: view south-east showing Wall 5132 running lower left to top right, the Cobbled Alley 5057 on right and the Concrete Base 5021, lower left

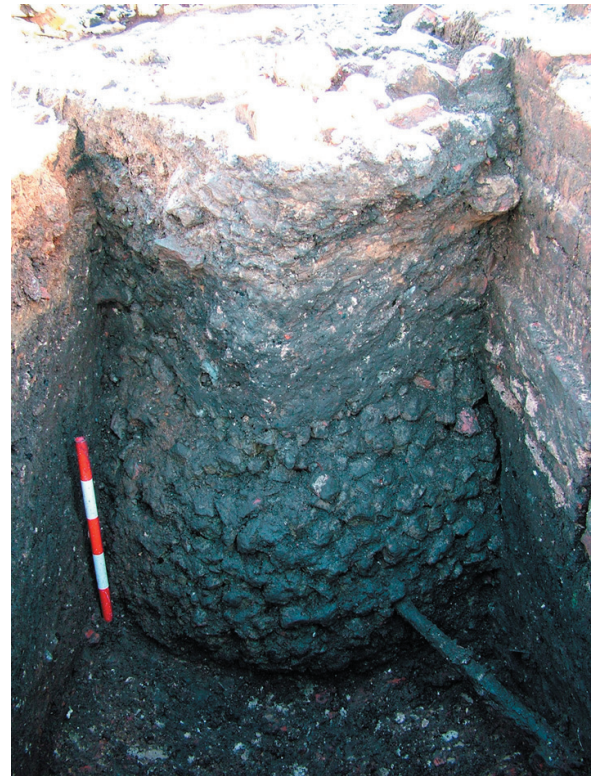
Plate 22 Area X: view north showing Concrete Base 5021 and Wall 5132 on right

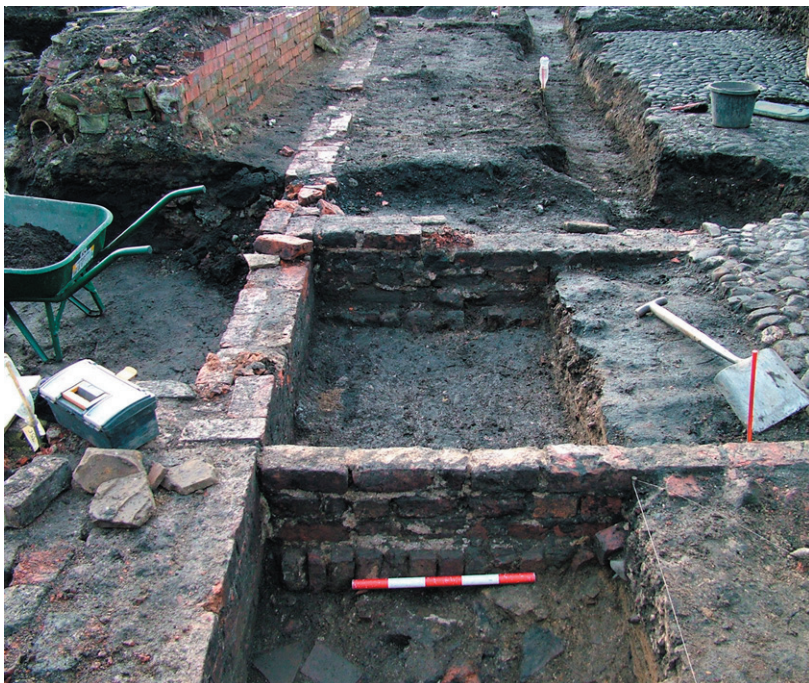
Plate 23 Areas W and X: view south showing Wall 5132 (left) and Walls 5096 and 5133 (beyond shovel)

South of Test Pit 6 above 5097 were two small secondary walls (5096, 5133; Plates 23 and 25) of the foundry, both aligned east – west. They had no obvious construction trenches and butted up to Wall 5132. Wall 5096, in Area X, 1.60m long, was one brick wide, with three surviving courses of bricks

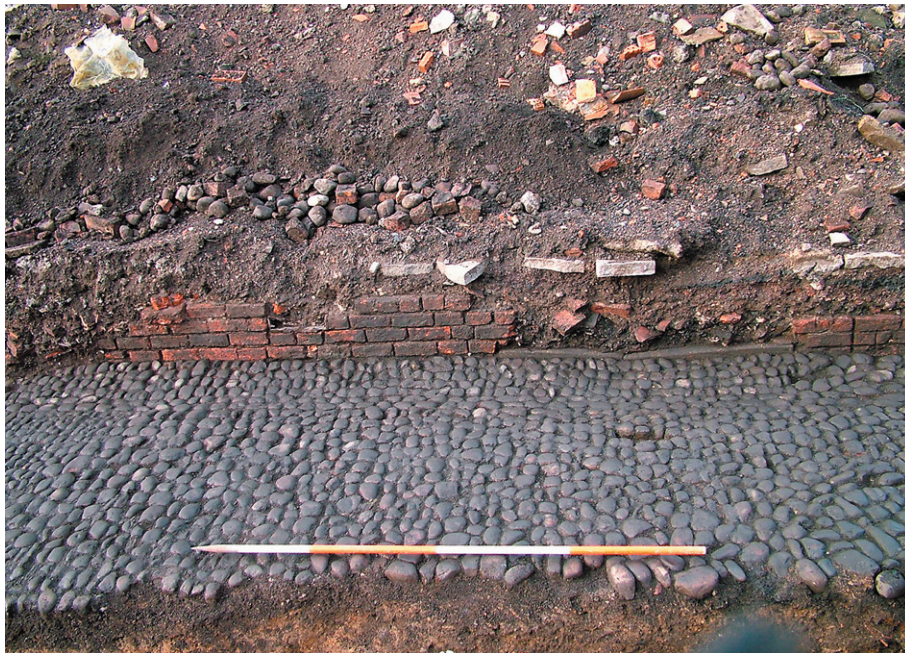
Plate 24 Areas AD and W: view west of Cobbled Surface 5057

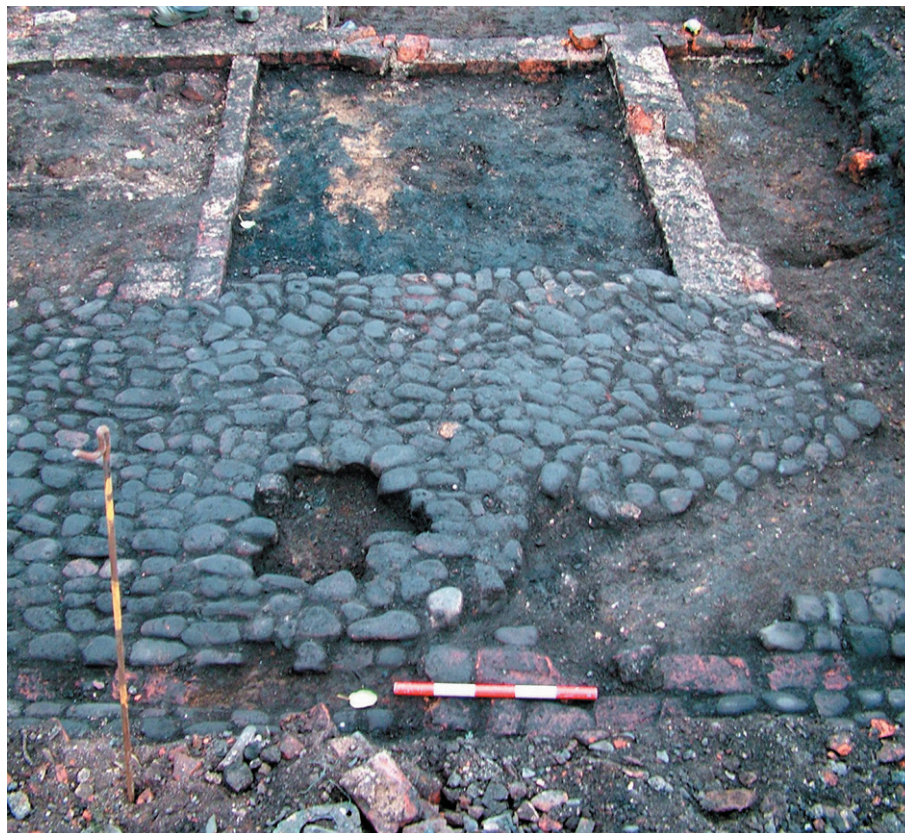
Plate 25 Area W: view east of Cobbled Surface 5057 and Walls 5096 and 5133 (right)

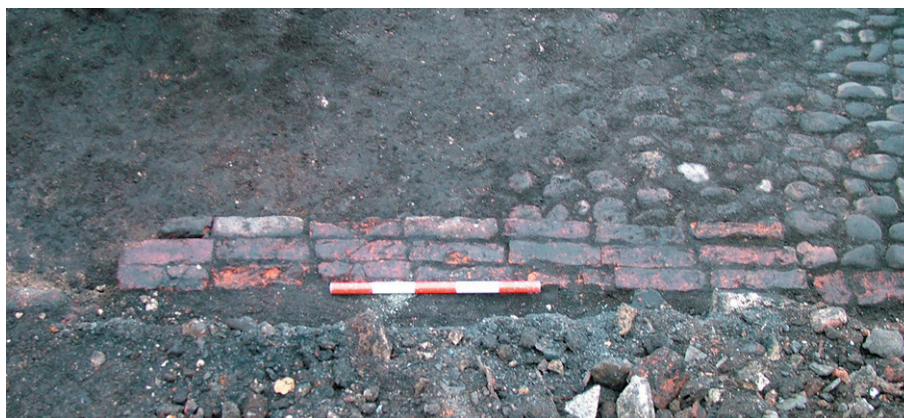
*Plate 26 Area X: view east of Wall 5024*

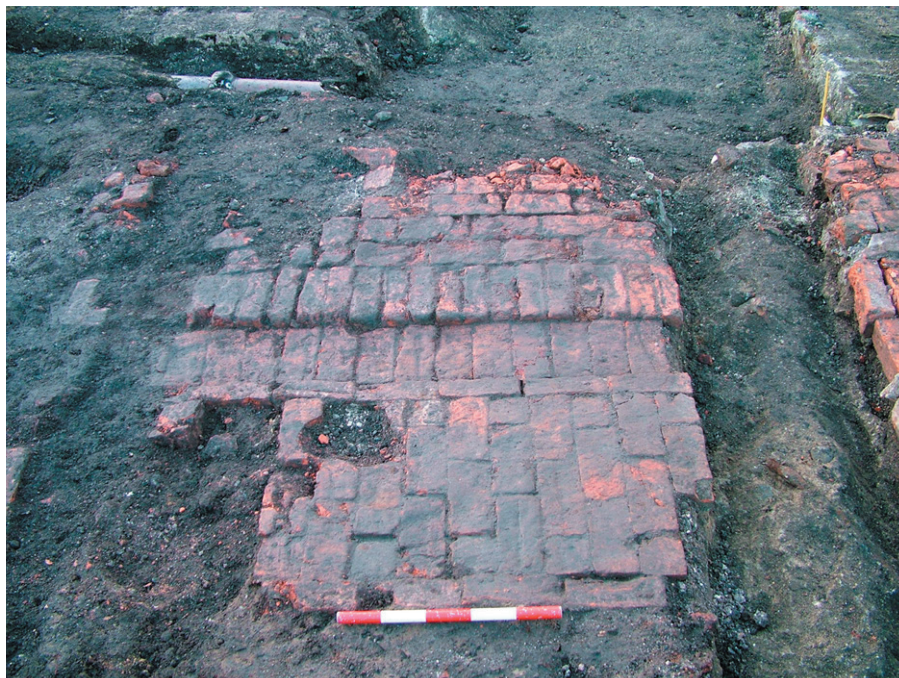
*Plate 27 Area AA: view west of Brick Floor 5105*

5112 = 5163 was a brick floor (5105) (Plate 27). This was made with irregularly laid bricks, some on edge and most on bed. It had a slightly recessed north – south channel or gully running through the middle. The bricks measured 0.23 x 0.11 x 0.09m.

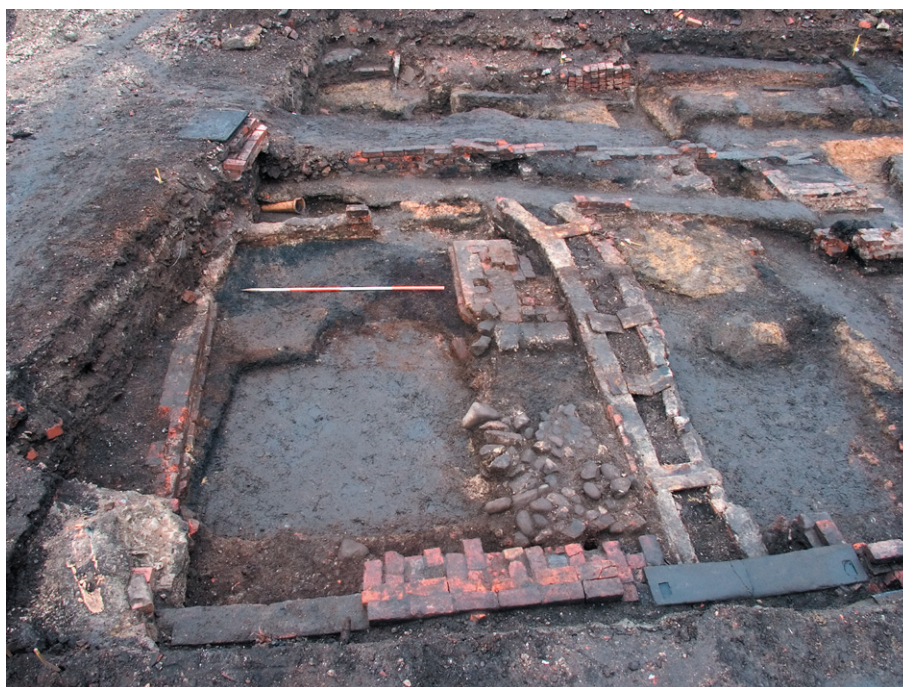
*Plate 28 Area Z: view west showing north-south Wall 5160 at base, east Wall 5198 on left and east-west Drain 5187, right of centre. Structure 5218 is immediately right of the scale*

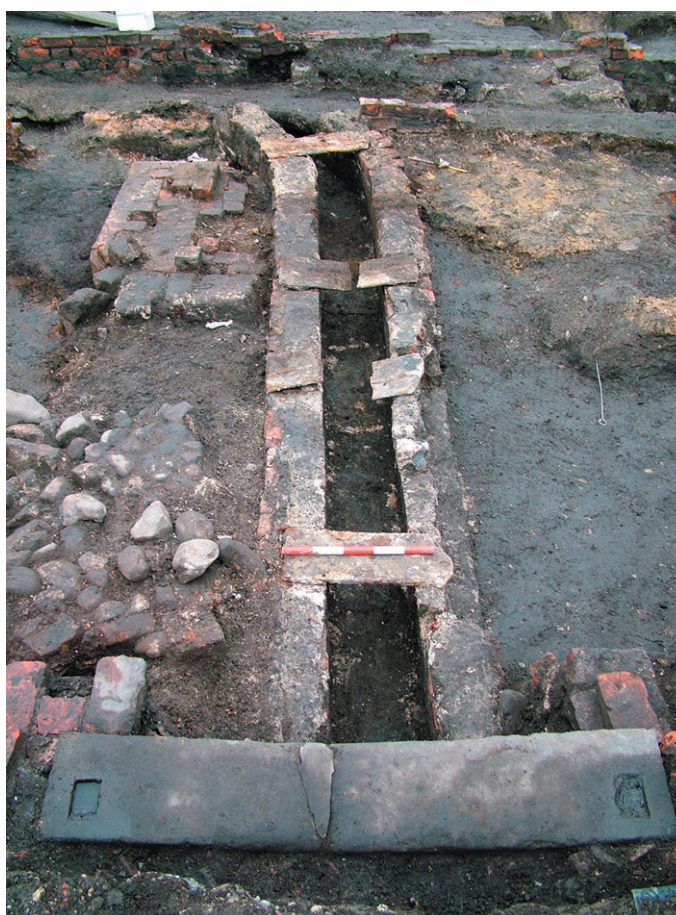
Plate 29 Area Z: Drain 5187 with stone slabs forming a lintel through north-south Wall 5160

Above Floor 5161 and Wall 5162 was a brick-lined drain (5187) (Plates 28-9). This was 5.2m long, aligned east-west, but curved slightly to the south – west at its western end before being truncated. The bricks were bonded with white mortar, and measured 0.23 x 0.11 x 0.05m. Five metal plates were placed at regular intervals on top of the drain. This drain disappeared beyond the east edge of Trench 5, passing through Wall 5160, in which it was capped by two large sandstone blocks, and it was probably connected to Drain 4306 in Trench 4. Filling 5187 was a soft, dark grey brown sandy silt, with occasional small fragments of building material (5235). Above the drain was a series of sandstone cap stones (5169), most of them broken.

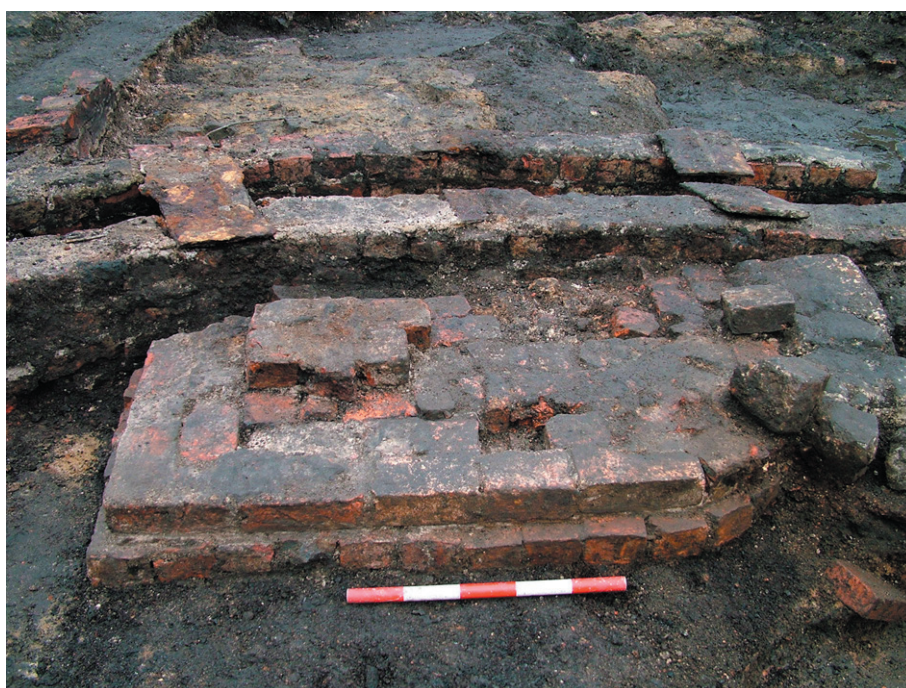
*Plate 30 Area Z: view north of structure 5218 with Drain 5187 beyond*
