# BISHOPTHORPE PALACE

## ARCHAEOLOGICAL INVESTIGATION

REPORT

JUNE 2008

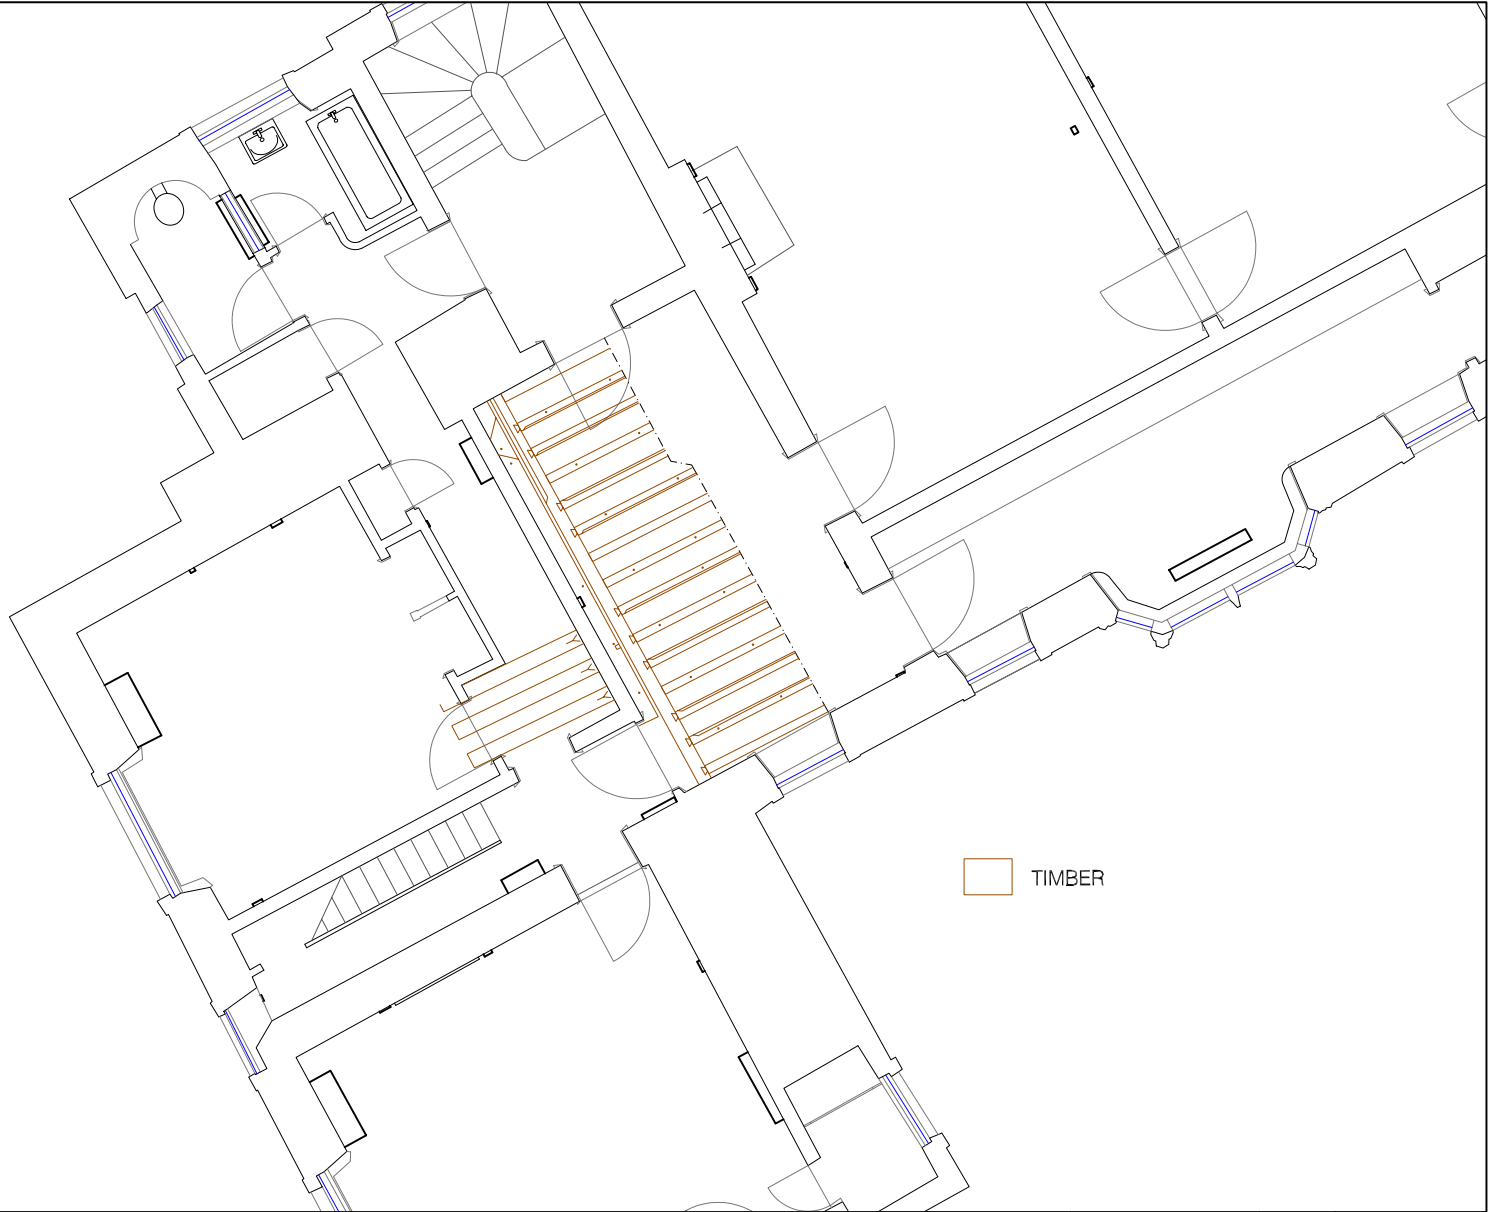
Intervention 5 - plan of re-used floor timbers at first floor level, southwestern half of the north range

The timbers exposed at the southwest end of the range were all reused, presumably during the 19th-century alterations, although of similar form to those identified as *in situ* (Figure 14). Original joists were halved and reused as thinner joists, but rotated 90 degrees so that the chamfered detailing was now located on one side of

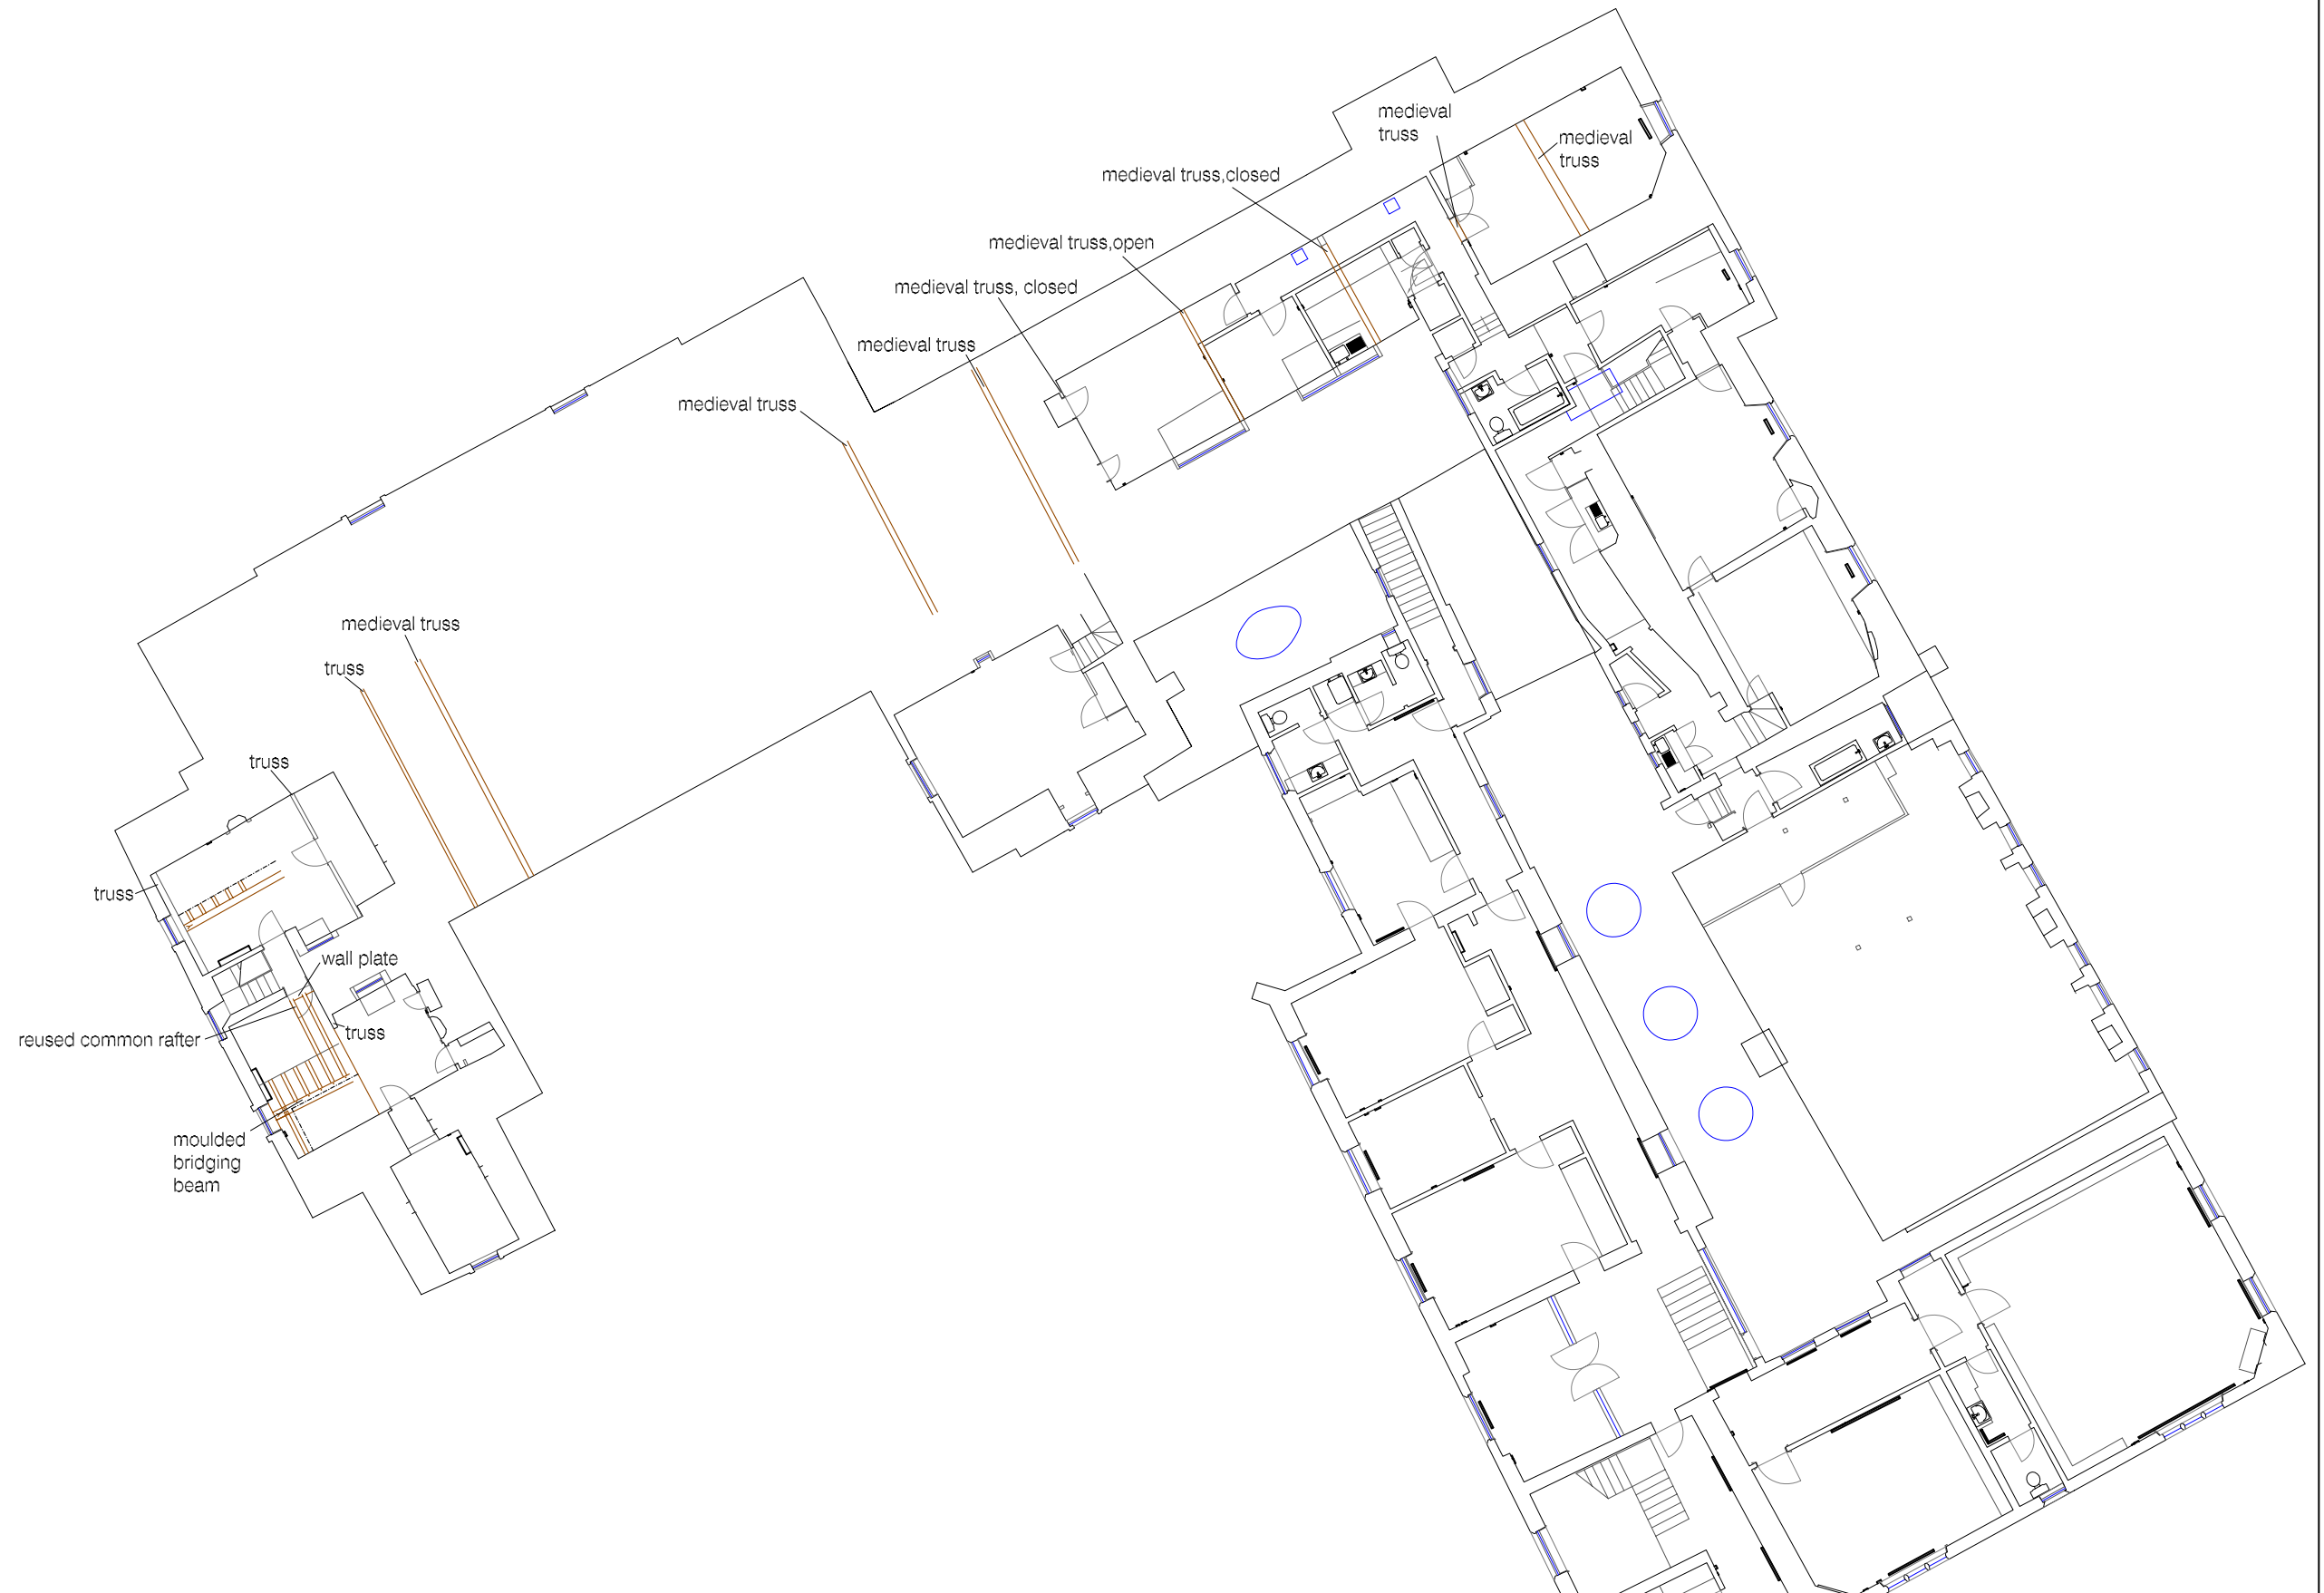
Intervention 5 - plan of in situ floor timbers and trusses at second-floor level, north range

Dendrochronological analysis of the timbers of both the floor structures and the main roof trusses of the north range (excluding those replaced in the 19th century) have provided a date of *c.*1502/3 for their felling. This would suggest that the north range (and possibly the two demolished ranges that were formerly attached to its northwest elevation), were the work of Archbishop Thomas Savage (Archbishop of York 1501 - 1507) rather than Archbishop Rotherham (Archbishop of York 1480 - 1500).
